DESIGN AND REPAIR OF A POWER INTAKE GATE SEALING SURFACE UNDER CHALLENGING CONSTRAINTS

Mike Carney, PE¹
Don Thompson, PE²
Roland Lwiindi³
Eli Lundberg, PE⁴
Joshua Phillips, PE⁵

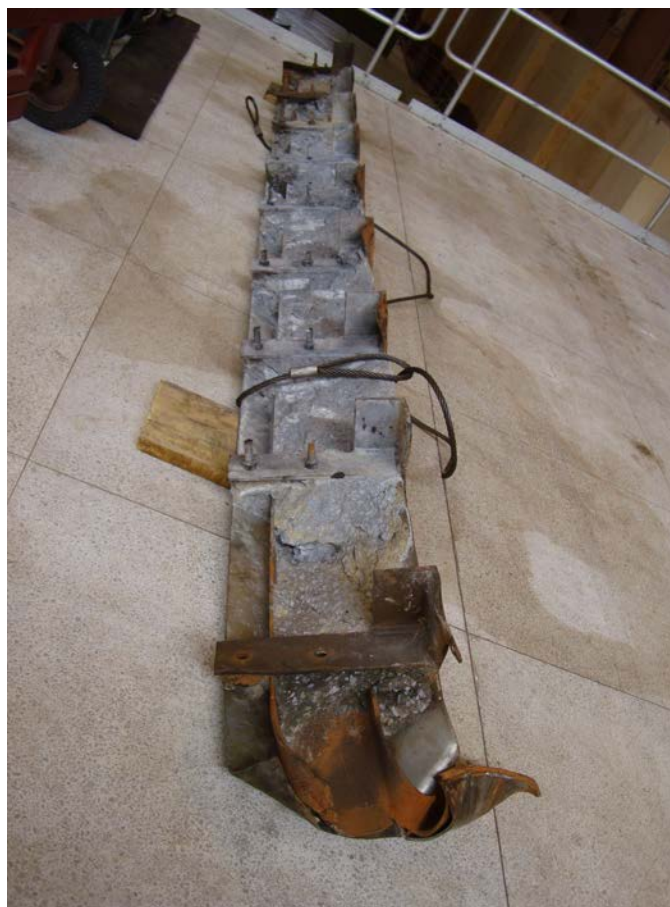
Figure 2. Lintel Seal Plate with Concrete Removed

The following is our best understanding of what occurred based on discussions with people that witnessed the event. During penstock filling sometime in 2010, the maintenance gate serving Unit G4 experienced high uplift pressures resulting in an unexpected jump up the gate slot and back down to the intake floor. This may have occurred multiple times. Banging noises were heard and spray was observed coming out of the gate slot at the crane deck level, El. 385. The service gate was in the closed position during the event, and when noise and spray subsided, operators completed raising the maintenance gate to the full open position. The downstream service gate was then opened to fill the penstock and Unit G4 was brought on line. Though the unusual observations were cause for alarm, there were no immediate indications that there would be any problems with generating power from this unit. Eventually, cooling water filters plugged with sand and concrete aggregate. When this occurred, operators closed both gates to investigate the problem only to discover the maintenance gate had not sealed despite indications it was in the fully closed position. Fortunately, the penstock could be dewatered with the closed service gate allowing the investigation to proceed. Investigators found large pieces of concrete and metal in the scroll case and immediately suspected it to be part of the maintenance gate slot. The original lintel seal plate retrieved from the scroll case is shown in Figure 2.

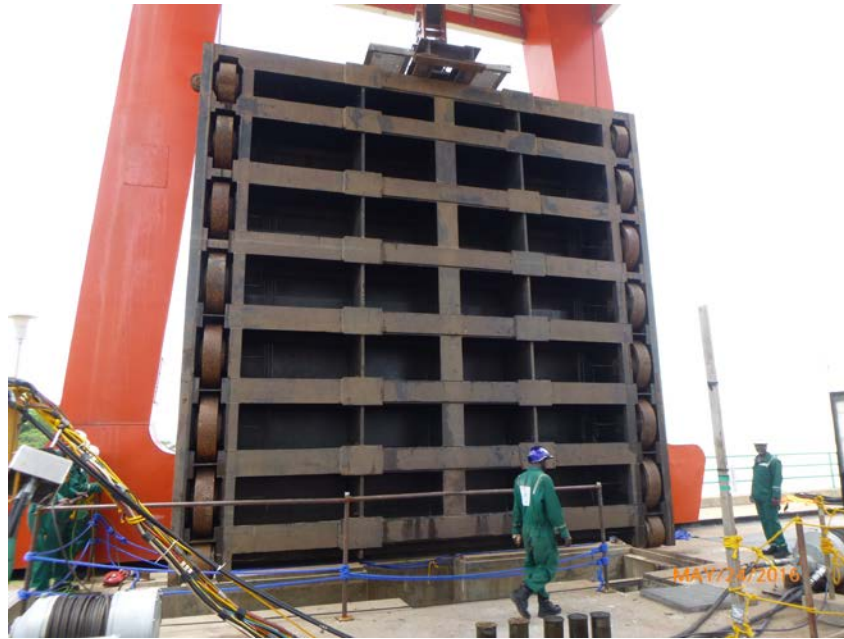
Figure 3. Downstream Side of Maintenance Gate Following Repair

The maintenance gate shown in Figure 3 was raised to the top of the intake tower and was found to have also experienced damage. The gate was subsequently repaired for use with the three other units, however the damage to the Unit G4 gate slot prevented using it there. Due to annual reservoir fluctuations, the damaged portion of the gate slot was under 30 to 55 meters of zero visibility water year-round, which complicated assessing the damage.

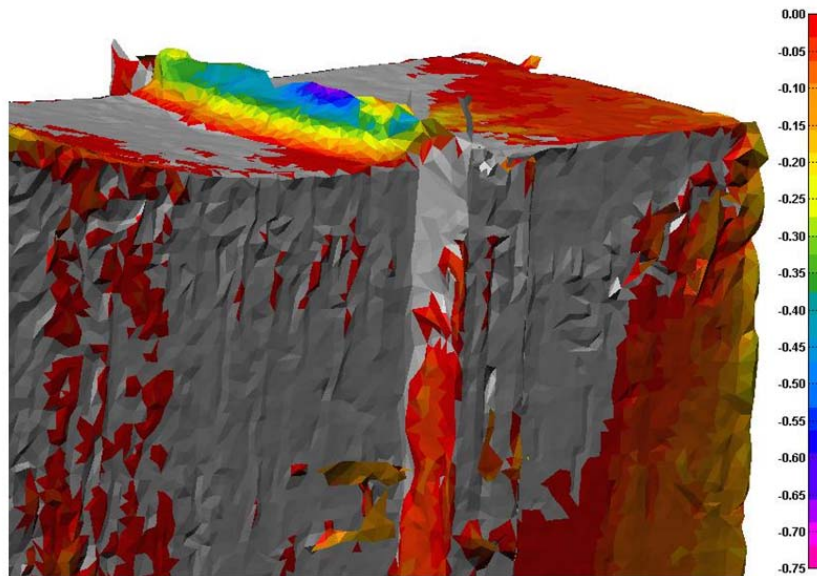
Figure 4. Sonar Scan Showing Extent of Damage to Unit 4 Intake Slot (Units in Meters)

The location and extent of damage was determined by comparing the scanned image of the damaged intake area of Unit G4 with the scanned image of the undamaged identical intake area for Unit G1. By comparing the difference between these two sonar scans a graphic of the damage to the gate slot could be visualized, as shown in Figure 4. The color zones represent the amount of lost material from yellow (200mm) to dark blue (650mm).

Comparing measurements taken from the sonar scans, and visual observations of the recovered concrete and metal materials, confirmed that the damage was confined to the lintel.

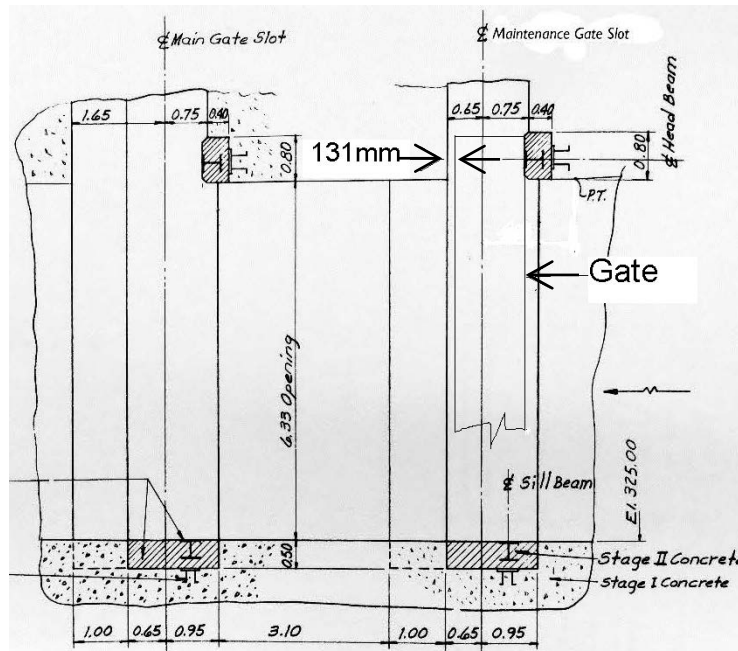
Figure 5. Maintenance Gate Slot and Gap Dimensions

The Shiroro intake gates use an upstream sealing design with a relatively narrow vent opening on the downstream side. Based on fabricator’s drawings there is a 131mm gap between the maintenance gate slot’s downstream concrete face and the downstream face of the gate as shown on Figure 5. The gap area has been referred by others as the “back-of-gate orifice”. Once the water level rises to the crown of the penstock the only outlet for penstock fill water is upward through the gate shaft through the gap, acting as an orifice, between the gate and the shaft wall. If this area is less than the area of the inlet orifice created by slightly raising the gate, then the risk of developing a spike in uplift pressure is increased. Since operating procedures specify cracking the gate open 150mm to fill the penstock, conditions were in place to temporarily develop high uplift on the gate. Add to this the fact that the means to raise the gate are not precise making it possible that the gate was raised higher than 150mm thereby increasing the probability and magnitude of developing adversely high uplift.

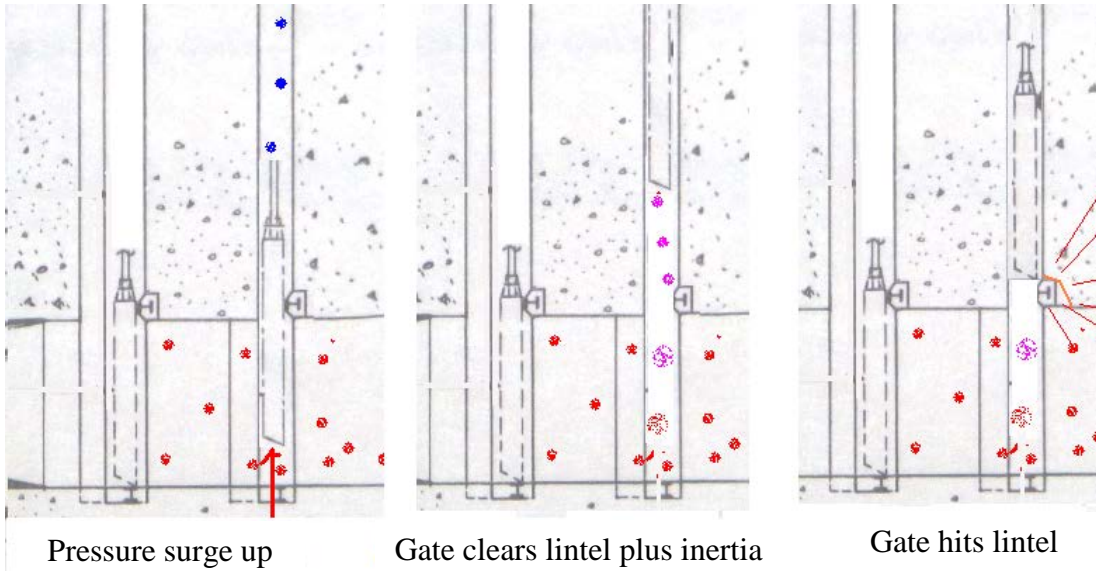
Figure 6. Sequence of Gate Jumping

The occurrence of upstream sealing gates jumping, or “catapulting”, violently upward in their gate slots is a known but somewhat rare phenomenon. Similar events have been documented at Dworshak Dam and Mossyrock Dam¹, and the U.S. Army Corps of Engineers has conducted hydraulic model investigations of this issue at Big Bend, Stockton, Harry S. Truman and Clarence Cannon Dams². The observations and information obtained at Shiroro Dam are consistent with these previously documented events and analysis.

The diagrams in Figure 6 illustrate the progression of gate movement through the gate jumping process.

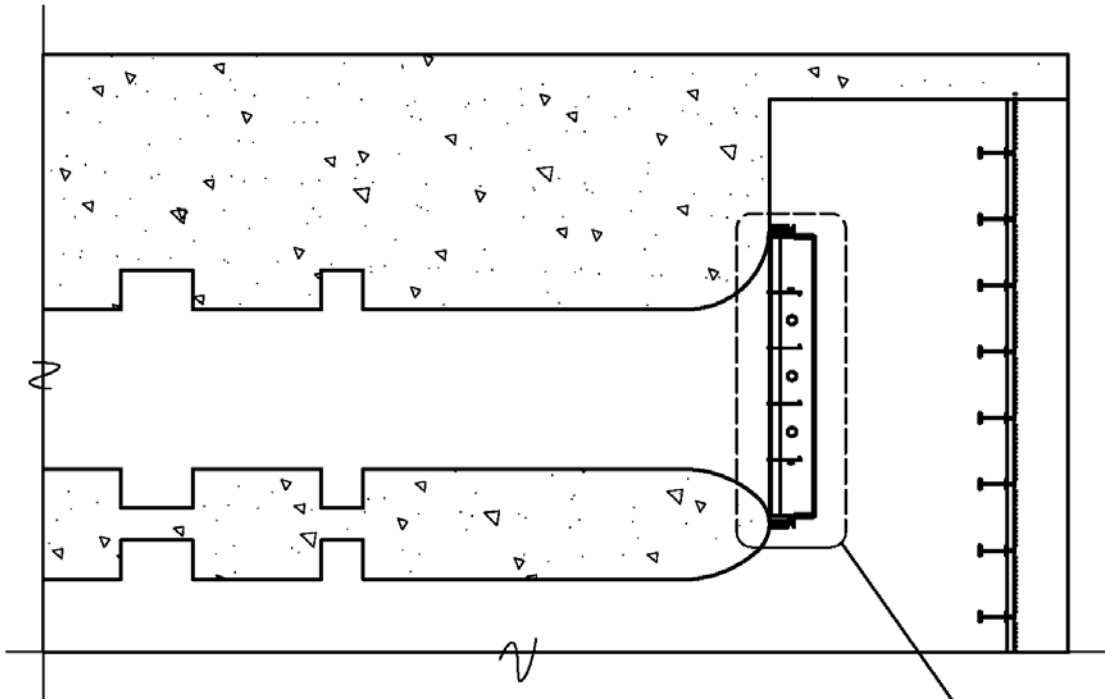
Figure 7. Plan View of Bulkhead Installation over the Intake

The first challenge was that the maintenance gate slot was designed to be the upstream-most closure in the system and there were no stoplog slots in place, therefore custom-made steel bulkheads would need to be installed across the bell-mouthed intake to seal it and allow dewatering. However the bell mouthed intake did not provide flat surfaces for a bulkhead to bear against during dewatering, requiring that the bulkhead seal against the curved surfaces, as shown in Figure 7 below.
