# Elderberry Park Master Plan Assessment of Existing Conditions

Municipality of Anchorage

With assistance from Earthscape, LLC

2/6/2015

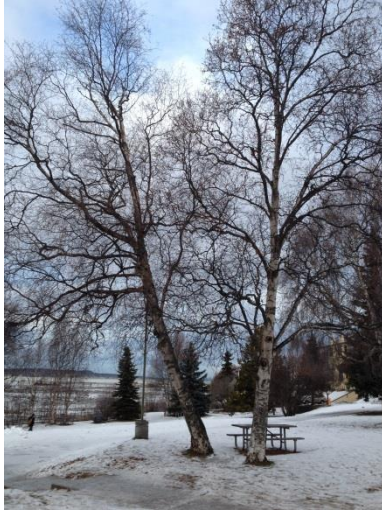
Figure 1 Stressed birch near entry walk

Vegetation is in generally good shape. Exceptions are two birch trees near the western end of the diagonal walk that connects from the 5<sup>th</sup> Avenue/M Street intersection to the central plaza. Those two trees appear stressed with large cracks at the base of the trees. One tree also leans markedly, possibly a reaction to previous construction activity coupled with crowding by the adjacent tree.

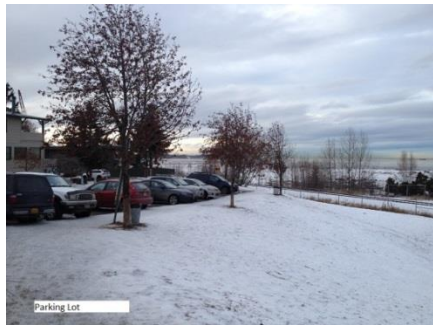
Figure 2 Parking lot

The parking area provides spaces for 12 vehicles. There is no charge for parking. The parking area is used both by park users and by those making trips to downtown and needing a parking space for a short period of time. Parking is limited to two hours thus the parked cars are encouraged to move on a routine basis. Handicap spaces are not provided and curb cuts are available only on the corners of the curb returns at the east and west ends of the parking lot. The parking lot is on parkland, not within the 5<sup>th</sup>

**Weaknesses:** The parking lot could be much larger and still there would be more demand. On the other hand, the presence of a parking lot at all changes the venue to some degree from a “neighborhood” park to a “community” park.

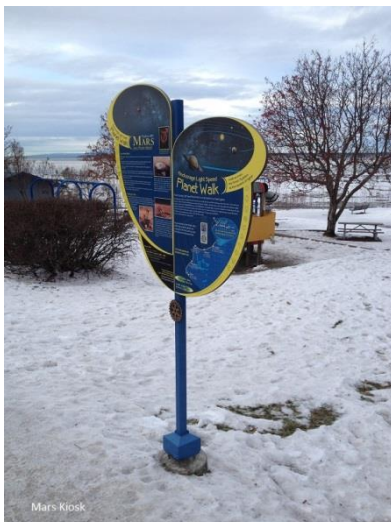
Figure 6 Planet Mars kiosk and interpretive material

**Weaknesses:** Other than the Oscar Anderson House interpretive material, the other interpretive pieces present lost opportunities. The Planet Mars kiosk is not viewed since it is not on a main walkway. The Tony Knowles Coastal Trail map is directly adjacent to the trail and those viewing the map often cause congestion at a location where people are watching for multiple trail users, some of which are unseen and around the corner as cyclists near the tunnel. Benches are directly adjacent to the trail and do not offer much separation for those sitting on them from trail users. Picnic tables have no sense of permanence and appear scattered as opposed to logically placed. The whale structure seems unassociated with other park features.

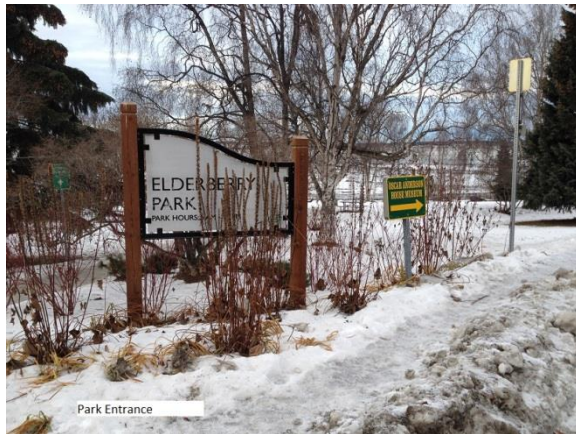
1. The Elderberry Park entry sign as seen from the 5<sup>th</sup> Avenue and M Street intersection. It is difficult to determine that this is actually the park entrance. The walkway from this location is not in compliance with ADAAG requirements due to slopes exceeding 5% and steps that restrict access by the disabled.

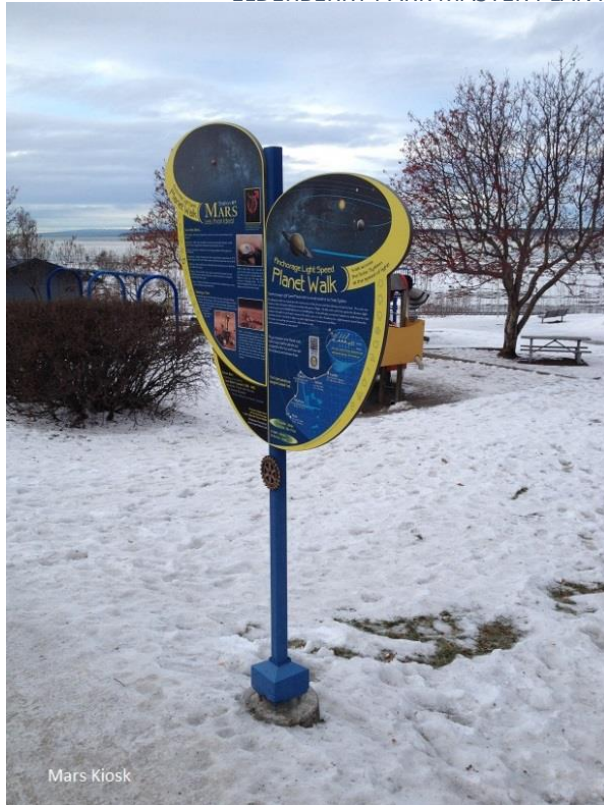
4. The Mars interpretive kiosk is a link in the Planet Walk and is located along 5<sup>th</sup> Avenue, just west of the park entrance corner. Its location tends to be missed by most people. It would benefit from a more prominent location where there are more people present.

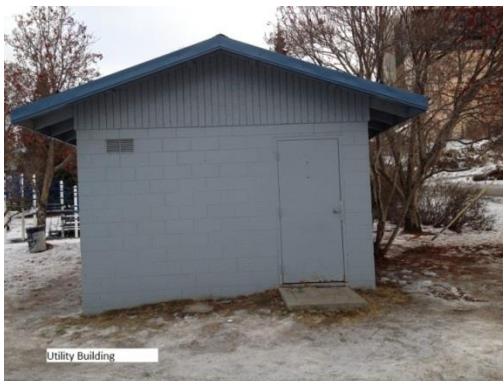
5. The utility building was a former restroom that is no longer used for that purpose. The building has water service and provides storage. It is heated but is not usable by park visitors.

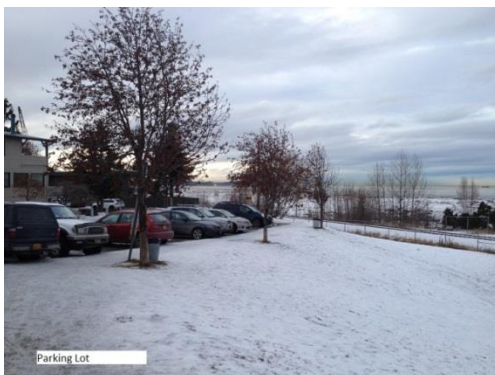
6. The parking lot is located along 5<sup>th</sup> Avenue. It is almost always occupied and many users are not parking in order to use the park. Some are using the parking lot for undesirable activities and some use the parking lot to gain access to the Tony Knowles Coastal Trail.

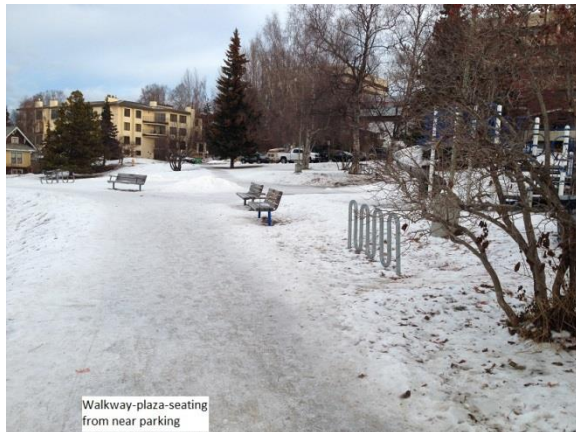
7. The central trail starts from the parking lot at the south and connects to the Tony Knowles Coastal Trail. It is the designated route to the trail but carries cyclists through an area that is the central plaza and a gathering point for pedestrians.

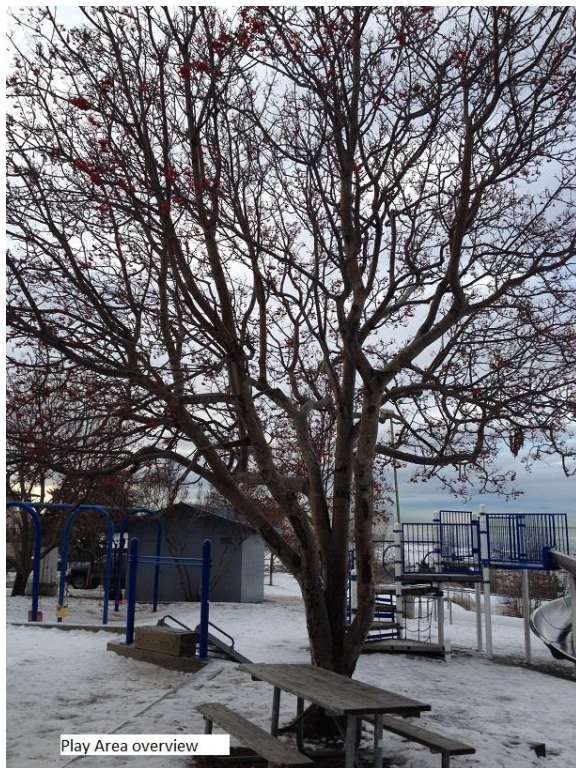
8. Play area as seen from the walkway that connects from the 5<sup>th</sup> Avenue/M Street intersection. The playground is not accessible and does not meet current playground standards for much of the equipment and surfacing. Play equipment includes two climbing structures and one swingset. Grade changes between play equipment limits use by the disabled.

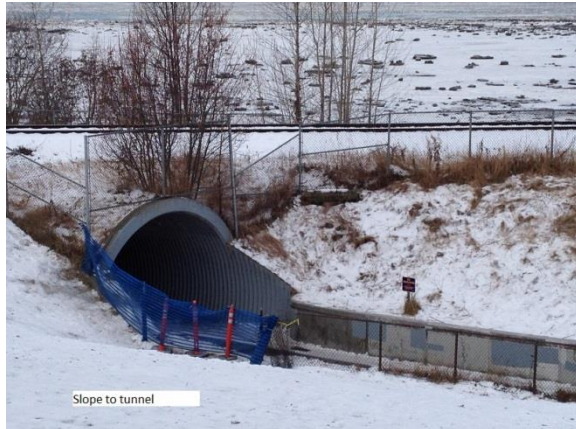
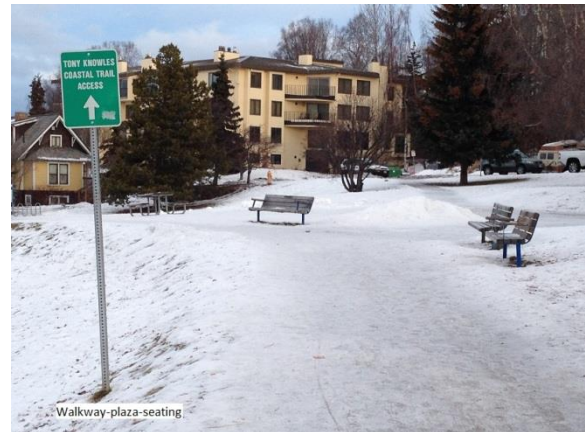
9. The slope from the central walkway and parking area leads to a fence that prevents accidental falls to the Tony Knowles Coastal Trail. The fence is in need of repair. The slope is little used though does provide a slope from which to enjoy the view and sunbathe in the summer.

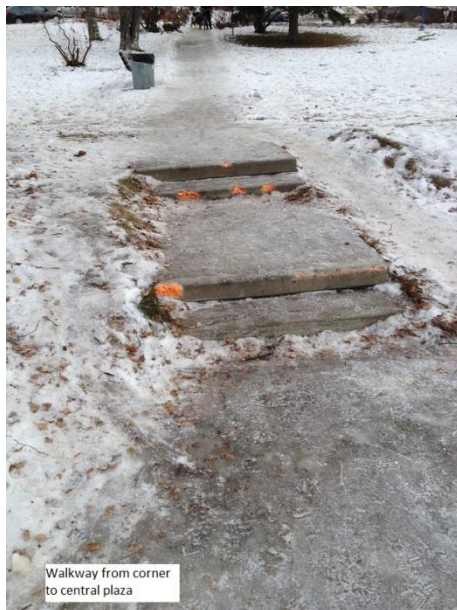
10. The walkway from the park entrance at the 5<sup>th</sup> Avenue intersection to the park central plaza exceeds ADAAG handicapped accessibility requirements. Steps provide further problems from an accessibility standpoint and are deteriorating as noted by paint.

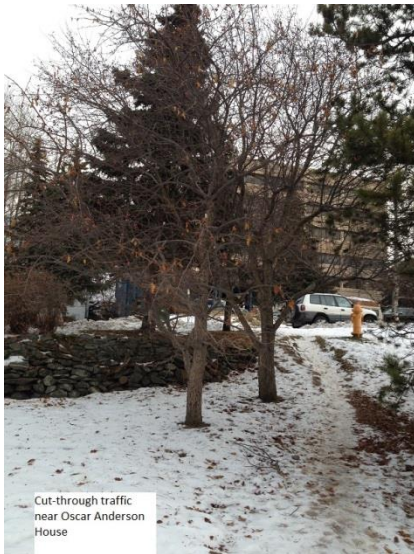
Cut-through traffic  
near Oscar Anderson  
House

16. A cut-through near the Oscar Anderson House entrance provides direct access to the Tony Knowles Coastal Trail and is used by both foot traffic and cyclists who do not want to haul bicycles down the stairs that provide the only access down the slope at this location.

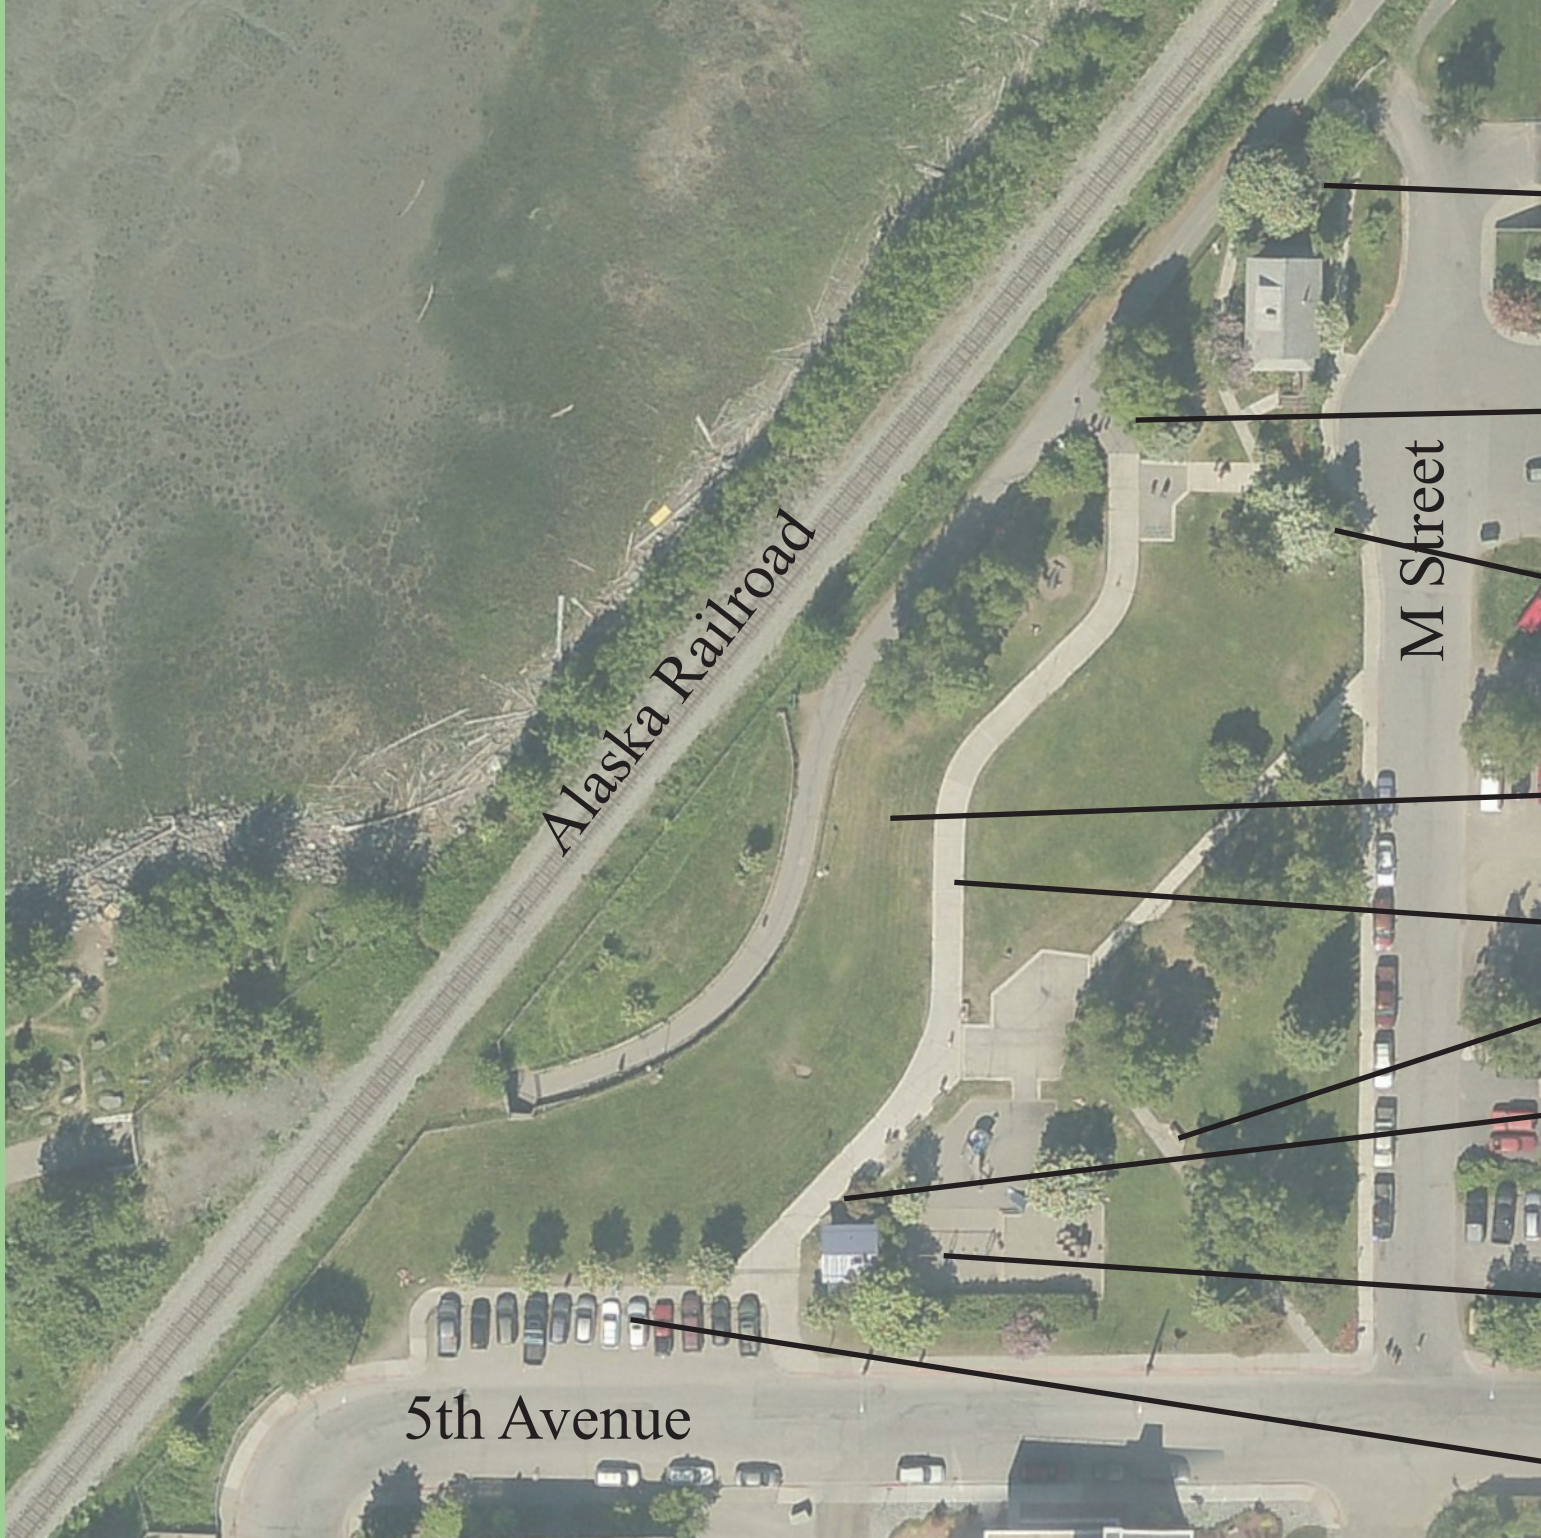
# Site Weaknesses

- Hidden Areas
- Conflict between Traffic to TKCT and Passive Use
- Short-Circuit Social Trails
- Slopes Limit Use
- Trails Do Not Conform w/ ADA Accessibility
- Conflict between Traffic to TKCT and Passive Use
- Site Visibility to Play Area Restricted
- Parking Often Occupied by Non-Park Use

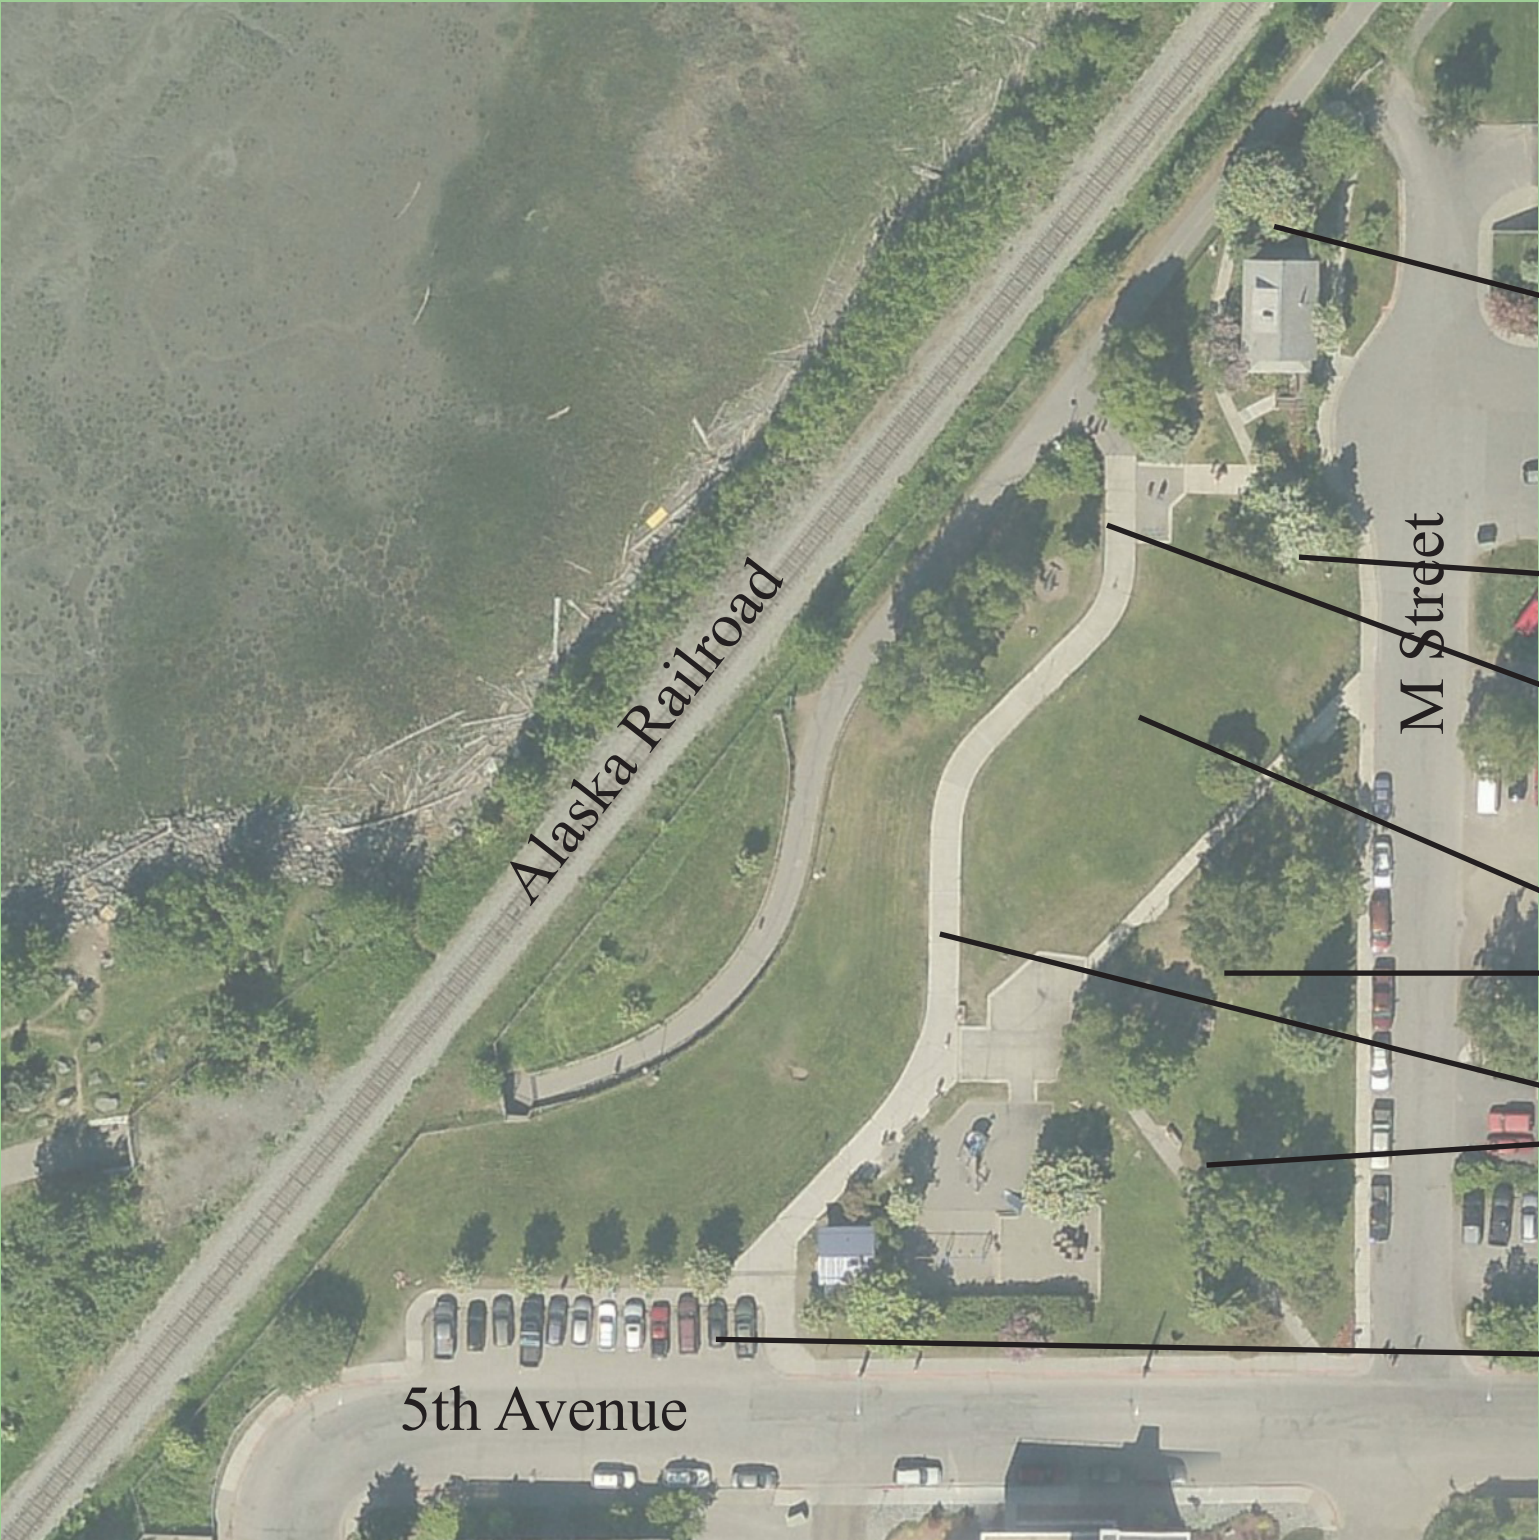
# Site Threats

- Vagrancy in Vicinity of Oscar Anderson House
- Continuation of Social Trails
- Conflicts between Trail and Park Users
- Overuse of Lawn Areas
- Grades Limit Access to Some Disabled Users
- Parking Conflicts
