**Electrospark Deposition for the Repair of  
Army Main Battle Tank Components**

**ARL-TR-3849**

**July 2006**

**Victor Champagne, Marc Pepi, and Brian Edwards  
Weapons and Materials Research Directorate, ARL**

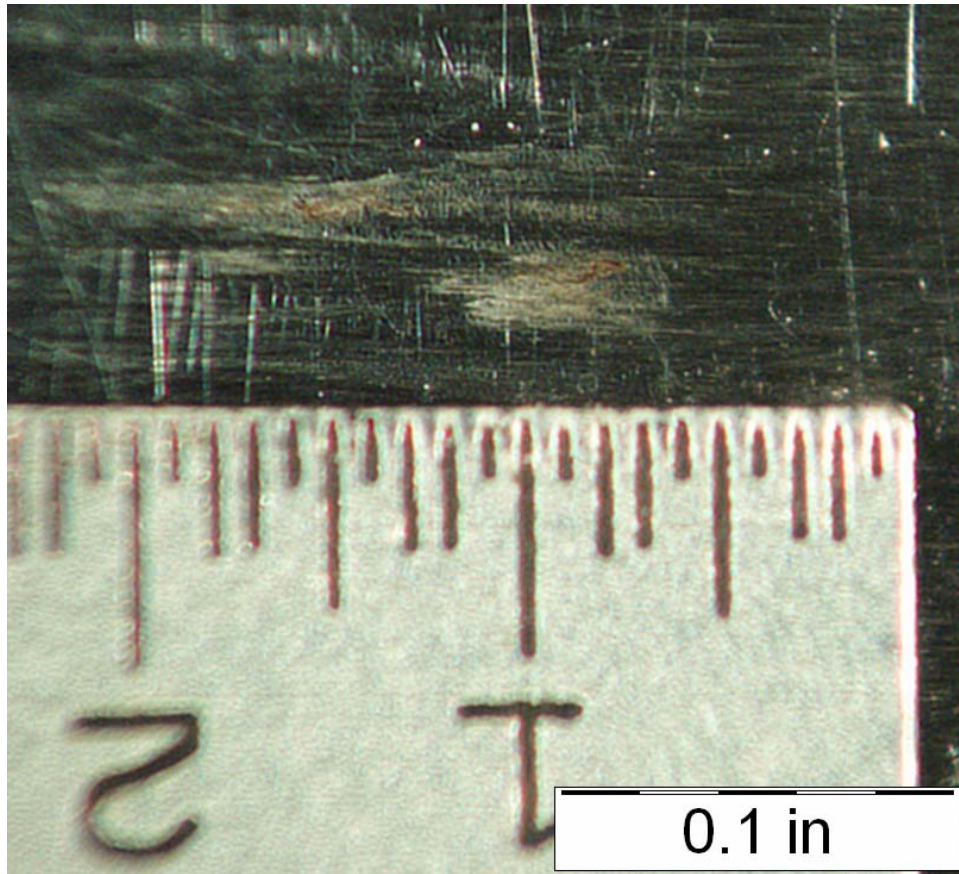
The M1A1 main battle tank components presented in this report were fabricated from alloy steels. After years of service, large corrosion pits ( $1/8 \times 3/8$  in and 0.060 in deep) and wear formed (figure 8). Systems were dead-lined based on surface anomalies discovered during inspection. Insufficient replacement parts were available. There was no approved repair procedure for these components, and conventional weld repair technologies had been eliminated at Anniston Army Depot (ANAD) to repair these large pits. Approximately 8% of the components overhauled at ANAD in 2003 were determined to be defective and were removed from the systems and put in storage.

Figure 8. An example of corrosion pits noted on a helical gear shaft (magnified 20×).

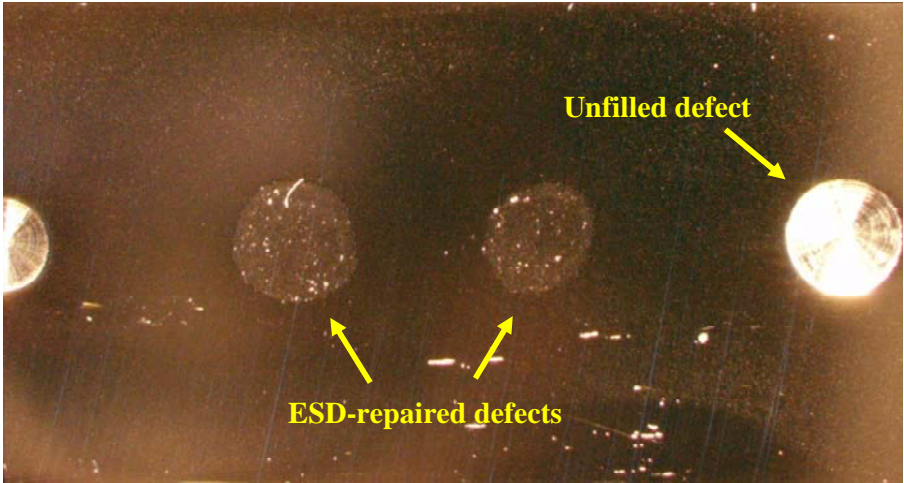
Figure 11. Optical macrograph showing two ESD-filled defects as well as one unfilled defect (magnified 2×).

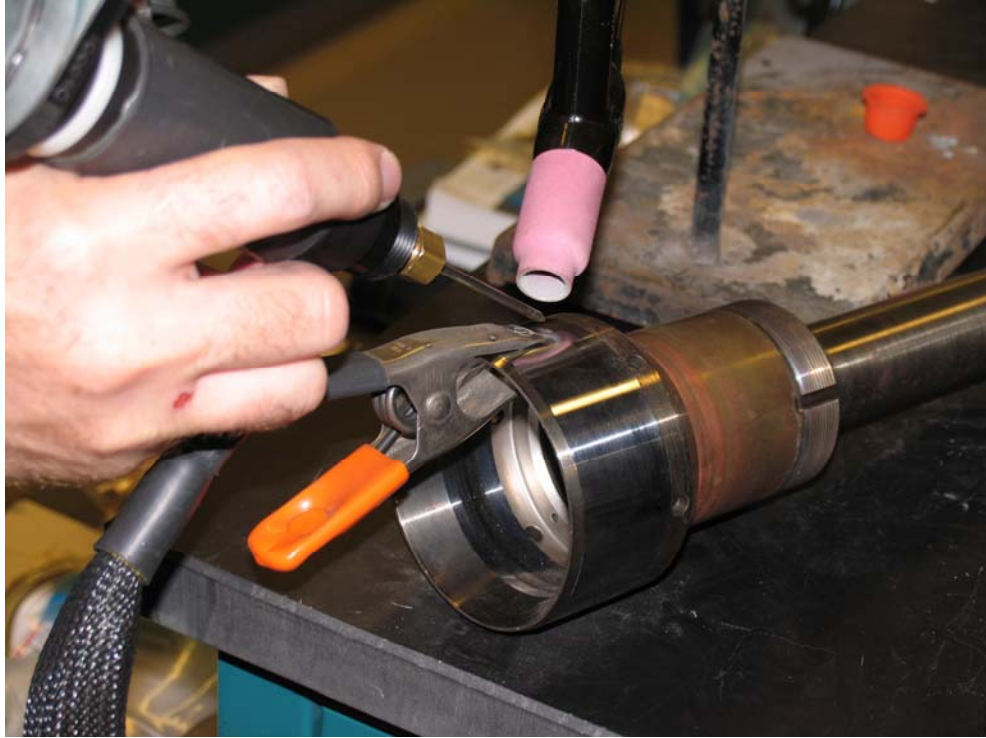
Figure 14. ESD being performed on an actual helical gear shaft containing defects at ARL.

Once these parameters were established, defects on actual helical gear shafts were repaired utilizing ESD (figure 14).

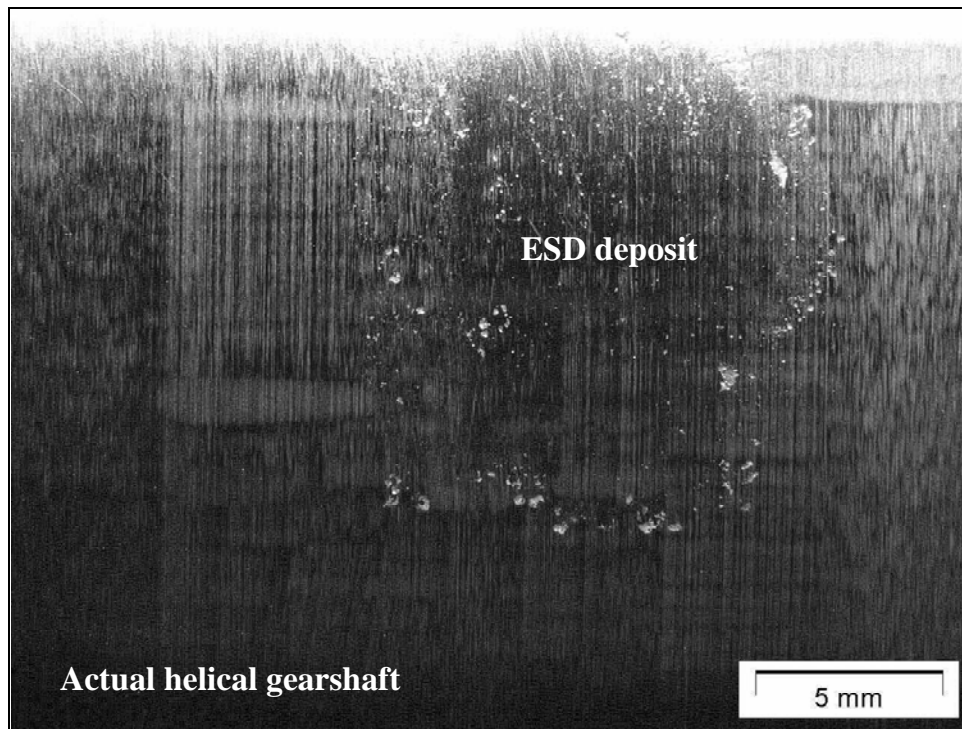
Figure 16. Porosity around the ESD deposit ("halo effect") of a chrome-plated sample (magnified 5×).

- ESD has been demonstrated to be a viable repair of corrosion pits and wear on both AISI 4130 and 9310 steels for use on nonrotating components.
- Caution must be taken when repairing chrome-plated components in order to reduce/eliminate the “halo effect.”

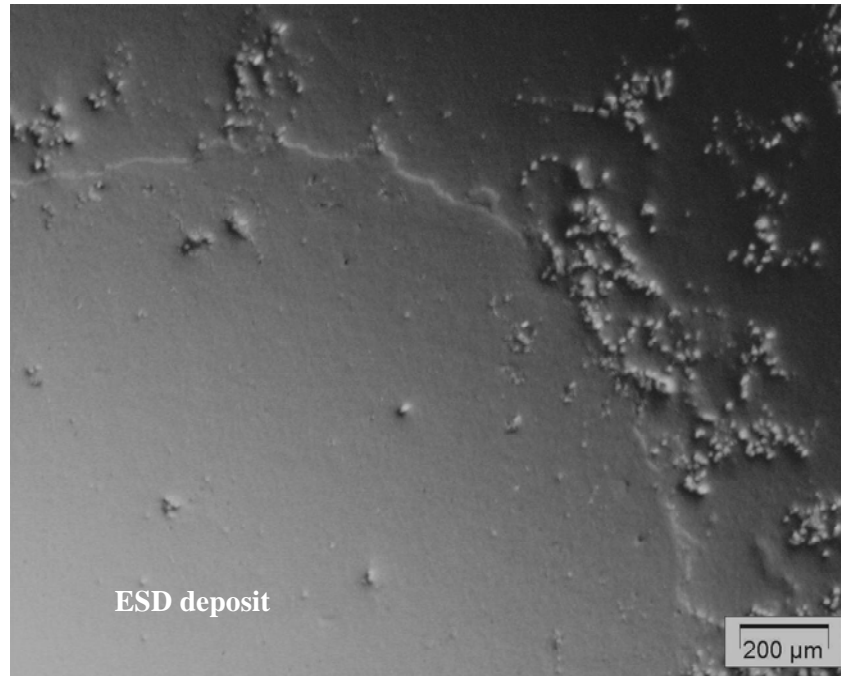
Figure 17. Magnified view of figure 16 utilizing the differential interference contrast mode for optical viewing (magnified 50×).

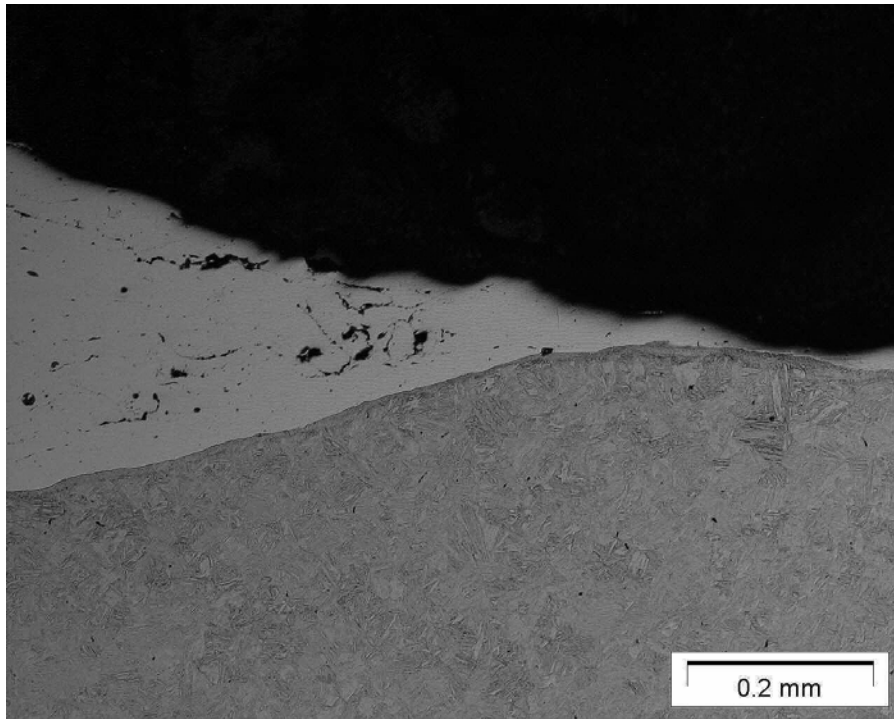
applying the ESD/chrome interface. Figure 18 shows a polished cross section displaying the porosity associated with the “halo effect,” while figure 19 shows no anomalies for a different chrome-plated ESD deposit.

Figure 18. Polished and etched cross section showing porosity associated with the “halo effect” in a chrome-plated 9310 steel sample. Etchant: 2% nital (magnified 500×).

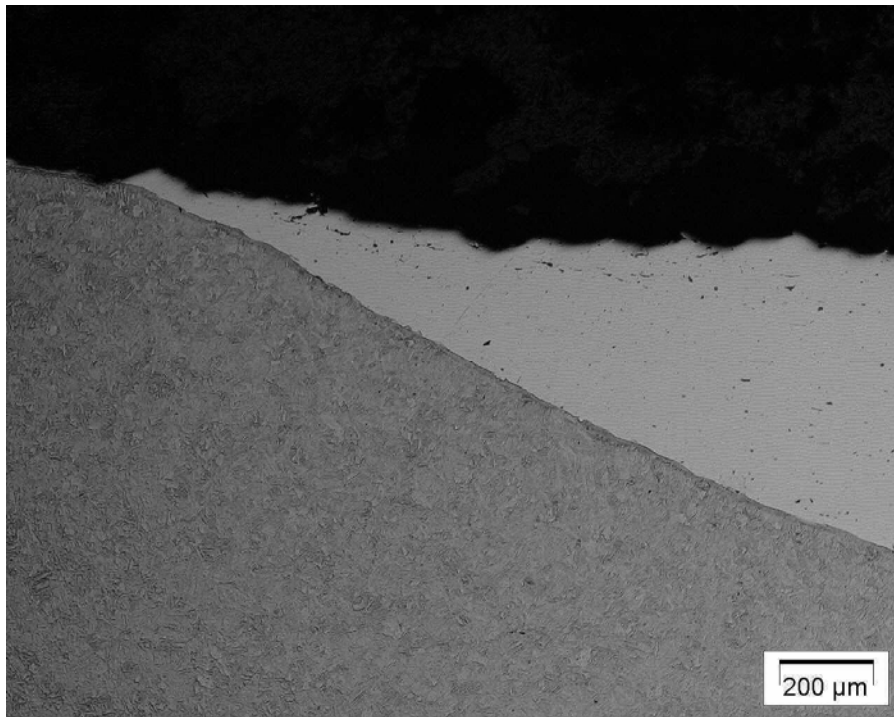
Figure 19. Polished sample cross section of an ESD-filled, chrome-plated defect showing no anomalies (magnified 200×).

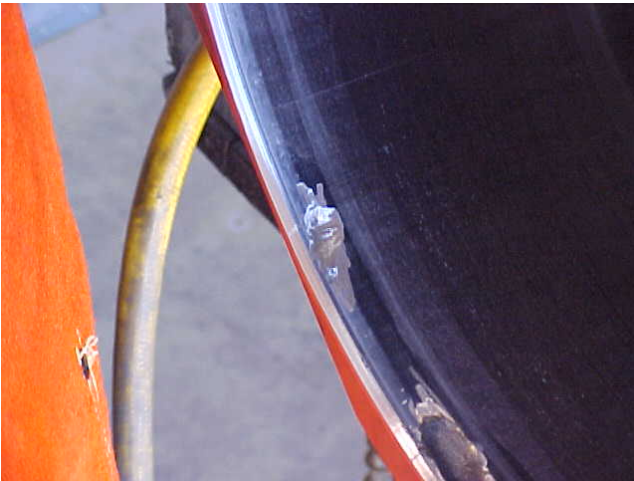
**PITS PREPARED FOR ESD REPAIR**

- a. Clean cradle using vapor degreaser.
- b. Using hand-held grinder w/wire brush, remove corrosion from pit.
- c. Using hand-held grinder w/grinding tool, break the sharp edges of the pit. If possible, maintain a width to depth ratio of 10:1 minimum to 20:1. The finish on the excavated defect should be in the 32-64 rms range for best ESD results.

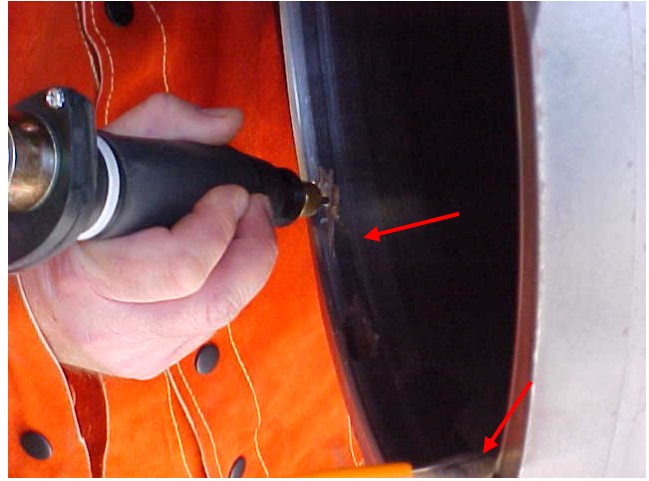
**REPAIR PROCESS**

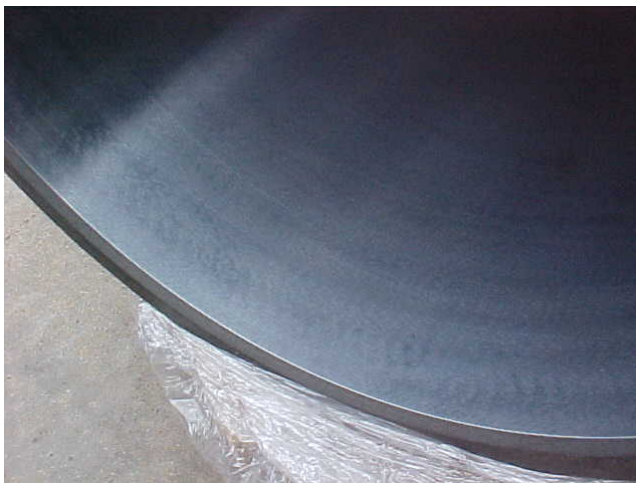
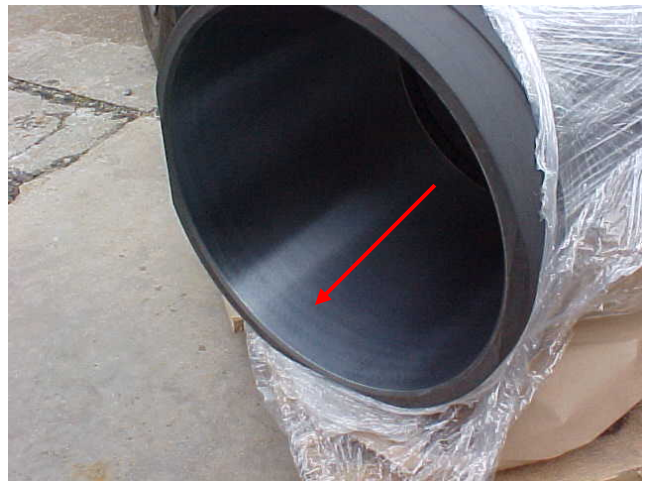
**AFTER ESD REPAIR, CHROME PLATING, AND FINISH GRINDING**

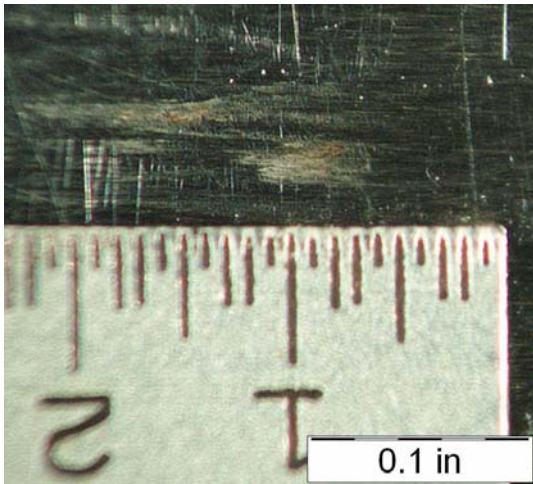
CORROSION PIT FOR ESD REPAIR

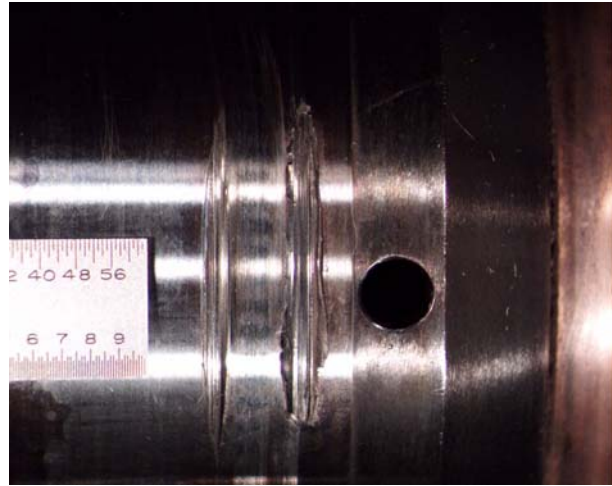
WEAR MARK FOR ESD REPAIR

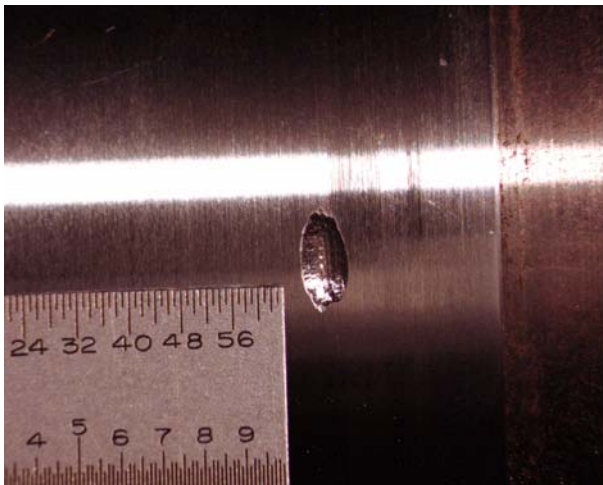
CORROSION PIT PREPARED FOR ESD

- d. Clean gear shaft using vapor degreaser.
- e. Using hand-held Dremel® tool (or equivalent), remove corrosion from pit.
- f. Using hand-held Dremel® tool (or equivalent), break the sharp edges of the pit or wear mark. If possible, maintain a width to depth ratio of 10:1 minimum to 20:1. The finish on the excavated defect should be in the 32-64 rms range for best ESD results.

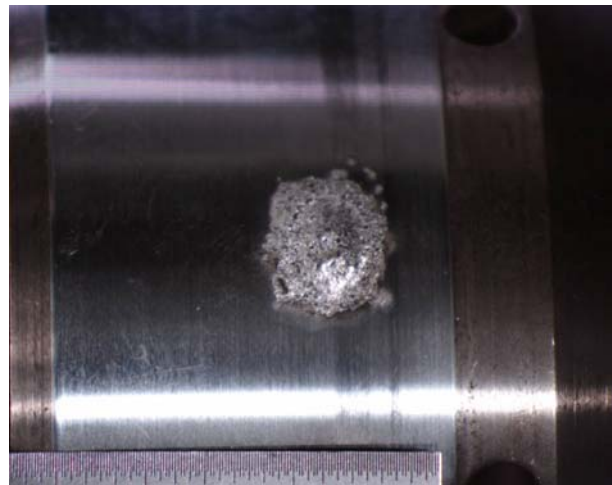
CORROSION PIT FILLED IN BY ESD

l. Using the ESD Equipment with the rotating torch (ASAP Model AH-98-MKIDD), the following settings/parameters and the electrode listed in paragraph 2c, fill the pit or wear mark to .005" - .010" above the parent material surface. This will ensure complete cleanup during grinding.

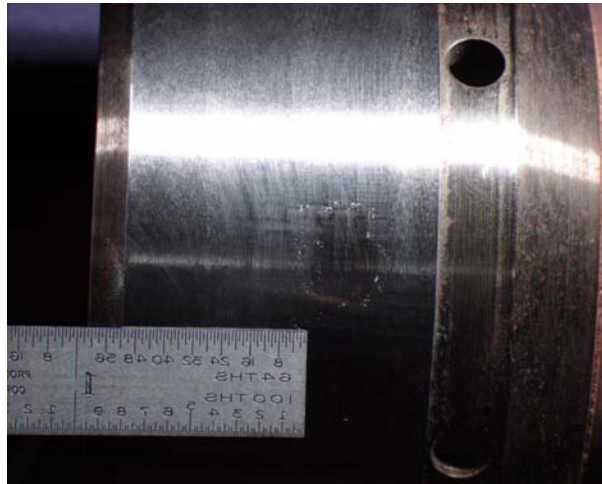
**CORROSION PIT AFTER ESD REPAIR AND FINISH GRINDING**
