EXAMINATION OF COPPER-NICKEL  
SEAWATER PIPING REMOVED FROM  
USS VINCENNES (CG-49)  
DURING POST-SHAKEDOWN AVAILABILITY (PSA)

FINAL REPORT

NORMAN J. CLAYTON

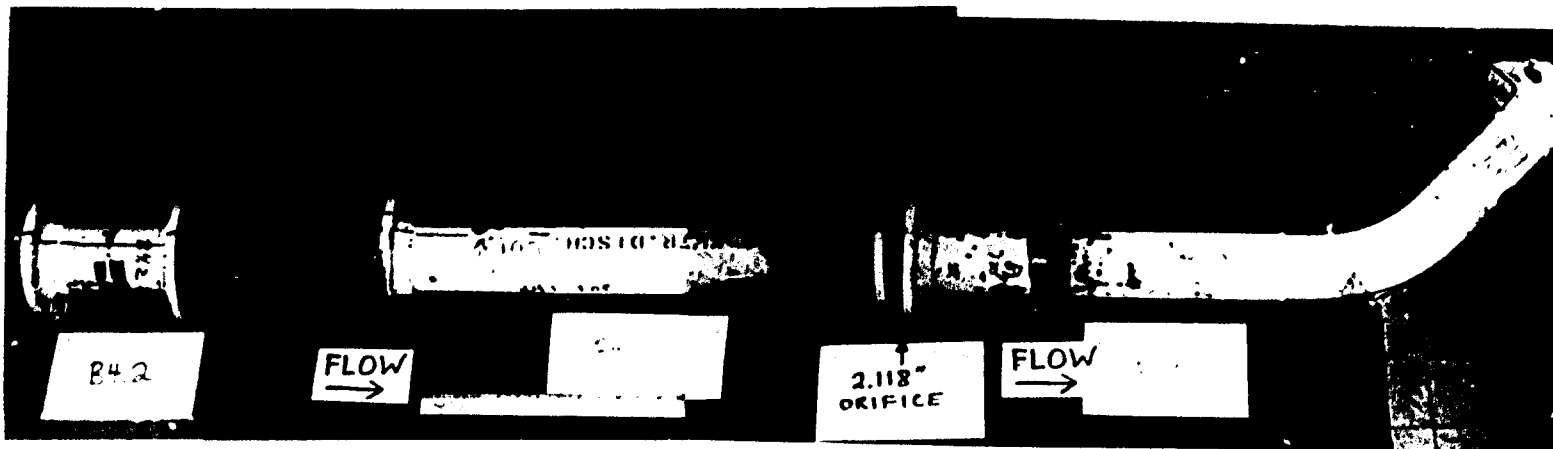
Sample B4. The configuration of this sample is shown in Figure 5a. The sample is actually made up of the two spool pieces (B4.1 and B4.2) which surrounded an in-line flowmeter (FM1). This 3-piece assembly was replaced with a single length of pipe during the PSA. Not shown in Figure 5a is the fact that a 90° elbow coupling from one of the Aeroquip flex hoses was located immediately upstream of specimen B4.2. The four flanges on B4.1 and B4.2 were all brazed. There were minimal or no gaps at the joints. These samples were arranged horizontally on the ship.

Figure 5a: Samples B4, B19, and flow meter FM1.

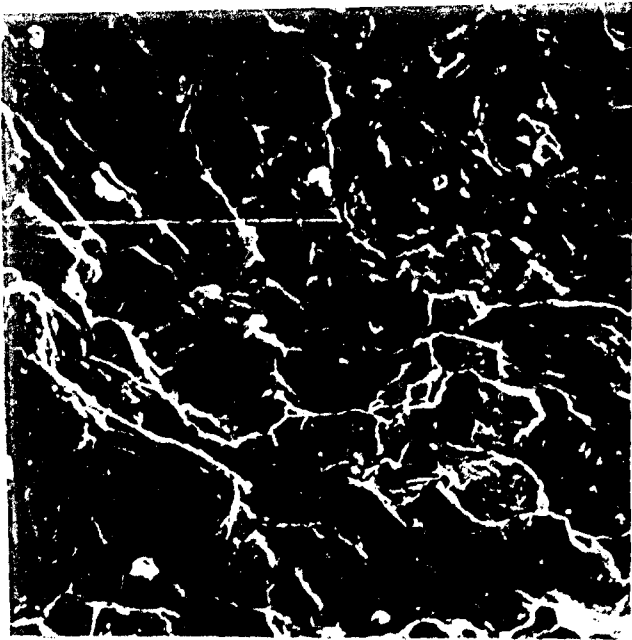
Figure 23: Sample B4.2, SEM view of surface of pipe under flake of black deposit. MAGNIFICATION: 480X.

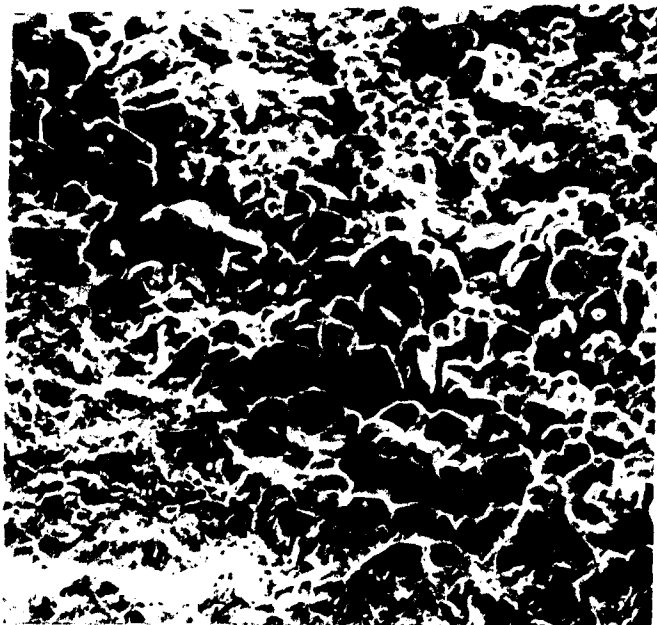
The compositions of the components of B4.2 were normal. Analysis of the white splotches on the pipe showed that they mainly contained titanium. These stains are considered to have come from white marking fluid, since titanium dioxide ( $TiO_2$ ) is a widely used white pigment. They did not affect the attack of the pipe, and probably got on the pipe after it had been removed. No sulfides were detected in the deposits by X-ray diffraction, and no sulfur was found in EDXA of the powdered X-ray specimen. However, Table IV shows that a trace amount of sulfur was detected by EDXA of a cross-section of the deposit which had collected at the outlet flange. The deposit cross-section is shown in Figure 24 and the accompanying EDXA spectrum is shown in Figure 25. The maroon undersides of some deposits were also examined. These areas had a part globular, part crystalline appearance. Figure 26 shows the typical appearance of the maroon deposit undersides found throughout this investigation. This figure is actually from sample G2.

Figure 26: Sample G2, SEM view of the maroon/purple underside of a flake of deposit. Typical of many samples, deposit is mainly copper.  
MAGNIFICATION: 600X.

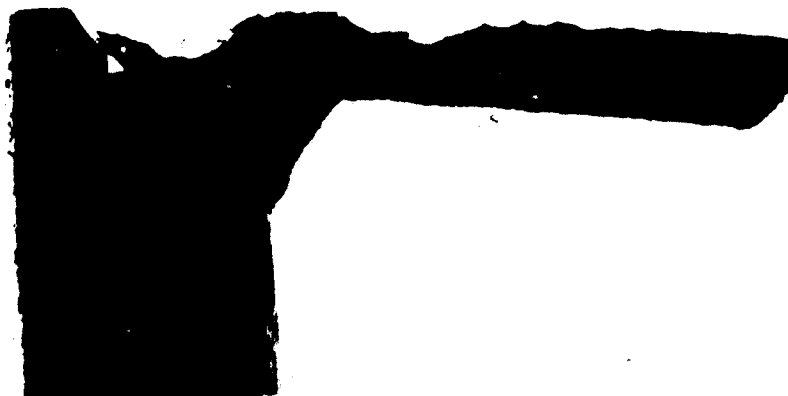
Figure 28: Sample J2, section through weld and flange at outlet end of pipe. Flow is from right to left.  
MAGNIFICATION: 2X.
