EVALUATION OF CROSS MEDIAN CRASHES

Final Report

February 2005

Rowan University
Department of Mechanical Engineering
Glassboro, NJ 08028

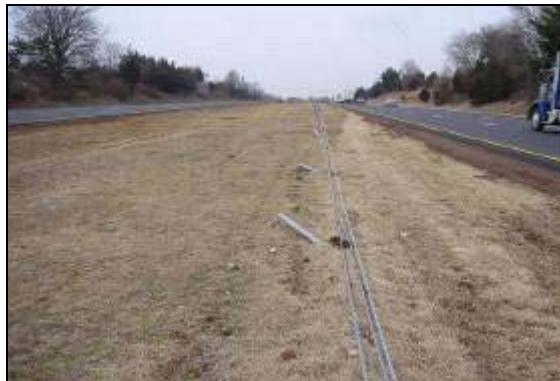
Figure 34. Impact 1: Barrier Damage

I-78 Impact 1: A total of 9 posts were damaged in this collision (approximately 130 feet of barrier) which occurred roughly at milepost 24.2. Based on vehicle tire tracks in the median, the impact angle of the vehicle was estimated to be approximately 10 degrees and the maximum deflection of the barrier was approximately 2.5 feet. Figure 34 is a photograph of the crash damage facing westbound.

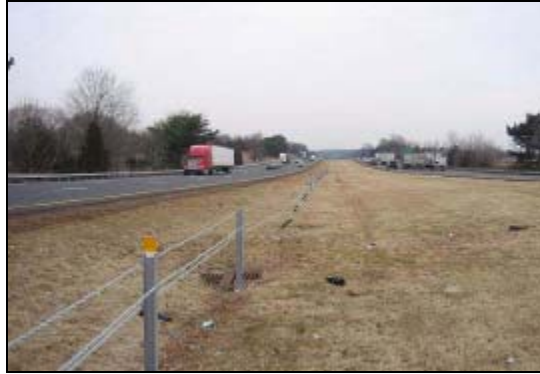
Figure 35. Impact 2: Barrier Damage

I-78 Impact 2 and Impact 3: These collisions occurred within close proximity and just westbound of milepost 23.8. In the first collision, a 3 post section of the barrier was damaged (approximately 35 feet of barrier) and appeared to be caused by a vehicle moving in the westbound direction. The angle of impact could not be determined based on the evidence at the time of investigation. Refer to Figure 35 for an image of the damaged barrier section.

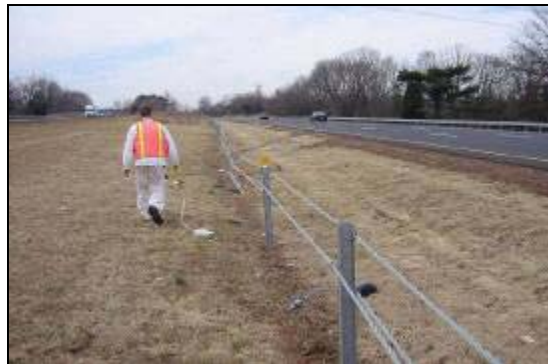
Figure 36. Impact 3: Barrier Damage

The second damaged barrier section occurs after approximately 30 feet of undamaged barrier and consists of 5 damaged posts (approximately 60 feet of barrier). Again, the damage to the barrier suggested that the errant vehicle had been traveling in the westbound direction. Tire tracks suggested a low impact angle of approximately 4 degrees. Refer to Figure 36 for a photograph of the barrier damage. In both instances, the vehicle was redirected with no barrier penetration; however, the research team could not discern whether the damage had been caused by a single vehicle or by two different vehicles on separate occasions.

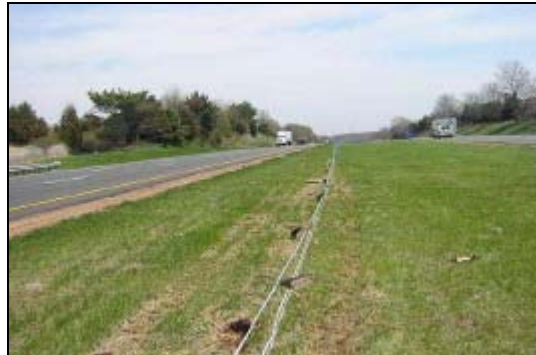
Figure 37. Impact 8: Barrier Damage

westbound, impacted the barrier and came to rest facing east. It should be noted that the occupant of the Pontiac Grand Prix was not injured. Refer to Figure 37 for a photograph of the barrier damage.

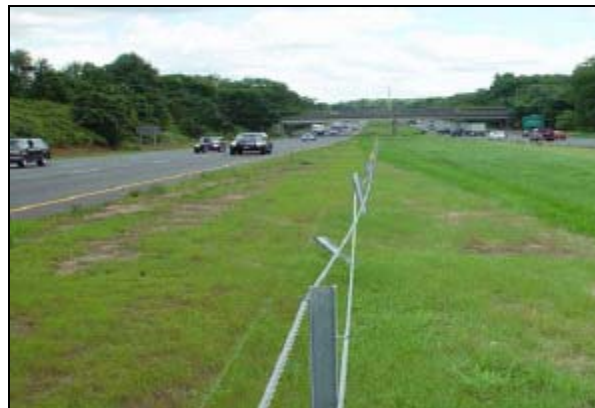
Figure 38. Impact 9. Barrier Damage

I-78 Impact 9: A total of 16 posts were damaged in this impact occurring near milepost 24.4. Note that only 2 posts were damaged and the remainder of the posts had at least one cable detached. The impact angle is approximately 50 degrees based on the tire marks at the scene, much greater than the other investigated collisions. Despite the apparently high impact angle, the barrier appeared to contain and redirect the vehicle. Refer to Figure 38 for an image of the barrier damage.

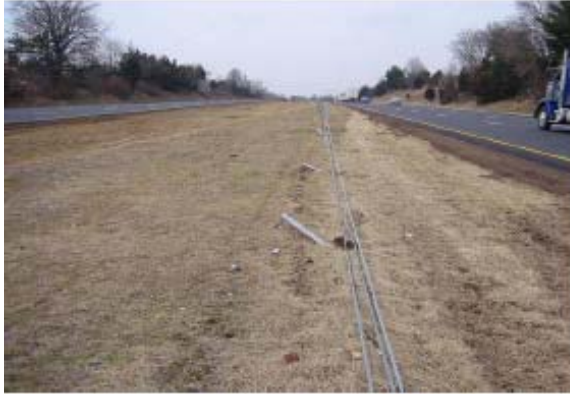
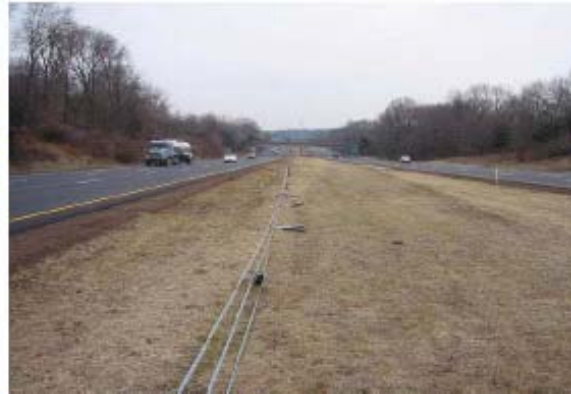
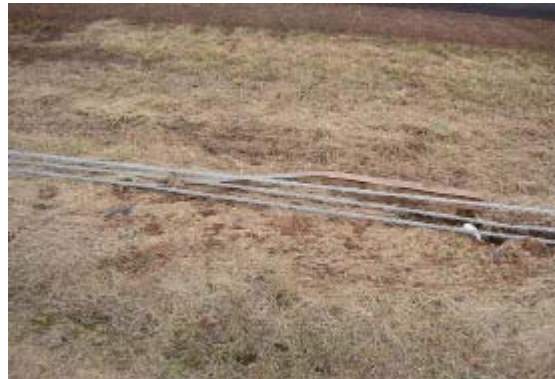
TOPELEFT: Front view of the damaged section of barrier, facing West. TOPRIGHT: Front view of the damaged section of barrier, facing East.
RIGHT: Extra photo of post #4, completely separated from the barrier.

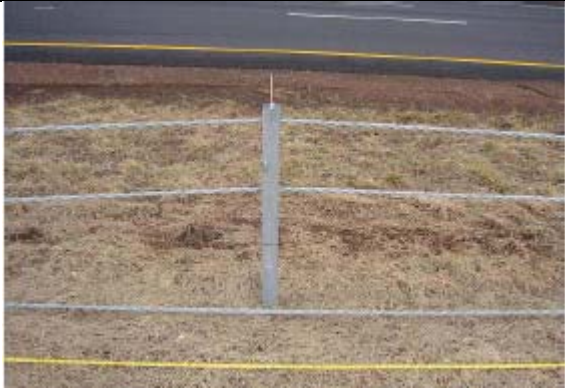
| Description of Damage to Post (Bending, Torsion, Shear, Rail Connectivity): The center cable was unhooked from the post, but the post was otherwise undamaged. | | | |

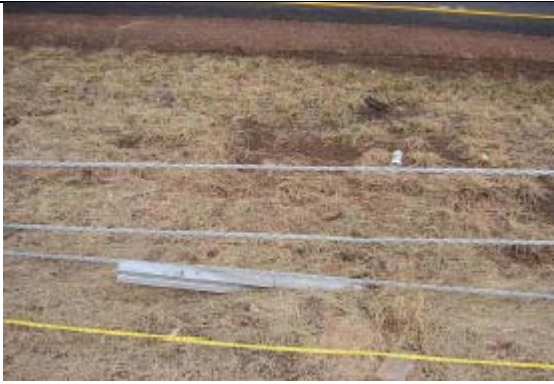
| Description of Damage to Post (Bending, Torsion, Shear, Rail Connectivity): Almost completely bent over to the ground. All cables were unhooked from the post. | | | |

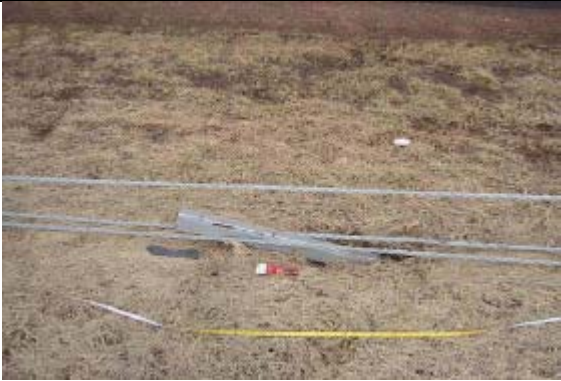
| Description of Damage to Post (Bending, Torsion, Shear, Rail Connectivity): Almost completely bent over to the ground. All cables were unhooked from the post. | | | |

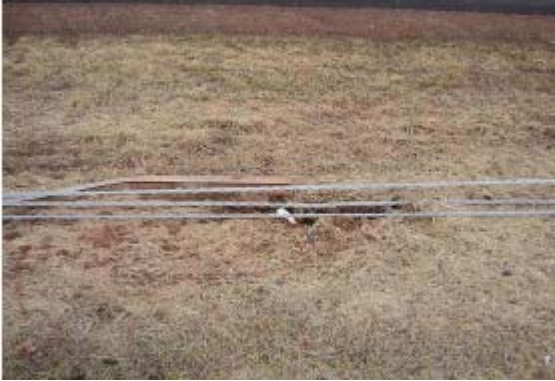
| Description of Damage to Post (Bending, Torsion, Shear, Rail Connectivity): Completely out of the ground. Post was bent and all three cables were unhooked. Post was completely separated from the barrier. | | | |

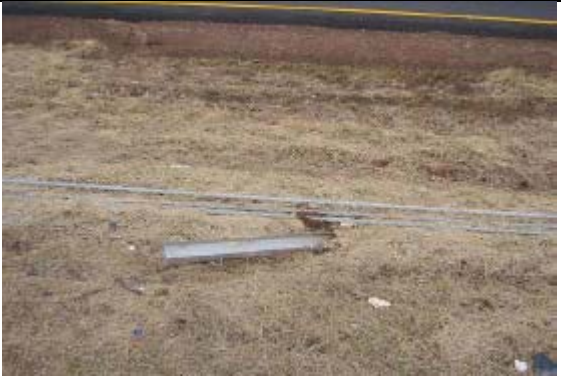
| Description of Damage to Post (Bending, Torsion, Shear, Rail Connectivity): Almost completely bent over to the ground. All cables were unhooked from the post. | | | |

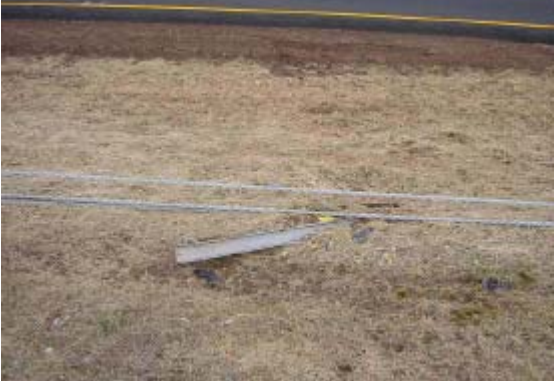
| Description of Damage to Post (Bending, Torsion, Shear, Rail Connectivity): Almost completely bent over to the ground. Partially sheared at ground level. All cables were unhooked from the post. | | | |

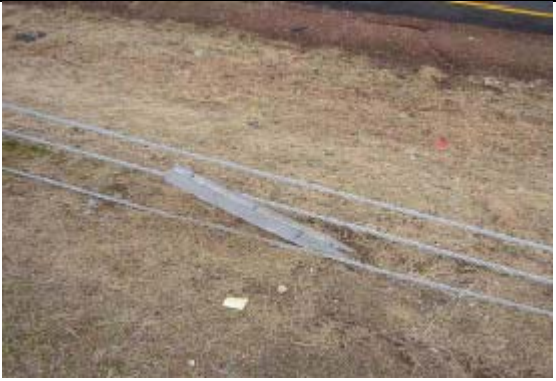
| Description of Damage to Post (Bending, Torsion, Shear, Rail Connectivity): Almost completely bent over to the ground. The top and middle cables were unhooked from the post. The bottom cable was still in its hook. | | | |

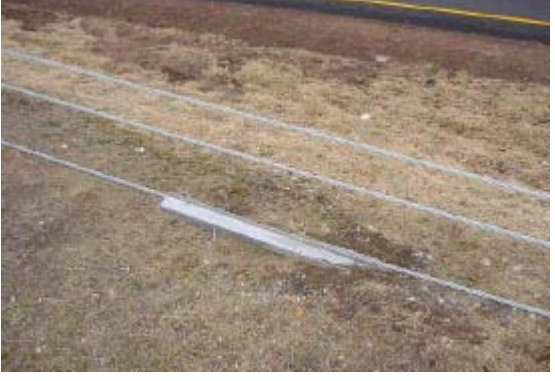
| Description of Damage to Post (Bending, Torsion, Shear, Rail Connectivity): Almost completely bent over to the ground. All cables were unhooked from the post. | | | |

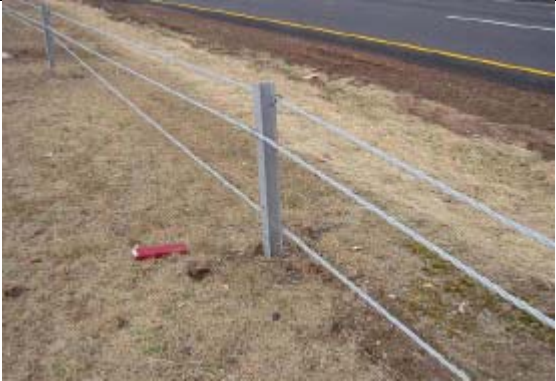
| Description of Damage to Post (Bending, Torsion, Shear, Rail Connectivity): The bottom cable was unhooked from the post, but the post was otherwise undamaged. | | | |

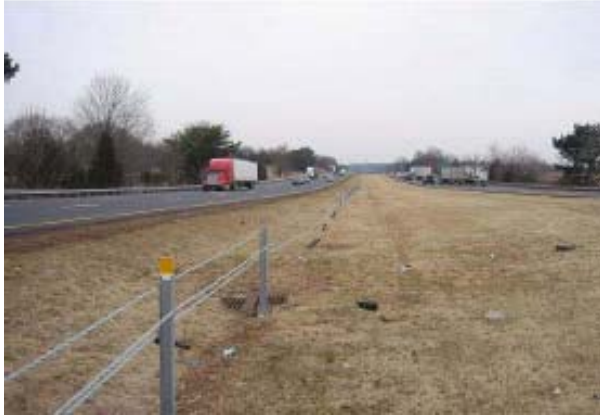
TOPLEFT: Front view of the damaged section of barrier, facing East.

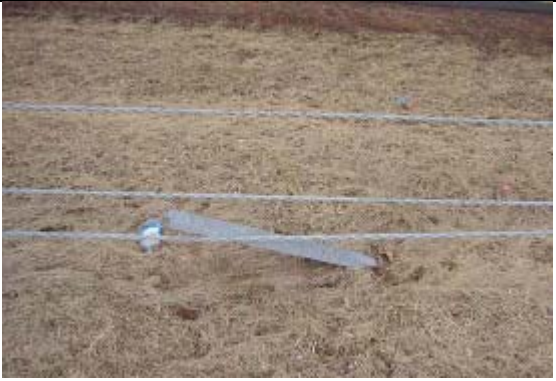
| Description of Damage to Post (Bending, Torsion, Shear, Rail Connectivity): Almost completely bent over to the ground. The top and bottom cables were unhooked from the post. The middle cable was still in its hook. | | | |

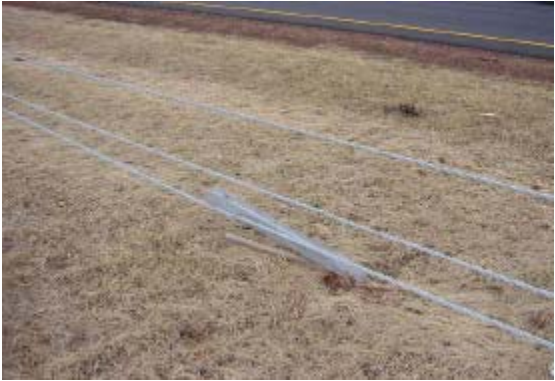
| Description of Damage to Post (Bending, Torsion, Shear, Rail Connectivity): Almost completely bent over to the ground. The top and bottom cables were unhooked from the post. The middle cable was still in its hook. | | | |

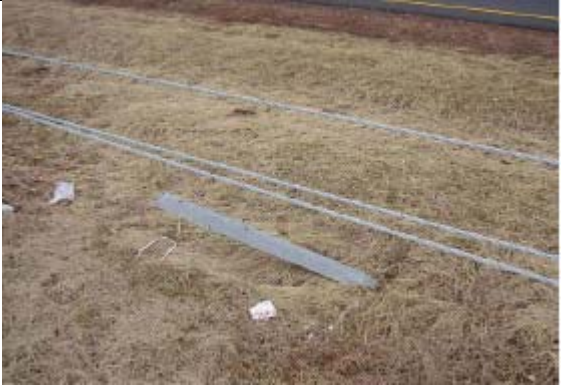
| Description of Damage to Post (Bending, Torsion, Shear, Rail Connectivity): Almost completely bent over to the ground. Partially sheared at ground. All three cables were unhooked from the post. | | | |

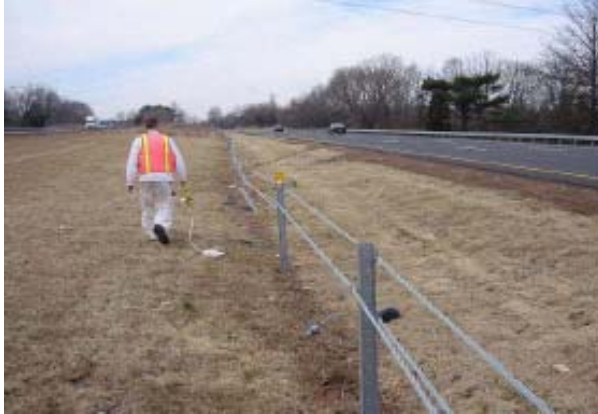
TOPLEFT: Front view of the damaged section of barrier, facing West.

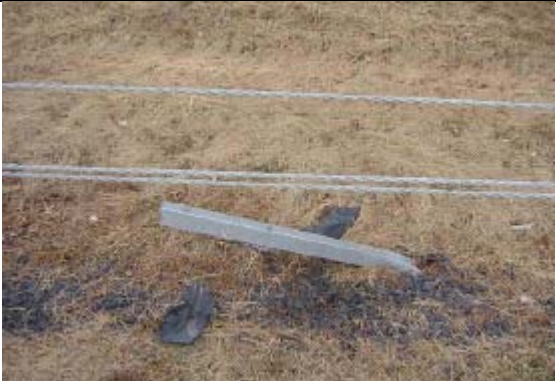
| Description of Damage to Post (Bending, Torsion, Shear, Rail Connectivity): Almost completely bent over to the ground. All three cables were unhooked from the post. | | | |

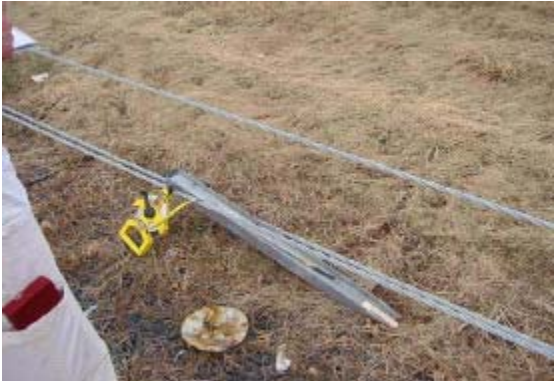
| Description of Damage to Post (Bending, Torsion, Shear, Rail Connectivity): Almost completely bent over to the ground. Partial sheared at ground. All three cables were unhooked from the post. | | | |

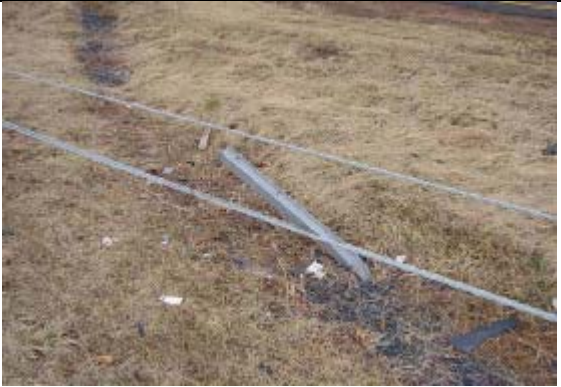
| Description of Damage to Post (Bending, Torsion, Shear, Rail Connectivity): Almost completely bent over to the ground. All three cables were unhooked from the post. Post was actually bent laterally towards the westbound lanes. | | | |

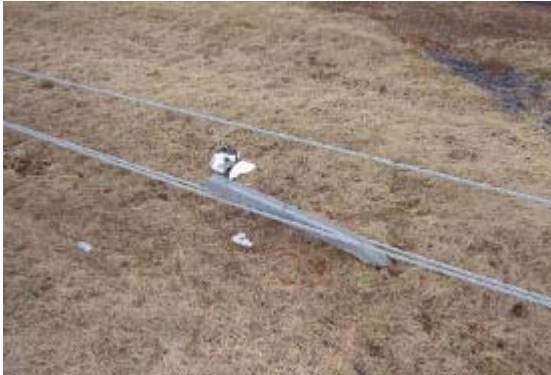
| Description of Damage to Post (Bending, Torsion, Shear, Rail Connectivity): Almost completely bent over to the ground. All three cables were unhooked from the post. | | | |

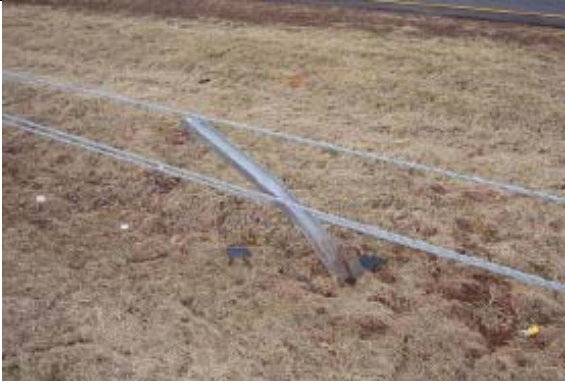
| Description of Damage to Post (Bending, Torsion, Shear, Rail Connectivity): Almost completely bent over to the ground. All three cables were unhooked from the post. Post was slightly ripped out of the ground, its soil plate was visible. | | | |

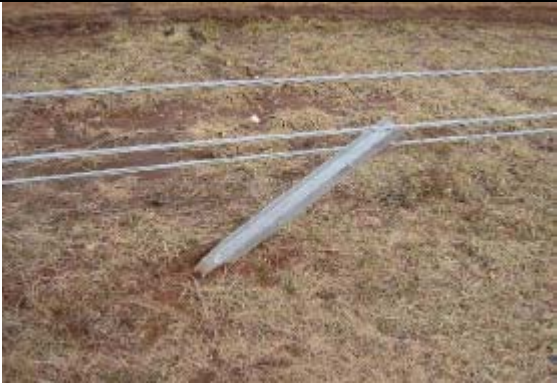
| Description of Damage to Post (Bending, Torsion, Shear, Rail Connectivity): All three cables were unhooked from the post, but the post was otherwise undamaged. | |

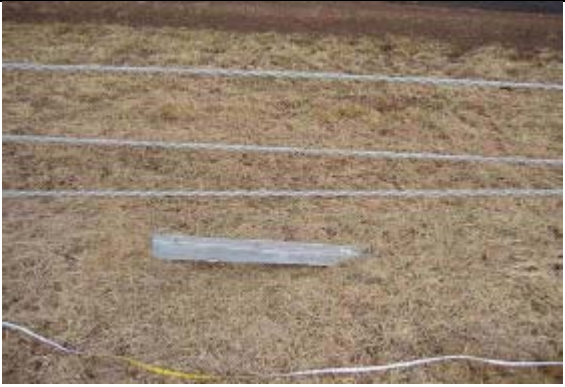
| Description of Damage to Post (Bending, Torsion, Shear, Rail Connectivity): All three cables were unhooked from the post, but the post was otherwise undamaged. | | | |

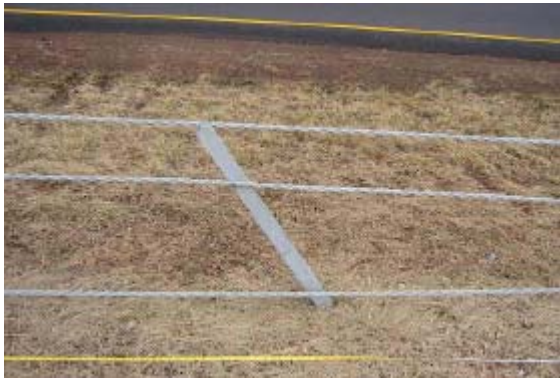
| Description of Damage to Post (Bending, Torsion, Shear, Rail Connectivity): Bent over slightly, towards the ground. The top and bottom cables were unhooked from the post. The middle cable was still in its hook. | | | |

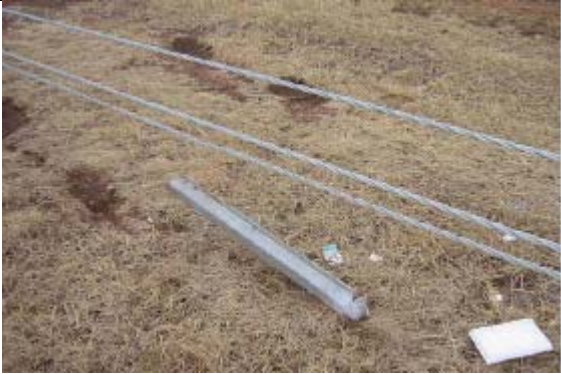
| Description of Damage to Post (Bending, Torsion, Shear, Rail Connectivity): Almost completely bent over to the ground. Partially sheared at ground. All cables were unhooked from the post. | | | |

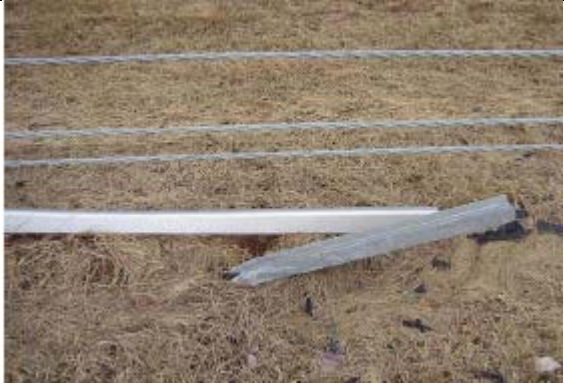
| Description of Damage to Post (Bending, Torsion, Shear, Rail Connectivity): Almost completely bent over to the ground. All cables were unhooked from the post. | | | |

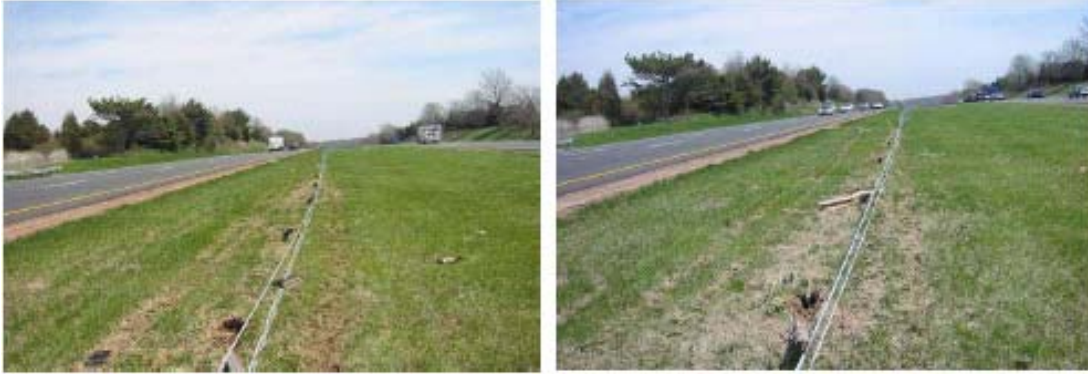
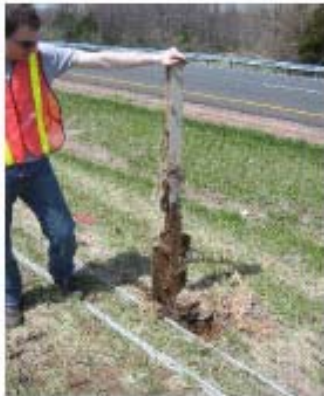
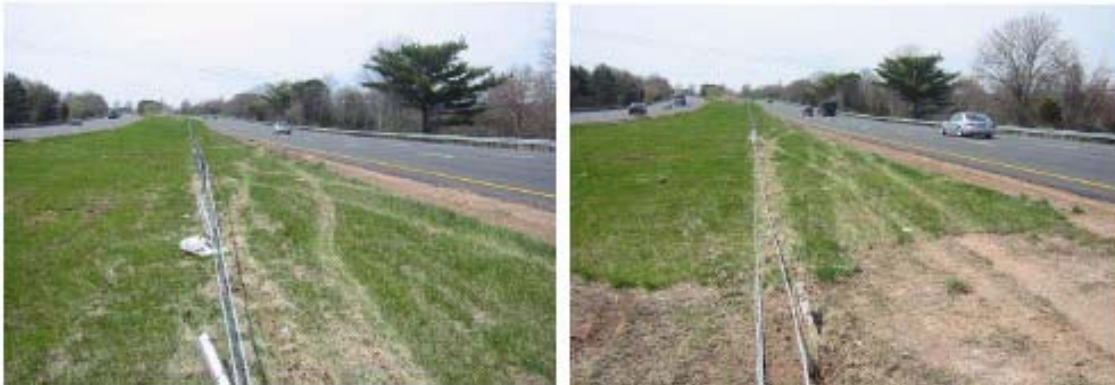
TOP: East views of the site showing damaged posts and vehicle tracks. LEFT: Post #9. The post was almost completely removed from the ground, yet completely undamaged. This indicates that the soil was very soft and wet at the time of the incident. BOTTOM: West views of the site showing damaged posts and vehicle tracks.

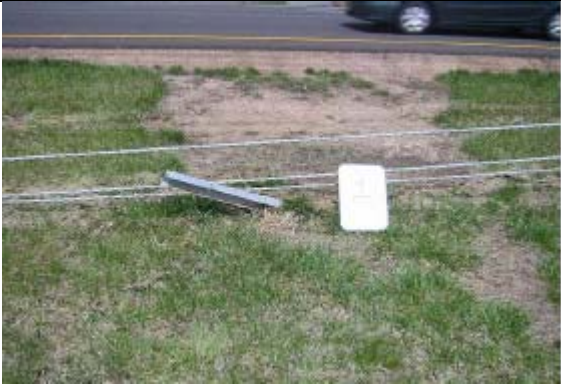
| Description of Damage to Post (Bending, Torsion, Shear, Rail Connectivity): Post was mildly bent over and partially sheared below the ground level. The post's soil plate was visible and all three cables were unhooked from their cable hooks. | | | |

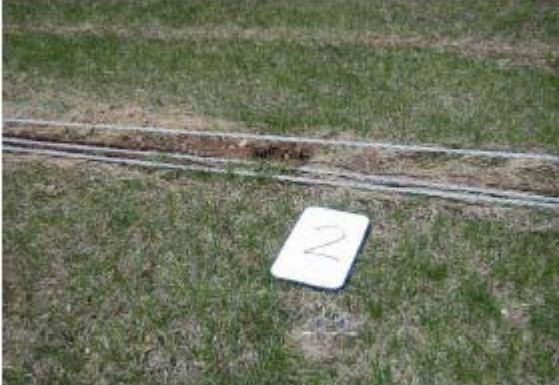
| Description of Damage to Post (Bending, Torsion, Shear, Rail Connectivity): Post was completely removed from the ground. This post was found on top of post #5 and appears in the photo for post #5. It was unhooked from all three cable hooks and was only mildly bent. | | | |

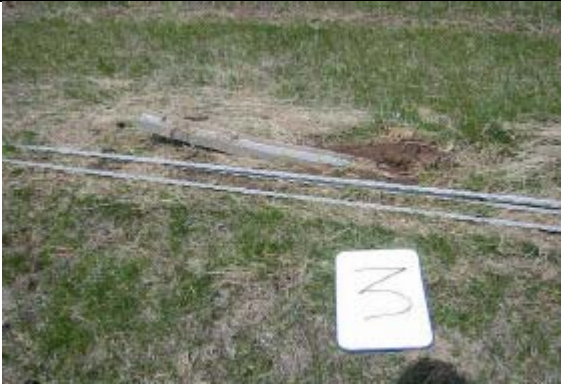
| Description of Damage to Post (Bending, Torsion, Shear, Rail Connectivity): This post was bent over almost completely to the ground and partially sheared below the ground level. The post's soil plate was visible and the post was partially removed from the ground. The bottom portion of the post (the part in the ground) was substantially tilted, indicating very soft/wet soil at time of impact. All three cables were unhooked from their cable hooks. | | | |

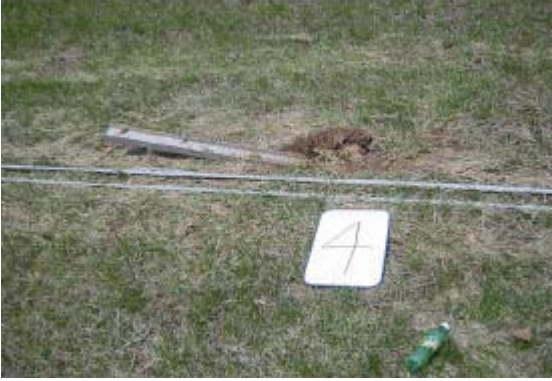
| Description of Damage to Post (Bending, Torsion, Shear, Rail Connectivity): This post was bent over almost completely to the ground and partially sheared below the ground level. The post's soil plate was visible and the post was partially removed from the ground. The bottom portion of the post (the part in the ground) was substantially tilted, indicating very soft/wet soil at time of impact. All three cables were unhooked from their cable hooks. | | | |

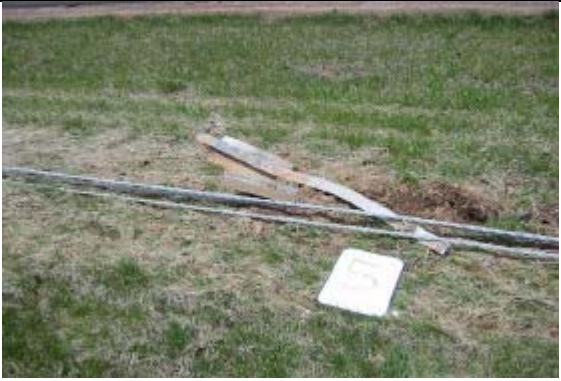
| Description of Damage to Post (Bending, Torsion, Shear, Rail Connectivity): This post was bent over almost completely to the ground and partially sheared below the ground level. The post's soil plate was visible and the post was partially removed from the ground. The bottom portion of the post (the part in the ground) was substantially tilted, indicating very soft/wet soil at time of impact. This post was twisted around about 135°. Post #2 was found on top of this post. Post #5 is the post still in the ground. All three cables were unhooked from heir cable hooks. | | | |

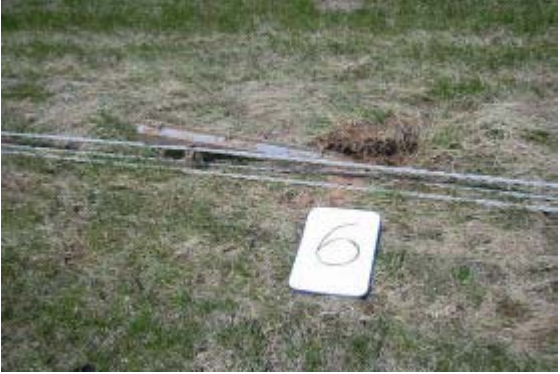
| Description of Damage to Post (Bending, Torsion, Shear, Rail Connectivity): This post was bent over almost completely to the ground and partially sheared below the ground level. The post's soil plate was visible and the post was partially removed from the ground. The bottom portion of the post (the part in the ground) was substantially tilted, indicating very soft/wet soil at time of impact. All three cables were unhooked from heir cable hooks. | | | |

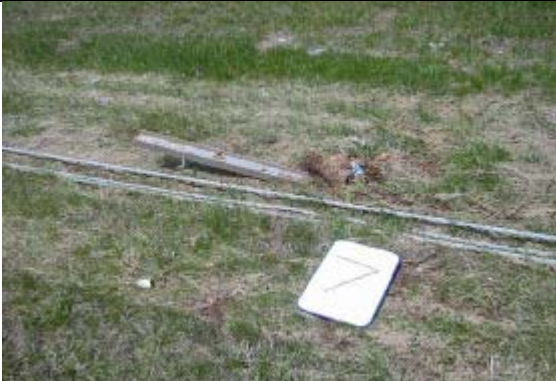
| <p>Description of Damage to Post (Bending, Torsion, Shear, Rail Connectivity):</p> <p>This post was bent over almost completely to the ground and partially sheared below the ground level. The post's soil plate was visible. The bottom portion of the post (the part in the ground) was substantially tilted, indicating very soft/wet soil at time of impact. All three cables were unhooked from their cable hooks.</p> | | | |

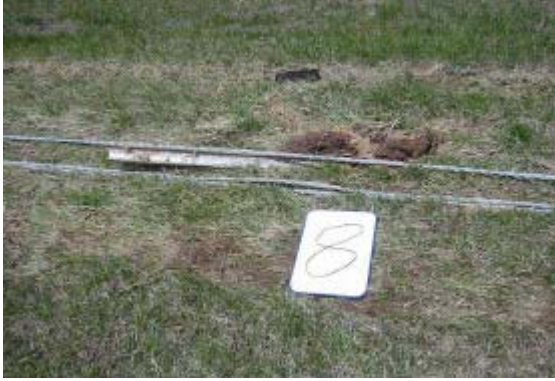
| <p>Description of Damage to Post (Bending, Torsion, Shear, Rail Connectivity):</p> <p>The post's soil plate was visible and the post was partially removed from the ground. The bottom portion of the post (the part in the ground) was substantially tilted, indicating very soft/wet soil at time of impact. All three cables were unhooked from their cable hooks. This post was otherwise undamaged and was still perfectly straight.</p> | | | |

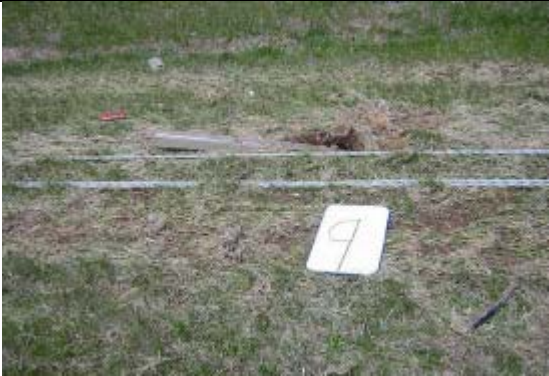
| Description of Damage to Post (Bending, Torsion, Shear, Rail Connectivity): The post's soil plate was visible and the post was partially removed from the ground. The bottom portion of the post (the part in the ground) was substantially tilted, indicating very soft/wet soil at time of impact. All three cables were unhooked from their cable hooks. This post was otherwise undamaged and was still perfectly straight. | | | |

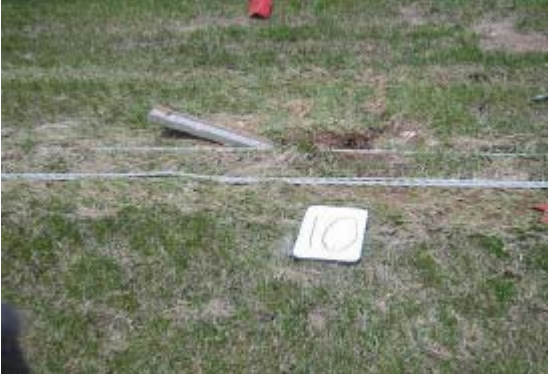
| Description of Damage to Post (Bending, Torsion, Shear, Rail Connectivity): This post was bent over almost completely to the ground and the post's soil plate was visible. All three cables were unhooked from their cable hooks. This post was twisted around about 15°. | | | |

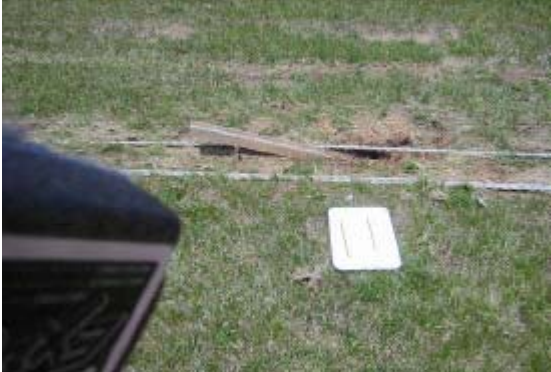
| <p>Description of Damage to Post (Bending, Torsion, Shear, Rail Connectivity):</p> <p>This post was bent over almost completely to the ground and partially sheared below the ground level. The post was partially removed from the ground. The bottom portion of the post (the part in the ground) was substantially tilted, indicating very soft/wet soil at time of impact. All three cables were unhooked from their cable hooks.</p> | | | |

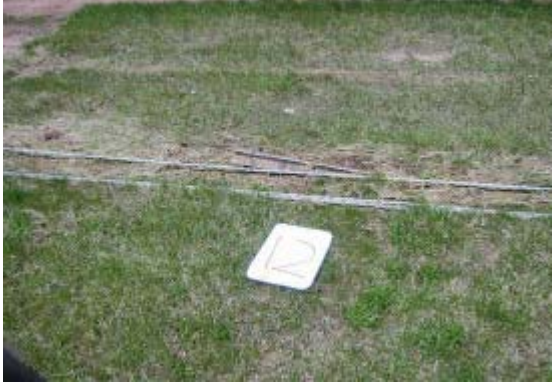
| <p>Description of Damage to Post (Bending, Torsion, Shear, Rail Connectivity):</p> <p>This post was bent over almost completely to the ground. All three cables were unhooked from their cable hooks.</p> | | | |

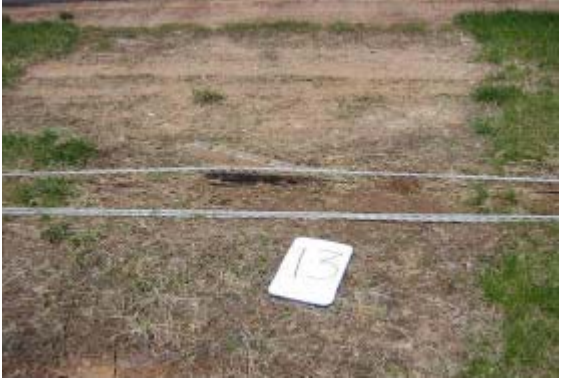
| Description of Damage to Post (Bending, Torsion, Shear, Rail Connectivity): This post was bent over almost completely to the ground and partially sheared below the ground level. The top and bottom cables were unhooked from their cable hooks. The middle cable was still in its cable hook. | | | |

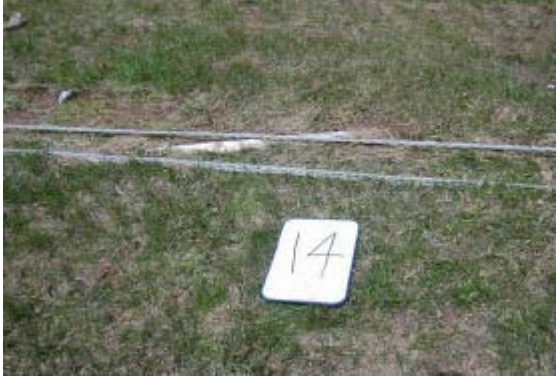
| Description of Damage to Post (Bending, Torsion, Shear, Rail Connectivity): This post was bent over back into the ground, creating a negative angle. It was partially sheared below the ground level. All three cables were unhooked from their cable hooks. | | | |

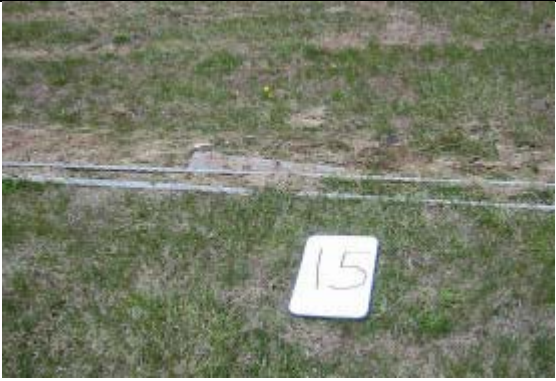
| Description of Damage to Post (Bending, Torsion, Shear, Rail Connectivity): This post was bent over almost completely to the ground and partially sheared below the ground level. All three cables were unhooked from their cable hooks. | | | |

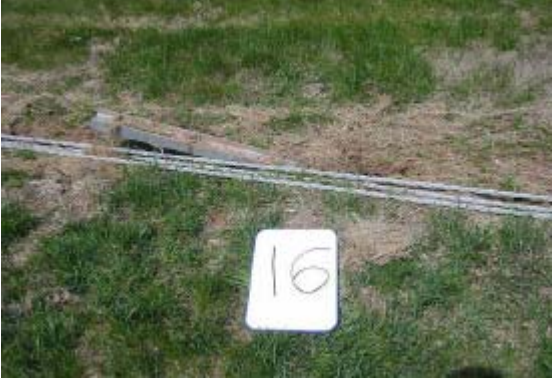
| Description of Damage to Post (Bending, Torsion, Shear, Rail Connectivity): This post was bent over almost completely to the ground and partially sheared below the ground level. The soil plate was visible. All three cables were unhooked from their cable hooks. | | | |

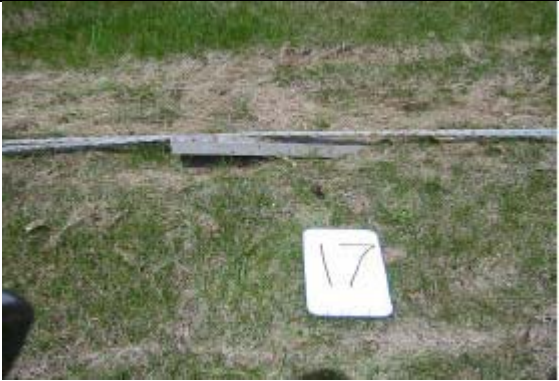
| Description of Damage to Post (Bending, Torsion, Shear, Rail Connectivity): This post was bent over almost completely to the ground and partially sheared below the ground level. The soil plate was visible. All three cables were unhooked from their cable hooks. | | | |

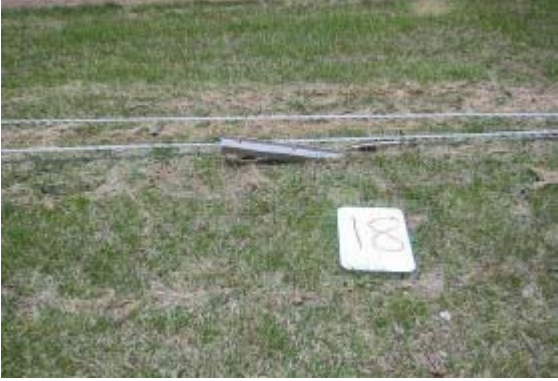
| Description of Damage to Post (Bending, Torsion, Shear, Rail Connectivity): This post was bent over almost completely to the ground and partially sheared below the ground level. All three cables were unhooked from their cable hooks. | | | |

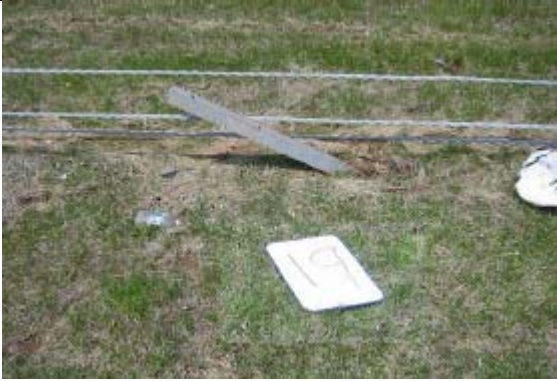
| Description of Damage to Post (Bending, Torsion, Shear, Rail Connectivity): This post was mildly bent over and partially sheared below the ground level. All three cables were unhooked from their cable hooks. | | | |

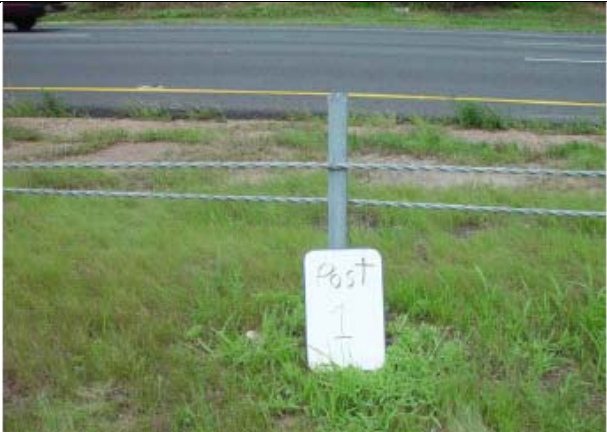
| Description of Damage to Post (Bending, Torsion, Shear, Rail Connectivity): No physical damage to the post other than bending of the upper cable hook bolt. Upper cable detached from post. | | | |

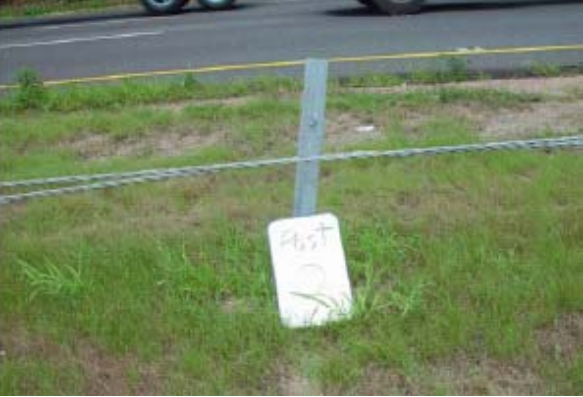
| Description of Damage to Post (Bending, Torsion, Shear, Rail Connectivity): Slight westbound bend in the post. All cable hook bolts bent outward; All cables detached from post. | | | |

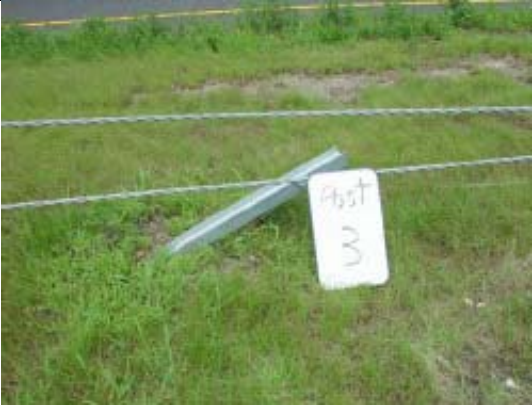
| Description of Damage to Post (Bending, Torsion, Shear, Rail Connectivity): Bending of the post near the ground line. All cables detached from the post. | | | |

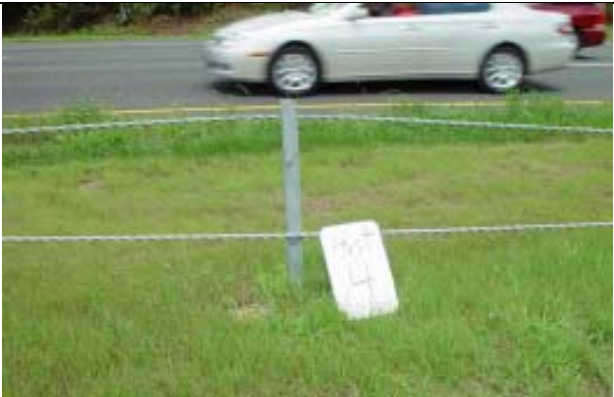
| Description of Damage to Post (Bending, Torsion, Shear, Rail Connectivity): Slight bend in the post toward the westbound lanes. Lower cable detached from post. | | | |
