RDT 00-009

# Evaluation of Undersealing and Diamond Grinding Rehabilitation

RI 86-002  
RI96-017

MISSOURI DEPARTMENT OF TRANSPORTATION  
RESEARCH, DEVELOPMENT AND TECHNOLOGY

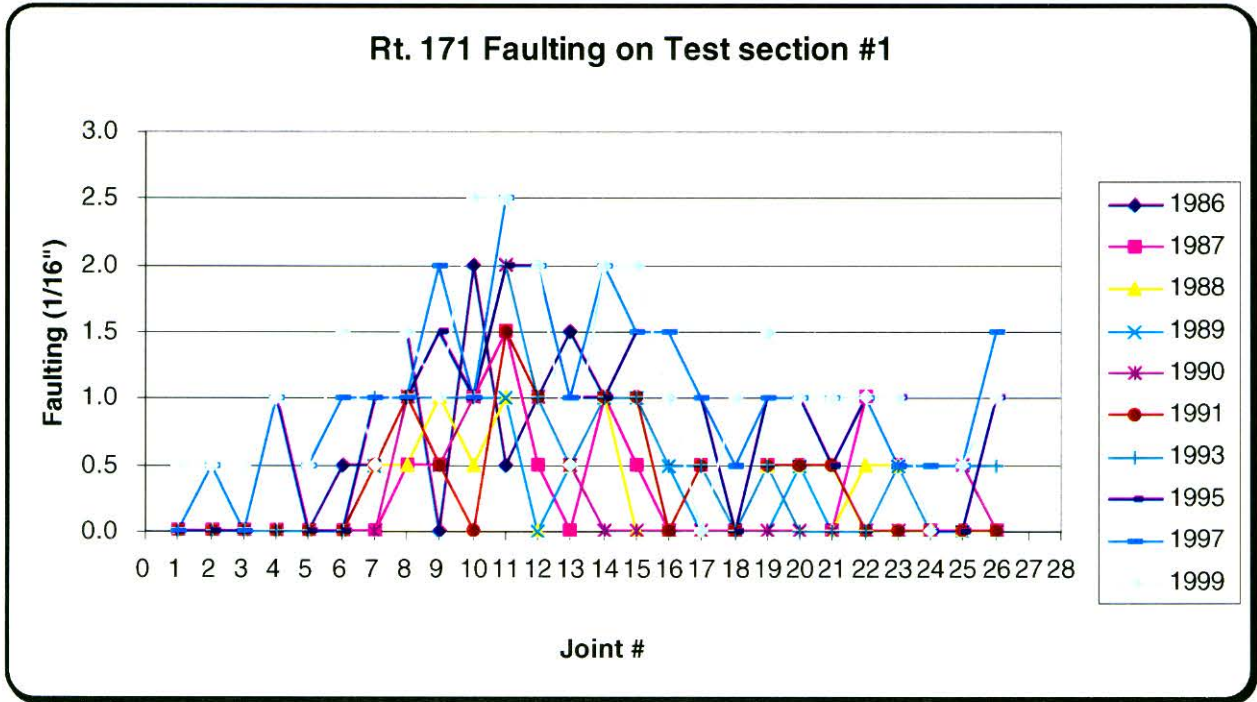
**FIGURE 1** Rt. 171 faulting history on Test Section #1

Faulting on the Rt. 171 test sections has increased at a slight pace since 1985. Figures 1 and 2 illustrate the progression at each joint. Each joint fault measurement on the graphs is the average of faulting in the inner and outer wheel paths.

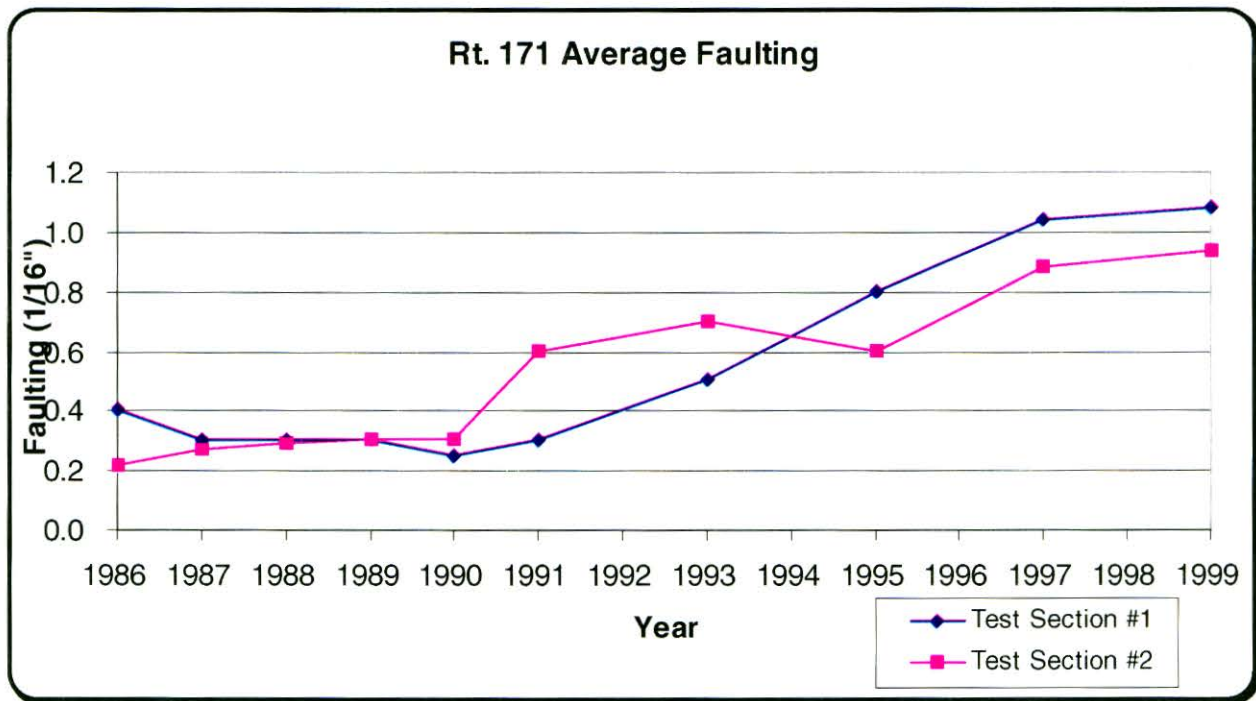
**FIGURE 3** Rt. 171 annual average faulting on Test Sections #1 and #2

Average faulting for the entire Test Section #1 (TS1) is slightly over  $1/16''$ , while average faulting for the entire Test Section #2 (TS2) is slightly under  $1/16''$ , as shown in Figure 3.

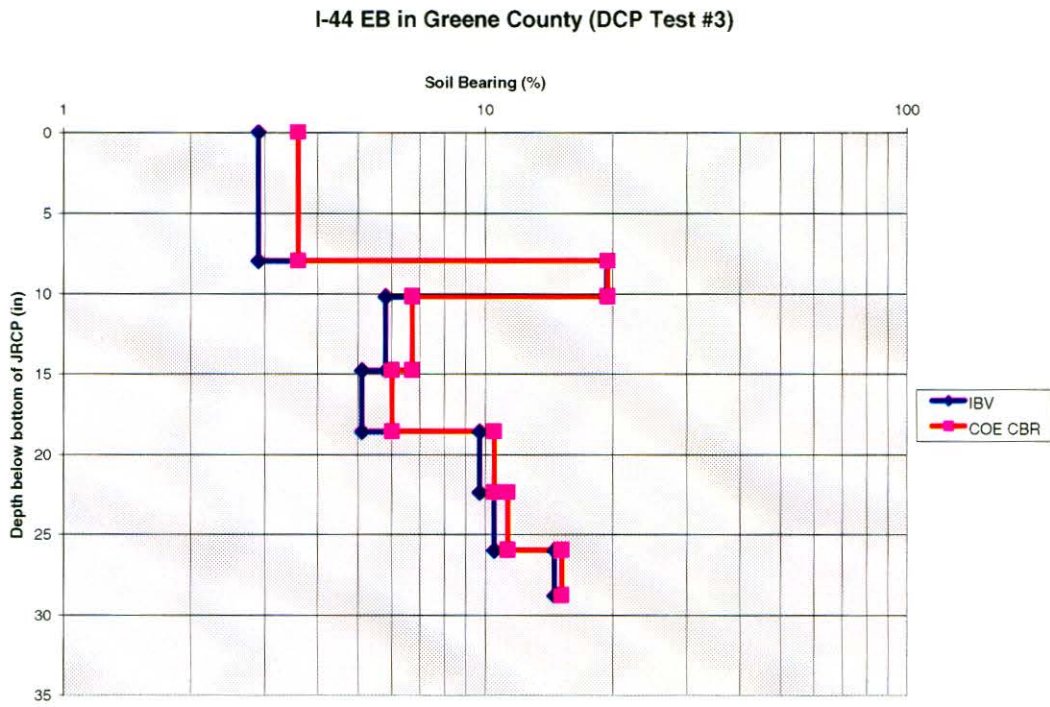
**FIGURE 4** DCP results on EB I-44 under old PCCP

Figure 4 shows rapid DCP penetration under an old section of PCCP after getting past the base material. Figure #5 shows similar results under a recent repair patch, but the immediate high penetration indicates a loss of base material. Both figures clearly illustrate the poor condition of the top 6"-7" of the subgrade.

- 1) Subsurface conditions - The results of the soil samples analyses and the DCP testing are not completely conclusive, but do provide some insight. There is little doubt, based on DCP testing under the I-44 driving lane and on the amount of pumping observed both under old pavement and new patches, that prevalent near the surface lies a layer of saturated soil with little bearing capacity. Proctor compaction and in-situ water content testing on the I-44 samples seem to indicate a soil that is well above the optimum water content in its natural state. FWD testing on a portion of the westbound test sections revealed poor load transfers at the majority of the joints. The I-35 test sections had also exhibited a lot of pumping prior to restoration. Subgrade in-situ water contents at these sections were well above optimum. Rt. 171 soil tests were less clear, but hinted that the in-situ state was on the dry side of optimum.

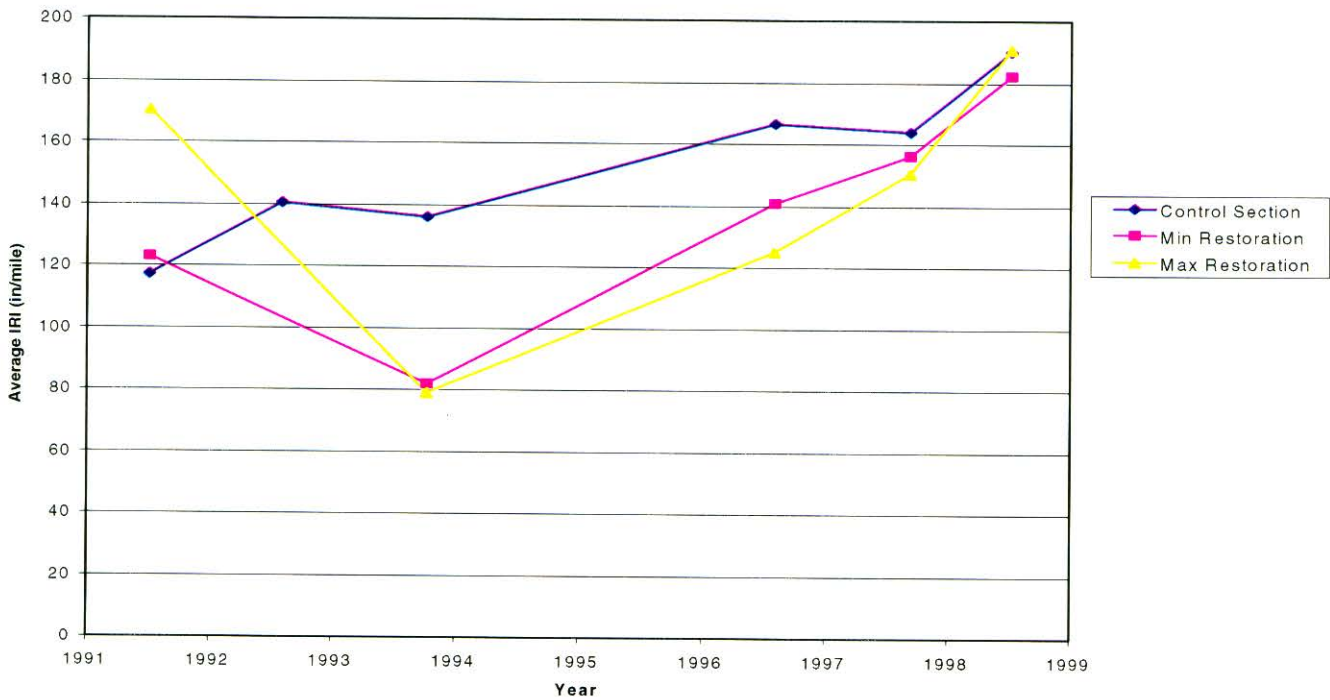
**FIGURE 6** I-35 SPS-6 test section IRI performance history

relates to ride (4). Figure 6 shows how the ride on both the minimum and maximum restoration sections at first decreased substantially to a fairly smooth level, but within seven years deteriorated to a level nearly equal with the control section. The initial IRI measurements were taken prior to restoration. Some full depth patch repairs were performed in 1995, but did not appear to interrupt the progression toward higher IRIs.

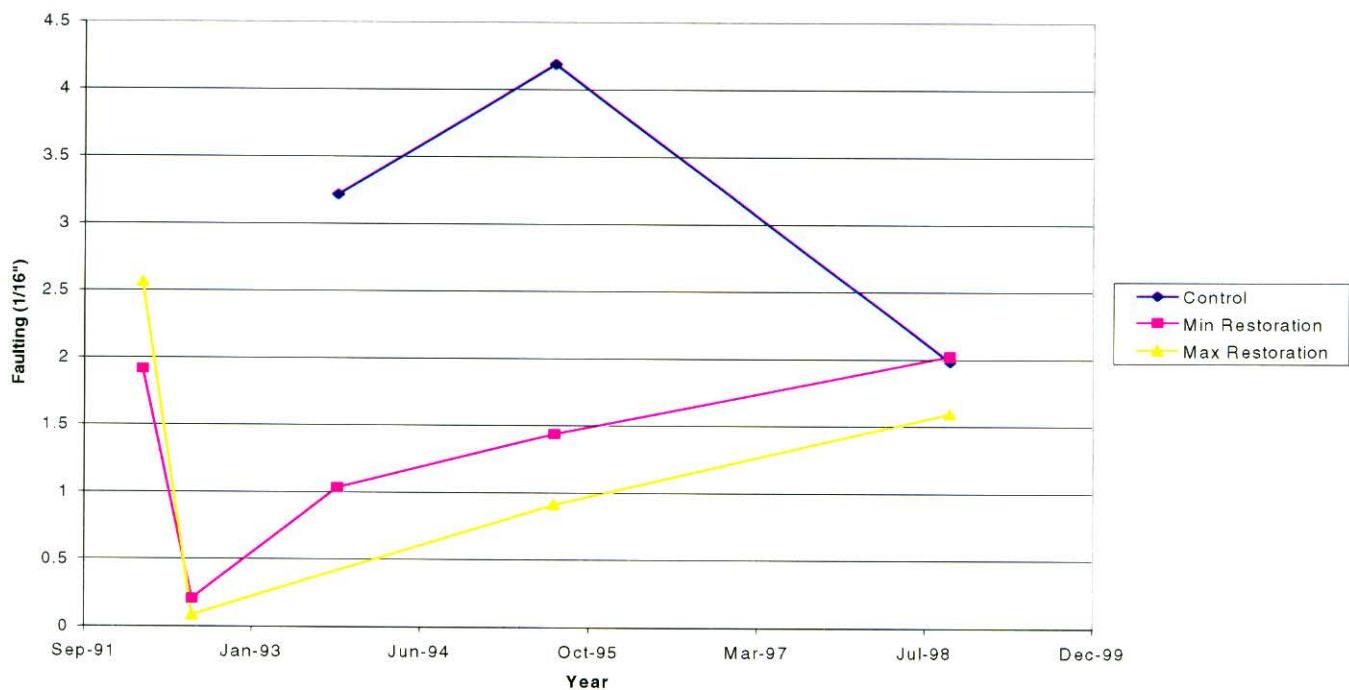
**FIGURE 7** I-35 SPS-6 test section faulting performance history

Prior to construction, faulting did not exceed 5/16" at any location on the minimum restoration section and did not exceed 7/16" at any location on the maximum restoration section. The results of the subsequent surveys are shown in Figure 7. The August 1992 survey, conducted soon after construction, indicates virtually no faulting at the joints of the two restoration sections. The full depth patch repairs performed in 1995 occurred mostly at transverse cracks and did not result in any noticeable improvement in joint faulting. The control section underwent multiple maintenance repair operations, which explains the noticeable improvement after 1995. Average wheel path faulting measured during the last survey shows the three sections approaching the same value.
