# Failure Analysis of a Kaplan Turbine Runner Blade by Metallographic and Numerical Methods

**Abstract:** The paper presents the results of the failure analysis of a Kaplan turbine runner blade from a hydropower station in Romania. In order to determine the causes that led to the crack, the authors carried out metallographic investigations on a sample obtained from the damaged blade. They led to the conclusion, that the cracking of the blade was caused by fatigue, initiated by the numerous non metallic inclusions, which were discovered in the vicinity of the blade surface. The results obtained by metallographic investigations were completed by numerical analysis regarding the resistance of the blade and service life estimations. The calculations showed that the cracking of the blade started and developed from the stress concentrator placed between the blade and blade flange. In order to avoid further damages, the blade geometry and the number of blades have to be reconsidered.

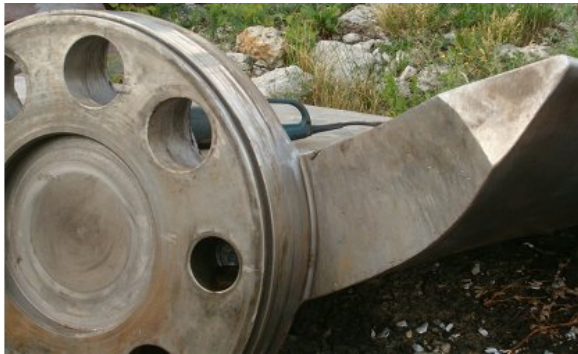
The analysis regarding the working conditions showed that the cracking occurred (Fig. 1) in one of

the turbines from hydropower plants cascade, which operated at a higher head than the rest.

**Fig.1** The cracked runner blade

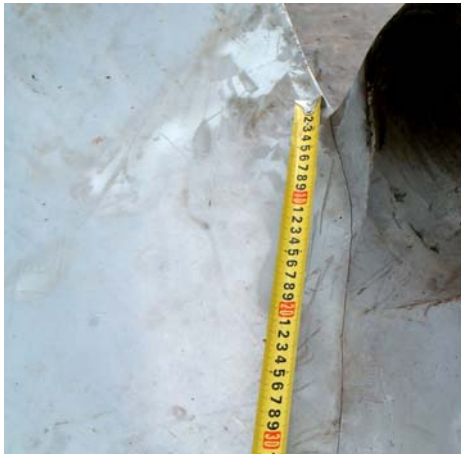
Fig.2 shows the path of the investigated crack, which penetrated the blade and developed to a final length of 600 mm, measured on the pressure side.

**Fig.2** The crack on the pressure side

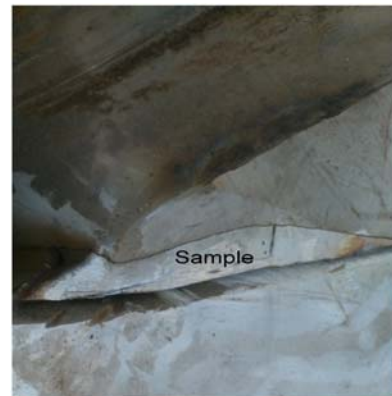
The sample for metallographic investigations was cut from the cracked blade as indicated in Fig.3.

**Fig.3** Position of the metallographic sample

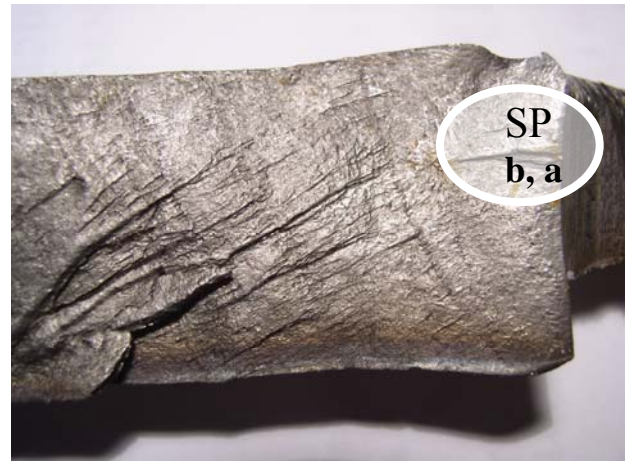
The macroscopic examination of the fracture surface (Fig. 4), revealed the specific appearance of fatigue cracking [1]. The surface is smoothened, resulting from the relative friction of the two pieces of the cracked blade one upon the other, during the alternative loads. The positions of the fan-shaped striations indicate that the cracking started from the region marked with “SP” (starting point) in Fig.4. The SEM-micrographs of the regions marked with “a” and “b” are presented in Fig.5.

**Fig.4** Macrograph of the fracture surface

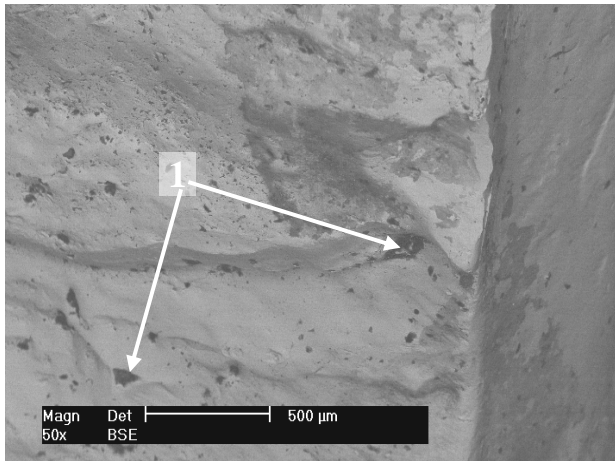
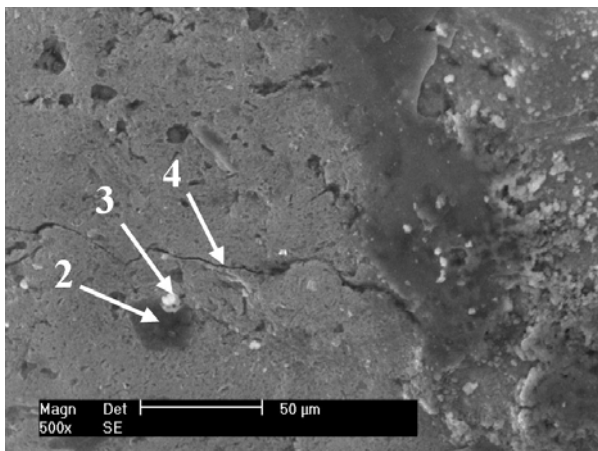
**Fig.5** SEM-micrographs of the fracture surface

The images shown in Fig.5 indicate a high content of non-metallic inclusions in the blade material (marked with 1 in Fig.5.a). During the crack propagation, the operating water determined the corrosion of the base material surrounding these inclusions. As a consequence, the non-metallic inclusions released from the surface, leaving craters behind (position 2 in Fig.5.b), which were filled in with corrosion products (position 3 in Fig. 5.b).

In the surface of the investigated sample numerous secondary cracks (as marked by 4 in Fig.5.b) were observed, which are specific for fatigue cracking [2], [3].

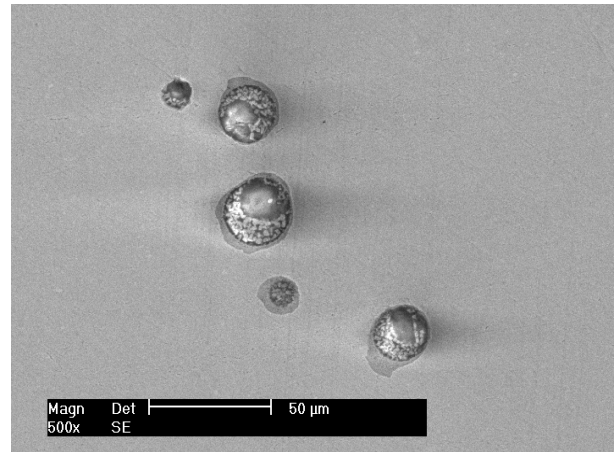
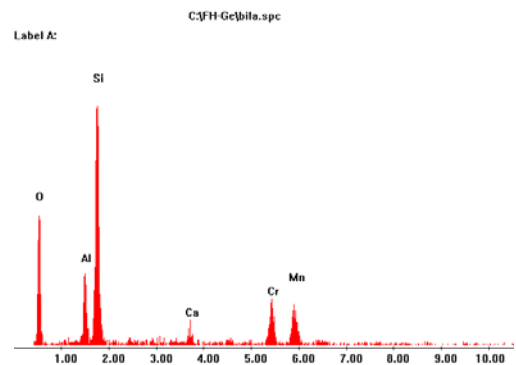
**Fig.6** Non-metallic inclusions in the vicinity of the crack surface

After SEM-examination, the crack surface was grinded, polished and examined with the scanning electron microscope (Philips XL30 ESEM). Globular non-metallic inclusions could be observed, as well as the surrounding corrosion attack of the metallic material (Fig.6.a). The XRD-analyze led to the conclusion, that these inclusions are silicates and oxides (Fig.6.b).

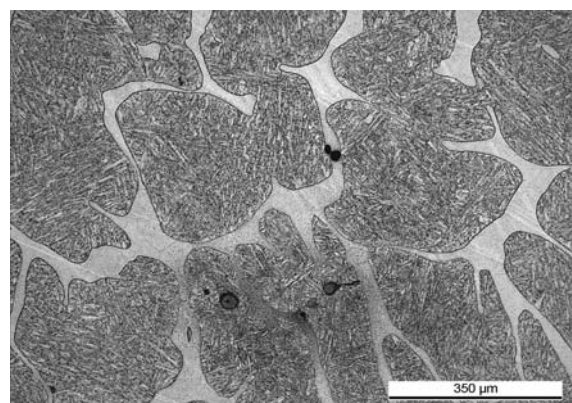
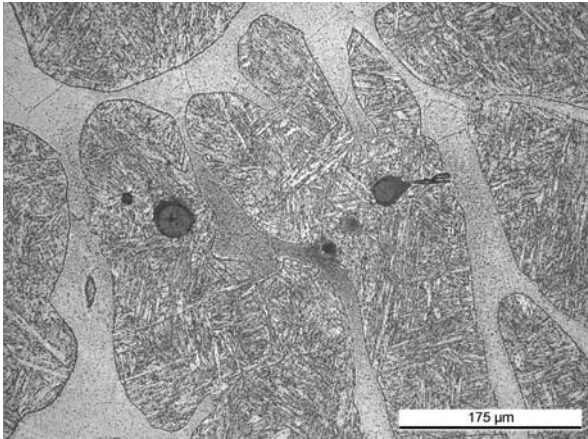
**Fig.7** Structure of the blade material

In order to visualize the structure of the blade material, the sample was etched using a V2A-solution and was examined with the light microscope (LEICA DM 6000M). As shown in Fig.7, the microstructure is consisting of martensite, containing a high percentage of ferrite, with grid-like distribution. The presence of numerous non-metallic inclusions is attested also by these images.

The metallographic investigations led to the conclusion that the cracking of the blade was caused

by fatigue and was initiated by non metallic inclusions existing in the vicinity of the blade surface. The crack propagation occurred gradually, through development of the principal fracture front. Because of the high content of non-metallic inclusions and the inhomogeneous structure of the blade material, additionally numerous secondary cracks developed inside the material.

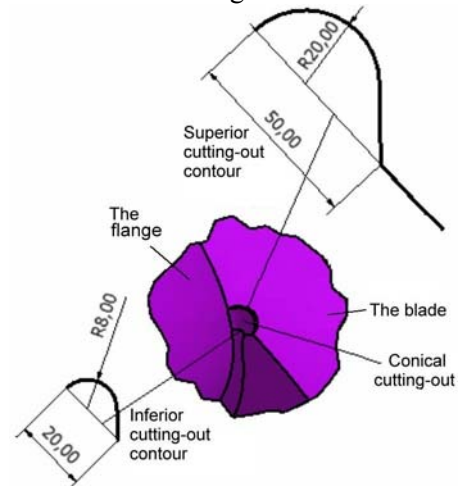
**Fig.9** The geometry of the stress relieve groove R20x50

To reduce the maximal stress values, the geometry of the stress relieve groove was modified from R8x20 to R20x50, Fig.9. The results are numerically shown in Table 2.

Table 2 presents a reducing of the Von Mises stress values for a power range of 30...15 MW, but not enough to promote the solution. In these circumstances, the blade loads can be reduced by blade number increasing. Table 3 shows the numerical results for stress relieve groove R8x20

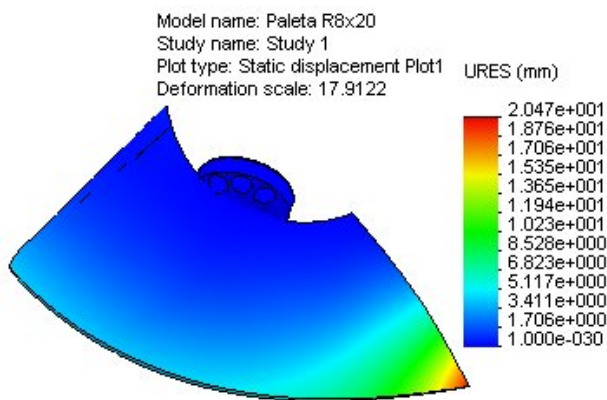
**Fig.15** The resultant displacement plot

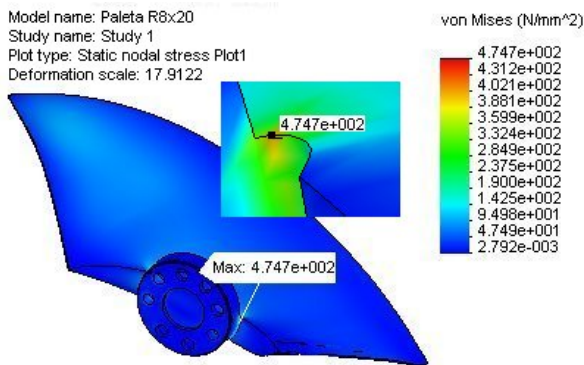
**Fig.16** The Von Mises stress plot

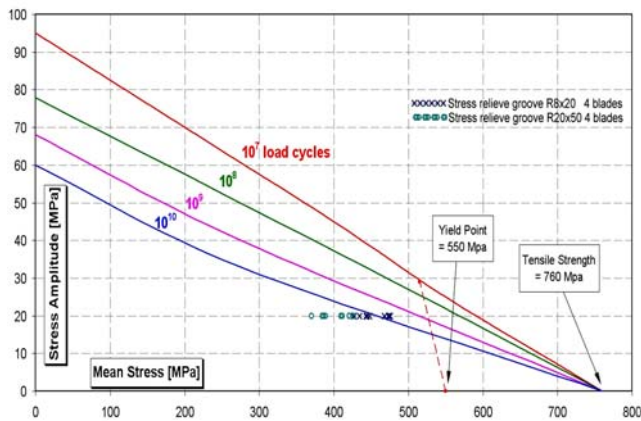
Fig.17 The Haigh diagram

For service life estimations a standard procedure for hydraulic turbine is used, for the operating points with maximal stress values. The amplitude oscillation for Kaplan blade turbine is experimentally obtained and is around 20 MPa. The yield strength value of the blade material is  $R_{p0.2} = 550$  MPa. The calculated values of the stress for stress relieve groove R8x20 and R20x50 and 4 blades were introduced in Haigh diagram, Fig. 17 [4].

From the Haigh diagram results that, for stress relieve groove R8x20, the blade cracks should be obtained between  $10^9 \div 10^{10}$  of the fatigue cycles. To reduce the stress concentrator values, a number of different stress relieve groove geometry were studied. The optimal solution was obtained for stress relieve groove R20x50, where the stress values were reduced in the range between 45...60 MPa (see

The results from Fig.17 are ideally, because the fatigue curves are obtained in laboratory for samples with controlled chemical composition and homogeneity, with no fissures and surfaces or deeply defects. For these reasons, in service life estimations and fatigue calculus is recommended that the stress concentrator values will not be higher than half of yield strength value of the material, in our case 275 MPa.
