Failure Analysis of Dielectric Breakdowns in Base-Metal Electrode Multilayer Ceramic Capacitors

Ronald J. Weachock
Dell System Federal Government, Inc.
NASA Goddard Space Flight Center
Greenbelt, MD 20771
Ronald.j.weachock@nasa.gov

David (Donhang) Liu
MEI Technologies, Inc.
NASA Goddard Space Flight Center
Greenbelt, MD 20771
Donhang.liu-1@nasa.gov

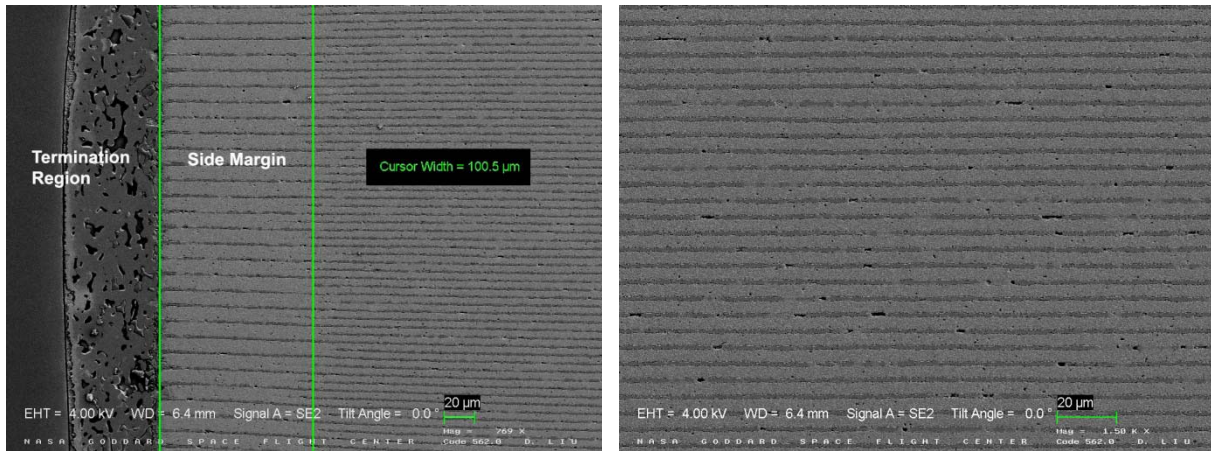
Figure 1 shows the low-magnification SEM images that have been used to determine the capacitor geometry and the overall quality of the product. The cross-section SEM images reveal a uniform structure without obvious processing flaws, with the exception of some internal electrode pull-out caused by the de-processing of the samples. The construction information was examined according to Electronic Industries Alliance (EIA) Standard EIA-496.

Figure 1. Low-magnification cross-section SEM images of BME capacitor B08X56416 for construction analysis. No processing flaws were revealed, with the exception of some internal pull-out due to sample de-processing.

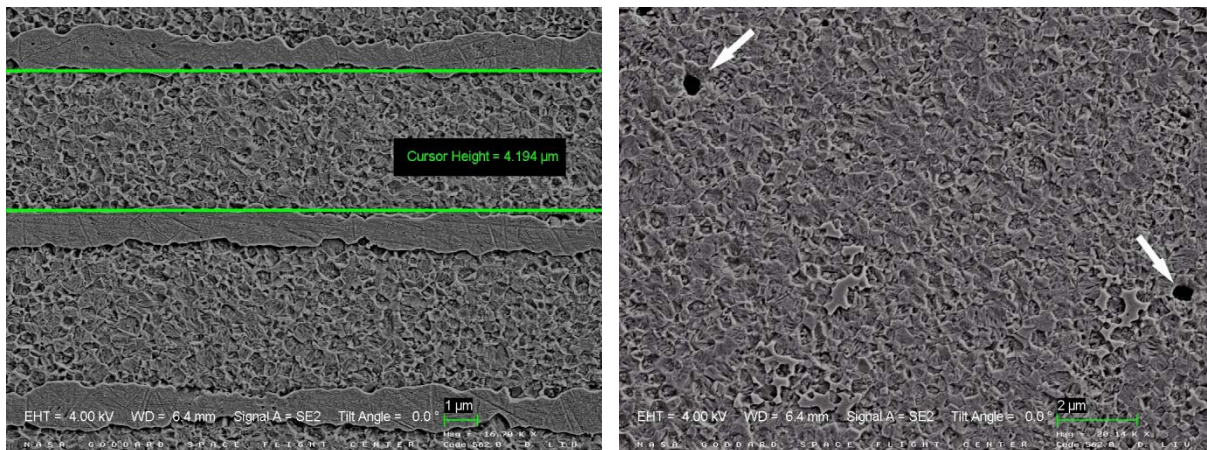
Typical high-magnification SEM images are shown in Figure 2. The dielectric layer appears to be dense and uniform, with an average layer thickness of 4.2μm and an average grain size of 0.36μm, with a maximum of 0.4μm measured. No dielectric cracks, either long-range or short-range, were observed in any of the samples. Some minor voids could be observed in the dielectric matrix (indicated by arrows).

Figure 2. High-magnification cross-section SEM images of BME capacitor B08X56416 reveal a uniform microstructure. Arrows indicate occasionally observed voids in the dielectric.

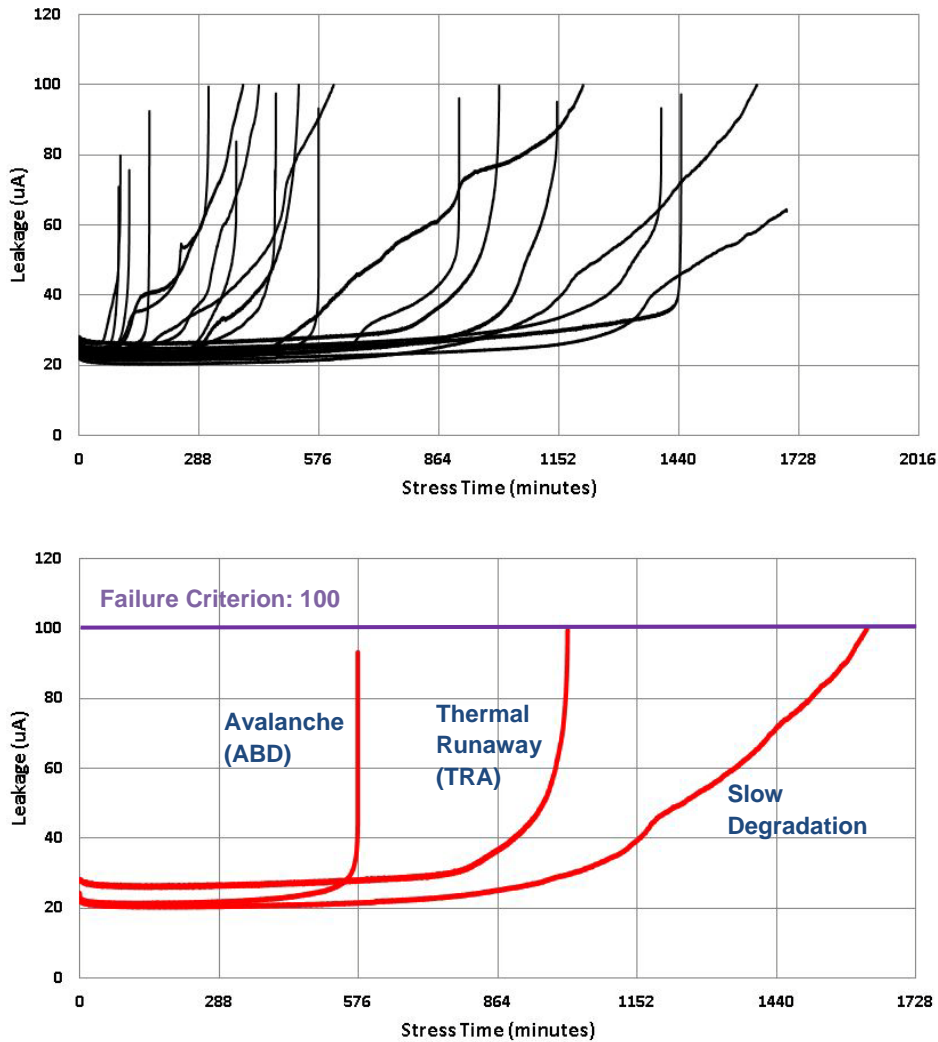
Table II summarizes the HALST conditions and corresponding failure modes with respect to those shown in Figure 3. The DC resistance of the failed BME capacitors was also measured prior to sample preparation for failure analysis. In general, the parts with TRA and slow degradation failures showed low resistance with an occasional short, and those that failed with ABD often failed with an electric short.

Figure 3. Three distinguishable failure modes observed in a typical leakage current measurement of BME capacitors.

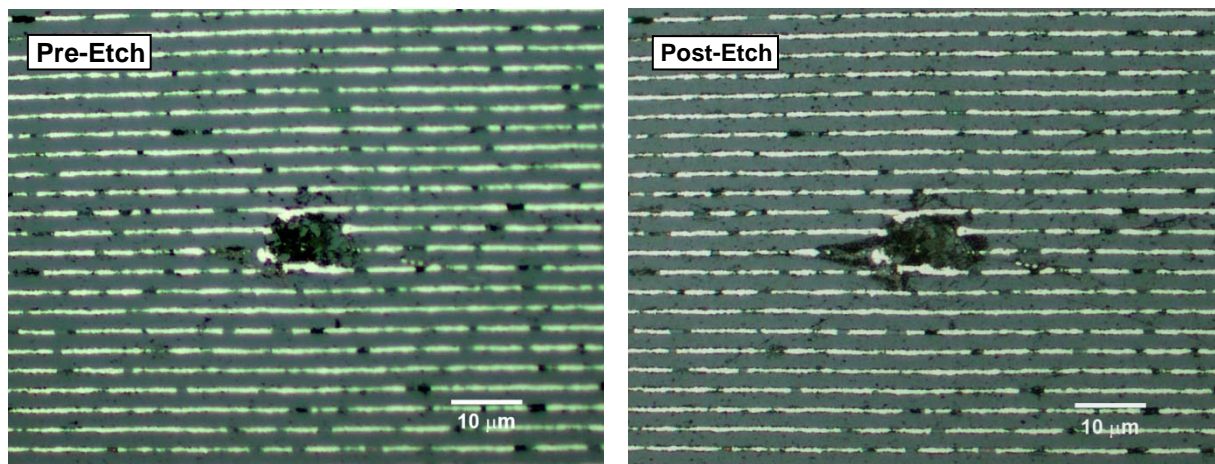
Optical images of sample SN1 before and after etch are shown in Figure 4. A damaged failure site was easily located. The etched image clearly delineates the long-range cracks that cross several dielectric layers, offshoot from the damage site. A high-magnification SEM image and corresponding EDX mapping result are shown in Figure 5. A high concentration of carbon was identified inside the failure site, and the carbon distribution was not uniform. Since no carbon-containing material (including polish media) was used in de-processing the FA samples, the localized carbon residuals detected by EDX scan are likely from the binder particles that were introduced during the dielectric sheet casting.

Figure 4. Optical images for SN1 before and after etch. A significant number of cracks are delineated in the etched image.

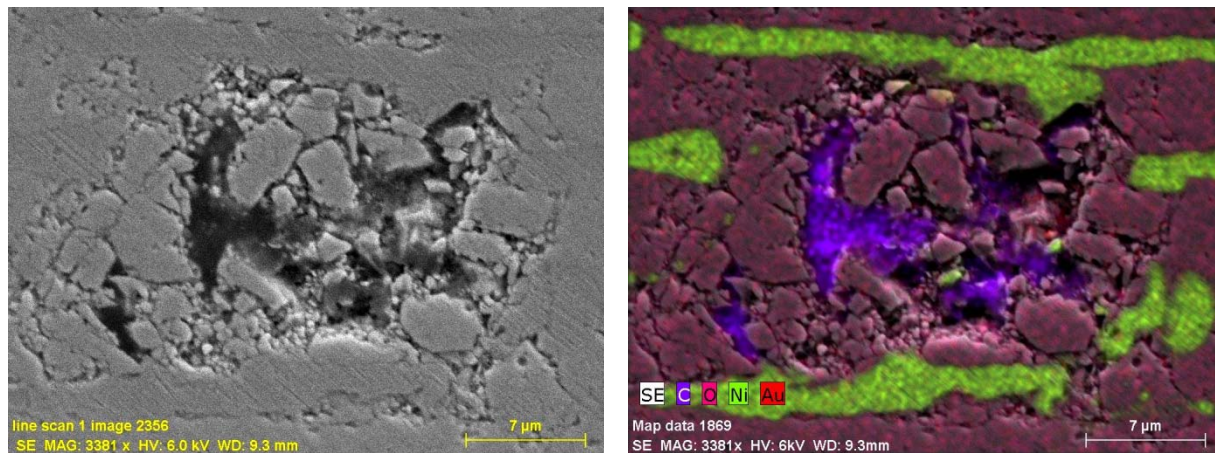
Figure 5. High-magnification SEM photo and corresponding EDX map of the damage site in SN1. EDX mapping of the area shows a high concentration of carbon within.

It is very clear that the ABD failures observed in both SN1 and SN3 may have shared the same failure mechanism: incompletely burned carbon binder residuals that behave as extrinsic defects. In addition, although both samples are characterized as ABD failures, the FA results clearly showed evidence that a high-temperature event also occurred and caused typical thermal damages in both FA samples.

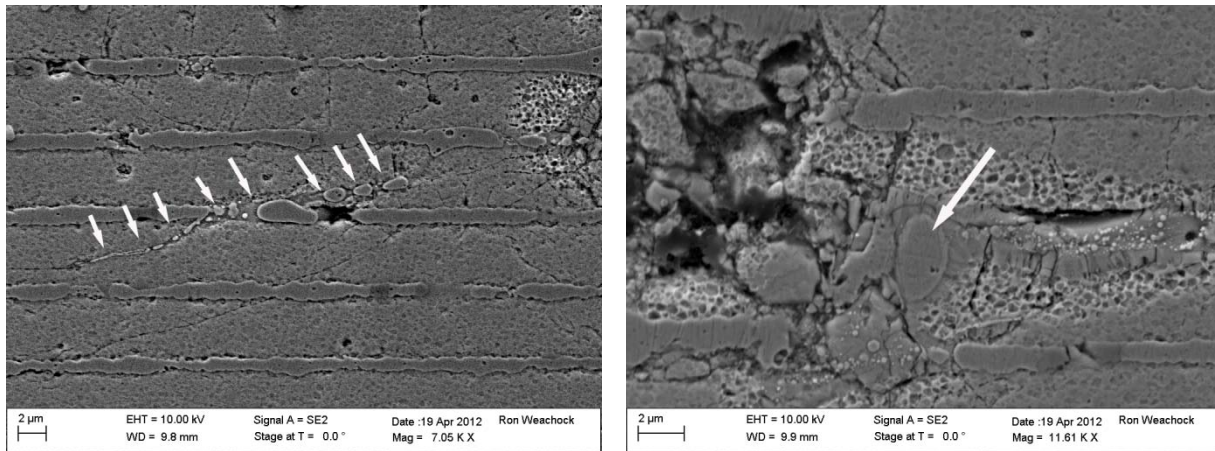
Figure 6 shows SEM images of the post-etched surface morphology of SN1. Arrows indicate the nickel spheres at the damage site that are distributed inside a transverse dielectric crack. This observation strongly supports the assumption that SN1 experienced a high-temperature thermal event that resulted in the melting and recrystallization

of internal nickel electrode material. Since the sample was identified as an ABD failure in the leakage current measurement, the results shown in Figure 6 suggest that even during an ABD process, a thermal event characterized by molten nickel spheres also occurred.

Figure 6. High-magnification SEM photos of SN1 near the damage site. Arrows indicate the conglomerates of Ni spheres distributed at the damage site and inside a transverse crack.

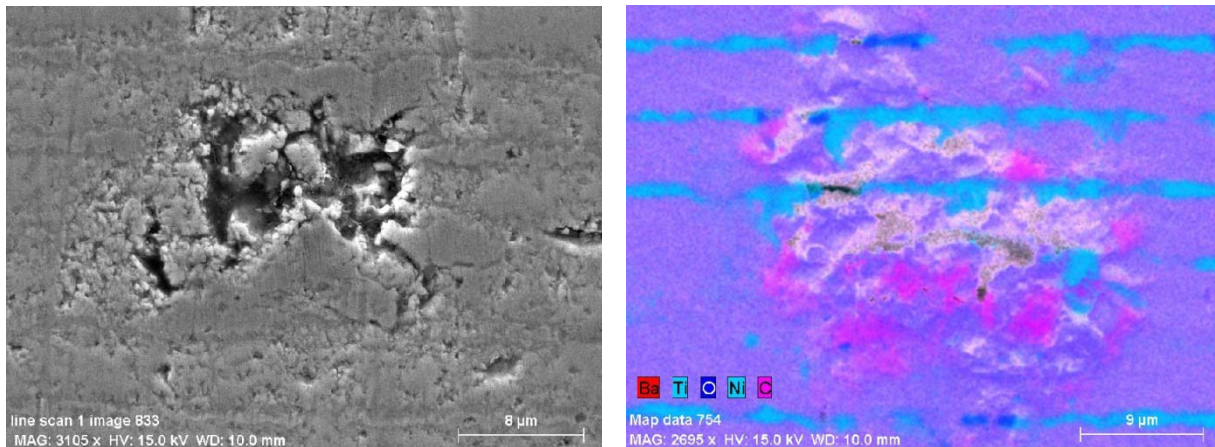
High-magnification SEM image and a corresponding EDX map of ABD-failed SN3 are shown in Figure 7. The size and morphology of the damage site look similar to that of SN1 (shown in Figure 5). Non-uniformly distributed carbon was also identified at the failure site. Figure 8 shows SEM images of the post-etched surface morphology for SN3. Arrows indicate the nickel spheres at the damage site and distributed inside a transverse dielectric crack.

Figure 7. High-magnification SEM photo and corresponding EDX map of the damage site in SN3. EDX mapping of the area shows a high concentration of carbon at the damage site.

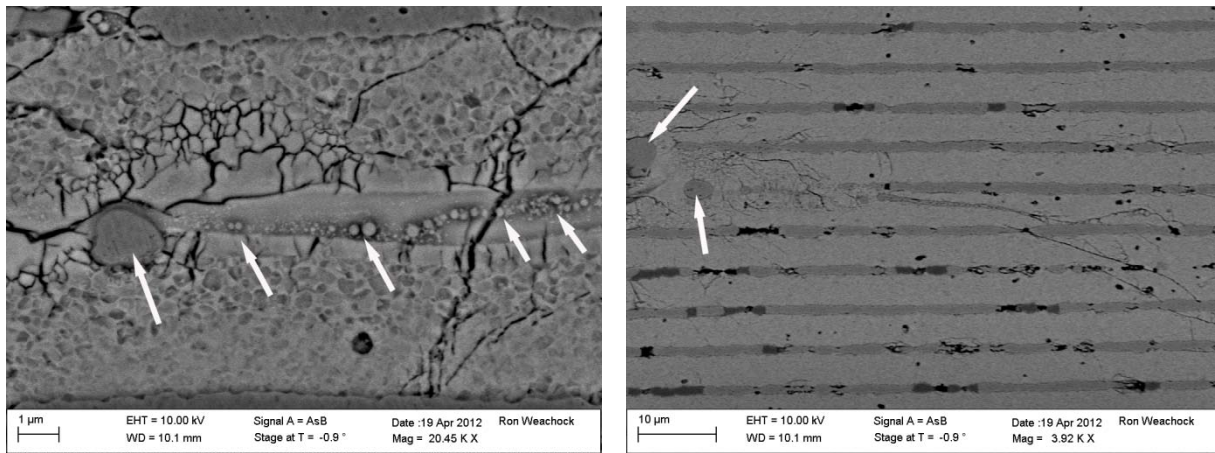
Capacitor SN4 was found to have failed with a resistive short that measured 245Ω. SN4 showed a constant resistance value as the de-processing analysis progressed through the capacitor. An infrared (IR) camera was used to isolate the area of interest. The resultant IR temperature imaging showed the location of the shorted area. A typical IR image that created a visible hot spot at ~4V and ~6mA, and a corresponding optical image identifying the failure site and a long-range crack that traveled through several dielectric layers are shown in Figure 9.

Figure 8. High-magnification SEM photos near the damage site. Arrows indicate the conglomerates of Ni spheres distributed at the damage site and inside a transverse crack.

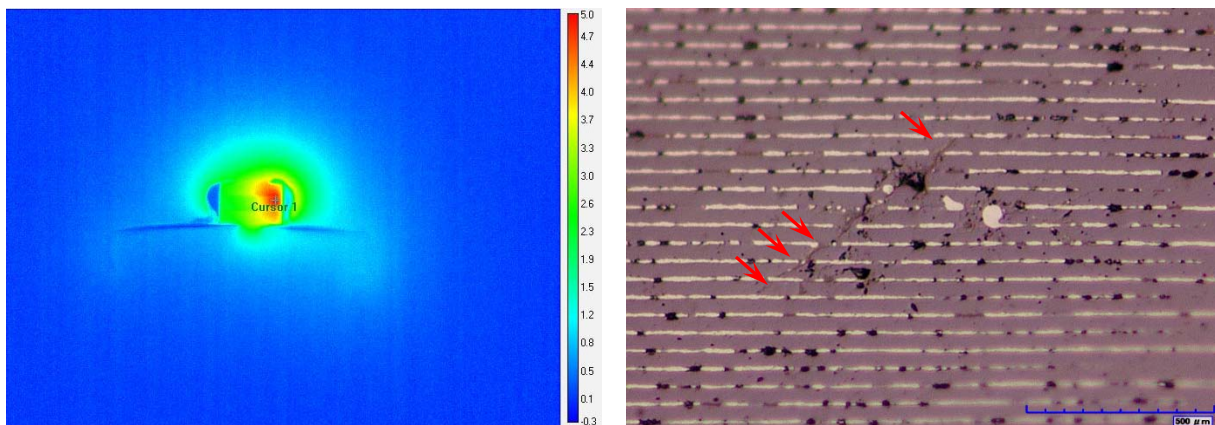
Figure 9. An IR camera image was used to localize the hot spot in SN4 by analyzing the temperature gradient of the heat dissipated by the short (left). The corresponding optical image shows the region isolated by IR images for which a thermal gradient between opposing electrodes, corresponding to vertical shorts between electrodes, was detected. The red arrows indicate the transverse crack (right).

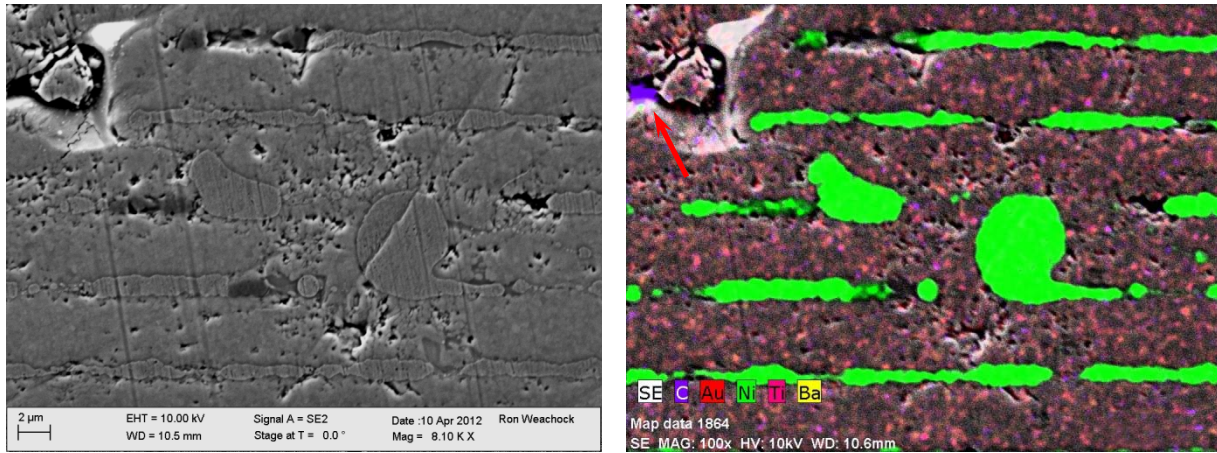
A high-magnification SEM photo and corresponding EDX map of the damage site are shown in Figure 10. The failure site morphology looks similar to that observed for SN1 (Figure 5) and for SN3 (Figure 7), but with a smaller feature size. Again, a localized high carbon concentration and the formation of nickel spheres were both revealed.

Figure 10. High-magnification SEM photo and corresponding EDX map of the damage site in SN4. Arrow in EDX map of the area indicates the high carbon concentration spot. The molten Ni spheres can be clearly identified.

SN4, which failed with TRA, revealed a local hot spot when an IR camera was used to map the temperature distribution in the ceramic body. A high carbon containing spot was also identified at the damage site, but it was much smaller in size when compared to that found in SN1 and SN3 for ABD failures. The failure site was also surrounded with extensive transverse cracks that traveled through many layers of internal nickel electrodes. Degraded dielectric and conglomerates of nickel spheres were also revealed, which is a typical result from a thermal event that generated heat high enough to melt both the local dielectric and the electrodes.

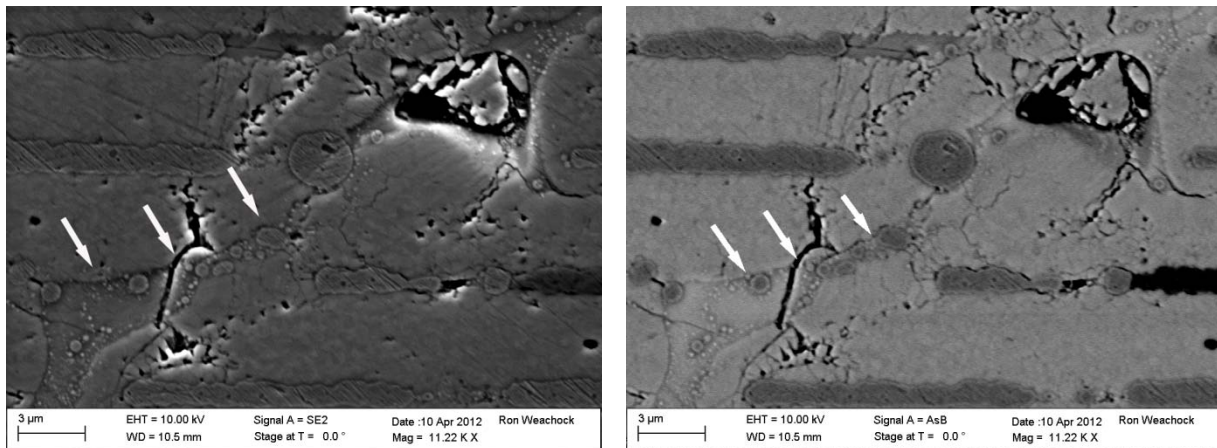
Figure 11 shows SEM images of an area close to the damage site. To better reveal the details of the area, both secondary electron mode (electrons show topography of a sample) and backscatter mode (contrast is due to the difference in the atomic numbers of the materials) SEM images were taken. It is interesting to note that at the lower left corner, a pool of molten material was formed inside an extensive crack, and the conglomerates of a number of nickel spheres are distributed in the molten material. Although the morphology shown in Figure 11 is very similar to that shown in Figures 6 and 8 for the ABD failures, the transverse crack found in SN4 appears to be more extensive, indicating that this sample might have experienced a longer and more intense high-temperature event prior to failing.

Figure 11. SEM images of an area close to the damage site. The left SEM photo was taken in secondary electron mode, and the right photo was taken in backscatter mode. An extensive crack filled with a molten material can be seen at the lower left corner of the image. Arrows indicate the Ni spheres distributed inside the pool.

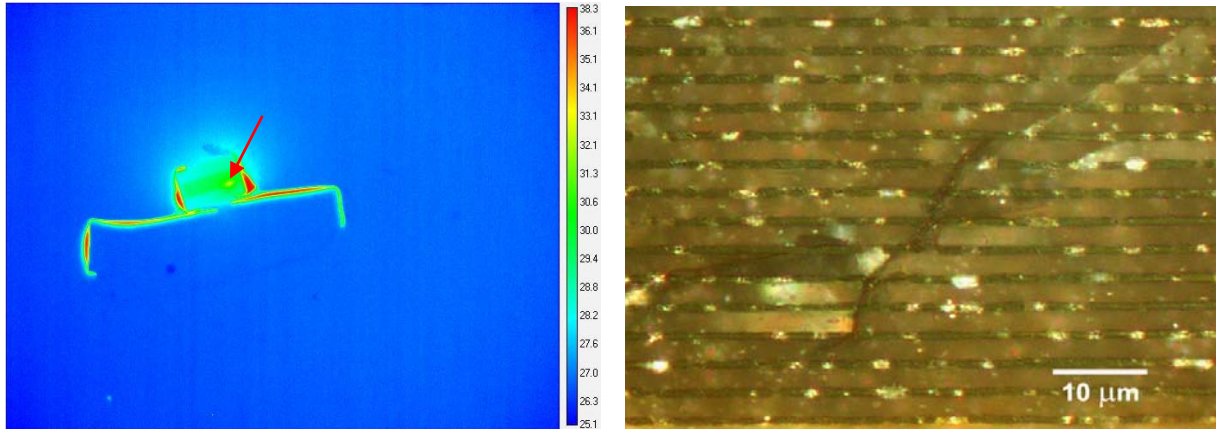
BME capacitor sample SN2, which failed in slow degradation mode, was carefully de-processed using numerous iterations of the steps for material removal. Resistance measurements were taken after each polishing interval to determine whether resistance changes were experienced during the destructive process that could indicate that the defect site had been reached or was in the process of being exposed. The initial resistance was 960Ω and did not change during the material removal process. To assist with the identification of the failure site, an IR camera was used again as 4V was applied and 4mA was measured to the sample to show the temperature elevation in the damaged area and to allow the camera to obtain IR thermograph images and delineate a thermal site of interest. Figure 12 shows the IR optical images that reveal the failure site.

Figure 12. SN2, which maintained a stable resistive short throughout the analysis, was analyzed using an IR camera to localize the hot spot at ~4V, 4mA (left). Physical verification of the IR imaging hot spot location showed vertical dielectric cracks crossing several internal electrode layers (right).

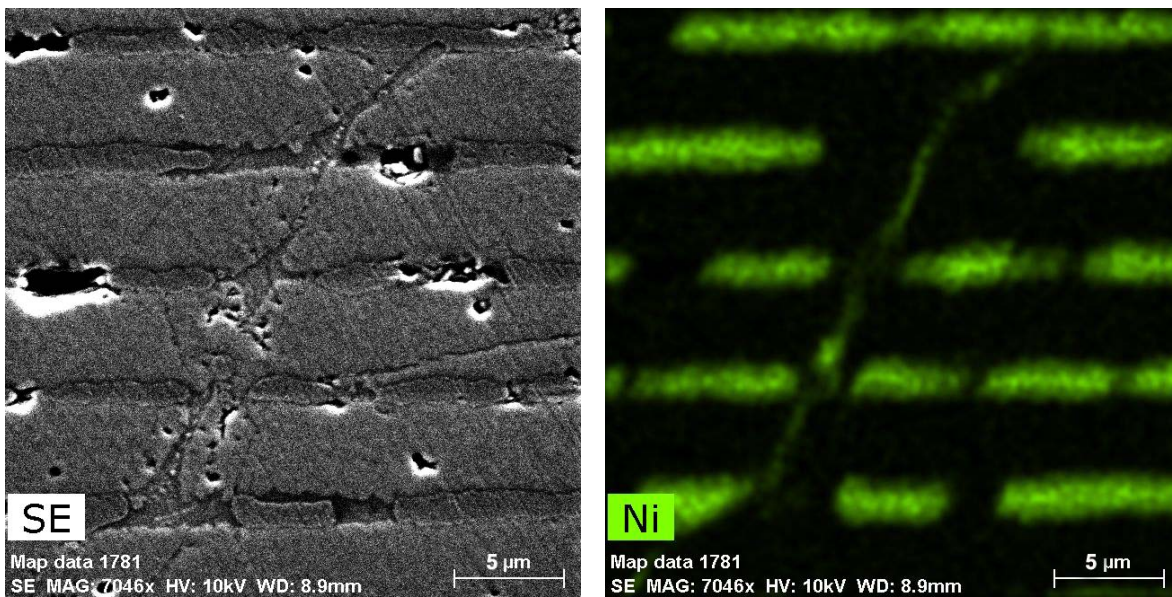
Figure 13 shows an SEM image and corresponding EDX map of the crack area identified in Figure 12. The result clearly shows a nickel bridging crossing several dielectric layers, and this is believed to be the cause of the low resistance measured in the sample. However, it is not clear why such a nickel bridging did not result in a complete electrical short.

Figure 13. High-magnification SEM photo of one region of a large transverse crack crossing several internal electrodes (left). Photo on the right is the corresponding EDS map, showing nickel bridging.

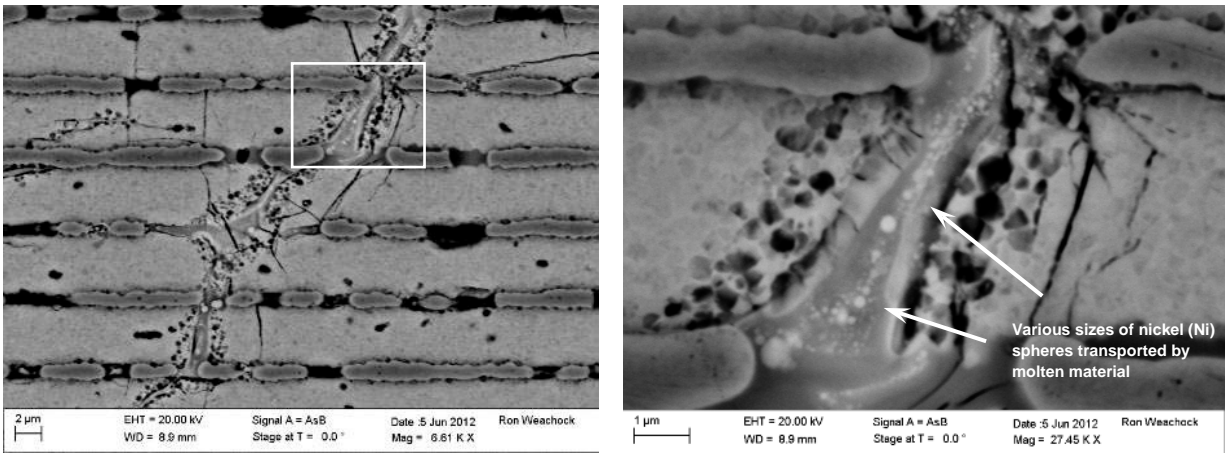
To better understand the failure mechanism in SN2, the area was etched with dilute HF in order to delineate the morphological details. Figure 14 shows SEM images of the same area post-etch. The extensive transverse crack was backfilled with a molten material with a conglomeration of nickel spheres of various sizes. Some hollows in the dielectric region can be observed near the crack. The morphology is clearly a consequence of thermal damage that occurred during the accelerated life stress testing.

Figure 14. High-magnification SEM photo of the same region shown in Figure 13 after dilute acid etch. The transverse crack contains amorphous-looking material that once appeared to be molten and that acted as a vehicle for transporting nickel spheres of various sizes across opposing electrodes.

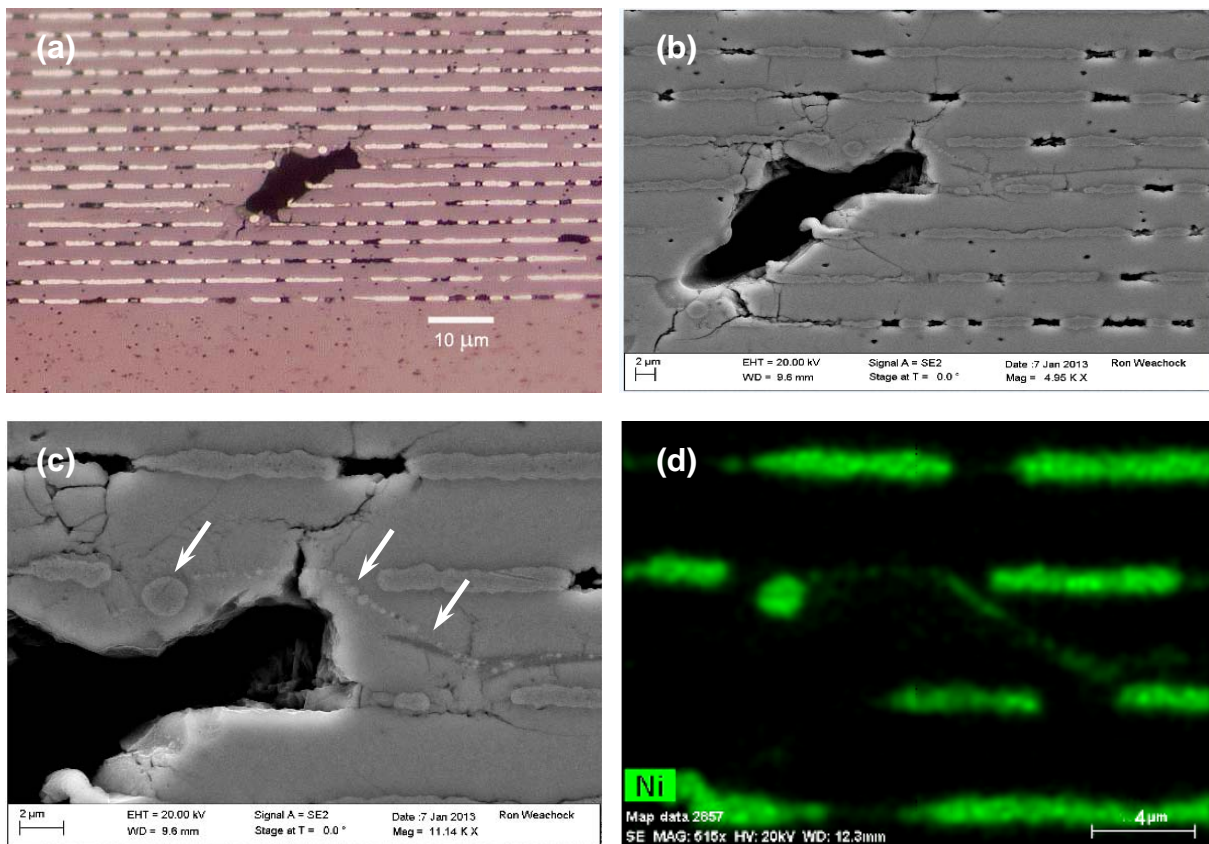
Figure 15 shows a void region when the sample was further de-processed for material removal. The void measured ~25μm long by 8.4μm wide and transverses several dielectric layers. Horizontal and vertical cracks propagate from the void region. Conglomerations of nickel spheres (indicated by arrows and confirmed by EDX mapping) are present in and around the void.

Figure 15. Optical image (a) and corresponding SEM image (b) of a void region due to dielectric degradation caused by localized heating. High-magnification SEM image (c), showing an intermediate cross-sectional plane with accumulation of nickel spheres within the dielectric layer that was confirmed by EDX mapping (d).

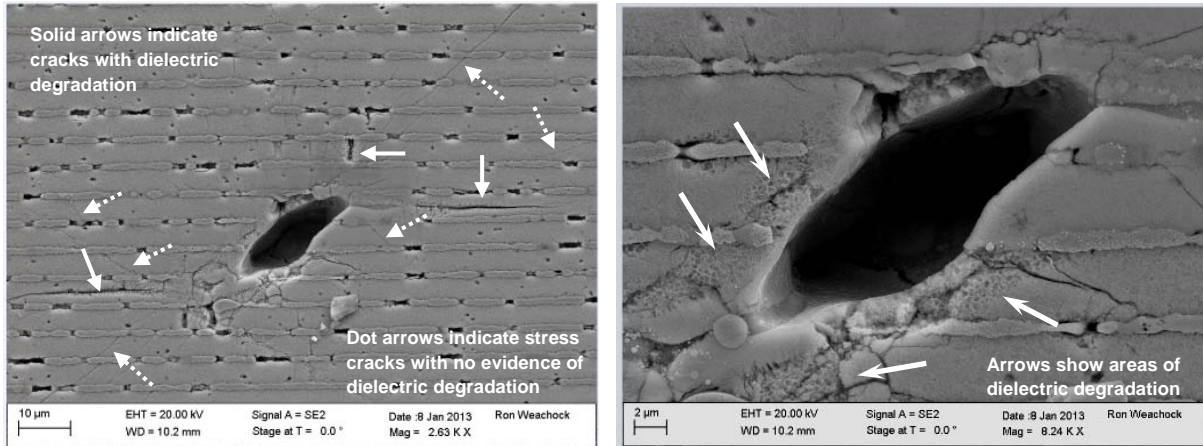
Figure 16 shows SEM images of the void region post-HF etch. The dielectric morphology is delineated and better characterized. Two different types of cracks were revealed: (1) cracks with dielectric degradation that are surrounded by hollow BaTiO₃ grains, and (2) regular stress cracks without dielectric degradation.

Figure 16. SEM images of void dielectric morphology post-acid etch reveal two types of cracks: cracks with dielectric degradation (indicated by solid arrows), and regular stress cracks (indicated by dotted arrows).

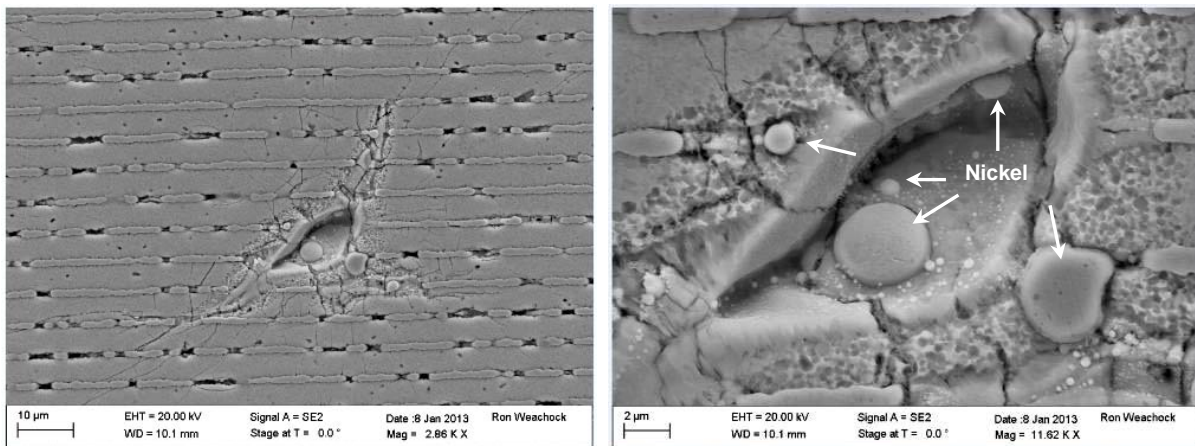
Figure 17 shows SEM images of the void region and the approaching void bottom after several iterations of further material removal. The images were taken after the area was etched to expose possible new evidence of secondary defects. The void walls were covered with a thin layer of amorphous-looking molten material. The large nickel spheres were present in and around the wall, which is apparently the consequence of nickel segregation and recrystallization after temperature had cooled off. There is no other explanation for how such big nickel spheres could be formed.

Figure 17. SEM images of void region after etch. Pools of nickel and degradation of the dielectric are shown. The internal surface area of the void was not affected by acid etch.

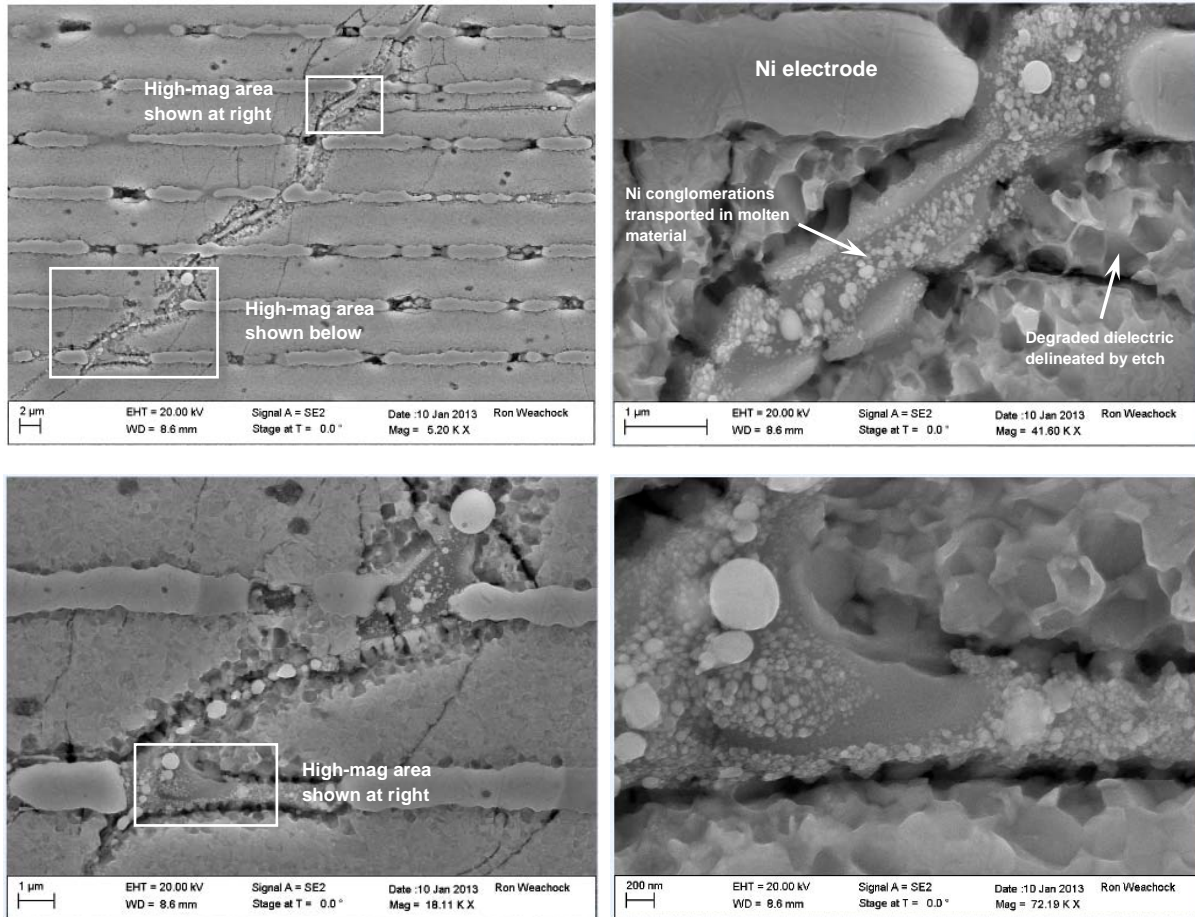
Figure 18 shows SEM images of a cross-section plane beyond the void region. An extensive long-range crack with dielectric degradation was revealed. Two selected areas were examined with high-magnification SEM. The results show: (1) nickel conglomerates can only be found in cracks with dielectric degradation; (2) no trace of nickels are found in stress cracks; (3) nickel spheres are always distributed on the surface of the molten dielectric, and (4) the molten dielectric is always surrounded by hollow BaTiO₃ grains that are formed by thermal degradation.

Figure 18. SEM images, showing post-etch dielectric cracks and degradation beyond the void region. Ni sphere conglomerations always were found to be distributed on the surface of the molten dielectric and to be surrounded by degraded BaTiO₃ grains.

The failure analysis results shown in Figures 18 and 19 indicate that slow degradation begins with the electromigration of ionized oxygen vacancies that changes the local stoichiometry of BaTiO₃ grains and causes the local hollowing and melting of BaTiO₃ grains and the formation of cracks. The molten dielectric dissolves the internal nickel electrodes and behaves like a vehicle for transporting the nickel along the transverse cracks and results in a reduction in resistance. Some of the cracks with dielectric degradation will eventually result in a catastrophic failure.

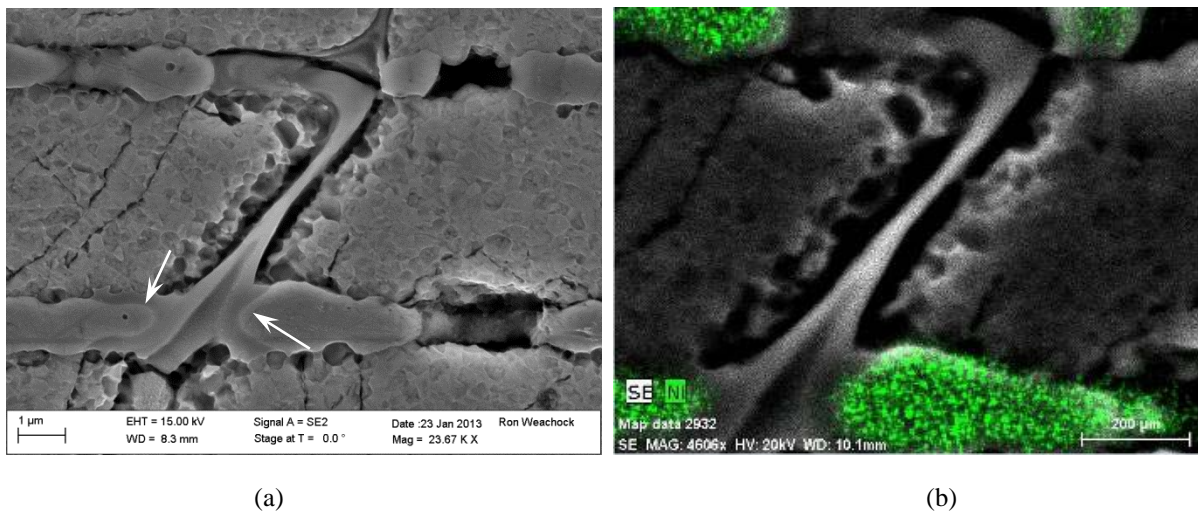
Figure 19 shows SEM images of the damage area post-etch that appears to be in the initial stage of a dielectric degradation. A needle-like molten dielectric material is bridging the adjacent nickel electrodes and is fully in contact with the neighboring nickel material (as indicated by arrows). The molten material is surrounded by hollow BaTiO₃ grains. The corresponding EDX map shows that the bridging material contains only Ba, Ti, and O. There is no evidence of the presence of nickel in the molten material.

Figure 19. SEM image (a) shows post-etch dielectric crack and what appears to be initial-stage degradation. The corresponding EDX map (b) did not reveal any nickel in the crack. However, the nickel electrode is fully surrounded by the molten dielectric (indicated by arrows).

This observation indicates that dielectric degradation began with the melting and traveling of dielectric materials along the cracks. When the molten dielectric was in contact with the nickel electrode, the nickel began to dissolve into the molten dielectric, and the molten dielectric behaved as a vehicle for transporting the dissolving nickel along the transverse cracks, which resulted in an electrical short. However, after the temperature had cooled off, the dissolved nickel segregated from the molten dielectric and solidified on the surface of molten dielectric to form conglomerates of nickel spheres. This observation clearly indicates that there was no nickel migration in the BME capacitors, even under highly accelerated life stress conditions being used in this study.
