# **FAILURE BEHAVIOR OF PIPING SYSTEMS WITH LOCAL DEGRADATION UNDER EXCESSIVE SEISMIC LOAD**

## **Abstract**

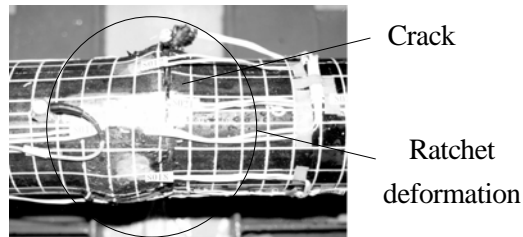
**Fig.5 Typical failure mode of the thinned wall pipe with internal pressure (EC05, 50% wall thinning)**

The test conditions and the results of the straight pipe element tests are shown in Table 1. The failure mode of the pipes with wall thinning was mainly the fatigue failure accompanied with ratchet deformation (\*1), and that of the pipes with cracks (EDM notch or SCC) was crack penetration caused by the fatigue crack propagation from the initial EDM notch or SCC. Figure 5 shows the typical failure mode of the specimen with wall thinning.

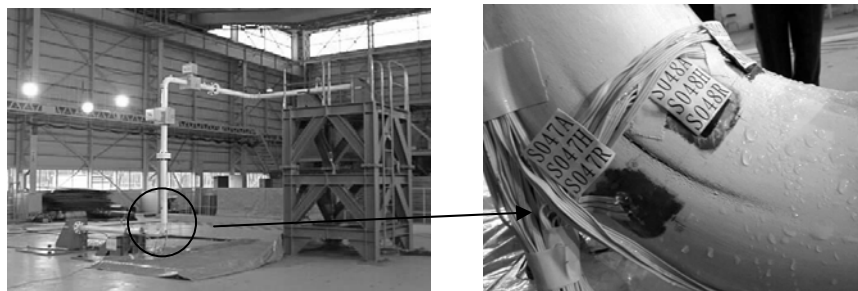
**Fig.13 Fatigue failure at the flank of the elbow**

The test conditions and the results of the piping system tests are summarized in Table 3 and Table 4. The failure mode of the models with wall thinning or without defects is the fatigue failure accompanied with ratchet deformation at the flank of the weak elbow. Figure 13 shows the typical failure mode of these models. The failure mode of the models with EDM notch was the crack penetration for 3D\_D02, and no failure for 3D\_D01. Tables 3 and 4 also show that the dominant frequency of the test model was reduced by the existence of wall thinning, but not by the existence of a crack. Residual deformation was observed in some models, but unstable failure, such as excessive progressive deformation, did not occur except for 3D\_D02, which was the model with a full circumferential 50% EDM notch.
