FAILURE OF A TRACTOR WHEEL -

ANALYSIS BY

ROBERT H. WAGONER AND GERALD S. FRANKEL

March 28, 2010

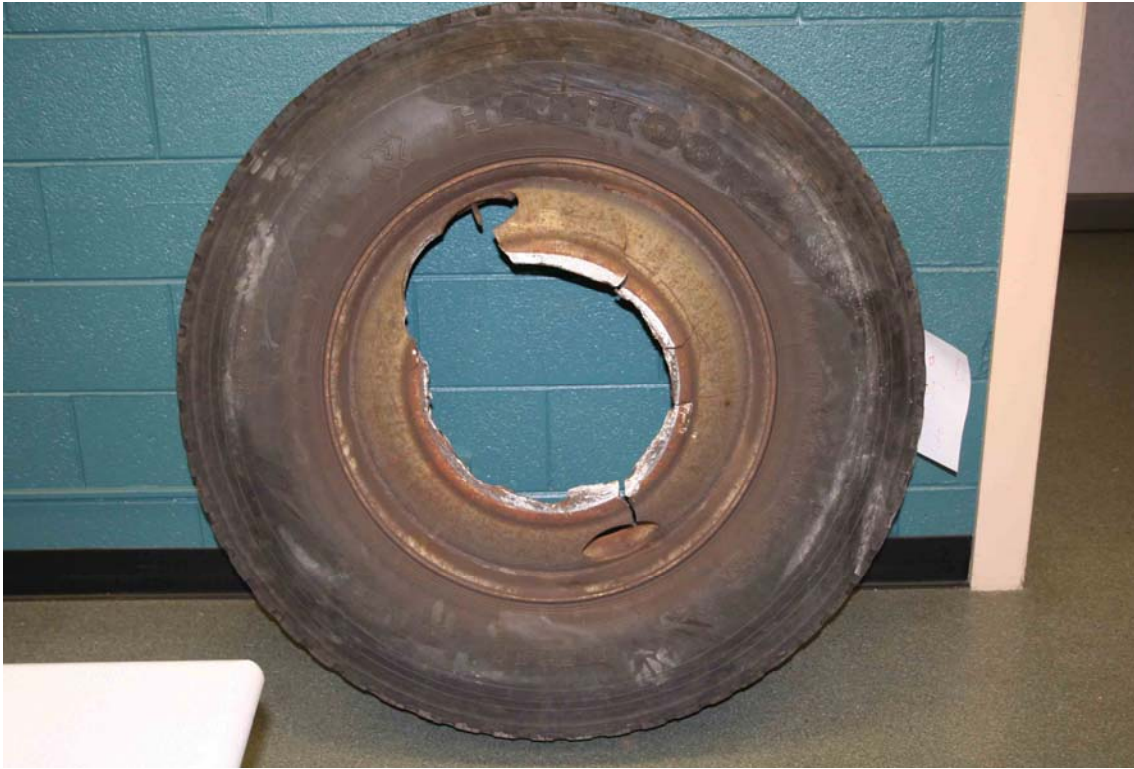
Figure 1-1. Wheel OP IV 1 LowRes.jpg

There is no question of the detachment of the wheel from the tractor at a circumferential crack. See Figures 1-1 and 1-2 for the major portion of the wheel that was detached, and Figures 1-3 and 1-4 for the spider section that remained attached to the tractor. The detachment crack is visible; running through the wheel mounting holes. See Figures 1-3 and 1-4.

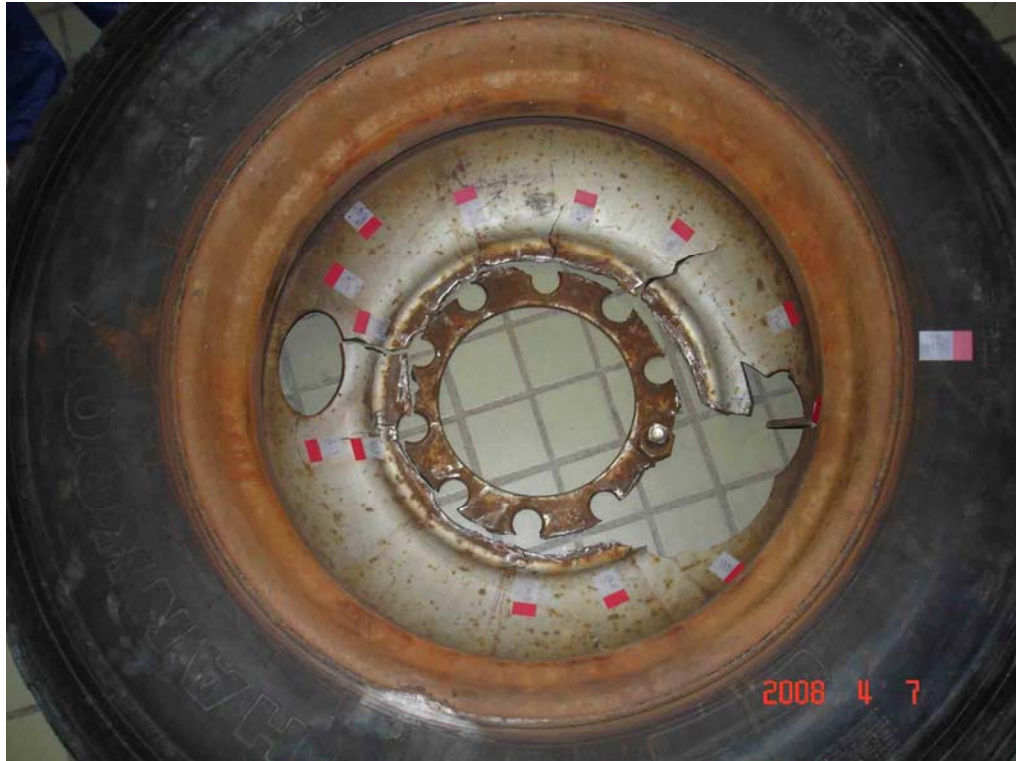
Figure 1-5. DSC01053 LowRes.jpg

Figures 1-5 and 1-6 show the wheel and spider in approximately the orientation before detachment, along with other cracks and the numbering system (clockwise numbers, starting from the fill valve at 12 o'clock when viewed from the outside of the wheel as mounted on the tractor).

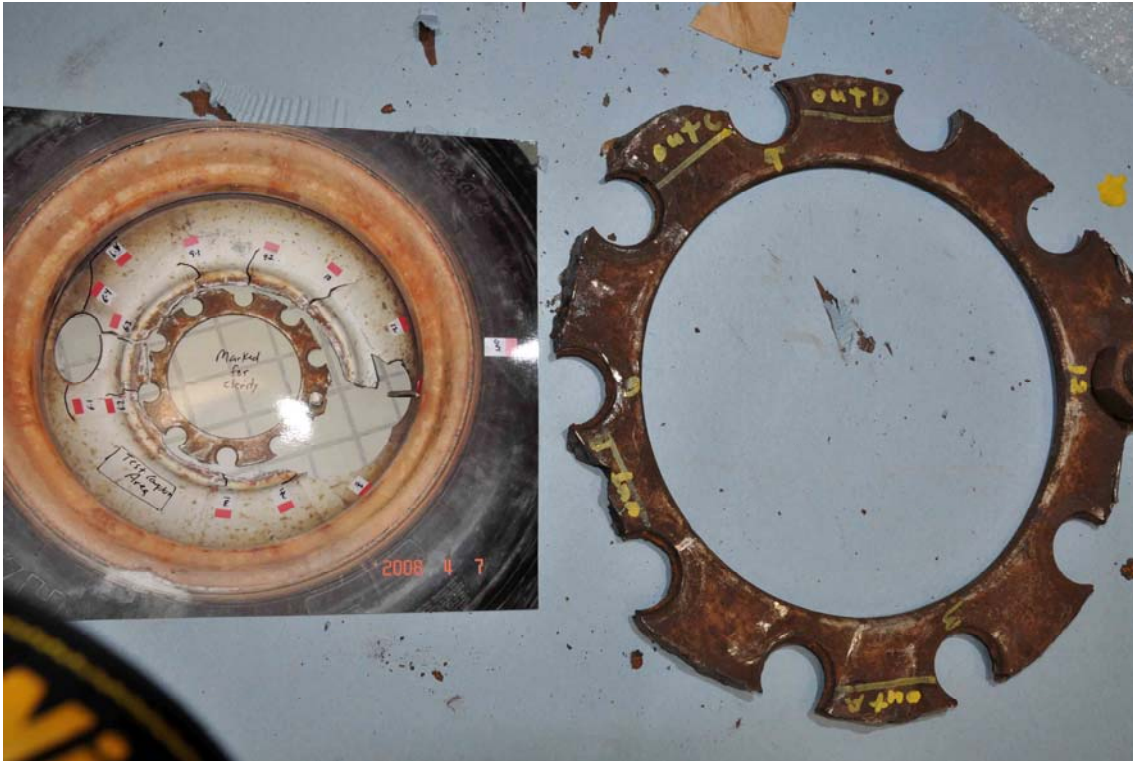
Figure 1-7. DSC_0062 LowRes.jpg

Figures 1-7 and 1-8 show enlarged spider portion of the wheel along with markings used to designate certain areas between the lug nut holes. The marked areas were cut to remove the portions with circumferential crack surfaces for further analysis. Figure 1-7 illustrates the reconstructed relative orientation of the spider relative to the remainder of the wheel based on matching fracture features during the inspection on April 7, 2008.

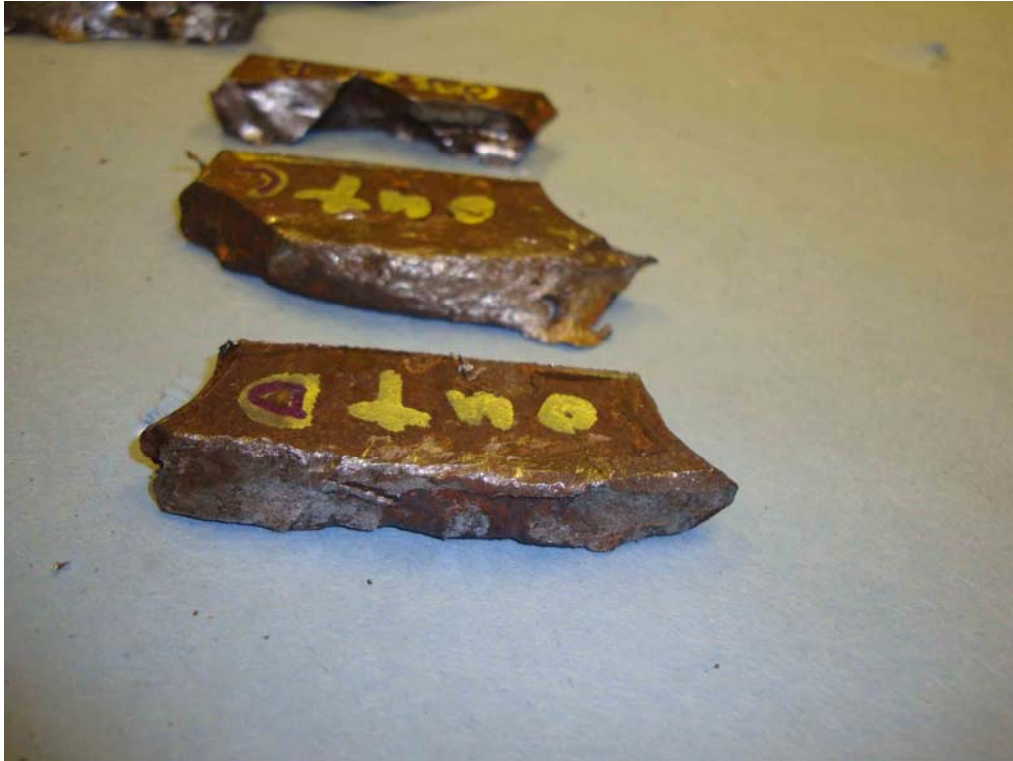
Figure 1-9. DSC00974 LowRes.jpg

Spider section D (Figure 1-9) shows shiny and dull aspects on a single crack surface, indicating existence of the crack surface prior to the detachment, with some portions rubbed shiny at the time of detachment.

Spider section B (Figures 1-9, 1-10, 1-11) shows the presence of a corrosion perforation, or hole, through which the final circumferential crack passed. Portions of the circumferential crack appear shiny, other parts dull, consistent with spider section D.

Spider section C (Figures 1-9 and 1-12) shows two crack surfaces with differing appearance. In Figure 1-12, the left surface is heavily corroded and dull, while the right surface (with propagation at a different angle) has the typical shiny/dull appearance of Spider sections B and D. This appearance corresponds to an older crack originating at the lug hole, and either a younger circumferential crack or one that has been partially rubbed during the final detachment cycles.

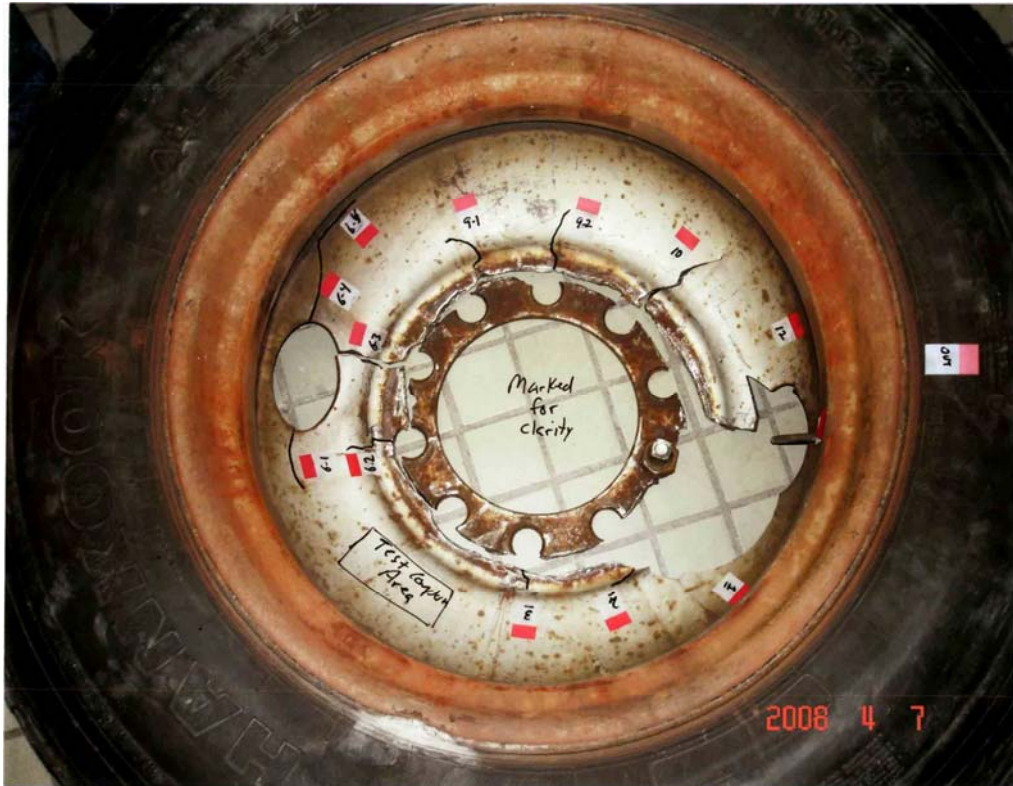
Figure 2-1. Wagoner 6 DSC01053 Scanned Marked

Figures 2-1 and 2-2 show the overall crack pattern on the subject wheel, and the numbering system used to identify them. (Figure 2-1 is the same as Figure 1-5, but the crack paths and original labels have been darkened using a felt marker and the figure was then scanned. This figure was used at the inspections to identify locations.

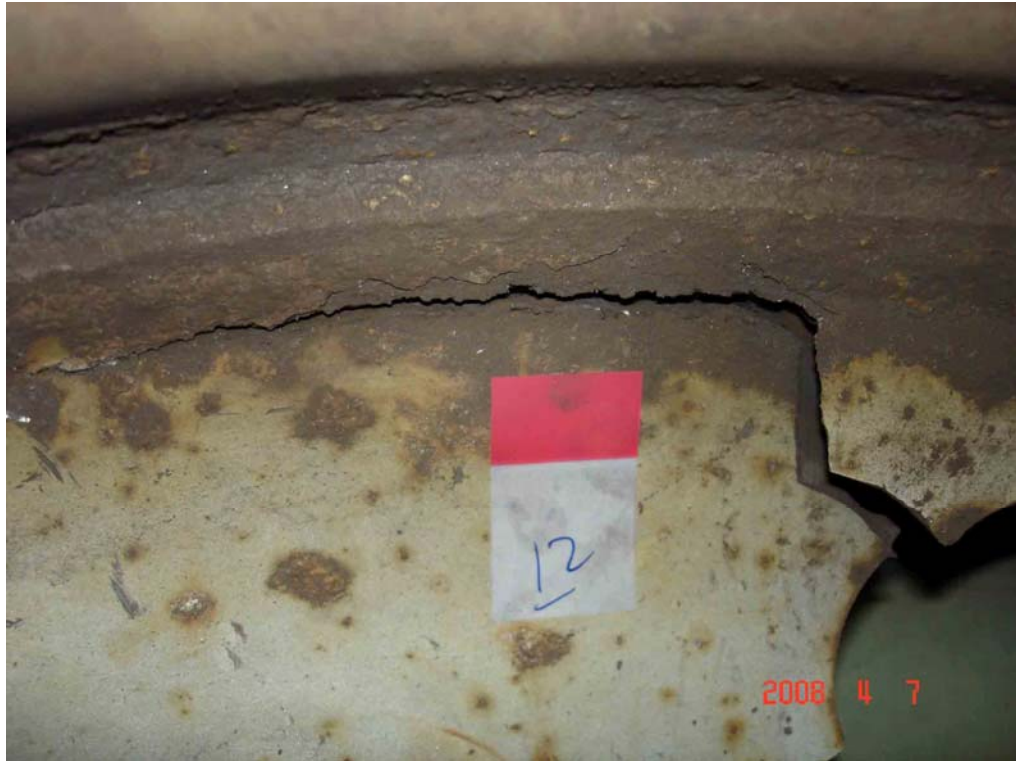
Figure 2-3. DSC01054 LowRes.jpg

Crack 12 was selected for further analysis because it was identified by visual inspection as appearing to be the oldest, most corroded fracture surface remaining. As can be seen in the sketch of Figure 2-2 and the photograph Figure 2-3, it has three distinct crack sections. One is gently curved and runs between the hub and rim portions of the wheel through the weld. One is substantially straight, orthogonal to the hub/rim portion and emanating from it. The remaining crack section is a curved portion emanating from the orthogonal portion that joins the hand hole in the hub area of the wheel. The visual appearance of the hub/rim part of Crack 12 is similar to the highly corroded area on the wheel surface near the crack region, Figure 2-3. The other two sections were also corroded, but without the apparent roughness, heavy oxide thickness and age of the hub/rim portion. The remaining photos in this section and many others available confirm this appearance (see, for example, Figure 2-5).

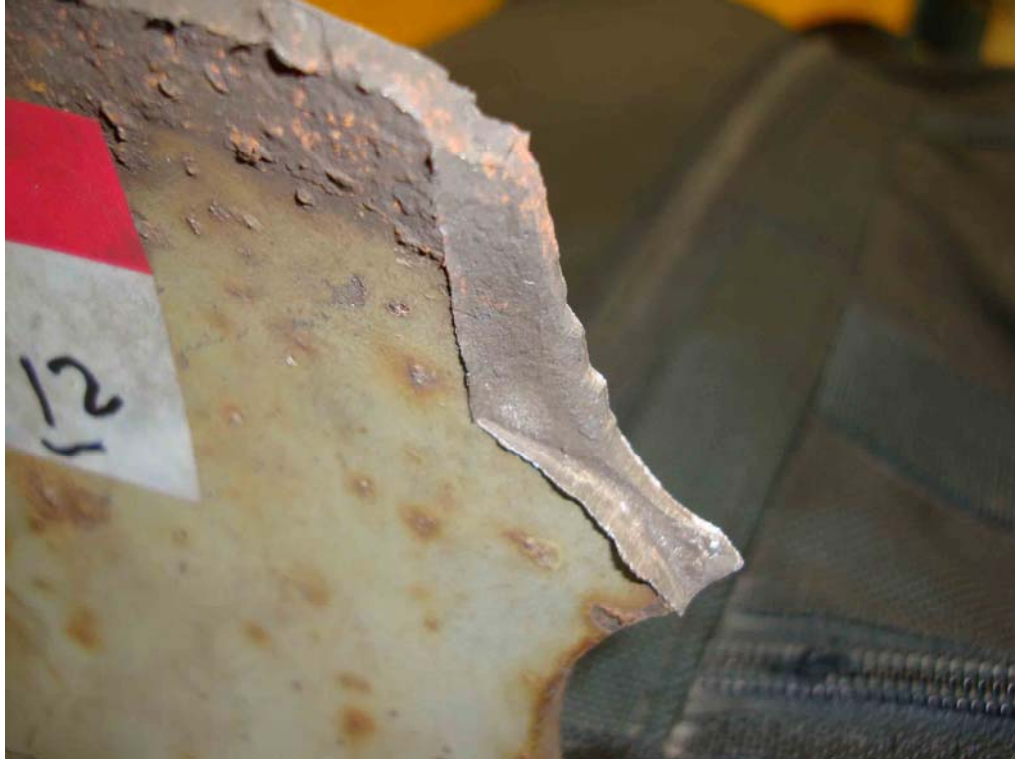
Figure 2-5. DSC00341 LowRes.jpg

Figure 2-5 shows the smoother fracture surfaces in the hub portion of Crack 12 as compared with the hub-rim portion.

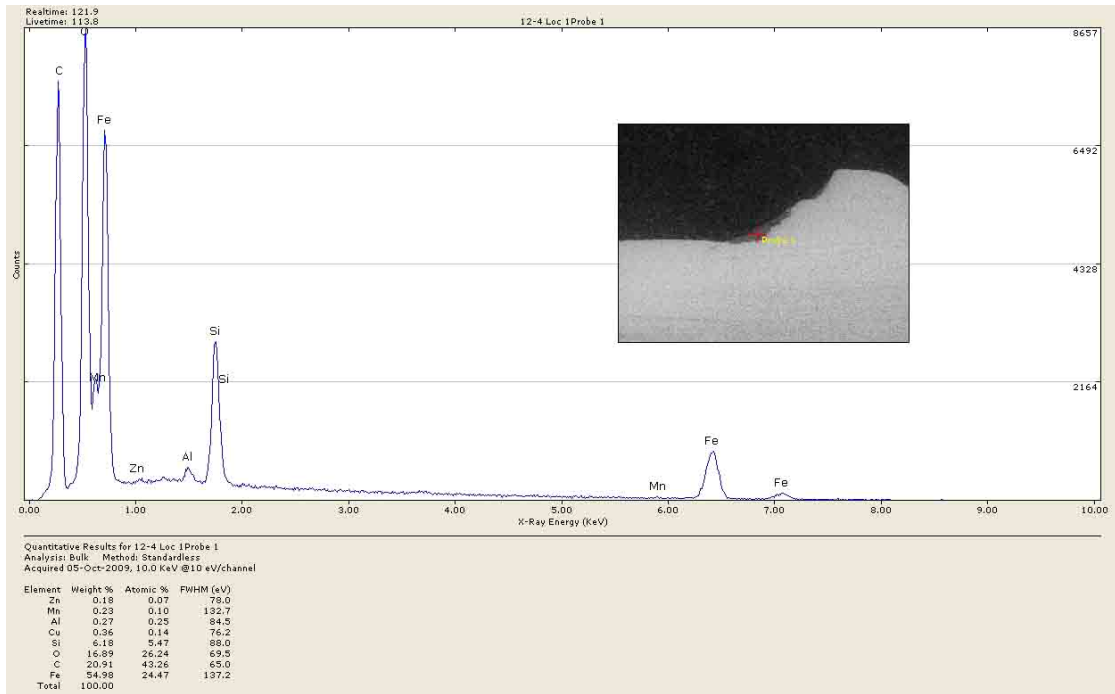
Figure 2-11. 12-4 Loc 1 Probe 1 LowRes.jpg

Figure 2-8 shows the sectioning that was performed to enable finer-scale analysis of Crack 12. Section 12-4 is shown in Figures 2-9 and 2-10 at two magnifications, and Figure 2-11 shows energy dispersive spectroscopy (EDS) results verifying the nature of the oxide. These figures show the following:

- The thickest oxide remaining of the fracture surface is at the center, in a protected, recessed area. Almost no oxide remains on other portions of that section.
- The maximum remaining oxide thickness on this section is 202 μm .
- Other recessed, protected areas show remnant oxide, in this case with thickness of 58 μm .
- Figure 2-9 shows that the oxide thickness on the fracture surface is approximately the same as on the wheel side surface (at the right-hand edge shown in the figure).

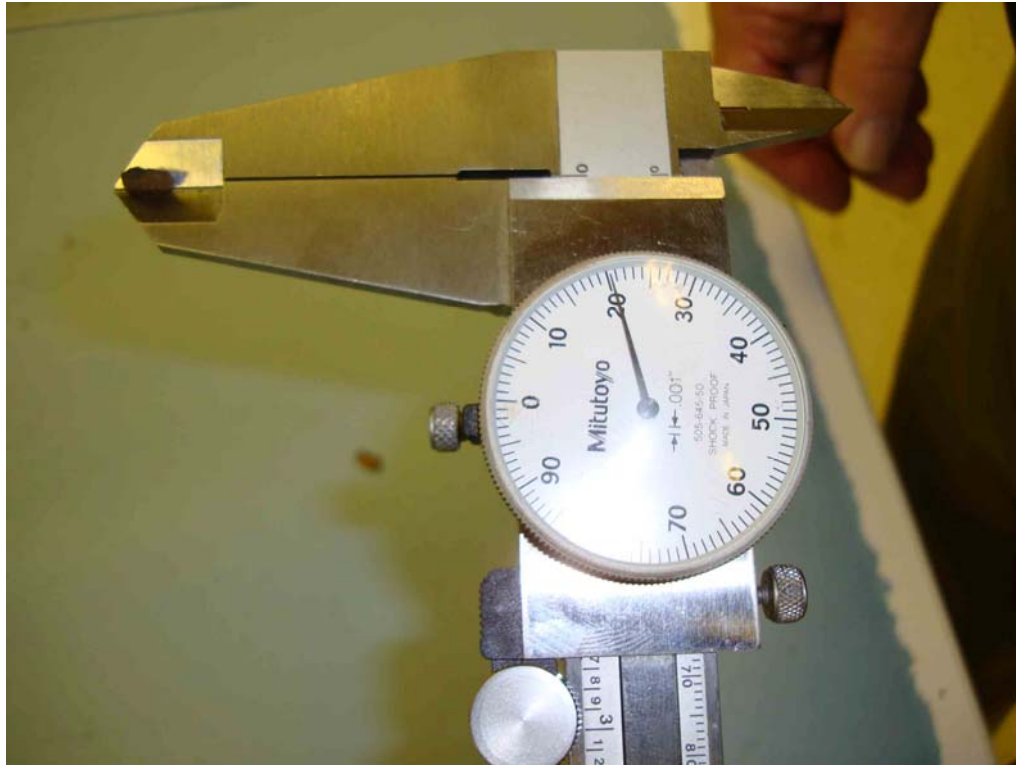
Figure 2-13. DSC00972 LowRes.jpg

The average corrosion rate experienced by the 1986 Firestone wheel under its actual operating conditions can be estimated by noting that the oxide layer thickness in the spider area is approximately 0.020" (500 μm), see Figures 2-13 and 2-14 of a rust chip that fell off the spider during handling. An oxide of this thickness corresponds to a thickness of iron converted of 280 μm .

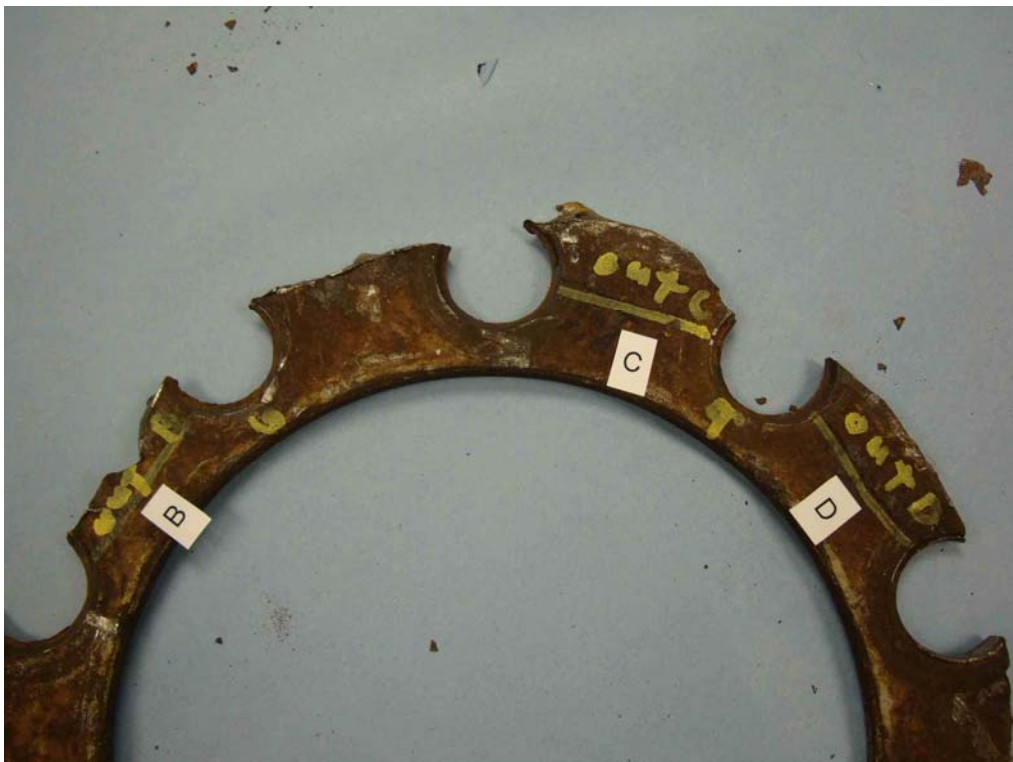
Figure 5-6. DSC00938 LowRes.jpg

Figures 5-5 and 5-6 provide an overview of the spider and one surface of the circumferential crack. Figure 5-5 is a view from the inside direction, before subsequent handling and sectioning. Note the spider hole area near the bottom of the spider in Figure 5-5 (Spider B), and slightly to the left. Also note the area two lug holes counter-clockwise (Spider C). Figure 5-6, a view from the outside of the wheel, shows the marking of these same areas for sectioning. Note that the spider hole B (Figure 5-7) is clearly visible from the inside and outside of the wheel, and also that the portion of Spider C that can be clearly seen as an old crack (the left-hand rusty surface, as shown in Figure 5-8) is much larger than any visible limit.

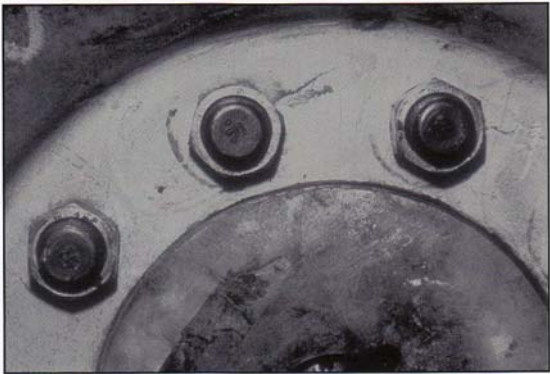
BOLT HOLE CRACKS	
APPEARANCE	Cracks that start at the bolt hole and radiate outward, typically in a 30 degree direction.
PROBABLE CAUSE	Loose wheel nuts, improper installation procedure, use of improper or worn studs or nuts, mounting area of wheel, hub or drum not flat.

VMRS SYSTEM CODE (CODE KEY 31): 018 VMRS TECHNICIAN FAILURE CODE (CODE KEY 18): 14	
ACTION	
WHEEL	Remove from service and scrap.
OPERATIONS	Review installation procedure, retorquing program, proper torque level.
VEHICLE	Inspect attachment parts for proper size, type and wear. Check flatness of mating surfaces and replace if necessary.

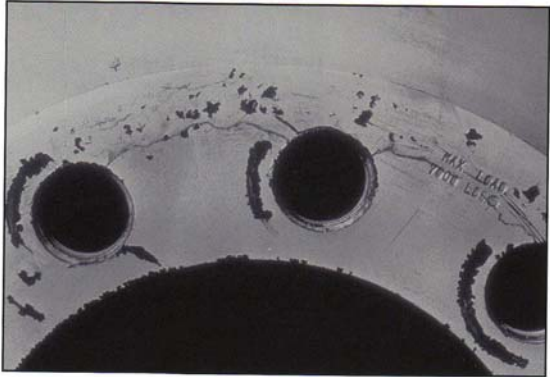
BOLT HOLE TO BOLT HOLE CRACKS	
DISC—OUT-OF-SERVICE CONDITIONS	APPEARANCE Cracks which run from one bolt hole circumferentially to an adjacent bolt hole or crack(s) which begin between bolt holes and progress toward them.
	PROBABLE CAUSE Loose wheel nuts, insufficient wheel support, improper installation procedure, mounting area of wheel, hub or drum not flat, use of worn studs or nuts. Corrosive or abrasive environments exaggerate this condition.

VMRS SYSTEM CODE (CODE KEY 31): 018 VMRS TECHNICIAN FAILURE CODE (CODE KEY 18): 14	
ACTION	
WHEEL	Remove from service and scrap.
OPERATIONS	Review retorquing program, proper torque level and installation procedure.
VEHICLE	Inspect hub and drum, studs and nuts for proper size, type and wear. Check flatness of hub backup diameter, and mating surfaces.

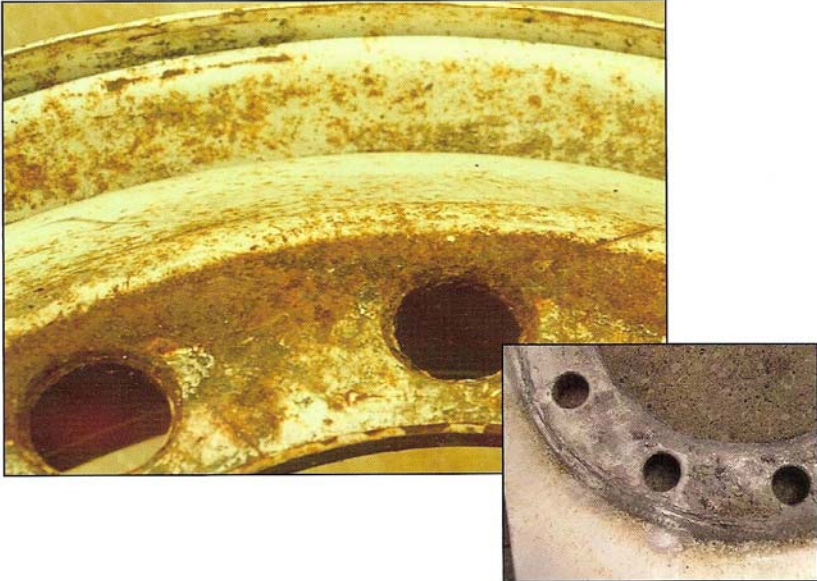
EXCESSIVE WEAR/CORROSION OF DISC FACE	
APPEARANCE	Abrasive wear, pitting and corrosion on disc mounting surface.
PROBABLE CAUSE	Insufficient reconditioning of mating surfaces prior to installation, insufficient hub or drum backup, or worn mating surfaces. Corrosive or abrasive environments aggravate this condition.

DISC—OUT-OF-SERVICE CONDITIONS	
VMRS SYSTEM CODE (CODE KEY 31): 018 VMRS TECHNICIAN FAILURE CODE (CODE KEY 18): 35	
ACTION	
WHEEL	Remove from service and scrap.
OPERATIONS	Recondition mating surfaces prior to installation. Review service application of the wheel.
VEHICLE	Check mating surfaces of hub or drum backup for wear or corrosion. Consider using wheel separators designed to control corrosion and wear.

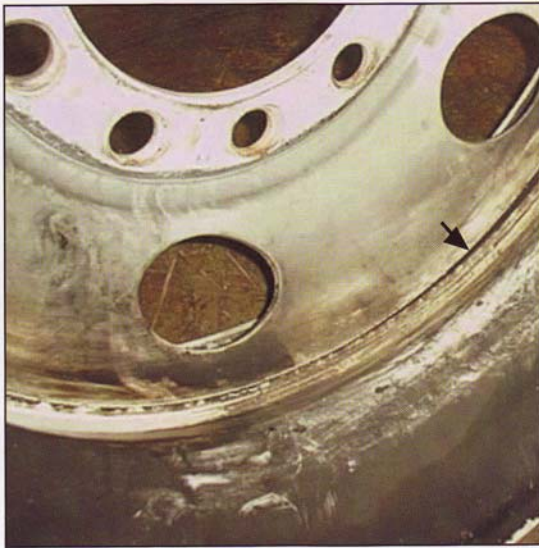
ATTACHMENT WELD CRACKS	
DISC—OUT-OF-SERVICE CONDITIONS	APPEARANCE Cracks at disc-to-rim weld.
	PROBABLE CAUSE Exceeding load/inflation capacity, faulty weld, use of radial tires on non-radial approved rims.

VMRS SYSTEM CODE (CODE KEY 31): 018 VMRS TECHNICIAN FAILURE CODE (CODE KEY 18): 14	
ACTION	
WHEEL	Remove from service and scrap. Request evaluation by supplier before scrapping.
OPERATIONS	Check wheel load capacity against actual service conditions. Ensure proper tire/rim combination is being used.
VEHICLE	None.

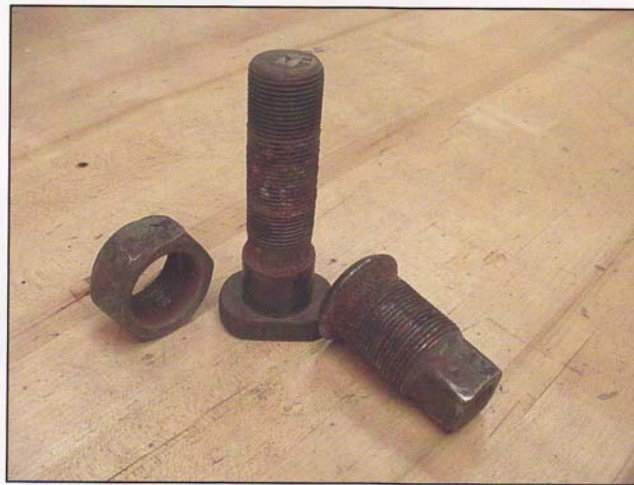
APPEARANCE	Evidence of rust and scale on fastener.
-------------------	---

PROBABLE CAUSE	Operating in corrosive environments, prolonged use, lack of proper maintenance, inadequate coating during manufacturing, and corrosive washes used to clean vehicles.
-----------------------	---

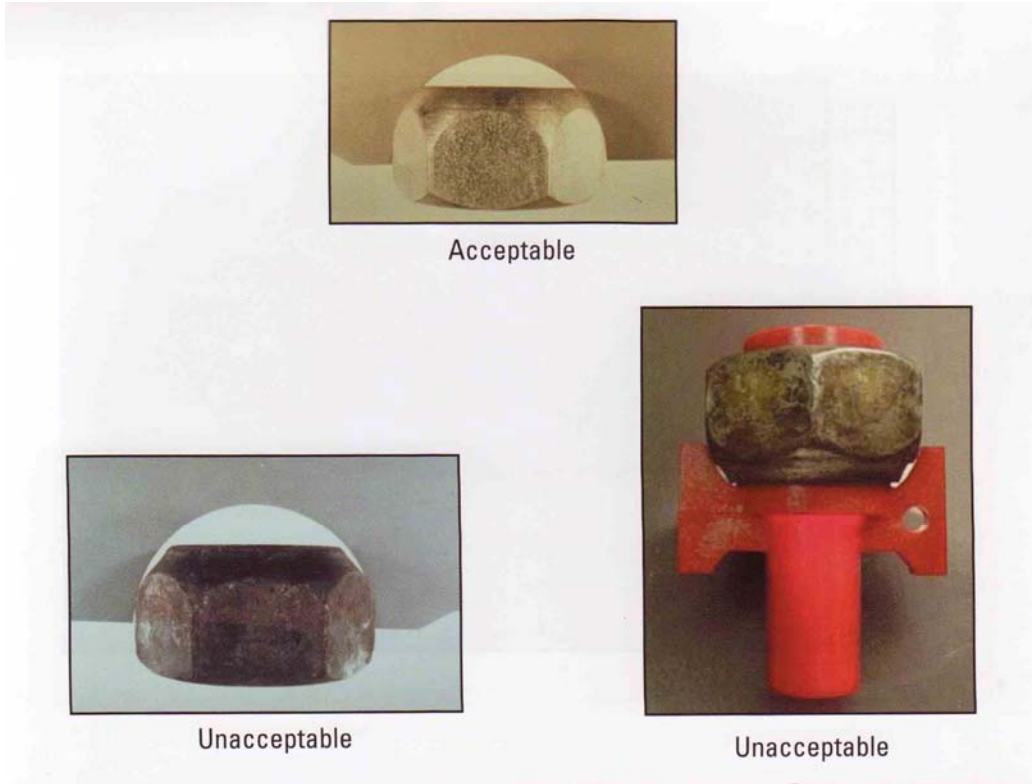
Figure 7-14. Users Guide p98 - Ball Seat Radius LowRes.jpg

WORN/DAMAGED BALL SEAT RADIUS	
FASTENERS—OUT-OF-SERVICE CONDITIONS	APPEARANCE The ball seat radius of either the inner or outer nut is worn or distorted and no longer spherical. A gap is apparent when checked with a radius or nut gauge.
	PROBABLE CAUSE Multiple re-use, low torque over prolonged operation, and worn/damaged wheel ball seat.
	  Acceptable
