Demining Programme Office in the Falkland Islands – Technical Support 2013

Submitted by: Fenix Insight Ltd

April 2013

EXPLOITATION OF ITEMS RECOVERED DURING DEMINING OPERATIONS: 2012/13

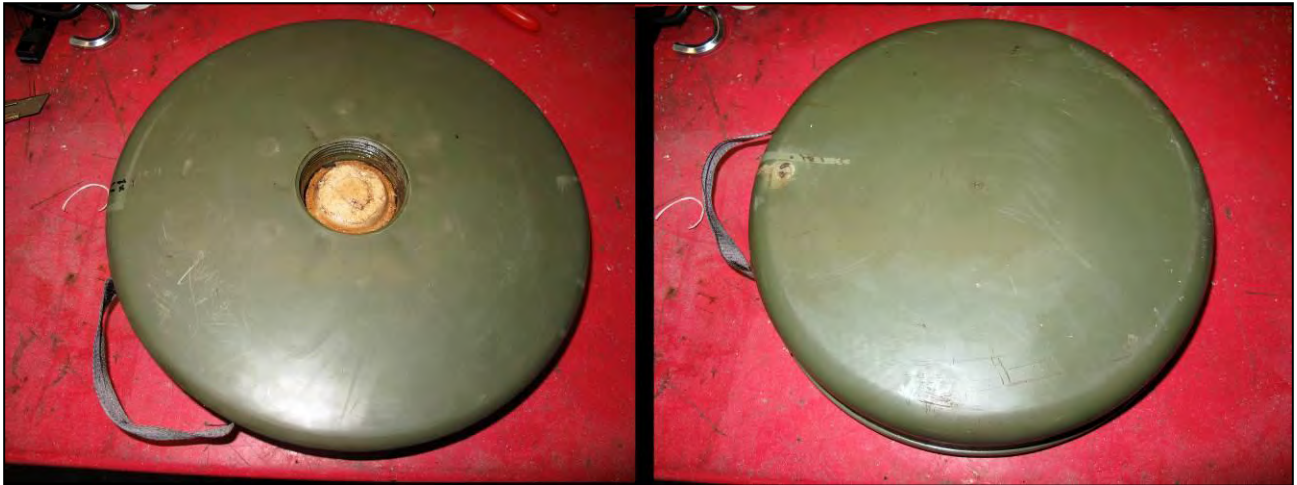
Figure A5

The top surface (left) and underside (right) of the mine body with fuze removed. All of the mines recovered appeared to be in good condition superficially; however, every mine had cracks in the casing

14. All of the C3B mines recovered from SA064 appeared to be in good condition superficially, but all of the casings were cracked. The ingress and subsequent freezing of water is gradually causing the deterioration of the casings, but the effect is slow due to the small volumes of water and the flexibility of the plastic. The process is likely to accelerate as existing cracks enlarge and the plastic becomes more brittle.

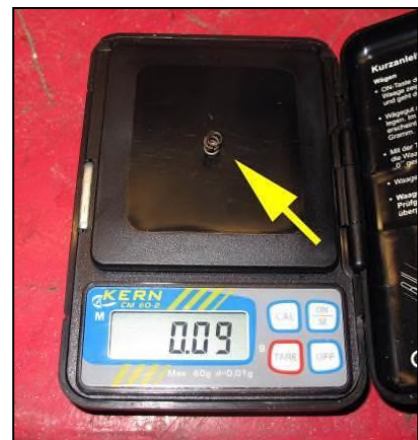
Figure A10
Due to corrosion, this striker Spring weighed only 0.09 g

17. All fuze mechanisms appeared to be operational, despite the corrosion of some striker springs. Fuzes are likely to remain functional despite the deterioration of the striker spring.

18. The striker spring is the only metal component within the mine. The spring weighs less than 0.15 g when new and is positioned around 20 mm below the surface of the pressure plate; this makes its detectability marginal at best. If the striker spring is corroded, the metal content of the mine may be reduced or eliminated altogether, making it impossible to locate with a metal detector.

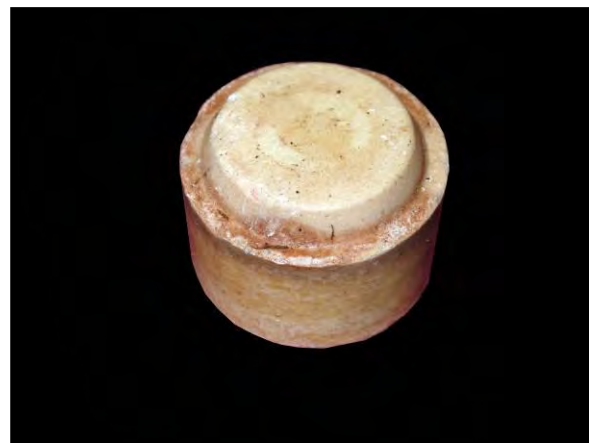
Figure A12
Booster pellets are composed of a pressed TNT/RDX (60/40) mixture and virtually all were in good condition. Despite the neoprene seal between the base of the fuze and the booster, all of the booster pockets contained water

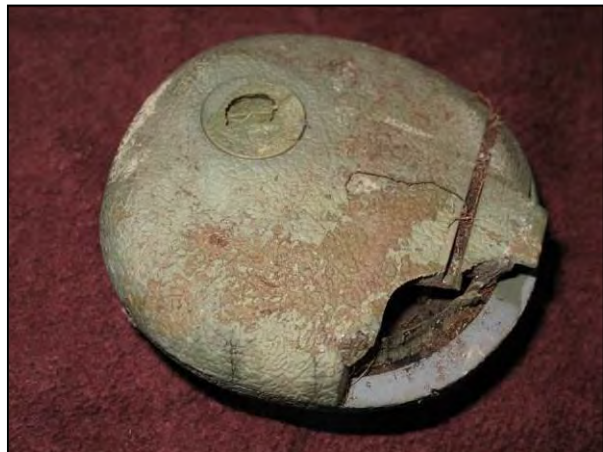
3. The isolated mine found in SA064 (**Figure B2**) showed obvious damage, particularly to the base (**Figure B3**) where the detonator plug was cracked and a section of the mine casing had been broken away. The broken section of the base was found close to the mine body.

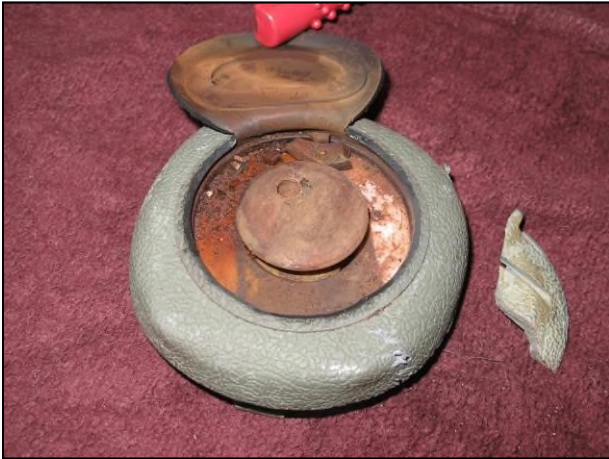
Figure B4

On initial inspection, the fuze and main charge appeared to be relatively intact. The ingress of water would not prevent the mine from functioning

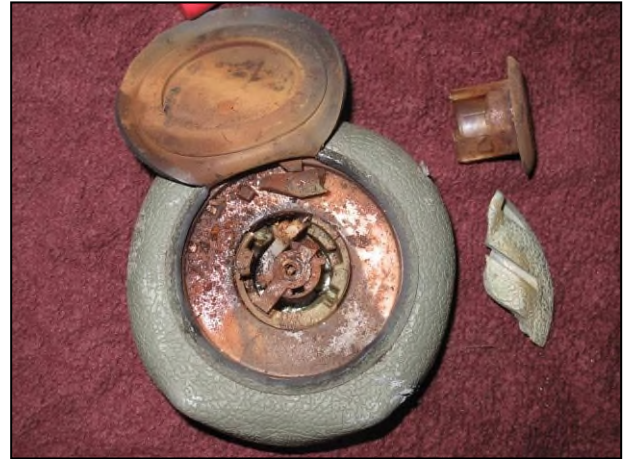
Figure B5

Removal of the fuze plunger revealed that the several of the fuze components had been shattered and the striker displaced

5. The isolated SB-33 mine discovered in SA064 had clearly been subjected to a substantial amount of shock. This was evident in the shattering of fuze components made from polycarbonate (the plastic used in protective visors) and the pulverisation of the main charge.

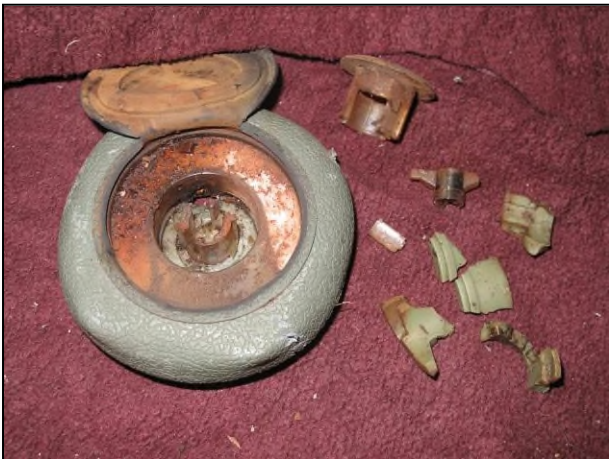
Figure B6

Removal of the fuze components exposed the full extent of the damage

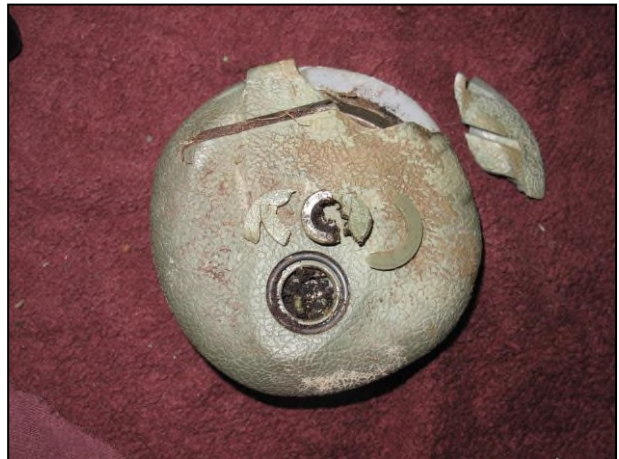
Figure B7

The detonator plug had also been shattered and could not be used to remove the detonator

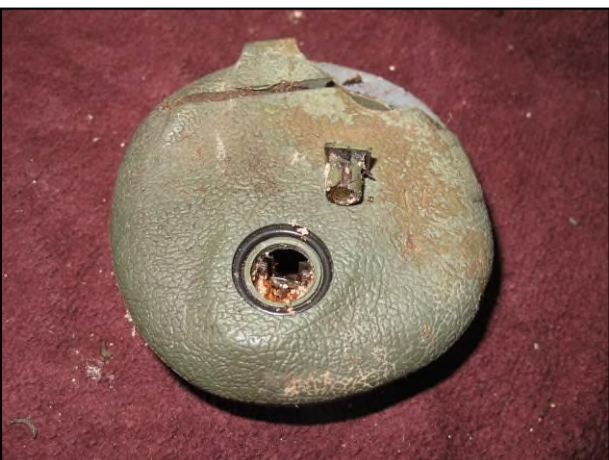
Figure B8

The detonator was seized into place and surrounded by impacted explosive from the main charge

8. The mine was incapable of functioning as designed; however, the condition of the detonator means that it might have been in an unstable state.
9. The demining team and DPO were absolutely correct not to attempt to defuze or disassemble this mine.

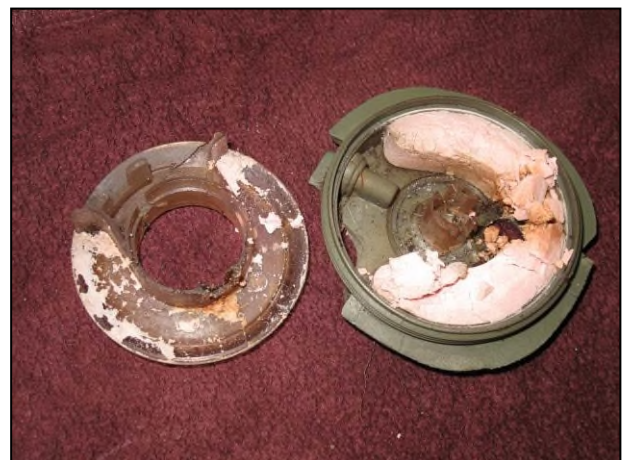
Figure B9

The main charge, normally a rigid horseshoe of pressed explosive, had been pulverised

6. Although the exterior of the mine casing showed no evidence of scarring from fragmentation, the internal damage is entirely consistent with the effects of a nearby detonation.

7. The damage to the mine, together with its displacement and the presence of a crater in the mine row, strongly suggest that this mine was thrown out by the detonation of an artillery shell during the conflict.

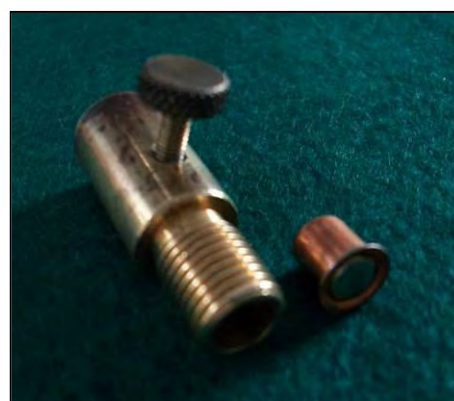
Figure C2

The fuze holder with percussion cap removed. The cap unit is a standard 12 bore shotgun primer. Although robust, these are unlikely to remain functional after 30 years exposure to wet conditions

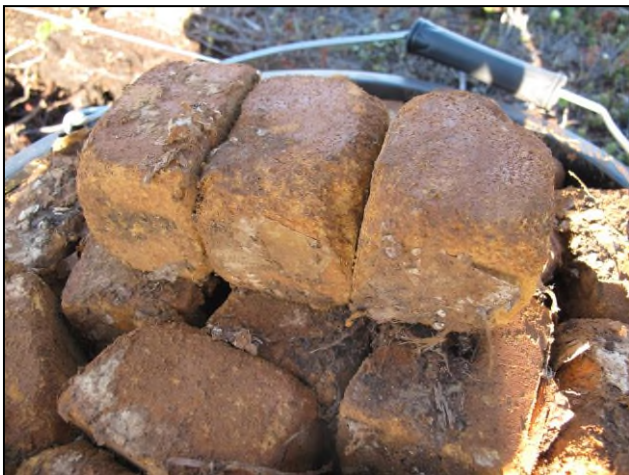
Figure C4
TNT charges from a booby trap in SA064. These appear to have been 400 g blocks of pressed TNT, wrapped in waxed paper. Pressed TNT is deemed 'cap sensitive', meaning that it can be initiated directly by a No 8 strength detonator. The edges of the blocks have been eroded but the bulk of the explosive remains intact. Historical data on TNT suggests that it can remain capable of detonation for several decades

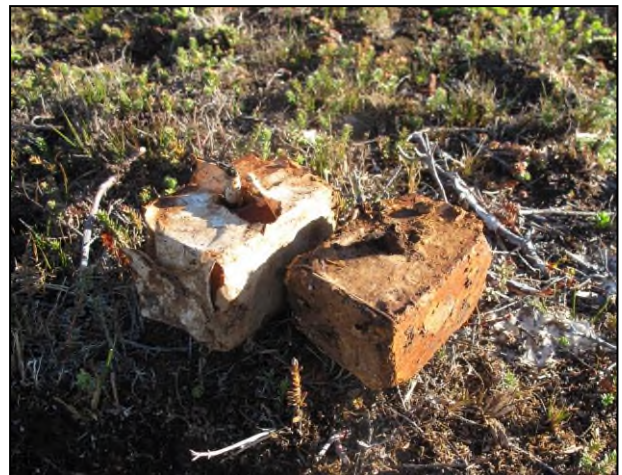
Figure C5
TNT blocks containing detonators and the remnants of safety fuzes. It is clear that any pyrotechnic composition in the fuse or detonator will be non-functional. However, findings from the Ageing Study (involving explosives of a similar type and age) suggested that the primary explosive in the detonator may be viable; this means that the explosive could be initiated by either fire or substantial impact

6. The Ageing Study suggests that the primary explosive within the detonator may still be capable of detonation. Initiation might arise from heat (such as a peat fire) or from shock (such as the impact from a flail hammer).
