# Farnsworth House Flood Risk and Conceptual Mitigation Evaluation 14520 River Road Plano, Illinois

Prepared for:  
NATIONAL TRUST FOR HISTORIC PRESERVATION  
1785 Massachusetts Avenue NW  
Washington, DC 20036

May 15, 2013

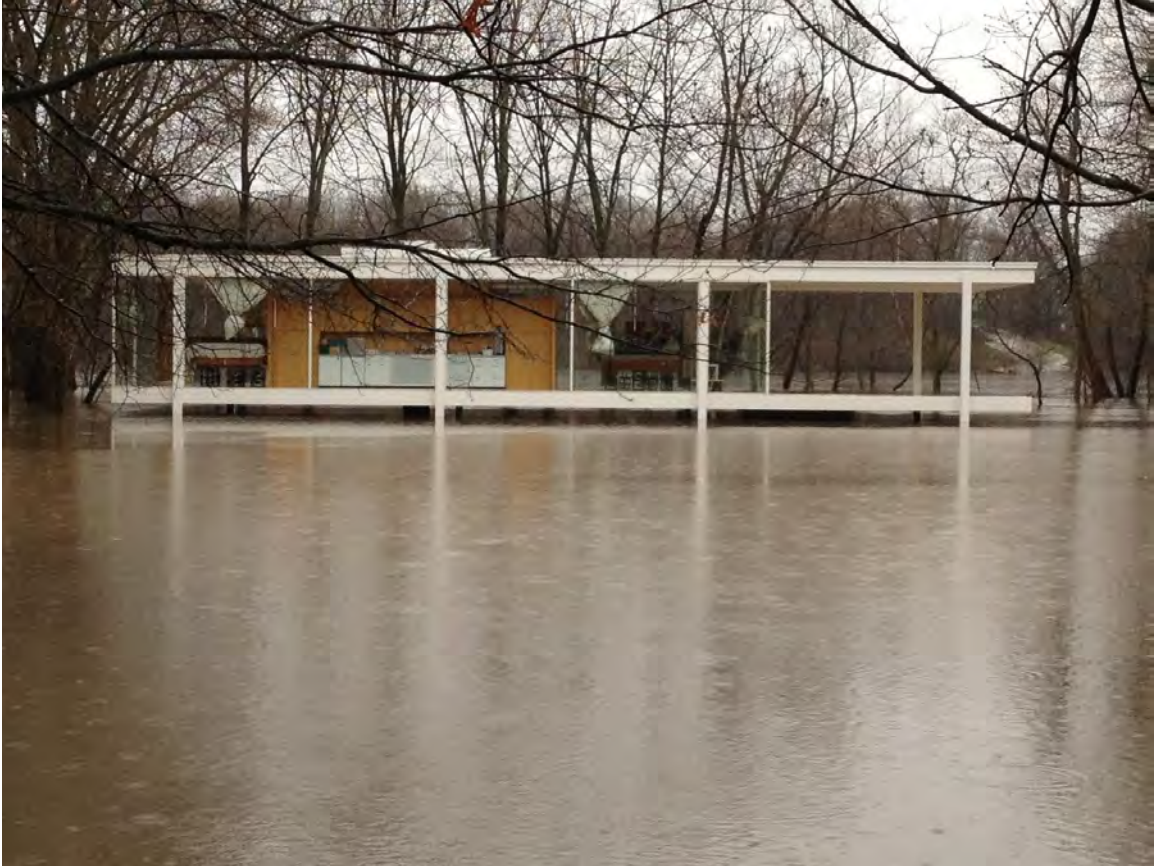
Flooding at Farnsworth House rising to near finished floor elevation, April 18, 2013  
*(Photograph from Deena Boatman of Farnsworth House site staff)*

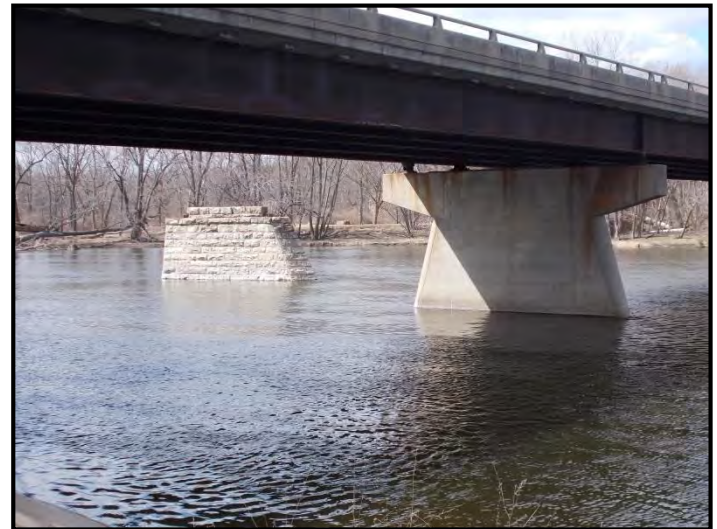
Photo 8. Fox River Drive Bridge with a view of one of two abutments remaining from the old bridge.

3. Channel dredging, modifications to the Fox River Road bridge abutments to reduce the constriction, and/or removal of the old abutments would lead to decreases in flood water surface elevations, but such improvements would likely reduce the 100-year water surface elevations by less than a foot and would be very costly, as well as difficult and expensive to obtain permits to conduct the work. Further, periodic future channel dredging would be required to maintain the channel slope as sediment naturally deposits. For these reasons, this is not a recommended alternative.

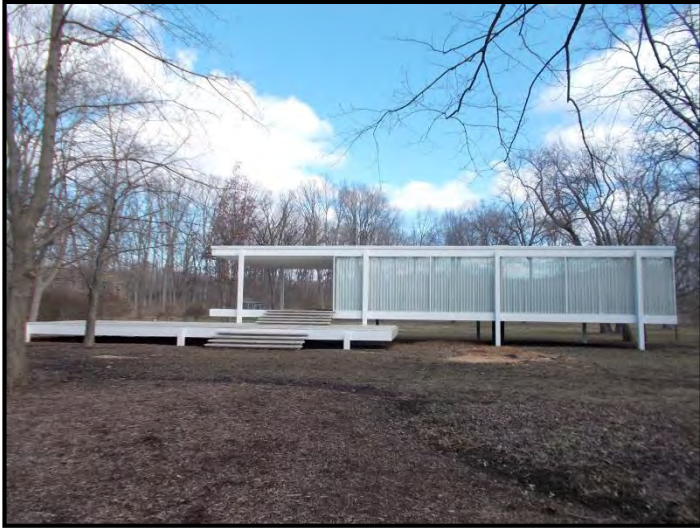
Photo 9. Farnsworth House elevated several feet above existing grade. Photo taken facing north.

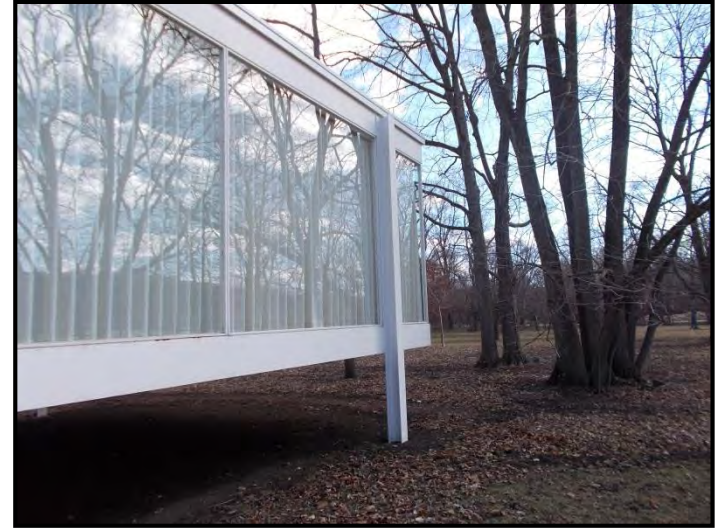
Photo 10. Close-up photo of Farnsworth House elevated several feet above existing grade.

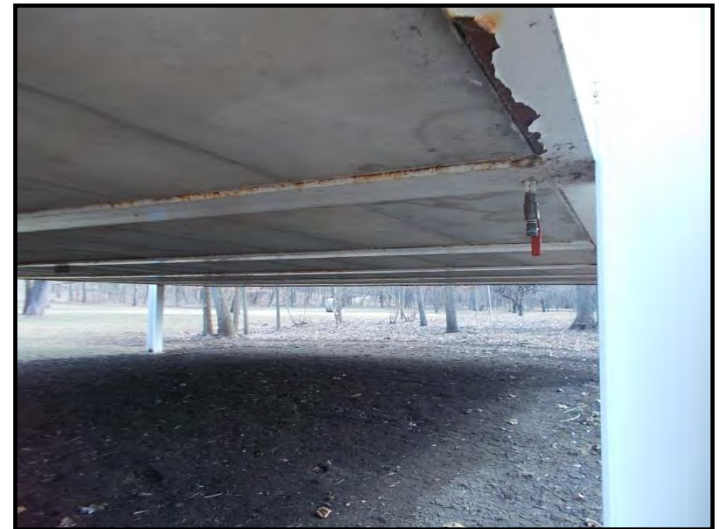
Photo 12. Evidence of water damage to underside of Farnsworth House.

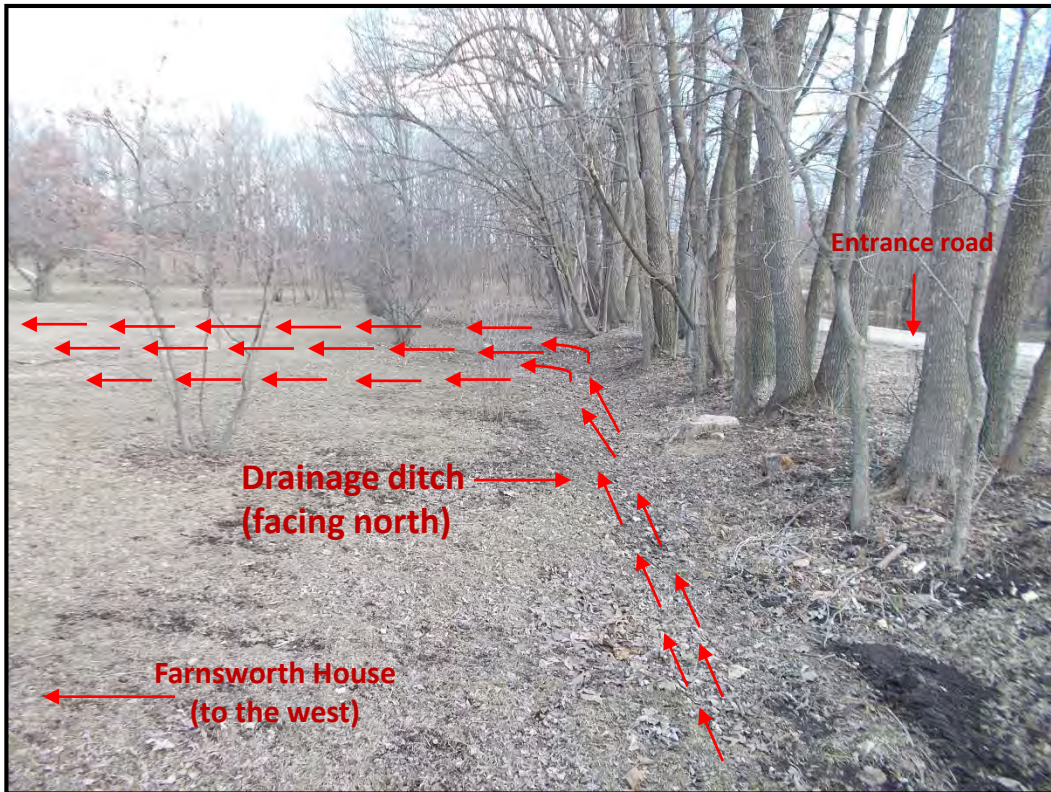
Photo 13. Looking north at drainage ditch that serves as a conveyance path for floodwaters as Fox River rises.

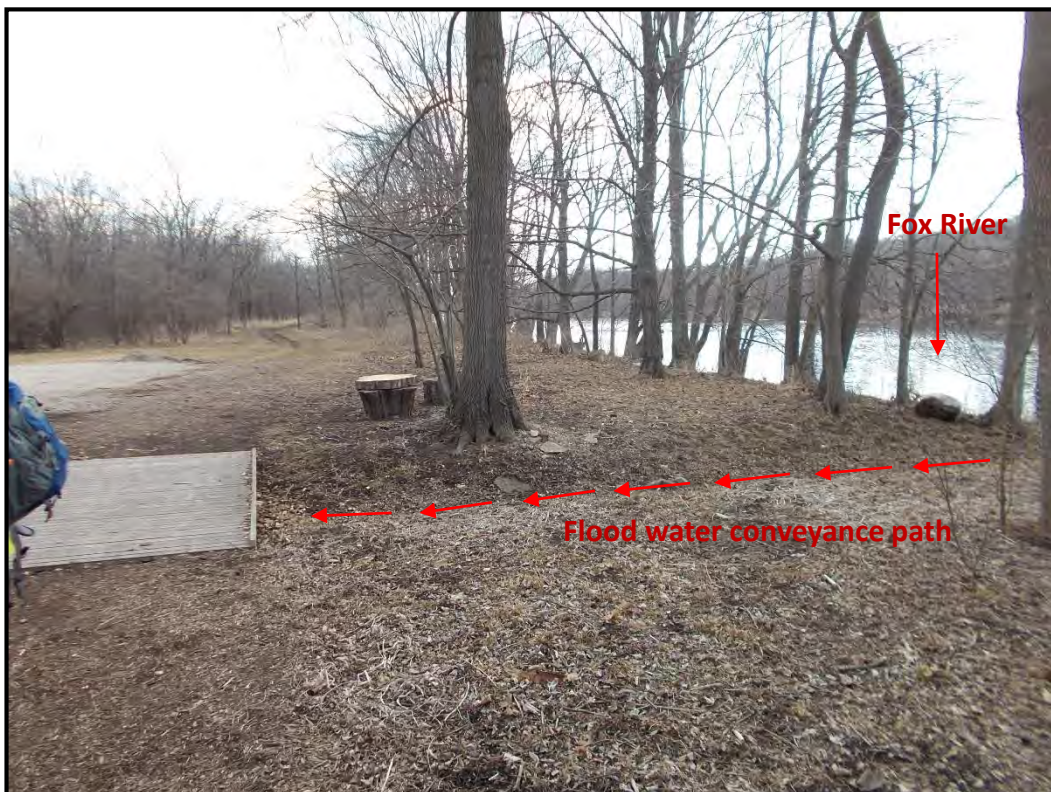
Photo 14. Looking east at drainage ditch on east side of Farnsworth lawn that serves as a conveyance path for flood waters as Fox River rises.
