Fatigue Failure Analysis Case Studies

Mehrooz Zamanzadeh and Edward Larkin
Exova, Pittsburgh, PA 15205
and
Reza Mirshams
Department of Engineering Technology
University of North Texas
Denton, TX 76207
Reza.Mirshams@unt.edu

3. Case Review: Broken Wheel Bolt

4. Case Review: Lightning Arrester Pole

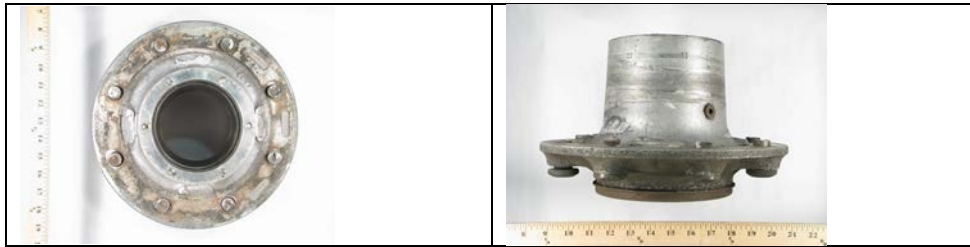
A failure analysis investigation was performed on the broken steel bolts from an aluminum wheel hub from a truck trailer. The wheel hub contained eight metric steel bolts that had all failed in service causing the wheel to become separated from the trailer, Figure 1.

Figure 1: The aluminum wheel hub

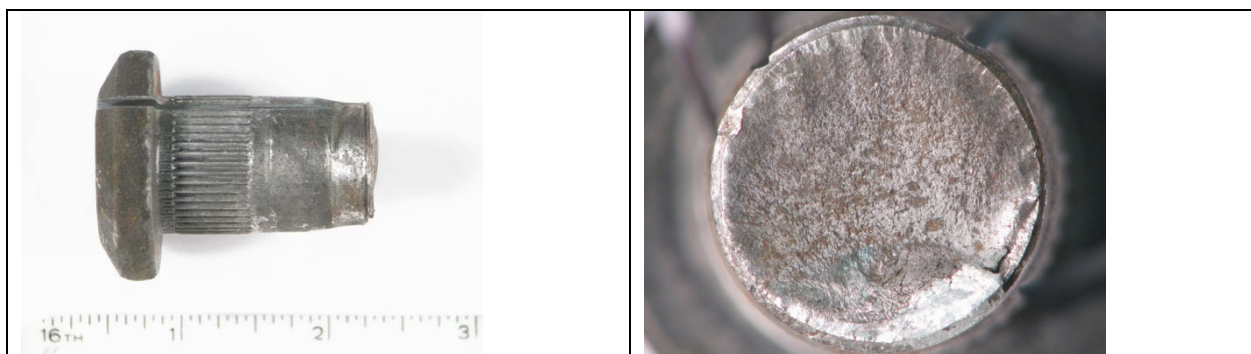
Figure 2: Photographs show one of the broken bolts and its fracture surface.

All of the bolt fractures were found to have initiated in the last thread root adjacent to the non-threaded shank. The primary fracture initiation location is at the top of the bolt fracture as shown in the photograph in Figure 2. The fracture surface profiles were observed to be relatively flat, or slightly concave, and perpendicular to the bolt axes. For five of the bolts, short radial ridges were observed to intersect the thread root at the fracture initiation locations.

These ridges represent steps between adjacent independent fracture initiation sites. These fracture surface features are characteristic of a fatigue mode of failure. The fracture surfaces of two bolts indicated that they had failed as a result of reverse bending fatigue with fractures initiating on opposite sides of the bolt diameters. Visual examination showed some fracture surfaces had initiated as a result of low cycle fatigue. It is apparent that the first bolts to fracture failed as a result of high cycle fatigue. Bolts which fractured second exhibited low cycle fatigue caused by greater stresses on the remaining bolts.

The broken bolts were found to have failed in service as a result of bending or reverse bending fatigue. All of the bolt fractures were found to have initiated in the last thread root adjacent to the non threaded shank. High cycle fatigue is the progressive failure of a component subjected to repeated or fluctuating strains at stresses less than the yield strength of the material. Low cycle fatigue generally occurs at stress levels which exceed the yield strength of the material. Fatigue cracks initiate at locations of maximum stress and/or minimum strength. Thread roots are a natural stress concentration site for the initiation of cracks.

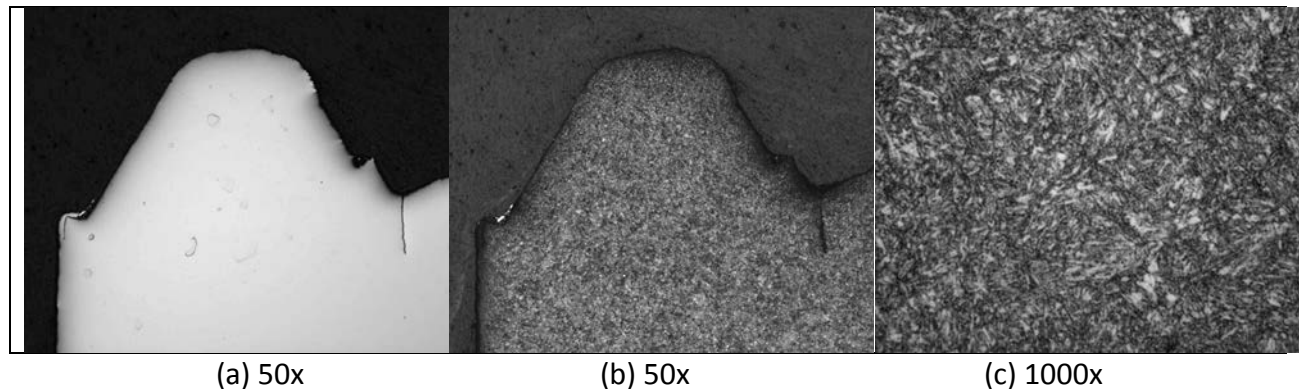
Metallographic examinations were performed on transverse and longitudinal cross sections through the bolts. Standard metallographic sample preparation was used to prepare polished scratch free surfaces and etched with a 2% nital solution. Figure 3 shows the microstructure of a polished and etched section. A secondary crack in the bottom of a thread root and tempered martensitic microstructure are evident.

Figure 3: Photomicrographs of a broken bolt (a) a crack in bottom of thread root, (b) same section after etching with 2% nital, (c) the microstructure at higher magnification.

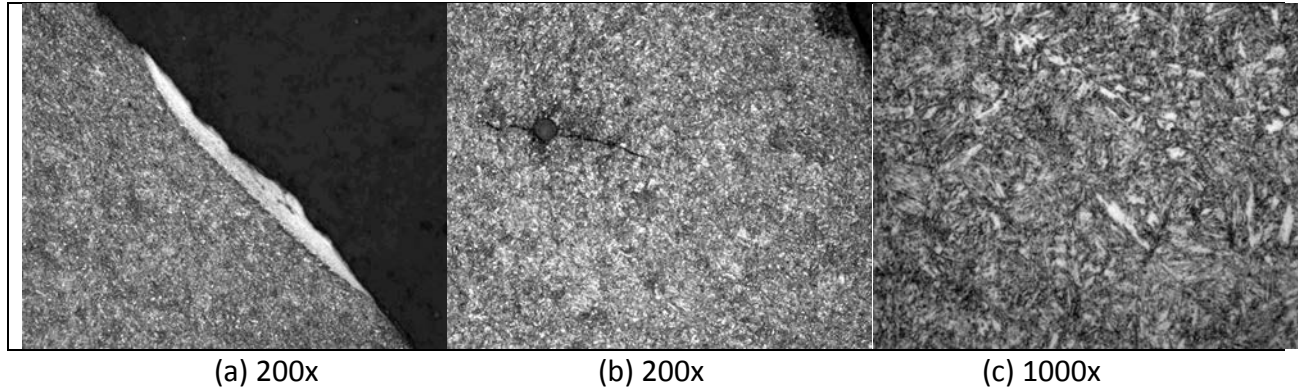
Figure 4 presents micrographs of a non-broken bolt from the trailer with the broken wheel similar to the failed bolts. The threads were actually observed to have been bent to one side. Localized wear produced plastically deformed layers some of which appear white in these photographs. Such plastic deformation can produce hard, brittle surface layers. At one location a secondary internal crack was observed to have initiated at a large inclusion within a thread profile as shown in Figure 4 (b).

Figure 4: Photomicrographs of transverse cross section of the non-broken bolt (NBB) show (a) a localized wear area on the flank, (b) an internal crack initiating at an inclusion, and (c) tempered martensite microstructure.

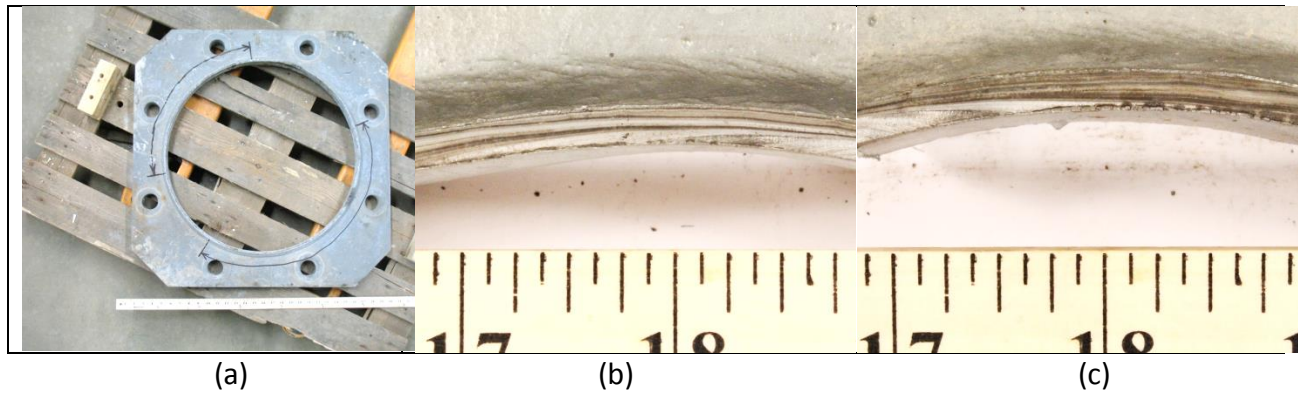
An examination of the fracture surface indicated that the fracture possessed two separate fatigue cracks in the pole shaft, as shown in Figure 5(a). The diameter of the lower part of shaft as shown in the figure 5(a) is 23 inches. The centers of the two crack lengths were diametrically opposite. This is characteristic of a reverse bending fatigue mode of failure. The failure occurred in the thinner pole shaft material immediately adjacent to the weld at the weld toe location.

Figures 5(a) and 5(b) show areas of fatigue crack initiation where, because of geometry, the fatigue crack arrest marks are parallel to the outside diameter surface where the fracture initiated. Oxidation subsequent to the formation of the fatigue cracks has resulted in the visible dark bands in these photographs.

Figure 5: (a) Location and partial extent of the shorter (right) and longer (left) fatigue fractures in the pole shaft; (b) the fatigue crack arrest marks for the longer fatigue crack and (c) the fatigue crack arrest marks for the shorter fatigue crack.

The lightning arrester pole failed in service as a result of high cycle reverse bending fatigue that initiated in the pole shaft at the weld toe location. Two separate fatigue cracks were found to have initiated at diametrically opposite sides of the pole. This is characteristic of reverse bending fatigue. High cycle fatigue is the progressive failure of a component subjected to fluctuating strains at stresses less than the yield strength of the material. Fatigue cracks initiate at the locations of maximum local stress and/or minimum local strength. No weld defects, or other defects, were observed at the fracture initiation sites. The weld toe location is a natural geometric stress concentration site. The reported wind event at the time of failure served to topple a pole that already possessed two fatigue cracks. However, wind loading during the service life of the pole almost certainly is partly to blame for the fatigue failure. It is likely that these structures have been designed without considering dynamic effects of winds, actual wind loads, and modes of vibration.

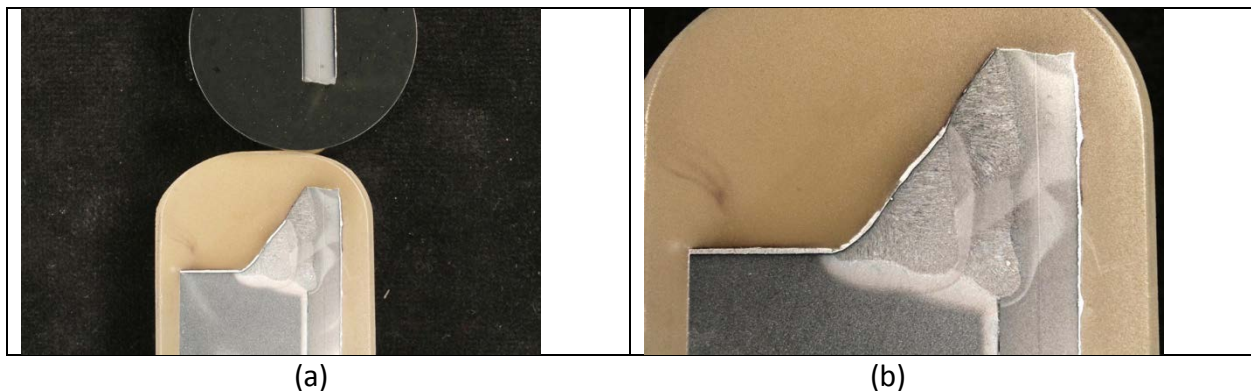
Transverse cross sections through the mating fracture surfaces of the longer fracture surface were prepared for subsequent metallographic examination. Etching with a 2% nital solution revealed the existing microstructures. The fracture occurred in the pole shaft at the weld toe location as shown in Figures 6(a) and 6(b).

Figure 6: Profile of through thickness of fracture on shaft and weld to the base plate.

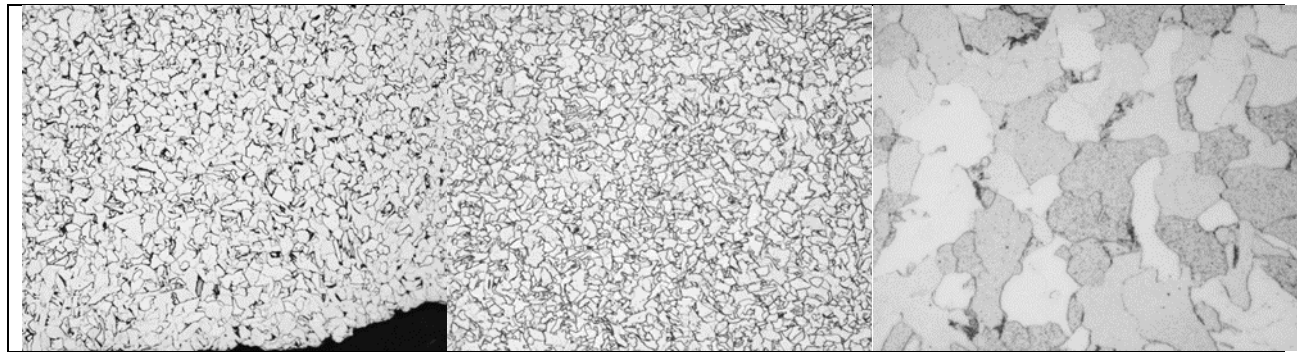
The microstructure of the pole shaft heat affected zone (HAZ), at the weld toe location, consisted of fine grain ferrite plus dark etching bainite as shown in Figure 7a. The microstructure of the pole shaft away from the weld was found to consist of fine grained ferrite plus darker etching carbides. See Figures 7b and 7c.

Figure 7: (a) the HAZ microstructure at the fracture surface. 2% nital; (b) the microstructure of the pole shaft. 2% nital; (c) the microstructure of the pole shaft. 2% nital.
