Fatigue Failure Analysis Of Marine Engine Crankshaft

Abstract

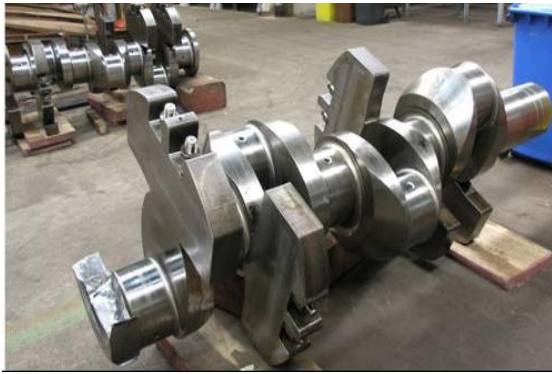
Figure 7 – General view of crankshaft with the fatigue fracture section at junction of n°4 crankpin and forward web

Figure 7 shows a failed marine web crankshaft. The catastrophic failure happened after more than 32,000 operating hours (1.15×10^9 cycles) on the crank web n°4, at the middle of the crankshaft. The bearing shells were found in good conditions after damage and only the crankpin bearing caps were changed nine months before, according to the maintenance plan. The alignment of bedplate was checked and the measured values were under standard recommended by the engine builders. Measurements of crank web deflections were available 1,147 hours before and no anomaly was found. In a first approach, the fatigue fracture seems to be as a consequence of high bending moments on the crank web n°4.

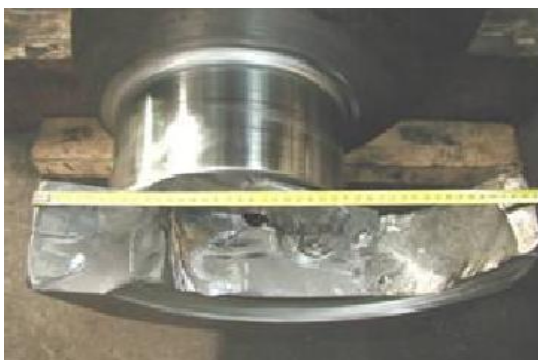
Figure 8 – Failure surface

Figure 8.a - Parallel to the axis (final fracture)

According to the Figure 8, it is possible to observe the region where the crack was initiated, starting from the elliptical lines (but distorted because the effect of steady torsion) and then to find the origin or the focus. Observing the fatigue crack surface, the fatigue crack initiation was by rotating

bending and the crack propagation was by rotating bending combined with torsion. The cause of failure will be analyzed in the following.

The morphology of the failure surface shows that the fracture presents two different surfaces: one almost perpendicular (with some deviation) to the crankpin section and other in a horizontal plan with the crankshaft axis. The latter one, the second, is the residual surface and corresponds to the final fracture, because the remaining section over the limit of material strength for that load, and therefore it is a ductile fracture. The first one shows a typical fatigue fracture characterized by a circular/semi-elliptical crack front profile starting from a point where the crack was nucleated, perpendicular to the crankshaft axis and another showing some deviation from the perpendicular plane.

The fatigue fracture appears in two distinct surfaces: a smooth almost to perpendicular to the crankshaft and a second one in a horizontal plane with the crankshaft, with transition zones between two surfaces, according to Figure 8. This confirms a typical fracture by fatigue, characterized by propagation with a crack front profile approximately elliptical from the crack initiation point until the fast final fracture. The beach marks show several stops of the main engine which permits to obtain the history of the fatigue crack growth Process associated to the vessel voyages. A fracture surface configuration perpendicular to the crankpin axis is generally associated to the loading bending in shafts. However a helical surface observed in this fracture clear shows a mixed-mode fatigue, i.e., a combination of rotating bending with steady torsion, and found in the literature [4, 5]. Consulting the main engine book on board, it is possible identify the beach mark zones of the fatigue fracture with the last voyages of the vessel (visited ports), starting from the fast fracture (catastrophic failure) towards the crack initiation point. The total estimated hours found were about 2400, computed from the catastrophic failure until the crack region of the nucleation. It is not possible to know the number of cycles of the nucleation process, but the experience has shown that is about 80-90 % of the total life time (≈ 16000 hours). It seems evident that the catastrophic failure has resulted of a fast fatigue crack growth rate. The local microstructure and the microscope observation close to the crack initiation zone didn't reveal any defect of the material. The experience has also shown that a crankshaft, after more than 30000 operating hours, an inclusion/flaw or a latent defect in the material, cannot be the root cause of damage.

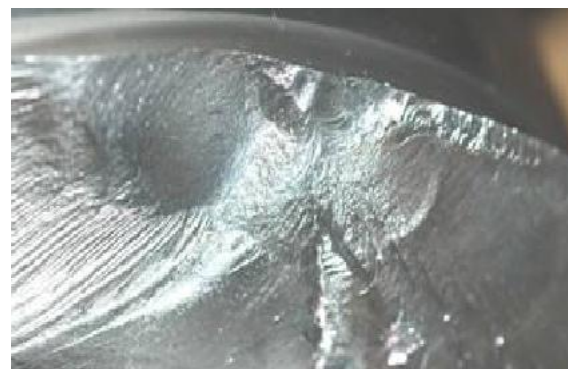
Observing this zone with more amplification, as shown in Figure 9, it is clearly seen that crack initiation occurred through the growth of three parallel cracks that linked together at a certain depth. It is also observed lines known as beach marks which correspond to the engine stopping or changes of loading in service. These lines are helpful to calculate the number of cycles among different stops or changes of load which allows reconstruct the history of the crack propagation. A crack with a configuration perpendicular to the shaft axis is generally associated to rotating bending. Here it seems to be clear that the fatigue surface is due to a high bending moment on the crank web. However in this case the fatigue surface there is some inclination which results of a combination of rotating bending with steady torsion, typical situation of the power shafts [4]. Observing the crack path since the crack initiation zone until final fracture, it is possible to see the beach marks with a semi-elliptical front profile with some distortion which is typical of the fatigue by bending combined with steady torsion. These beach marks are centered in a focus which is generally associated to the crack initiation

Figure 9– Crack initiation zone

the origin. The reason is because, in the beginning, the crack initiation starts from three short parallel cracks nucleated by rotating bending, that were linked, after some millimeters of depth, by the effect of torsion. After this joining, the crack propagation goes on with a typical helical surface due to the effect of torsion [4]. The propagation observed from a perpendicular direction to the crankshaft axis shows a crack path in zigzag, typical from the crack growth under bending combined with steady torsion [4,5], and see Figures 8 and 9. The crack length on the surface grows faster for one side than the other side which is understood because the direction of applied torque [5] and this is clearly seen with a more distance among the elliptical fatigue lines during the propagation. Close to the final fracture, the distortion or warping of fatigue crack surface is more significant than that observed in the beginning of propagation because the effect of torsion is predominant regarding to the bending. After an accurate observation of the fatigue surface and material close to the crack initiation, after micrographs and material examinations carried out at the laboratory, if there is no evidence of a latent defect, it is necessary to find the causative factors in other sources namely the operations conditions of the last months.

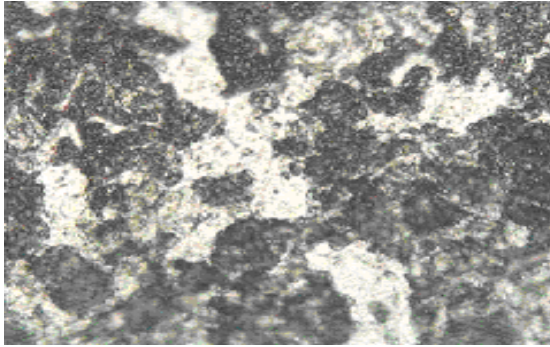
Figure 10 – Micrographs of the material

The material closed the crack initiation was analyzed at the laboratory and shown a bainitic structure, Figure 10 and the hardness Vickers was about 285, Figure 11, which is according to the standard values for this type of steel and delivered by the manufactory and confirmed by the class certificate.

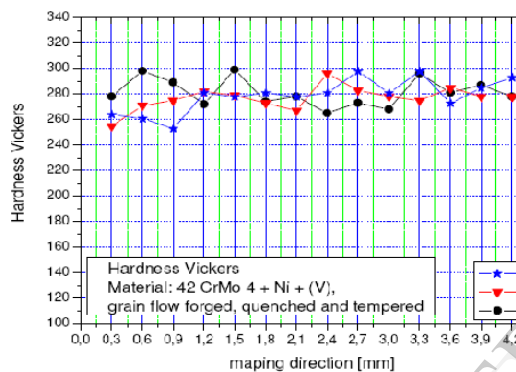
Figure 11 – The Vickers hardening in the first millimeters from surface

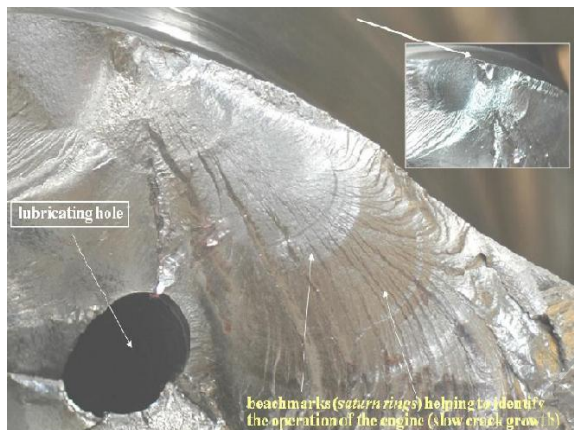
The number of cycles to failure of this crankshaft was achieved by recording of the main engine operation on board, taking into account the *beach marks* left on the fatigue crack surface. Through the beach marks (stopping or starting of the machine) left on the fatigue crack surface, observed on Figure 12 it is possible obtain a correlation between a certain crack length and the time spent during the corresponding voyage of the ship. Using the crack growth equation which gives the number of cycles by integrating the Paris Law for a considered crack length, it is possible to estimate the applied remote stress ($\Delta\sigma$) for $R=-1$ (reversed bending).

Figure 12 – Crack initiation site and beach marks of crack growth

by integrating this equation between an initial and final crack depth, for example $a_f=55$ mm, $a_i=32$ mm, that can be related to the onboard records, a stress level of $\Delta\sigma \approx 30$ MPa can be estimated.

It is now possible to estimate the life spent to grow the crack between an initial small crack and final fracture, by integrating the same equation with the applied stress of $\Delta\sigma \approx 30$ MPa, between $a_f=55$ mm, $a_i=2.5$ mm, therefore 2400 hours were estimated which corresponds to approximately to a time less than the time spent since the scheduled change in the journal bearings.
