RE: **Proposed Pipeline Repair Procedure** for 18" BLKG Right-of-Way Pipeline (ROW G-13511),  
Segment No. 3472, Originating at Main Pass 140, Platform B and Terminating at Main Pass 56,  
F/S, Federal Waters, Offshore, Louisiana.

**Fieldwood Energy LLC**  
Main Pass 140 B, Segment Number 3472  
Pipeline Repair Procedure  
Rev. 0

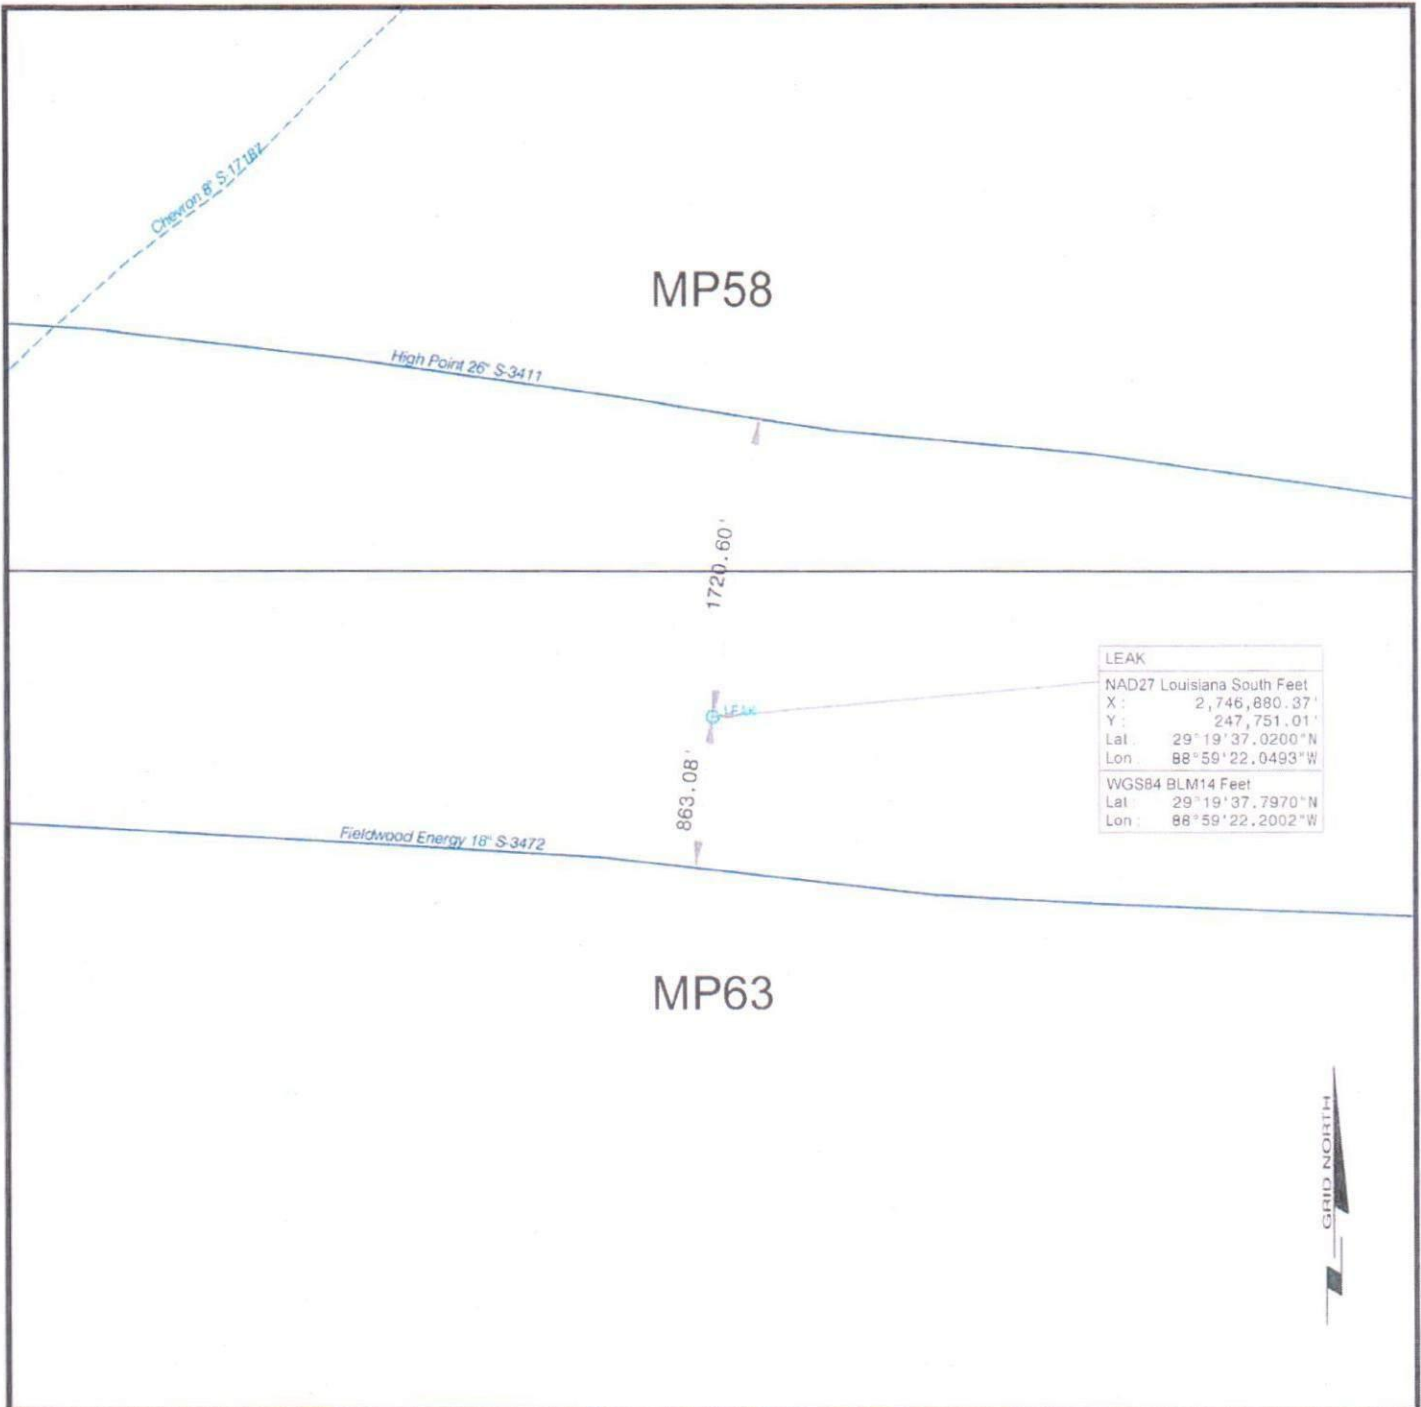
**PLANNING MAP  
REPORTED LEAK**

LEAK	
NAD27 Louisiana South Feet	
X :	2,746,880.37'
Y :	247,751.01'
Lat :	29° 19' 37.0200" N
Lon :	88° 59' 22.0493" W
WGS84 BLM14 Feet	
Lat :	29° 19' 37.7970" N
Lon :	88° 59' 22.2002" W
