# FINAL INVESTIGATION REPORT

## CHEVRON RICHMOND REFINERY PIPE RUPTURE AND FIRE

### CHEVRON RICHMOND REFINERY #4 CRUDE UNIT RICHMOND, CALIFORNIA

REPORT NO. 2012-03-I-CA  
JANUARY 2015

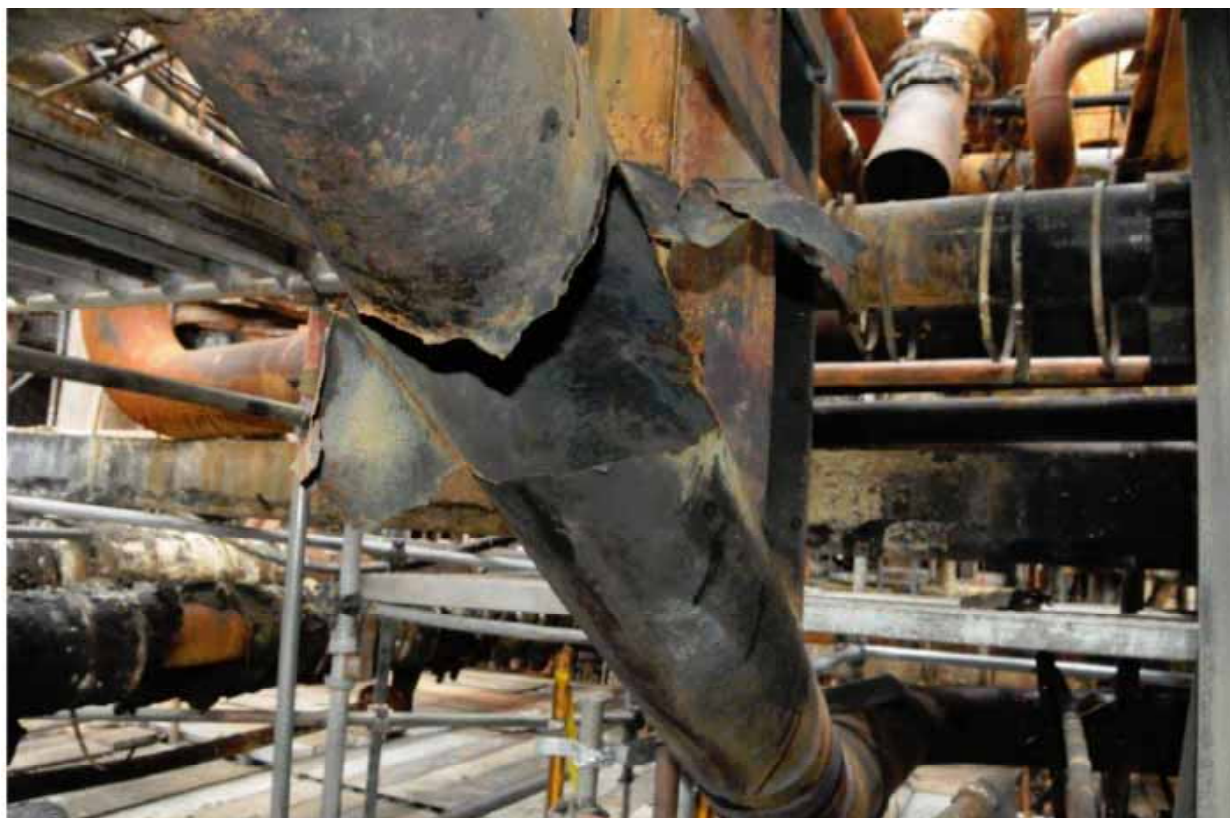
Figure 5. Photo of rupture on 4-sidecut 52-inch component.

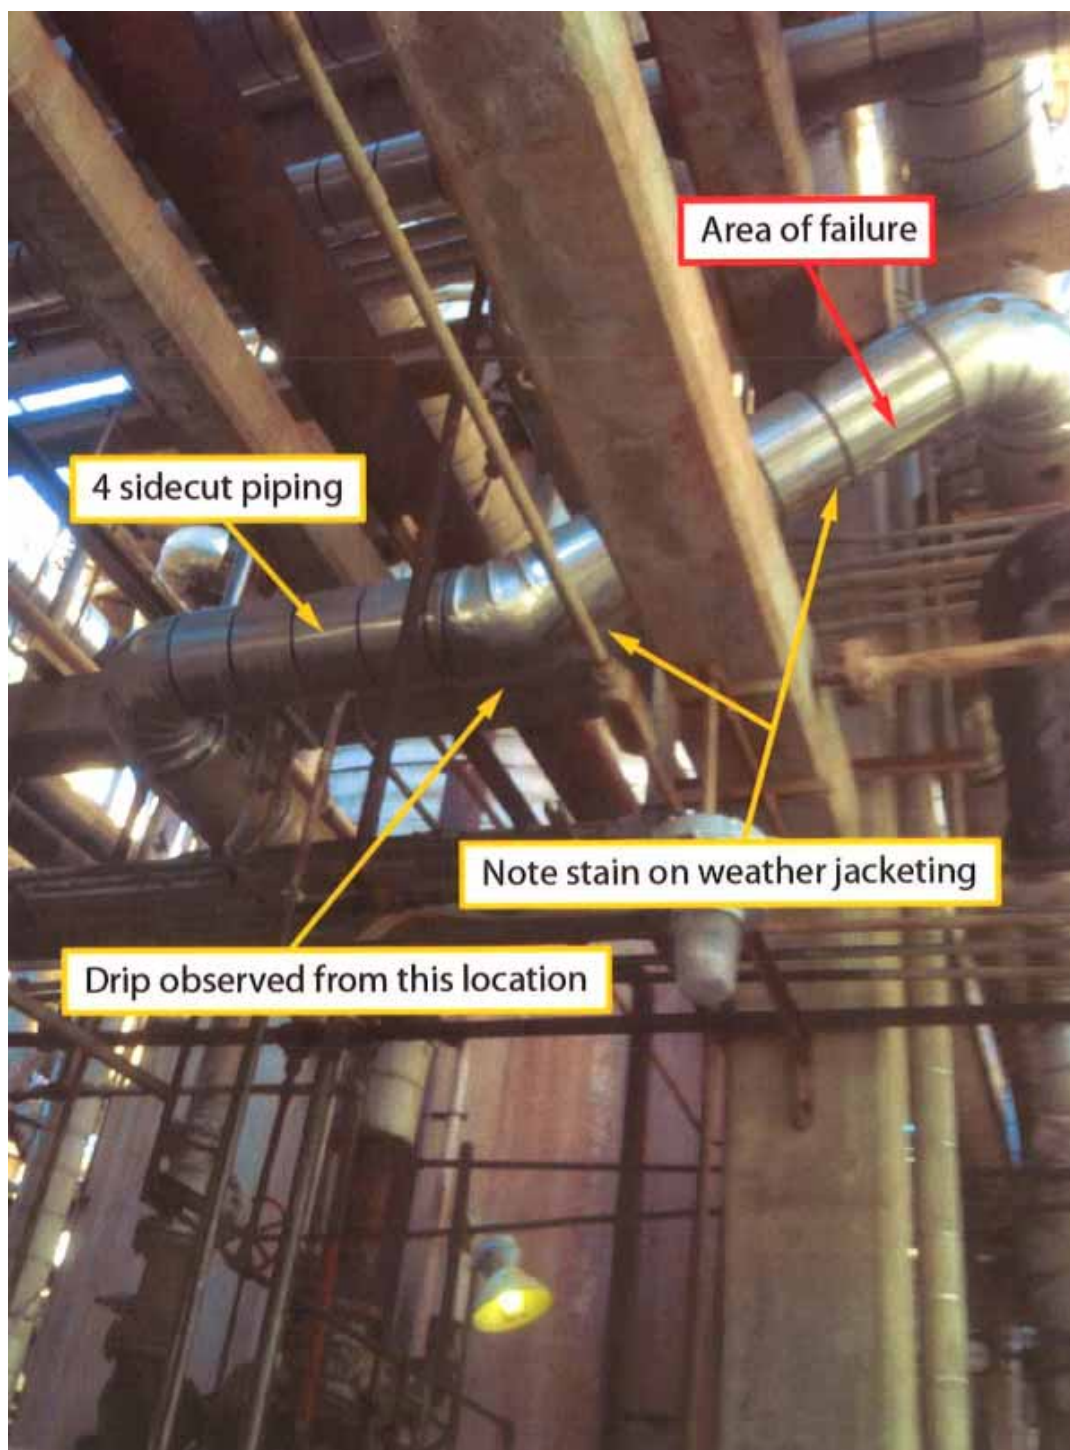
Figure 7. Photo taken of the leaking 4-sidecut pipe on August 6, 2012, at the Chevron Richmond Refinery.<sup>49</sup> Insulation obscured the actual leak location. Stain signifies where hydrocarbon process fluid was leaking from the 4-sidecut piping.

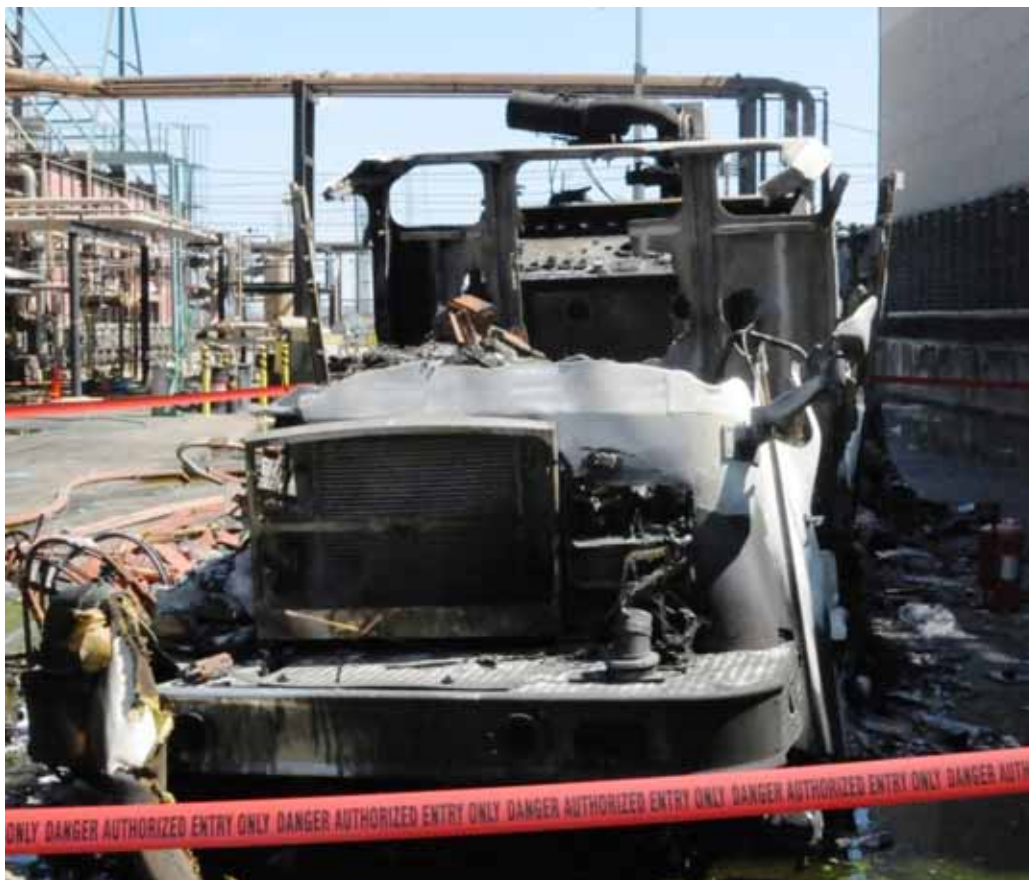
**Figure 14. Photo of the burned remains of the fire truck that was consumed by the fire. A firefighter was in the cab when the light gas oil ignited. The fire truck was positioned in the cold zone approximately 65 feet from the leak location.**

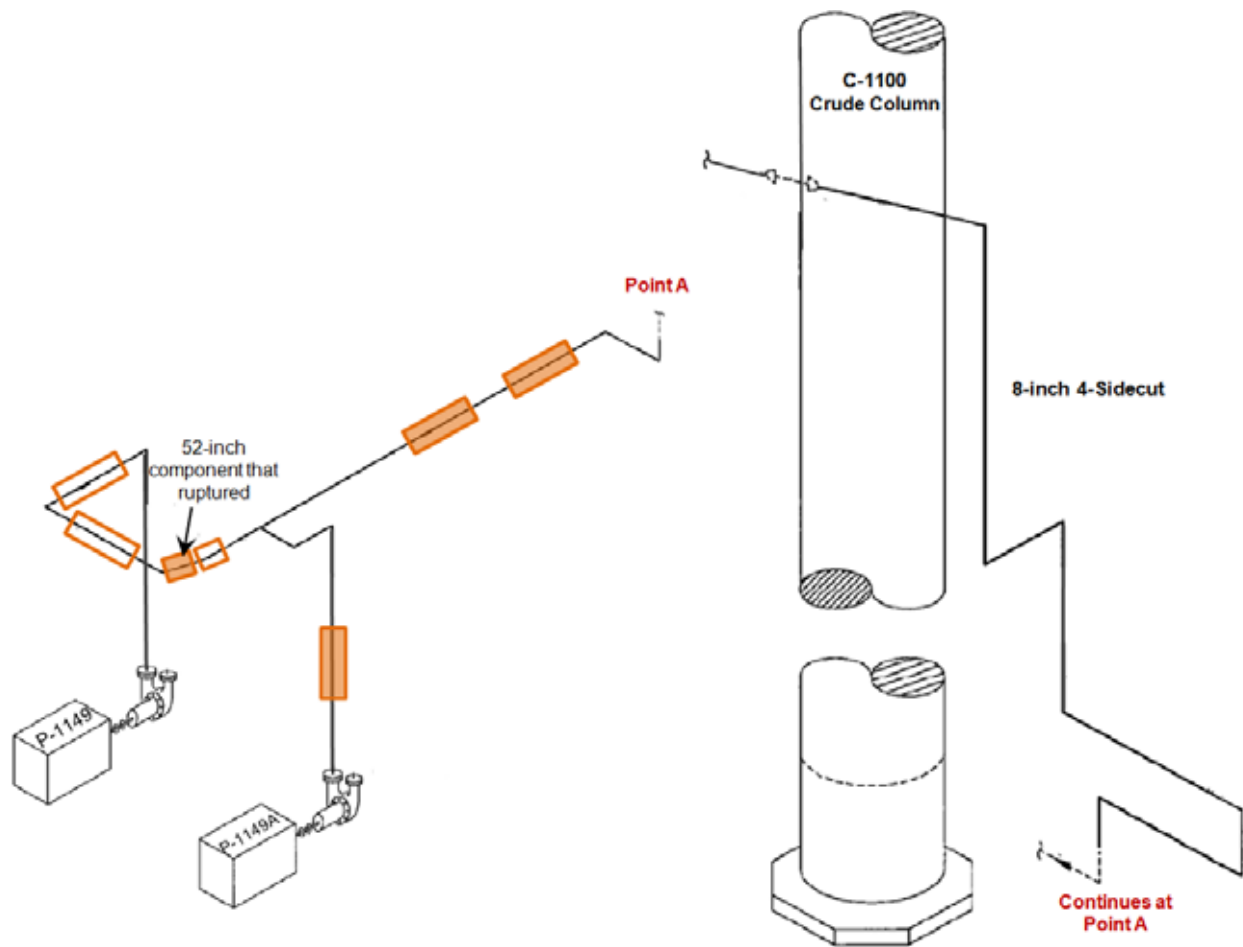
**Figure 18. Locations of metallurgical samples taken from 8-inch 4-sidecut piping post-incident. The seven samples taken are boxed in orange. Four of the seven components sampled (shown with an orange fill) were found to have a silicon content less than 0.10 weight percent.**

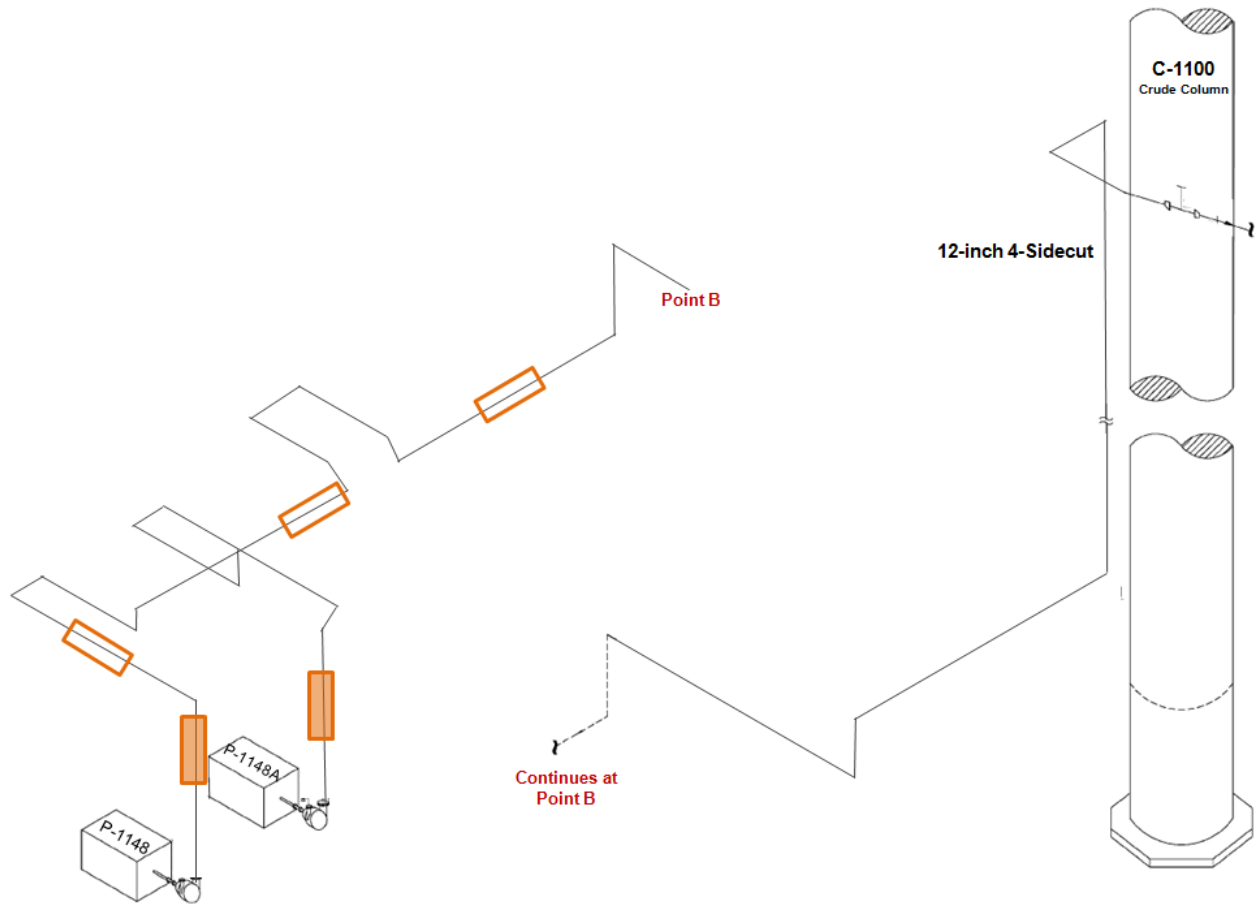
**Figure 19. Locations of metallurgical samples taken from 12-inch 4-sidecut piping post-incident. The five samples taken are boxed in orange. Two of the five components sampled (shown with an orange fill) were found to have a silicon content less than 0.10 weight percent.**

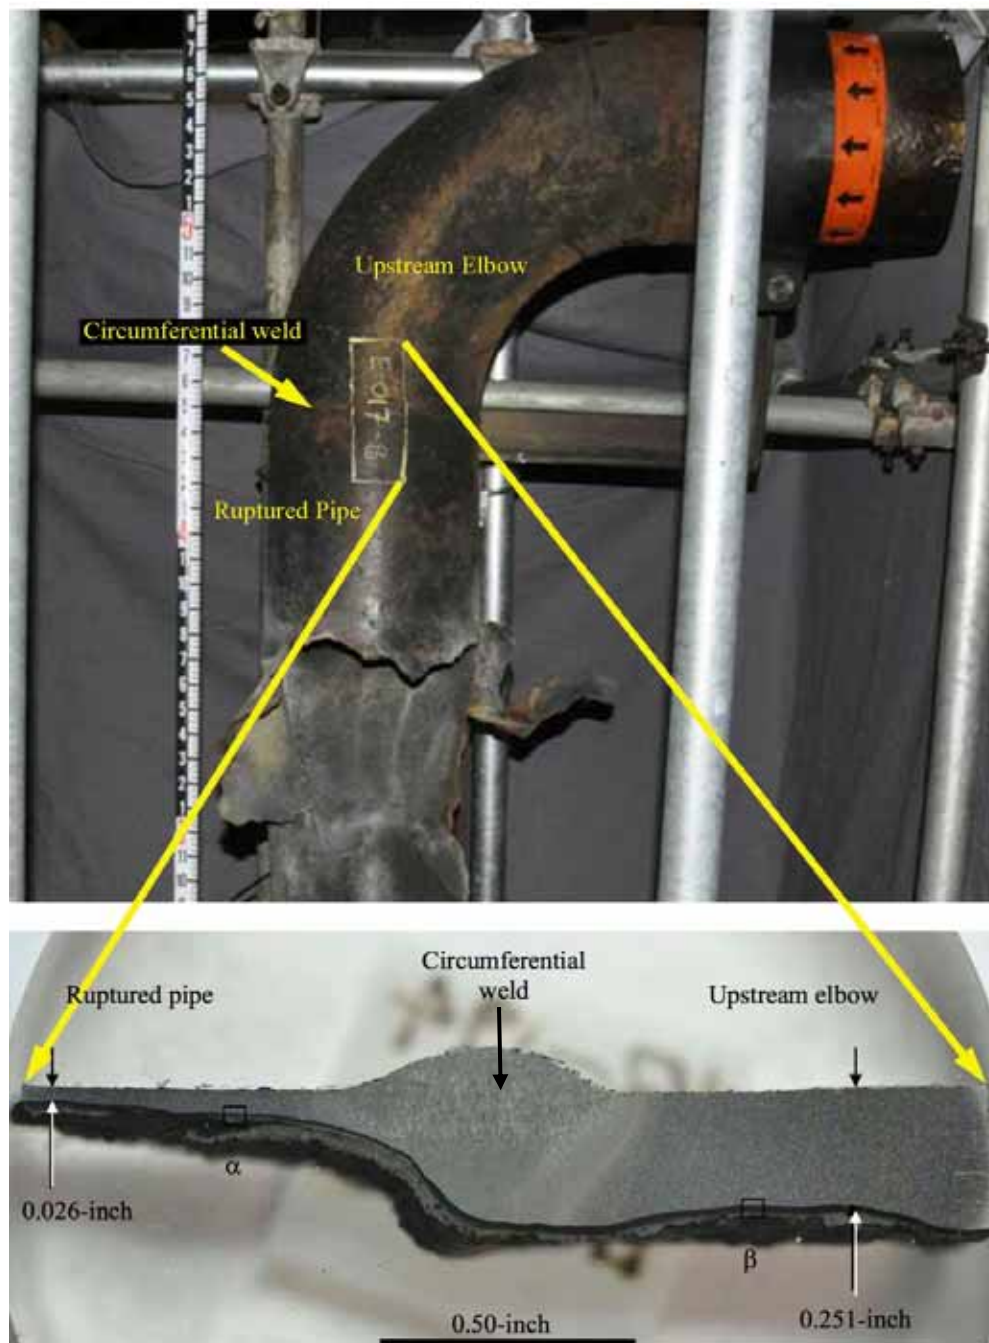
**Figure 20. 4-sidecut piping sample (E-017-8) analyzed by Anamet Labs showing the relative thickness of low silicon piping on the left and the high silicon piping on the right. The ruptured 52-inch pipe component (left) contained 0.01 weight percent silicon, and the upstream elbow component (right) contained 0.16 weight percent silicon.<sup>75</sup> The initial nominal thickness of this piping was 0.322-inch.**

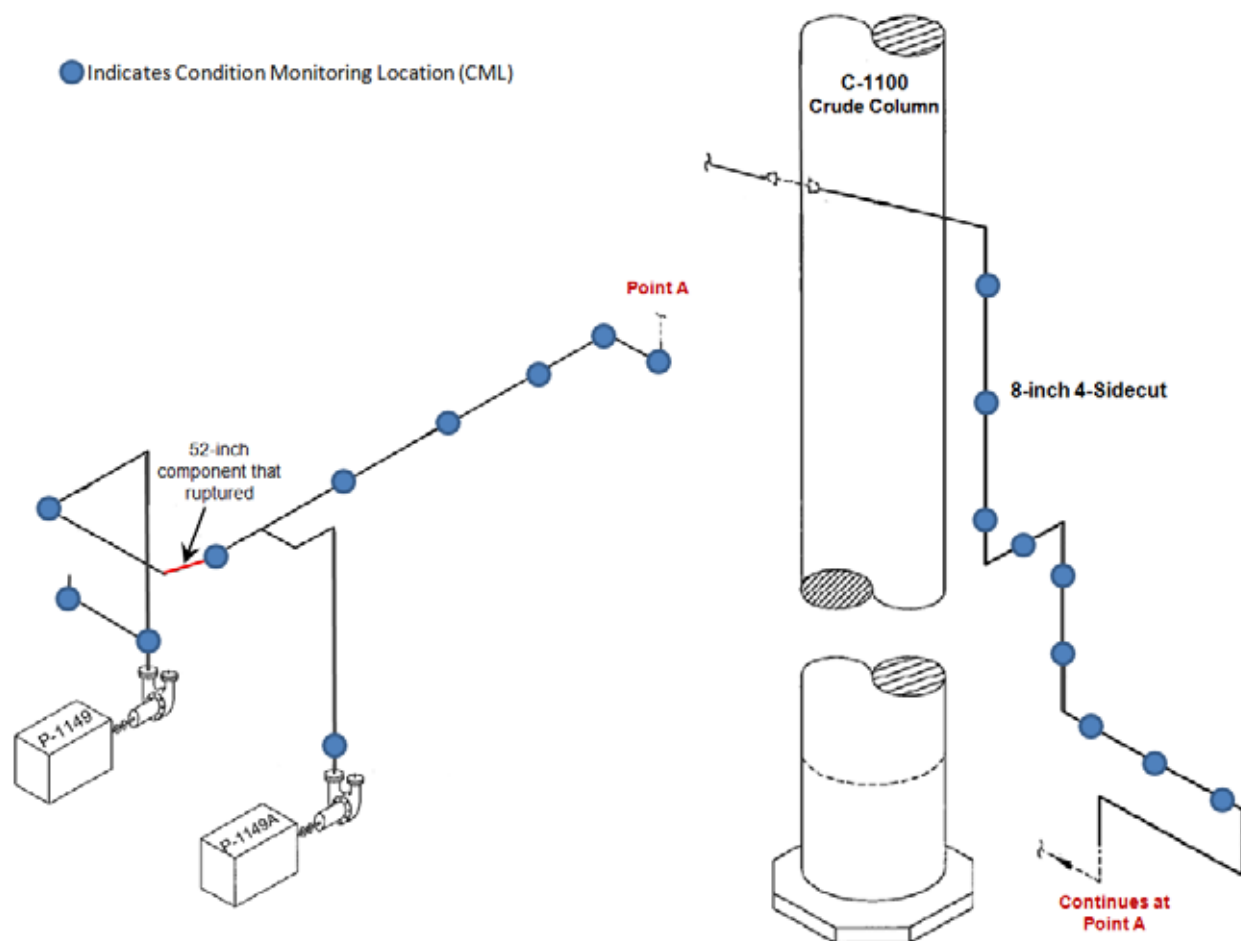
the 8-inch 4-sidecut piping circuit, although 100 percent component inspection was not performed. The CSB found that, although a CML was located on the adjacent upstream elbow, no CMLs were placed on the low silicon piping component that failed (Figure 21). Chevron identified corrosion in the 52-inch component during a supplemental 2002 inspection,<sup>87</sup> but the inspection results were not entered into the CML-tracking portion of the inspection database, and no new CML was required to be added to ensure future monitoring. As a result, the 52-inch component was never inspected again (Section 5.1.2.1.1).

**Figure 21. CML placement on 8-inch 4-sidecut piping. Nineteen CMLs were used to monitor corrosion rates in the 8-inch 4-sidecut piping. A CML was not placed on the 52-inch component that ultimately failed. A CML was placed, however, on the upstream elbow adjacent to the 52-inch component.**

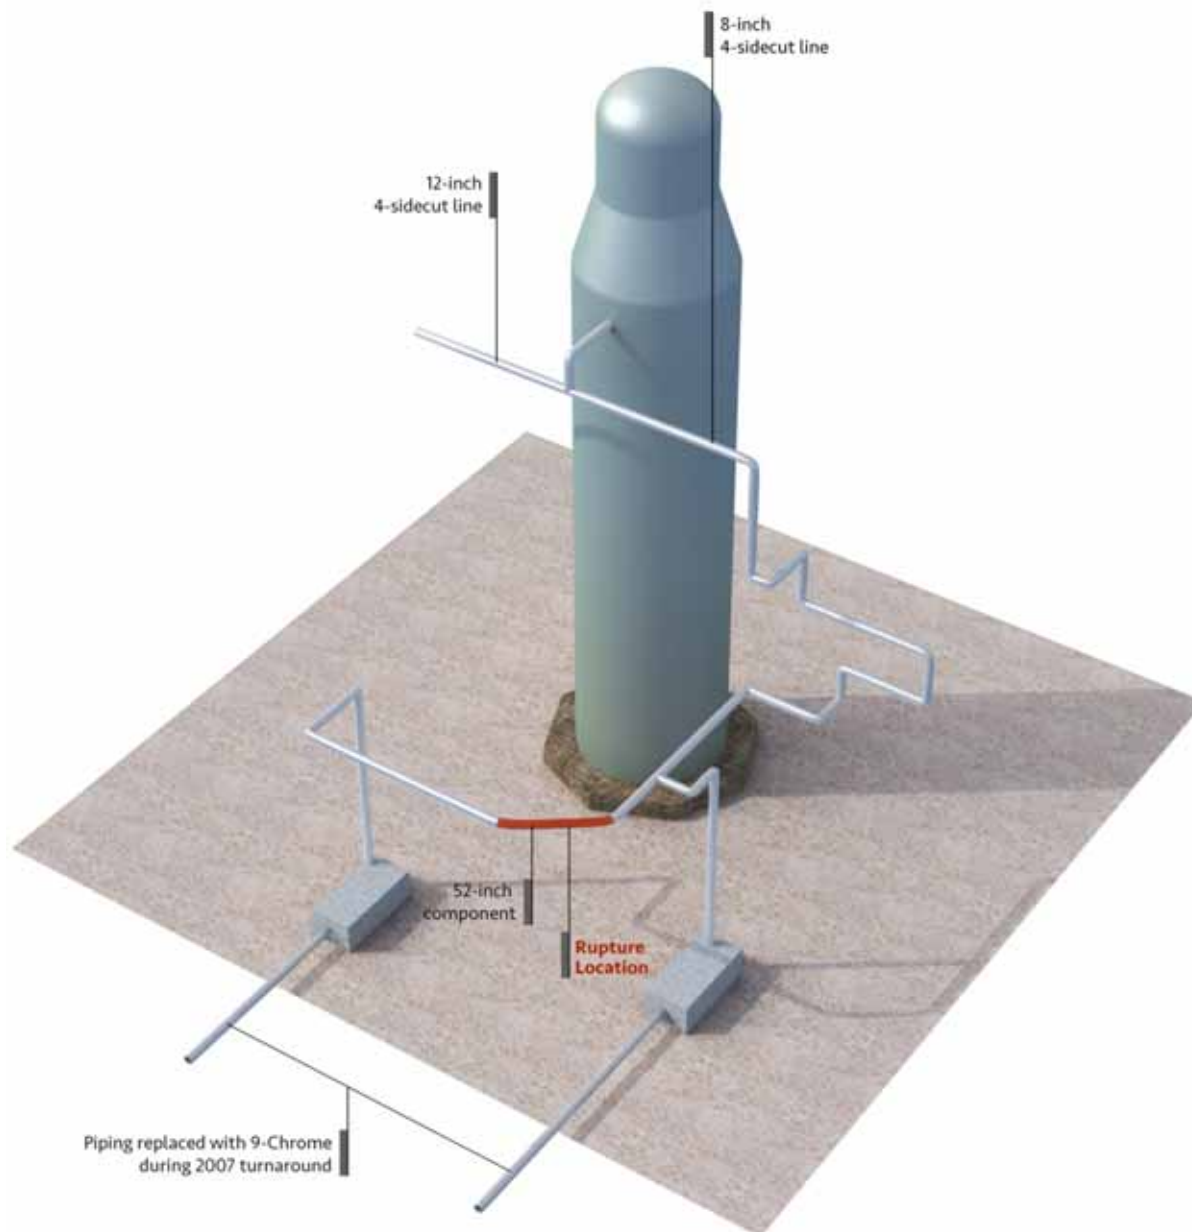
**Figure 33. Crude column schematic indicating the piping downstream of the 4-sidecut pumps that was replaced during the 2007 Crude Unit turnaround. The portion of the carbon steel line containing the component that failed on August 6, 2012 was not replaced.**

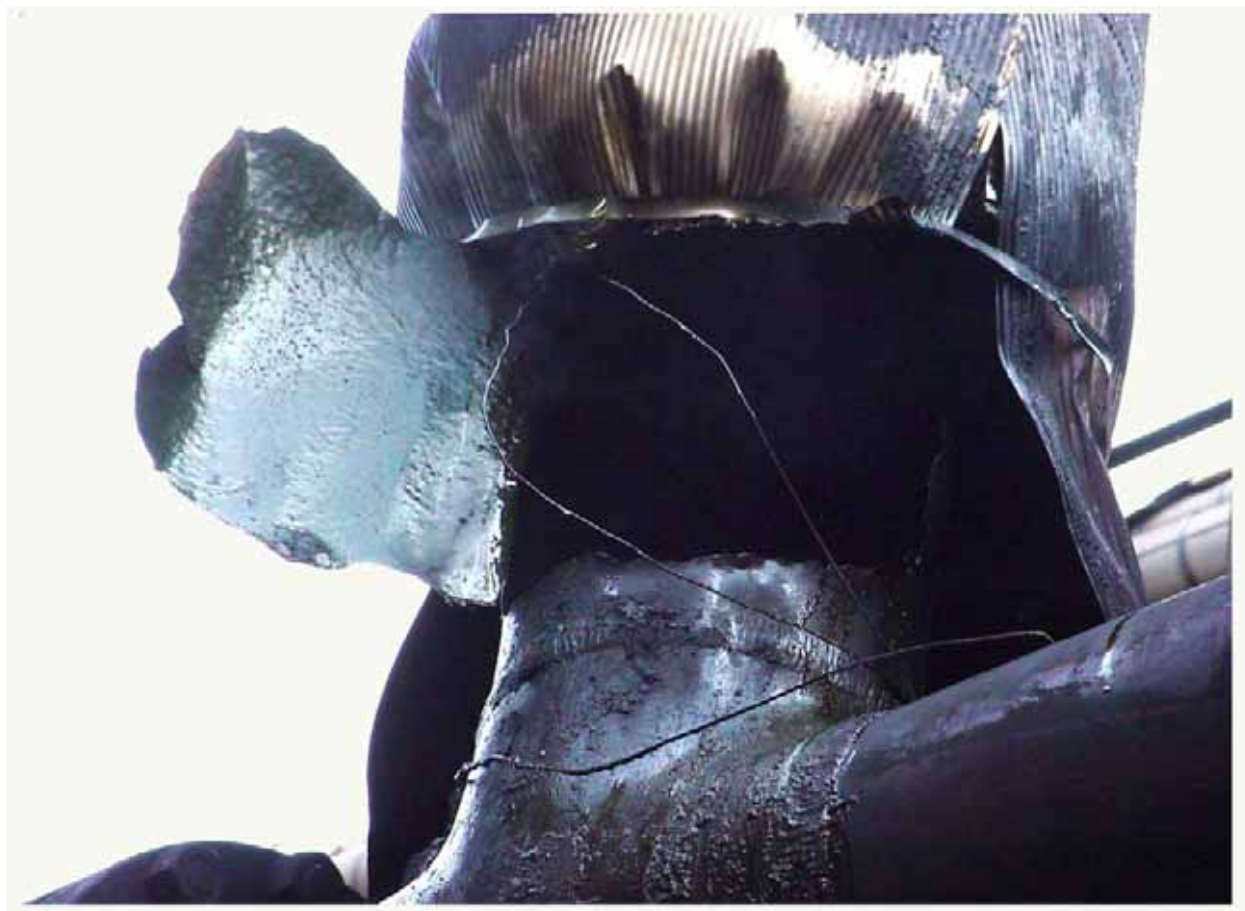
**Figure 38. Photo from *API RP 939-C* of a low-silicon pup piece that ruptured at a BP refinery. The surrounding piping had higher silicon content, and the pup piece’s accelerated corrosion rate was unmonitored.**

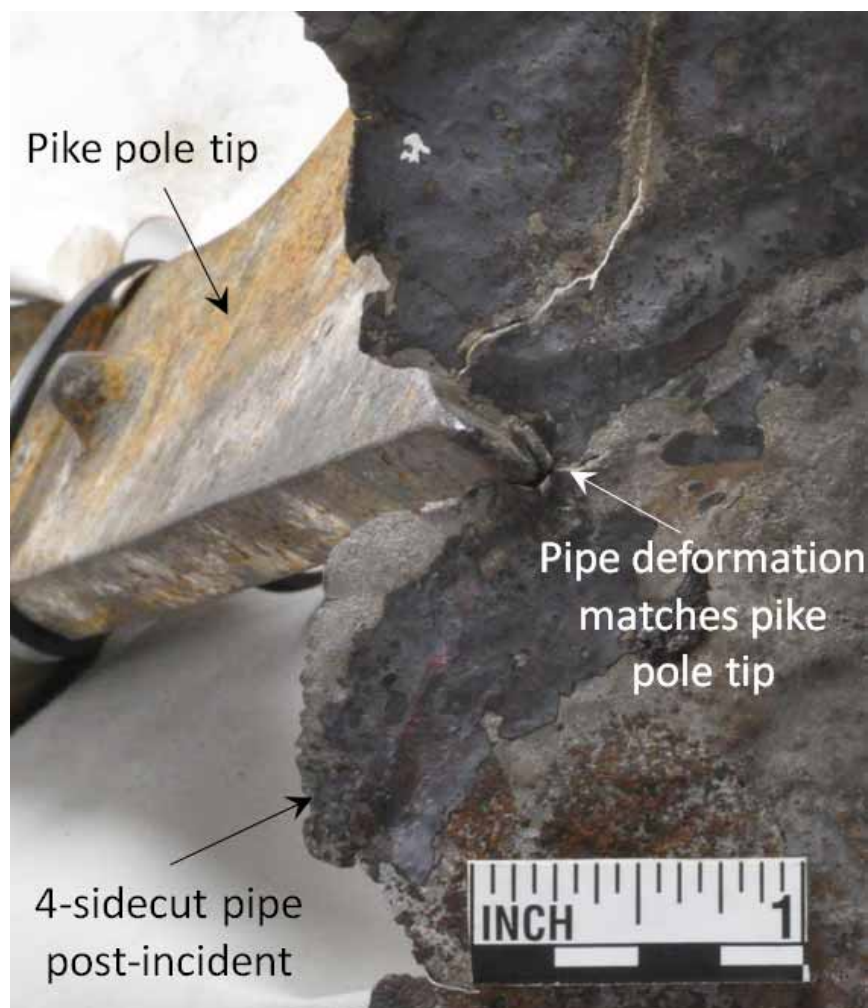
**Figure 41. Photo showing that tip of fire pole matches apparent puncture location in failed 52-inch component of 4-sidecut piping.**
