AIR ACCIDENTS INVESTIGATION INSTITUTE
Beranových 130
199 01 PRAGUE 99

CZ-19-0776

FINAL REPORT

**Investigation of causes of a serious incident
of the Boeing B737-800 aircraft, registration mark OK-TVO,
flight TVS1125 from LGSM to LKPR
on 22 August 2019**

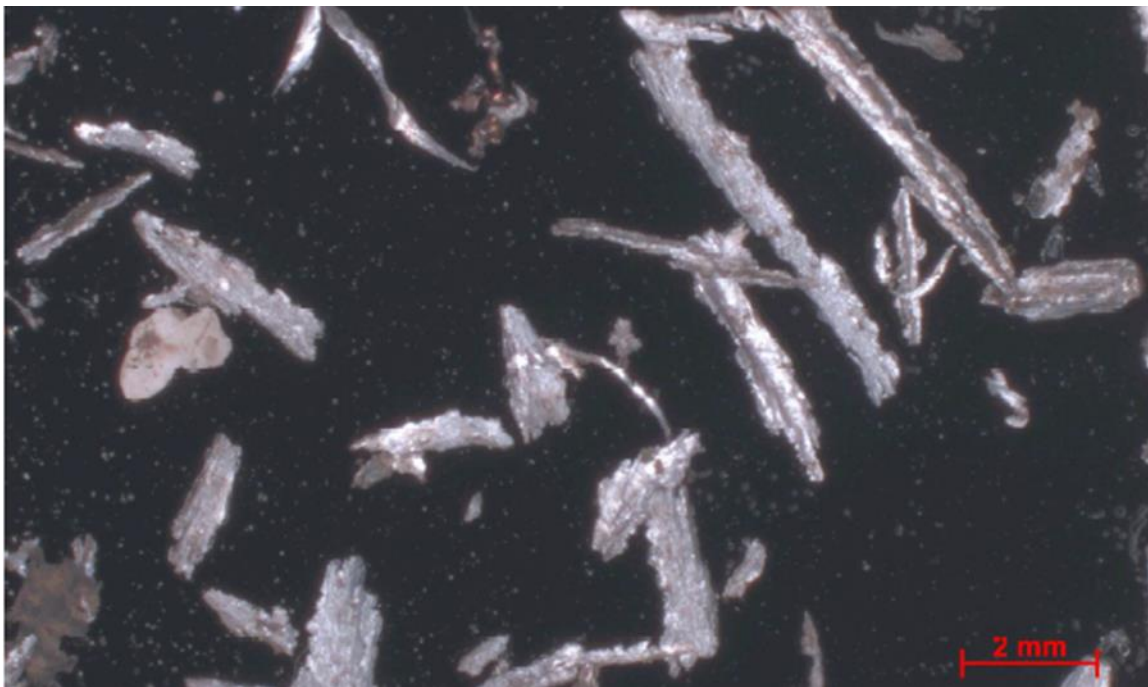
The filter was contaminated with swarf and fragments in size from 1 to 10 mm and in number greater than 100 pcs. Swarf analysis identified the material composition: aluminium-copper-magnesium (AlCuMg) and aluminium-silicon alloy (AlSi). Apart from the said swarf and fragments, the filter did not show any other abnormalities. The main fuel filter was not found to be the cause of a fuel pump defect leading to engine failure.

Fig. 7 Fragments collected by the main fuel filter

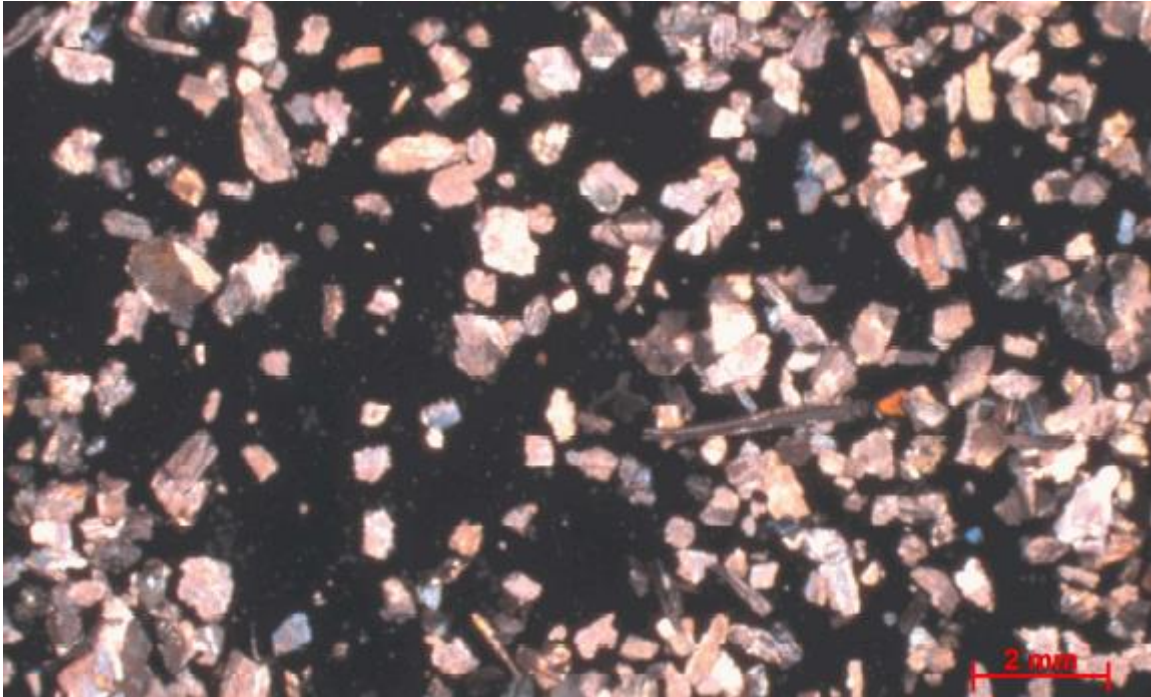
The filter was contaminated with scales in size from 0.5 to 1.5 mm and in number greater than 100 pcs. All the analysed fragments contained copper alloy and corresponded to a copper, tin and lead alloy (CuSnPb). Apart from the said swarf and fragments, the filter did not show any other abnormalities. The fuel nozzle filter was not found to be the cause of a fuel pump defect leading to engine failure.

Fig. 8 Fragments collected in the fuel nozzle filter

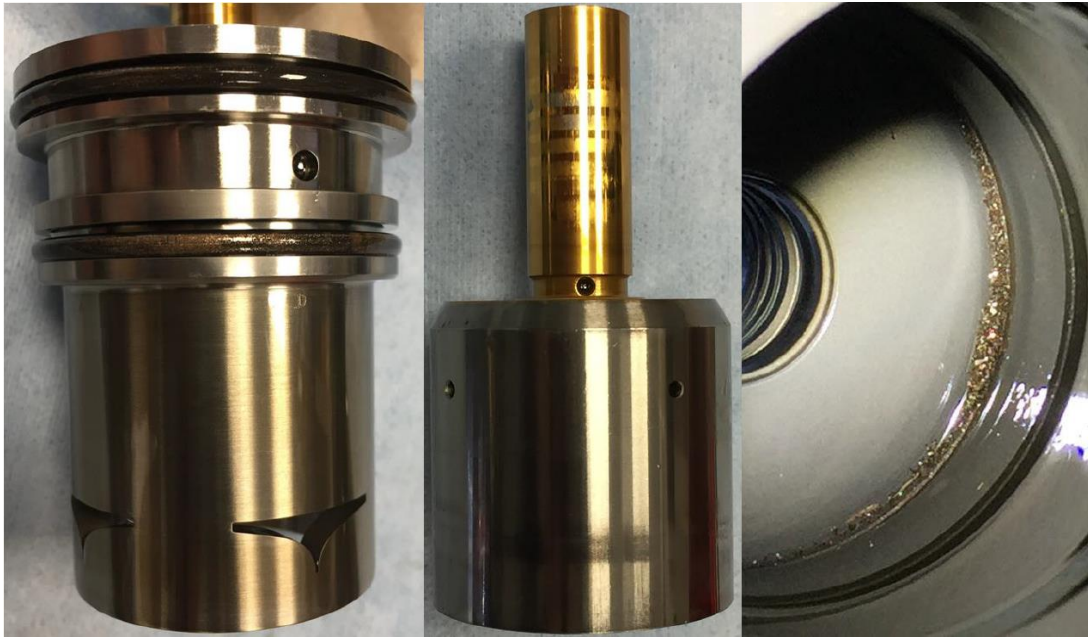
The entire HMU was completely dismantled. All parts of the HMU were highly contaminated with bronze-stained swarf and fragments. This high level of contamination significantly affected, even prevented, the operation of various moving parts of the HMU and thus the functionality of the entire hydromechanical unit. This is documented with the pressure/shut-off valve found in a closed position and heavily contaminated with bronze-stained swarf and fragments. For this reason, the valve piston was “sticky” and difficult to remove.

Fig. 9 The shut-off valve was in a closed position and had limited functionality due to contamination.

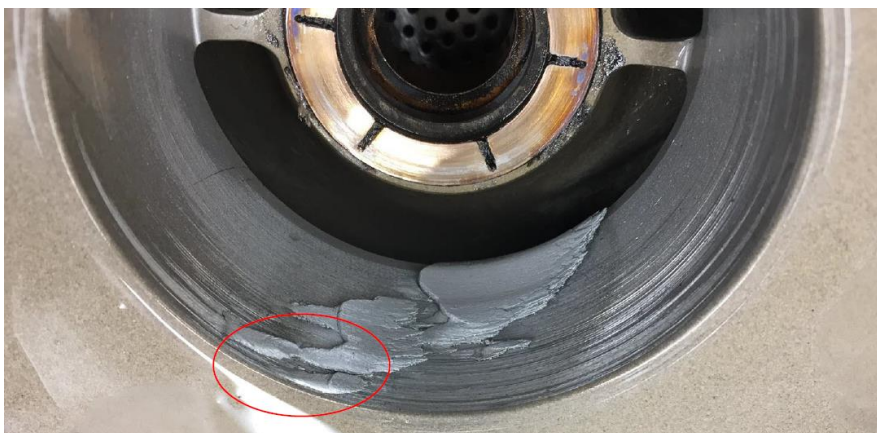
The fuel pump was contaminated with swarf and fragments in size from 1 to 10 mm and in number greater than 100 pcs. Swarf analysis identified the material composition: aluminium-copper-magnesium (AlCuMg) and aluminium-silicon alloy (AlSi). The following material was extracted from the pump: copper (Cu) in alloy with traces of nickel (Ni) and lead (Pb), carbon (C), fluorine (F), and aluminium (Al). The rotating part of the pump showed wear due to dry friction. The flaky fragments removed from the impeller blades were composed of aluminium alloy with about 10% of silicon. The pump housing showed traces of friction with the rotating part of the pump – impeller. Swarf collected from the housing corresponded to the material composition of the impeller. Traces of melted metal were also found on the pump housing, demonstrating high operating temperatures caused probably by running “dry”, i.e. without fuel as a lubricant.

Fig. 10 Traces of melted metal in the pump housing.

Findings on the main fuel pump indicate the operation of the pump without fuel which works as a lubricant during normal operation. Operating the pump “dry” may well explain the damage to the fuel pump and the resulting contamination with so produced swarf and fragments of other engine fuel system components. This gradually significantly reduced the functionality of the entire fuel system, which resulted in engine failure.

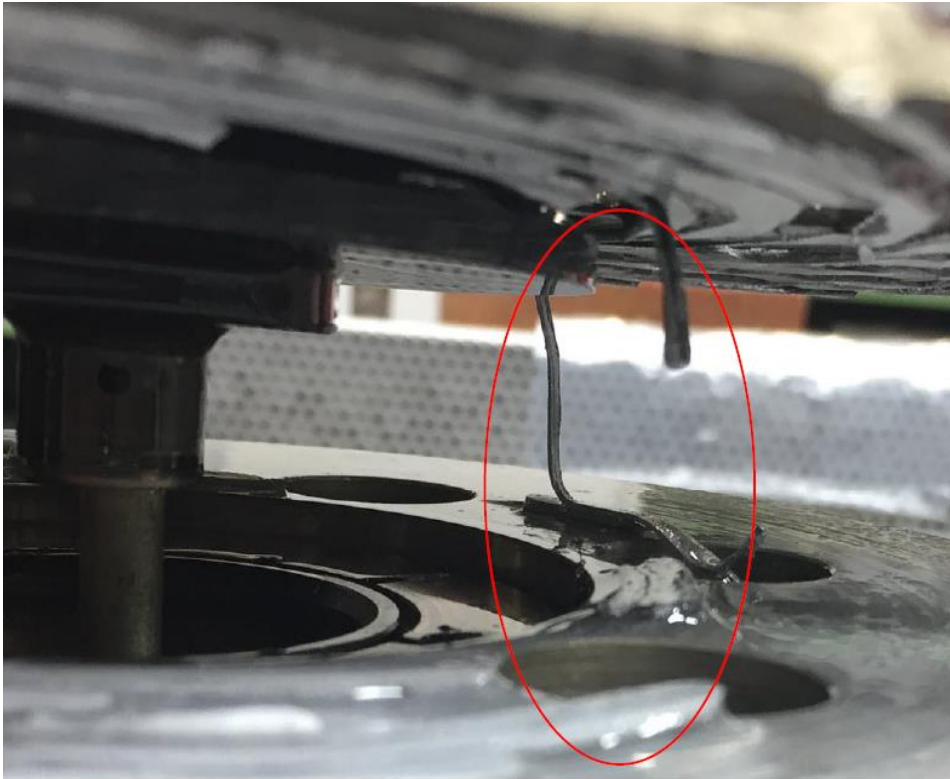
Fig. 11 When the impeller was dismantled, there was noticeable partial welding with a pump housing wall there.
