# Service Bulletin

OCTOBER

1960

NO. 358

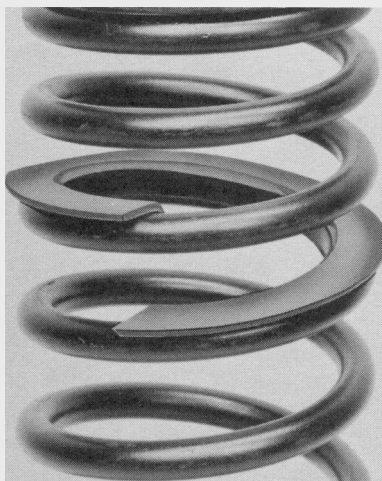
FIG. 1

The installation of rubber Insulator, Part No. 526249, between the coils of the front spring will eliminate noise caused by coil-to-coil contact of the front spring which sometimes occurs under light load conditions.

Place the rubber insulator on top of the center coil with the inner flange of the insulator down (See Fig. 1) and then thread the insulator upward as far as possible. The weight of the car will hold the insulator in place. In some instances, it may be necessary to install two insulators to completely eliminate spring interference noise. The second insulator is installed in the same manner, and positioned adjacent to the first insulator.

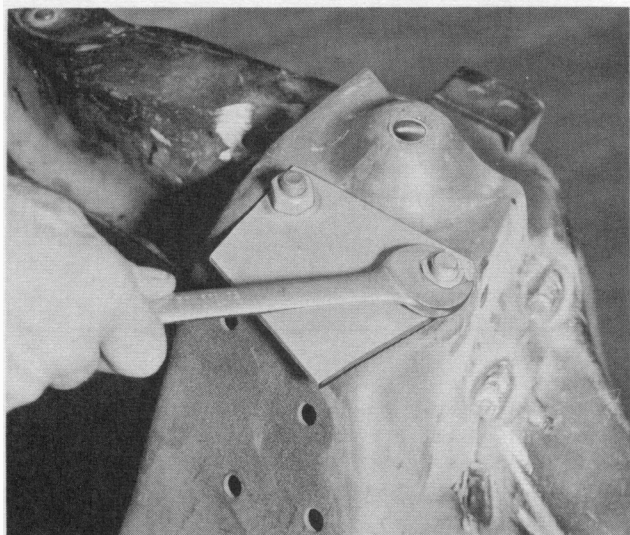
FIG. 2

We have received some field reports of front crossmembers cracking in the area of the upper control arm pivot shaft. In each instance the cars involved are used in severe type service and the cracking occurred at comparatively high mileages.

1. Remove the upper control arm pivot shaft.
2. Bolt the re-inforcing plate to the crossmember as shown in Fig. 2.
3. Arc weld the plate to the crossmember as shown in Fig. 3. Continue the weld around the part of the plate that sits flat on the crossmember.
4. Bend the remaining part of the plate down so that it will fit tight against the crossmember.
5. Continue the arc weld around the remaining portion of the plate. (See Fig. 4).
6. File the area of the re-inforcing plate on which the pivot shaft will be bolted as indicated in Fig. 5.
7. Install upper control arm pivot shaft.

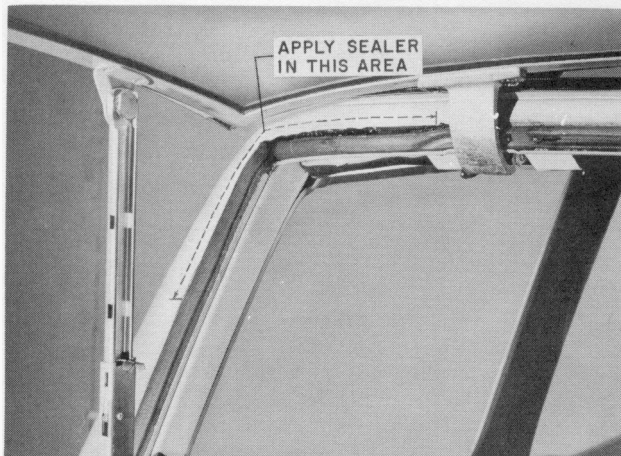
FIG. 6

Sealer is now being applied in production to the upper corners of the tail gate weatherstrip channel between the rubber weatherstrip and the outer edge of the channel. The sealer is applied after the weatherstrip is installed and prevents water from running behind the weatherstrip.

Apply a bead of Studebaker-Packard Weatherstrip Cement, Part No. SP-50045, between the rubber weatherstrip and the outer edge of the channel. The sealer should extend from the upper hinges to the corners, and then downward for a distance of approximately 5 inches. (See Fig. 6).

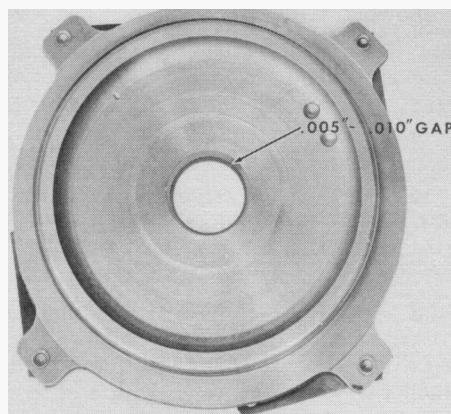
FIG. 10

This malfunction may be caused by piston rings that are butting because of insufficient ring gap. It is recommended that all piston rings be checked for gap before installation. Each of the four outer rings should be checked for gap in the bore of the clutch housing. (See Fig. 9). File the ends as necessary to provide a gap of  $.010''$  -  $.015''$ . Clean off all burrs or roughness caused by filing. Upon installation, make sure ring gaps are spaced so that no two gaps are in line.

To check the inner ring, insert the ring into the bore of the piston and check the gap as shown in Figure 10. The ring gap should be  $.005''$  to  $.010''$ . Remove any burrs or roughness caused by filing if it is necessary to file the ring to provide a gap within the prescribed limits.

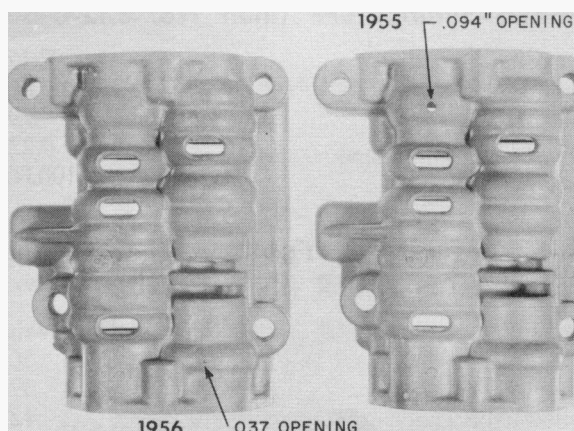
FIG. 11

The 1955 assembly has a  $.094''$  vent opening, drill size No. 42, over the direct shift valve in the rear upper valve body. (See Fig. 11).

The 1956 valve body assembly has a  $.037''$  vent, drill size No. 63, located over the low high shift piston. (See Fig. 11).

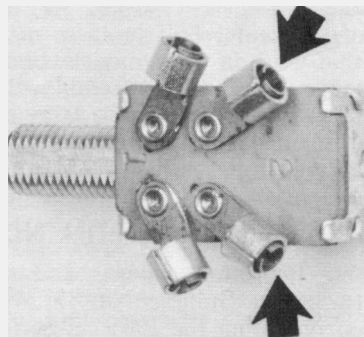
FIG. 12

We have received a few complaints regarding the automatic transmission down-shifting on light throttle application. In each instance it has been found that the wires to the kick-down switch were placed in the wrong terminal.

The correct method of connecting the kick-down switch on the 4E and 5E Series trucks is shown in Fig. 12.
