TO: ALL VOLVO RETAILERS
RE: RECALL 181

<h1 style="margin: 0;">VOLVO</h1> <h2 style="margin: 0;">Service Manager Bulletin</h2>				TITLE:		GROUP:	NO:									
				Recall 181: Fuel Pressure Sensor		23	181									
				2003-2004 S60, V70 Engine VIN Codes 52, 59, 61, 64		ISSUING DEPARTMENT:										
						Warranty										
						CARMARKET:										
						United States, Canada										
				REFERENCE BULLETINS:		DATE:										
				TNN# 23-181, PB# 23-181		YEAR	MONTH	DAY								
<table border="1" style="width: 100%; border-collapse: collapse;"> <tr> <td style="width: 20%;">Service Personnel: read and initial.</td> <td style="width: 20%;">SERVICE MANAGER</td> <td style="width: 20%;">SERVICE WRITER</td> <td style="width: 20%;">WARRANTY ADMINISTRATOR</td> </tr> <tr> <td> </td> <td> </td> <td> </td> <td> </td> </tr> </table>				Service Personnel: read and initial.	SERVICE MANAGER	SERVICE WRITER	WARRANTY ADMINISTRATOR							2007	06	27
				Service Personnel: read and initial.	SERVICE MANAGER	SERVICE WRITER	WARRANTY ADMINISTRATOR									
						Page 1 of 3

NO: 23-181
DATE: 06-27-2007
MODEL: S60, V70 with engine code 52, 59, 61, 64
M. YEAR: 2003 – 2004
CHASSIS: S60 235112 – 372809
V70 28615

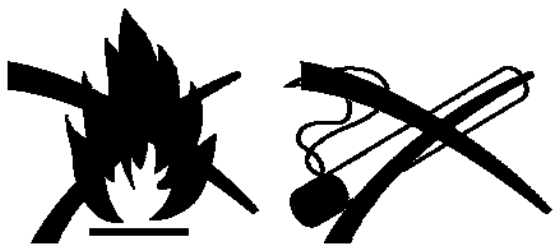
1.

Safety precautions for handling fuel

Caution!

Avoid ignition sources.

Use breathing protection when there is a risk of breathing in fuel vapors.

Use protective gloves to avoid skin contact with fuel.
