TOPICAL REPORT
GENERAL ELECTRIC VERTICAL INDUCTION MOTORS
INSIDE CONTAINMENT RECIRCULATION SPRAY PUMPS
FOR THE SURRY AND NORTH ANNA STATIONS
OF
VIRGINIA ELECTRIC POWER COMPANY

THIRD ADDITION TO COVER REBUILDING MOTORS
USING NEW BEARINGS

Docket Nos. 50-280 and 50-281

July 23, 1979

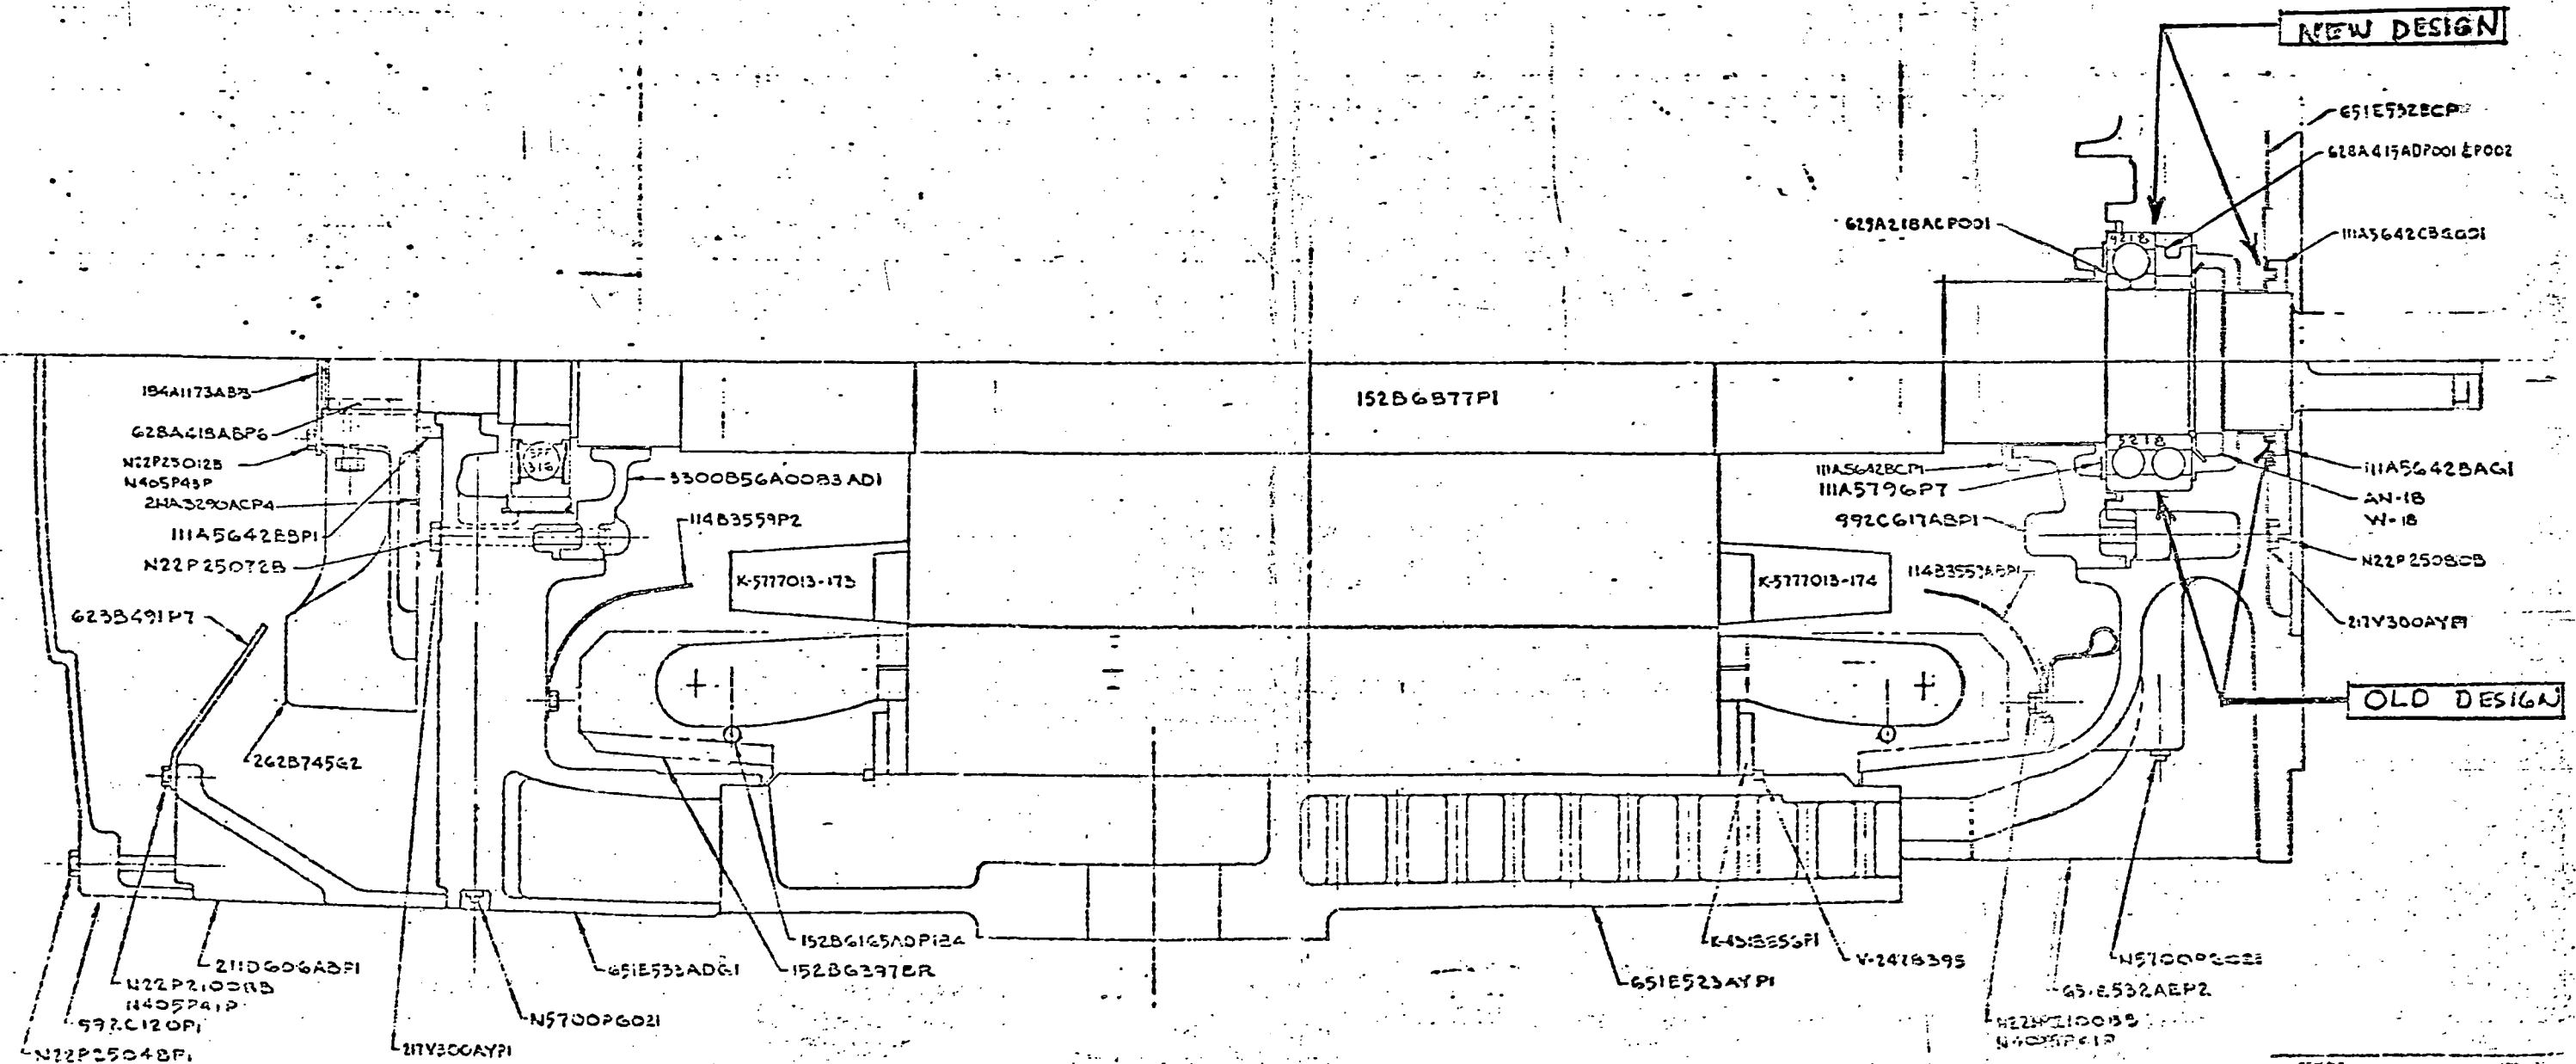
MOTOR ASSEMBLY DRAWING WITH NEW
AND OLD BEARING CONSTRUCTIONS

Electric San Jose and a lower bearing failure was found. The bearing internal parts had frozen due to tightening up of the bearing parts. The motor was rebuilt and again failed. Again, the motor was returned to San Jose and again the problem was a lower bearing failure. After reviewing the failure and discussing the problem with the bearing manufacturers and the General Electric Laboratory, it was concluded that the failure was due to the bearing seizing due to the elimination of the internal bearing clearance due to low internal bearing clearance, shaft heating due to motor loading of the TEFC construction where the rotor heat is carried off by the shaft to a greater degree than other motor constructions and an accumulation of tolerances on the lower motors parts. See assembly drawing in Appendix C.

To eliminate the shaft to endshield problem, the endshield opening was increased to give a greater radial clearance around the shaft where it passes through the endshield. To minimize this increase, the labyrinth sealing slinger on the lower end of the endshield was made larger in diameter, one labyrinth surface was added, plus the labyrinth clearances were

made closer and the distance the lab seal sits on the shaft was made longer. The overall length of the seal was increased at least .4 in. See the assembly in Appendix C. By making the above changes, the possibility of rubbing by the slinger to the endshield was eliminated, even with the tighter clearances.

The new slinger is made larger in diameter (5 in. diameter compared to 4.625 in.), has one added axial labyrinth surface (.5 total axial labyrinth length compared to .25 in.), has tighter clearance at the axial labyrinth surface (.032 in. compared to .0925 in. mean diametrical clearance), longer shaft fit (.515 compared to .320 mean length), and less runout between shaft hole and axial labyrinth fits (.005 in. TIR). The overall length of the sealing surface was increased by at least .4 in. The longer shaft fits prevent cocking of the slinger, thus preventing rubbing. See the assembly drawing in Appendix C for details on the above assembly.

The new slinger, with the above changes, will minimize the effect of the larger radial clearance (.0055 additional radial mean clearance) where the shaft passes through the endshield. The above assembly limits the amount of contaminants that can enter the lower end of the motor during the five pressure excursions during the qualification test. The length of the path as compared to the size of the path, plus centrifugal force from the running of the motor, limits the amount of contaminants that can enter the motor during the pressure excursion. Based on the original tests, it was concluded that the only time contaminants can enter the motor is during the five pressure excursions and that the amount was minimal and had no effect on the motor winding or the bearing operation. See the test conclusions in Appendix B. The new slinger should offset the larger shaft clearance, thus no additional contaminants should enter the motor during the five pressure excursions and affect the operation of the motor. Even if additional contaminants did enter the motor, their passage through the bearing would be more restricted because of the large cage construction of the 9218 bearing which acts like a shield as compared to the double row bearing used on the FIRL test motor. If they pass through the bearing, they would then have to pass through the explosion proof shaft seal, which is two inches long and is located between the bearing cap and the shaft, plus the inboard labyrinth sealing slinger at the bearing cap. If it did pass through all the seals, it would still only collect in the endshield and not affect the winding which is four inches above the endshield and separated by an air deflector. Based on the above data, it is concluded that the above changes will not affect the qualification of the motor. See Appendix C for motor assembly drawing.

The addition of these steel rings, as shown in the assembly drawing in Appendix C, will not affect qualification. Both rings are held in place during the locking of the bearing and cannot move during the running and starting of the motor.

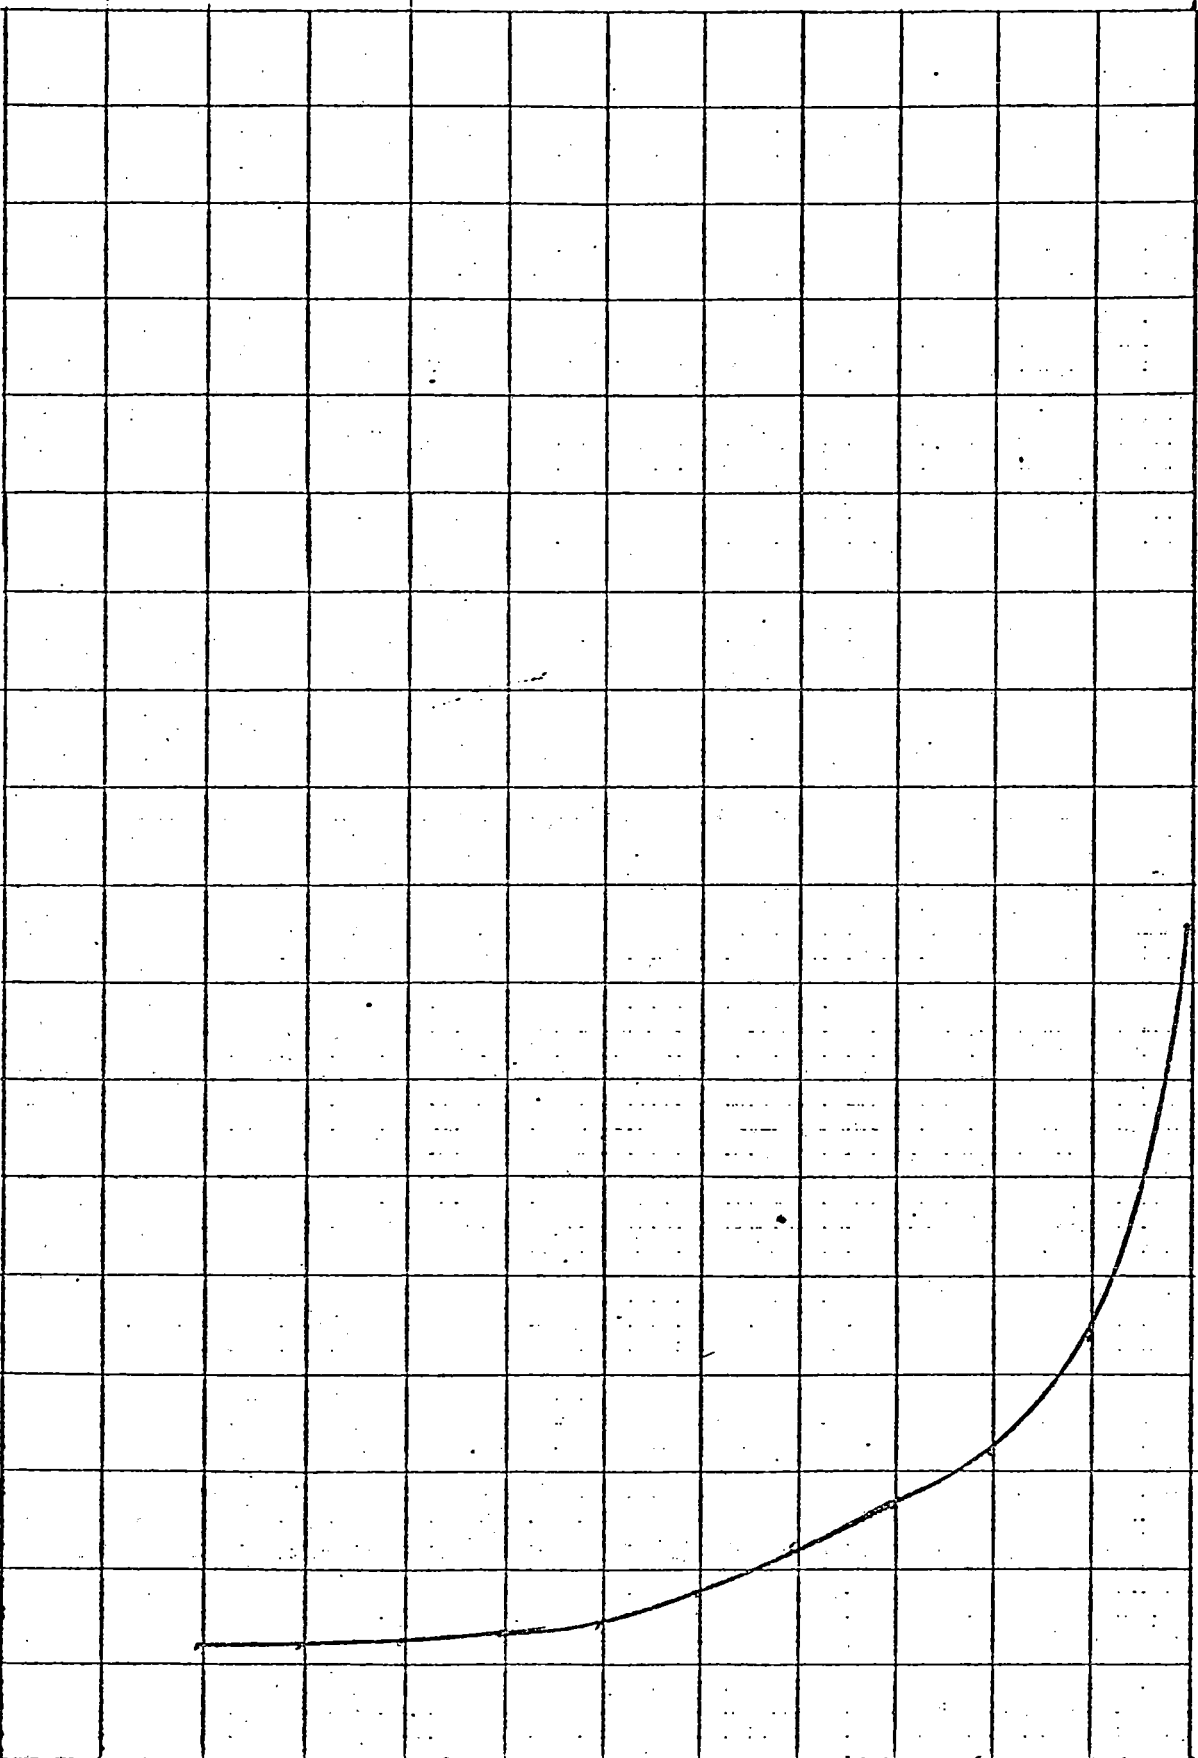
Further tests on four other motors were made on pumps with a thermocouple mounted against the outer race of the lower bearing. After running at least 24 hours with the pumps operating at the loaded condition, no problems were detected. The bearing temperatures showed no rapid rise, which would indicate a tightening of the bearing. Two of the tested motors were installed in the North Anna No. 1 Station and determined operable and will be rebuilt with the new construction when the plant is refueled. Appendix D shows the test results on the motors in North Anna No. 1.

TEST DATA CURVE OF BEARING ONE RACE TEMP
VS TIME FOR LOWER THRUST BEARING FOR
MOTOR MARK NO. 1-RS-PIA MOTOR LOADED WITH
PUMP AT NORTH ANNA UNIT #1 (DOUBLE ROW BRG)

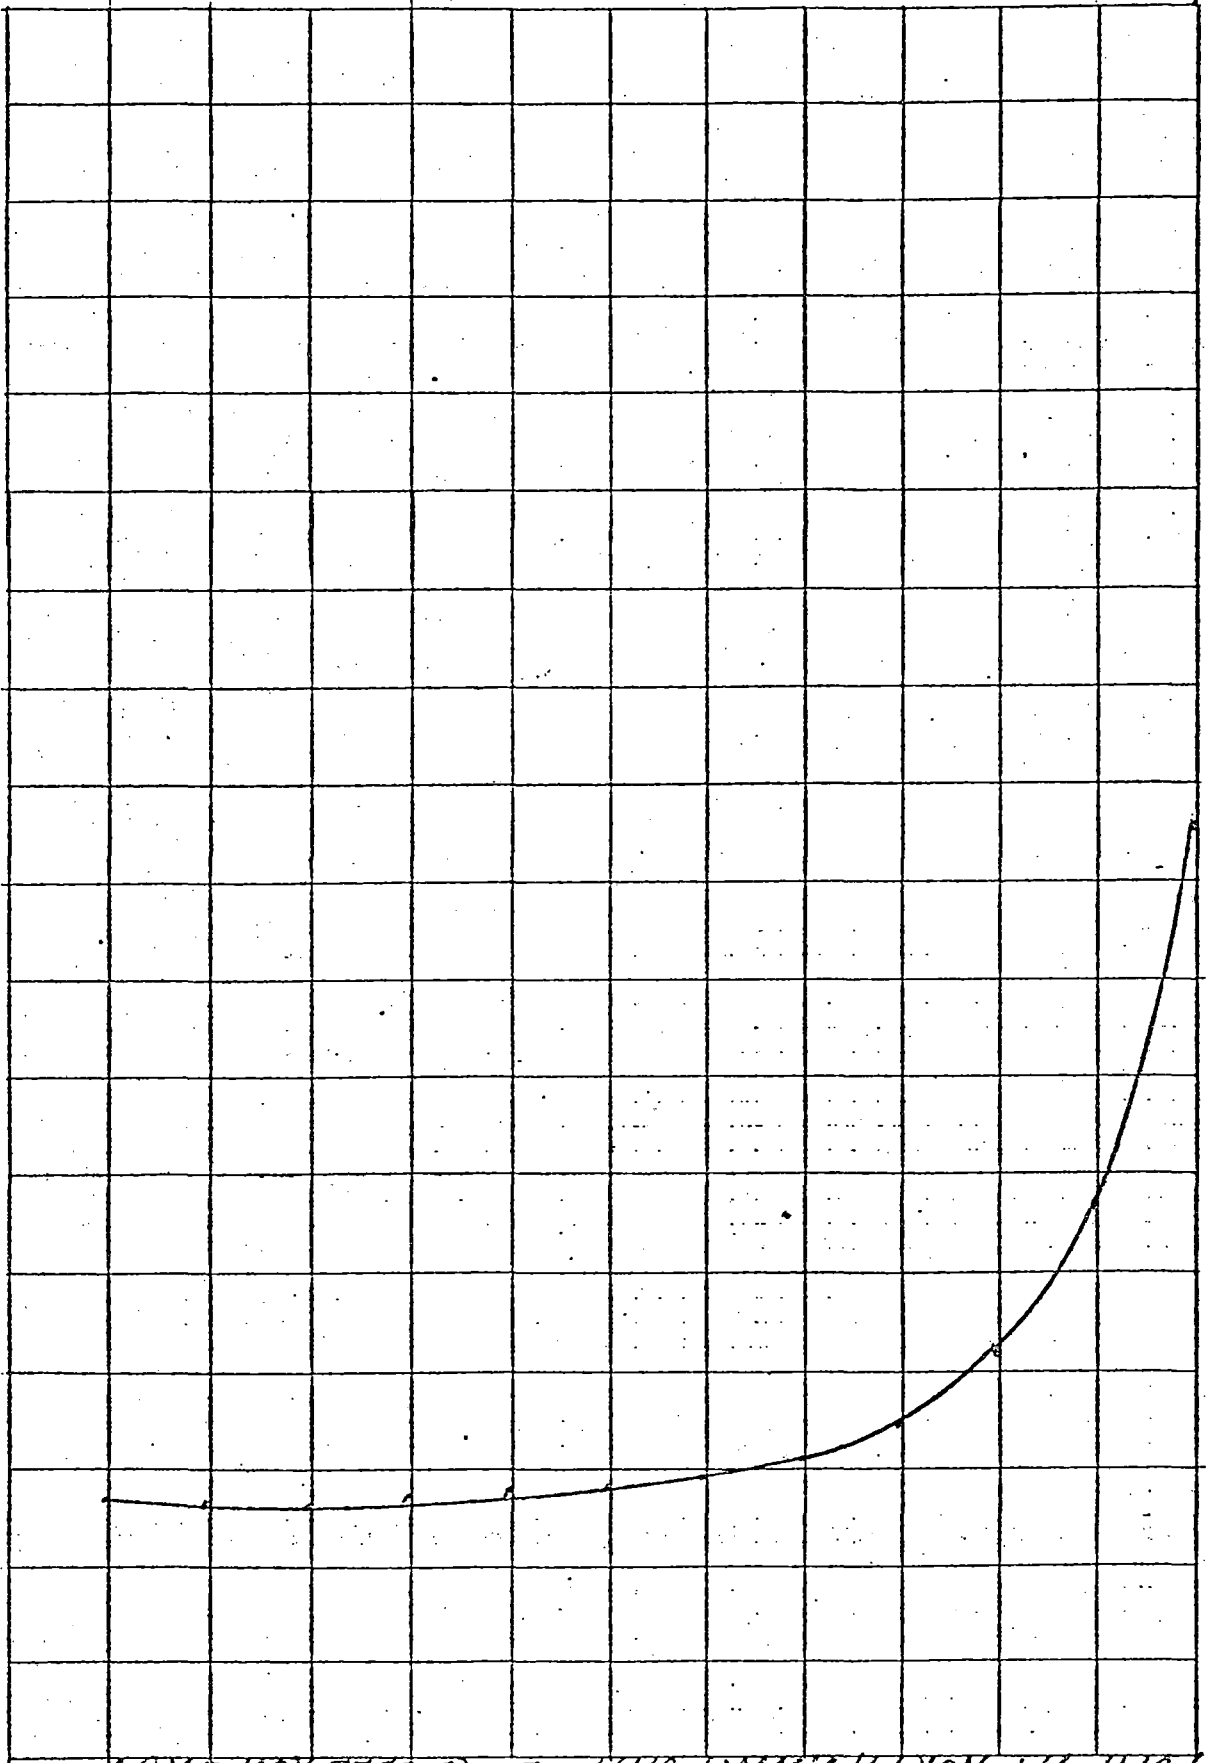
TEST DATA CURVE OF BEARING OUTER RACE TEMP.
 VS TIME FOR LOWER THRUST BEARING FOR
 MOTOR MARK NO. I-RS-PIB MOTOR LOADED WITH
 PUMP AT NORTH ANNA UNIT #1 (DOUBLE ROW BRG)

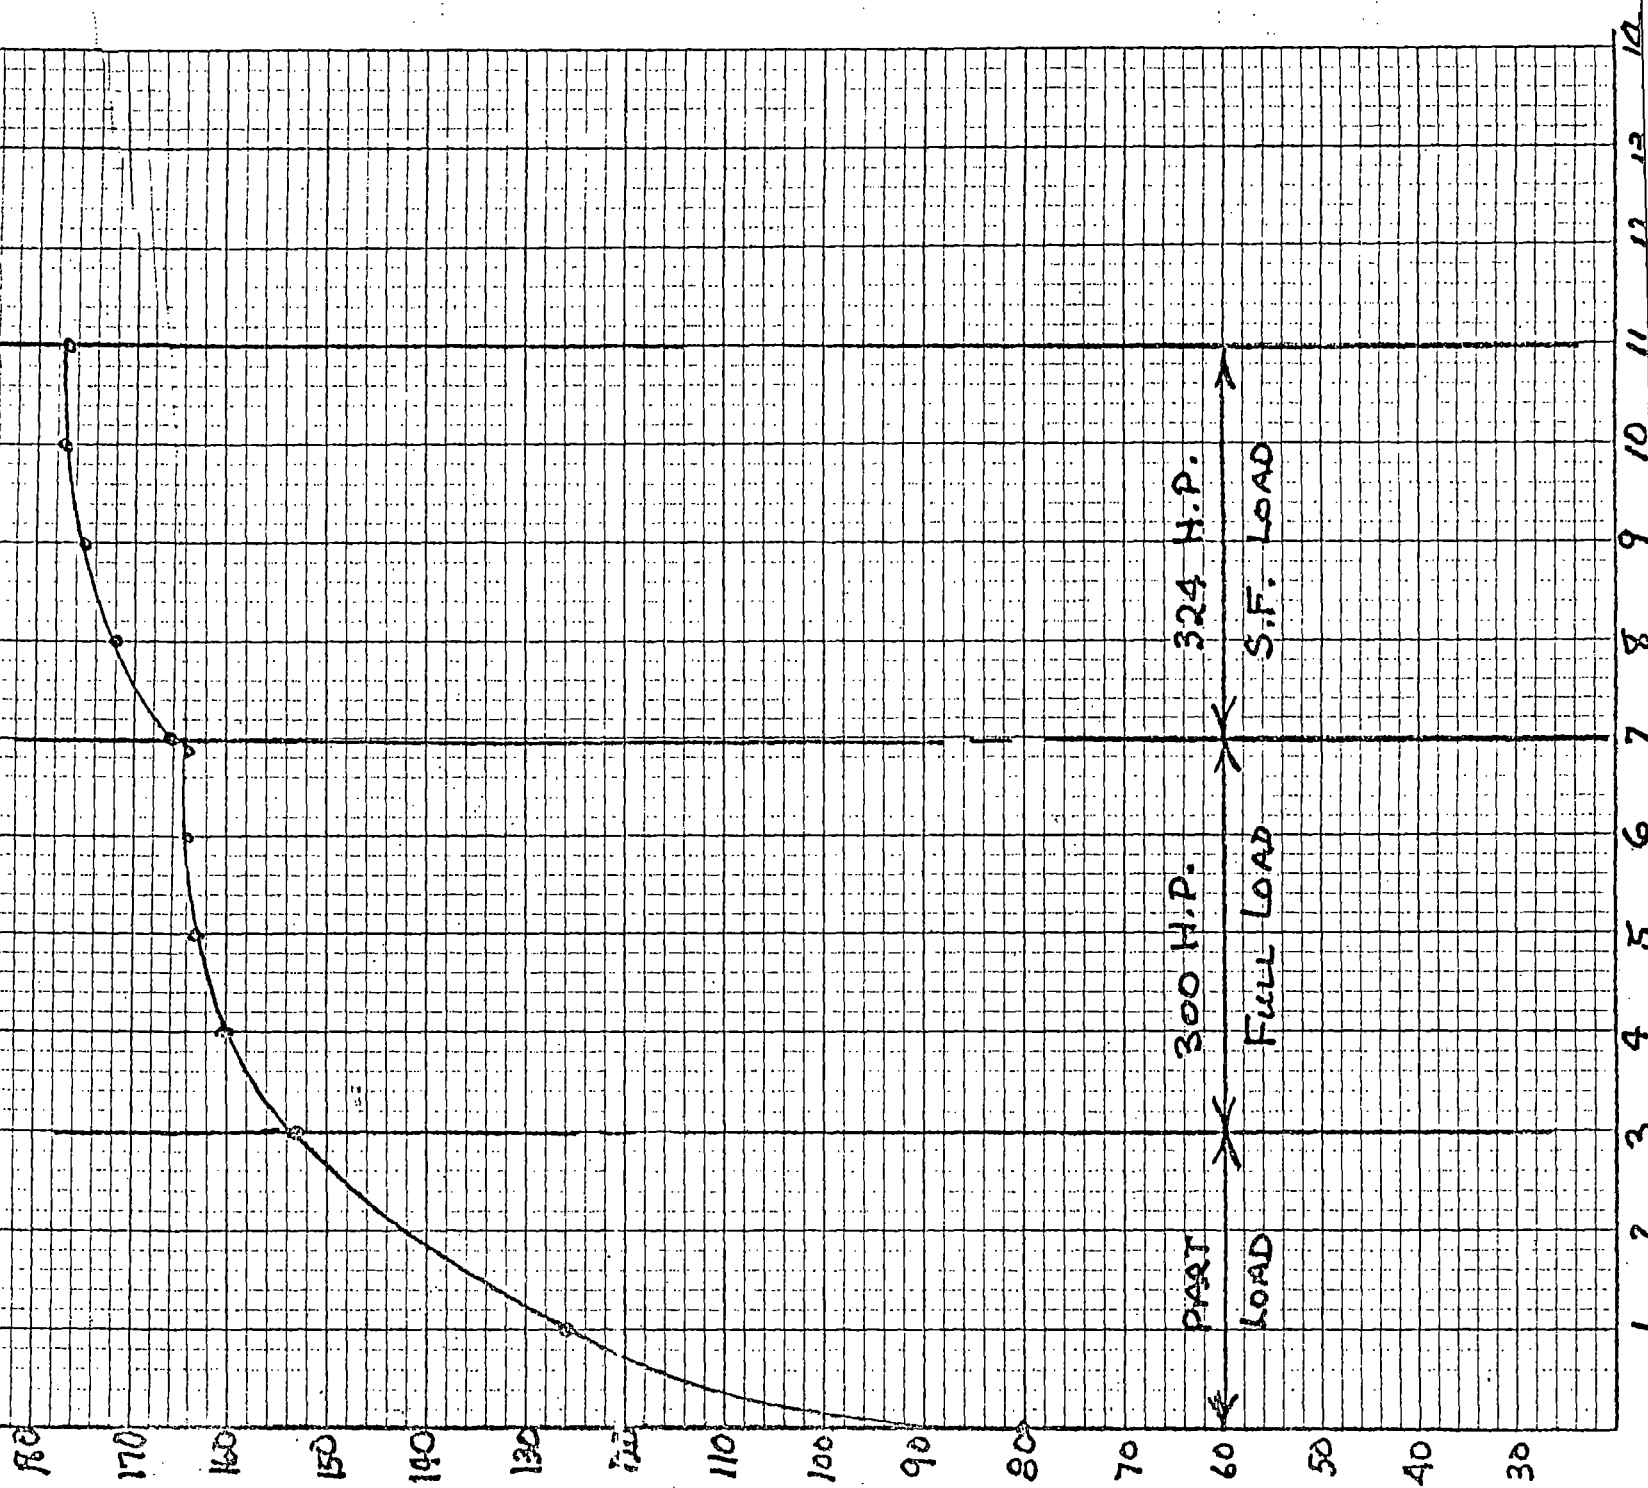
To test the new bearing, a seven hour run was made at G. E. San Jose on a test motor built up from parts from the failed motor and the Franklin Institute Research Laboratory test motor. The motor was loaded with another 300 hp motor hung to simulate a 2700 lb. thrust load. The Stone & Webster specification for VEPCO indicated the thrust loading on the motor would be 1700 lb. continuous down. During the first ten minutes of full load test at 300 hp, a shaft rub occurred. This problem was corrected through re-alignment of test setup and reduced vibration. The vibration was reduced to below .002". The test was restarted and run at full load at 300 hp for six hours with no problems. Following the full-load run, the motor was run at an 8% overload for an additional 4 hours with no problems. Appendix D shows the test data.

TEST DATA CURVE OF BEARING OUTER RACE TEMP.
 VS TIME FOR LOWER BEARING FOR MOTOR BUILT
 UP OF PARTS FROM MOTORS RETURNED TO SAN
 JOSE AND WITH NEW BEARING CONSTRUCTION PLUS
 THRUST LOAD. TEST RAN AT G.E. SAN JOSE
 (MRC 9218 BRG.) (SAME MOTOR USED IN APPENDIX F)

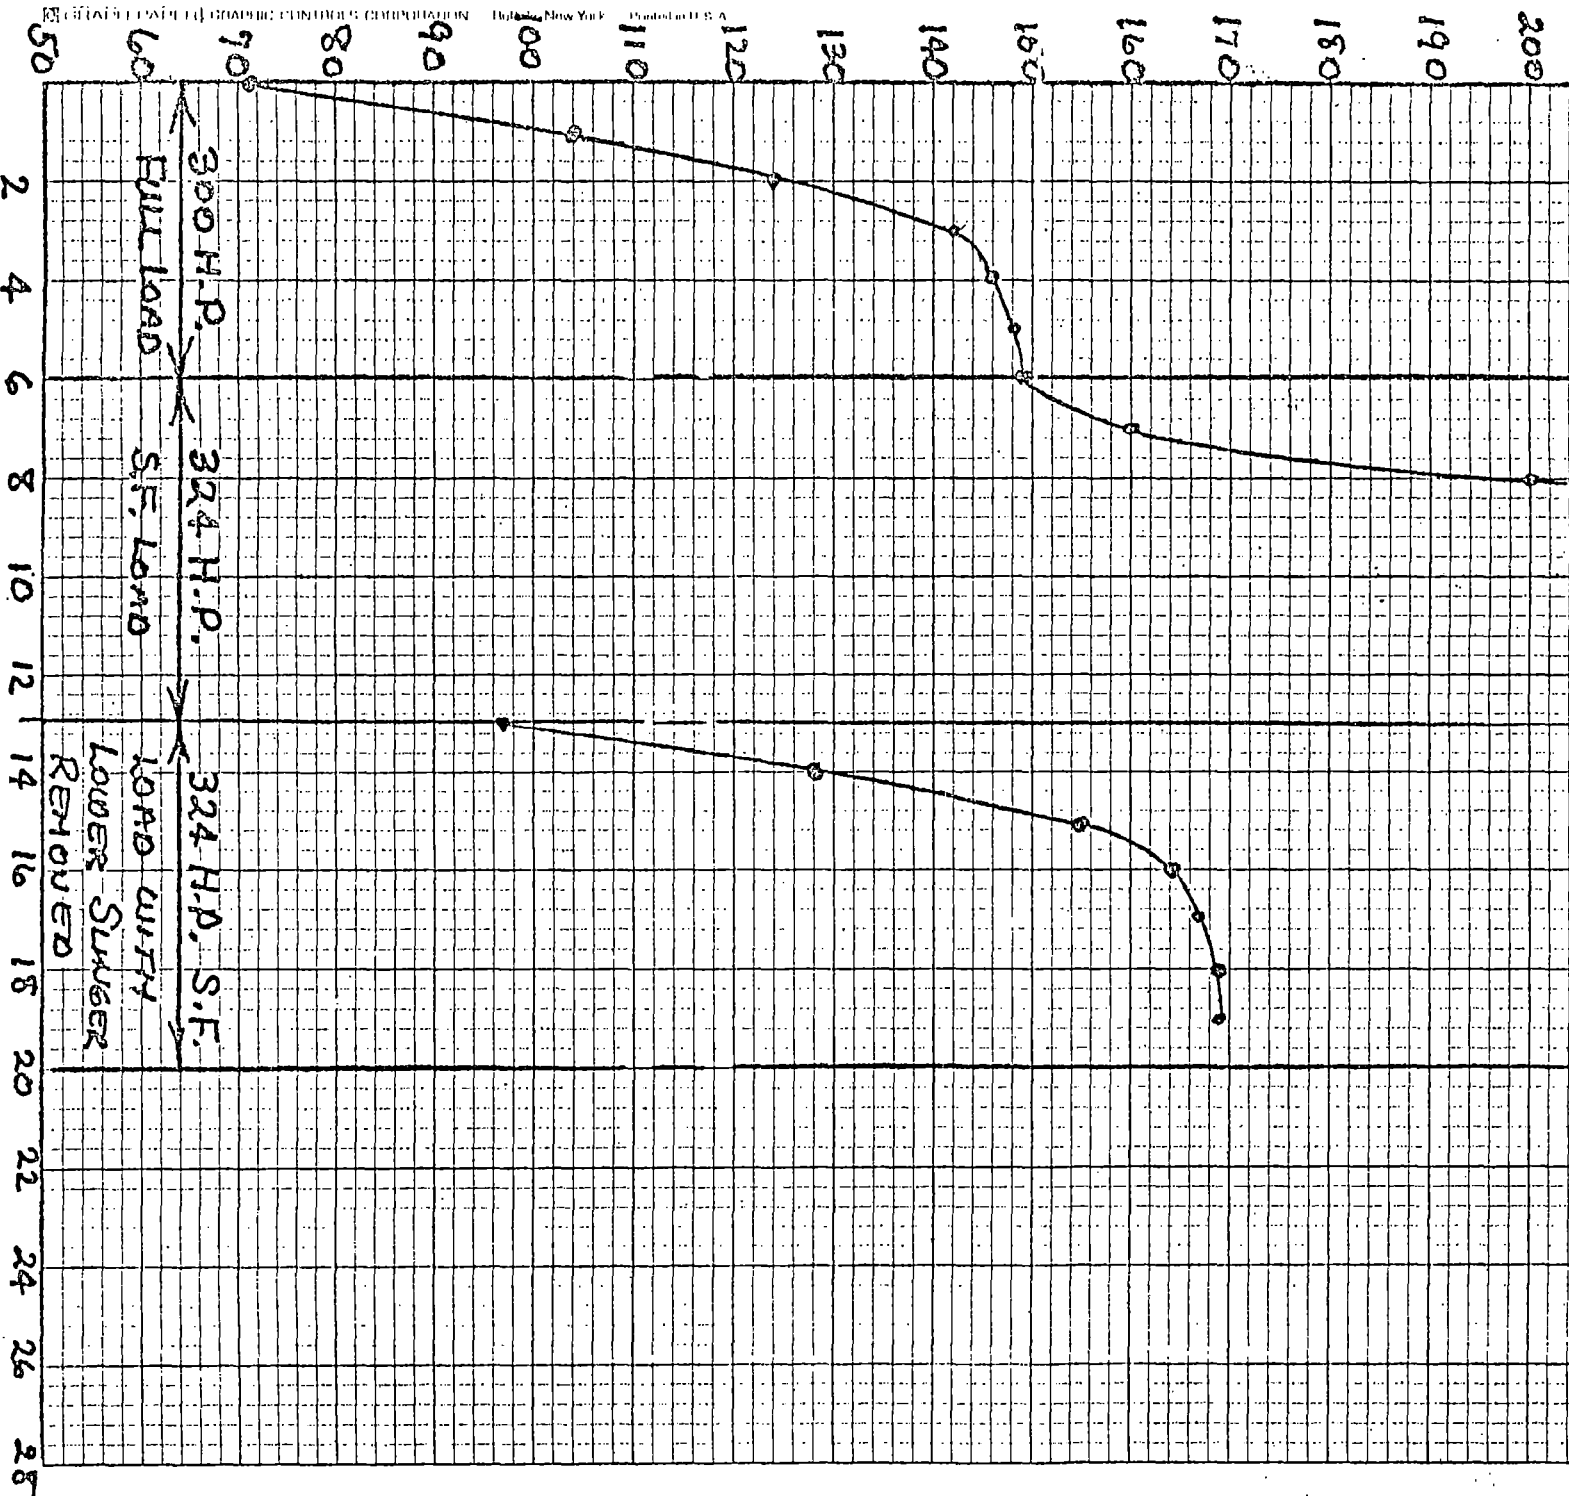
The test motor was then sent to Bingham Willamette Pump Company where it was tested on a pump similar to that used by VEPCO. At the time of installation, it was noted that the radial clearance where the shaft passes through the lower endshield was only .003 in. The motor was run loaded on the pump for six hours at full load, with no problem. It was noted that the vibration was in excess of .005 in. The load was raised to an 8% overload and within one and one half hours rubbing was detected where the shaft passed through the endshield. The motor was shut down and the slinger on the shaft at the lower endshield was removed and the overload test was continued. The motor ran successfully for an additional six hours, plus four stops and starts, with no rapid rise in bearing temperature. Appendix E shows this test data.

When the motor was returned to General Electric San Jose and disassembled the shaft and endshield showed wear, but the bearing and grease looked in excellent shape. No bearing problems were noted as seen in the earlier failures where the bearing froze due to overheating due to the tightening of the bearing internal parts. It was concluded that the problem at Bingham Willamette was due to the close clearance where the shaft passes through the endshield (.003 in. radially), excess vibration (over .005 in.), the radial looseness of the bearing (over .005 in.) and the additional heating of the shaft at overload.

TEST DATA CURVE OF BEMING OUTER RACE SPACER RING
 TEMP VS TIME FOR LOWER BEMING (RINGS LOCATED DIRECTLY
 BELOW BEMING OUTER RACE) FOR MOTOR BUILT UP OF
 PARTS FROM MOTORS REMOVED TO SHOW JOSE AND WITH
 NEW BEMING CONSTRUCTION PUS KOPING BY PUMP
 AT BINGHAM - WILLAMETTE CO. IN PORTLAND OREGON
 (MRC 9218 006) (SAME MOTOR USED IN APPENDIX E)

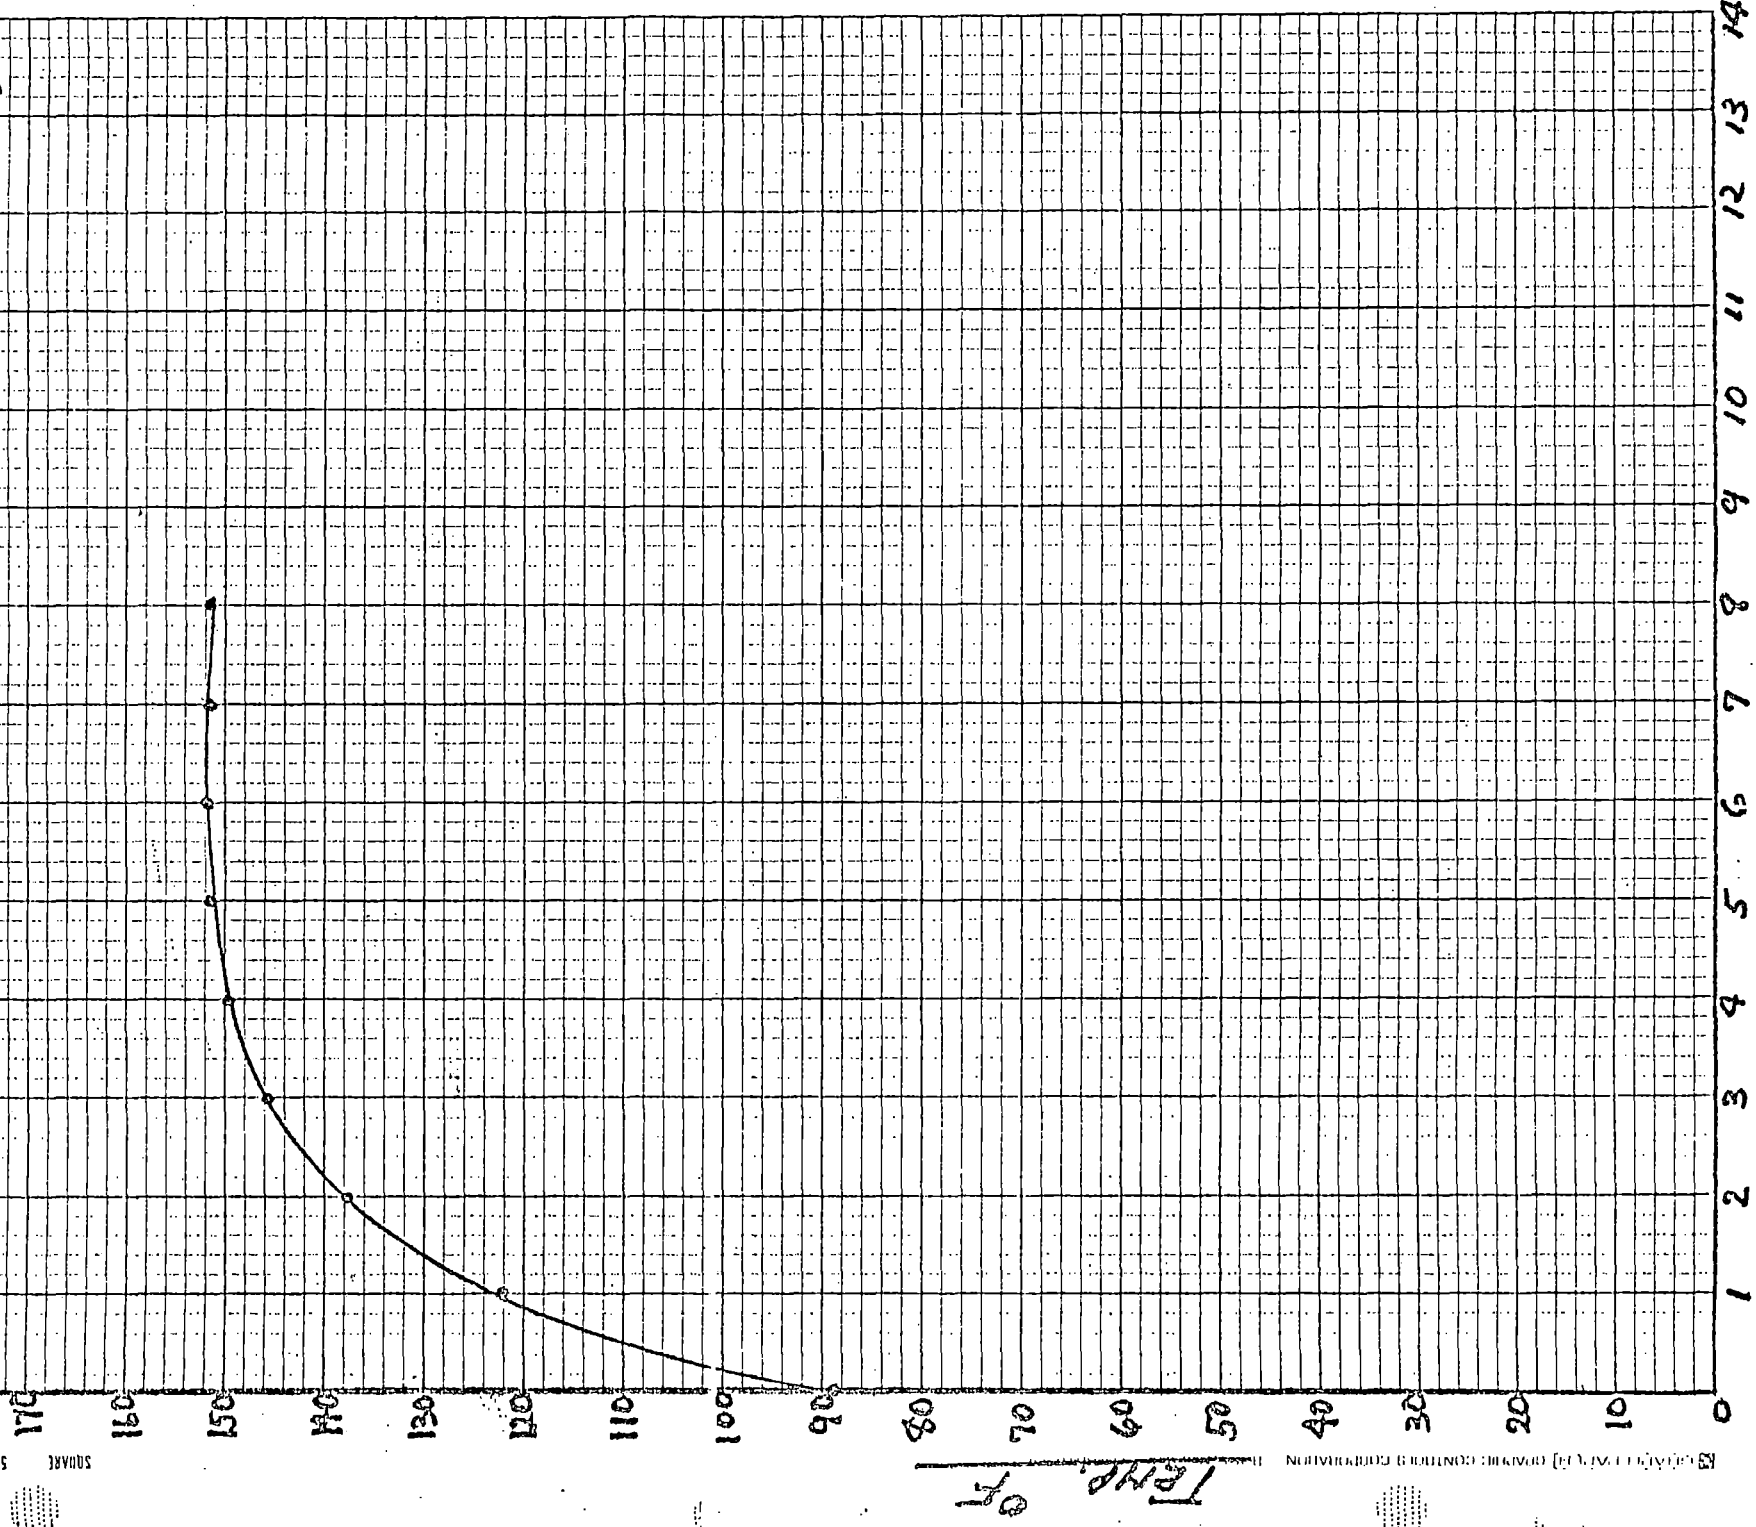
TEST DATA CURVE OF BEARING OUTER RACE TEMP.
VS TIME FOR LOWER THRUST BEARING FOR
MOTOR S/N ENJ 531021 WITH MOTOR LOAD 50
WITH PUMP AT NORTH ANOVA (MRC 9218 BRG.)

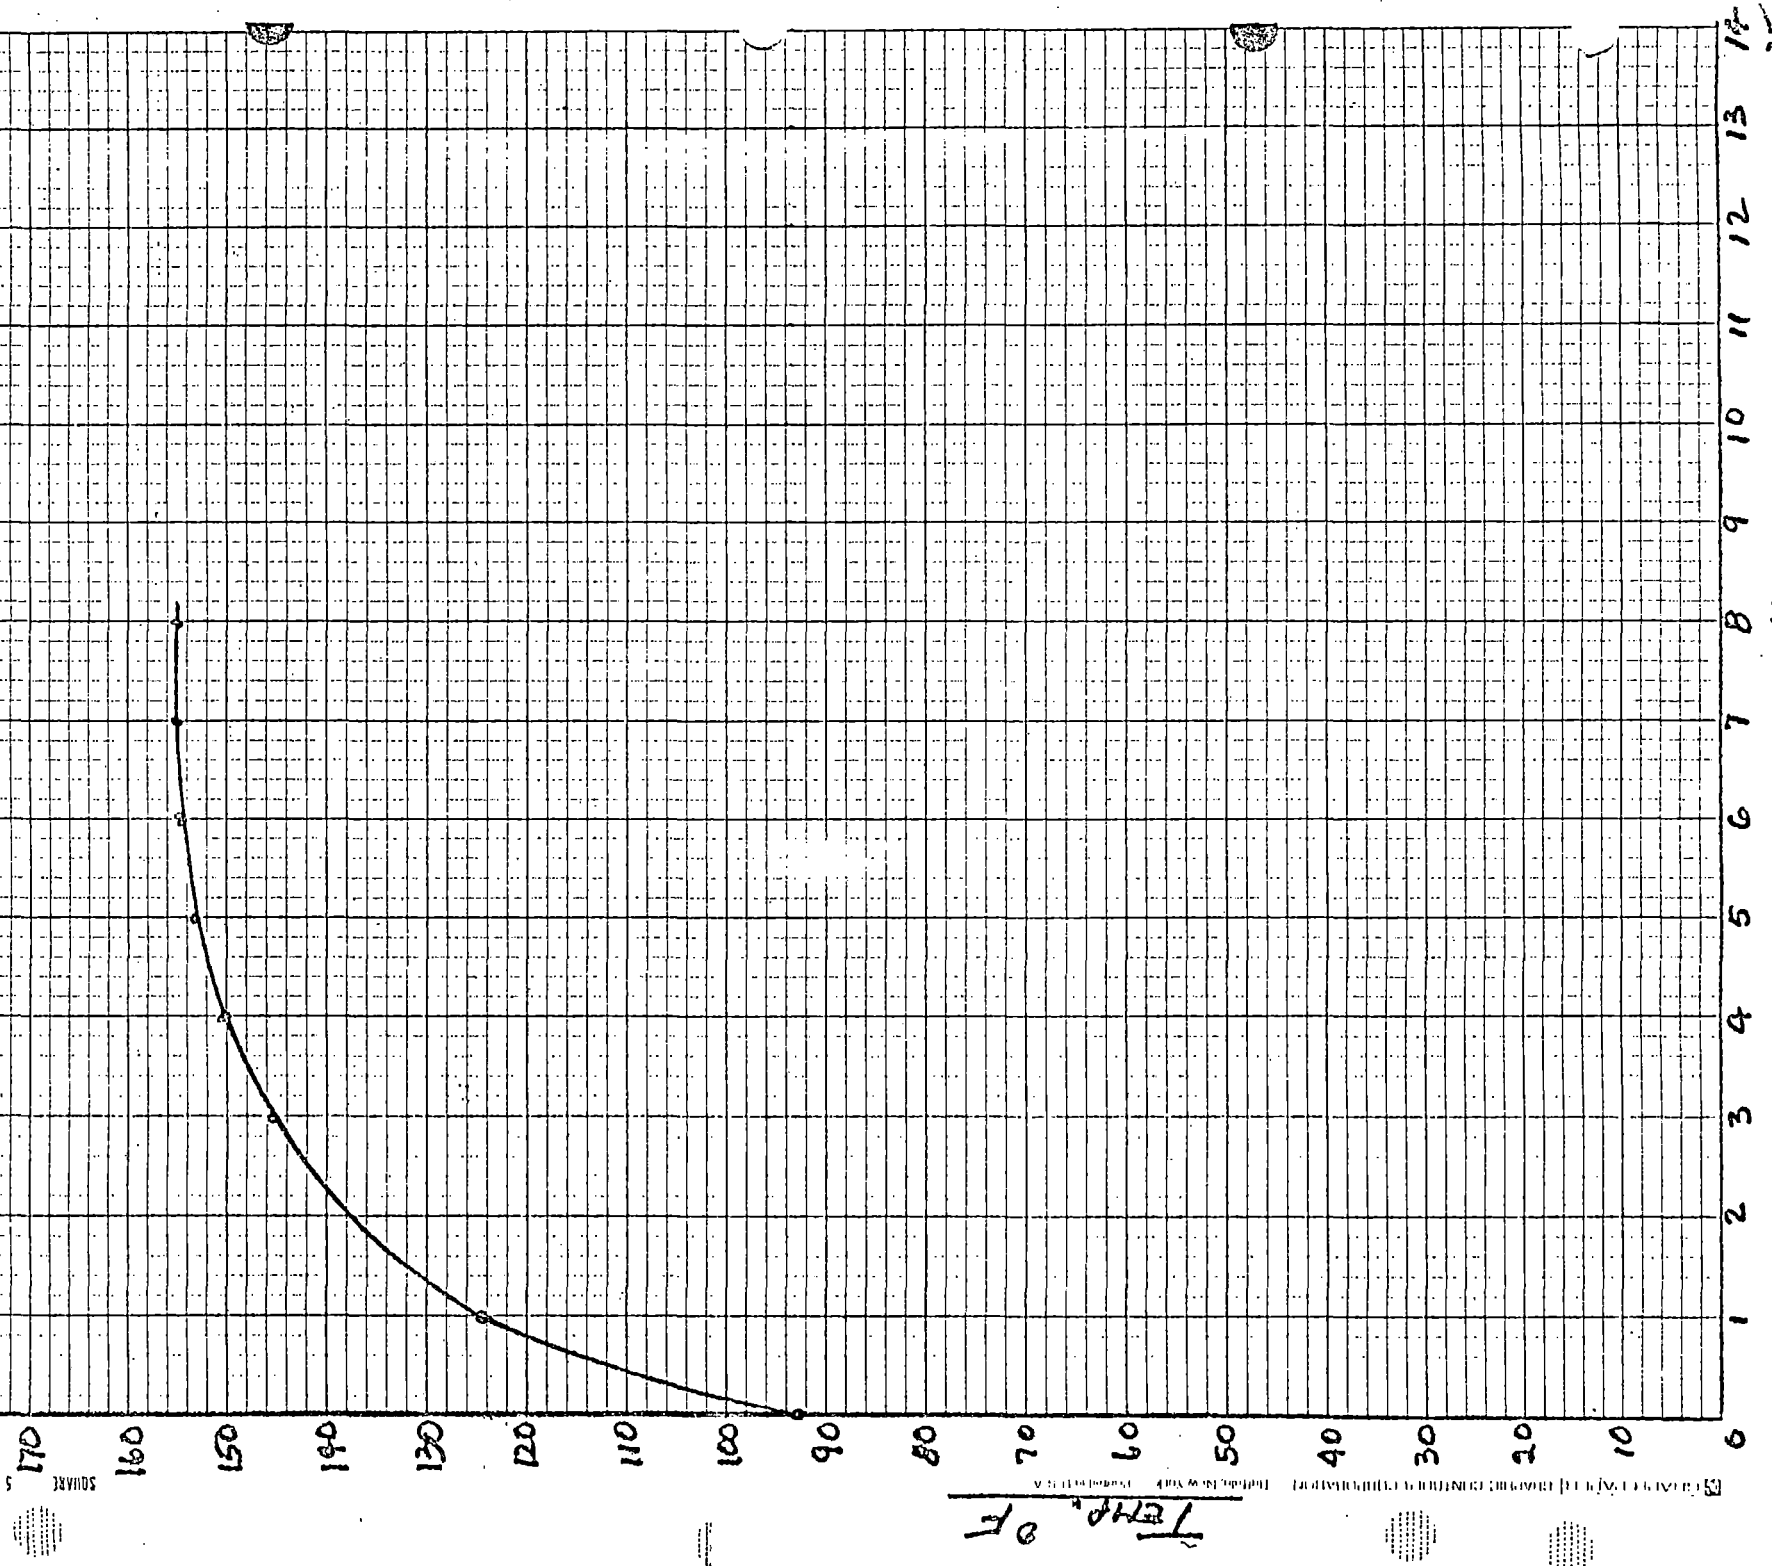
TEST DATA CURVE OF BEARING OIL RACE TEMP.
VS. TIME FOR LOWER BEARING FOR MOTOR
S/N EHT524018 WITH MOTOR LOADED WITH
PUMP AT NORTH ANNA (MRC 9218 BRG.)

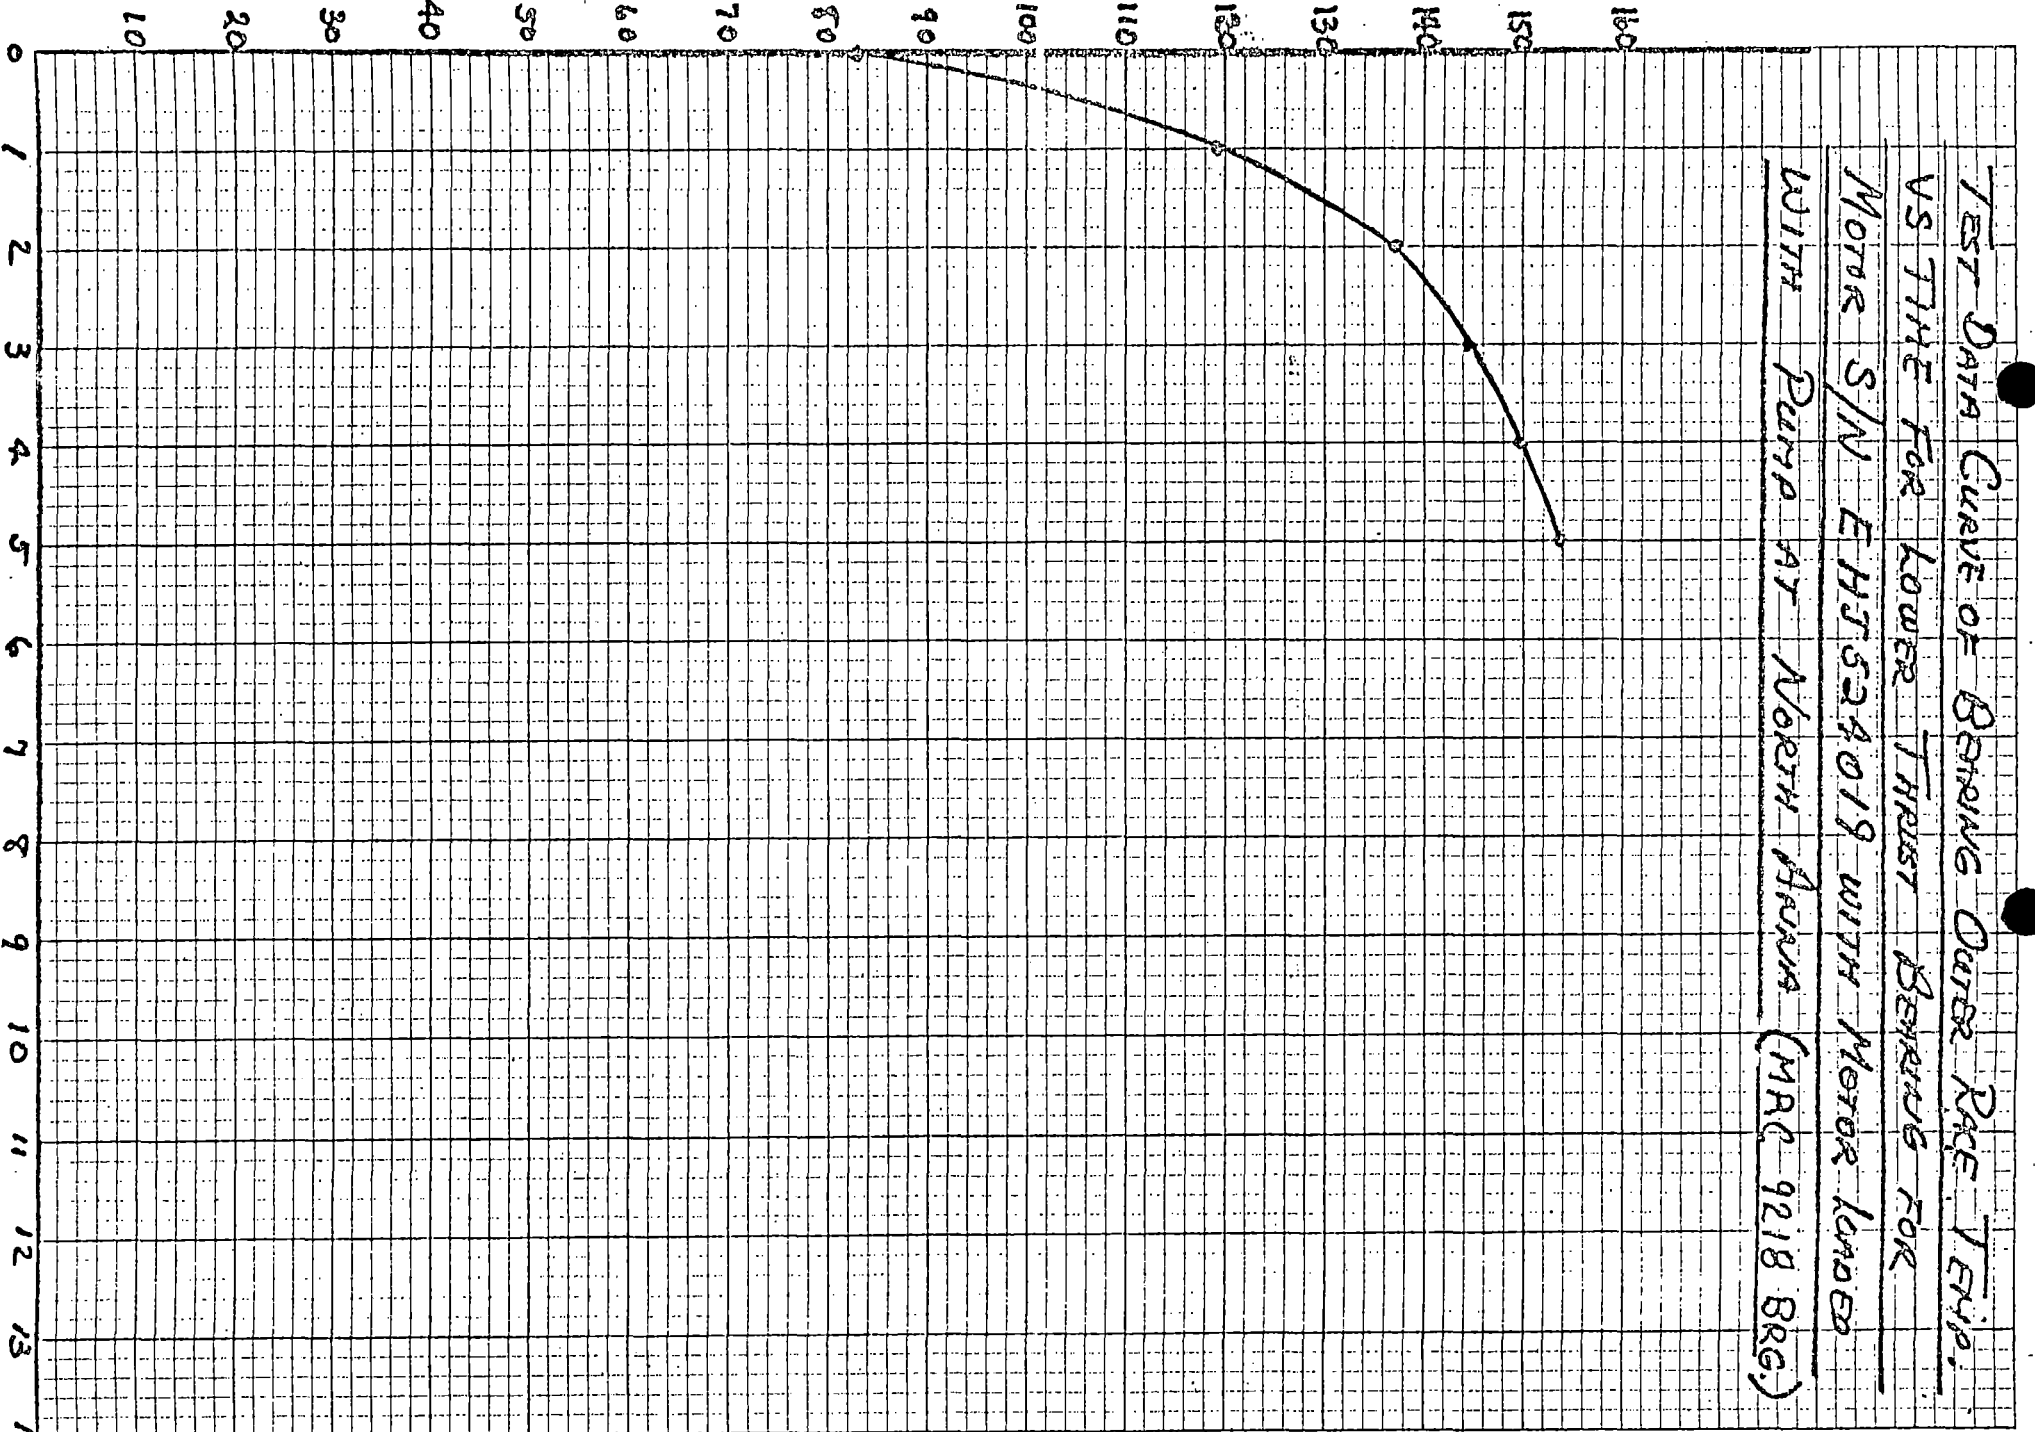
TEST DATA CURVE OF BEARING OUTER RACE LIFE.
 VS TIME FOR LOWER THRUST BEARING FOR
 MOTOR S/N EHT524019 WITH MOTOR LOAD 50
 WITH PUMP AT NORM AHEAD (MRC 9218 BRG)
