TOPICAL REPORT
GENERAL ELECTRIC VERTICAL INDUCTION MOTORS
INSIDE CONTAINMENT RECIRCULATION SPRAY PUMPS
FOR THE SURRY AND NORTH ANNA STATIONS
OF
VIRGINIA ELECTRIC POWER COMPANY

THIRD ADDITION TO COVER REBUILDING MOTORS
USING NEW BEARINGS

Docket Nos. 50-280 and 50-281

July 23, 1979

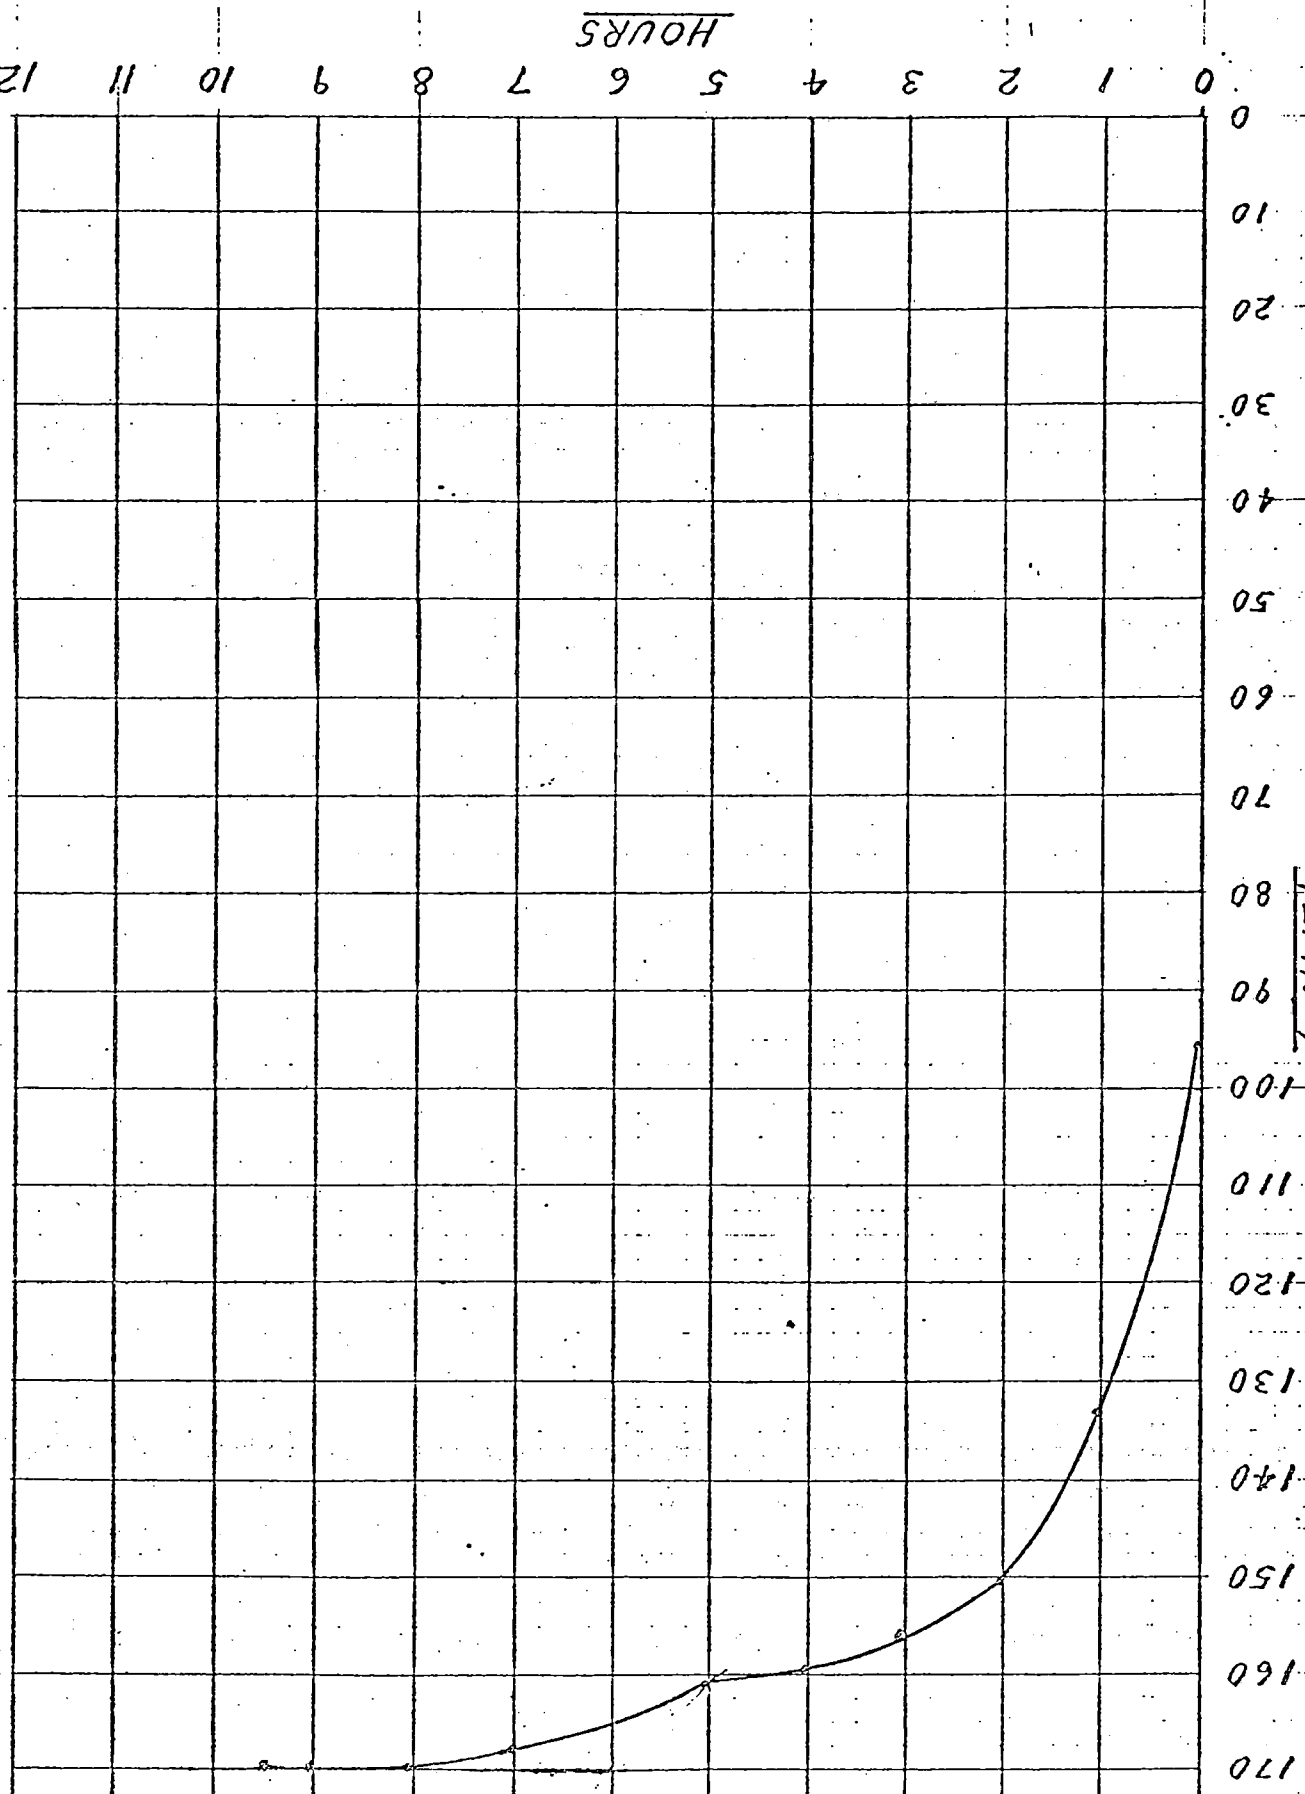
TEST DATA CURVE OF BEARING OVER RACE TEMP.

VS. TIME FOR LOWER THRUST BEARING FOR

MOTOR S/N JT 919019 WITH MOTOR LOADED

WITH PUMP AT NORTH ANNA (MRC 9216 BRG)

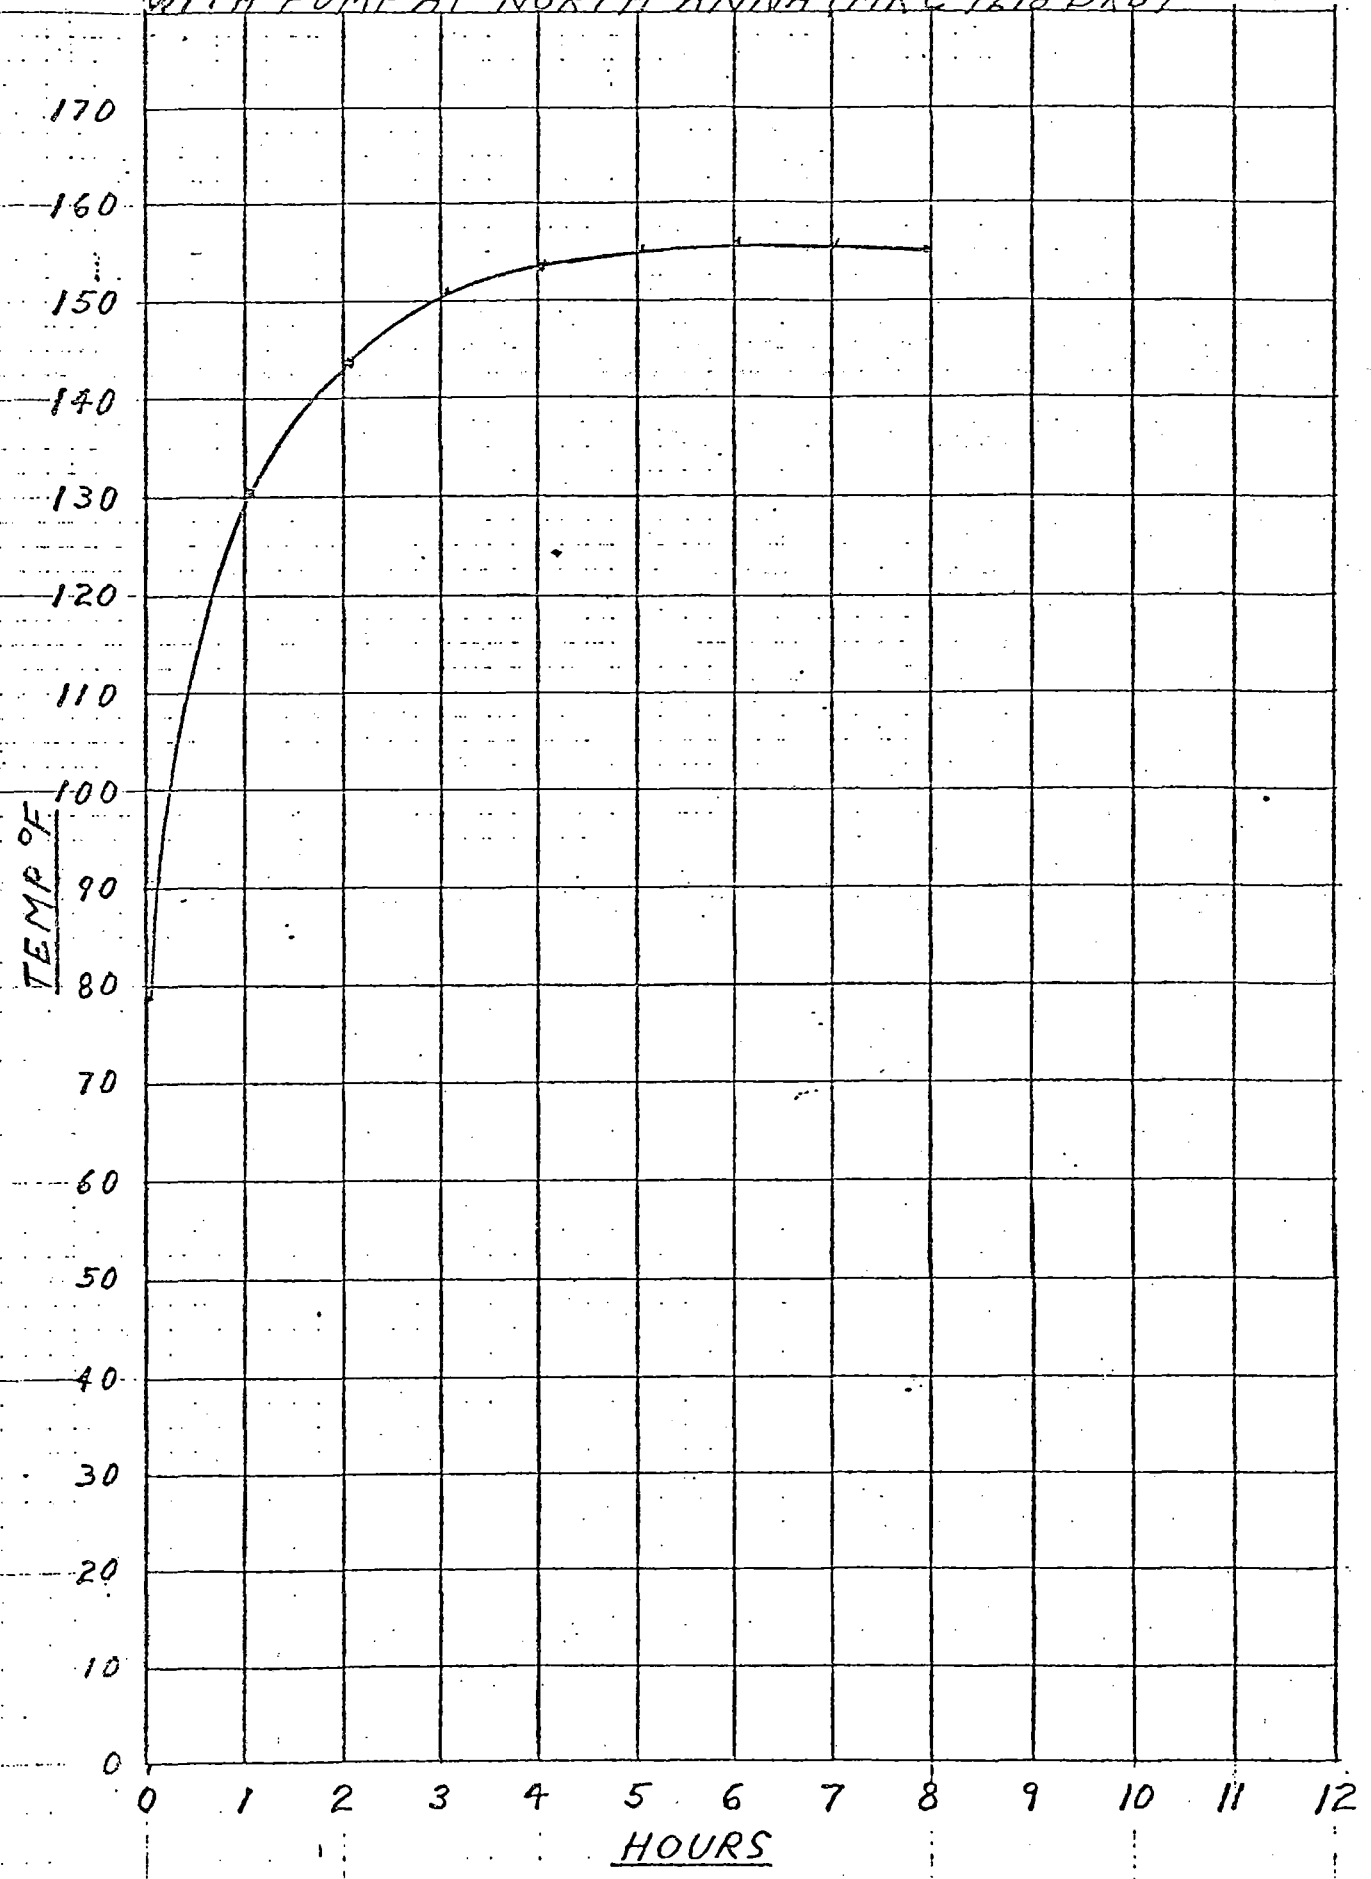
TEST DATA CURVE OF BEARING OUTER RACE TEMP
VS TIME FOR LOWER THRUST BEARING FOR
MOTOR S/N LHJ1129013 WITH MOTOR LOADED
WITH PUMP AT NORTH ANNA (MRC 9218 BRG)
