Rig- Aban VI

Auditor- Dr Omar Thakur - Regional QHSE Manager

Purpose-

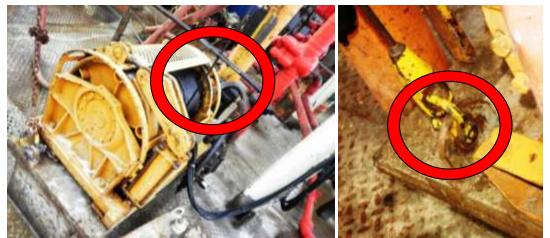
2- ALL rig floor utility winches should have fiberglass spring loaded cable wind devices to spool the cable properly on the drum. This prevents the operators from attempting to guide the cable on the spool with their hands and they can concentrate on the banks-man and the man in the belt. The winches should also have a clearly marked (RED) emergency stop.

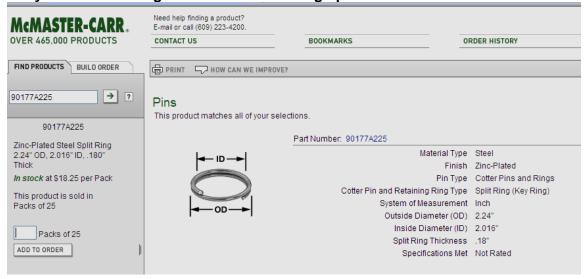
Currently there is one man riding winch available on the rig floor but no man-riding winch available for operations below the rig floor. There is also no designated equipment in use for the man riding operations. The rig is using a two part shackle for man-riding operations. The following is suggested to the rig. Man riding winches to be color coded (LG inspection), identified as "For man Riding Only" and marked with SWL i.e 330lbs / 150kg. All equipment relating to man-riding operations must be used and stored separately. Utility winches are not to be used for man-riding

The 3/4" (4.75t) Crosby G-2130 bolt-type shackle along with the retaining key ring i.e. McMaster Carr part number 90177A225. The key ring is easy to use, cost effective and does not easily get knocked out of the slot. It can be easily changed out when needed.

This is the recommended combination for man-riding to be used when using the man-riding winch. This shackle and other man-riding equipment should be used <u>only for man-riding</u> and stored separately. The drilling supervisors should ensure that this equipment is ordered in adequate quantity.

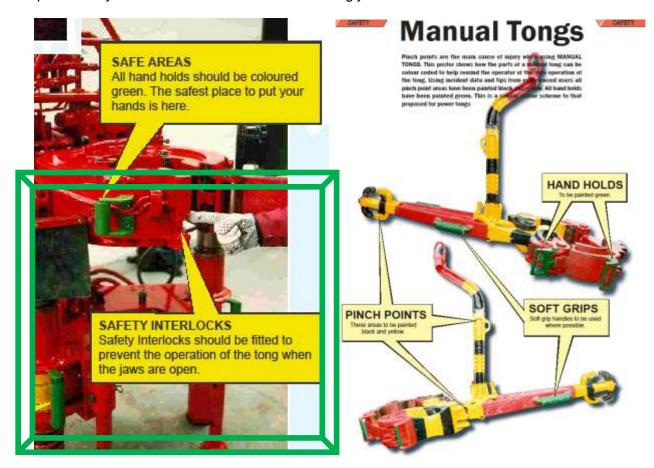
3- The manual tongs to have their hand placement areas painted in green and hazardous areas to be identified in yellow and black stripes. Not all parts of the tongs are clearly identified. This is a piece of equipment very commonly involved with hand injuries and the safe and unsafe areas should be prominently marked and crews trained accordingly.

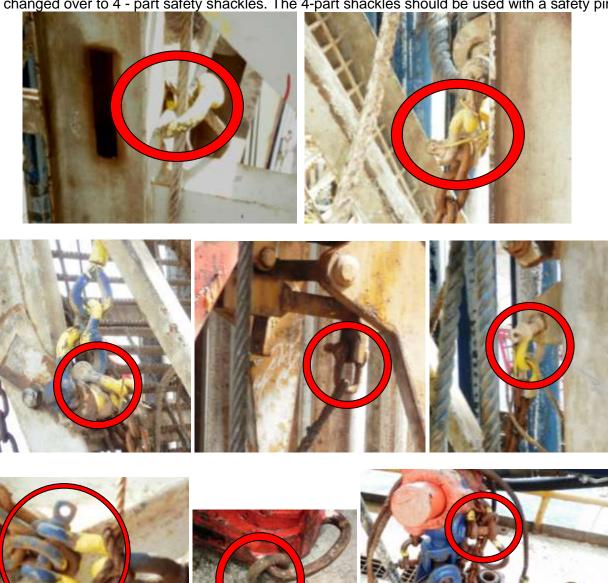
4- Many TWO-Part shackles were evidenced in use on the rig floor and some areas of the derrick. It has become a standard practice for most companies now to do away with all 2-part (screw-pin) shackles in the derrick and overhead areas. These are unsafe to use in permanent overhead applications as they have a tendency for the pin to back out due to vibration and other stresses on the shackle and pin. The rig needs to ensure that all the shackles on the rig floor and in the derrick are changed over to 4 - part safety shackles. The 4-part shackles should be used with a safety pin

Safety pins to be used for ALL 4-part shackles. Wire / welding rods are not to be used as retaining safety pins. Lifting gear seen here has more than one color code. Some lifting gear in the derrick also had no color code and found excessively corroded.

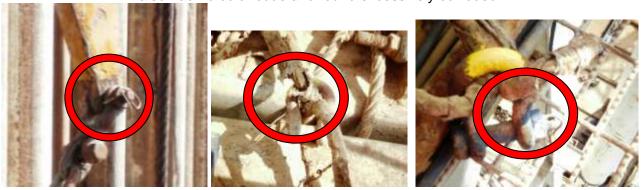
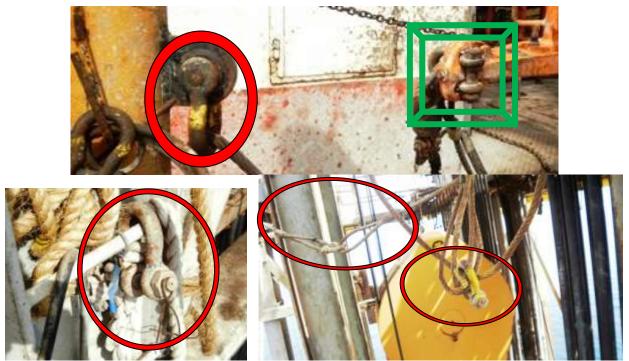
5- The four part shackles in use should have current color code and proper retaining pins and not welding rods or other wires. Many such 4-part shackles were seen with welding rods / wires used as securing pins.

Cotter pins (properly bent), Air king pins or the above mentioned Mc-master key rings should be used as retaining pins on shackles.

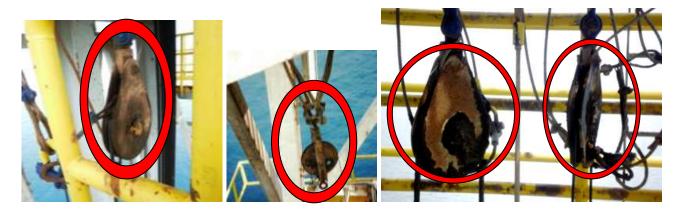
6- The rig should look into changing out old sheaves in the derrick. Certificates and Lifting gear records for this equipment should be maintained along with all other lifting gear.

Safety slings attached to the sheaves are seen rubbing against the slings passing through the sheaves. These should be diverted to avoid damage to either sling.

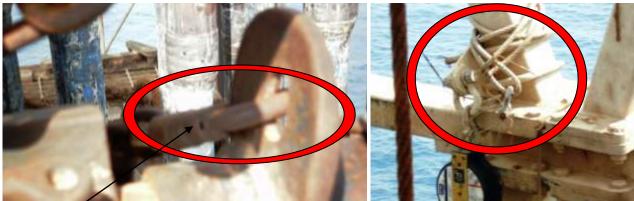
7- A carabiner was in use at the monkey board as part of lifting gear attachment. This should be removed and only the properly rated shackles should be in use as connectors. Seen above is also derrick-mans SALA with no color coding of block, sling or shackle.

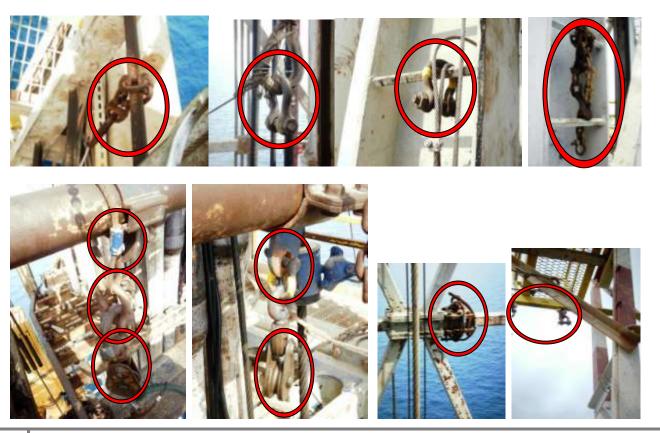
8- Some unused items were found in the derrick and these items were not secured. ALL unused items are a potential dropped object and should be taken down to rig floor if not in use.

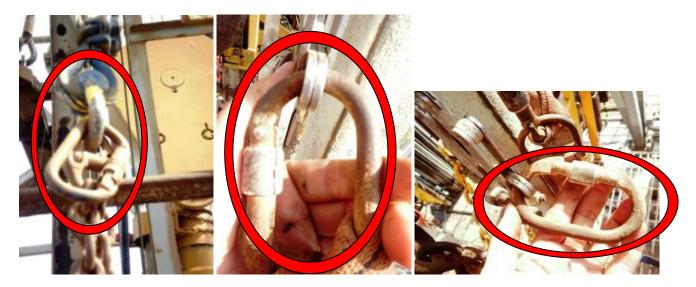
The carabiner shown above on the derrick ladder was heavily rusted and the fall protection device could not be used due to this. An alternate arrangement had to be made to proceed up the derrick using another fall protection device.

The rig should order the approved Lad safe device for use as shown in the Safety Catalogue. The equipment should be serviced and maintained on a regular basis.

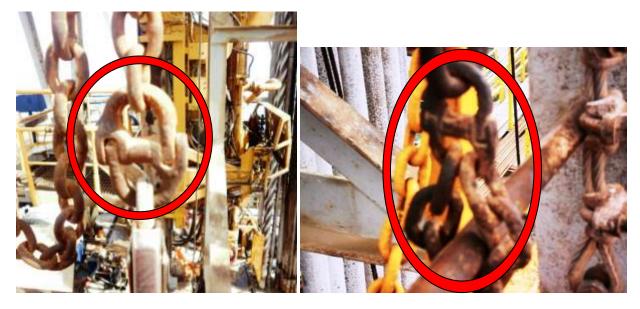
The link and chain securing the climb assist to the ladder rung is also old and showing excessive rust. This needs to be changed out immediately.

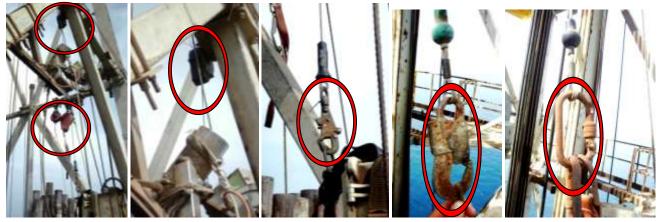
11- Fall protection devices like Self retracting lines do not have any color coding and the cables were found pulled out. The hooks and carabiner were found excessively rusted and need to be changed out.

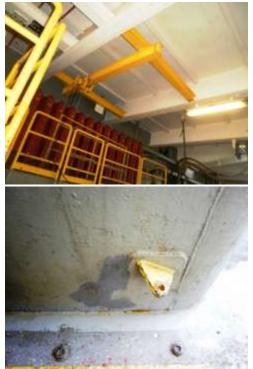
21- All trolley beams, pad-eyes etc to be color coded and SWL marked. Flame cut pad eyes are not to be used. Only plasma cut pad-eyes to be used.

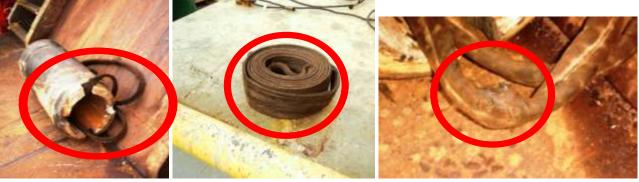
22- The use of Nylon straps to be controlled under a PTW system. Indiscriminate use of nylon straps to be avoided.

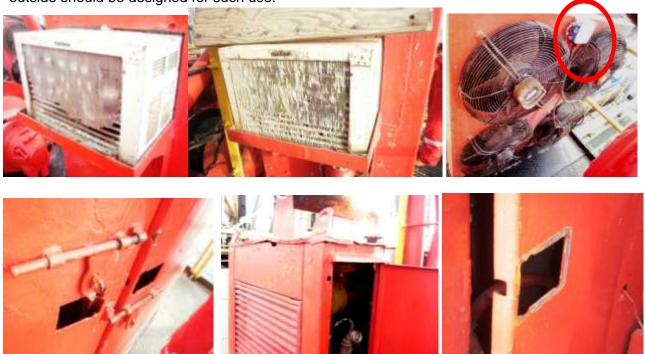
29- Air conditioners of both cabs are highly corroded and to be replaced and so also engine housing cabins which is again cracked in various places with door handles missing. Electrical boxes used outside should be designed for such use.

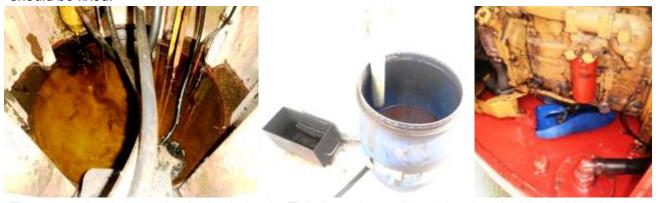
30-There is excessive accumulation of oil inside the crane pedestals and also from drains coming from the crane cab itself. One hose is run down and left into an open drain to the sea. These leaks should be fixed.

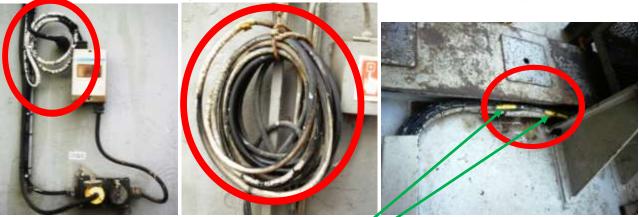
33-Being an old operating rig, many of the electrical cables have cracked insulation and these need to be replaced a.s.a.p. A survey to be done to identify these cables and all to be replaced.

One heavy duty cable running along the starboard side main deck was seen with insulation tape in two places. These damaged/ worn out cables have a serious potential for a hazard as it could lead to electrocution either by contact/ using a pressure washer on deck.

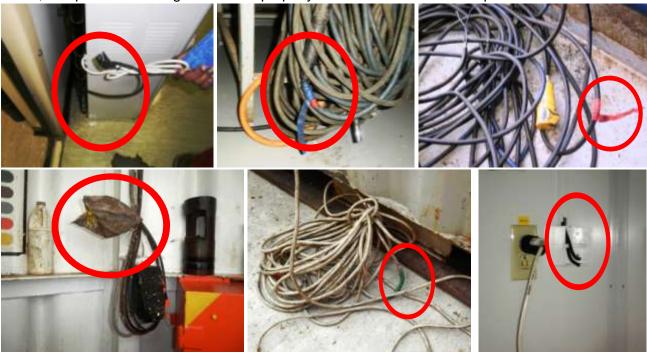
34-Poor standards of electrical safety were evidenced both inside and outside the accommodation. It is not safe to use insulation tape on damaged cables. These cables are to be either replaced or the wires cut at these points and a proper male-female plug-socket attached. This applies to third party equipment also and should be identified in the 3rd party equipment checklist.

Wires, irrespective of voltage should be properly terminated and not left exposed.

Electricians should have a schedule to check all electrical cables on hand tools and remove from service any found damaged. End users should also be educated to inspect their equipment every time before each use. Area inspections to be done to identify exposed / damaged cables.

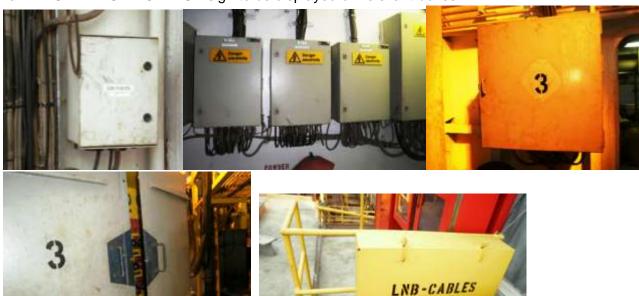
36- All electrical junction boxes to be labeled with source and supply to which equipment, voltage and a DANGER- HIGH VOLTAGE sign to be displayed on relevant boxes.

All electrical / hydraulic control boxes to me labeled / marked as such.

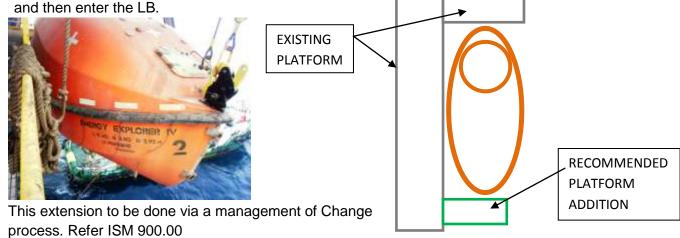
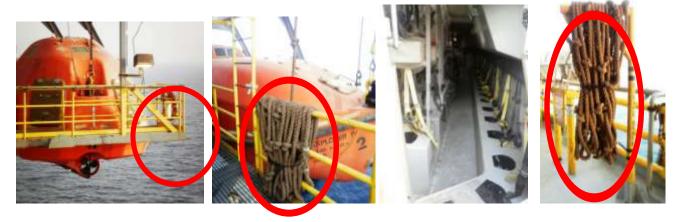
39-Lifeboat platforms will need some modification as the bow end of the LB safety sling in not accessible from the existing platform and the crew has to enter the lifeboat from the aft hatch to secure the bow safety cable. This is unsafe and the management should look into extending the bow end of the platform for easy access to the safety sling where crew can secure the sling first

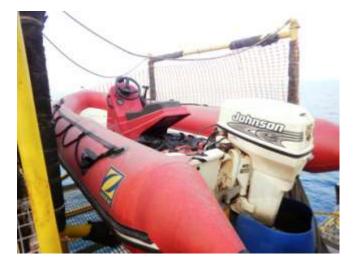
- 45- The rig does not have adequate BA packs/boxes and also needs to order a BA compressor and air quality test kit to maintain the BA's on board.
 - A log to be maintained of locations of BA packs and frequent inspections done and logged on same.
- 46- A tarpaulin cover to be ordered for the FRC to protect it from the elements

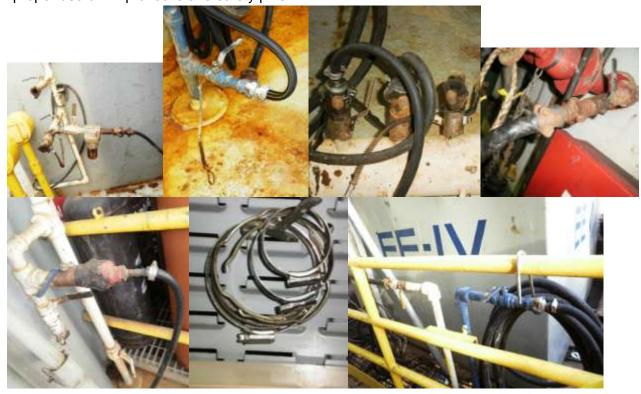
48-Whip checks and safety pins are not in use for hose connections. Crews to be educated on the proper use of whip checks and safety pins.

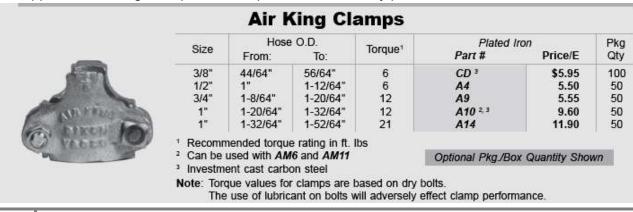
49- Worm clamps are not safe to use and a cause of many incidents and injuries. The rig should use approved "Air king Clamps" with whip checks and safety pins.

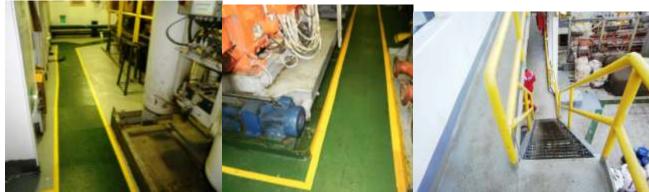
52-General areas of the rig are well maintained. The green mile should be extended to the muster station/ lifeboats showing arrow indications leading to the life boats. Upper decks and machinery spaces should also have the green mile demarcated on deck with arrow indicators..

←---- This picture is from the Aban VIII, post audit
