**Bureau of Mines Report of Investigations/1975**

**Report of Investigations 8022**

# **Geologic Investigations of Underground Coal Mining Problems**

**By C. M. McCulloch, P. W. Jeran, and C. D. Sullivan  
Pittsburgh Mining and Safety Research Center, Pittsburgh, Pa.**

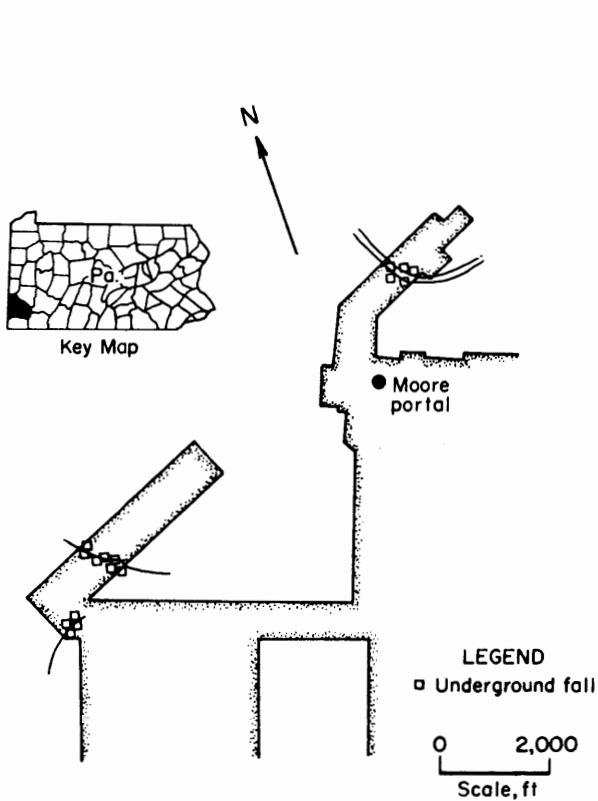
FIGURE 3. - Overlay of mine streams on surface related to underground falls.

topography over the mine with problems encountered underground. A number of falls seem to align with and occur under streams in the area. Because most streams form along zones of weakness, it was felt that this zone parallel to the stream would be a problem whenever it was encountered (fig. 3). Research currently underway further supports this idea. Another zone of falls associated with abnormally high gas emissions was found where the cover changed abruptly from 300 to 700 feet. This was attributed tentatively to differential overburden pressures.

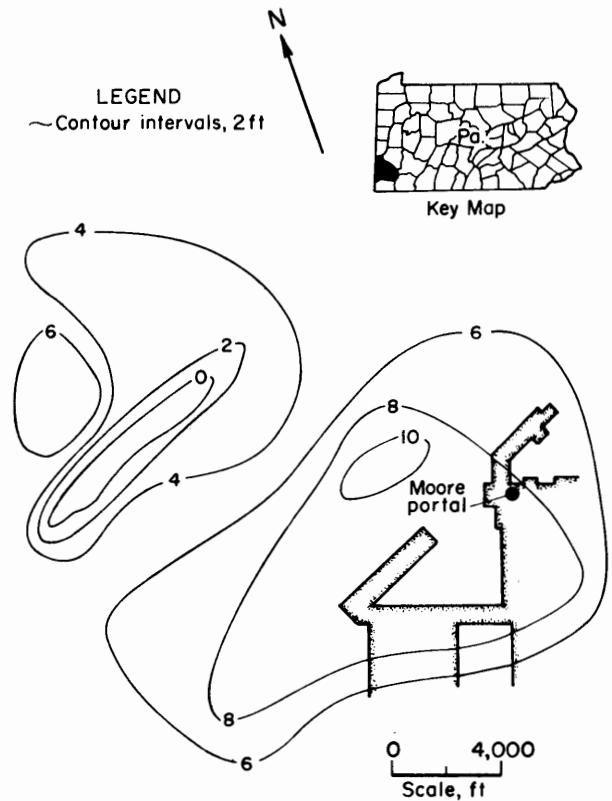
FIGURE 4. - Isopach of the wild coal interval over the Pittsburgh coalbed in the Marianna No. 58 mine.

The major problem throughout the mine was the wild coal interval formed by alternating thin bands of claystone and coal that overlay the coal. The interval ranged in thickness from 1 to 9 feet and could not support itself. The company was using roof bolts with a minimum length of 6 feet and a standard length of 7 feet; these were adequate where the wild coal was less than 6 feet thick. An isopach map of the wild coal interval (fig. 4) showed where this unit is greater than 6 feet thick; longer roof bolts would be needed in these areas.

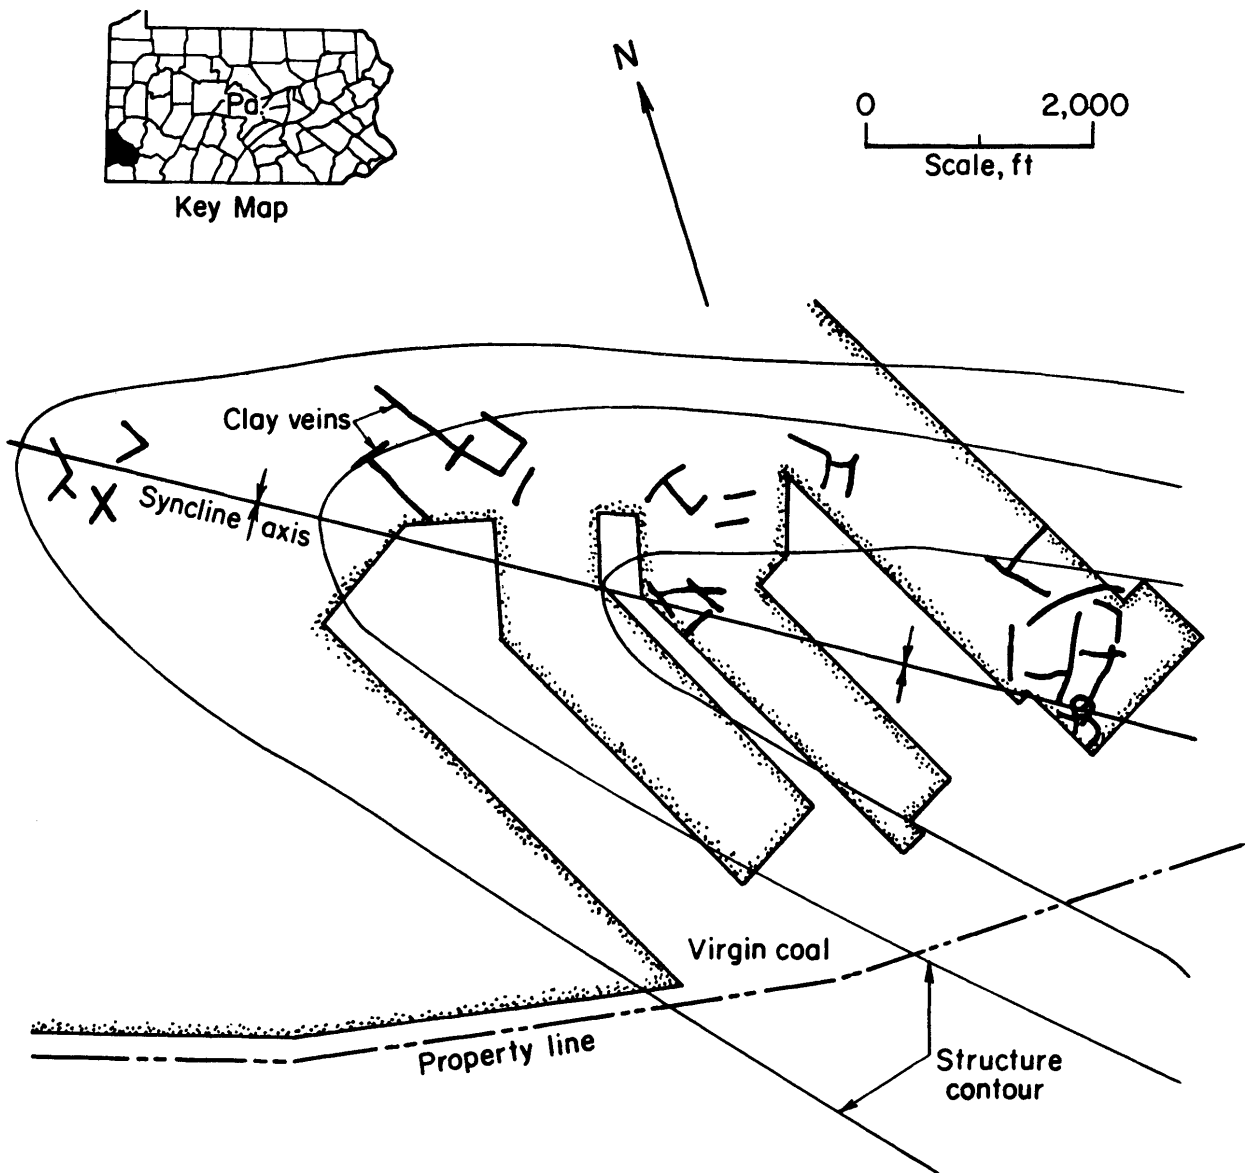
FIGURE 5. - Location of clay veins in the Marianna No. 58 mine.

A section affected by clay veins was carefully mapped. Comparison with a structure map of the area revealed the presence of a syncline with the clay veins located along its axis (fig. 5). As some of the mine entries had

already passed through the axis and were now encountering few clay veins, it was anticipated that when mining approached the axis of this syncline the occurrence of clay veins would increase.

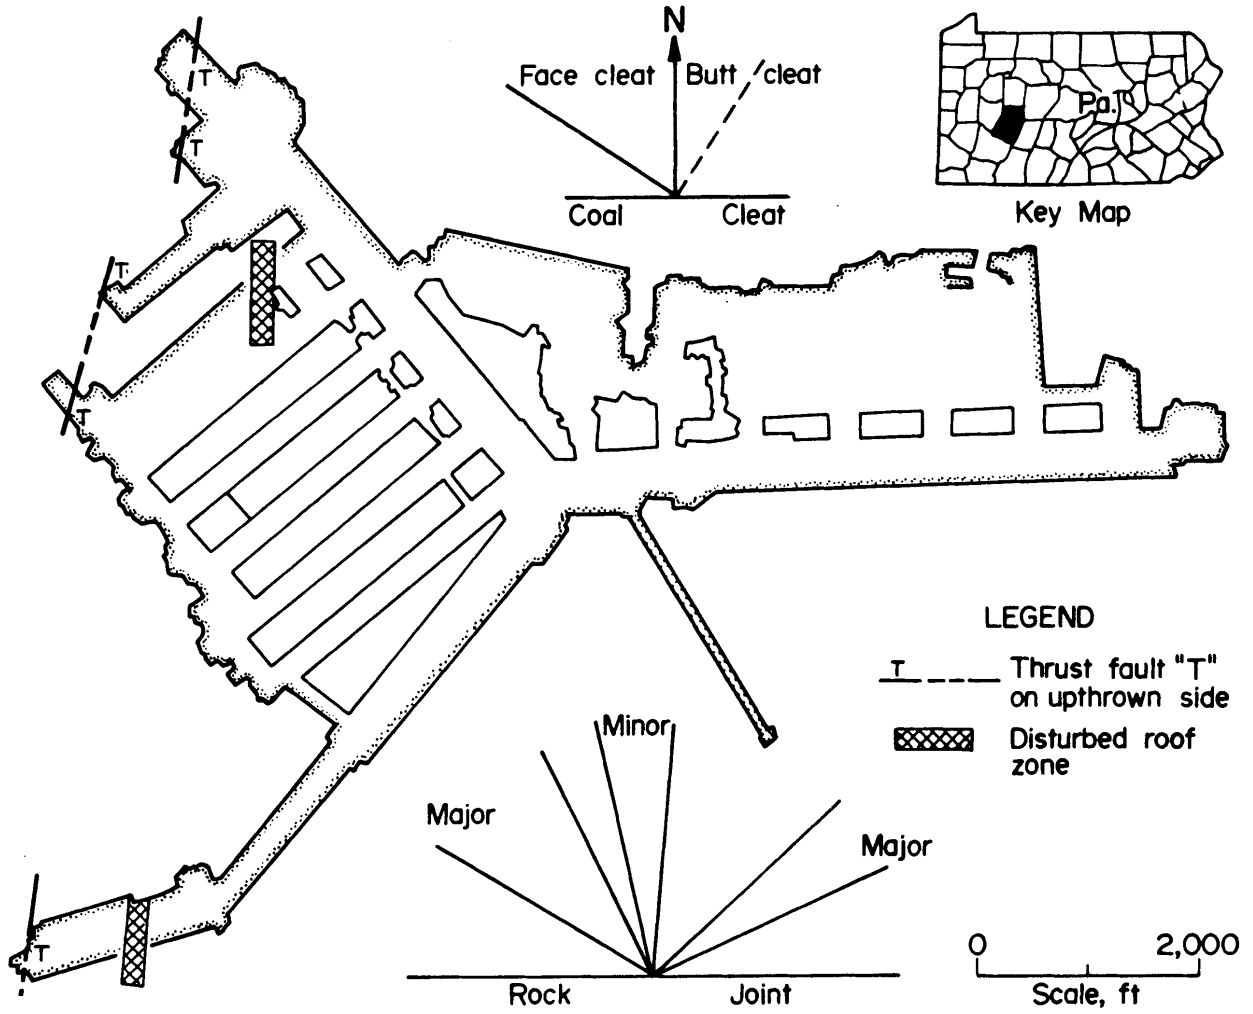
FIGURE 7. - Fault exposure at Lucerne No. 6 mine.

in March 1972. Cleat measurements showed a uniform pattern with the face cleat striking  $N56^{\circ}W$  and the butt cleat  $N32^{\circ}E$ . The dip was essentially vertical. The spacing of the face cleat, on the order of an inch, appeared to be uniform throughout the mine, except near the fault exposures, where the cleat was more closely spaced. The most significant geologic features of the mine were the fault exposures (fig. 7).

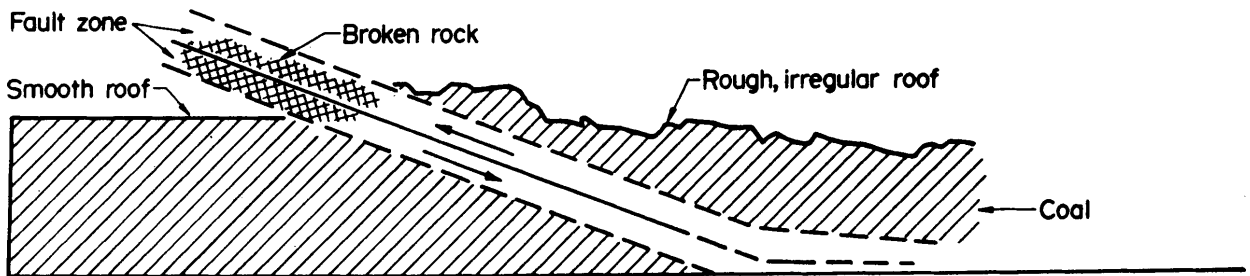
FIGURE 8. - Generalized sketch of typical thrust fault exposure at the Lucerne No. 6 mine.

They are low-angle thrust faults which offset the coal only a few feet along the fault plane (fig. 8). They affected both coal and roof rock, but did not appear to disturb the floor rock. These faults are not the result of sedimentary slumping. They occur at regular intervals and can be traced to the surface. When encountered by mining, the fault zones emitted large quantities of gas and water. There is insufficient evidence to conclude that all the faults observed were laterally connected. It is more probable that they were a group of small thrust faults occurring within a narrow thrust zone.

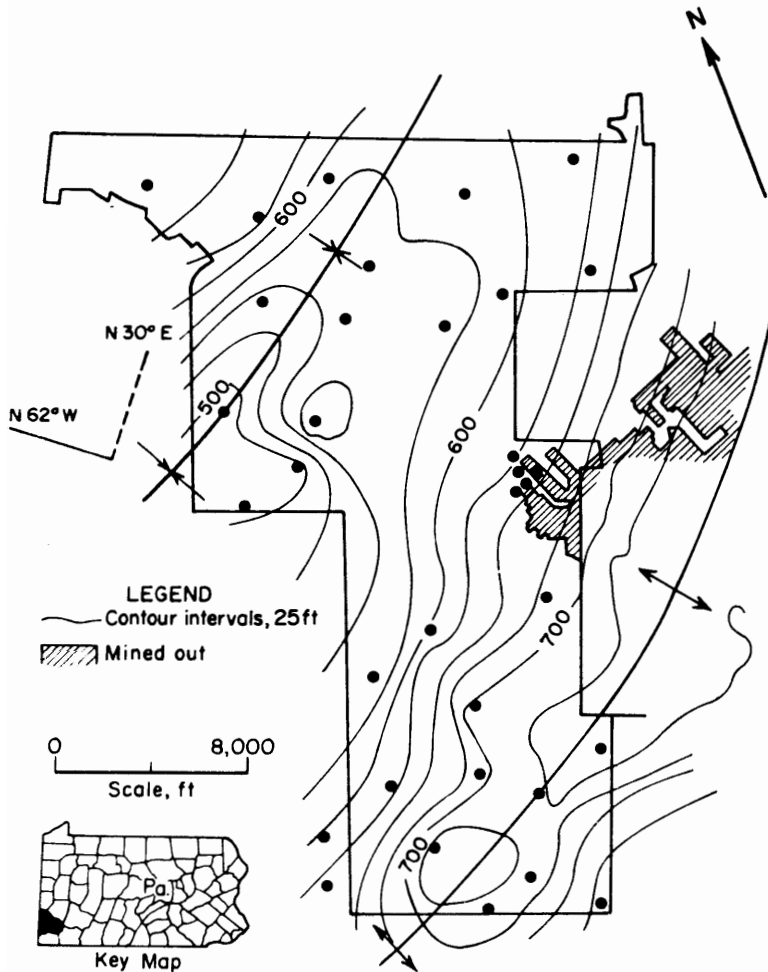
FIGURE 11. - Structure map drawn on the base of the Pittsburgh coalbed at Somerset No. 60 mine.

that mining is preceding down the northwest flank of the Amity anticline towards a syncline (fig. 11). Water is reportedly accumulating at the face of entries being driven to the northwest. This condition may be expected as long as the entries dip into the working face. Once they advance on the axis of the syncline, the floor will dip away from the face and water should no longer accumulate there.

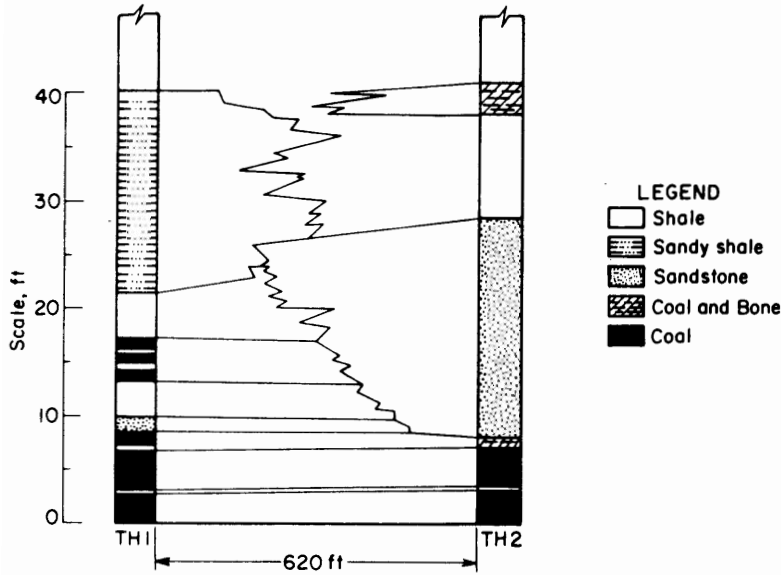
FIGURE 13. - Lithologic change between drill holes TH1 and TH2.

holes TH1 and TH2 (fig. 13) drilled 620 feet apart. The change in lithology is due to stream erosion of strata that were originally deposited over the coalbed in the same way as in the northern part of the area. Subsequently, sand was deposited in these erosion channels. The depth of erosion varied from place to place so that the coal is only removed locally. The thinner the interval between the coalbed and the overlying sandstone, the greater the probability that erosion will affect the coalbed. A map based on present drill hole data shows areas where cutouts may be expected (fig. 14).

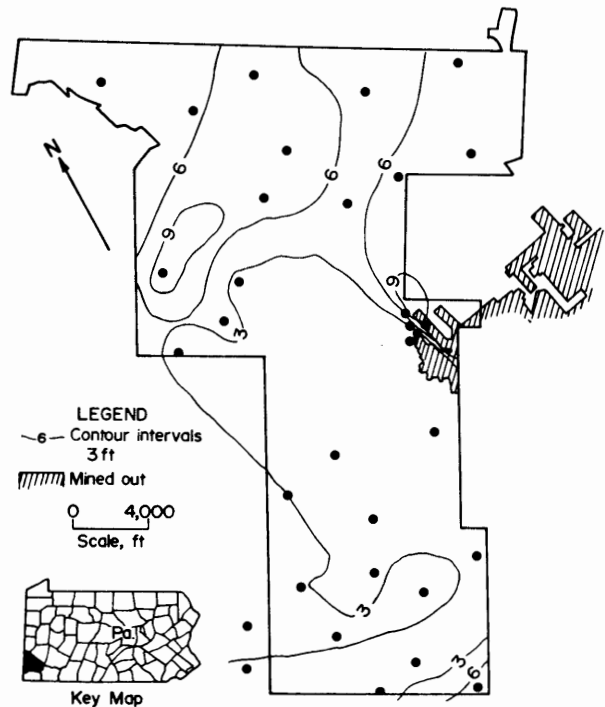
FIGURE 15. - Isopach of the draw slate unit above the Pittsburgh coalbed, Somerset No. 60 mine.

problems. Most mines prefer to anchor roof bolts in the more competent rock above this interval. Figure 15 can be used in a general way to determine the minimum length of bolt that would be necessary to bolt through the interval in any given area.

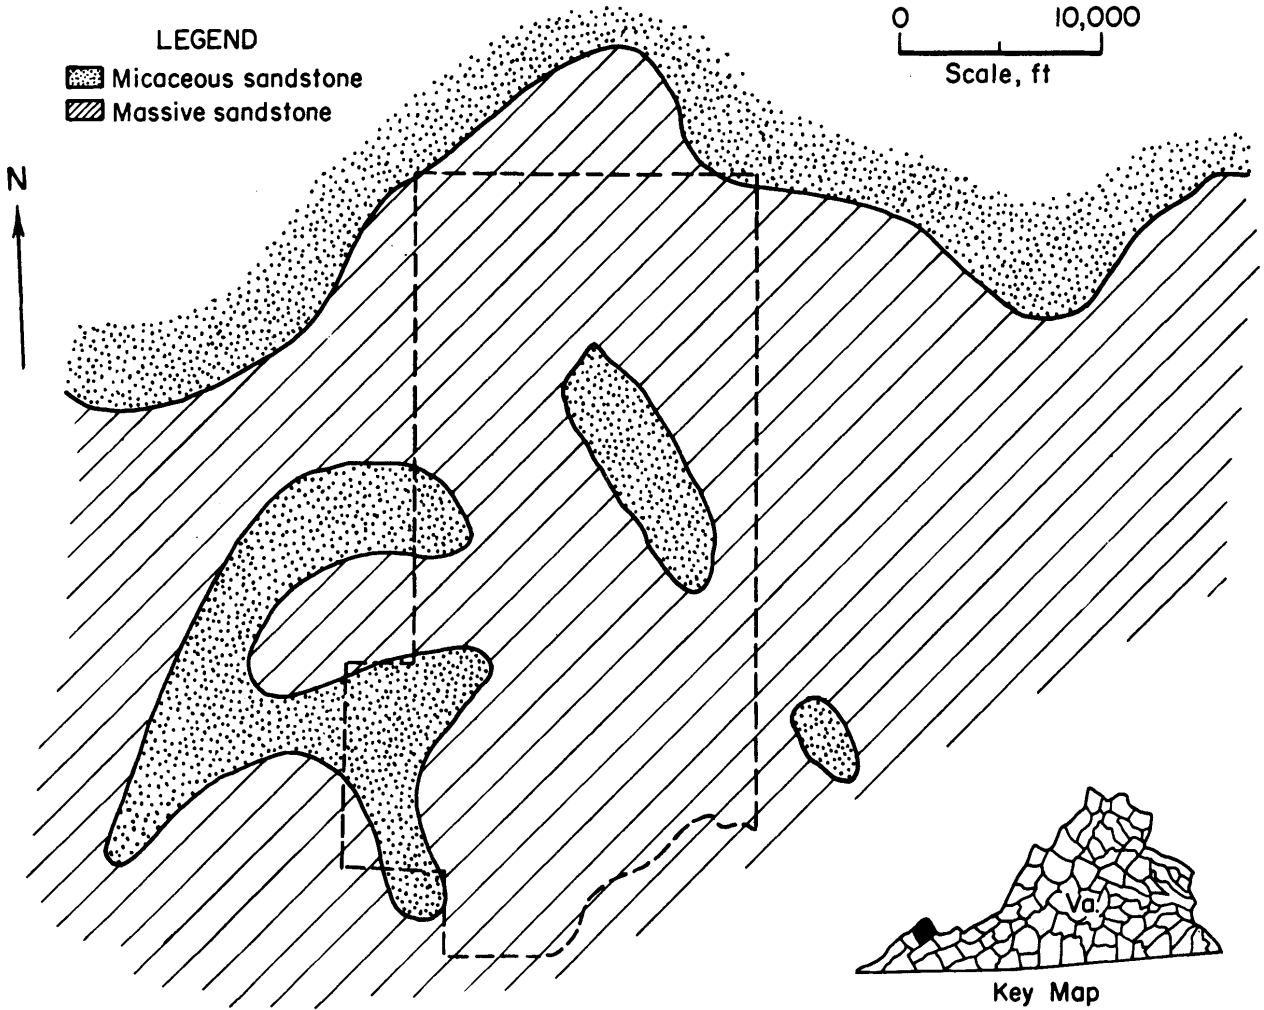
FIGURE 24. - Nature of sandstone above Pocahontas No. 3 coalbed, Beatrice-Pocahontas mine.

During the survey, it was noted that washouts occurred with massive sands, and a majority of the falls observed had micaceous sands composing the fall unit. A map of the type of sandstone (massive or micaceous) found above the coal (fig. 24) should anticipate such problems and make it possible to modify mining techniques before problem zones are encountered.
