**Geotechnical investigation for the
rehabilitation of Albert's Farm Dam
– Braamfontein West Water
Management Unit**

Reference: 504630-G3-00

Report No: 12239

26 July 2019

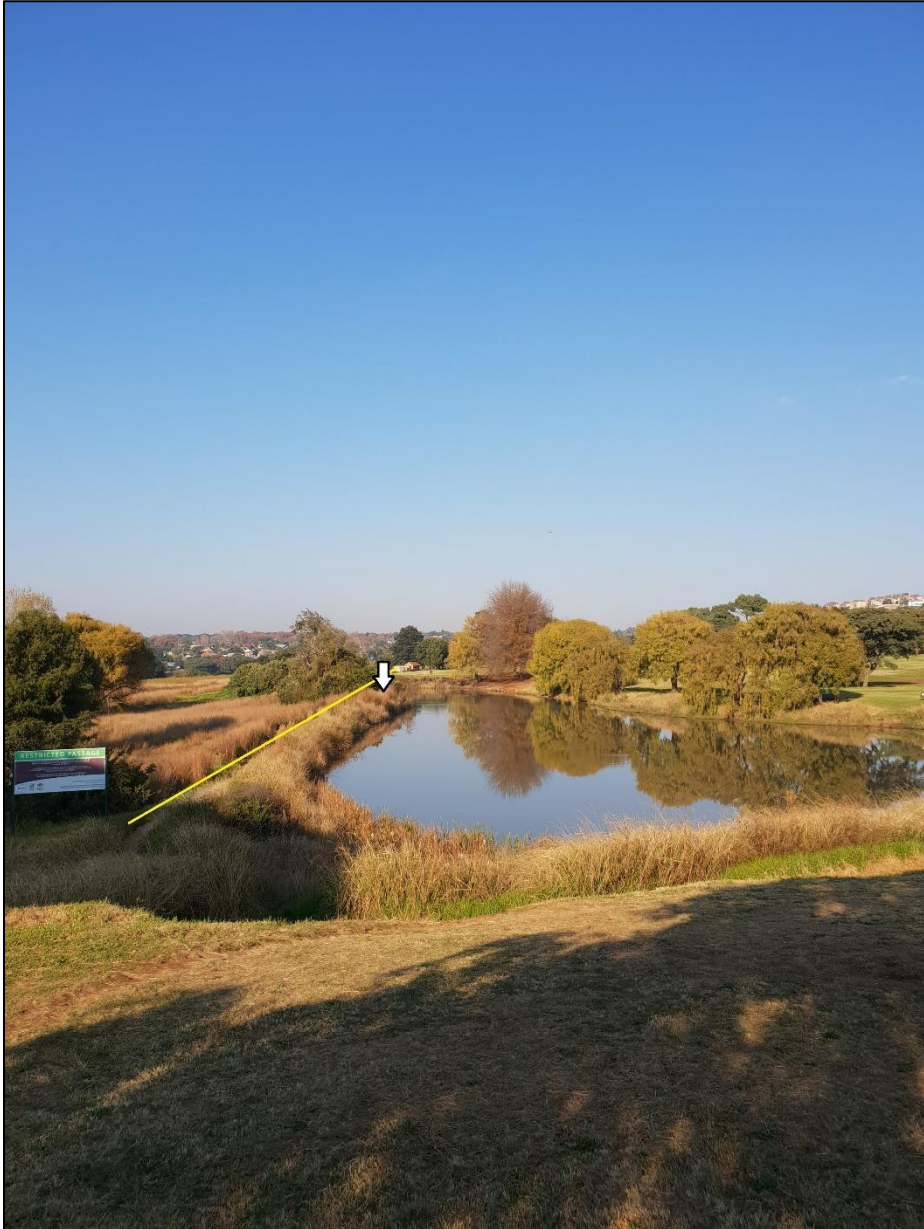
The dam comprises an earth embankment (Figure 2) and is approximately 200m in length. The results of the dam survey show the embankment crest to be 1085mm and the height of the embankment is 5.4m and slopes at 60 degrees.

Figure 2: View of the dam from the north (approximate centre line and position of breach are shown by yellow line and arrow, respectively)

- Repair of the breach section on the embankment,
- Raising the embankment by a nominal 500 mm,
- Reinstatement of the upslope protection,
- Placing material on the downstream slope,
- Construction of the spillway channel with a concrete overflow sill, and
- Placing Reno mattresses for erosion immediately downstream of the sill for about 3m.

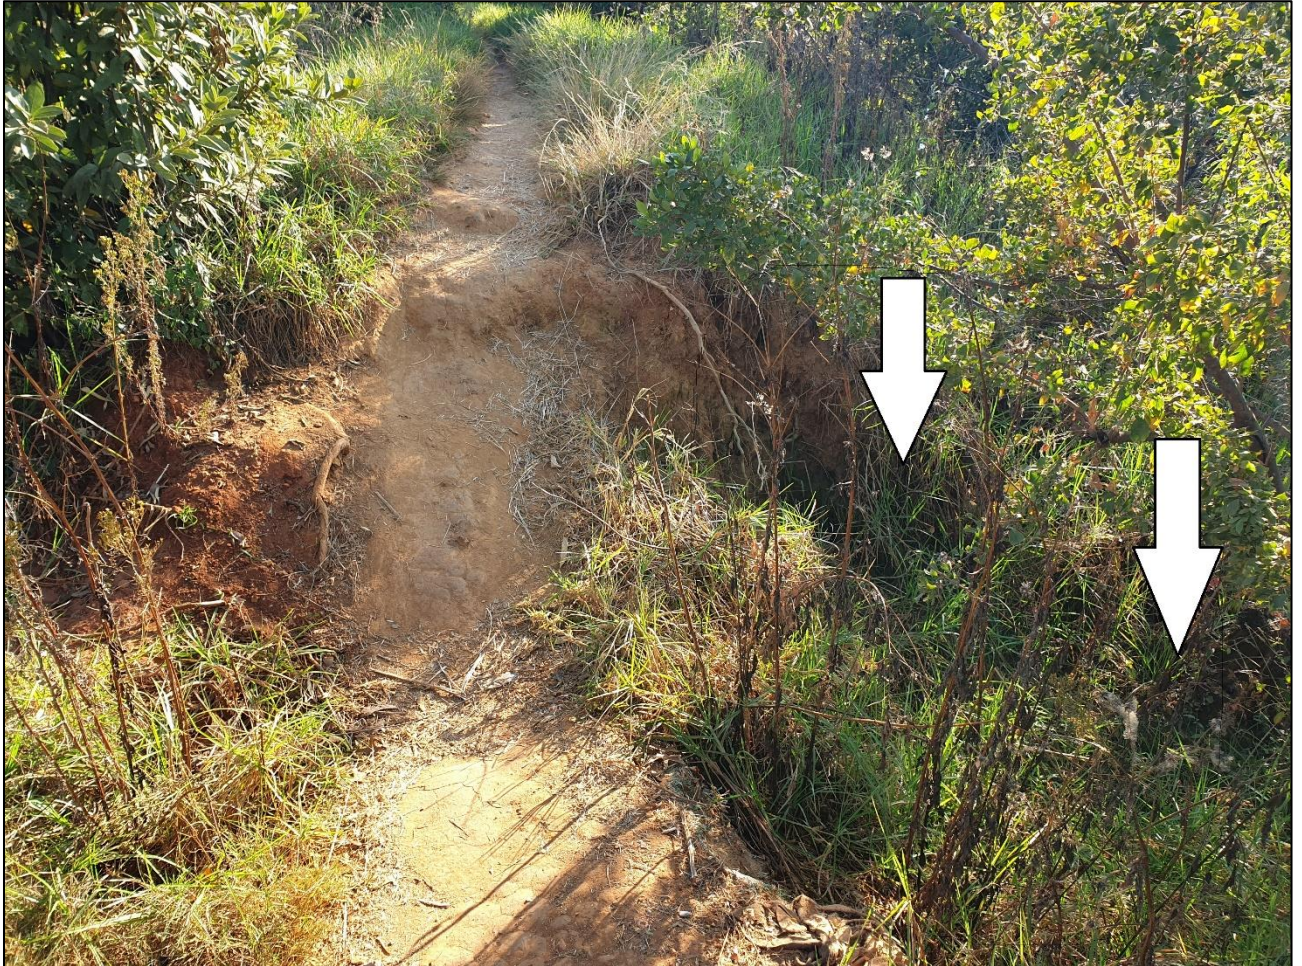
Assessment of the embankment showed that previously the dam wall had been breached and this breach is now plugged using sand bags, but flow was noted. This was noted at the vicinity of AFD TP7. Further visual assessment showed erosion of the dam wall on the upstream side. The wall has very narrow crest, 3m at most. The embankment's downstream face is grassed. It must be noted that no survey data of the dam was available at the time of the investigation.

The dam is eroded on the upstream side and a previous failure of the wall was observed (Figure 3) in the vicinity of AFD TP7. Sand bags have been used to plug the breach, but flow was noted. Natural slopes around the dam are moderately sloping. The area downstream of the dam is understood to be a conservation area (*pers. comm. City Parks officials*).

Figure 3: Close up view of the breach section – in the vicinity of AFD TP7. Arrows indicating approximately where water flow was noted – although clear view is obstructed by vegetation

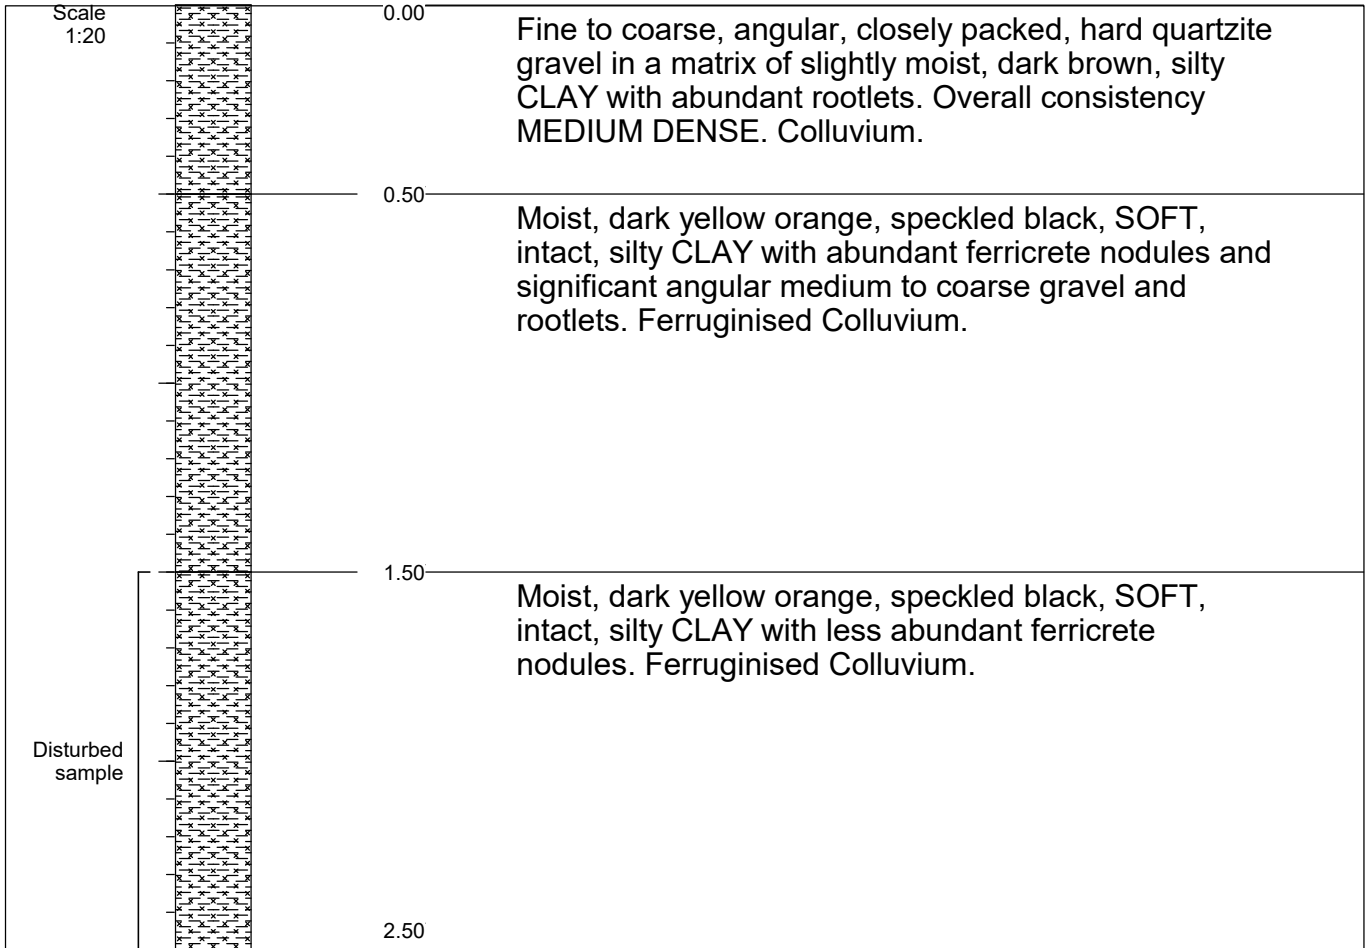
The ferruginised colluvium was encountered at Test Pit AFD TP1 from 0.5 to 2.5m. comprising moist, soft, silty clay with significant medium to coarse, angular, quartzite gravel and ferricrete nodules. A pinholed structure was noted in this layer.

Final depth at 2.5m on ferruginised colluvium
 Dislodgement of coarse gravel into test pit
 No groundwater or seepage encountered
 FI sample taken at 1.5-2.5m
 Coarse gravel in vicinity of hole

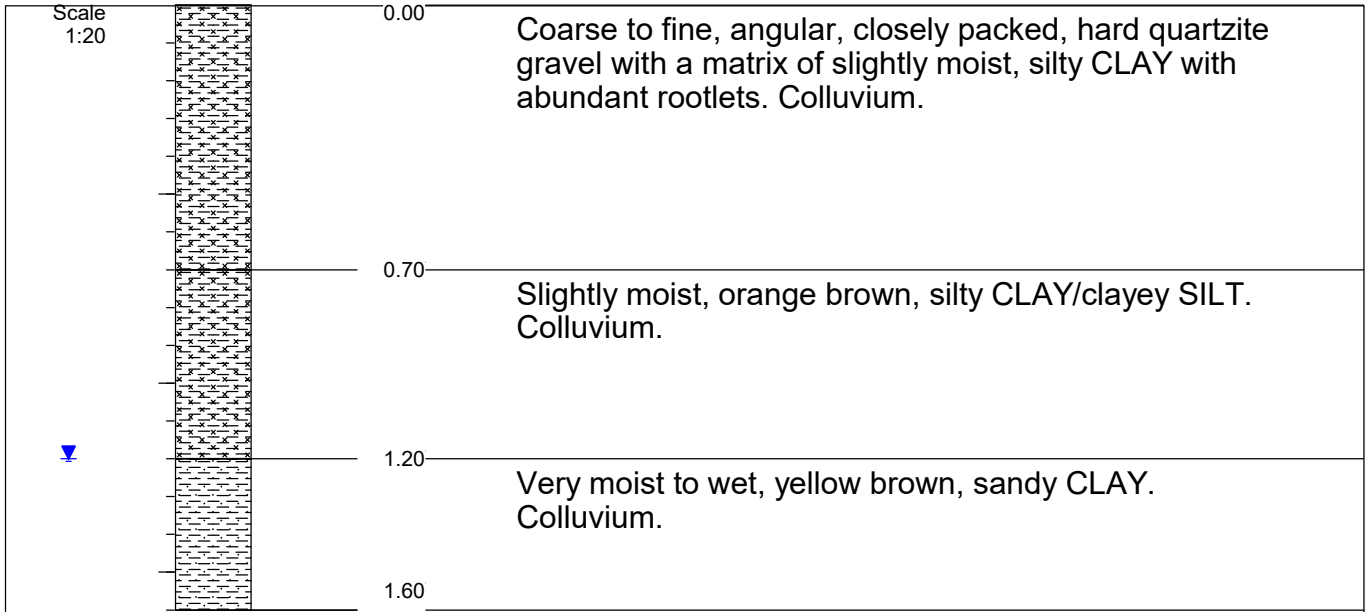
Seepage was encountered at AFD TP2, the test pit located at the proposed spillway position. The seepage occurred at a depth of 1.2m below surface. The test pit was actually moved from the proposed position due to wet conditions being noted. Thus, the general area is defined by such conditions which possibly results from overflow.

Test pit terminated at 1.6m on colluvium
 Seepage encountered at 1.2m
 Sidewalls unstable (collapsing)
 Test pit not entered due to unsafe conditions -
 material profiled from stockpile
 Test pit moved 8m from the original position

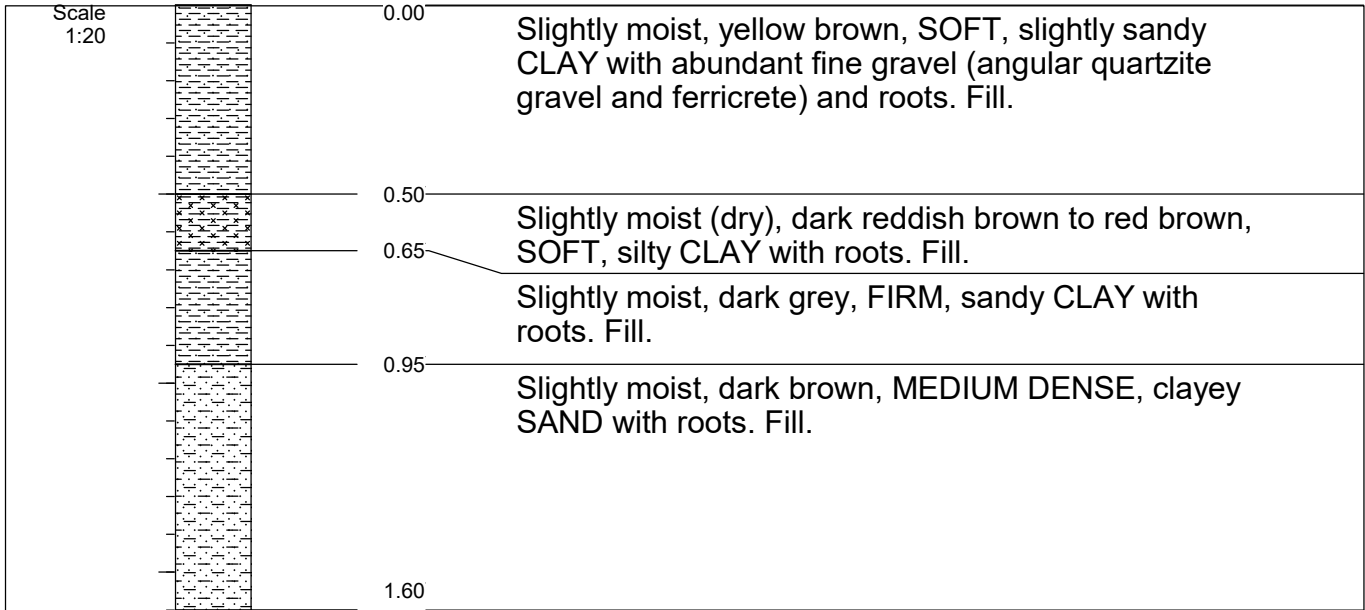
Final depth at 1.6m on fill
 Sidewall stable
 No groundwater or seepage encountered

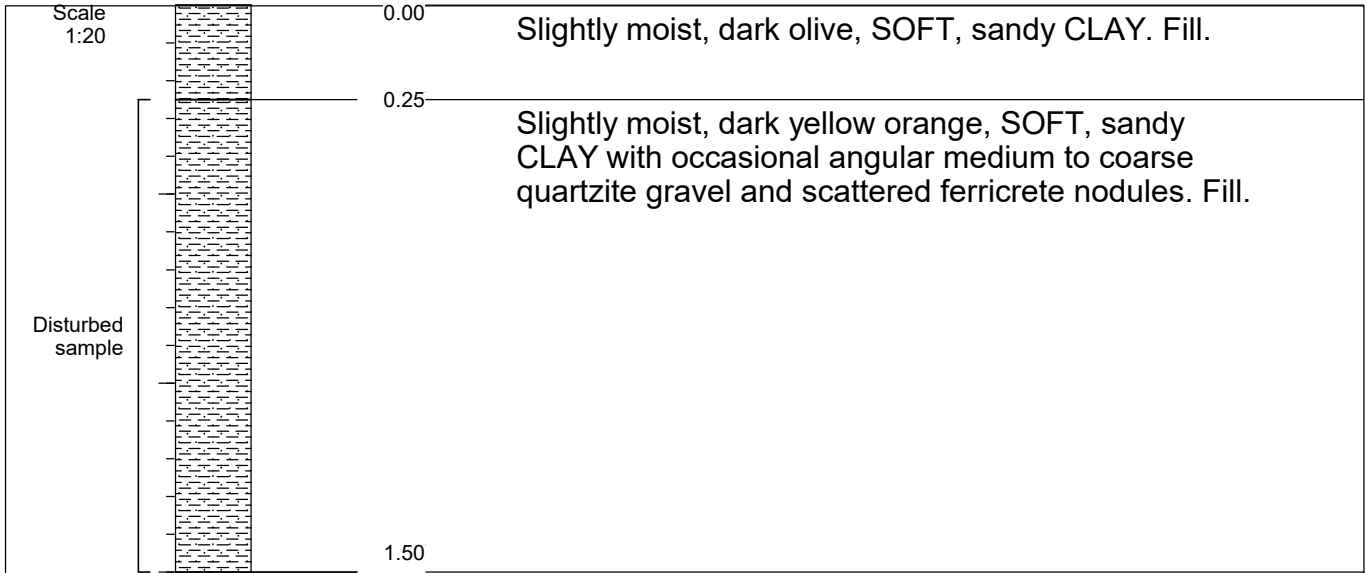
The different fill layers are of various thicknesses, ranging between 0.15 to 0.65m with a maximum thickness of 1.25m recorded at Test Pit AFD TP5, the slightly moist to moist, soft sandy clay with occasional medium to coarse angular and scattered ferricrete nodules.

Final depth at 1.5m on fill
 Sidewall stable
 No groundwater or seepage encountered
 FI, proctor, shearbox and permeability sample taken at 0.25-1.5m
 Test pit on embankment slope
