GPBE – OdE – ANIPB – UNL International Seminar on Precast Concrete Structures Lisboa, 21 October 2010

PRECAST STRUCTURES AND L'AQUILA 2009 EARTHQUAKE

Marco Menegotto

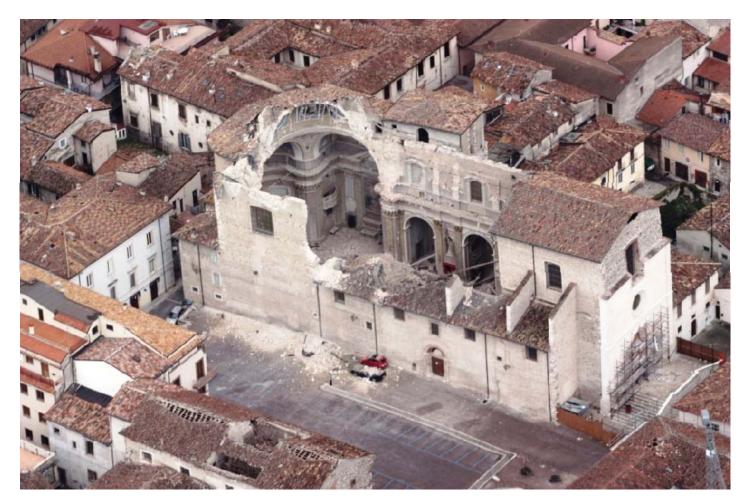
size and shape critical

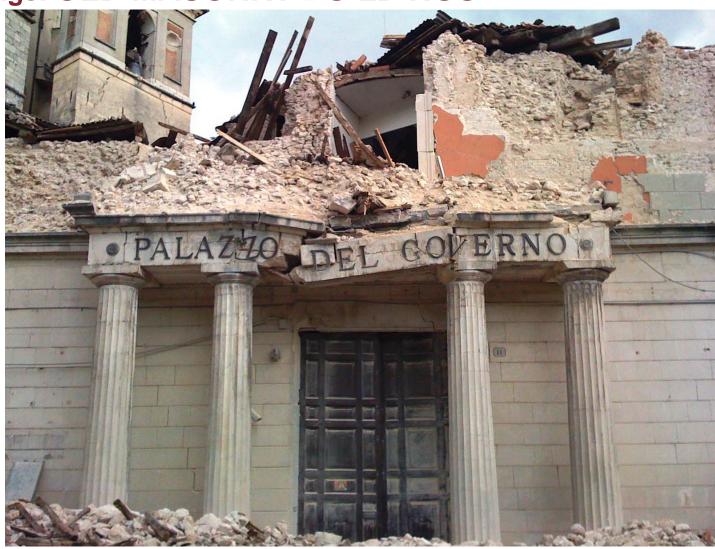
irregular layout

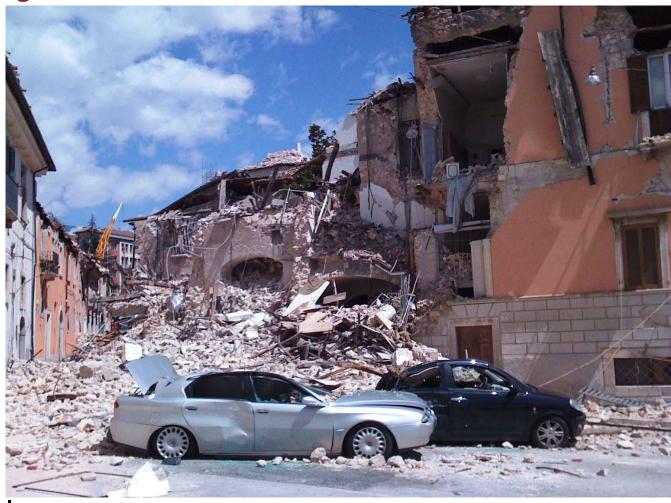
poor materials

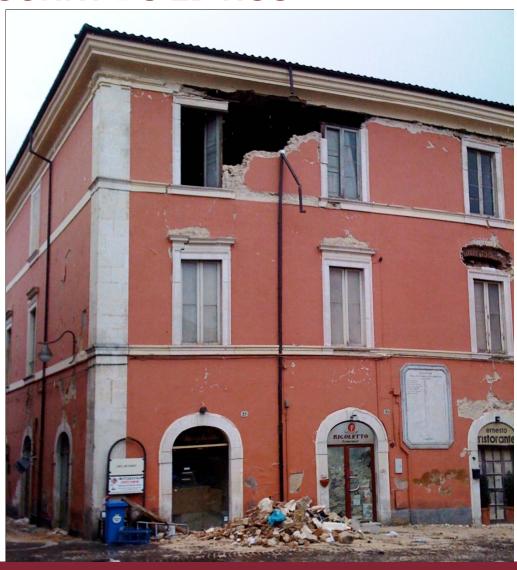
poor maintenance

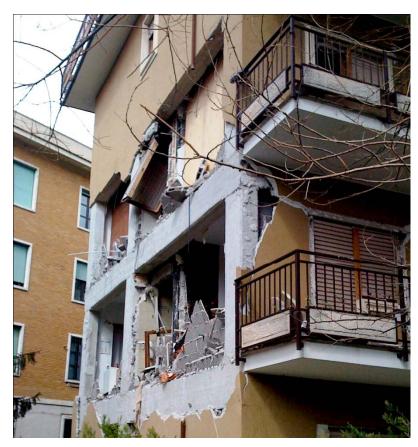
"non-structural" damage outer infill masonry expelled

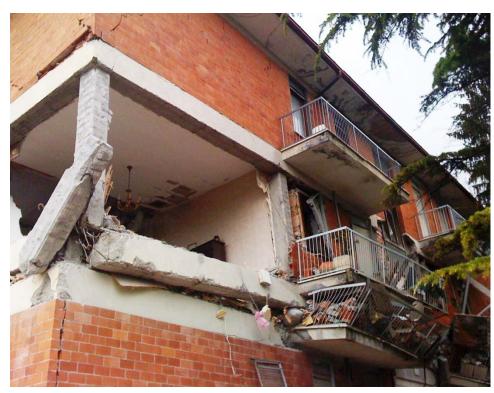
squeezed-in soft storey

unconnected diaphragms

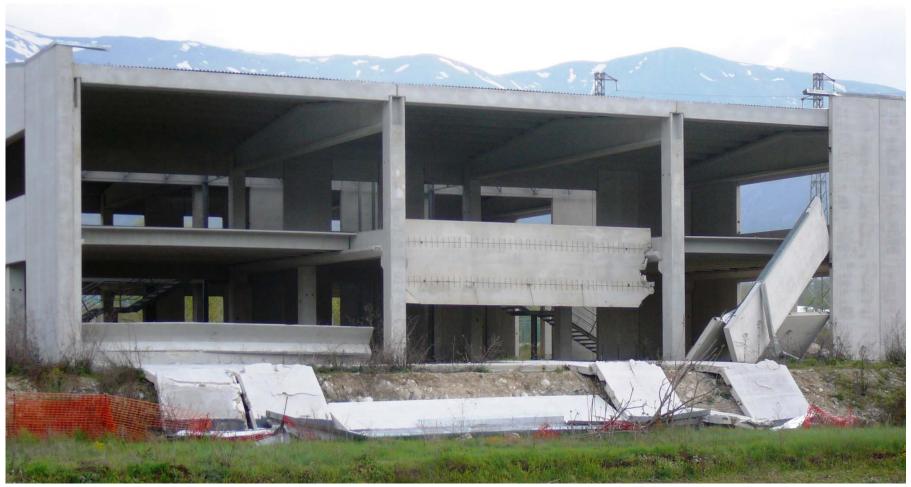
Building under construction: walls and TT slabs failed

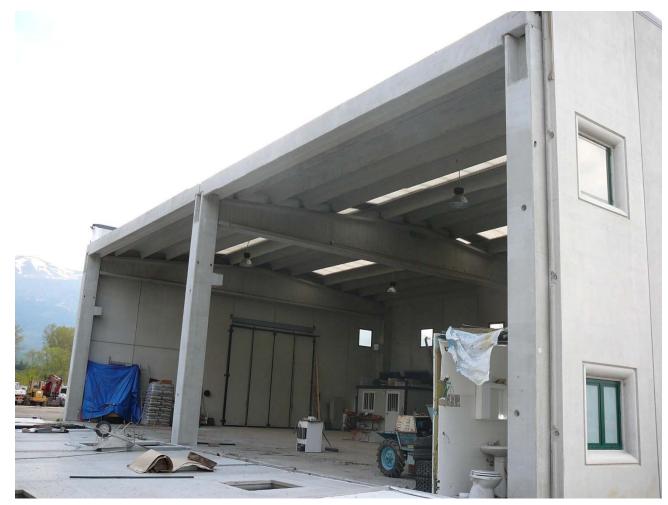
operating factory building: wall panels tilt off

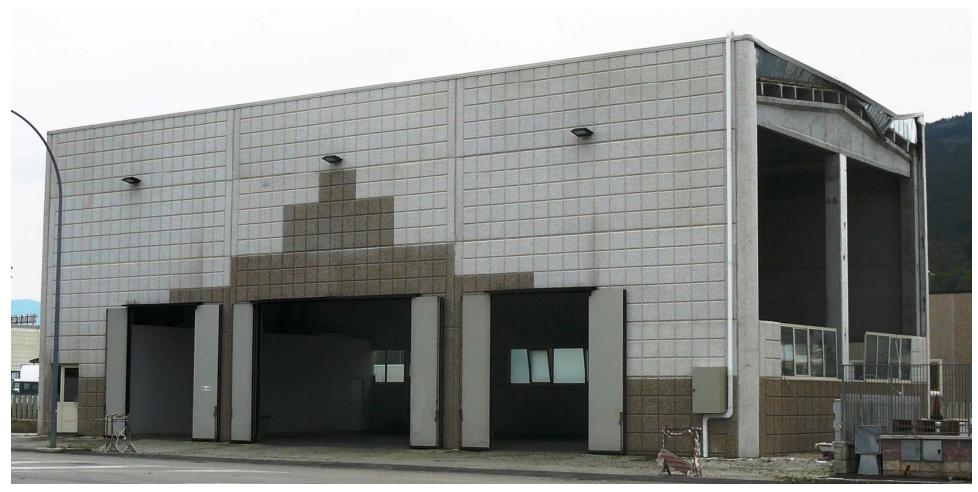
fallen façade of horizontal panels (right-hand side)

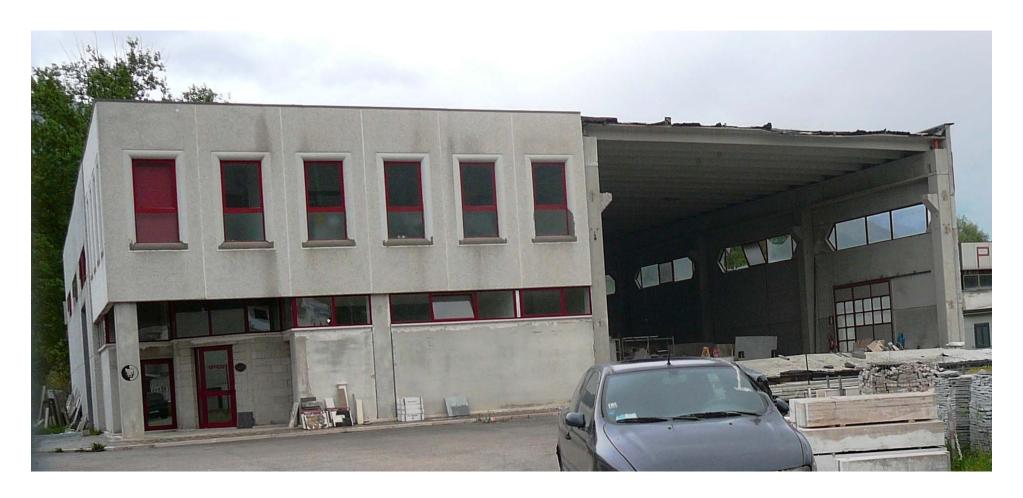
Stiffening façade of the most deformable part fallen down

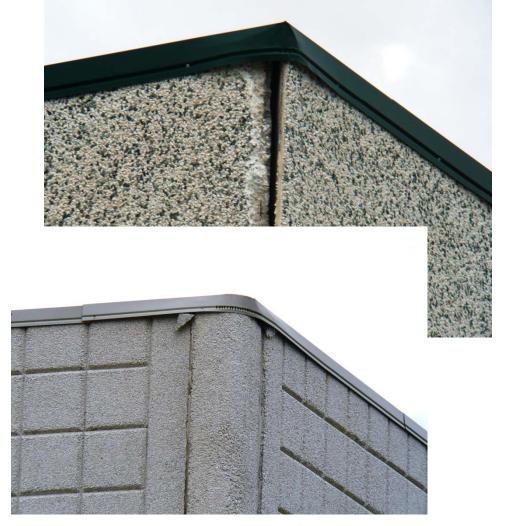
corner panel failures of various degrees

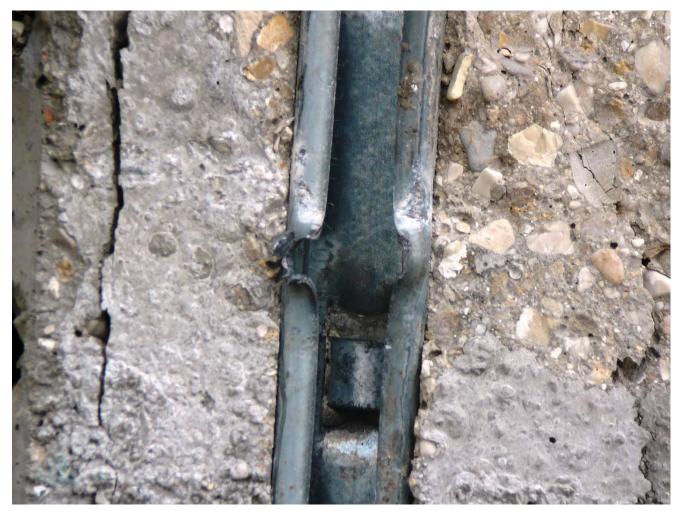
Channel embedded in wall panel opened by unforeseen action

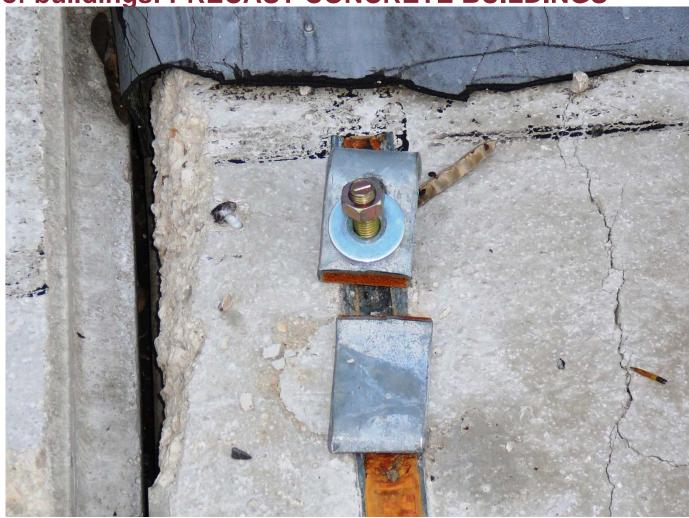
Fastener plate of wall panel failed by unfereseen action

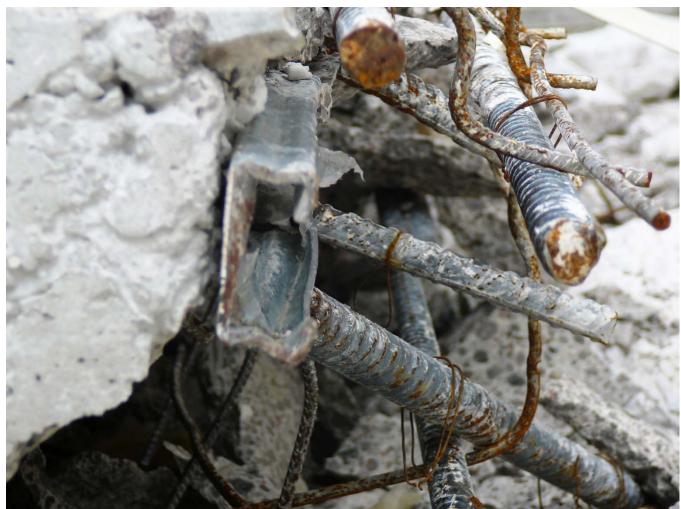
Channel anchor bars rip in wall panel by unforeseen action
