H-1-BB-MEE-1878

Hope Creek 'B' Recirculation Pump
Vibration Analysis

Revision 1
December 16, 2004

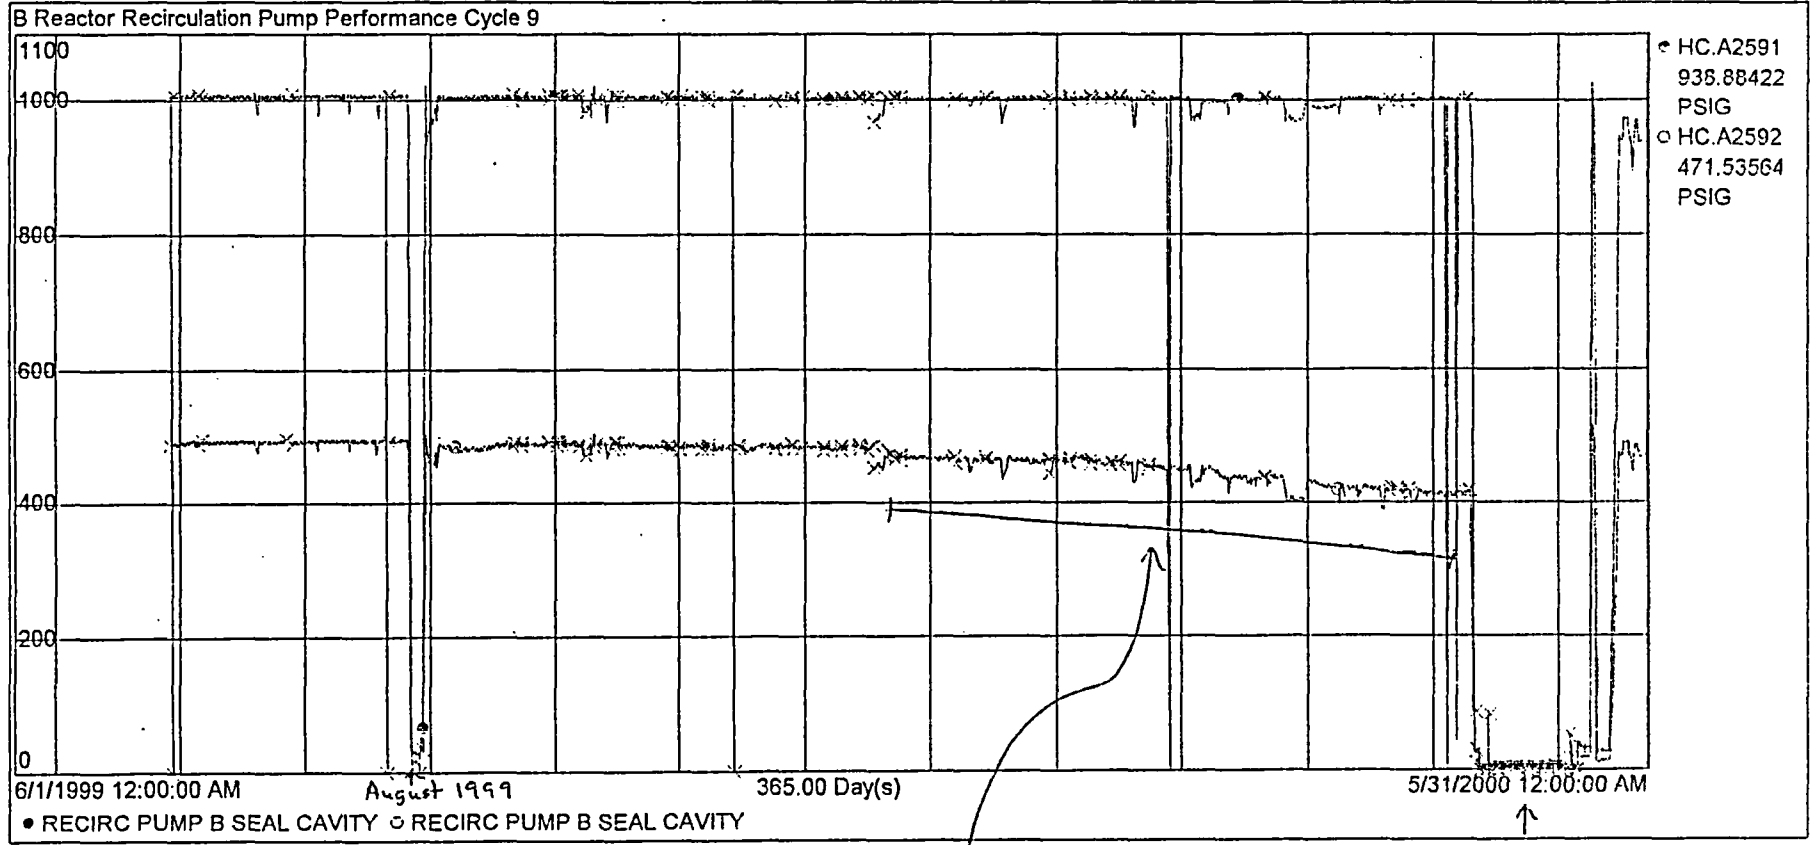
Att 8.2 Pg 2

First and Second stage Mechanical Seal Pressures

Second Stage Seal Degradation

outage
Replace Mech
Seal

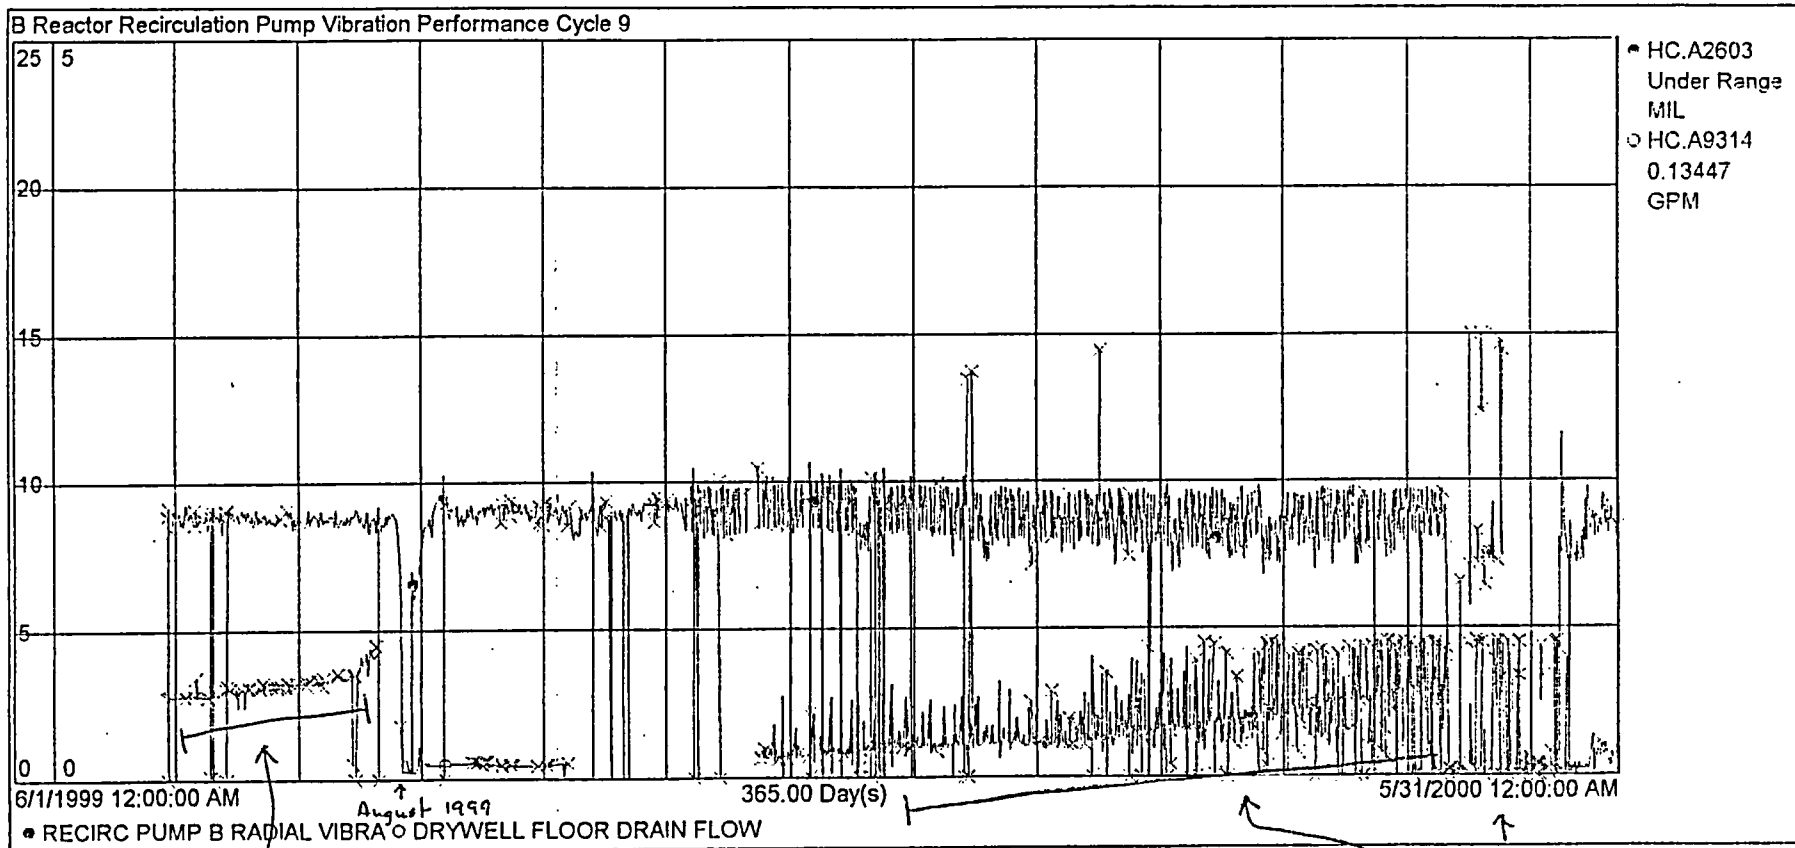
H-1-BB-MEE-1978-1
ATT 8.2 Pg 3

Reactor Recirculation Pump Radial Vibrations and Drywell Floor Drain Leakage

Elevated leakage due to inadequate seal venting

Outage
Replace Mech Seal

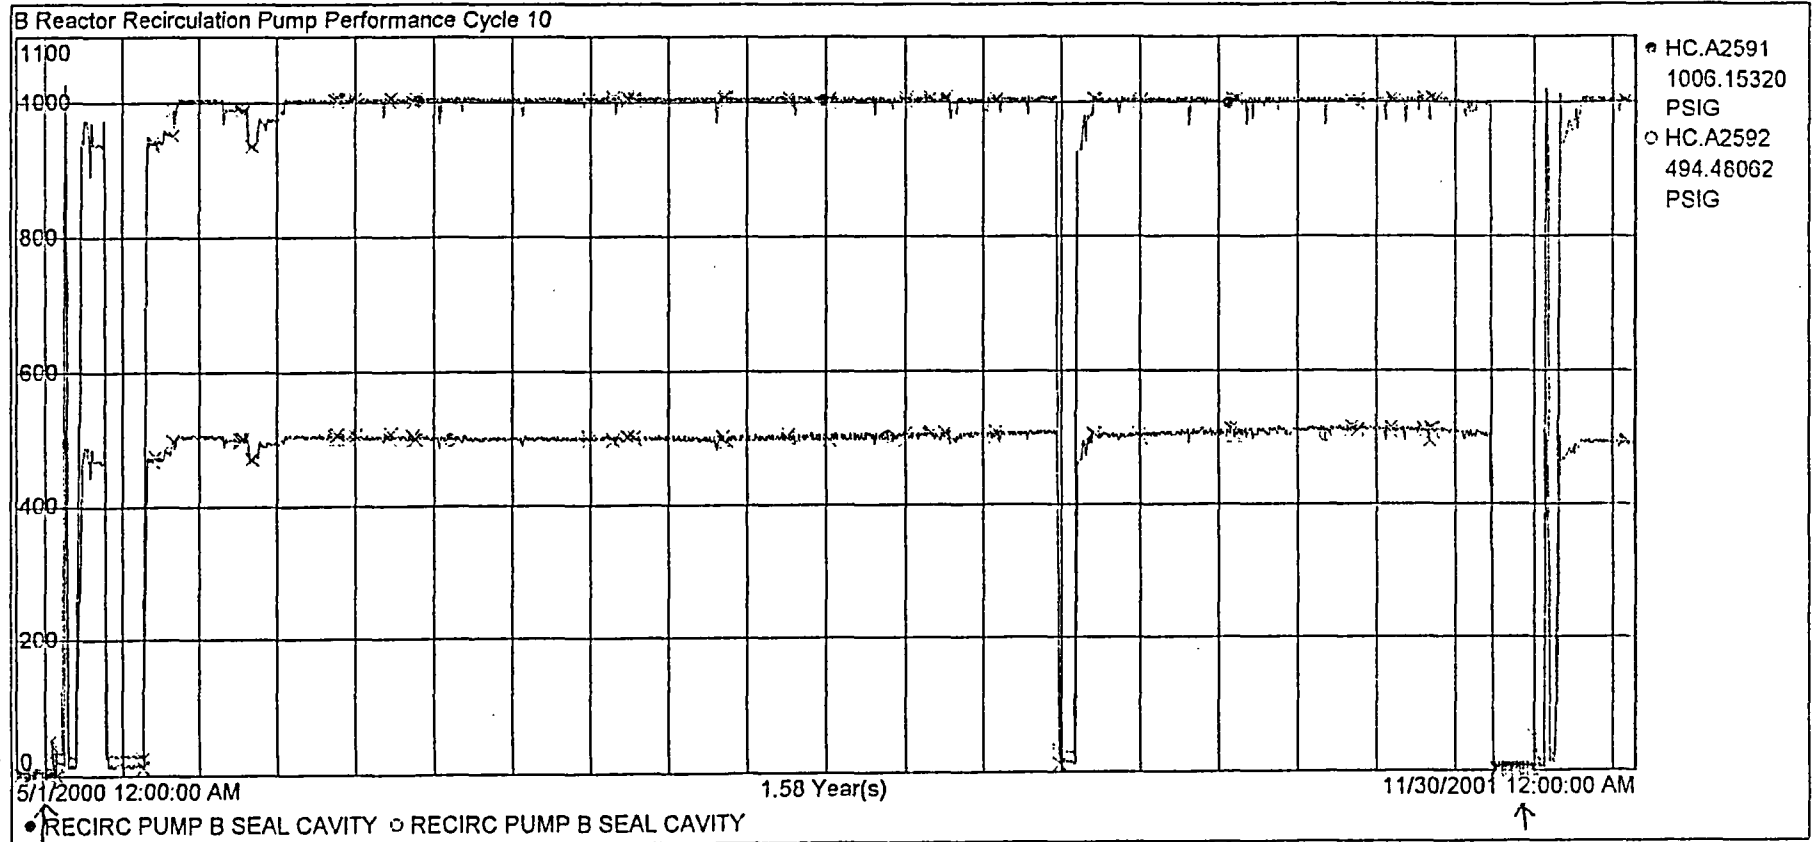
Att 8.2 pg 4

First and Second stage Mechanical Seal Pressures

RF09
Replace Mech
Seal

RF10
Replace Mech
Seal

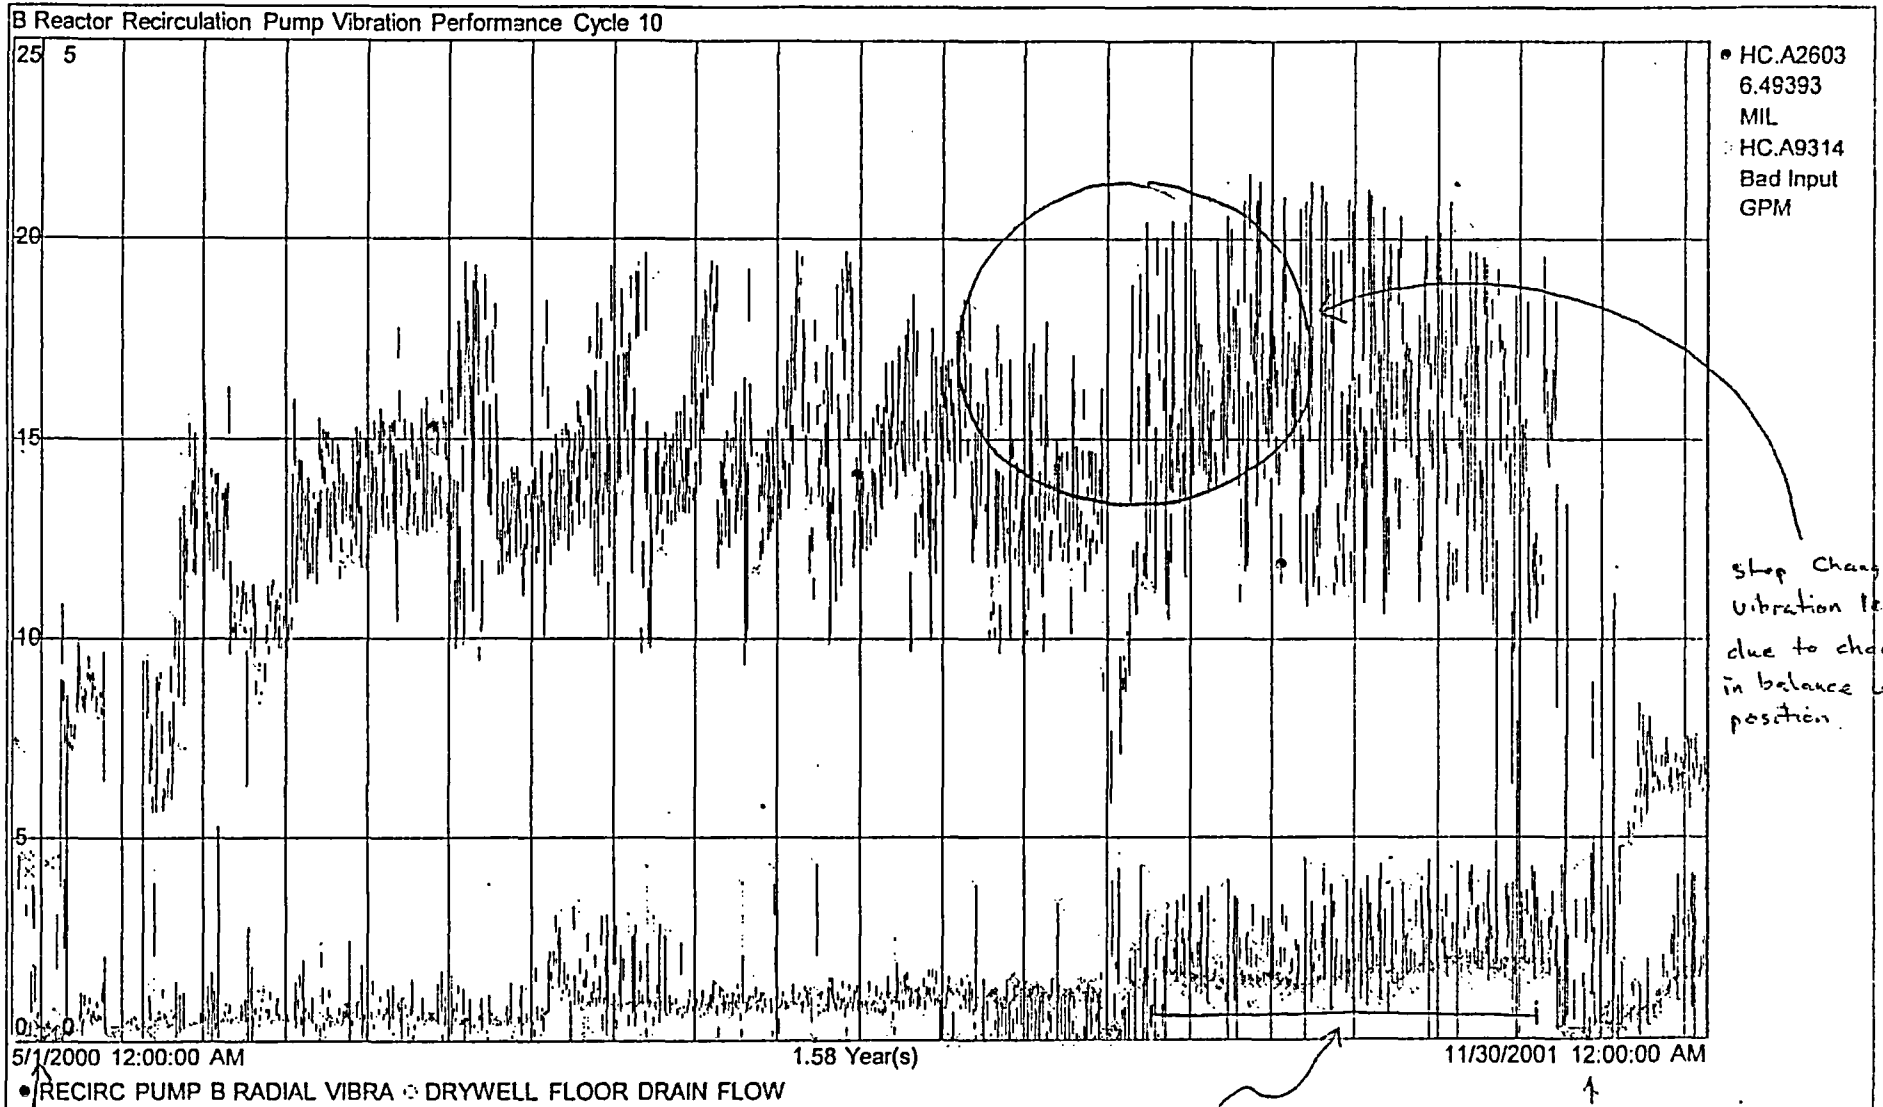
H-1-BB-MEE-1878-1
A# 9.2 pg 5

Reactor Recirculation Pump Radial Vibrations and Drywell Floor Drain Leakage

Nonq Mechanical
seal related drywell
Leakage

RF09
Replace Mech
Seal

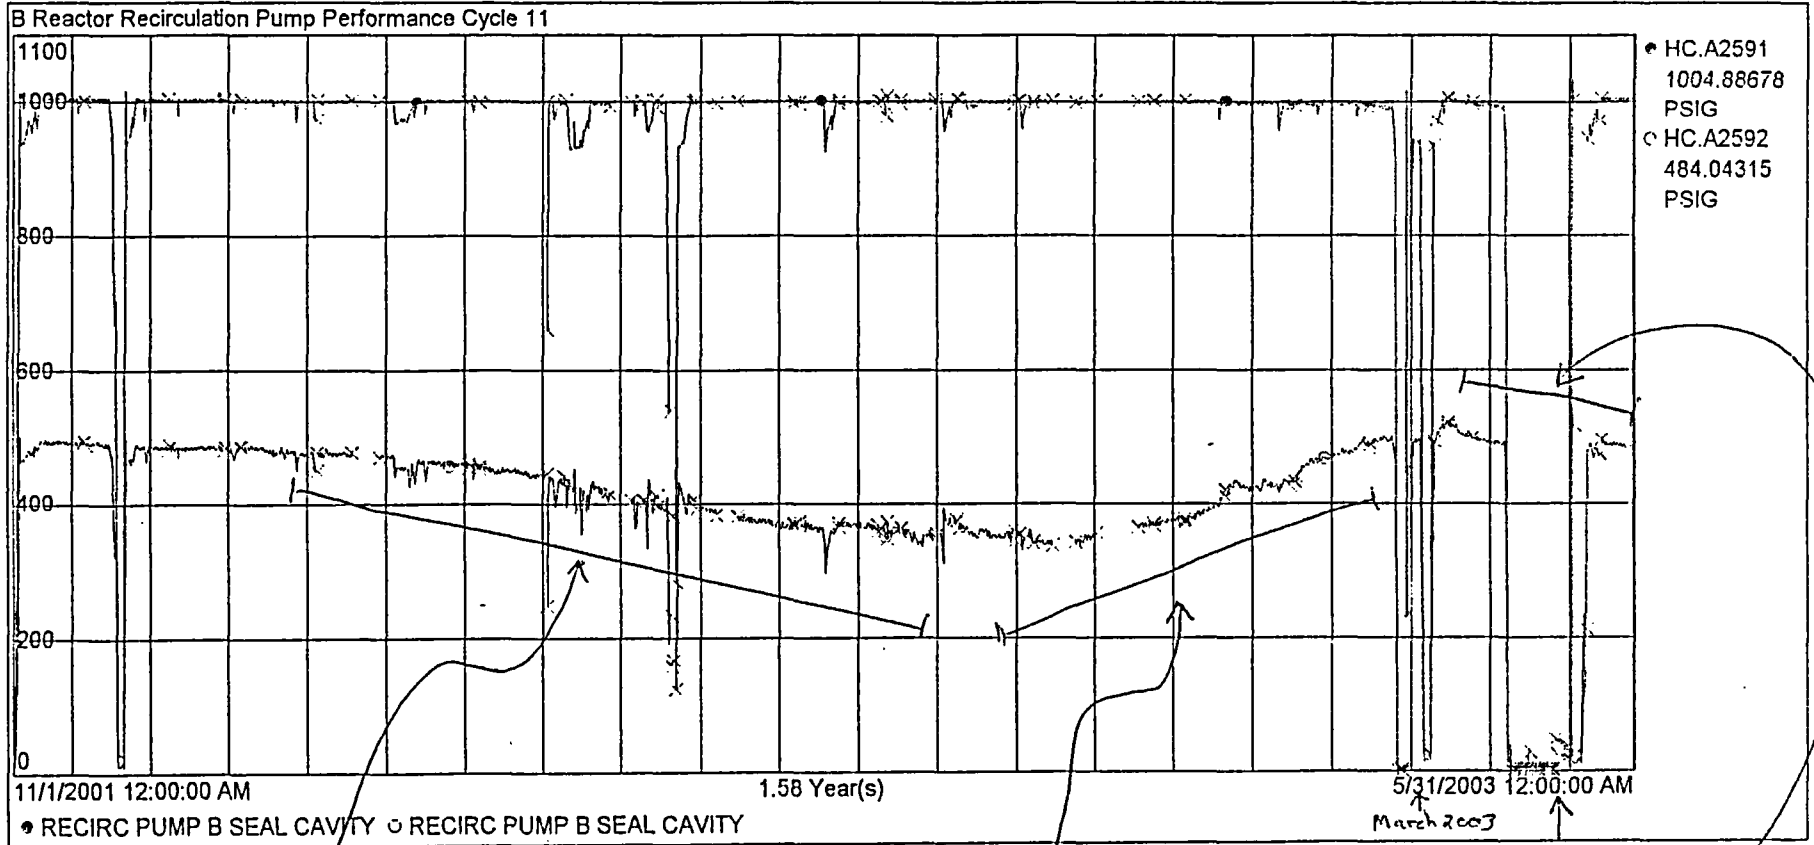
Att 8.2 pg 6

First and Second Stage Mechanical Seal Pressures

Second stage Seal leaking
due to scoring on
seal faces

First Stage Seal leaking
due to scoring on
seal faces. The first
stage leakage is
greater than the
second stage leakage

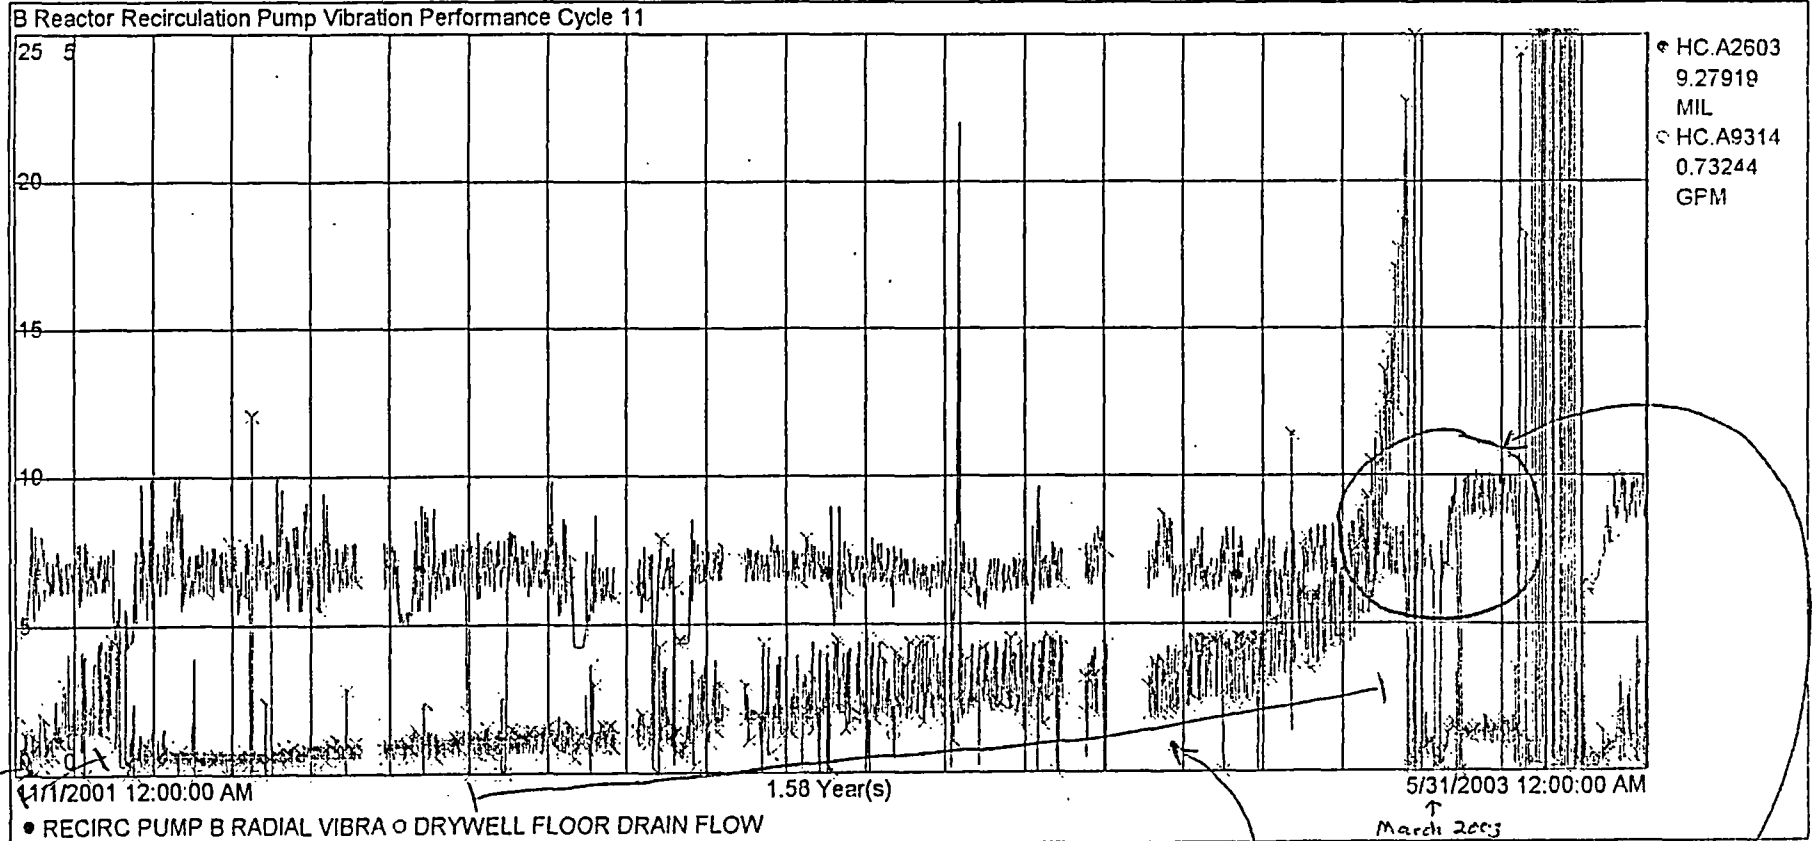
H-1-BB-MEE-1978-1
AH 8.2 pg 7

oversized. This resulting in a relatively "loose" fit of the spacer to the pump hub. In this condition, the pump can be properly coupled, but repeatability to the as-found pump alignment would be very difficult. See Attachment 8.2 for Cycle 11 pump performance graphs to see the March 2003 step increase in vibration level.

Reactor Recirculation Pump Radial Vibrations and Drywell Floor Drain Leakage

Vibrations steady (6-8mils) until March 2003 Mech Seal Replacement
Vibrations steady (8-10mils) After March 2003 Mech Seal Replacement

outage RFI
Replace Mech No Pump
Seal work

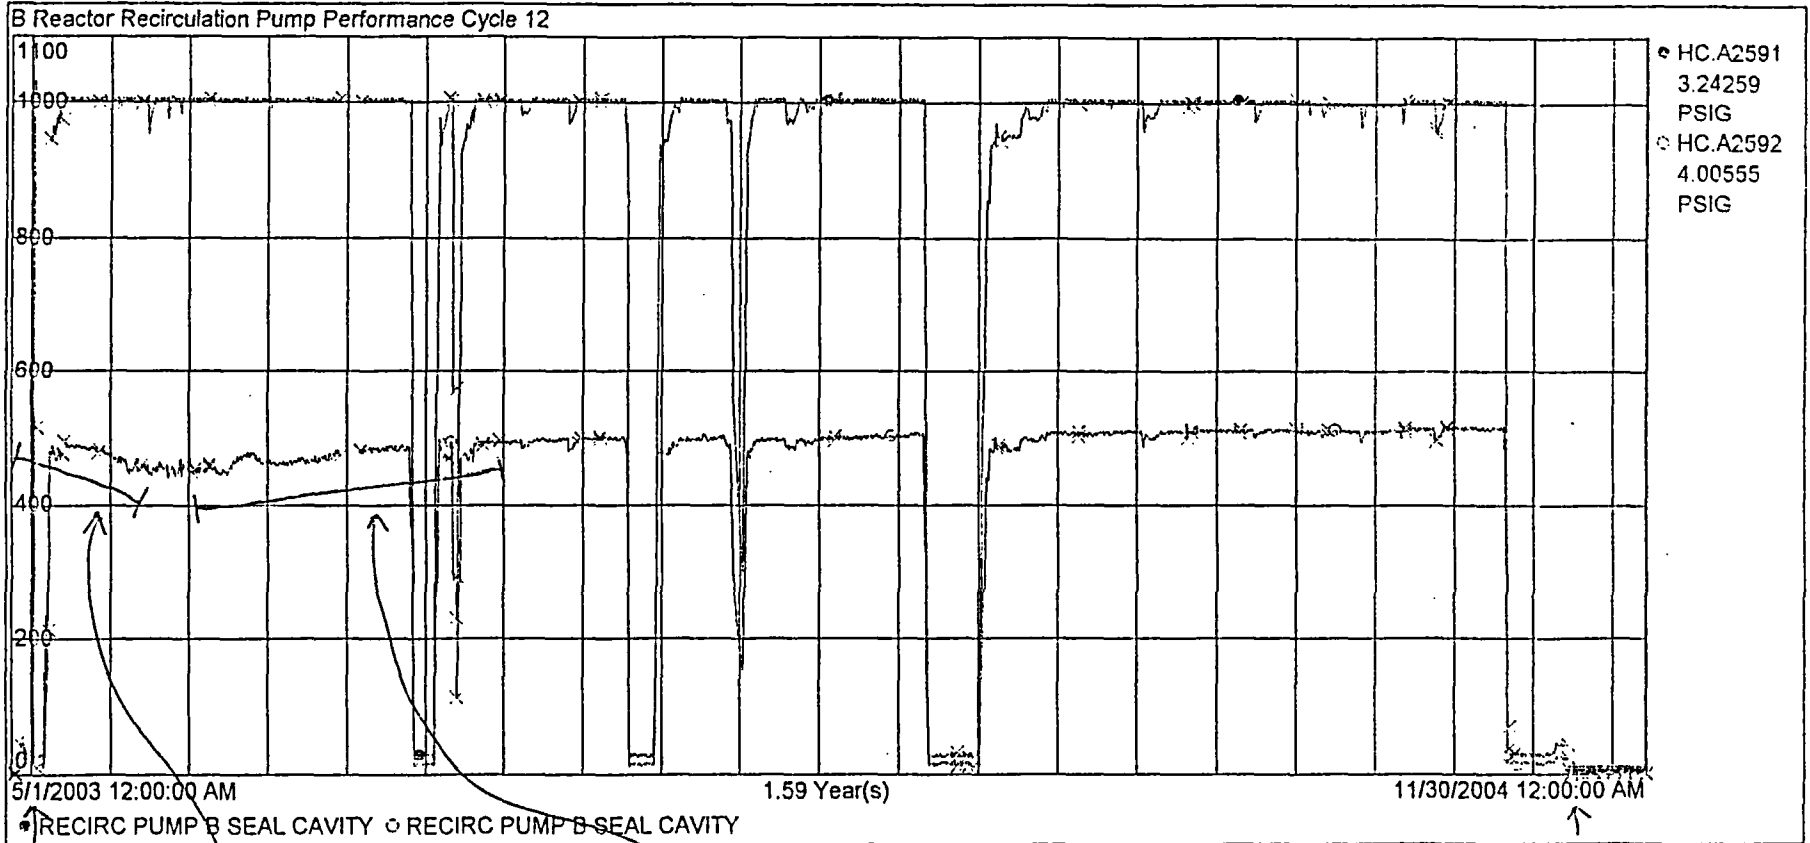
ATT 8.2 pg 8

- (3) Mechanical seal (ser# 324023) performed satisfactorily during Cycle 12. The second stage seal pressure degraded for the first two months of Cycle 12, but then returned to 500 psig and remained steady for the remainder of the cycle. The RF12 mechanical seal inspection (ser# 324023) found that the dip in second stage seal pressure to be due to damage to the second stage carbon face from inadequate venting. See Attachment 8.2 for Cycle 12 mechanical seal performance graphs.

First and Second Stage Mechanical Seal Pressures

Second stage Seal leakage
due to carbon seal face
damage caused by
inadequate venting.

RF11
No Pump
work

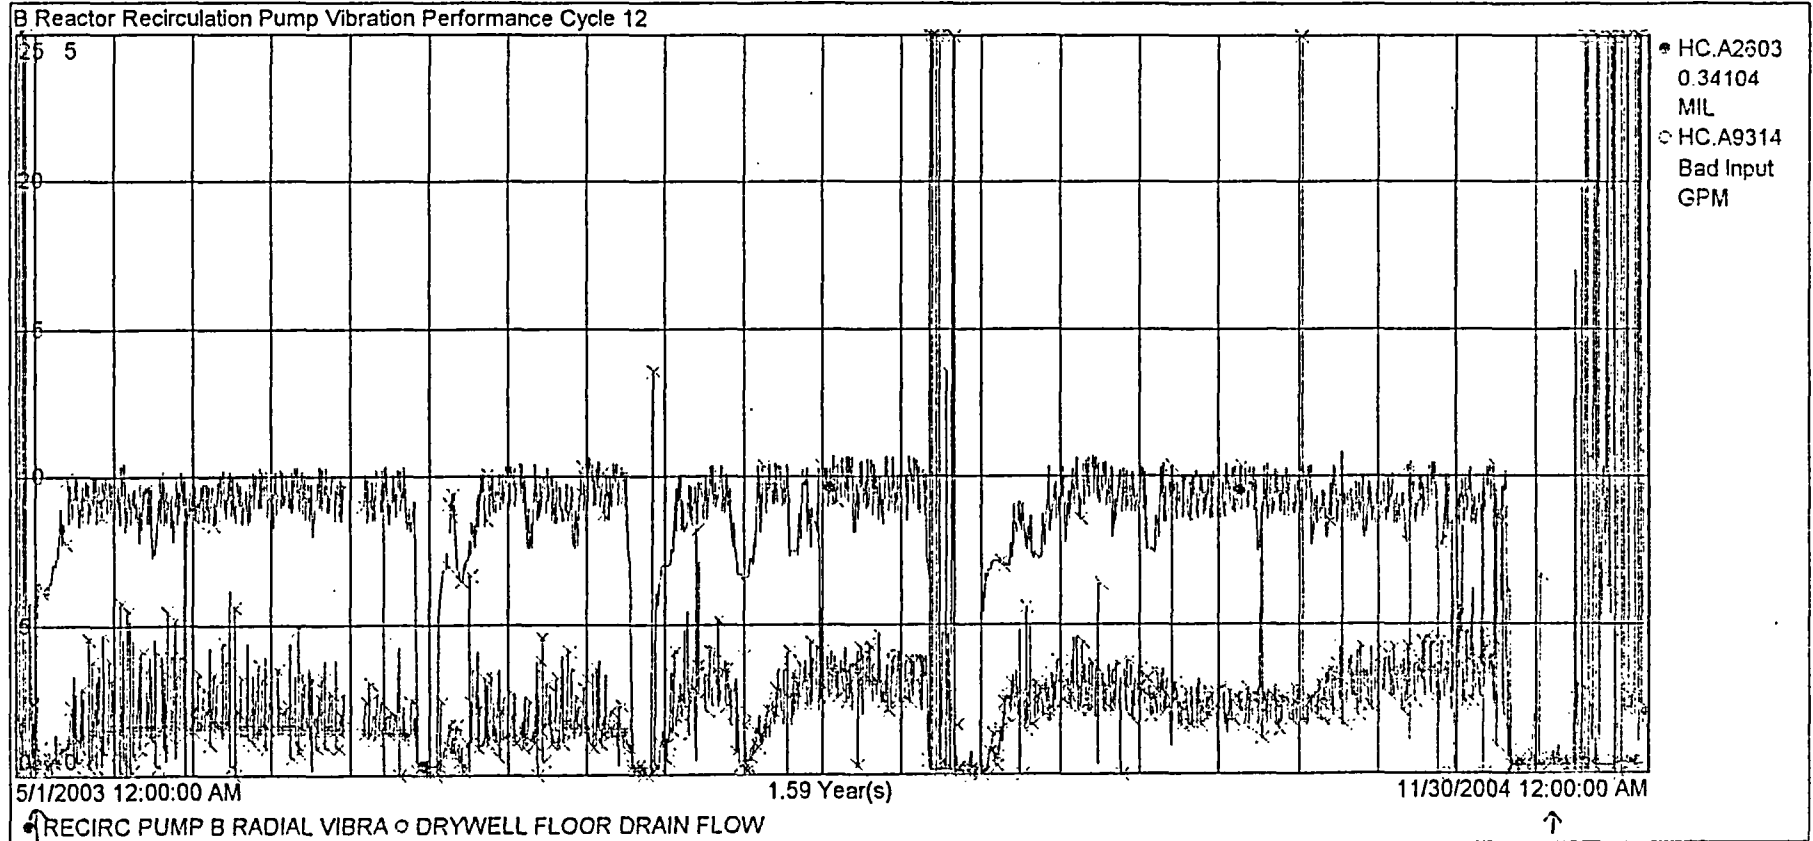
Att 8.2 P39

Reactor Recirculation Pump Radial Vibrations and Drywell Floor Drain Leakage

RF11
No Pump
work

RF12

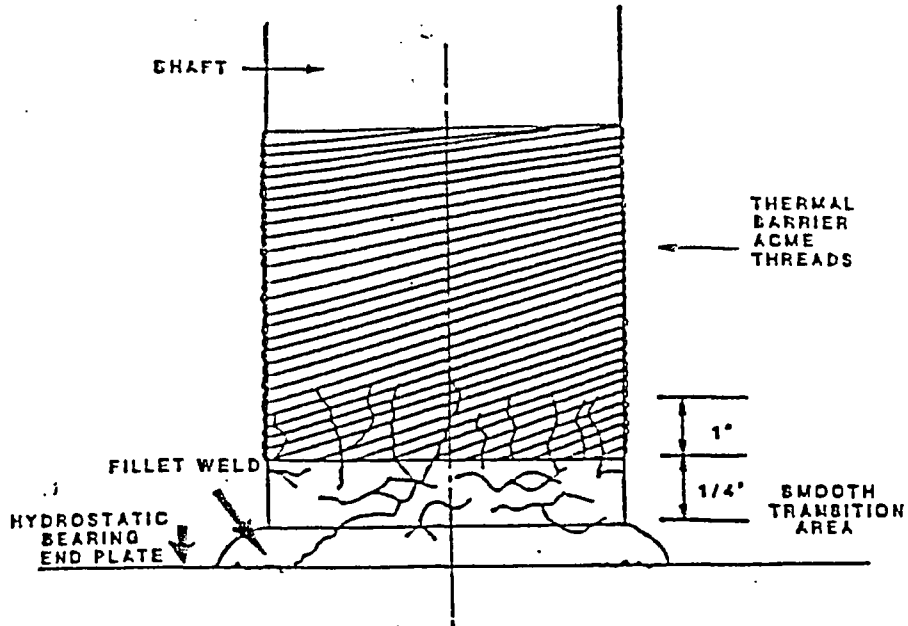
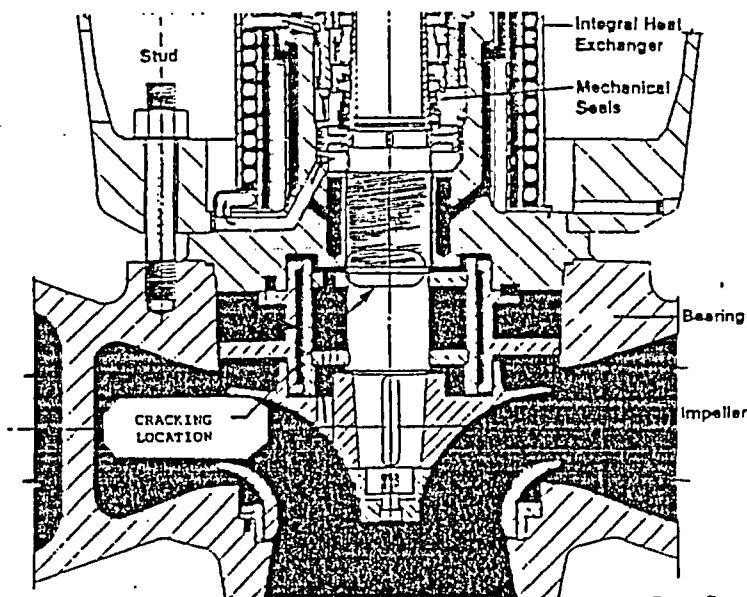
ATTACHMENT 8.3

Location of Reactor Recirculation Pump Shaft Cracks

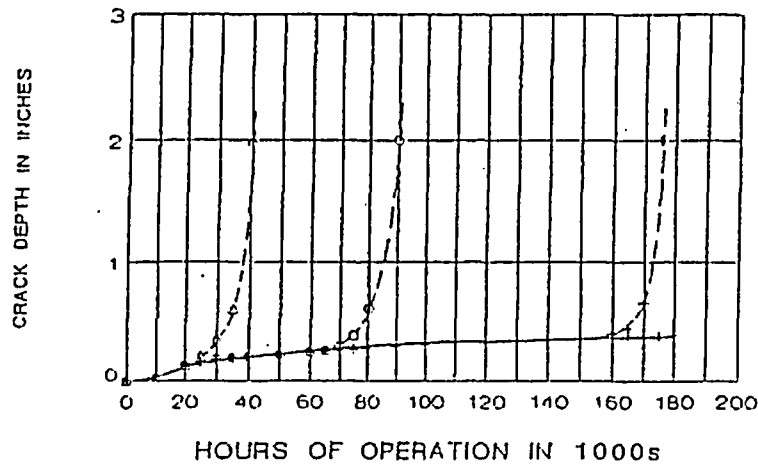
Over time, the axial thermal cracks can transition into circumferential cracks. As the crack becomes deeper, the thermal stresses become less and the crack self-arrests. See Attachment 8.4 for a Crack Growth Prediction graph. The horizontal line across the bottom of the graph represents the growth rate of thermally initiated cracks over the life of the plant. This thermal cracking alone is not detrimental to the pump. The three vertical lines represent the crack growth rate of circumferential cracks under three different assumed mechanical loads sufficient to continue crack propagation. Circumferential cracks propagating under mechanical loading, propagate much faster than axial cracks, and can result in shaft failure. The line to the left represents pumps with higher levels of mechanical loading. The amount of time between when the crack departs from the thermal crack progression line until the shaft fails is calculated to be one to two years, for pumps that have high mechanical loading. However, there is no empirical data to confirm that estimate. GE and Flowsolve found in their investigations that the amount of shaft mechanical loading being experienced by any particular pump is difficult to quantify. They have been unable to develop a methodology to definitively quantify shaft mechanical loading. The loading is a function of the forces on the shaft, which include shaft torque, radial impeller thrust, pump vibrations, and residual loads from initial pump installation tolerances. Of these forces the radial impeller thrust is considered the largest. A pump that is operating close to its design flow rate will have the minimal radial thrust possible for its design. None of the shaft crack failure analyses, shaft cracking testing, or industry operating experience has identified elevated vibrations

CRACK GROWTH PREDICTIONS EFFECTS OF MECHANICAL LOADS

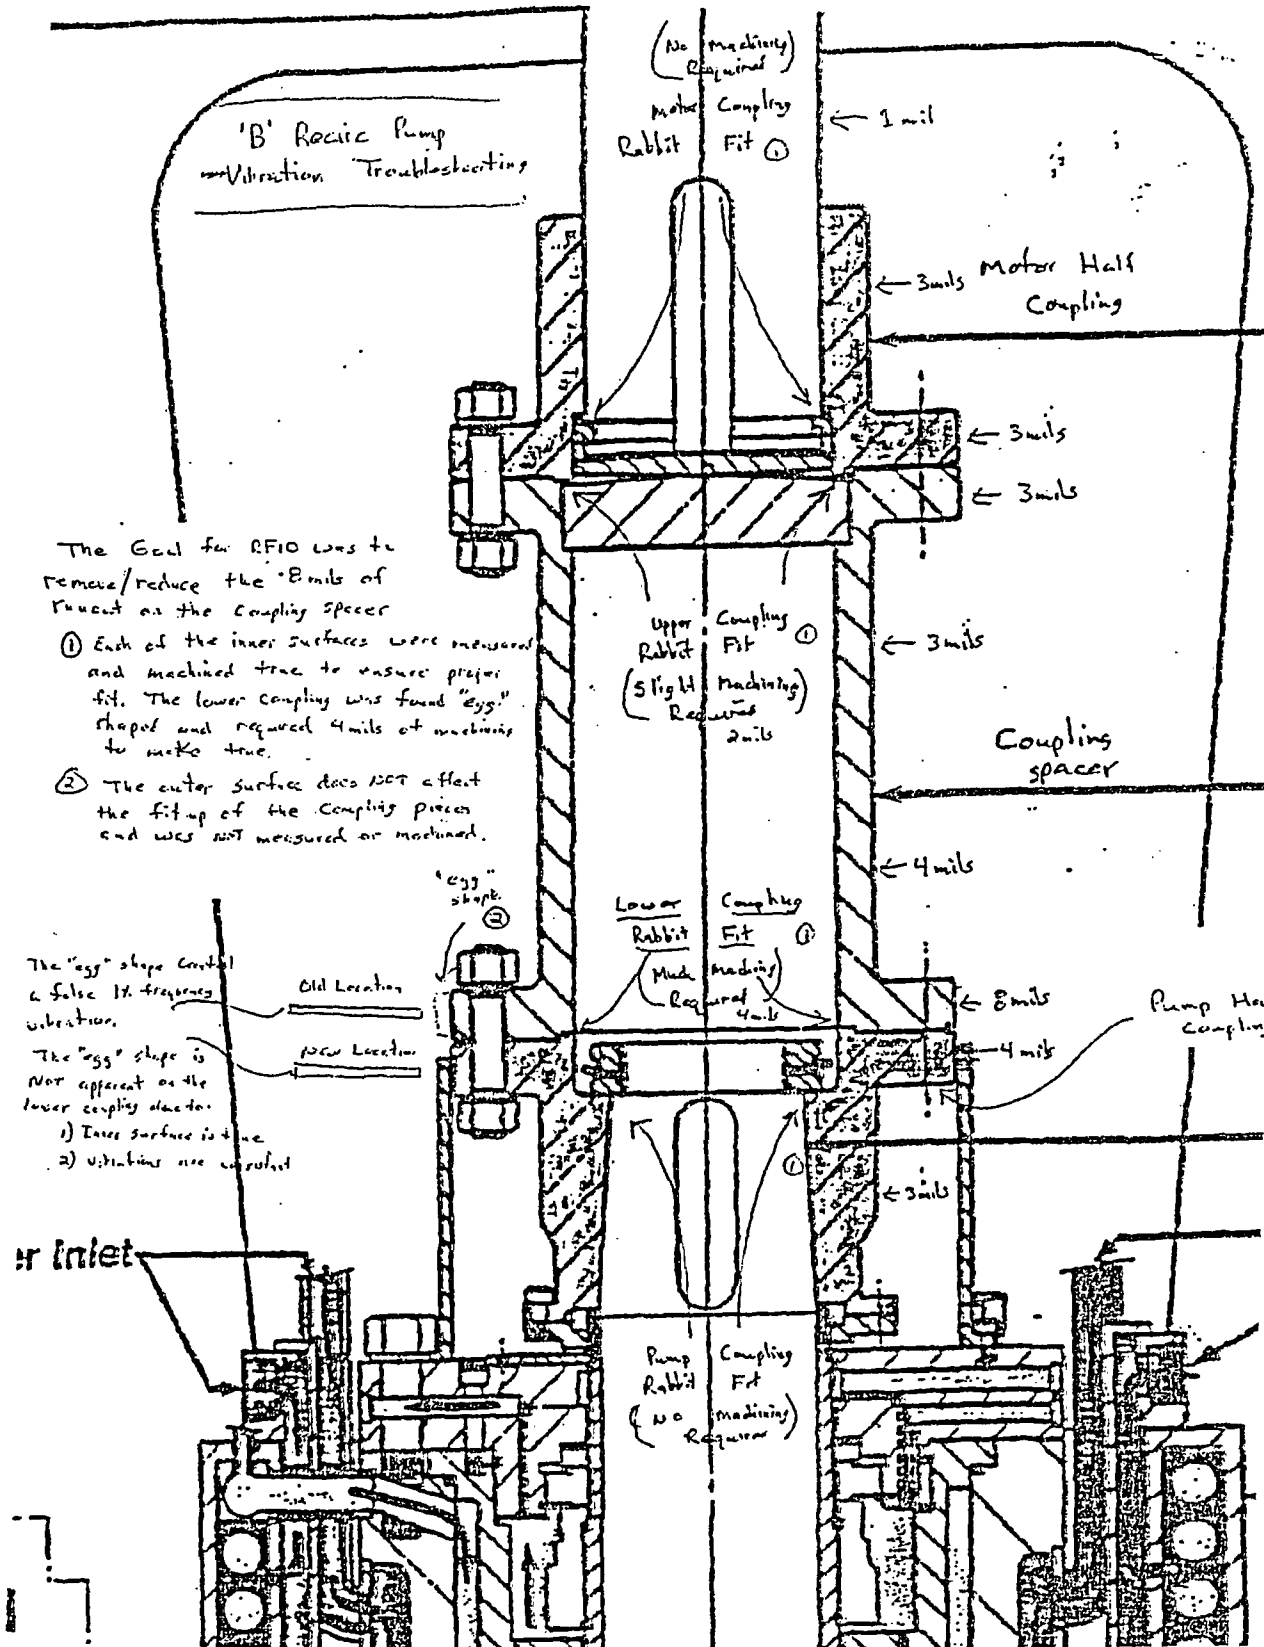
ATTACHMENT 8.5

- (5) During the initial pump startup, measured vibration levels at several locations on the pump coupling and associated shafts. Found the vibration levels at the lower spacer flange were significantly higher than any other location. Concluded that the OD of the lower spacer flange was out of round producing a false 1X vibration reading. Relocated the pump vibration probes to the pump hub flange to improve accuracy. See Attachment 8.5 for additional details on the shaft vibration probe move.

- (a) The coupling spool piece lower rabbet fit was found to be non-concentric, and repaired by enlarging the rabbet fit area to permit the spool piece to be moved into proper concentric alignment with the pump hub. This corrected the coupling stack-up concern and reduced the coupling runout from 8 mils to 4 mils. However, the enlarged rabbet fit would make repeatability of the improved stack-up difficult since the technicians would be required to realign the coupling spool piece during every future pump coupling evolution.

RF10 'B' Reactor Recirculation Pump Coupling Maintenance / Troubleshooting Summary
