HOFFMAN PARK AND CRYSTAL SPRINGS STREAM RESTORATION PROJECTS: MONITORING PROJECT SUCCESS

Kathleen Hale and Tara Petti, New Jersey Water Supply Authority
Jennifer Brunton, John Finkeldie and Donald Stevens The Louis Berger Group

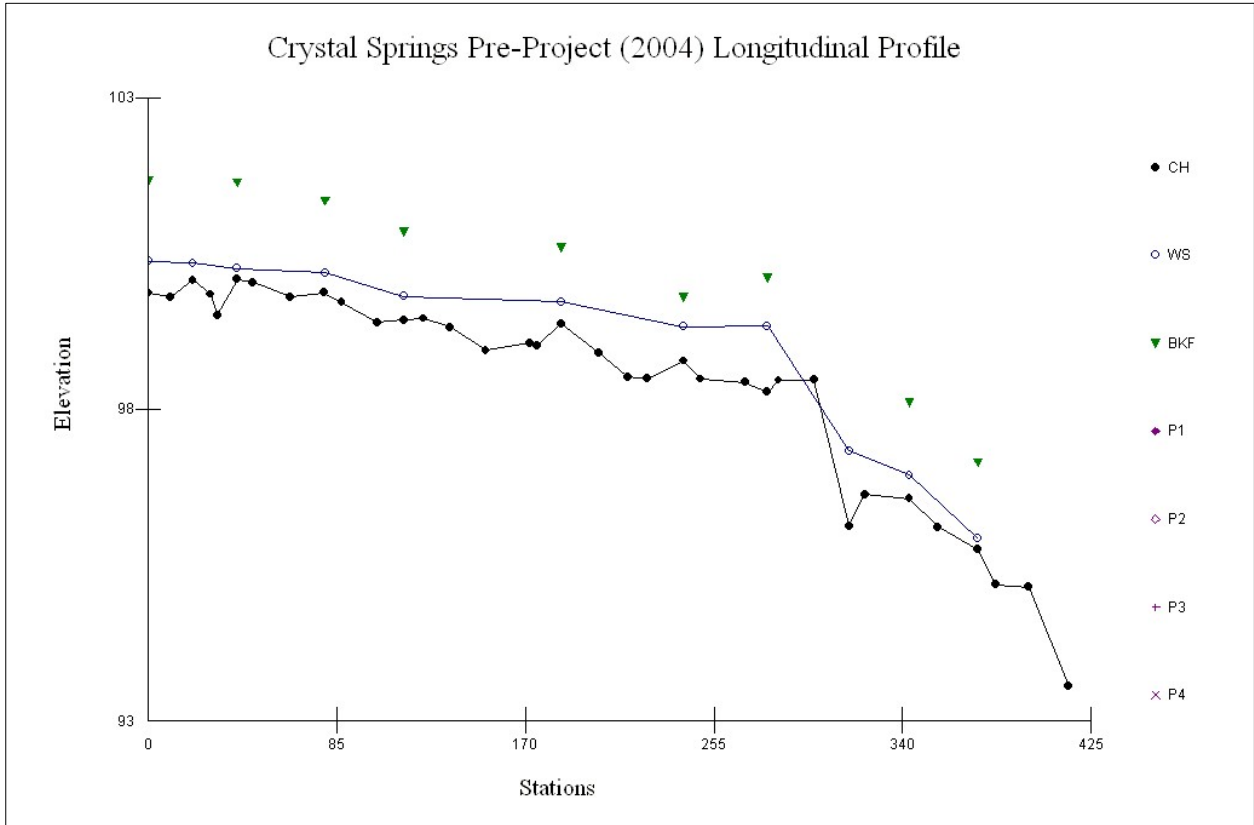
**Crystal Springs Stream Restoration Project
Pre-Project Longitudinal Profile - 2004**

The pre-restoration geomorphology survey confirmed the visual observations of the lack of appropriate riffle-pool spacing. The pre-restoration longitudinal profile that the reach above the culvert is relatively flat, then below the culvert the gradient increases.

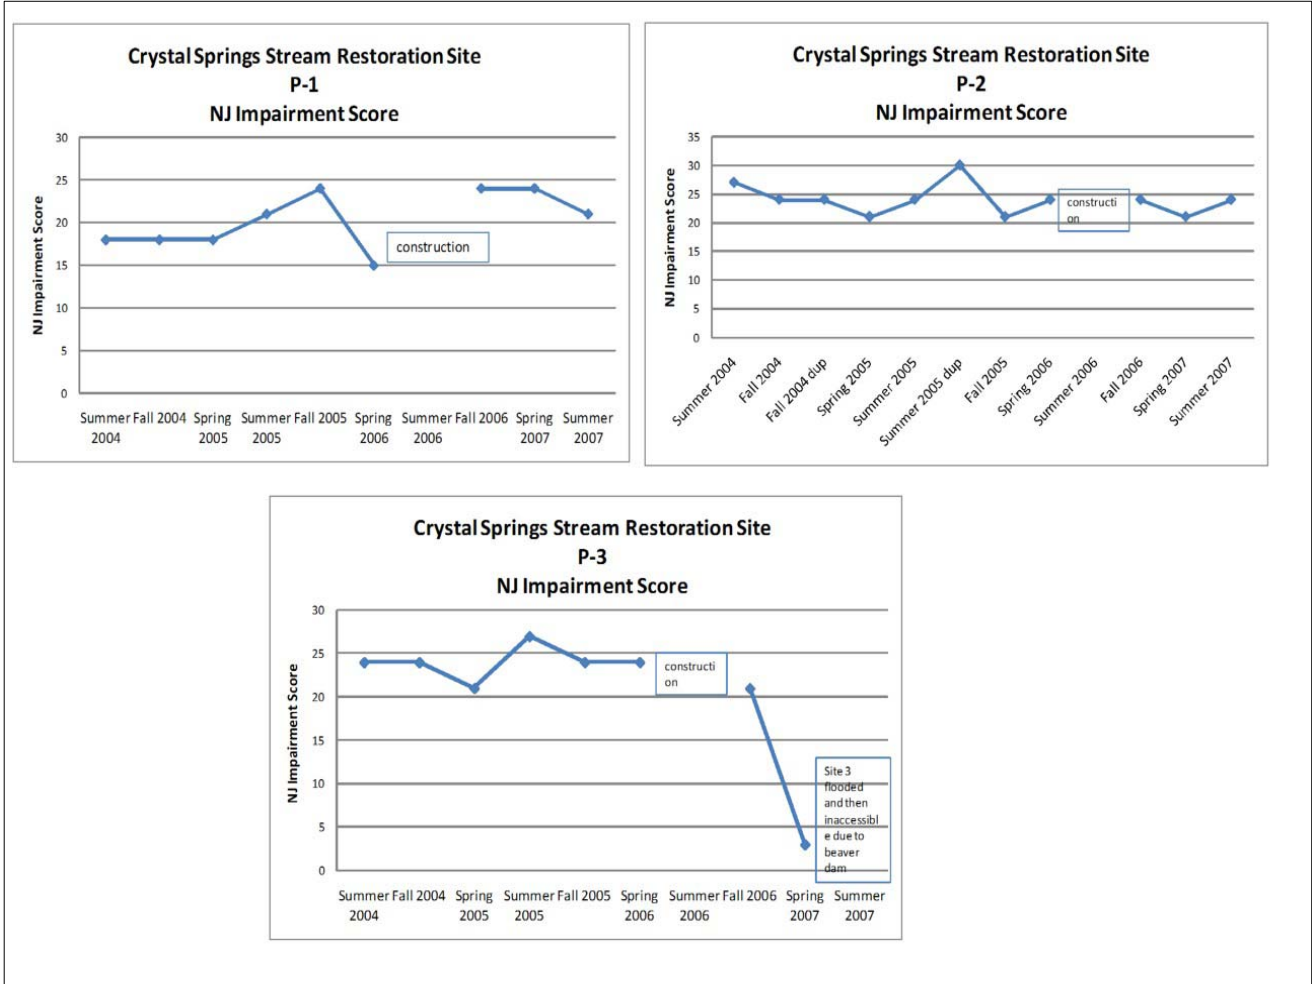
Crystal Springs New Jersey Impairment Scores (Macroinvertebrates)

The macroinvertebrate sampling has not indicated any significant changes to the NJ Impairment score at the Crystal Springs sites, with the exception of P-3. This site was impacted by the construction of two large beaver dams slightly downstream in Winter 2006/2007. In Spring 2007, water at the sampling site was much deeper than it had been previously, and in Summer 2007, the water was too deep to allow sampling and lacked velocity. NJWSA will continue to

monitor the impacts of these beaver dams to the restoration project.

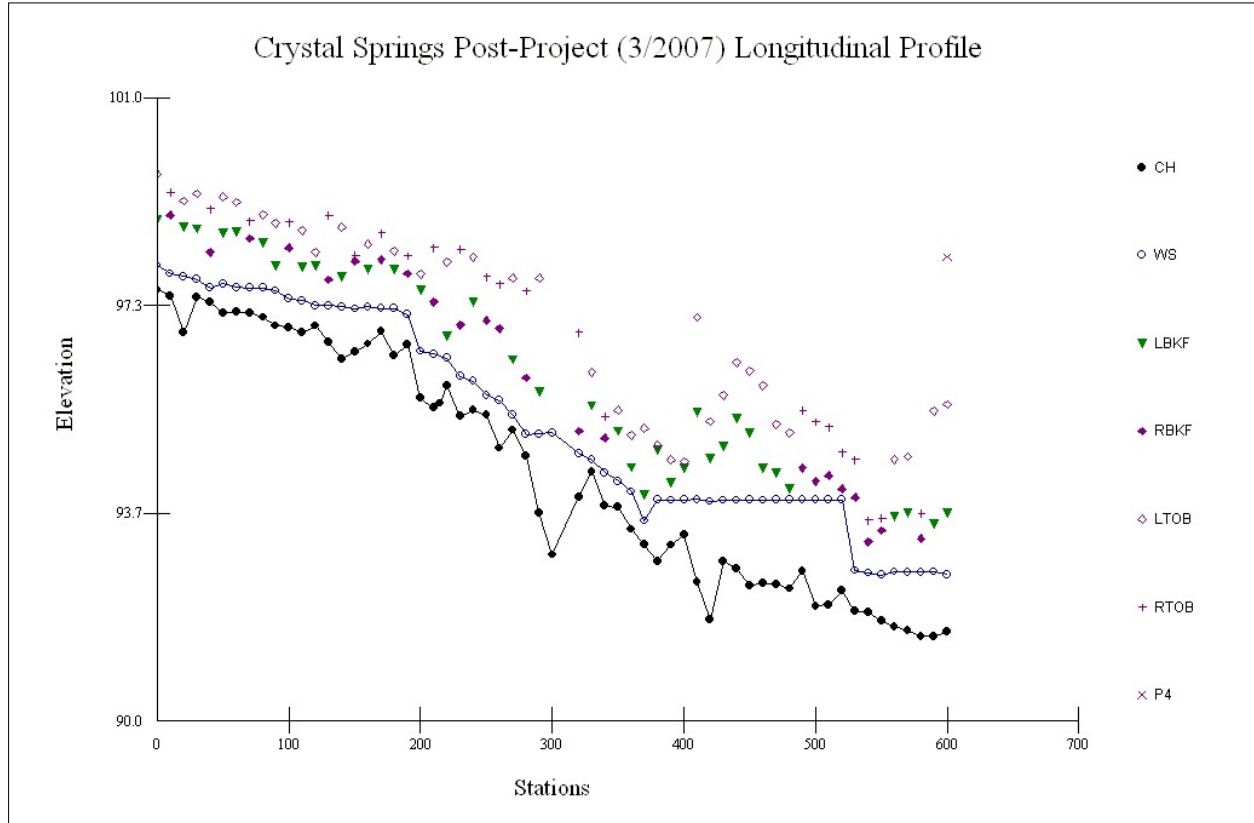
Crystal Springs Post-Project Longitudinal Profile - 2007

The geomorphology survey indicated that a more natural riffle-pool sequence is being re-established upstream of the culvert, as hoped. Visual observations confirmed this.

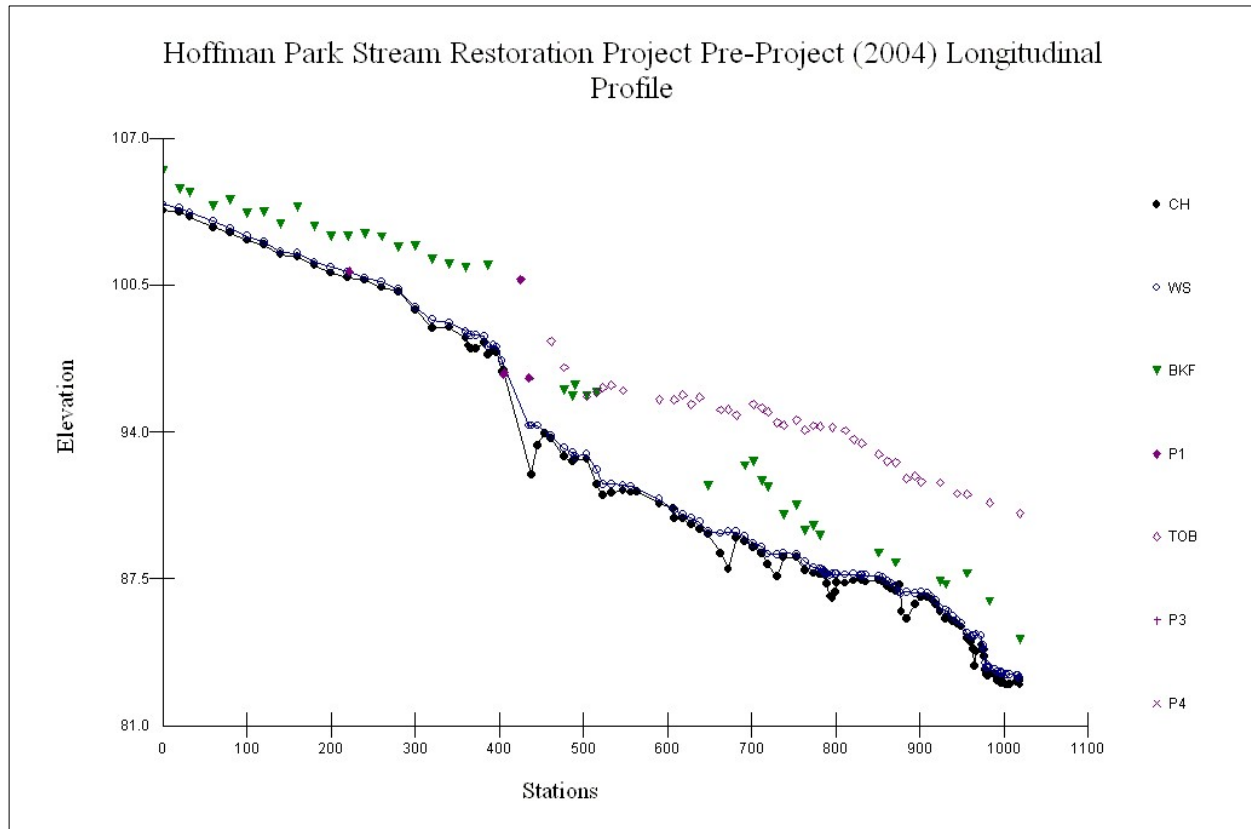
Hoffman Park Stream Restoration Project Pre-Restoration Longitudinal Profile - 2004

Downstream of the road crossing, the channel was deeply incised with vertical banks and no accessible floodplain. This portion of the reach was classified as an F4 stream type according to Rosgen's stream classification. At several locations, trees had fallen into the channel where the banks had failed. Shallow, concentrated flow that drained wetland areas adjacent to the stream on the historical floodplain had eroded headcuts in two locations along the left bank (looking downstream), which were actively migrating towards the wetland areas.

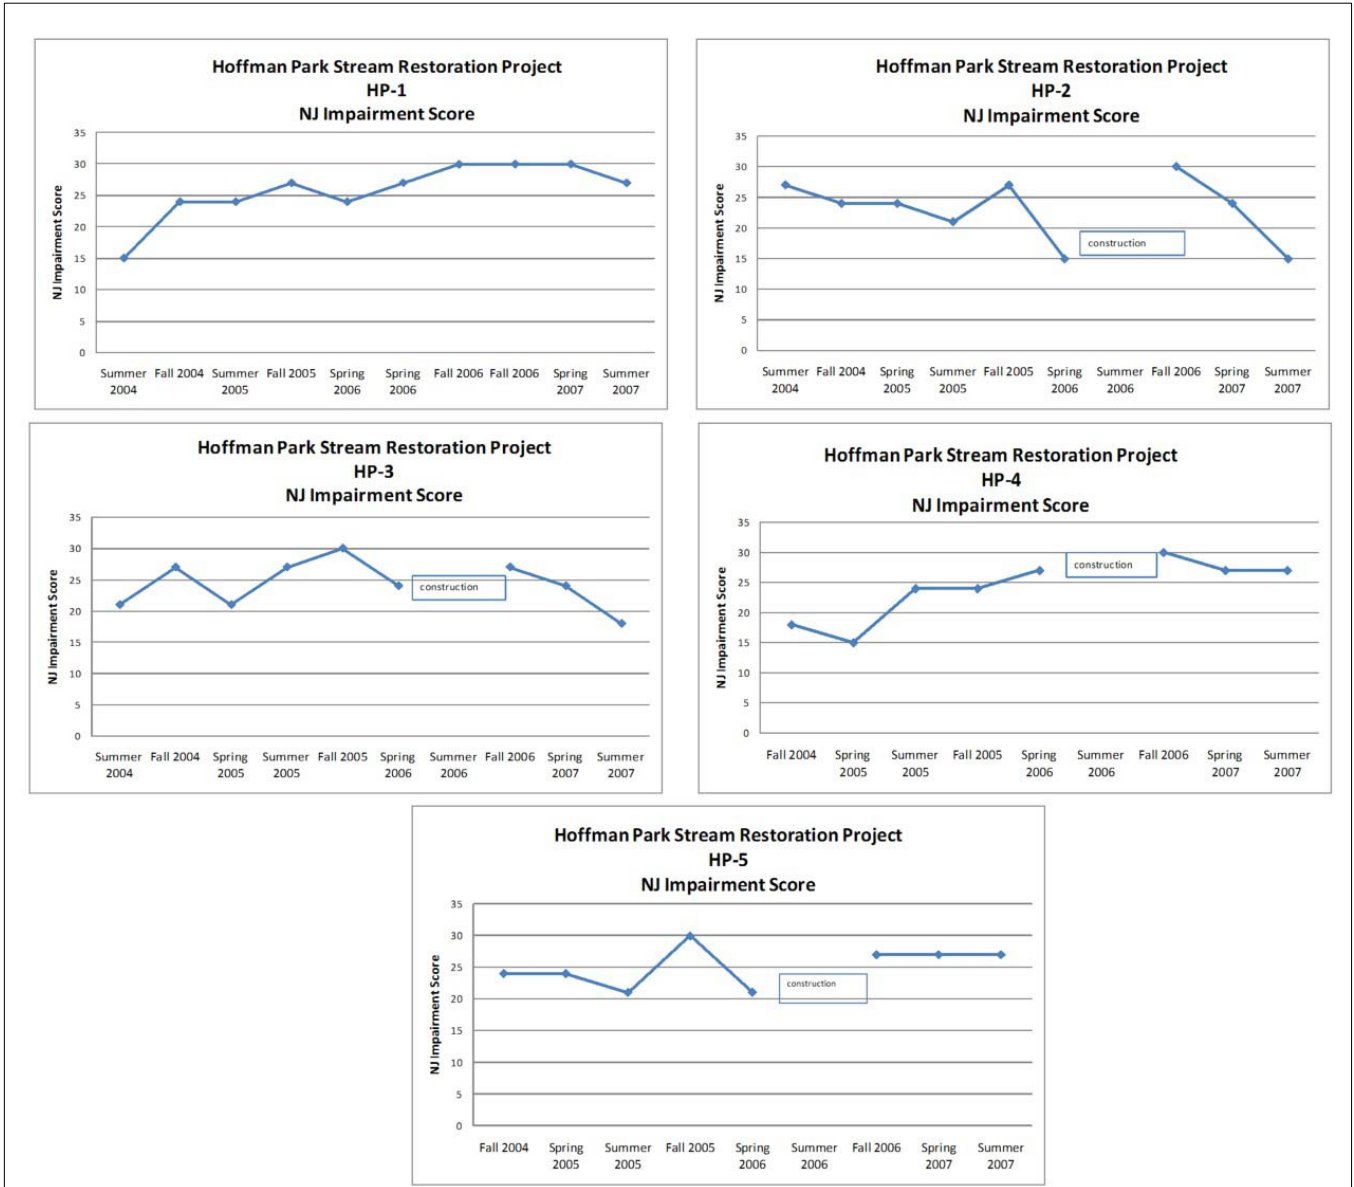
Hoffman Park Stream Restoration Project New Jersey Impairment Scores (Macroinvertebrates)

The macroinvertebrate sampling has not indicated any significant changes to the NJ Impairment score at the Hoffman Park sites. At HP-2 a decreasing trend in the score has been observed since construction, but the score immediately after construction was surprisingly high..

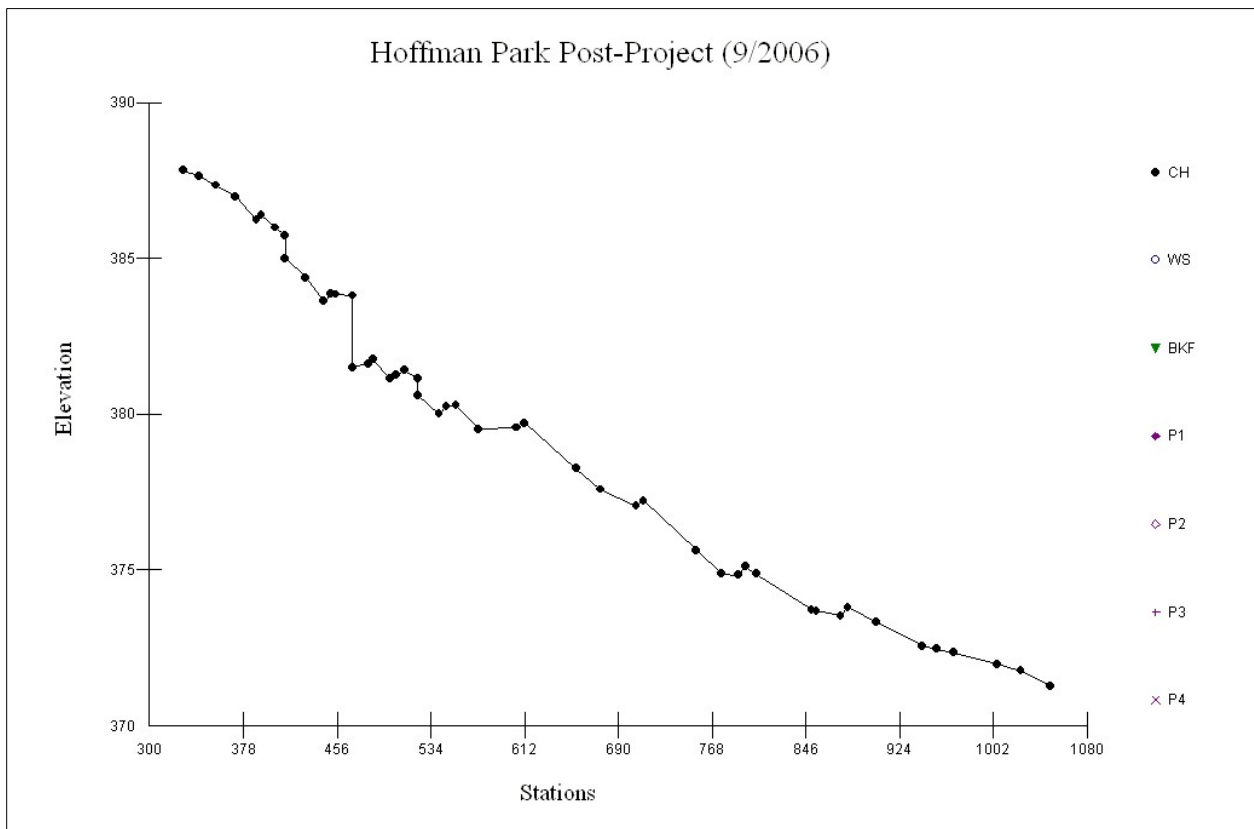
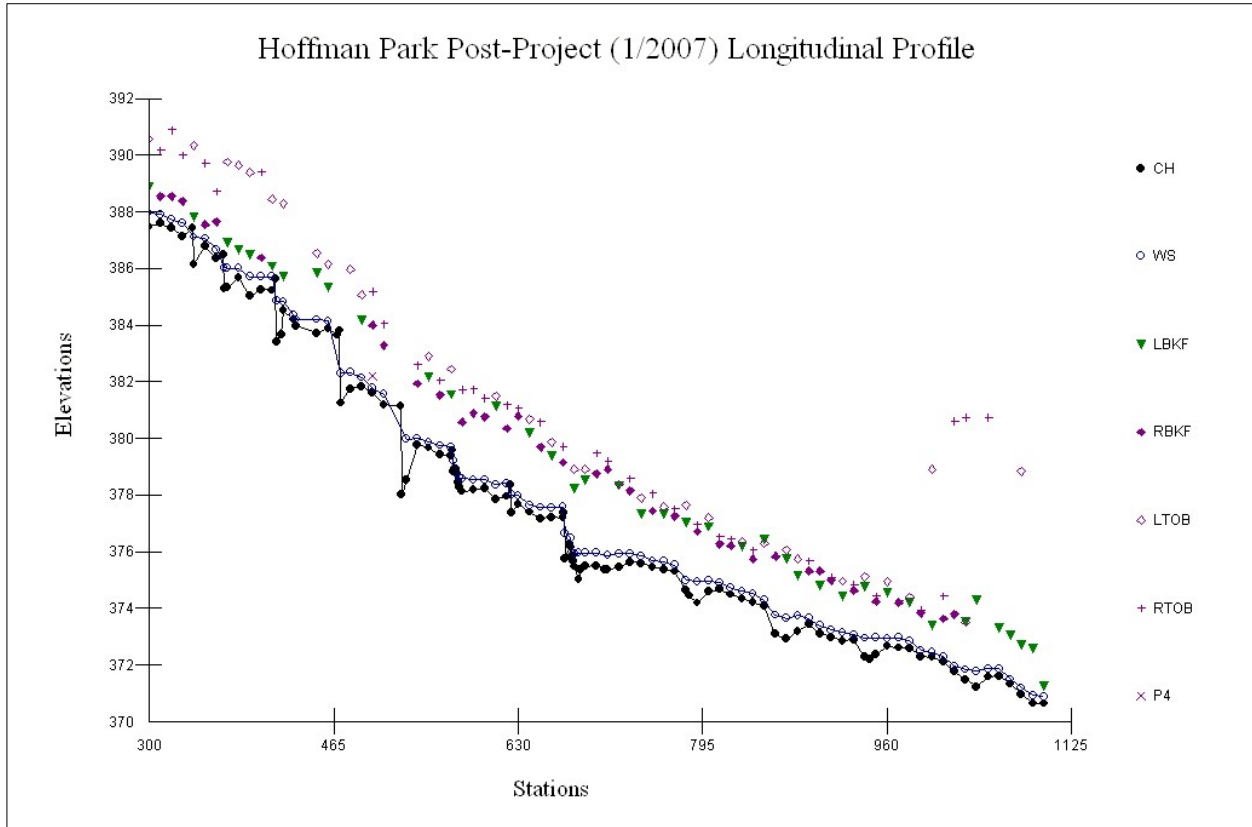
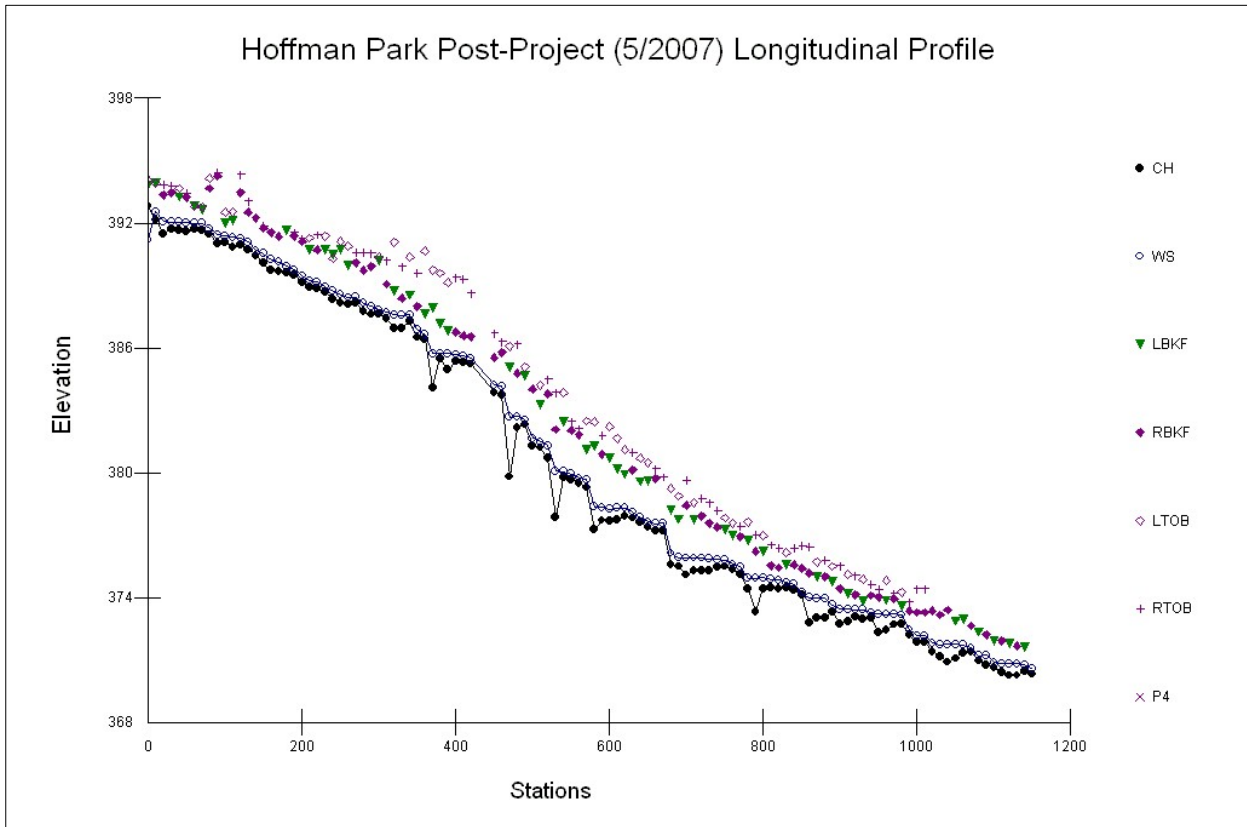
The geomorphology surveys show the gradual dissipation of gradient through the restoration reach. The surveys also show that the stream is no longer incised.
