# Hot-Dip Galvanized Reinforcing Steel Performance Report

Longbird Bridge • Bermuda 1953 - 2020

### EVALUATION OF GALVANISED REINFORCING STEEL IN THE LONGBIRD BRIDGE, BERMUDA

**EVALUATION OF GALVANIZED REBAR: LONGBIRD BRIDGE, BERMUDA**

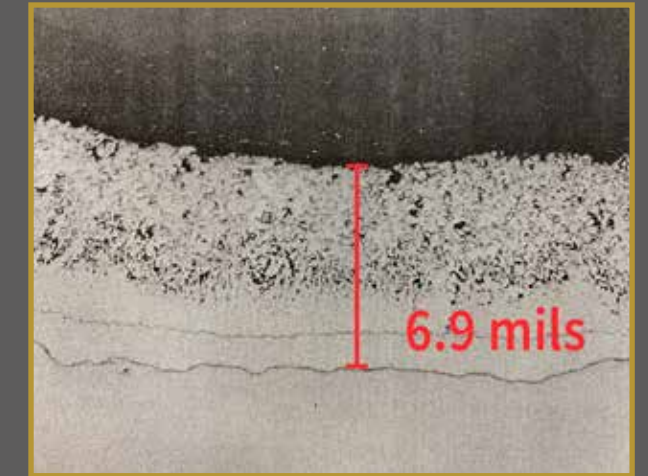
The results from the Longbird Bridge analysis revealed an average hot-dip galvanized coating thickness of 6 mils (152 μm) despite an extremely high concrete chloride concentration of 1.7 to 2.2 lbs/yd<sup>3</sup> (1.0 to 1.3 kg/m<sup>3</sup>) present in the concrete at the level of the top mat of HDG reinforcing steel. This concentration is well above the 1.1 lbs/yd<sup>3</sup> (0.65 kg/m<sup>3</sup>) to initiate corrosion of uncoated steel bars.

Photomicrograph from 1976 ILZRO report showing 6.9 mils (175 μm) of HDG coating thickness in one location after more than 20 years of service. Average thickness across all measurements in report was 6.0 mils (152 μm).

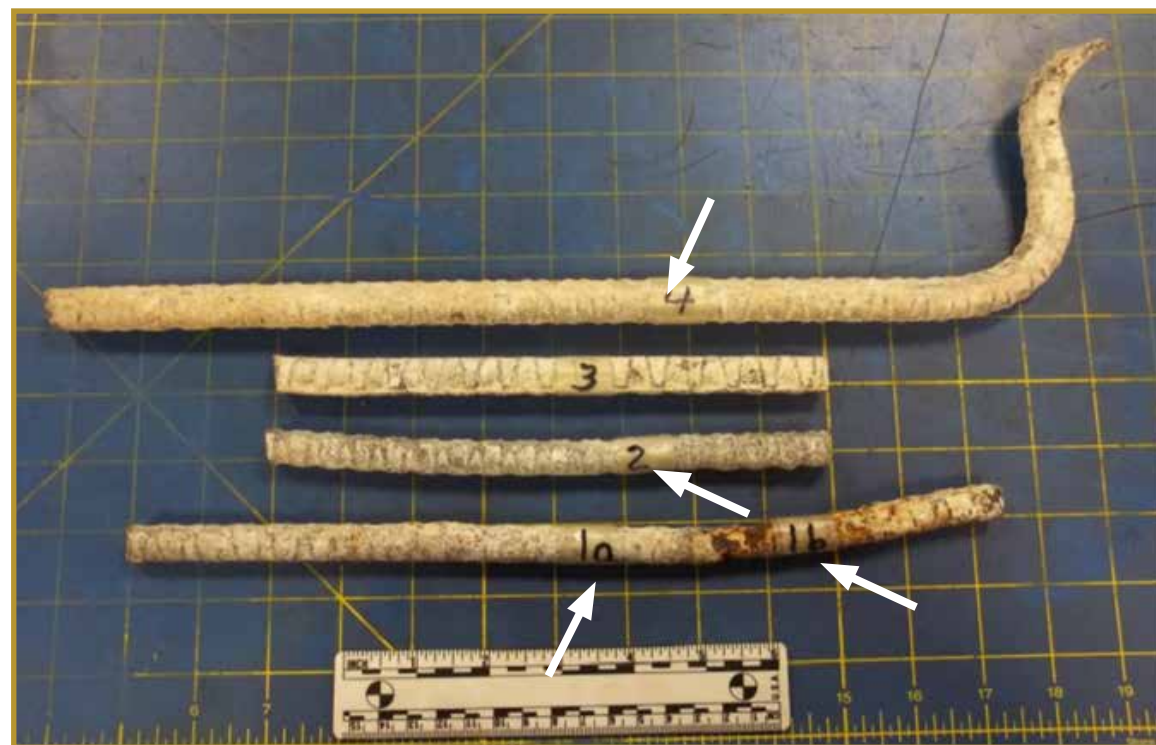
The rebar samples were not labeled or identified as to their location. Figure 1 shows the as-received samples. The evaluation included metallographic examination of the coating cross sections, and optical coating thickness measurements.

The rebars were cut at the locations shown in Figure 1 (arrows). Sections were taken from each of the four bars and prepared for metallographic examination of the coating cross sections. Sample 1 had two sections removed, since there were areas of coated and uncoated rebar (Samples 1a and 1b). The sections were mounted in epoxy, ground, polished, and etched to reveal the zinc coating. Two photos were taken for each coating cross section. However, since the coating microstructures were similar, only two of the photomicrographs were selected for inclusion in this report. In addition to the coating, the photos also show a layer of aluminum foil; this is NOT part of the galvanized coating. Foil is often used during the metallographic preparation to maintain flatness in the galvanized coating during grinding and polishing.

Figure 1. As-received galvanized rebar sections showing the locations of the samples removed for metallographic examination and optical coating thickness readings.

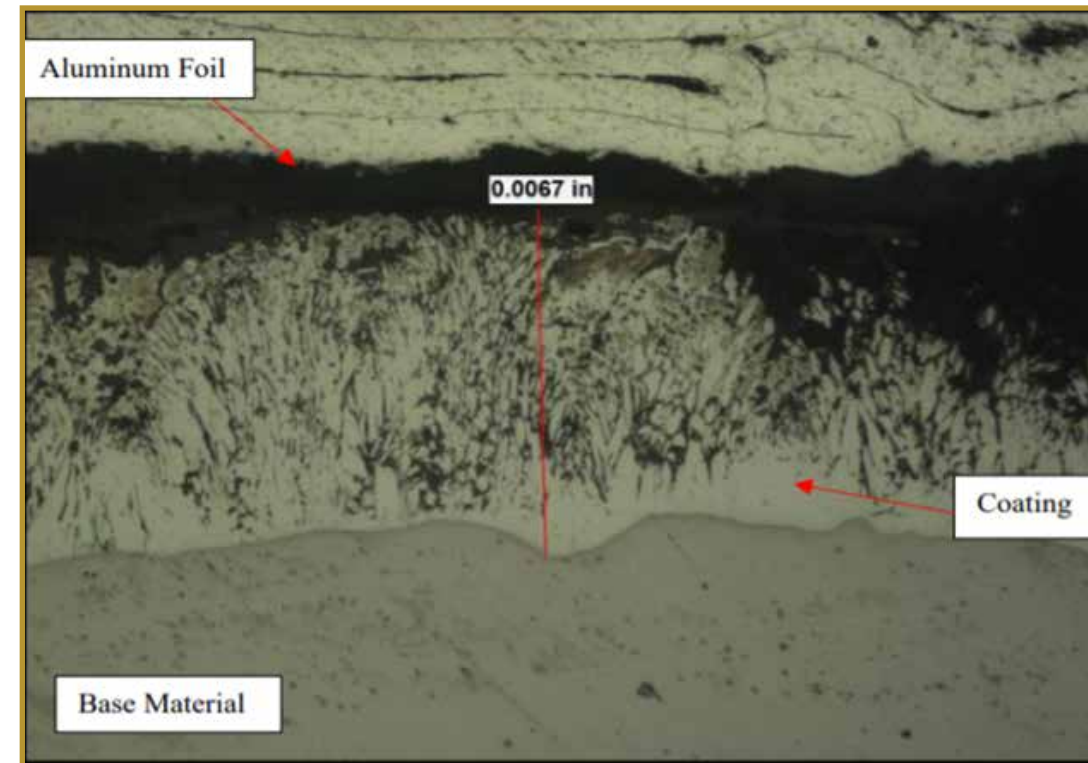
Figure 2 shows the coating cross section for Sample 2, where the coating consists of a diffuse delta layer next to the base steel, and a columnar growth of zeta crystals. These iron-zinc alloy layers are partially covered by remnants of the pure zinc layer (eta). The total coating thickness measures 6.7 mils.

Figure 2. Coating cross section through Sample 2. The total coating thickness measures 6.7 mils.

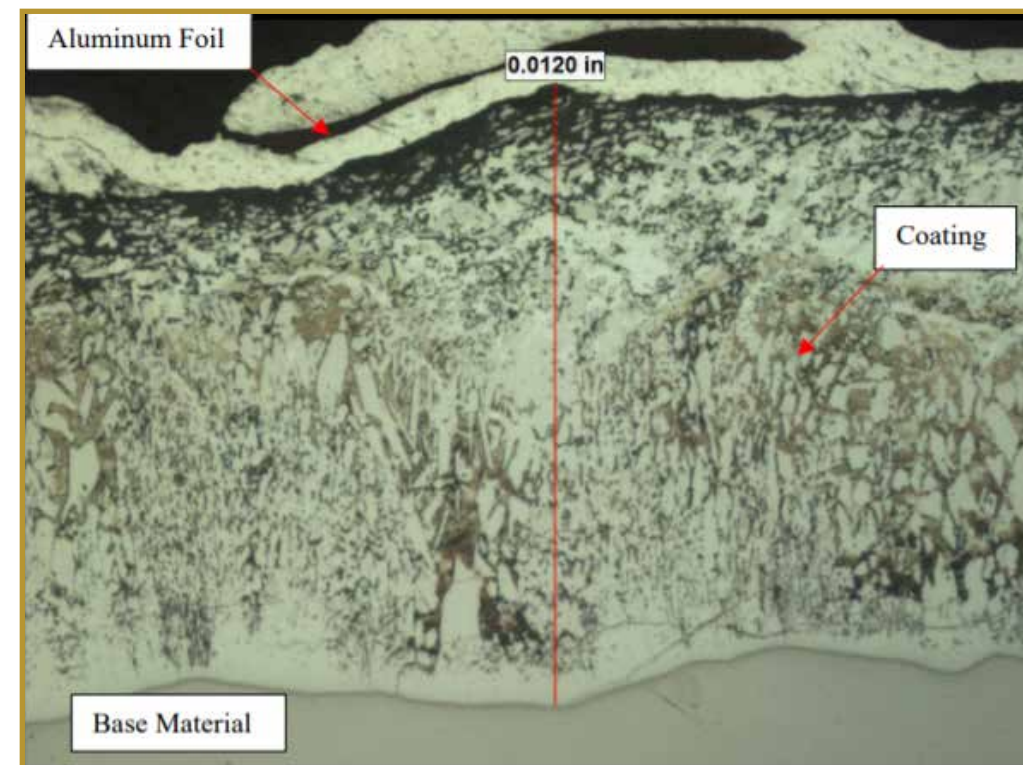
Figure 3 shows the coating cross section for Sample 3. The coating structure is similar to the above sample, with layers of delta and zeta crystals. The sample has a much thicker pure zinc layer. The total coating thickness measures 12.0 mils.

Figure 3. Coating cross section of Sample 3. The total coating thickness measures 12.0 mil
