I-40 Hernando deSoto Bridge

Fracture Investigation

Memphis, Tennessee

FINAL REPORT

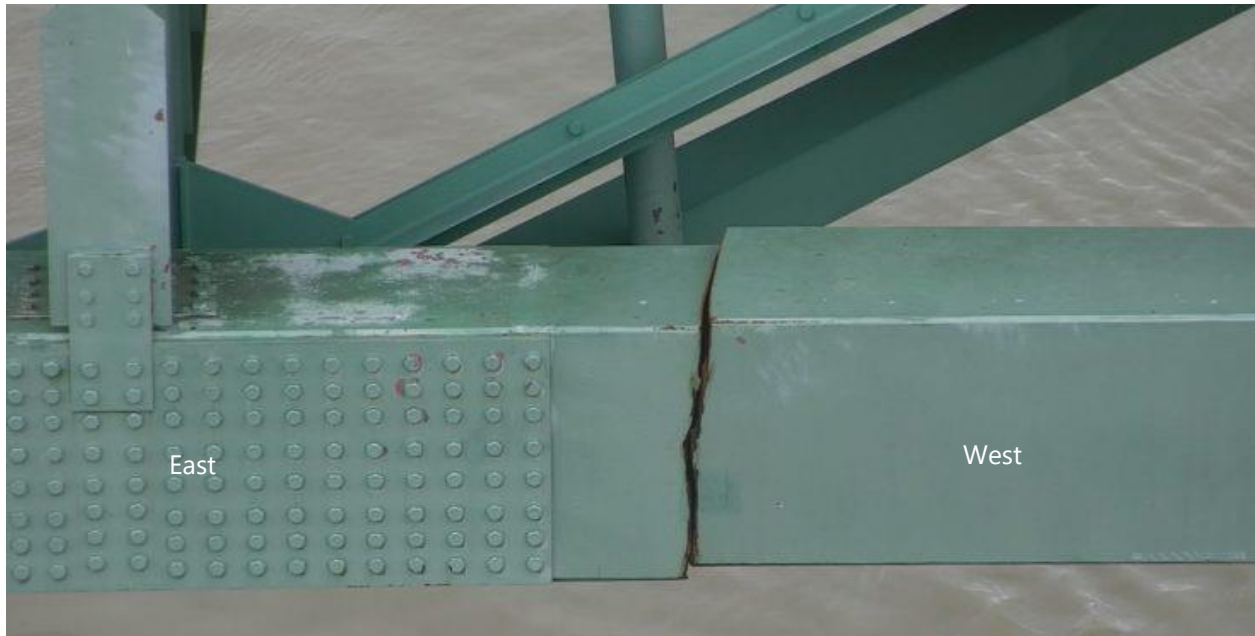
The 3.3-mile long I-40 Hernando deSoto Bridge crossing the Mississippi River was closed May 11, 2021 after inspectors performing a routine inspection identified a partial fracture in a tension member that supports one of two tied-arch truss spans. The fracture occurred at a welded plate transition in the upstream (north), box-shaped tension tie member (Figure 1). The six-lane bridge was subsequently closed to traffic.

Figure 1. Annotated photo of partial tie girder fracture identified in May 2021 (photo courtesy of TDOT).

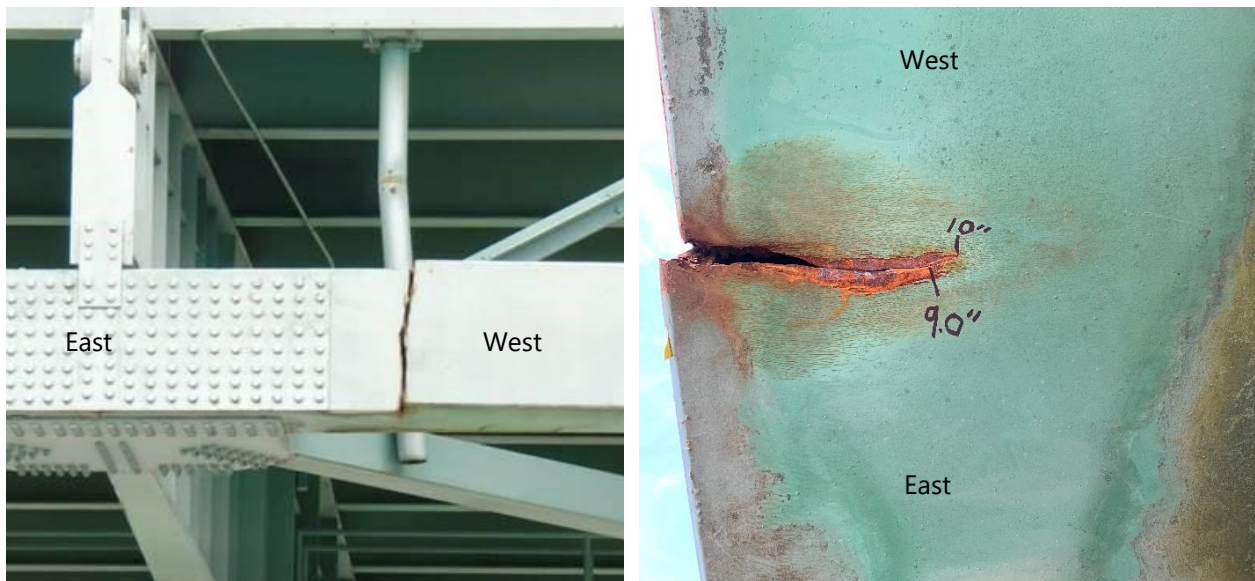
On May 11, 2021, while performing an inspection of the bridge hanger cables, bridge inspectors from Michael Baker International (MBI) observed a partial fracture of the tie girder just west of T22 at the welded splice in the north tie of Span B (NB222W). Figure 7 show views of the tie fracture. The bridge was subsequently closed to traffic.

a. Fractured outboard tie plate (photo courtesy of TDOT). b. Partially fractured bottom cover plate.

Figure 7. Annotated photos of partial tie girder fracture identified in May 2021.

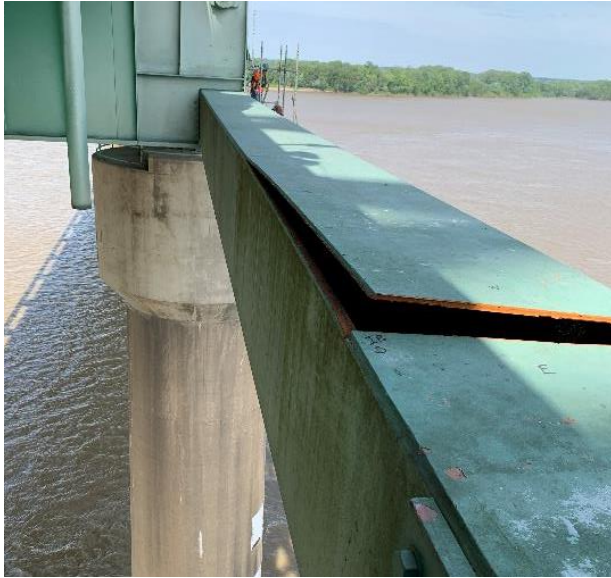
A review of previous inspection records showed that a crack was present in the outboard side plate and likely the bottom cover plate in 2019 (Figure 8) and that it had extended between 2019 and 2021, fully fracturing the outboard side plate, top cover plate, and the longitudinal fillet weld connecting the top plate to the inboard side plate.

c. Cracked longitudinal fillet weld connecting top plate to inboard side plate (view looking west).

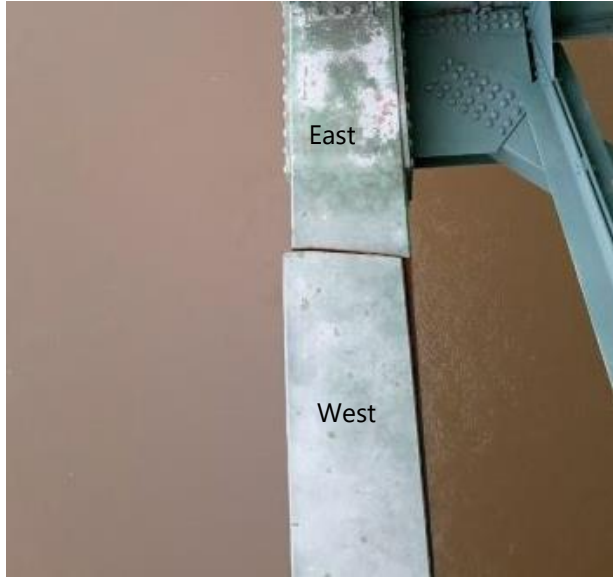
d. Fractured top cover plate (photo courtesy of TDOT).

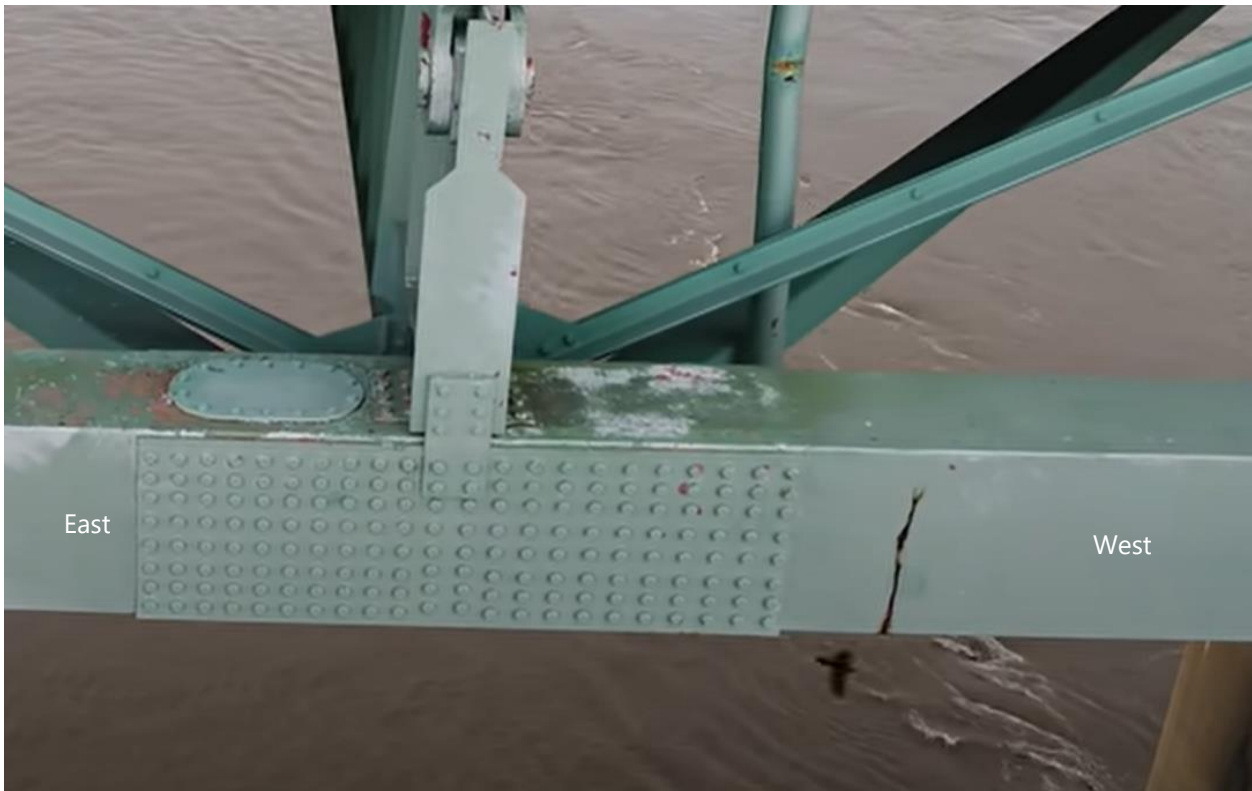
Figure 8. An annotated screen-capture of the crack found by drone video footage from the May 2019 MBI inspection.

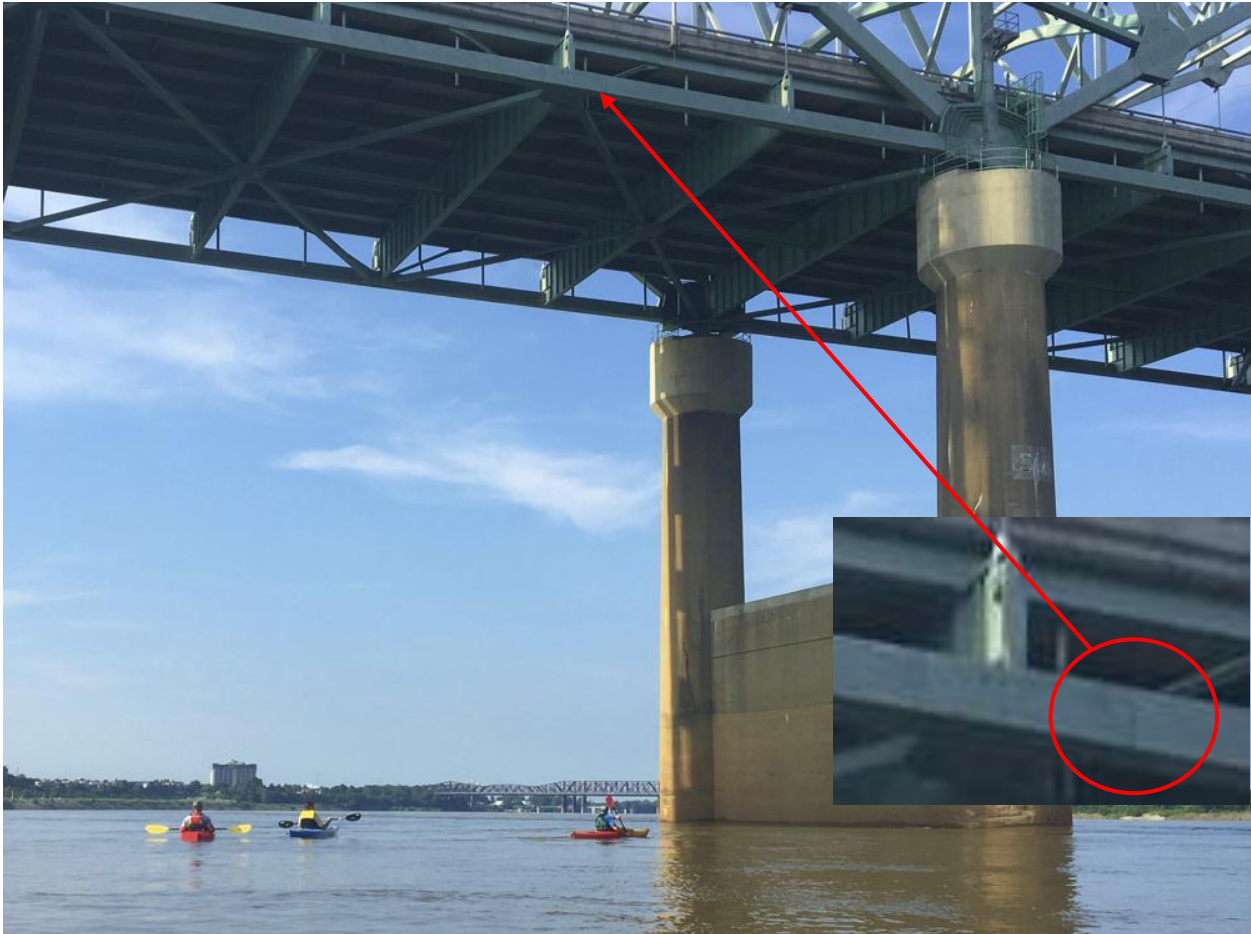
A photo taken by a kayaker in 2016 appears to show a crack-like indication from afar (Figure 9) at this same location.

Figure 9. 2016 crack-like indication in tie girder (photo from Barry W. Moore via AP).

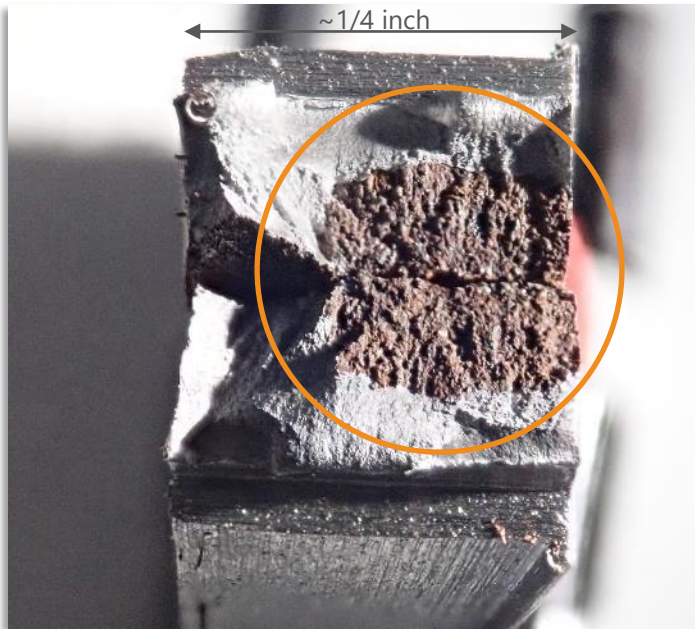
After removal of the fractured pieces from the bridge, WJE was able to also identify this same defect using phased array ultrasonic test methods (PAUT). Subsequent sectioning of that location identified a shallow interior surface-breaking crack. The crack surface was opened as shown in Figure 11, revealing a 3/32-inch deep by 5/32-inch long crack.

Figure 11. 1982-identified defect (circled) after crack surfaces revealed.

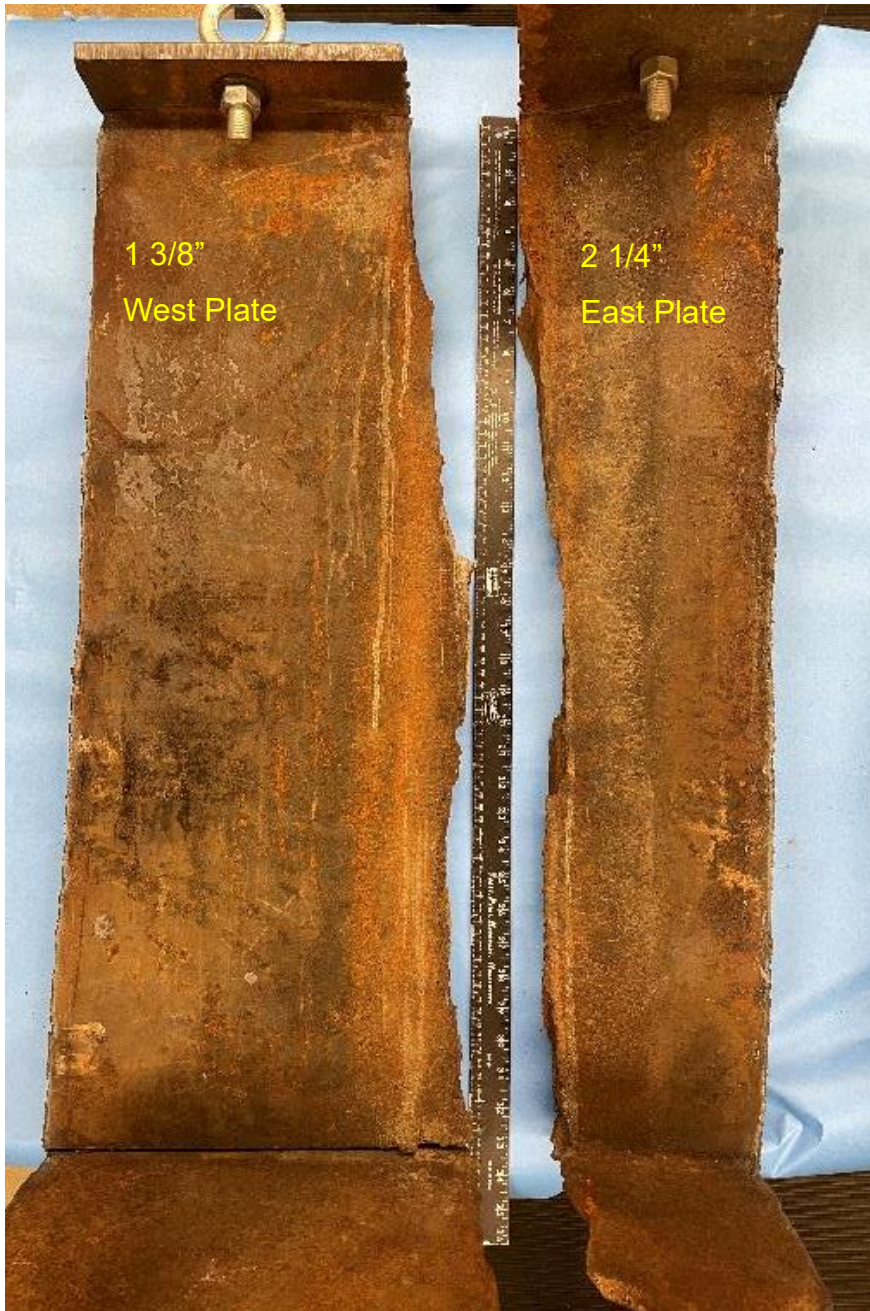
Figure 17 shows the two as-received east and west mating fracture surfaces from location NB222W. The photograph was taken prior to any cleaning or sectioning. Most of the fracture had occurred near the fusion line between the weld metal and the thinner 1 3/8-inch side plate on the west side of the fracture.

Figure 17. As-received sample from the fracture at NB222W for laboratory analysis.

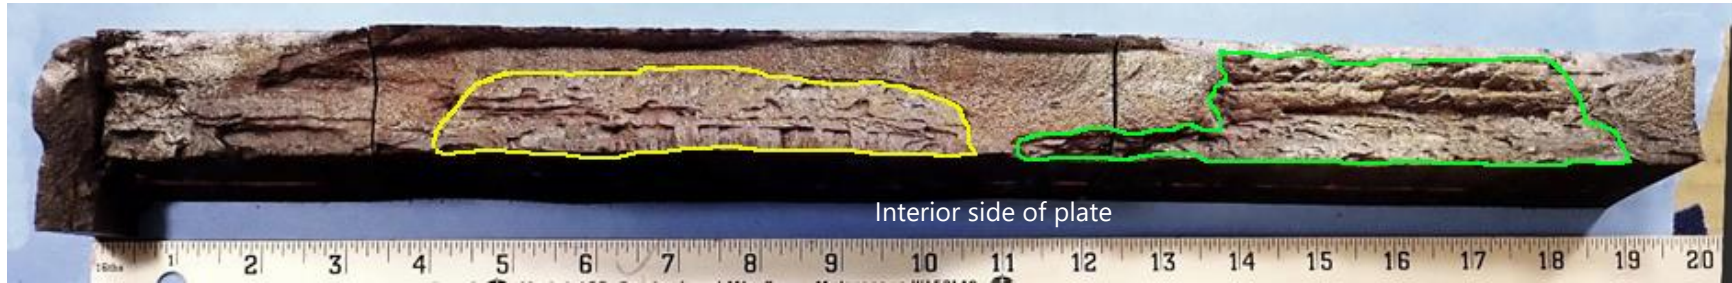
Two regions in the samples exhibited markedly different macrotopography from the rest of the main fracture surfaces and are noted in Figure 20 and Figure 21 as Primary Preexisting Crack and Secondary Preexisting Crack. The former had a maximum depth of about 1 1/16 inch and a length of 6 3/4-inches. The latter extended nearly 1 5/16-inch through the 1 3/8-inch thickness of the side plate with a length of 8 inches. After ultrasonic cleaning in a solution of Alconox in water at ~100 deg. F for about one hour, enough rust had been removed from the east fracture face to discern essentially all of its macrotopography. Radial lines and chevron patterns emanating from both regions indicated that the region closest to the bottom plate, shown as View A in Figure 21, was the overall fracture origin and therefore the primary preexisting crack.

Figure 20. Lower portion of fracture showing Primary Preexisting Crack Region (yellow) and the Secondary Preexisting Crack Region (green).

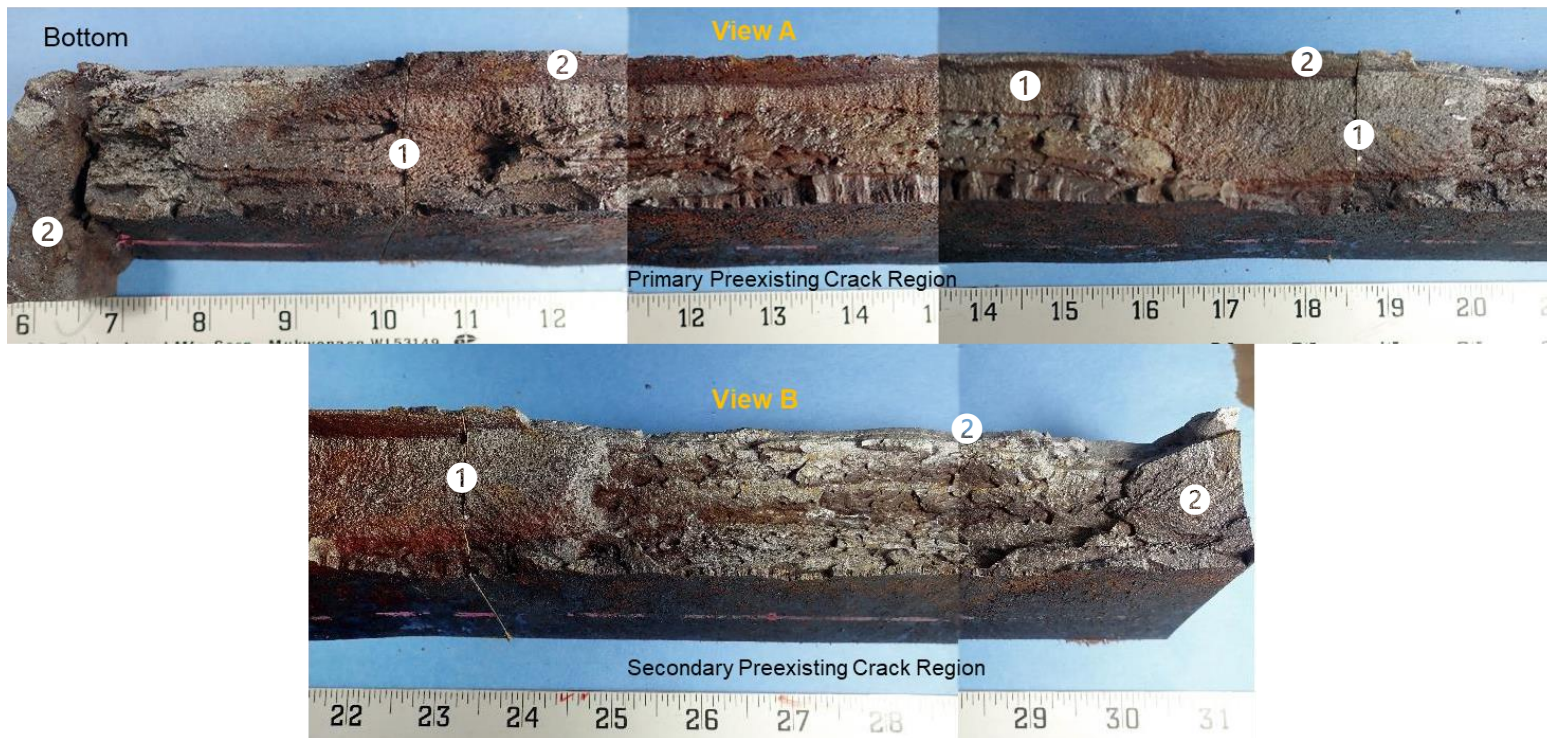
The initial unstable fracture (❶) that propagated out of the primary preexisting crack extended in all possible directions: through a portion of the remaining plate thickness toward the side plate's exterior surface; downward toward the bottom plate, where it arrested at the bottom plate fillet welds; and upward toward the top plate, where it was arrested by the secondary preexisting crack (Figure 21, View B). In the through-thickness direction, the initial fracture was arrested before it reached the external (outboard) surface of the side plate, leaving an intact ligament ~3/16 thick (Figure 21). In the upward direction, the arrest of the initial fracture within the secondary preexisting crack apparently did not rupture the ~1/8-inch-thick ligament that remained between the outer tip of the secondary preexisting crack and the exterior (outboard) surface of the side plate (Figure 21).

The upper tip of the upper, secondary preexisting crack exhibited a second fracture initiation site (Figure 21), from which a fracture (❷) extended upward for approximately 8 inches, then rearrested in the 1 3/8-inch plate material. This transient fracture event appears to have caused the tensile-shear rupture of

Figure 21. Higher magnification of the two preexisting crack regions after cleaning (1 first fracture and 2 second fracture).

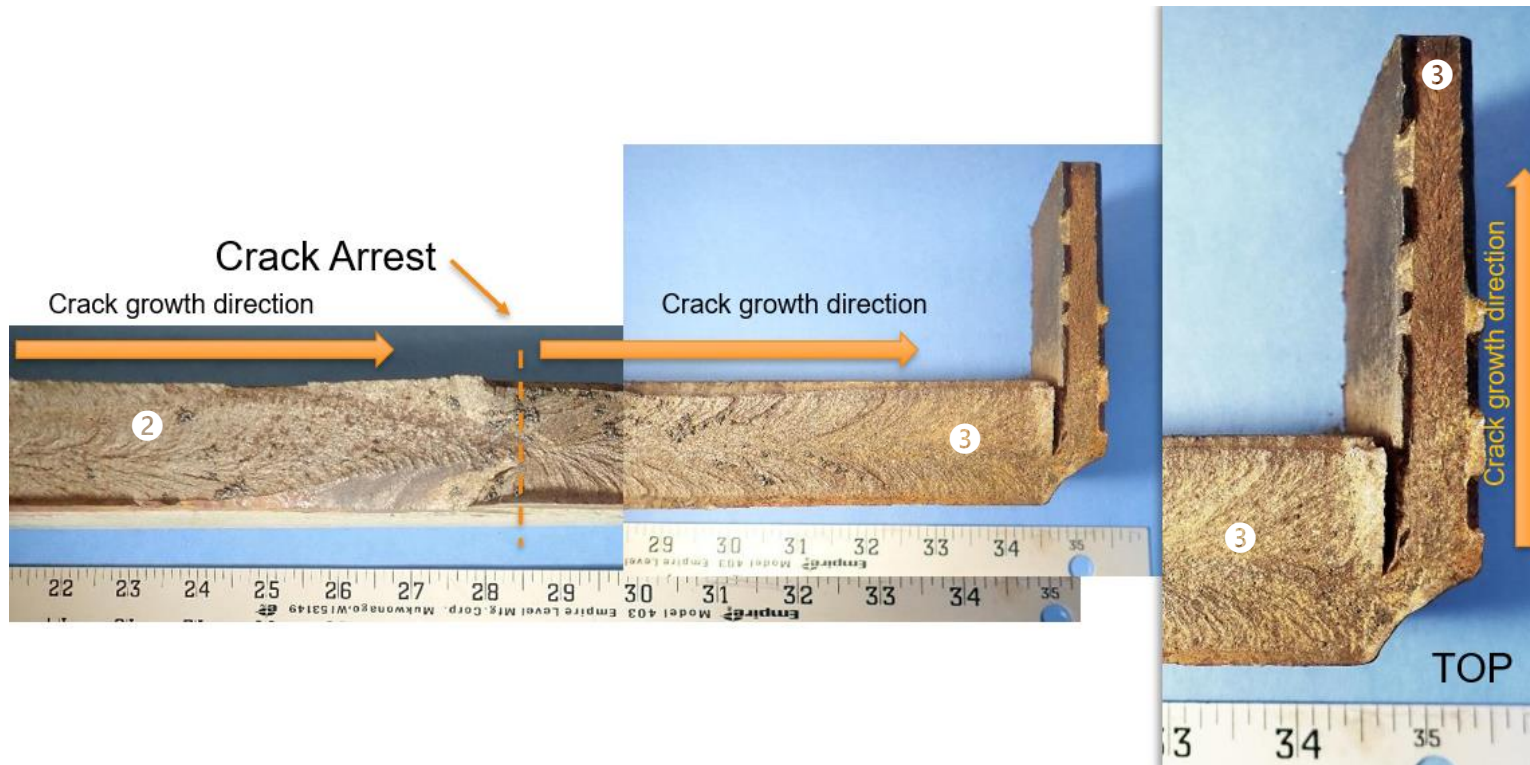
A third fracture initiation (③) resulted in yet another fracture that separated the remaining 6 1/2 inches of the side plate's height and continued into the top cover plate (Figure 22). Careful examination of the entire length and width of the preexisting cracks and fracture surfaces associated with NB222W produced no evidence of fatigue crack growth.

Figure 22. Top section of the crack in the west fracture. The orange arrows indicate the direction of crack growth (2 second fracture and 3 third fracture).

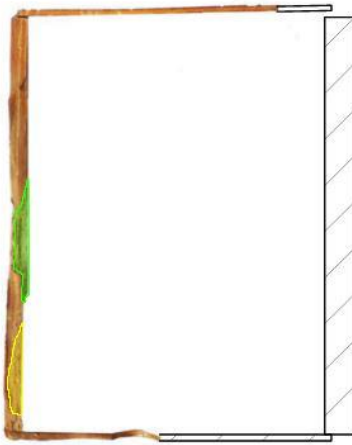
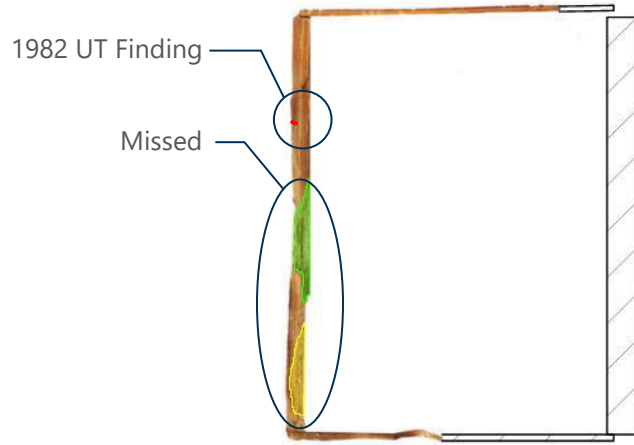
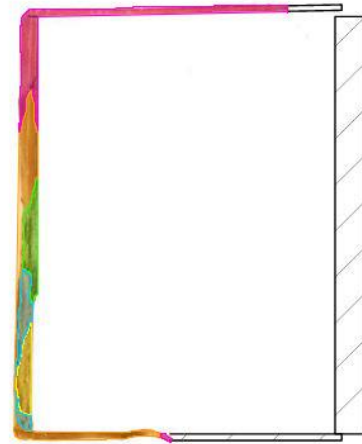
A summary of the fracture propagation through the tie girder cross section is shown in Figure 23. The yellow and green represent the initial preexisting cracks. The colors blue (①), orange (②), and magenta (③) represent the first, second, and third unstable fracture growth, respectively.

Figure 23. Postulated progression of fracture through tie girder cross section. Initial hydrogen cracks (yellow and green). First fracture (blue). Second fracture (orange). Third fracture (magenta).

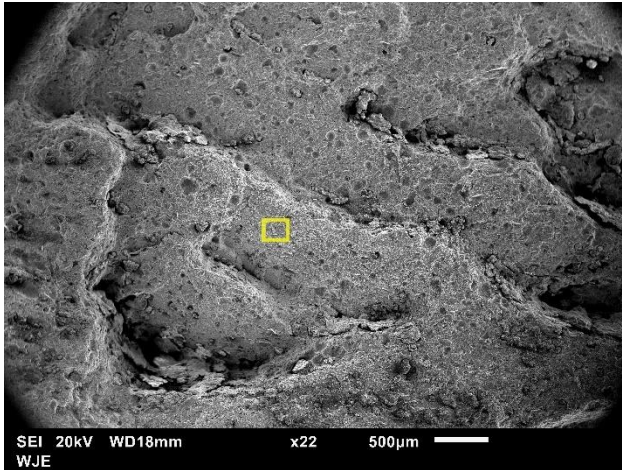
Examination of the fracture surfaces by scanning electron microscopy (SEM) began with the secondary (upper) preexisting crack on the east fracture face since it had been less corroded than the primary (lower) preexisting crack. Although the entire surface was found to be somewhat damaged by sandblast overspray and corrosion, a careful survey of the secondary preexisting crack region like that shown in Figure 24 identified several locations consistent with the microtopography produced by transgranular hydrogen cracking (Figure 25). Weld-related hydrogen cracking may be intergranular or transgranular, depending on the microstructure, hydrogen concentration, and state of stress.

Figure 24 Low-magnification (22X) SEM image of secondary preexisting crack.

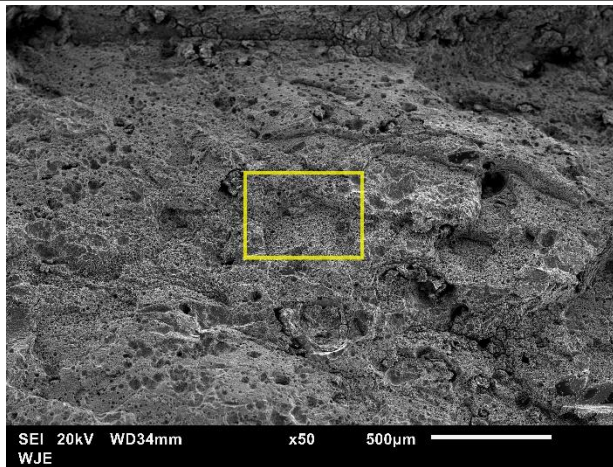
The surface of the primary (lower) preexisting crack (Figure 26) was found to be more extensively damaged by post-failure corrosion, as typified by the pitted microtopography shown in Figure 27. However, a careful search provided fractographic clues at two separate locations within the area shown in Figure 28, just beneath the inside surface of the side plate. As interpreted within the context of the overall macrotopography, the microtopography at these locations indicated plateaus of intergranular hydrogen cracking in columnar-grained weld metal, connected to each other by ductile tearing (Figure 29 and Figure 30).

Figure 26. Low-magnification (50X) SEM image of primary preexisting crack.

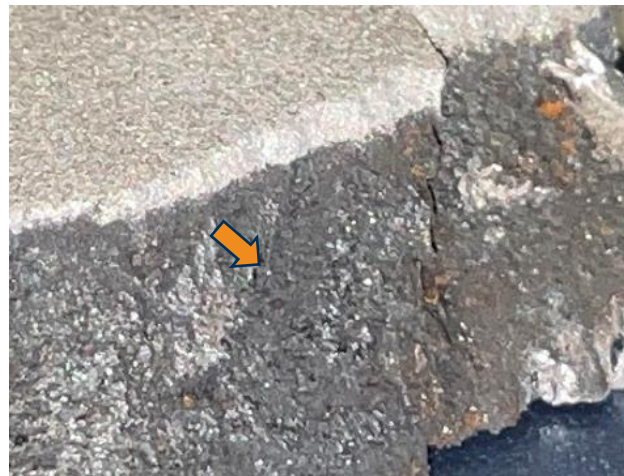
A core sample was taken from the arrested crack tip in the bottom cover plate in preparation to remove the two fracture surfaces from the tie girder. Photographs of the core sample are shown in Figure 31 and Figure 32. A small pie wedge shape was removed from the core and broken open to observe the crack tip at higher magnifications, which revealed shear fracture driven by tension. The exposed crack tip is shown in Figure 33. No evidence of fatigue was observed. Figure 34 depicts a prior arrest mark on the exposed surface.

Figure 34. Previous arrest mark (arrow away from the crack tip).

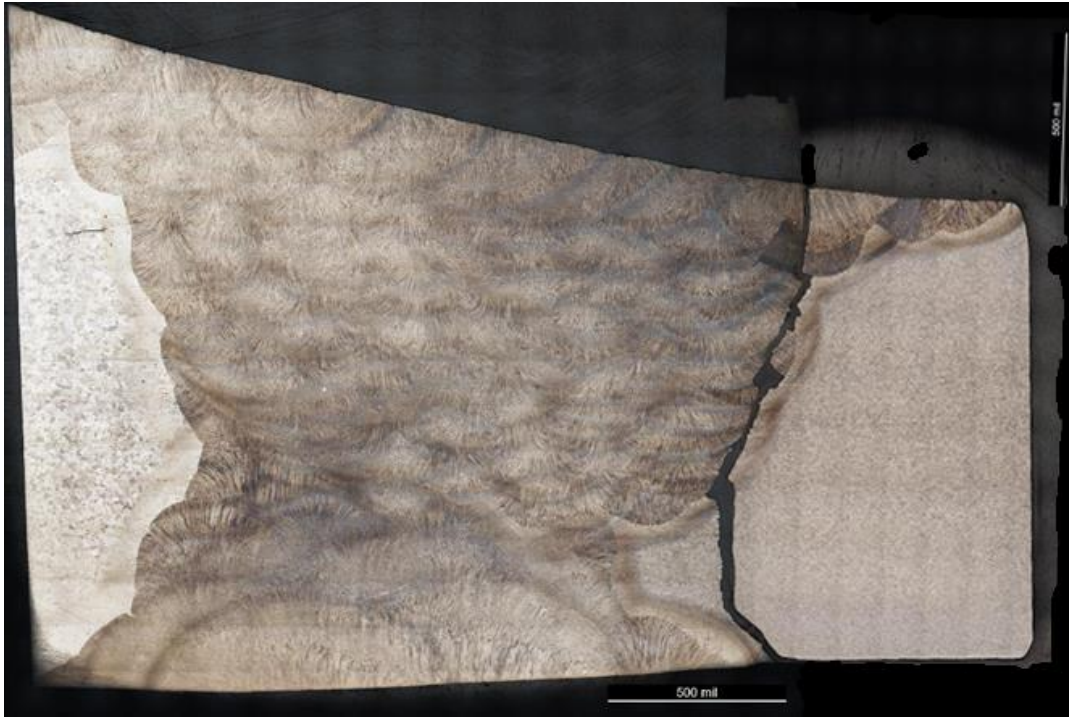
When the two montages of the weld profiles cut from the preexisting crack regions (Figure 36 and Figure 37) were viewed in comparison to the weld region near the top of the fractured side plate or with welds contained in the core samples, the weld profiles from the preexisting crack regions were significantly wider. Figure 39 and Figure 40 show these comparisons. Moreover, the placement of the weld beads differed in that welds shown in Figure 39b and Figure 40a and b indicated the inside bevel weld had been placed first with the two plates laid flat, as shown in the photo, followed by the second bevel weld after the plates were flipped over. In comparison, the welds in the preexisting crack regions showed the inside weld beads having been placed after the outside weld, and the weld bead stacking arrangement appeared to have been misaligned with the root of the weld. This suggested that the two preexisting crack regions were likely weld repairs.

Figure 36. Primary (lower) preexisting crack region shown in a low-magnification montage.

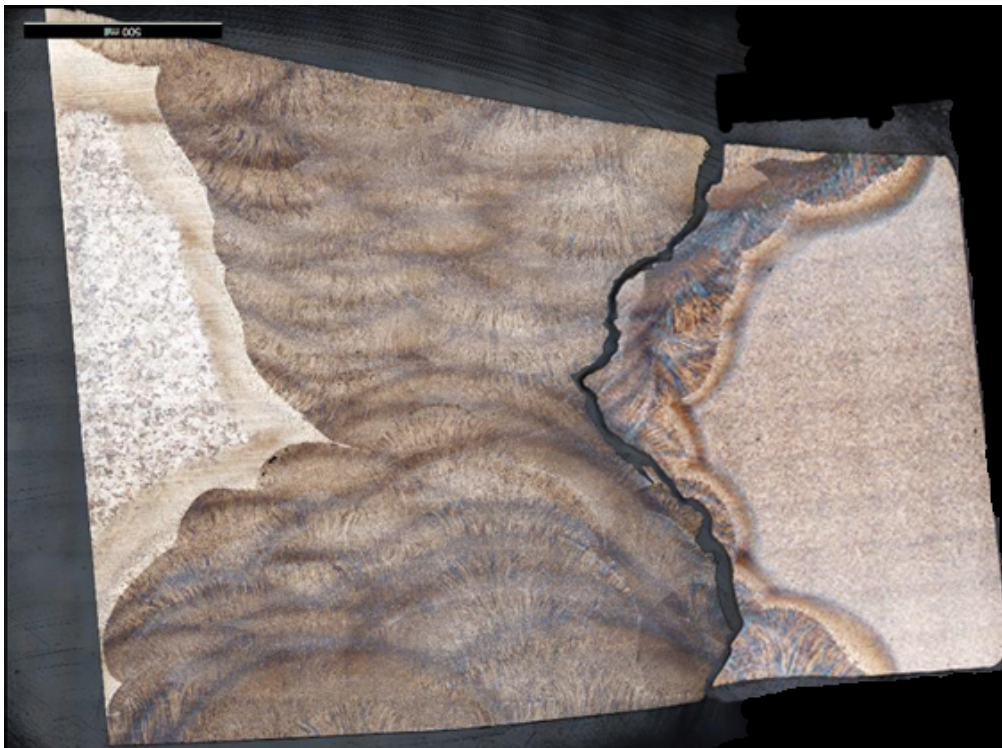
Figure 37. Secondary (upper) preexisting crack region shown in a low-magnification montage.

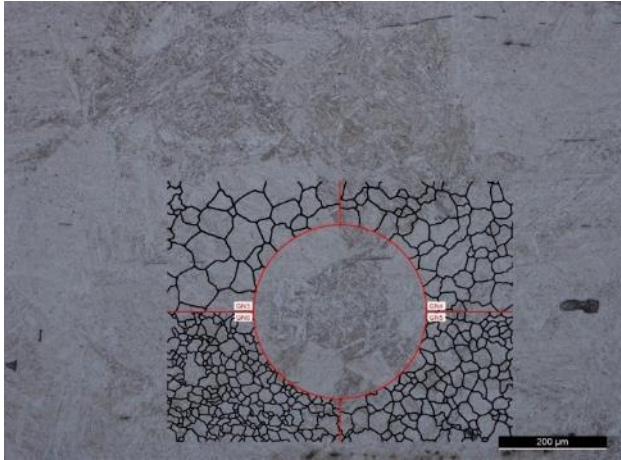
Coarse grains were observed in the base metal of the 2 1/4-inch plate adjacent to the weld fracture. ASTM-A517-69a requires a grain size of 5 or finer for this material. Figure 38a highlights an area in the 2 1/4-inch base metal viewed at a magnification of 100X with a grain size comparator overlayed. The austenite grains are coarser than an ASTM grain size of 1. Using the core samples removed from other welds in the bridge as comparators, samples of the 2 1/4-inch plate were examined and found to have average grain sizes much finer and meeting the ASTM specifications. Micrographs of three core samples are shown in Figure 38b-d.

a. Large grain size in fractured plate.

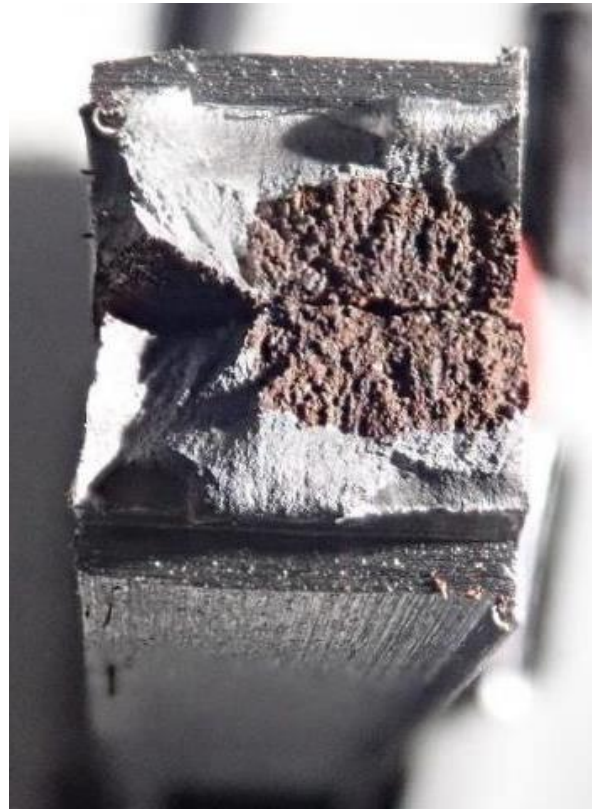
A previously identified flaw in the vicinity of the fracture is shown in Figure 41a. Optical and SEM fractography were performed to evaluate its characteristics. The crack was opened to view the fracture surface (Figure 41b). Surface oxides were present on the fracture surface, which exhibited a typical thumbnail shape. This fracture was further examined in the SEM at magnifications of 25X (Figure 41c) and 250X (Figure 41d). Figure 41d indicates that the fracture mode of the crack was intergranular.

b. Fracture surface of the flaw (circled region from a).

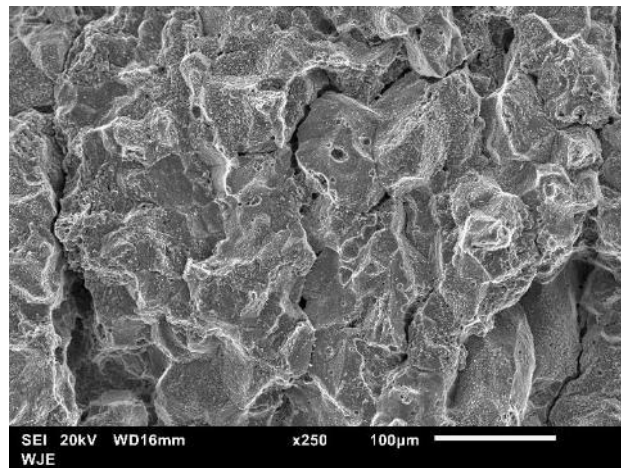
d. SEM micrograph of crack at 250X magnification.

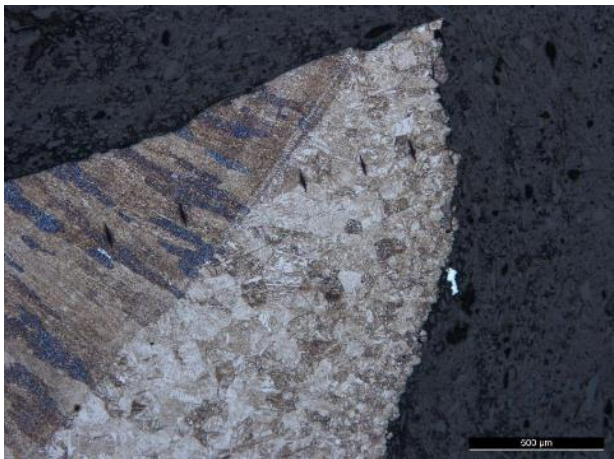
Figure 46 and Figure 47 were captured at 50X magnification near the toe of the weld. The crack exhibited an intergranular path through the GCHAZ and GRHAZ, but had not propagated beyond the ICHAZ. The base metal fracture visible in Figure 45 was caused intentionally in order to separate the crack faces for examination.

Figure 46. Core Sample SA158W on the weld metal side of the crack – 50X magnification.

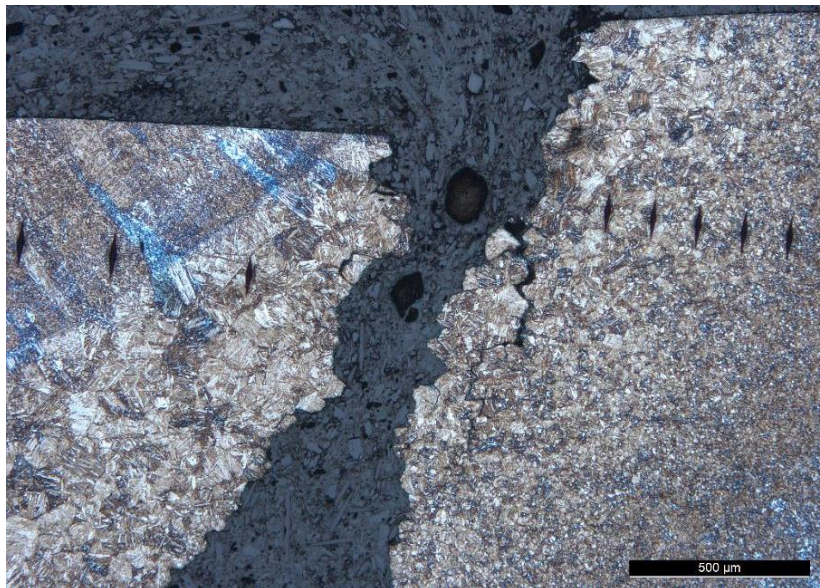
The intergranular path of the crack in Core Sample SA008E is clearly visible in Figure 49 and Figure 50. As in SA158W, it progressed through the GCHAZ and GRHAZ before arresting at the ICHAZ. The base metal fracture visible in Figure 48 was caused intentionally in order to separate the crack faces for examination. At 500X magnification, it was clear that the martensite in the GCHAZ had experienced significantly less tempering (Figure 51) than the base metal (Figure 52).

Figure 49. Core Sample SA008E near crack tip. Knoop hardness indentation marks are shown adjacent to the crack – 50X magnification.

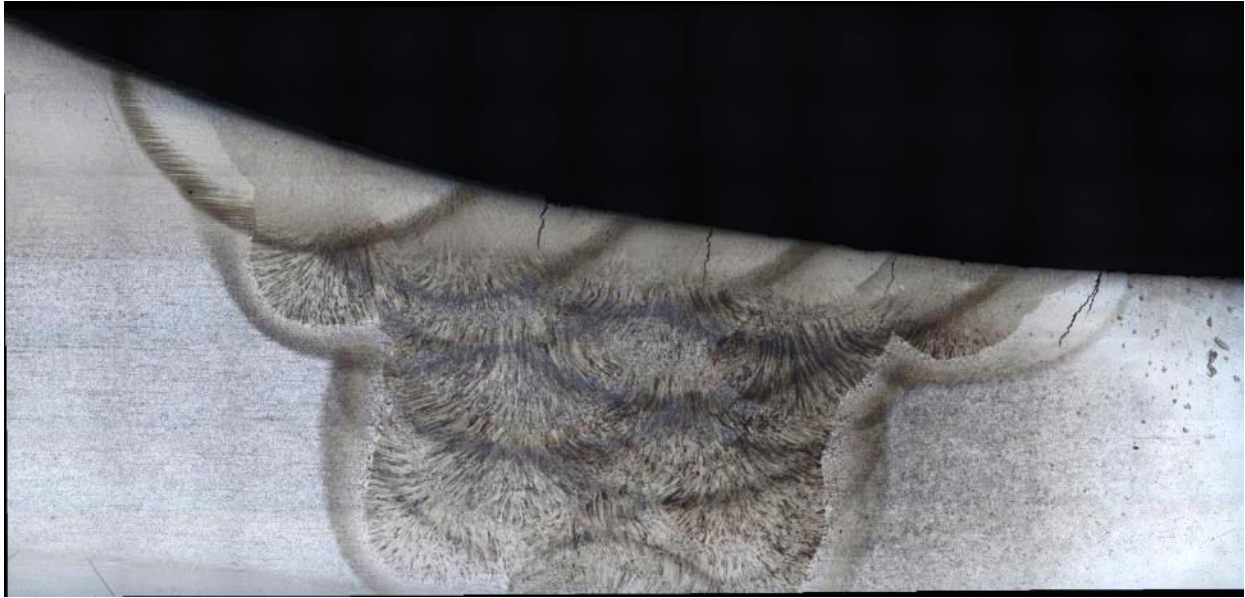
Cracking was observed in the top weld passes in Core Sample SA168W (Figure 54). Higher magnification of the left-most crack from this location is shown in Figure 55.

Figure 54. Cracks in the top weld passes at location SA168W

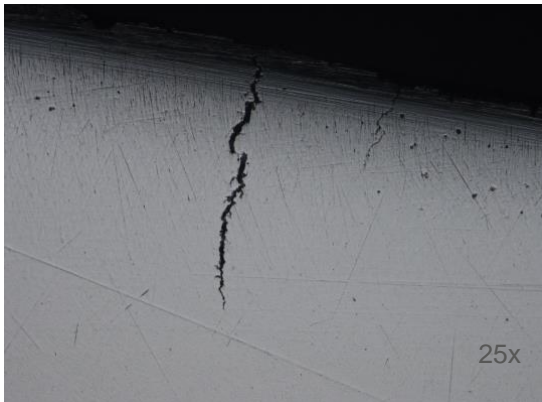
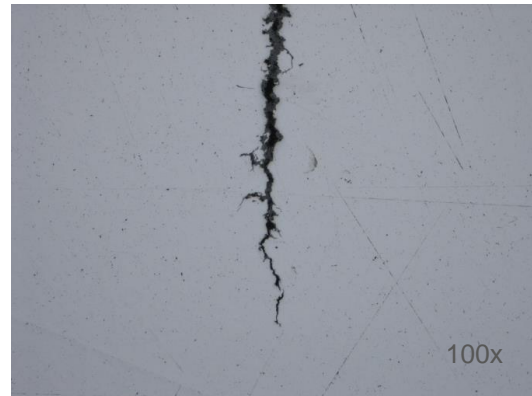
Figure 55. Higher magnification views of a crack observed in SA168W. Unetched.

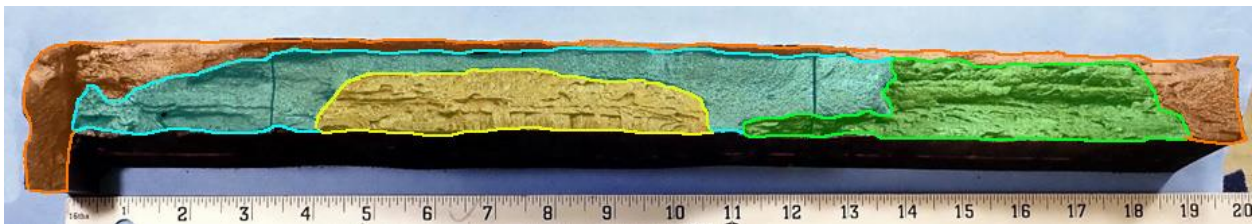
Figure 61. Lower portion of fracture, color-coded to indicate failure sequence.

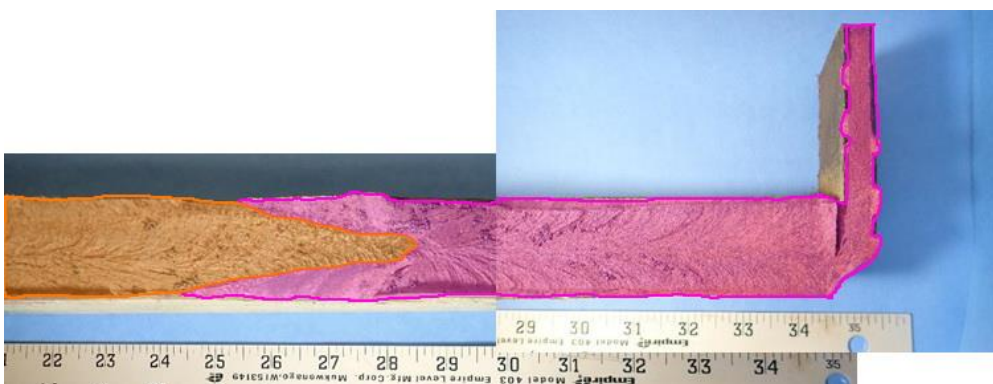
The photographic documentation indicates that at some point after 2019, the crack tip of the arrested second unstable fracture (orange) became unstable, ran upward over the remaining 6 1/2 inches of the side plate's height and continued into the top plate (magenta in Figure 62). It then turned and ran longitudinally along the fillet welded connection between the tie girder top cover plate and the inboard side plate for some distance before it was found in May 2021.

Figure 62. Upper portion of fracture, color-coded to indicate failure sequence.
