**PATHOLOGIES IN OLD BUILDINGS OF THE HISTORIC  
CITY CENTER OF VILA REAL**

Andreia Queirós<sup>1,a</sup>, Anabela Paiva<sup>2,b</sup> and Jorge Pinto<sup>3,c</sup>

**Abstract**

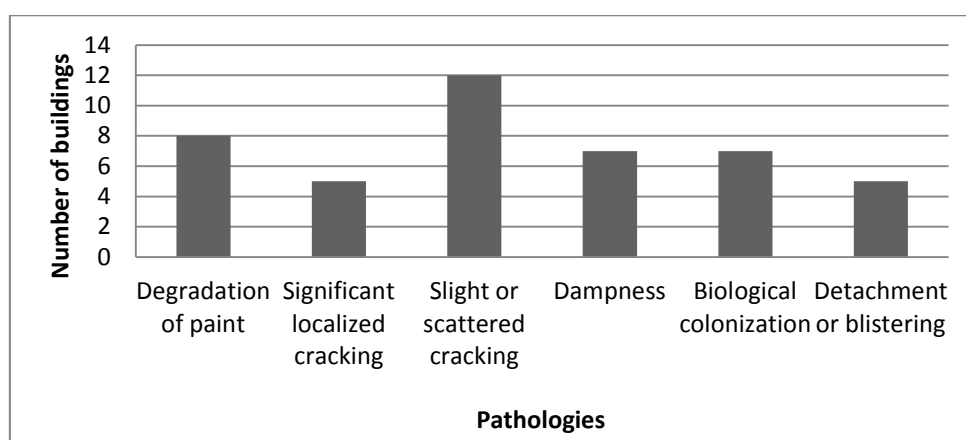
Most of the buildings of the historic center of Vila Real need to be rehabilitated, as already referred to, so a survey of major pathologies was carried out. The results of this survey, in what concerns the facades, showed that there is slight or scattered cracking in 12 of the studied buildings, degradation of the paint in 8 of them and dampness and biological colonization in 7 others, Figure 5.

.Figure 5 - Pathologies in facades

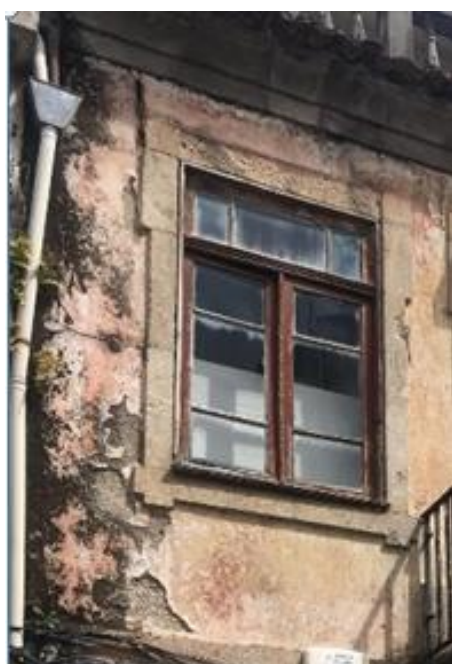
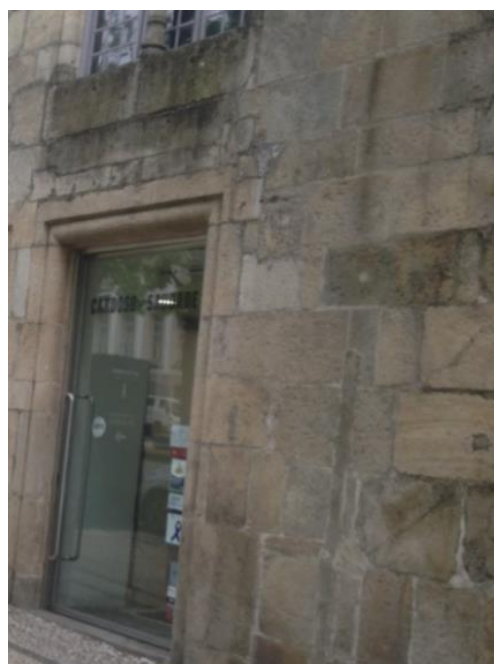
In Figure 6 the facades of two buildings are presented. On the left photo the facade of the building presents dampness, mould and peeling paint. On the right photo the granite is cracked, and there is dampness under the window sill.

Figure 6 - Facades with dampness, mould, peeled paint and cracks.

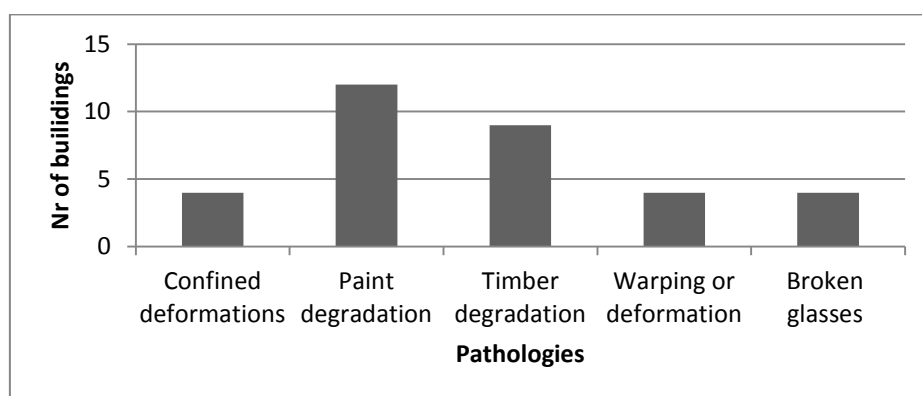
The most frequent pathologies found in window frames are the degradation of the paint, in 12 buildings and the degradation of the wood in 9 of them. 4 buildings have broken glasses, Figure 8.

Figure 8 - Pathologies in windows

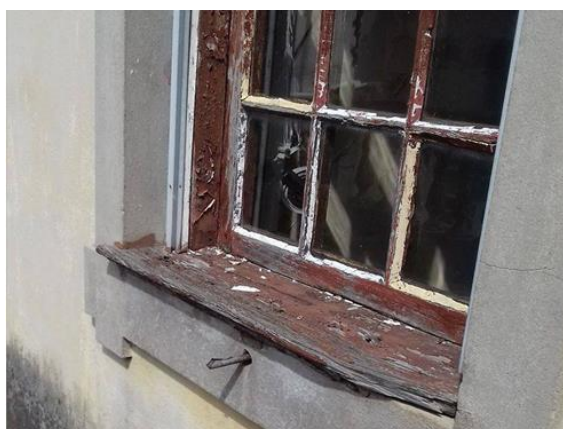
Several pathologies in a window can be observed in Figure 9, such as degradation of the paint and of the timber frame, broken glass and window sill.

Figure 9 - Pathologies in window.

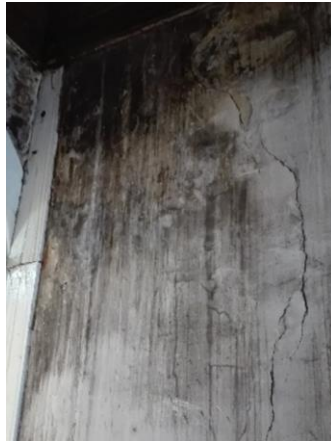
The more frequent pathologies in interior walls are crack, in 15 of the studied buildings and dampness in 10 of them. In the example presented in Figure 10, the main cause of these pathologies

can be water infiltration, due to roof or drainage problems. The dampness leads to the appearance of mould and possibly to the cracking and blistering of the mortar.

Figure 10 - Dampness, cracks and mould in an interior wall

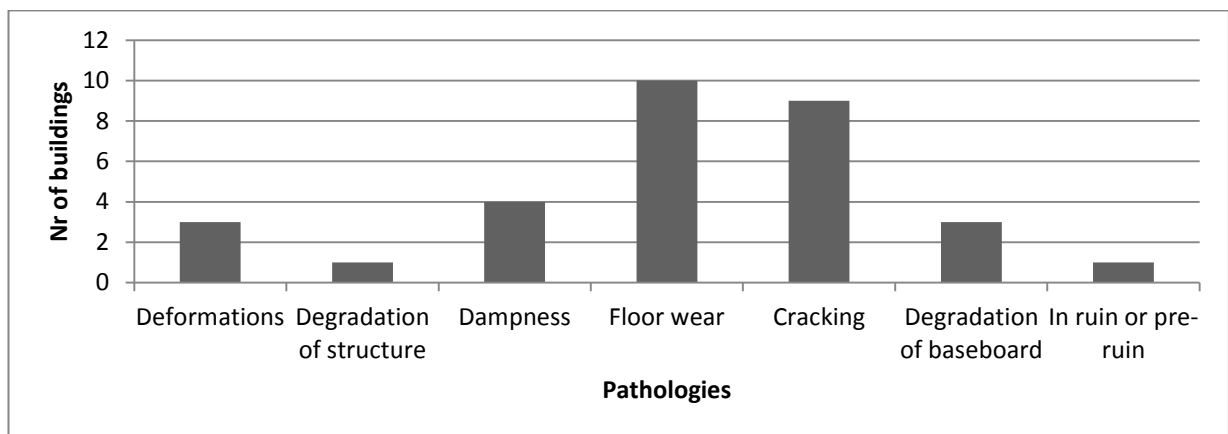
The floors, as well as the doors and their frames are made of wood. In Figure 11 the pathologies in floors are presented. The main problems are the floor wear in 10 of the buildings (Figure 12) and cracking in 9 of them. Deformations and degradation of the baseboard is also present. These pathologies are due to the use and the lack of maintenance.

Figure 11 - Pathologies in floors

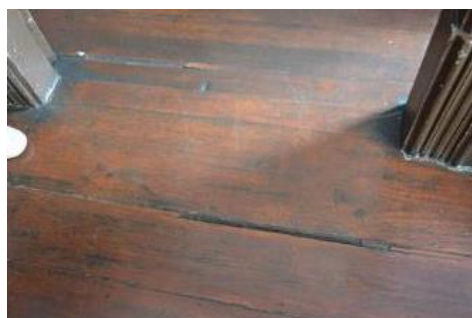
The stairs have as main pathology the wood wear in 14 of the buildings. Cracking and degradation of the wood are others pathologies shown. Also the use and the lack of maintenance are responsible for their degradation.

Figure 12 - Wood wear on stairs

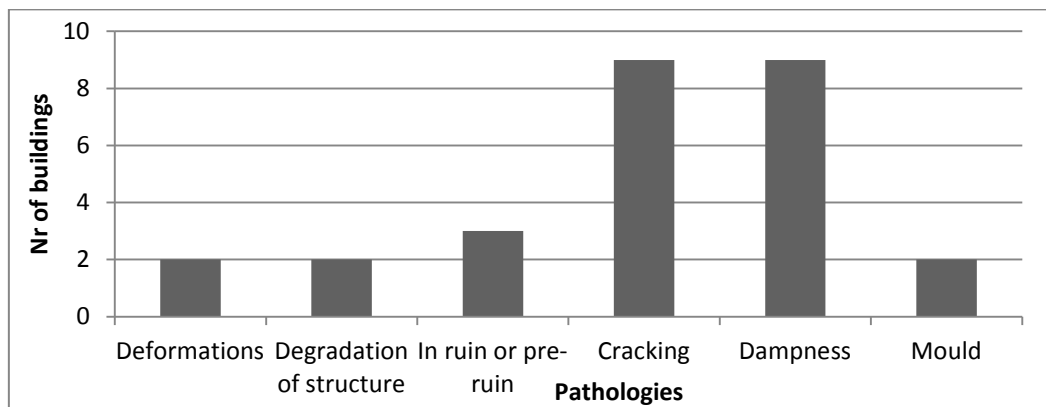
The more frequent pathologies that affect the ceilings are the cracking and dampness that appear in 9 of the studied buildings, as can be seen in Figure 13. The ceilings in 3 buildings are in ruin or pre-ruin and 2 of them are deformed or have the structure degraded or have mould.

Figure - 13: Pathologies in ceilings

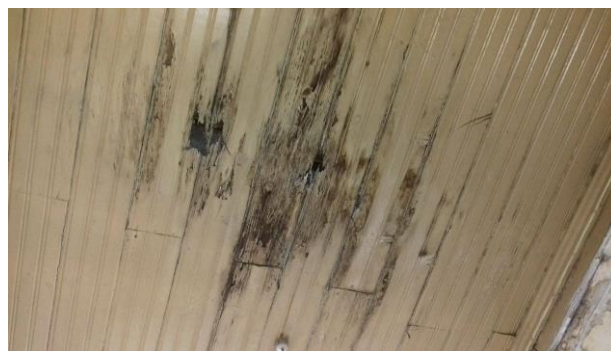
The pathologies in ceilings are mainly due to problems in the roof or condensations, Figure 14.

Figure 14 - Consequences of dampness in ceiling
