Impact Damage Formation on Composite Aircraft Structures

Project Description Paper Supporting Presentation Given at
Federal Aviation Administration JAMS 2012 Technical Review Meeting
5 April 2012, Baltimore, MD

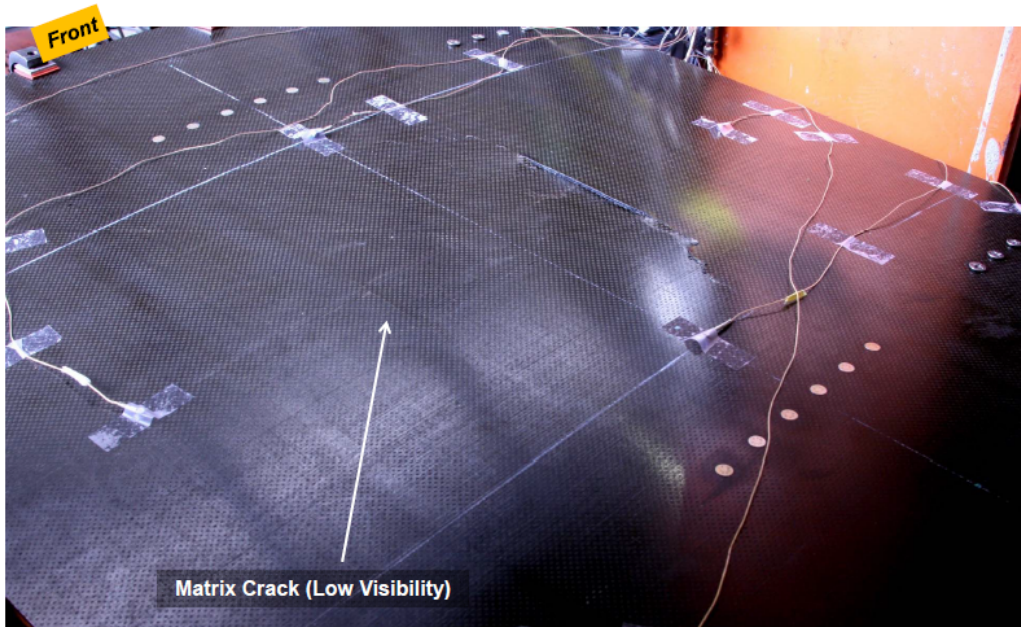
In the last year, two StringerXX specimens were tested. Test specimen Stringer05 (2-stringers, impacted between stringers) and Stringer06 (3-stringers, impacted on center stringer) have been dynamically tested with a D-shaped, OEM rubber bumper at a velocity of 0.5 m/s. The test setups for the two specimens are similar to prior StringerXX tests documented in Table 2. During both tests, the back of the bumper displaced 114.3 mm into the panel, creating significant skin cracks, panel stringer-to-skin delamination, and stringer flange/radius cracks. Post-test photos of Stringer05 with damages are shown in Figures 3 and 4 respectively.

Figure 3. Post-Test State of Stringer05 Showing Surface Cracks Along the Stringer Radius Locations Adjacent to the Impact Location

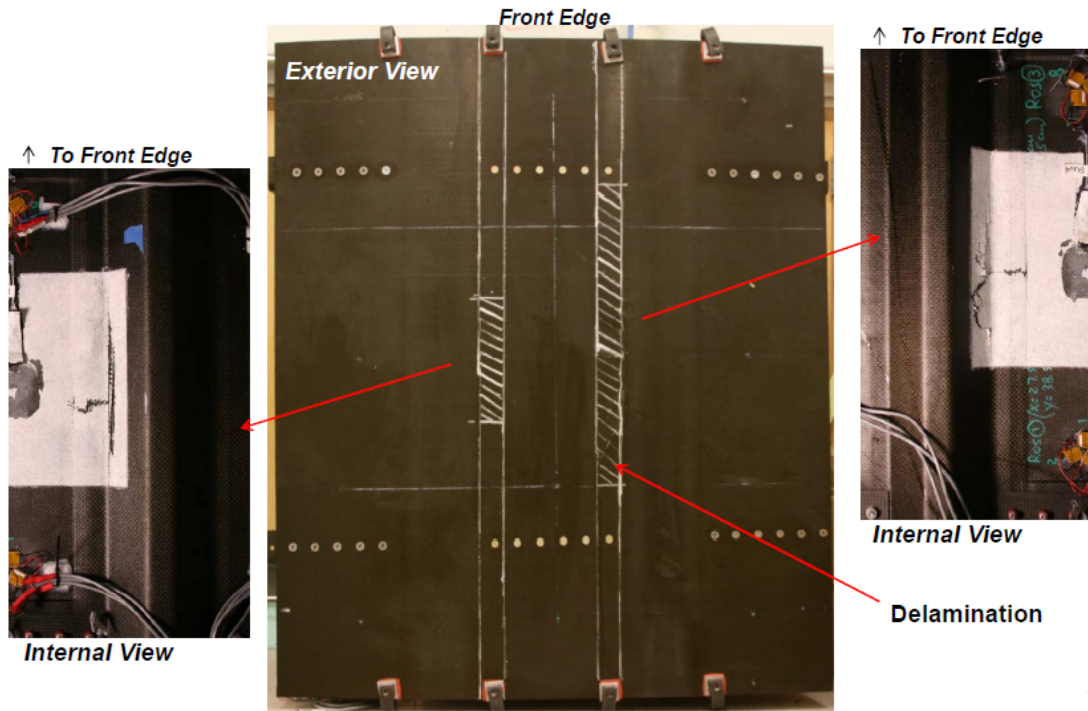
Figure 4. Center Image: Post-Test A-Scan Map of Stringer05 (Hatched Area = Skin-Stringer Delamination); Side Images: Crack Formations along the Stringer Radii and on the Flanges Viewed from Panel Inside

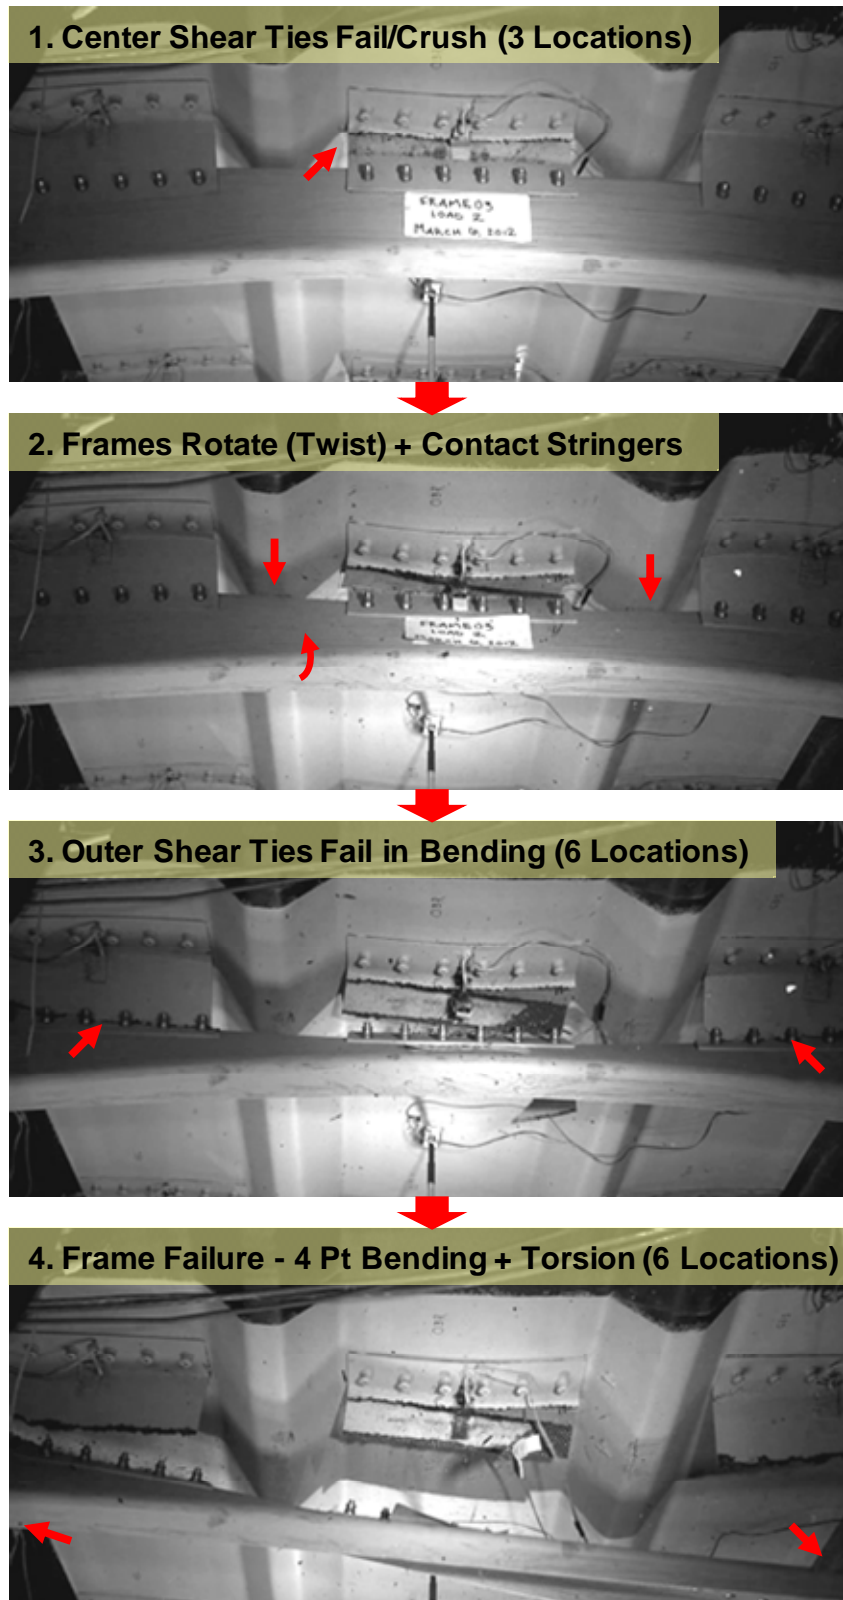
and C-frames. As the impactor displacement increased, the C-frames rotated further, scraping along the stringer, leading to failure of the outer set of shear ties (see image 3 of Figure 10). Final failure occurred in the C-frames away of the impact region (i.e., non-local failure) due to a combination of torsion, bending and shear (see image 4 of Figure 10).

Figure 10. High Speed Video Stills Showing Sequence of Failure in Frame03

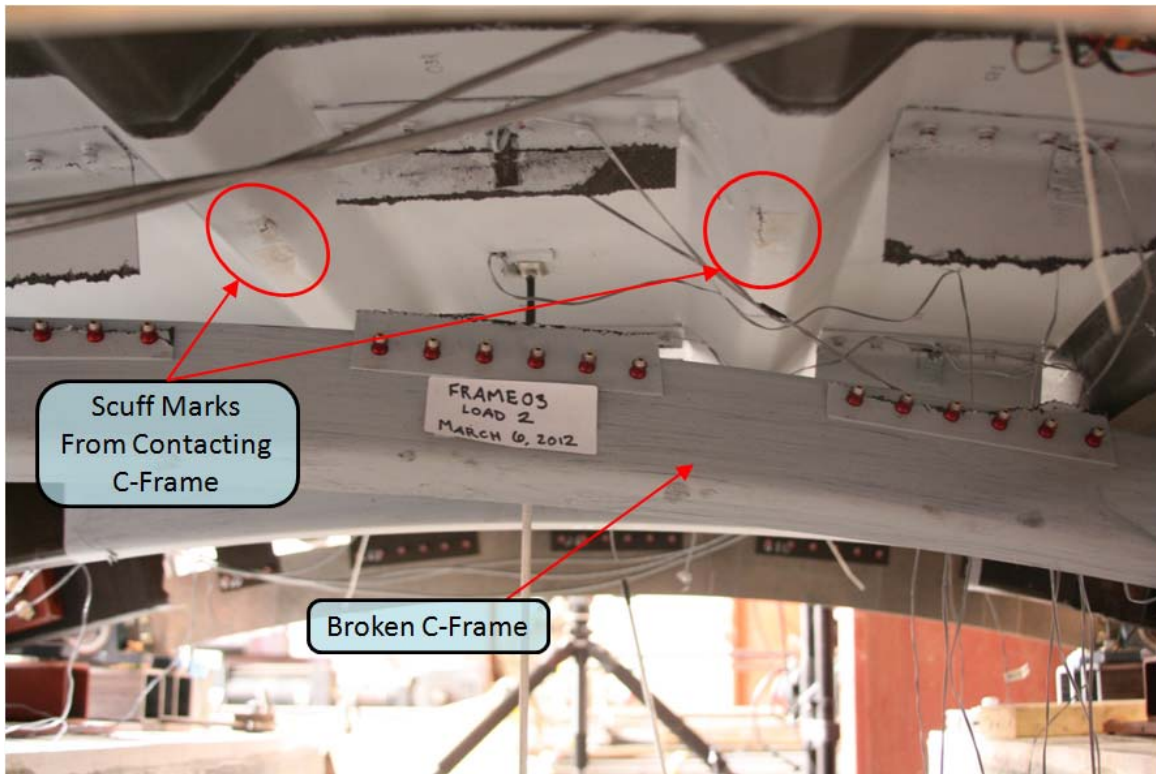
The final internal damage state is shown in Figure 11 and a view of the outside of the specimen after impact is shown in Figure 12. It should be noted that even after the frames were severed, the specimen still held a load of ~15kN per frame before unloading. While no immediately obvious damage is visible (i.e., no gross cracks), a minor surface geometry change was noted. The photogrammetry method was used, as summarized in Figure 13, to measure a 4.5 mm permanent deformation (relaxed state measured over 24 hours following test). The visual detectability of 4.5 mm acting over a “dent span” of 1 m has been found to be difficult to perceive by casual observation.

Figure 11. Frame and Shear Tie Damage of Frame03 after Loading L2

When Frame03 was impacted dynamically, the frames experienced a combined torsion+shear+bending failure close to the boundary conditions, and away from the impact area. This suggests the load transfer through the frames into the boundaries, and the resulting response leading to failure of the frame, is load-rate dependent. In both dynamic and quasi-static cases the stringer-frame interaction played a critical role in the damage evolution. It should be noted that for this type of impact, not only should the impact site be inspected but also the surrounding areas (i.e., where the frames join to other structures, such as the connection to the cargo or passenger floor).

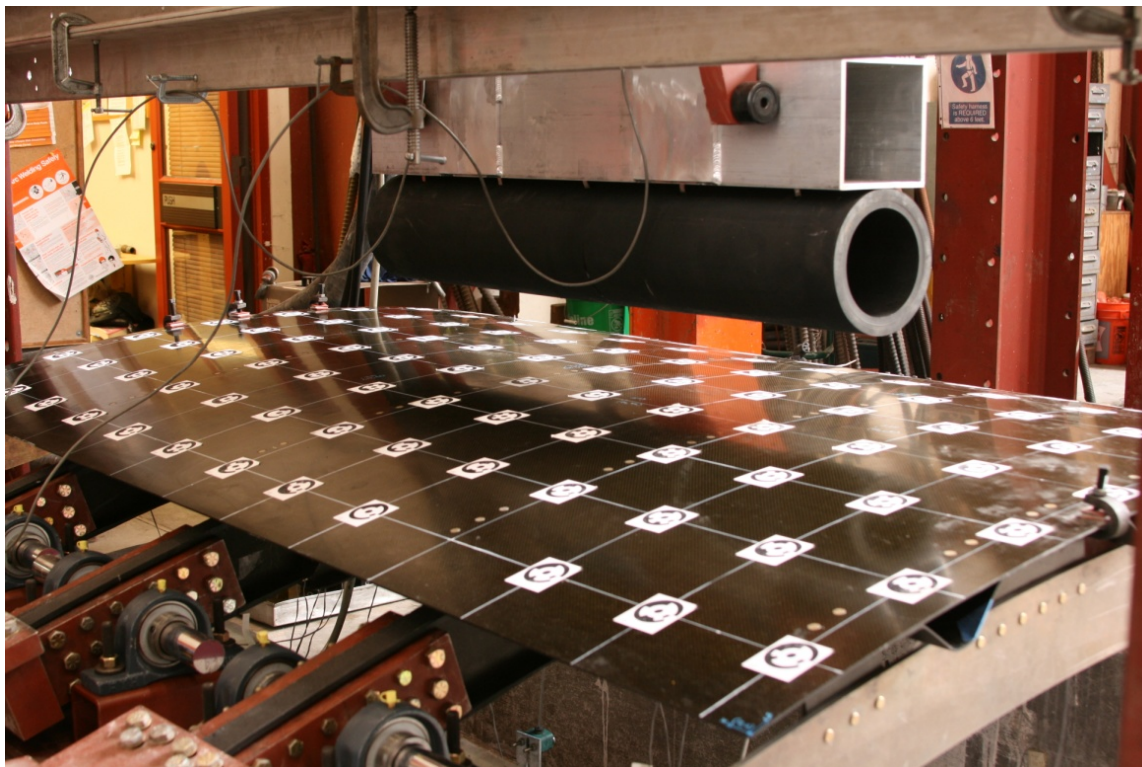
Figure 12. Frame03 after Loading L2

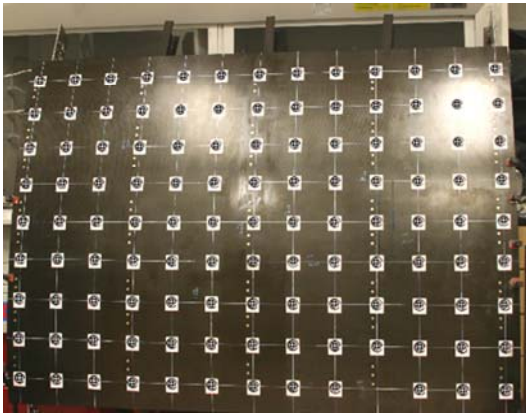
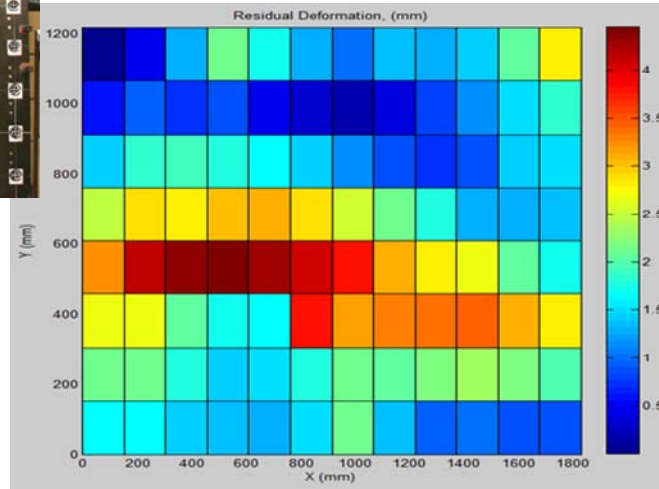
Residual Deformation (Change in Surface Profile)

- 4.5 mm deformation
 - difficult to visually detect over large ~1 m span
- measurement made several days post-test → permanent deformation

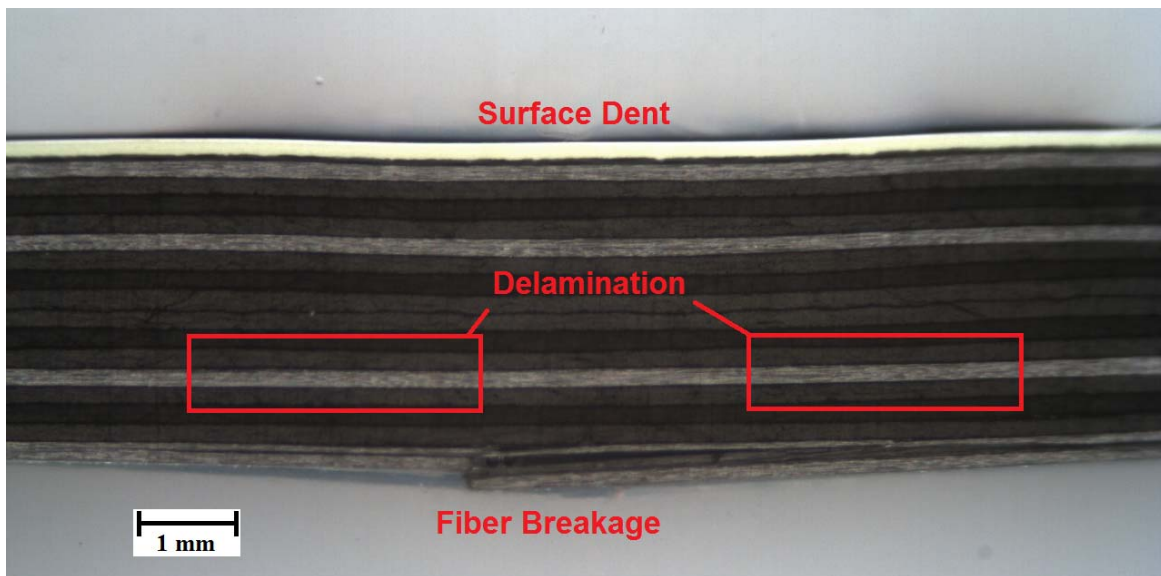
The primary forms of damage from impacts on the panels are surface denting and delamination. Higher energy impacts can also result in back face fiber breakage. Figure 30 shows a microphotograph of the cross section of a damaged 16 ply panel, impacted by a 12.7 mm radius tip. In this figure all three forms of damage are present. Although the delamination in the image is not obvious, it is apparent with close (destructive) inspection under a microscope.

Figure 30. Microphotograph of Damaged 16 Ply Panel Created by 12.7 mm Radius Tip Impact
