U.S. CHEMICAL SAFETY AND HAZARD INVESTIGATION BOARD

# INVESTIGATION REPORT

## SUGAR DUST EXPLOSION AND FIRE

### IMPERIAL SUGAR COMPANY

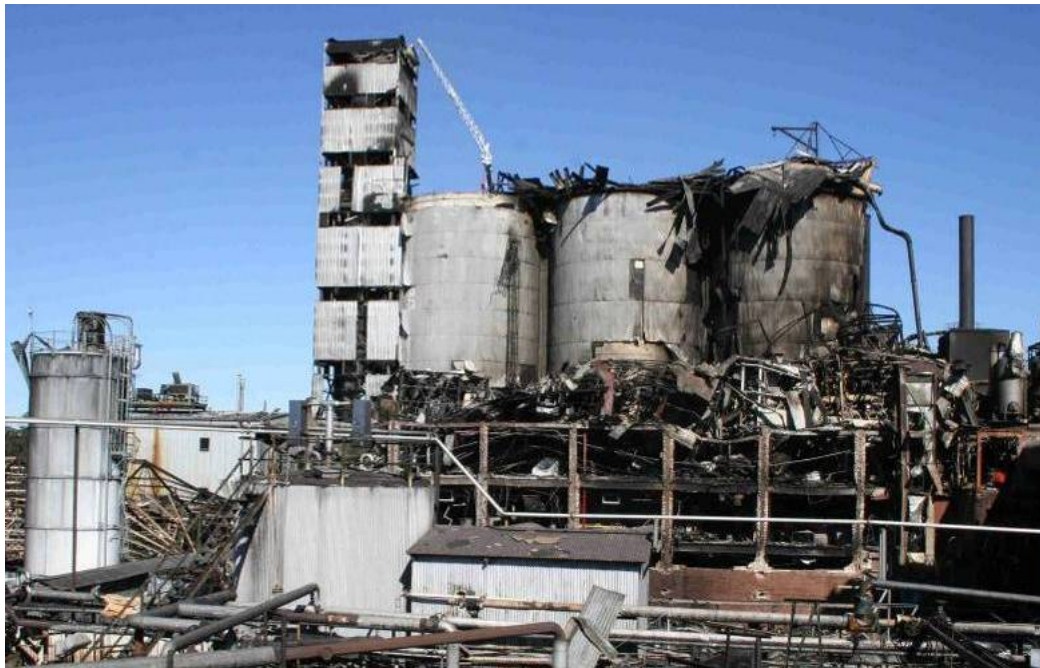
The major fires in the buildings were extinguished the next day, but small fires continued burning for many days. The granulated sugar fires in the 105-foot tall silos continued to smolder for more than 7 days before being extinguished by a commercial industrial firefighting company. The packing buildings, granulated sugar silos, and palletizer room were destroyed. The bulk sugar loading area and parts of the refinery were severely damaged by the explosion and fires (Figure 1).

Figure 1. West bucket elevator tower; silos 3, 2, and 1; and south packing building destroyed by the February 7, 2008, sugar dust explosions and fires

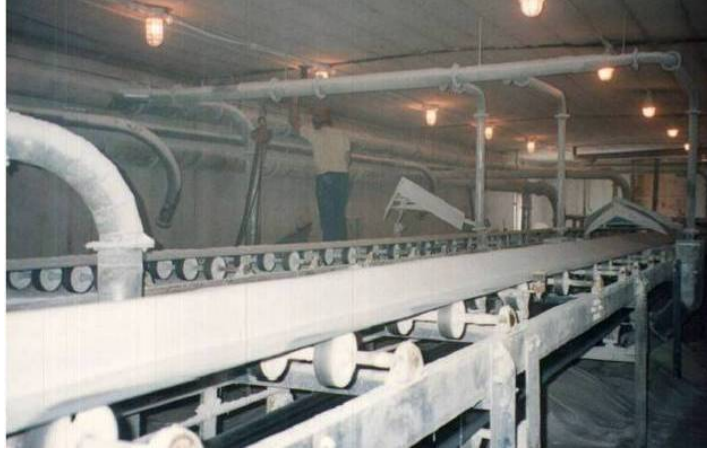
Figure 8. Granulated sugar steel conveyor belts above the silos, circa 1990. Heavy dust accumulation on conduit and spilled sugar on the floor (Imperial Sugar photo)

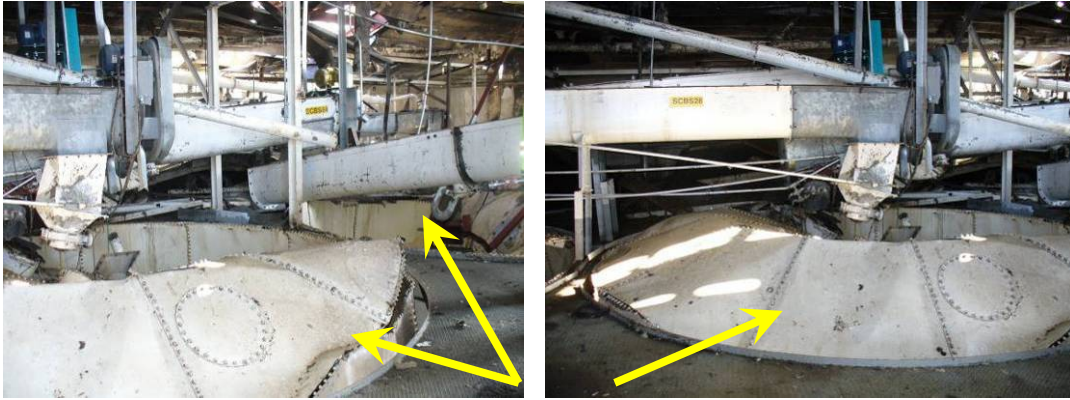
conveyors in the Port Wentworth facility acted as conduits and ignited fires and ruptured equipment hundreds of feet from the packing building where the incident originated (Figure 12).

Figure 12. Pressure waves traveled through screw conveyors and ruptured steel bulk granulated sugar bins (arrows) hundreds of feet from the sources of the dust explosions

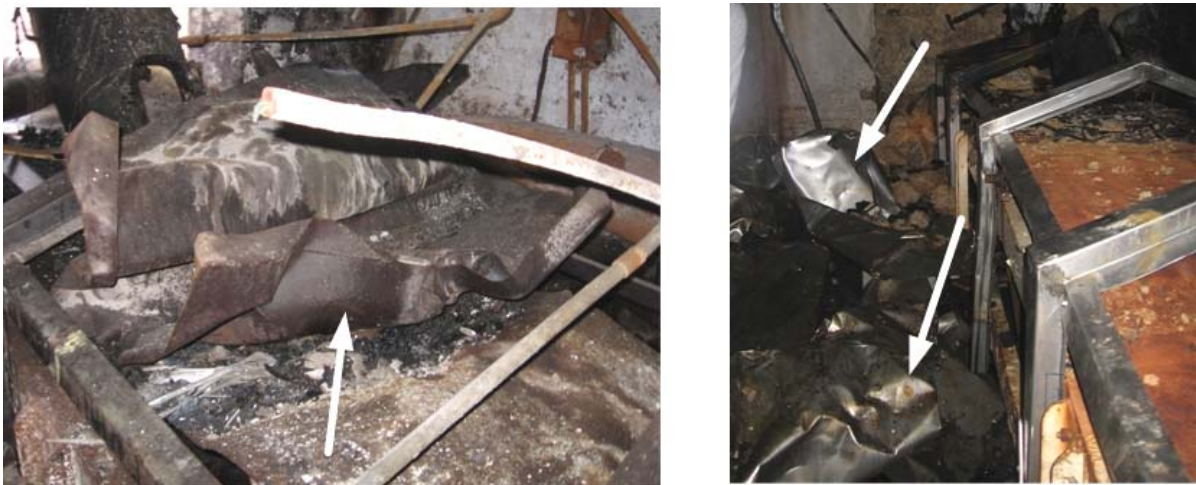
Examination of the equipment in the silo tunnel found that every panel used to enclose the 80-foot long steel belt conveyor had been violently blown off the support frame (Figure 13). Panels east of the approximate midpoint of the conveyor (directly under the silo 1–silo 2 abutment) were deflected eastward, and panels west of the midpoint were deflected westward. Pressure damage inside the pantleg rooms above the tunnel was greatest inside the silo 2 pantleg room and least inside silo 3 pantleg room. Major equipment damage was observed at the east entrance of the silo tunnel with all equipment deflections eastward, away from the tunnel. The equipment under silo 3 and outside the west end of the tunnel had damage patterns clearly indicating that a pressure wave traveled west out of the tunnel.<sup>24</sup>

Figure 13. Steel belt covers (arrows) crumpled from an initial dust explosion inside the steel belt enclosure (steel frame structure, right photo)

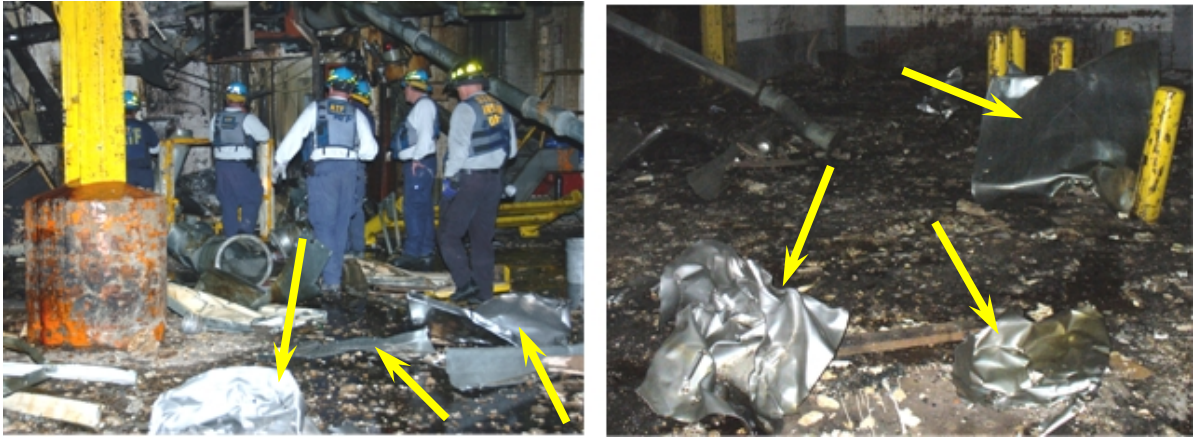
Pressure waves blew the wood walls and doors off the west and east tunnel entrances. Mangled steel belt cover panels were blown out of the east end of the tunnel (Figure 14). The pressure wave also

Figure 14. Stainless steel cover panels (arrows) blown off the steel belt enclosure and out of the tunnel into the packing building

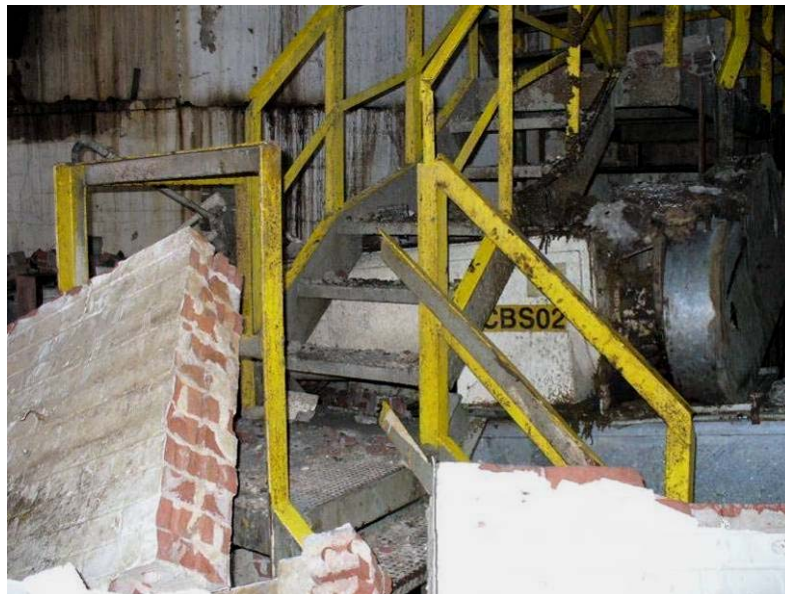
traveled up between silos 1 and 2 and blew the brick walls that enclosed the south stairwell into the work areas on each floor of the south packing building (Figure 15).

Figure 15. South stairwell brick walls blown into the packing building

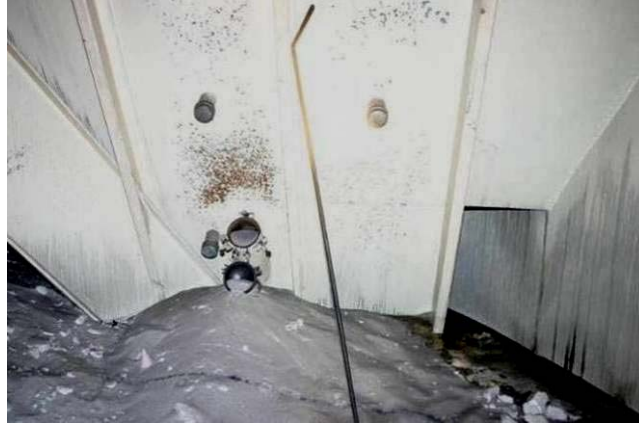
Figure 16. Access port inside the pantleg room and steel rod used to break sugar lumps in the sugar outlet on silo floor

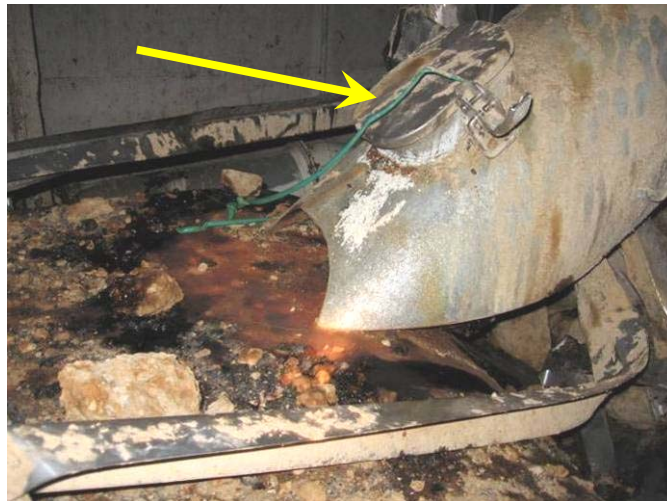
Figure 17. Limited clearance between sugar discharge chute and the steel belt would sometimes be blocked by large sugar lumps; lump-clearing access port (arrow) is on top of the chute

The CSB concluded that as granulated sugar spilled off the moving steel conveyor at the blocked outlet, sugar dust accumulated above the MEC inside the enclosed conveyor, and then ignited. The explosion triggered a series of secondary explosions that rapidly progressed through the packing buildings, palletizer room, and into the bulk sugar station.

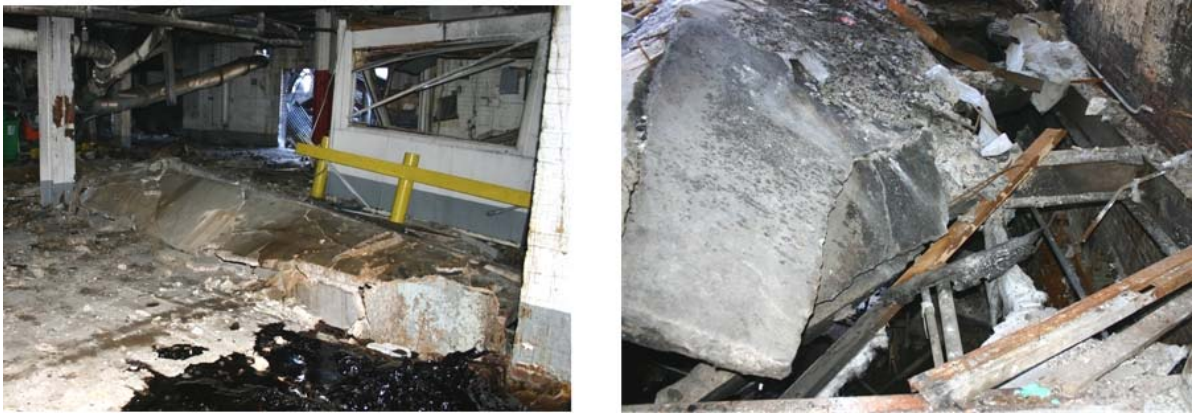
Figure 18. Three-inch thick concrete floor slabs lifted off the steel supports by the explosion pressure waves

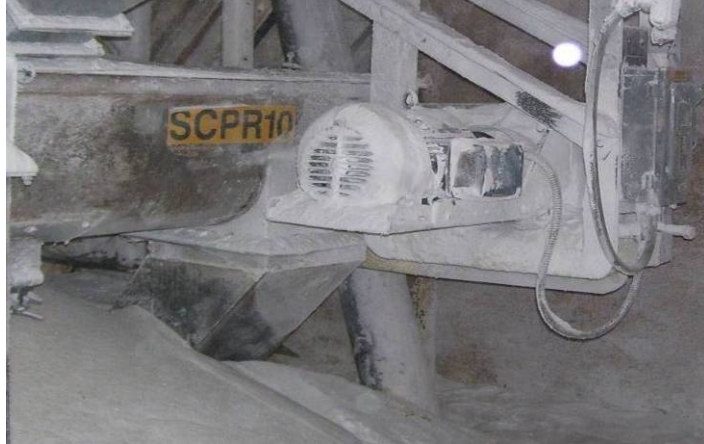
Figure 19. Motor cooling fins and fan guard covered with sugar dust; large piles of sugar cover the floor (Imperial Sugar photo)

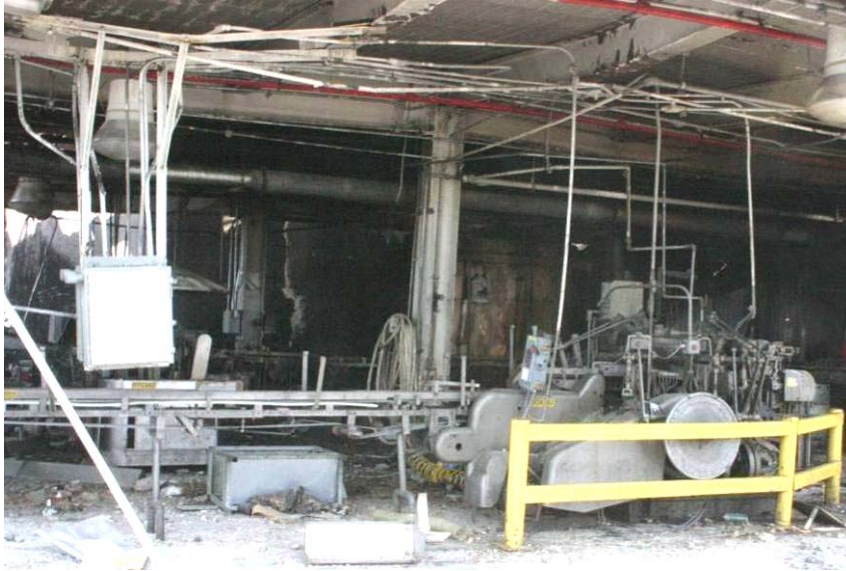
Figure 20. Packaging equipment hindered evacuation in the darkened building

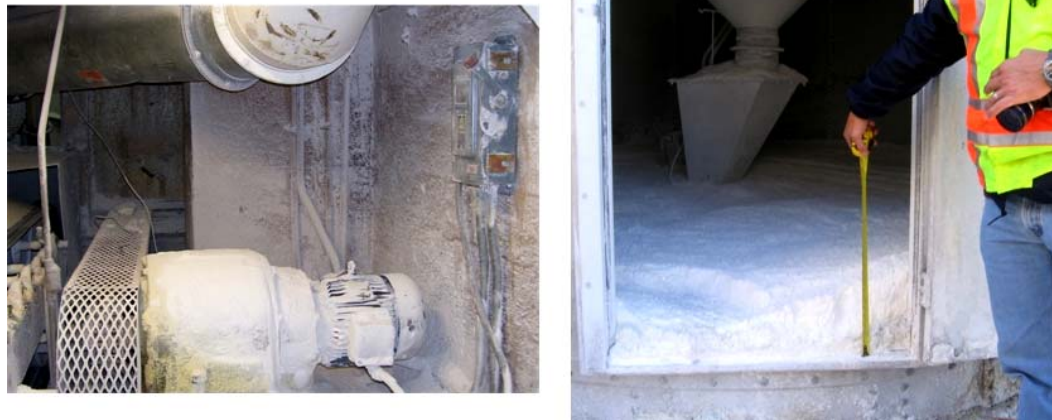
Figure 21. Left: Sugar dust accumulation on steel belt drive motor in silo tunnel (Imperial Sugar Co. photo, Oct. 2006). Right: Cornstarch spilled under cornstarch silo (March 2008).

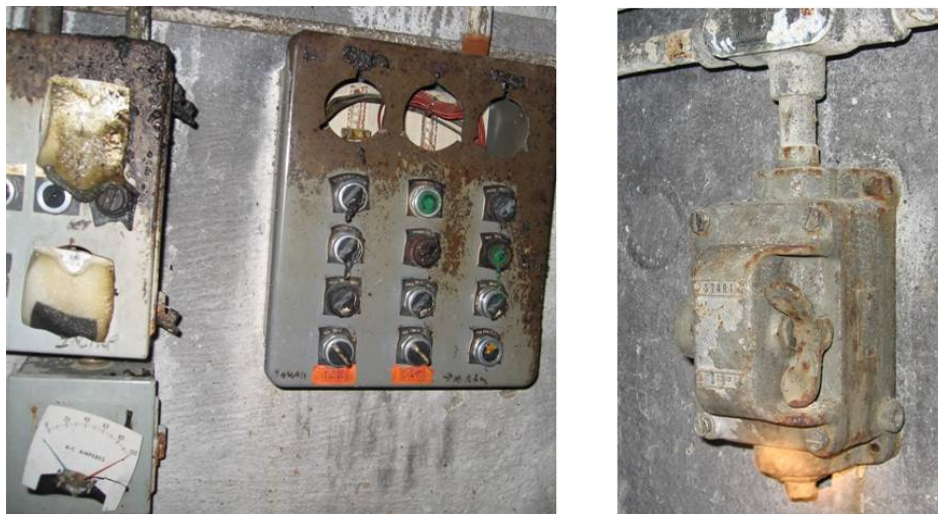
Imperial Sugar had no written policy or procedure to require classifying hazardous areas or require electrical devices rated for such locations at the Port Wentworth facility. Some locations at the facility contained significant accumulations of combustible sugar or cornstarch dust (Figure 21). The CSB investigators noted that some electrical devices were rated for use in hazardous work locations, but non-rated devices were also installed in the same location, frequently near the rated devices (Figure 22). The CSB investigators also observed many non-hazard classified electrical devices installed in dusty work areas and equipment enclosures. Furthermore, some electrical devices in dusty areas were poorly maintained, such as having missing covers or open doors on many breaker panels and other electrical enclosures.

Figure 22. Non-dust rated and rated electrical devices in the silo tunnel

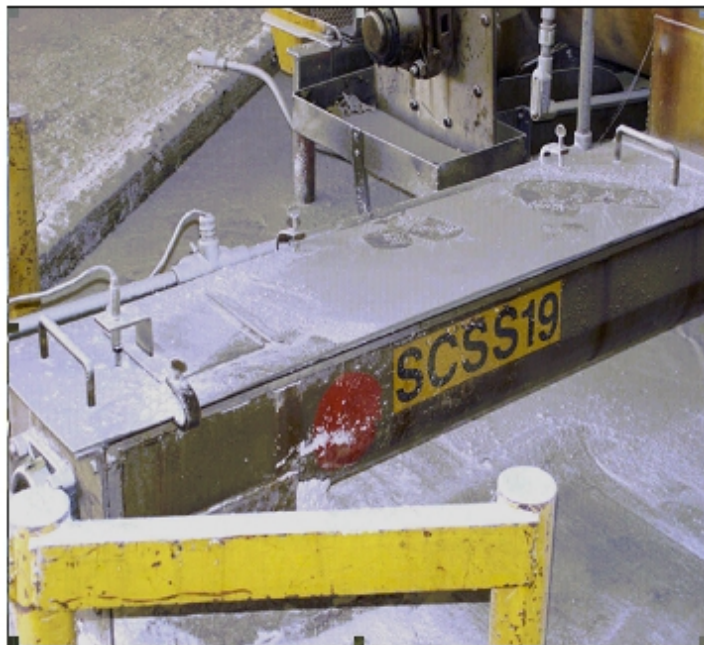
Figure 23. Sugar and dust accumulation on a screw conveyor in the south packing building fourth floor near silo 1 (Imperial Sugar photo)

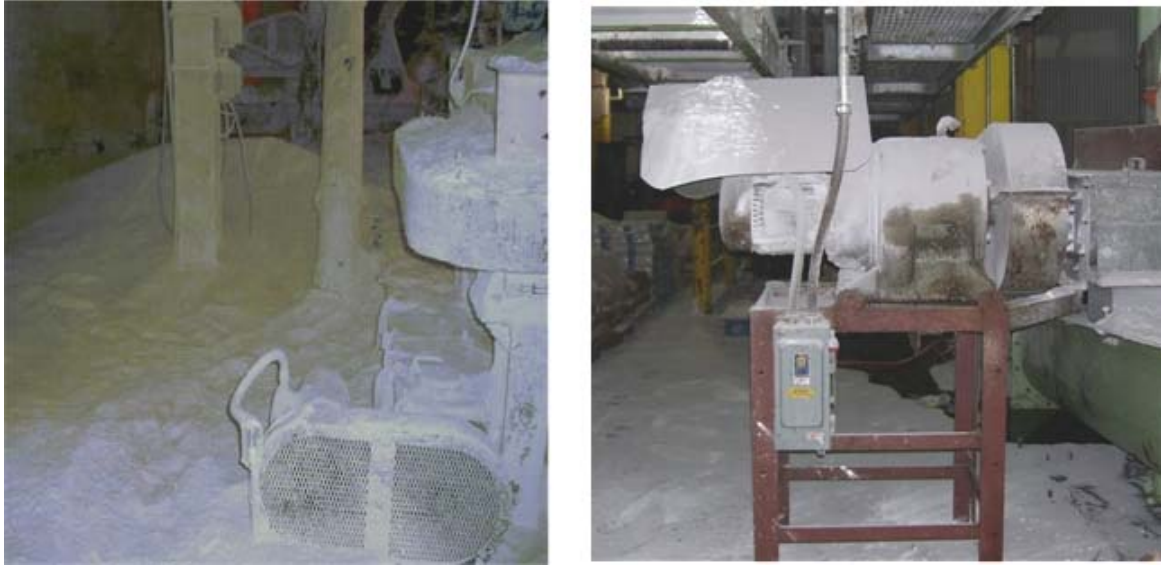
Figure 24. Deep piles of sugar accumulated on floors and equipment. Note shield installed above screw conveyor drive motor to deflect sugar dust (Imperial Sugar photos).
