AIRCRAFT ACCIDENT REPORT

IN-FLIGHT LOSS OF PROPELLER BLADE
AND UNCONTROLLED COLLISION WITH TERRAIN
MITSUBISHI MU-2B-60, N86SD
ZWINGLE, IOWA
APRIL 19, 1993

**Adopted: November 16, 1993
Notation 6201**

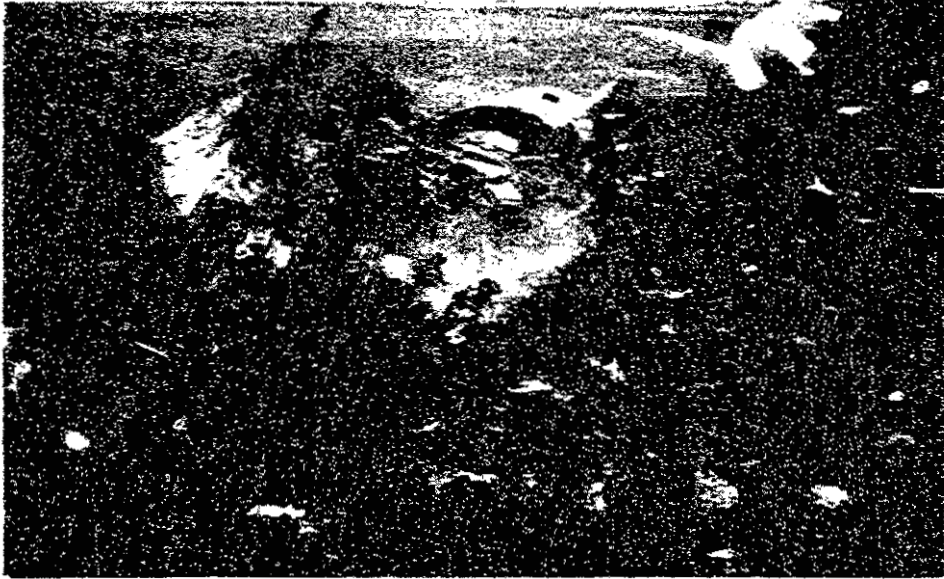
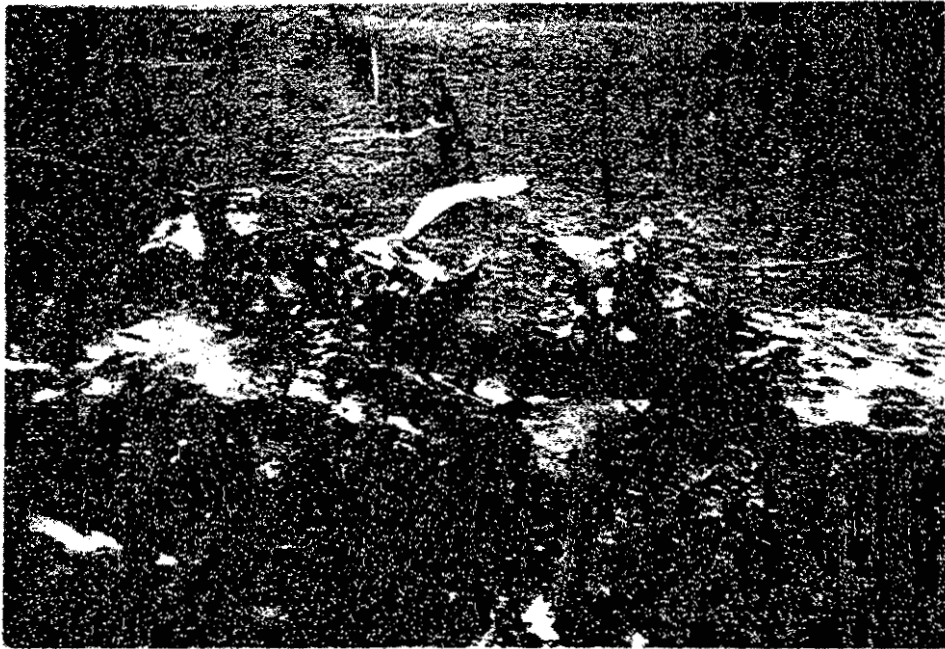
Figure 3.--Airplane wreckage.

The airplane *came* to rest on a **heading** of **303 degrees** magnetic in a barnyard. During the **postcrash** fire, about 75 percent **of** the fuselage was consumed by fire. The **wreckage** path **began** at a demolished 75-foot concrete and steel **silo** and continued for about **498** feet on a magnetic **heading** of **between 290 and 320 degrees**. The farthest pieces of airplane debris that were found were the left and **right tip** tanks, which showed minor frontal damage and no fire damage. The fuselage was found to be heading **303** degrees and was largely consumed by fire from the front to the *aft* pressure bulkhead. (See figures 2 and 3).

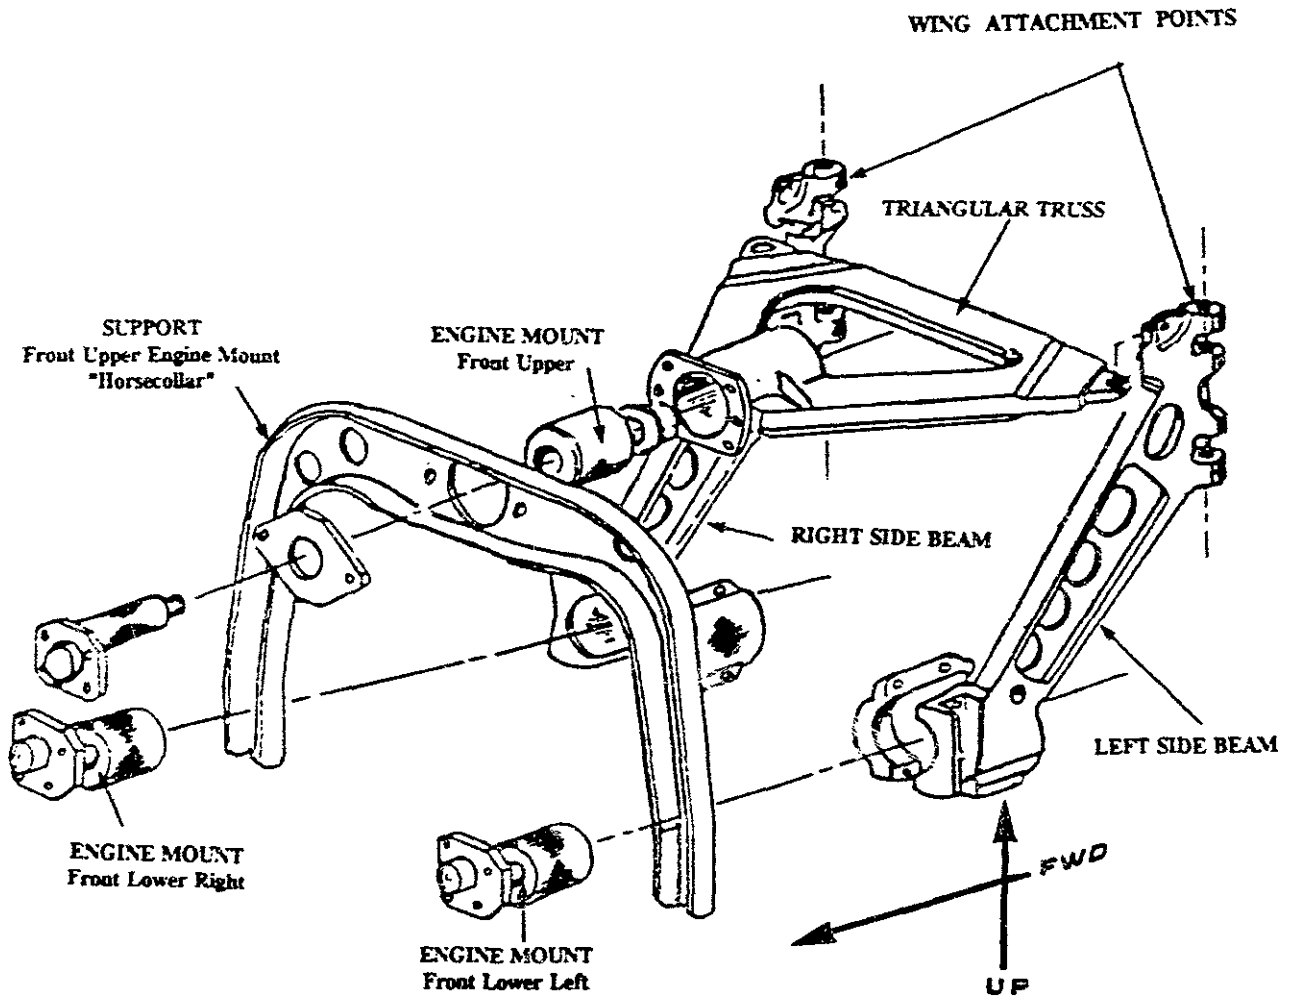
Figure 4.--Engine mount diagram.

The left side panel beam separated from the front wing spar, with the beam hinge type attachment and bolt intact; the separation occurred at the wing spar riveted joint. (See figure 4). The left beam was bent at mid length to the right (*aft* looking forward) approximately 50 degrees and slightly twisted in a clockwise direction. The cover and vibration isolator were intact and relatively free of damage. The engine mount spindle plate was attached to the vibration isolator, however, the spindle plate separated from the accessory gear box (AGB) when the threaded inserts were stripped from the cast aluminum AGB housing. The inserts made multiple imprints at the attach point on the engine. The right beam also separated at the wing spar in tension and in a forward direction. The separation was at the web just *aft* of the vertical bolt. However, the right beam was not bent or twisted. The spindle or the right beam spindle plate failed at the minor diameter, and the separated piece of the spindle remained with the vibration isolator.

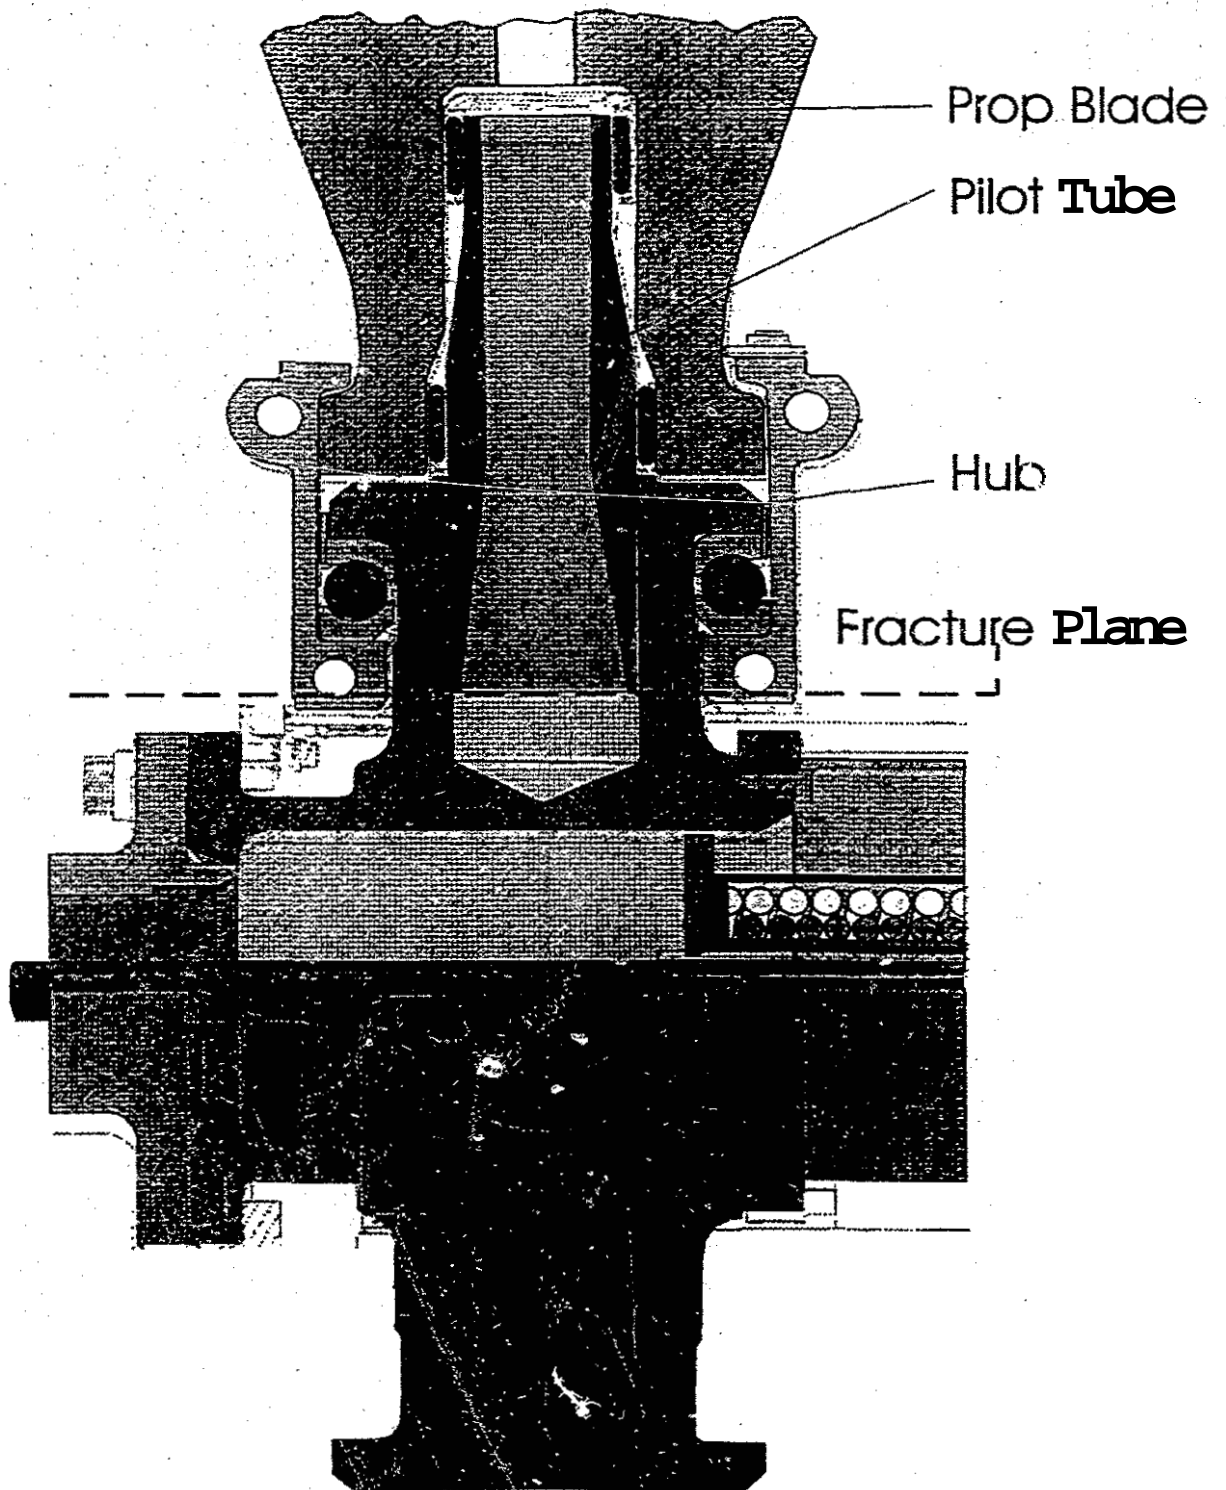
figure 5.--Cross section of propeller hub arm.

The examination of the left propeller revealed that the fracture in the separated hub ~~ann~~ was the result of a fatigue crack that initiated from the inside diameter of the pilot tube hole in the hub arm. Figure 5 is a drawing of a cross section through the hub arm of the Hartzell HC-B4 propeller, with the location of the fracture indicated. Figure 6 is a view looking inboard on the fracture surface on the main portion of the propeller hub. The circumferential location of the origin area of the fatigue crack was at the 7:30 position, looking inboard at the fracture, with forward at the 12:00 position. This portion of the hub arm would experience maximum tensile stresses during normal operation of the propeller (forward thrust). The axial location of the origin was about 0.028 inch outboard of the bevel on the inboard end of the pilot tube. The fatigue cracking propagated through about 45 percent of the hub arm cross section before final fracture occurred.
