Aviation Short Investigations Bulletin

Issue 41

ATSB Transport Safety Report
Aviation Short Investigations
AB-2015-043
Final – 10 June 2015

Main landing gear wheel failure involving a Boeing 737, ZK-ZQB

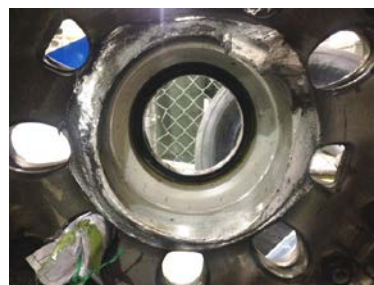
Inboard wheel half remnant

On 10 June 2014, a Boeing 737 aircraft, registered ZK-ZQB and operated by Jetconnect Limited landed at Sydney Airport, New South Wales. During taxiing, the crew felt a slight shuddering from around the main landing gear; they also observed that they required a higher-than-normal thrust to taxi the aircraft. At the crew's request, personnel in the Air Traffic Control tower and a passing aircraft observed ZK-ZQB, but did not see anything abnormal. The crew then requested that Rescue and Fire Fighting Services conduct a close-up inspection. They advised the crew that pieces of metal had fallen onto the runway and that the right, outer main wheel was leaning over. After parking the aircraft, an examination by Licenced Aircraft Maintenance Engineers confirmed that the inboard wheel half-hub had fractured into several pieces and that the wheel bearings were intact (Inset figure).

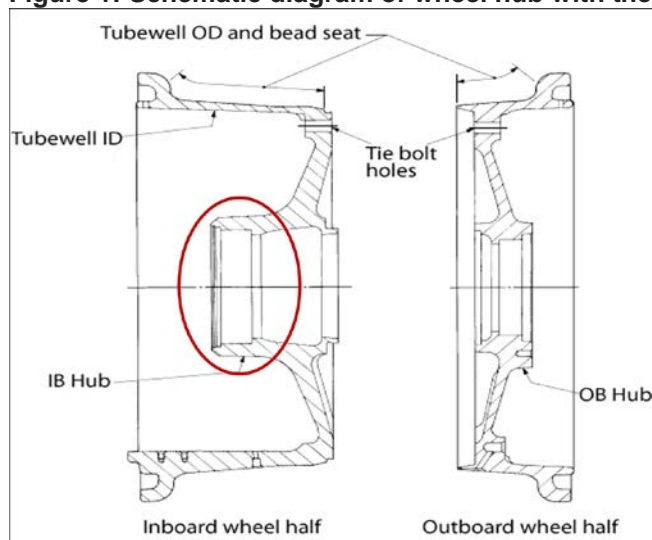
Figure 1: Schematic diagram of wheel hub with the failure location circled

The wheel hub consisted of an inboard and outboard section (Figure 1). The inboard wheel half on ZK-ZQB was part number 2612462 and serial number B3902.

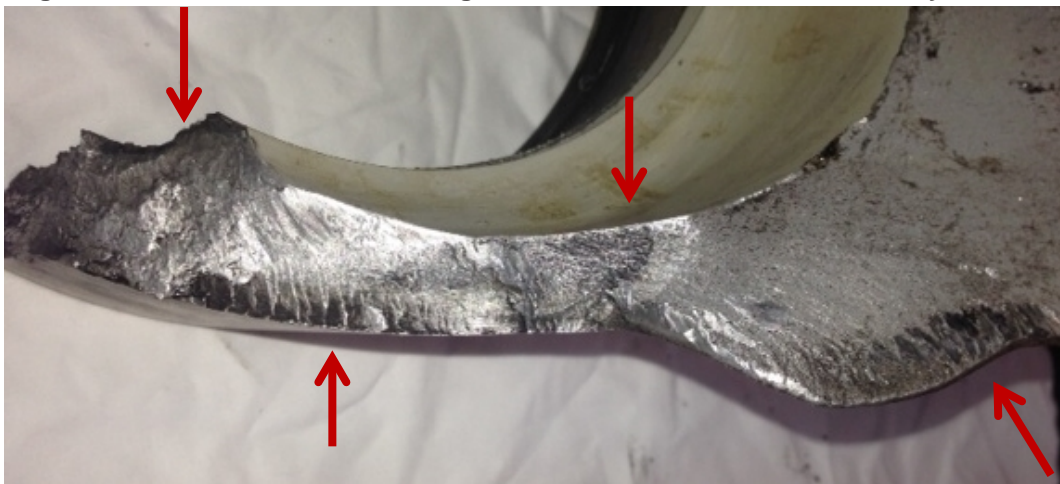
together over a period of time, obliterating some detail. The crack then became a singular front with beach marks, an indicator of fatigue cracking. The area of ultimate failure changed from fatigue to the more rapid, overload mode.

Figure 3: Secondary, circumferential crack showing, from left to right, the damaged origin area, ratchet marks/burnishing, beach marks and ultimate failure by overload

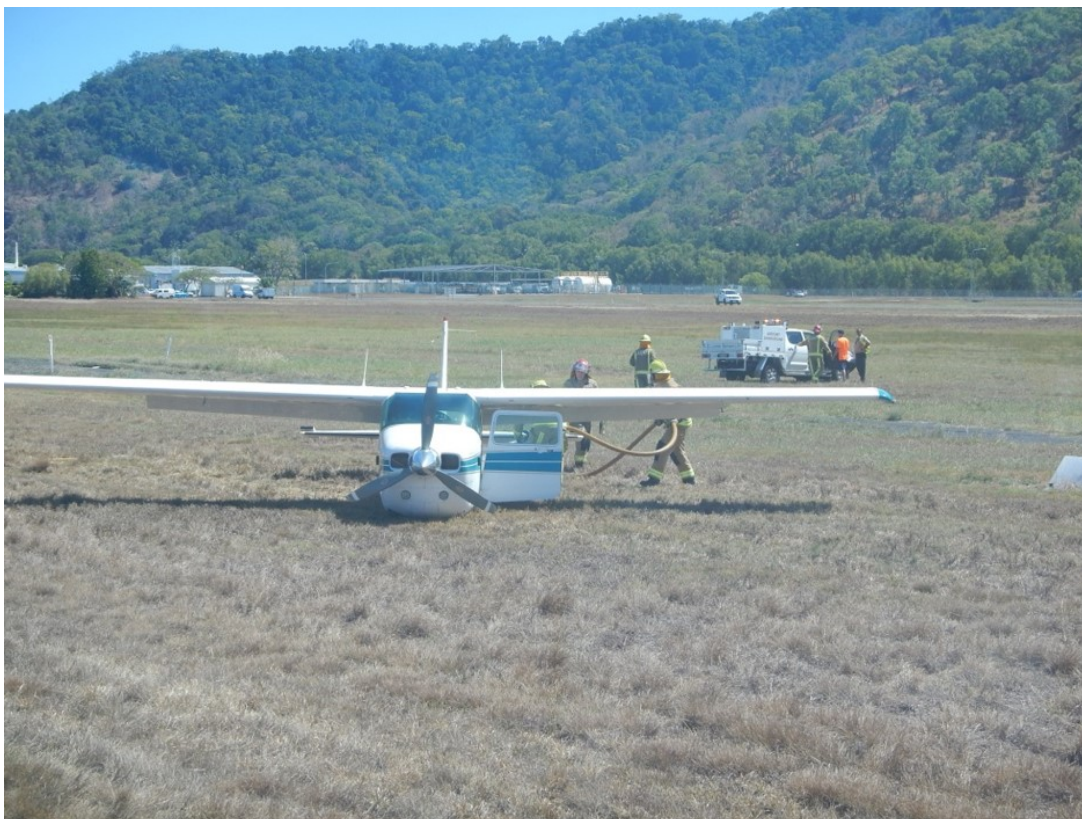
The pilot of JGA conducted two practice approaches to assess the aircraft configuration and landing area before beginning the approach for a wheels-up landing. The pilot extended the flaps to help slow the aircraft and, after turning onto a long final, briefed the passengers for the landing and instructed them to take up the brace position. Just prior to touchdown, the pilot turned off the master switch and moved the engine mixture control to the cut-off position. At about 1416, the aircraft landed on the fuselage underside on the grass area abeam runway 33 and came to a stop. The pilot and four passengers were uninjured and the aircraft was substantially damaged (Figure 1).

Figure 1: Damage to JGA

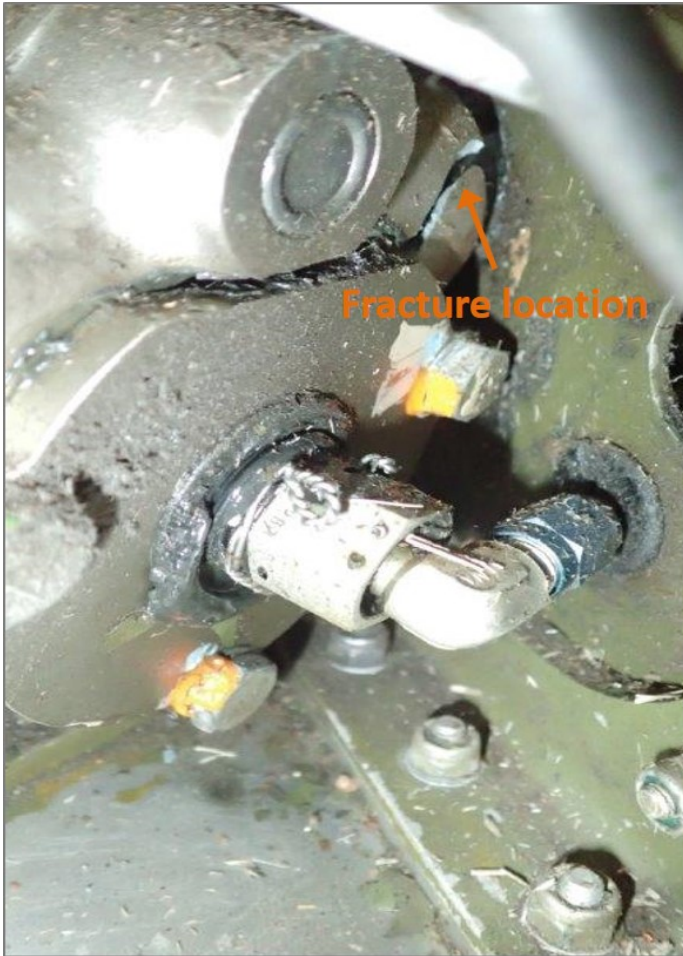
The operator conducted an investigation into the accident and determined that the housing of the left main landing gear had fractured (Figure 2), resulting in the gear not extending to the down and locked position. The operator reported that they conducted a visual inspection of the left and right main landing gear actuators for cracks and checked the tightness of the actuator mounting bolts at the periodic (100 hourly or 12-month) maintenance inspections with the actuator in-situ. The last inspection was conducted about 50 hours prior to the accident, with no defects found.

Figure 2: JGA left main landing gear actuator showing the fractured housing

Information provided to the operator by the aircraft maintenance organisation was that the actuator fractured in what appeared to be one clean break and not a crack that slowly progressed, and that type of crack could occur in a sudden overload situation during the take-off when the landing gear is selected up and the wheels contact the ground. The maintenance organisation also recommended that the Service Bulletin requirements be carried out on aircraft that have exceeded 5,000 airframe hours.

The operator's Cessna 210 aircraft fleet will undergo further examination to see if there is any evidence of other potential failures within the fleet.

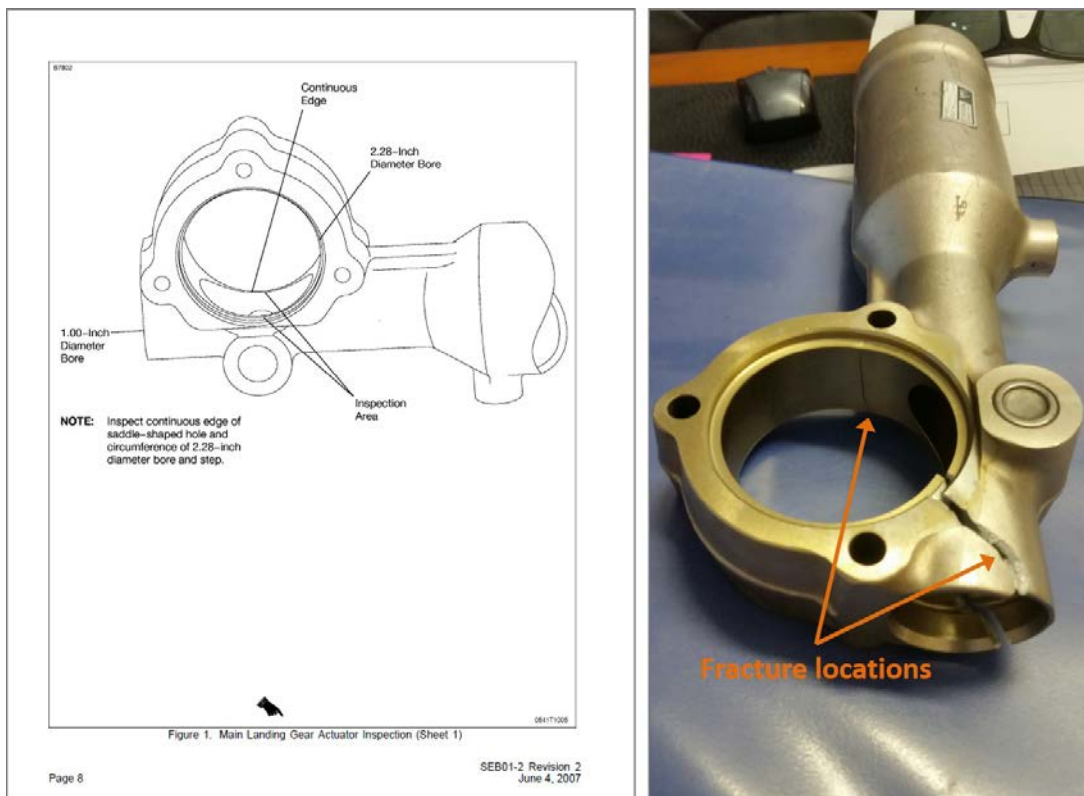
Cessna Service Bulletin SEB01-2 *Main Landing Gear Actuator Inspection* revision 2 dated 4 June 2007, required the inspection of the main landing gear actuators for the presence of cracks. Indicating that non-compliance with the service bulletin could result in failure of the main landing gear actuator. The service bulletin required the removal and disassembly of the main landing gear actuators and a fluorescent penetrant inspection of the actuator body to be carried out using black light and a magnifying glass to detect any cracks (Figure 3). The inspection was to be carried out initially every 3,000 hours total time in service within the next 100 hours operation and subsequent inspections every 500 hours total time in service thereafter.

Figure 3: JGA left main landing gear actuator showing the fractured housing

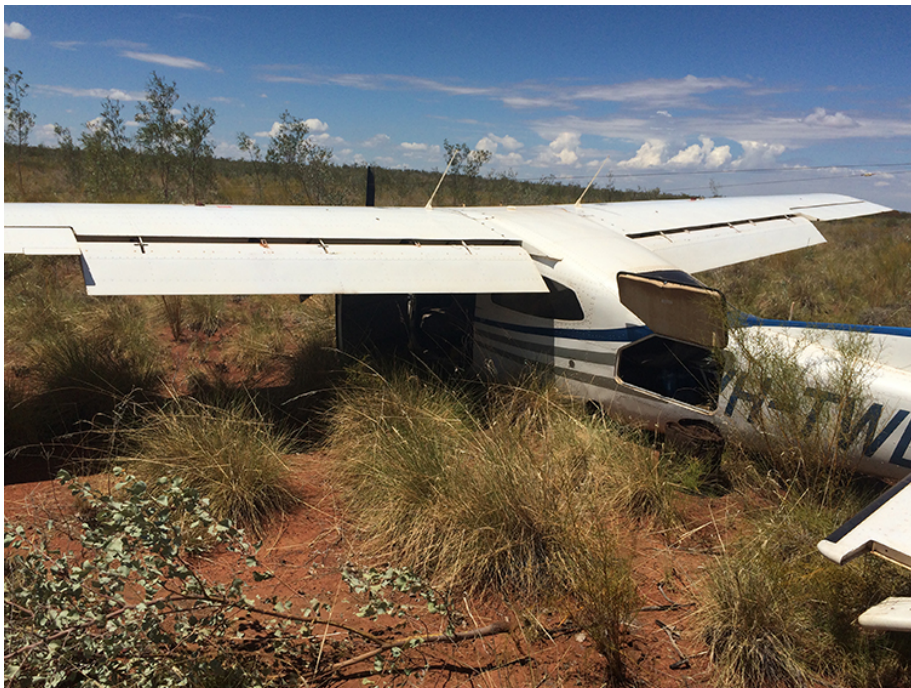
The passenger reported he had a minor head injury while the pilot was uninjured. The aircraft was substantially damaged (Figure 2).

Figure 2: VH-TWD after emergency equipment had been retrieved

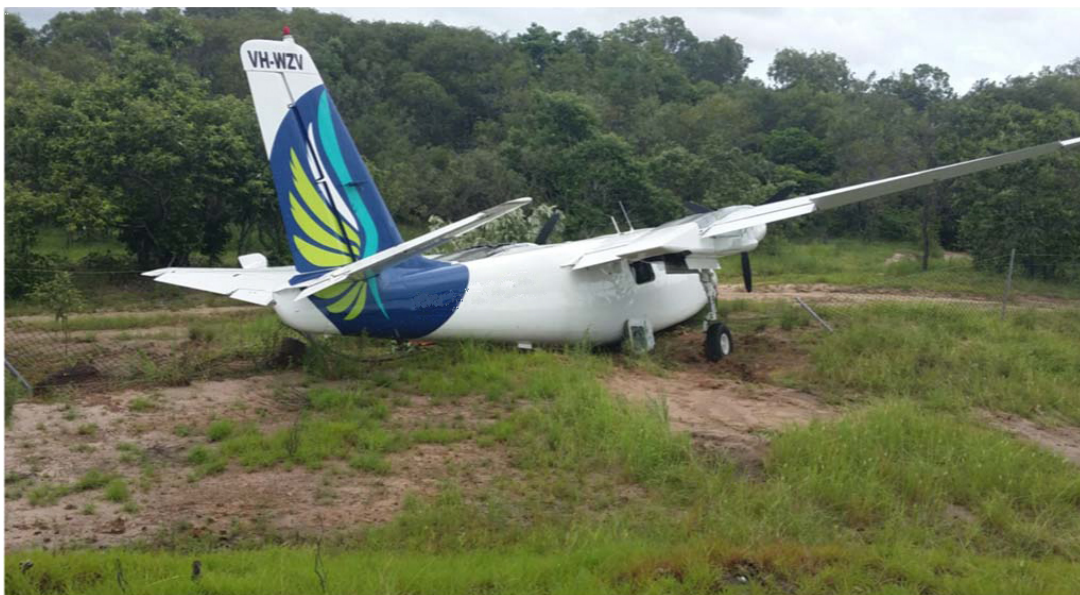
The pilot initially assessed that there was sufficient runway remaining to stop on but, due to the wet runway surface, the aircraft did not decelerate as quickly as expected and he anticipated that the aircraft would overrun the runway. As there was a steep slope and trees beyond the end of the runway, he steered the aircraft to the right towards more open and level ground. The aircraft departed the runway to the right, collided with a fence and a bush resulting in substantial damage (Figure 1). The pilot and passengers were not injured.

Figure 1: Damage to VH-WZV

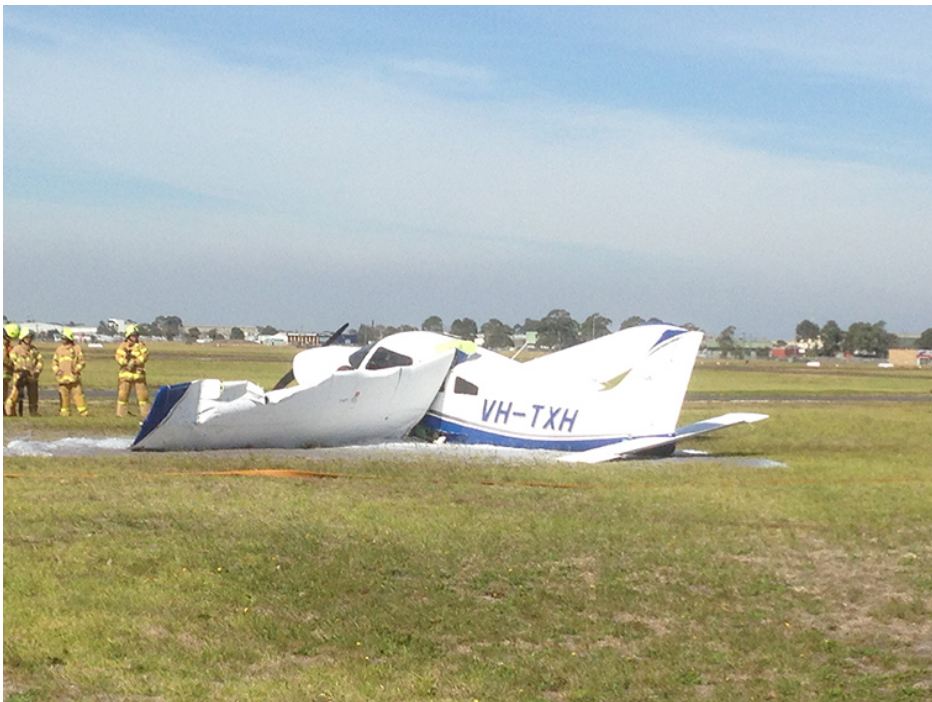
The pilot of TXH observed fuel spilling from the ruptured fuel tank and immediately exited the aircraft and reported that he was not injured. The pilot of EUU reported that he momentarily lost consciousness at the time of the collision, but came to within seconds. He then observed fuel leaking, and although feeling disoriented, he conducted a normal aircraft shut down, including switching off the aircraft electrics and fuel. He and the passengers disembarked and were treated for minor injuries. Both aircraft sustained substantial damage (Figures 3 and 4).

Figure 3: Damage to VH-TXH

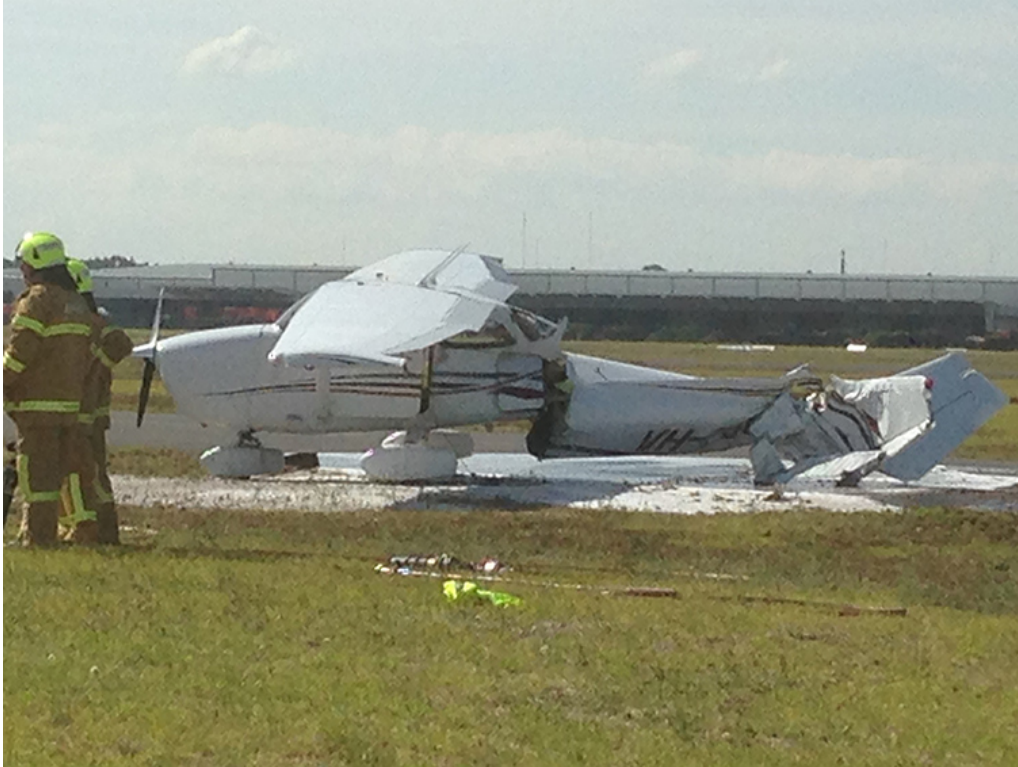
Figure 4: Damage to VH-EUU

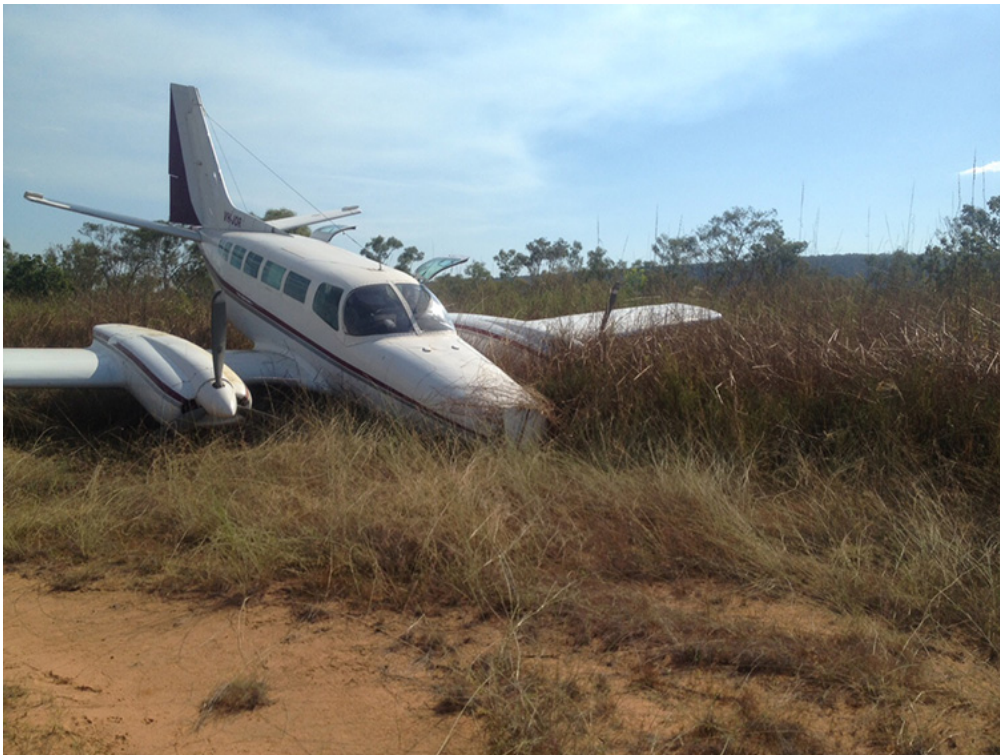
The left main landing gear momentarily lifted off the ground and the aircraft tipped to the right. As the aircraft veered off the runway and entered longer grass, the pilot regained control of the aircraft and it started to turn right and return towards the runway. The nose wheel then collided with a runway marker and collapsed, resulting in the aircraft nose contacting the ground and the aircraft skidded to a stop (Figure 2). The pilot secured the aircraft and assisted the passengers to disembark. One passenger had a cut to the back of the head from a loose object and another sustained a bleeding nose. Three other passengers and the pilot were not injured, however the aircraft sustained substantial damage.

Figure 2: Accident site

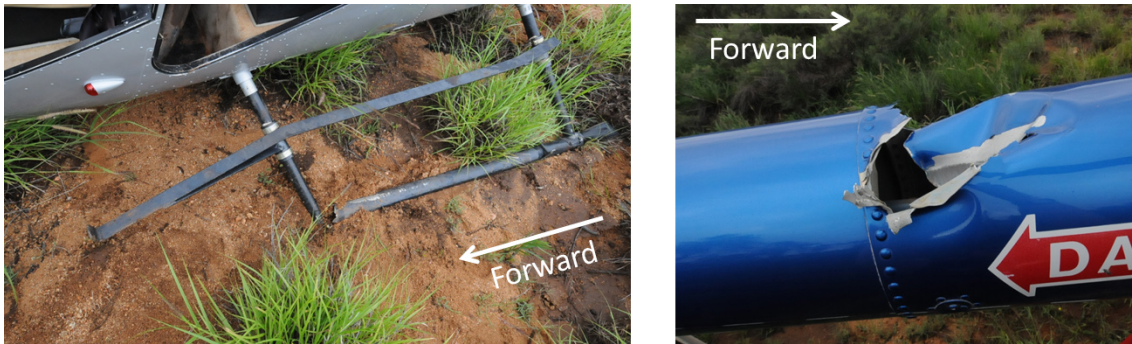
During the run-on landing, the left skid sank into mud and struck a rock. The left skid was substantially damaged by the impact (Figure 4) and the helicopter tipped precariously. As the helicopter came to a stop, it was on a substantial lean. The pilot reported that he considered the situation to be unsafe, so he immediately lifted off again and repositioned the helicopter on the ground with a level attitude. During the second lift off, a passenger recalled that the main rotor of the helicopter struck the limb of a tree, and that this was when damage to the tail boom occurred³ (Figure 4). The pilot then shut down the engine and the passengers evacuated the helicopter.

³ Damage to the tail boom is consistent with damage that could be expected if the main rotor struck the tail boom.

Figure 4: : Damage to VH-YMD skid (left) and tail boom (right)

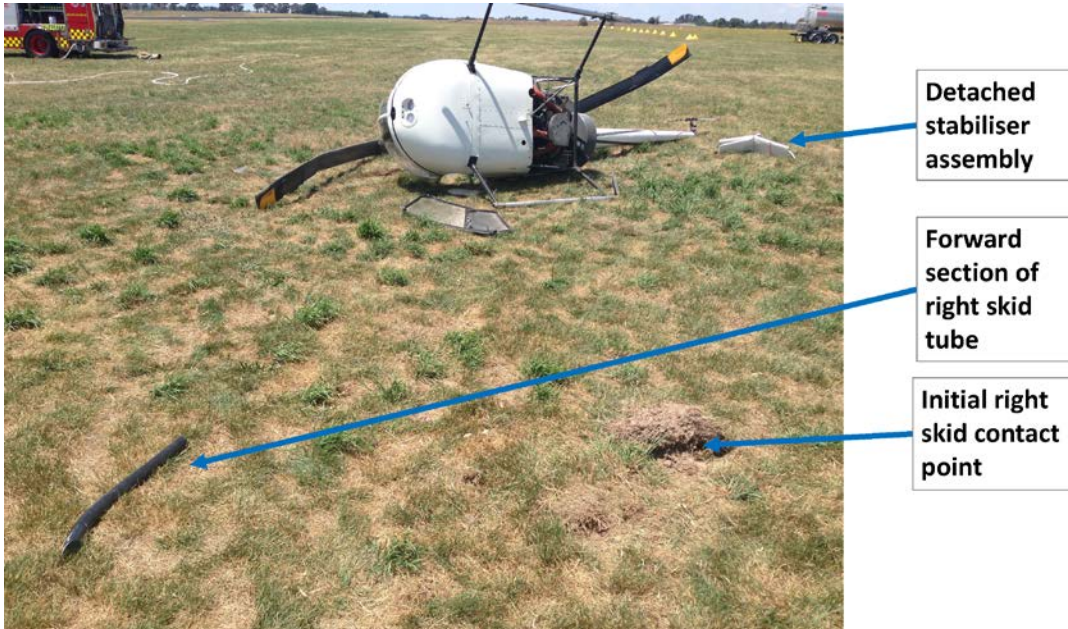
Figure 1: VH-YLP showing initial contact point

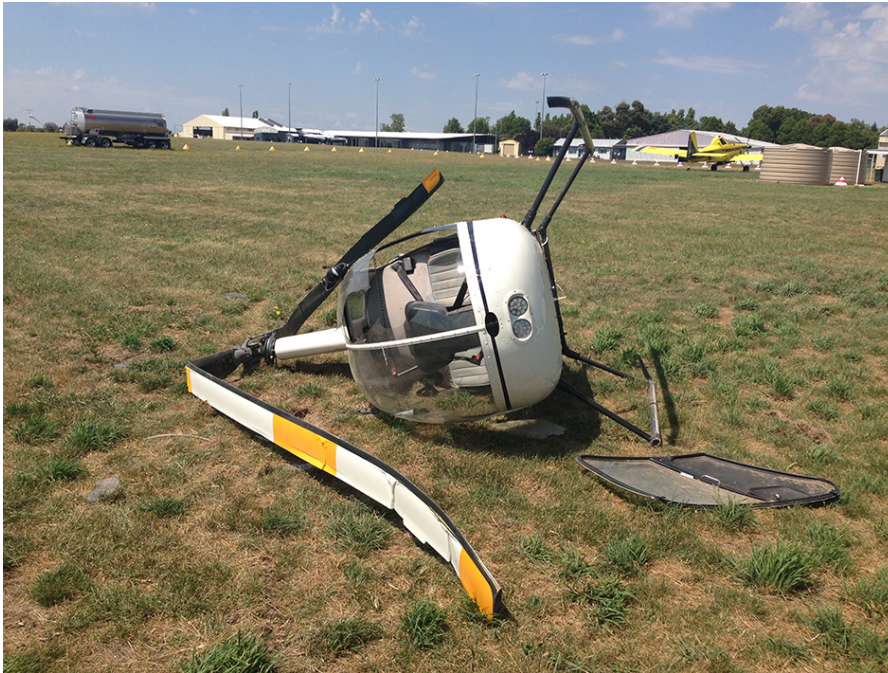
Figure 2: Detached right door and damaged rotor blades

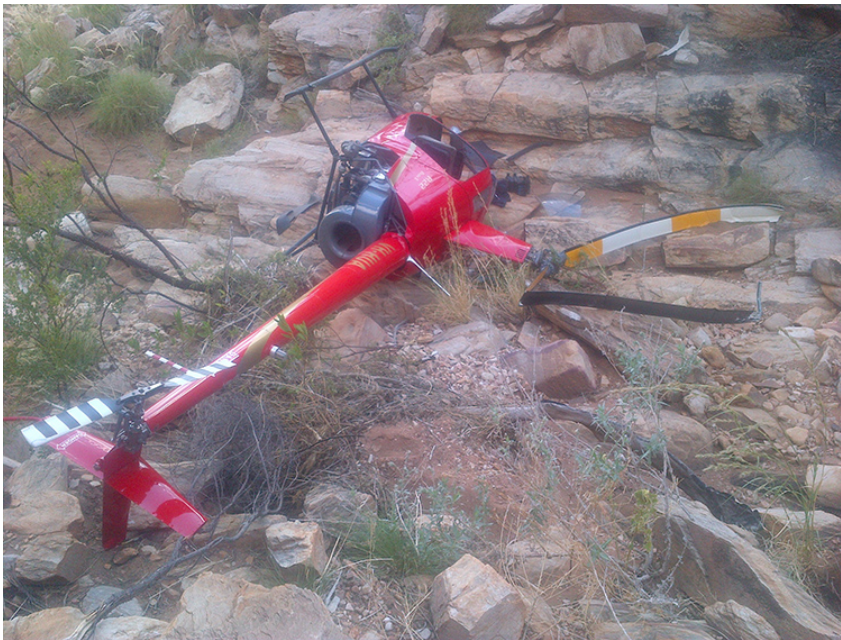
The right skid landed heavily on uneven ground, followed by the left skid. The main rotor then collided with a rock and the helicopter rolled onto its right side. The pilot and passengers exited the helicopter and were not injured. The helicopter sustained substantial damage (Figure 1).

Figure 1: Damage to VH-HUA
