Inspection Report

SGS Report No.		IN-NB-5301-11095-002	
SGS Order No.		IN-NB-5301-11095	
SGS Contact Information (Coordinator Information)		Contact Person	
		Telephone	
		Email	
Client		Macmahon	
Client Contact Information		Contact Person	
		Telephone	
		Email	
Primary Supplier			
Primary Supplier Contact Information		Contact Person	
		Telephone	
		Email	
Manufacturer			
Manufacturer Contact Information		Contact Person	
		Telephone	
		Email	
Equipment/Material Inspected		1. 32pcs - 18m long 900mm OD x 20mm wall thickness, grade S355JR steel pile casings, including 900mm OD x 50mm wt x 1000mm driving shoe 2. 38pcs - 10m long 900mm OD x 20mm wall thickness grade S355JR steel pile casings, with one end beveled 3. 40pcs - Splicing backing rings	
Technical Specification		API 5L , EN10025 and ANNEXURE A – SCOPE OF WORKS	
Project Name			
Inspection Location			
Client Ref. No.	N/A	Manufacturer Order No.	N/A
Date of inspection	3 Dec.~11, 15~19 and 22~23 Dec., 2011	Inspector	Isaac Li & Todd Guo & Kim Xu & Arvin Wang & Junquan Liu & Ivan Pan

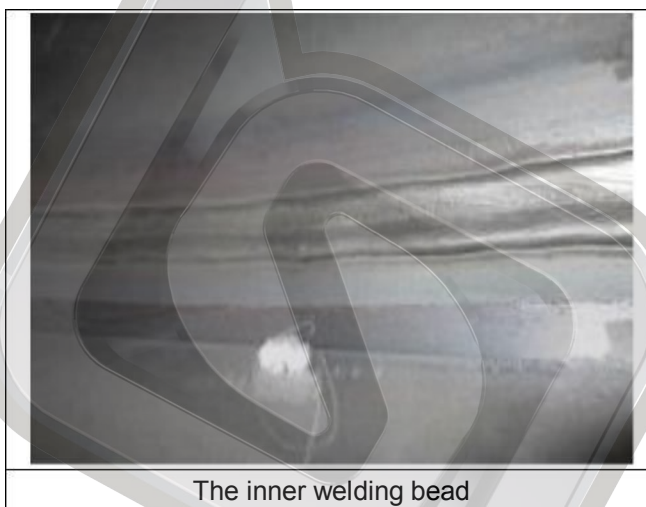
During this inspection, visual inspection of welding bead was carried out after repaired welding bead were finished. Undercut \leq 0.8mm, internal weld reinforcement \leq 3.5mm and external weld reinforcement \leq 4.5mm, no obvious defect was found.

No porosity, crack, spatter, weld flash and weld defect were found on pile casings. The internal concavity was found and not lower than the base metal. The detail is as below,

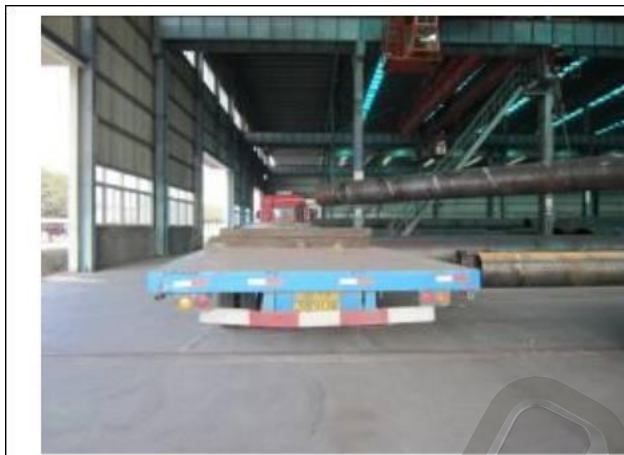
Loading onto the truck at the factory

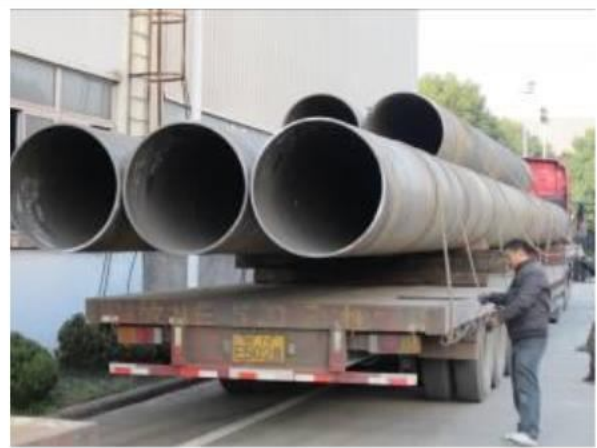
Loading onto the truck at the factory

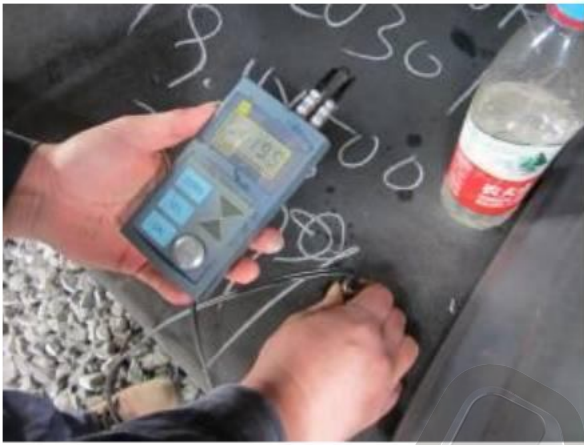
Check the thickness of raw material

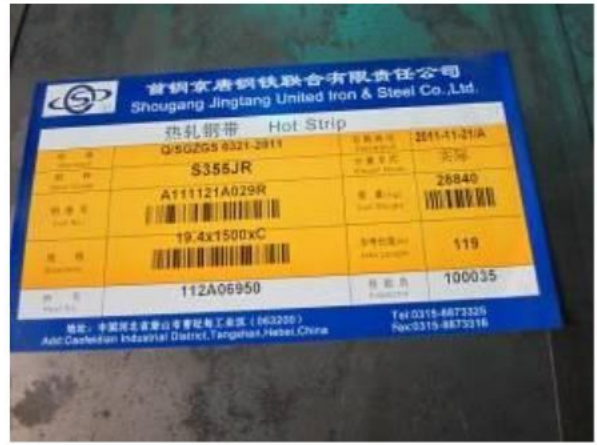
The label on the raw material

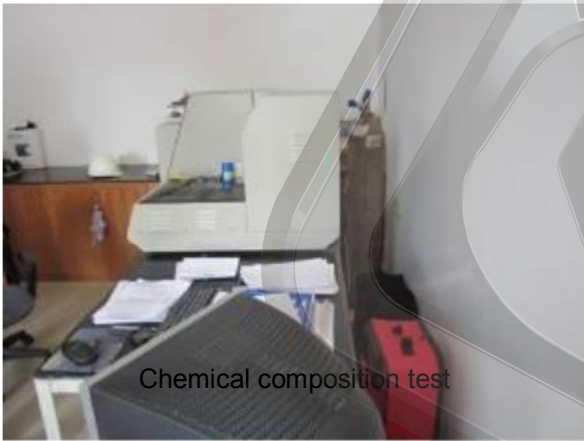
Chemical composition test

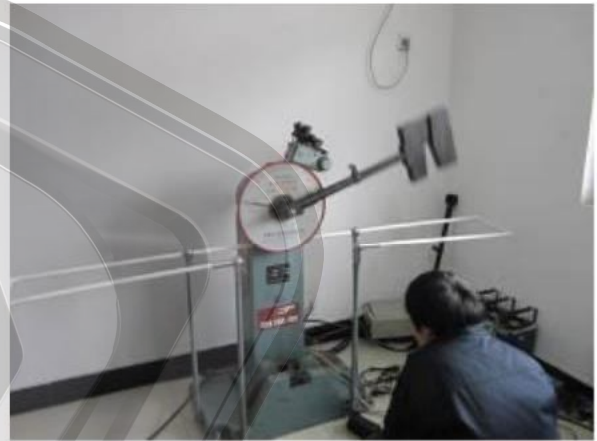
Impact test

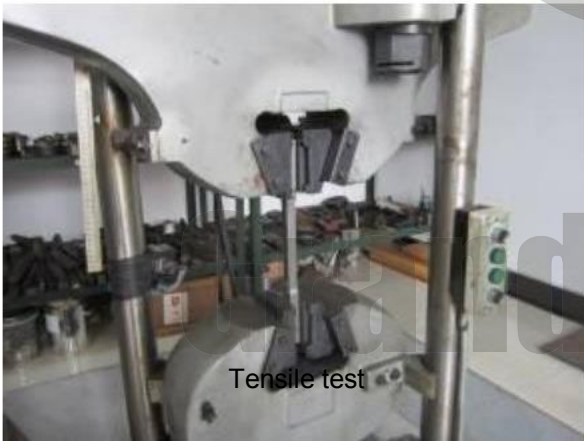
Tensile test

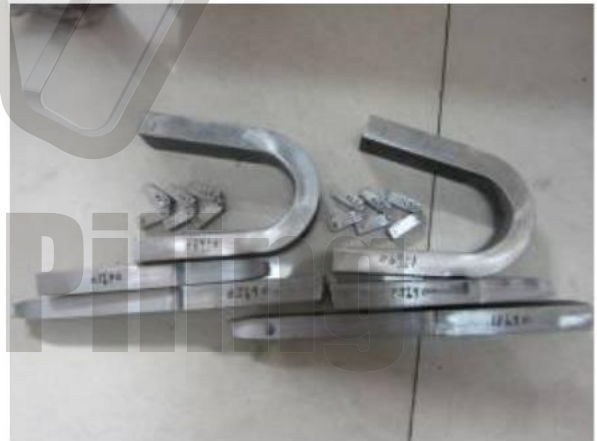
The bending test specimens of raw material

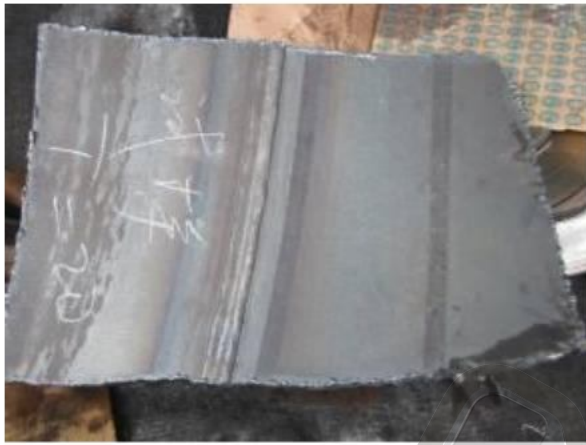
The sample of welding bead

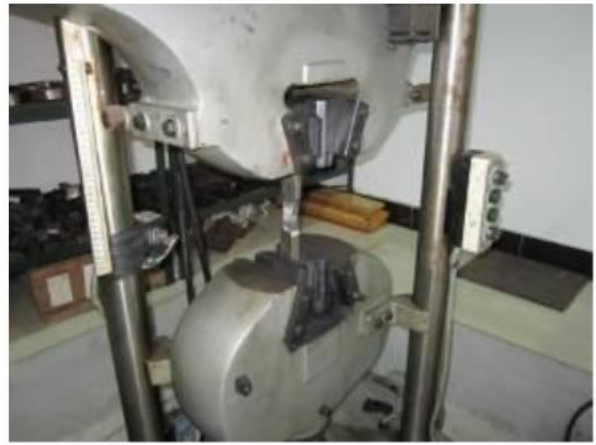
Material tensile test for welding bead

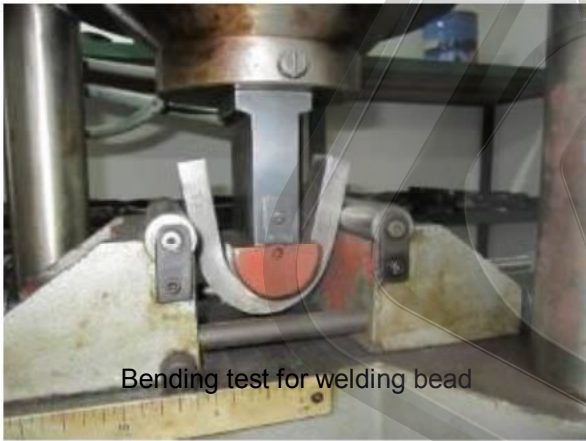
Bending test for welding bead

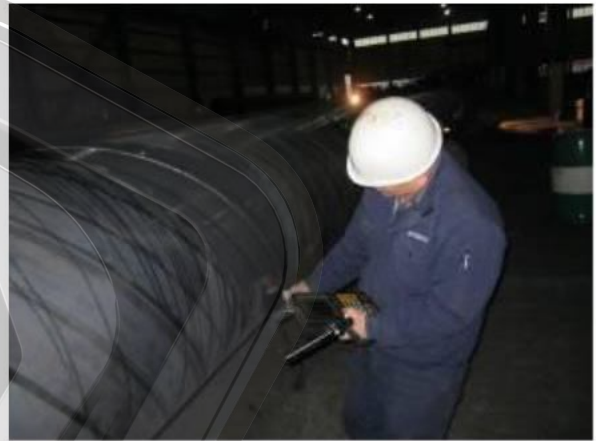
UT test

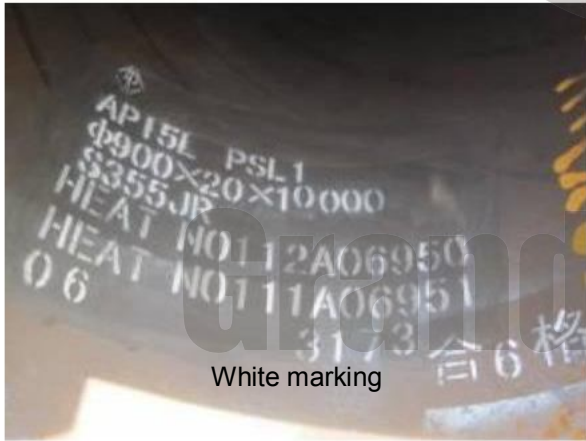
White marking

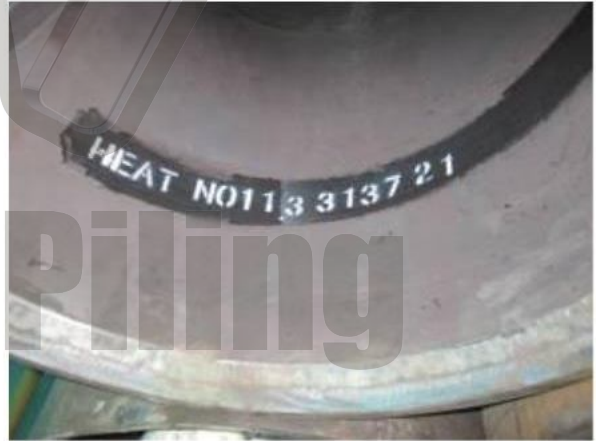
White marking

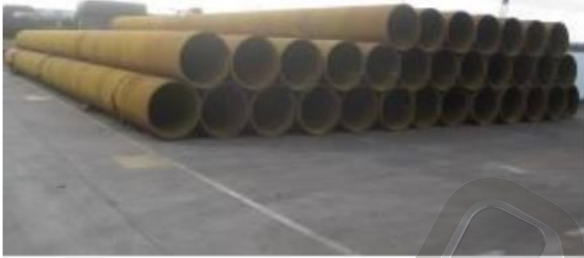
Cargo were found stored on yards up to 3 tiers high without covering protection. And without dunnage supported to separation ground and bottom tubes.

Storage cargo condition on open yard
Size:900 x20x19000mm

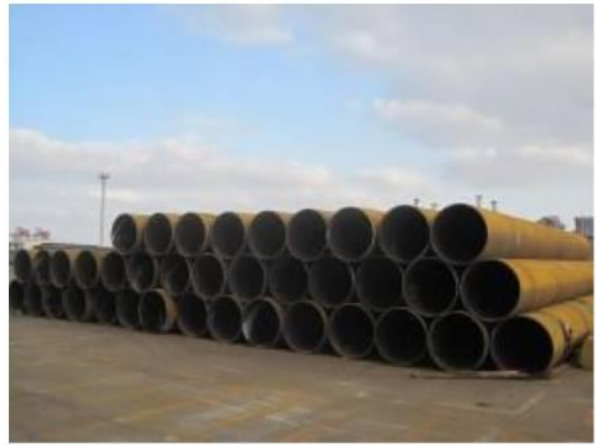
Storage cargo condition on open yard
Size:900x20x10000mm

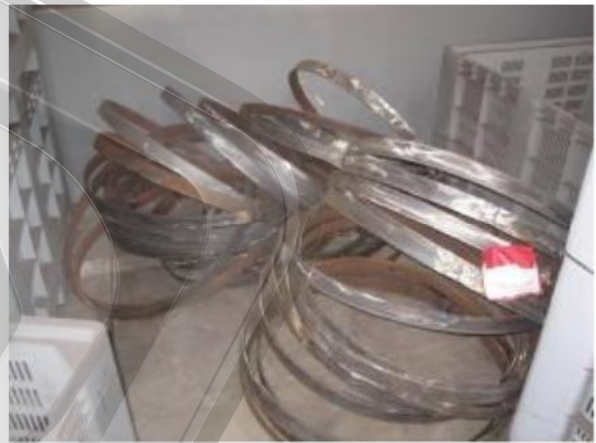
Splicing backing rings: 860x6mm

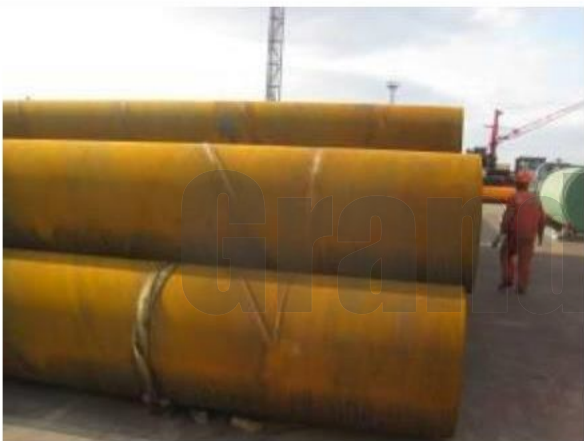
As far as visible and accessible, all of the steel pipes were found slight scrape and rust stained on the surface.

Rust stained on surface

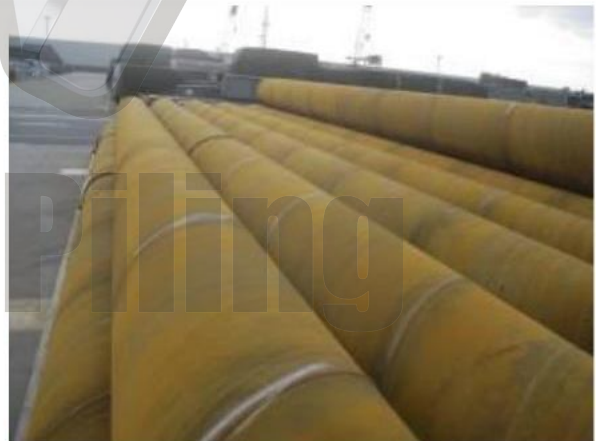
Rust stained on surface

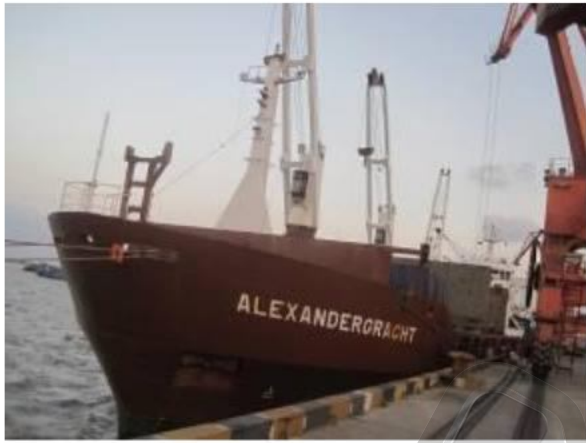
Carrying vessel

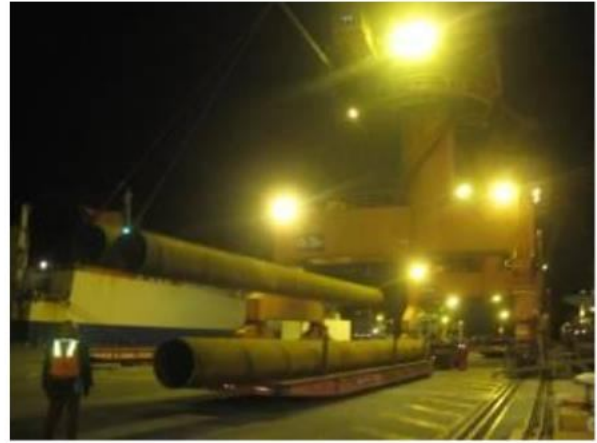
During loading

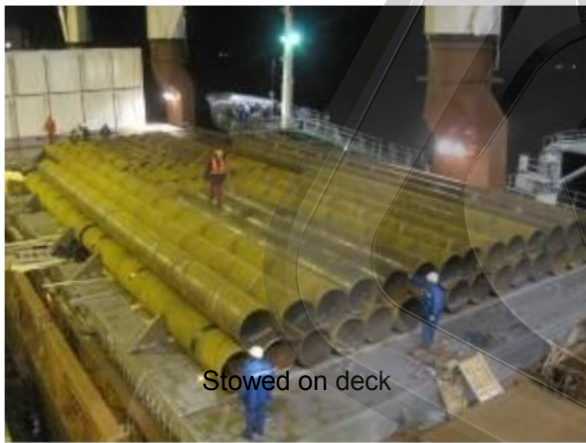
Stowed on deck

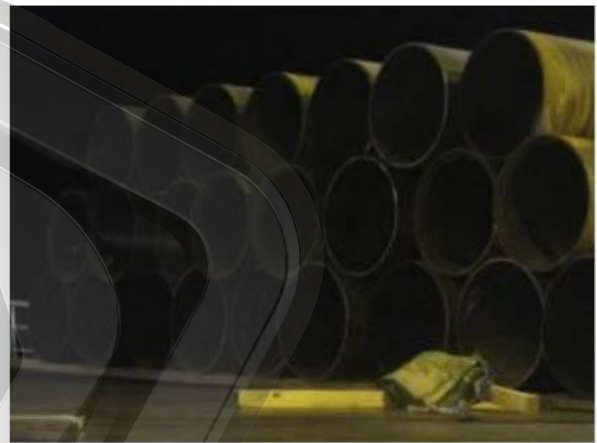
Stowed on deck

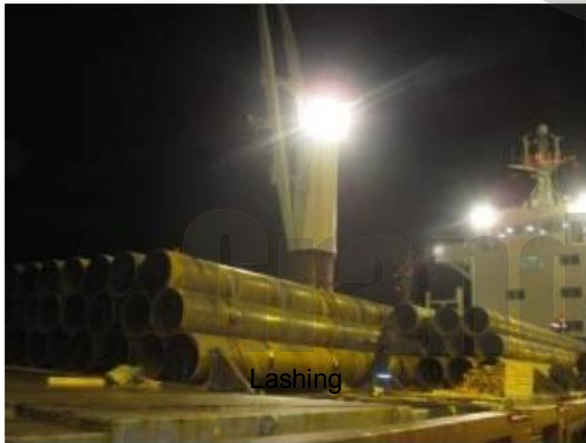
During loading, wooden timbers were used between the deck and pipe to avoid cargo touch the ship directly. After the loading completion, our cargos (Steel pipes) were lashed by up to 6 pieces of steel wire on deck. The entire lashing and securing checked by Chief Mate and SGS surveyor found in sound condition.

Lashing
