# Integration Relay - Poor Ground

YEAR(S)	MODEL(S)	ADDITIONAL INFORMATION
2012 – 2013	Camry HV	
2012 – 2013	Camry

Some 2012 – 2013 model year Camry and Camry HV vehicles may exhibit a condition where the passenger-side headlight and rear defogger operate continuously.

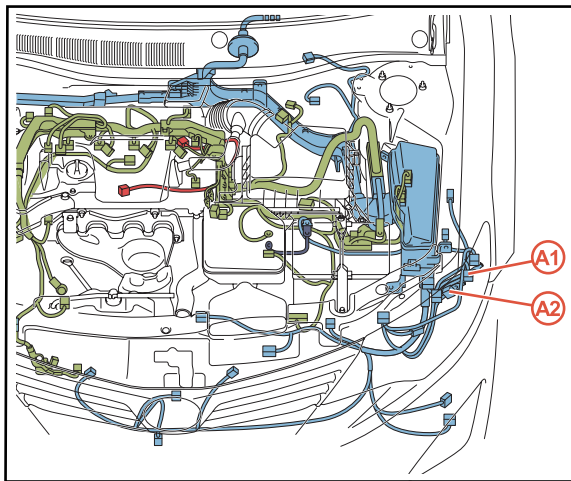
Figure 1.

1. Has the vehicle had body work or the A1/A2 grounds, or apron mounting bolts disconnected?
  - **YES / UNSURE** — Continue to step 2.
  - **NO** — This bulletin does NOT apply. Continue diagnosis using the applicable Repair Manual.

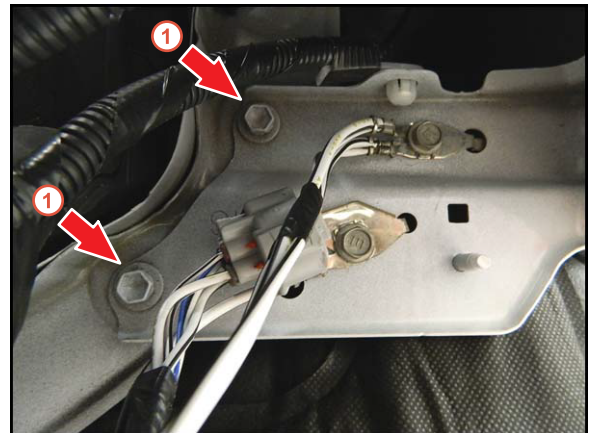
Figure 2.

<b>1</b>	<b>Apron Bolts</b>
----------	--------------------

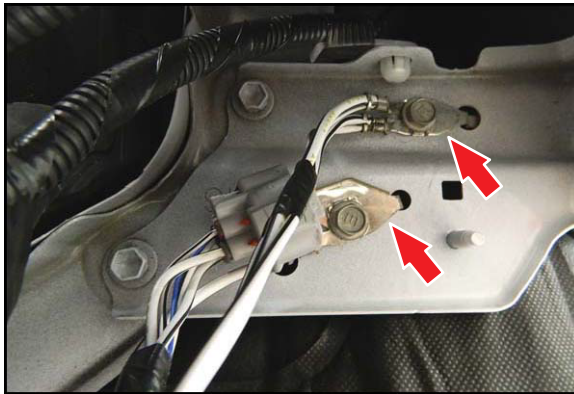
Figure 3.

7. Perform voltage drop test\* from the two left fender bracket ground wire eyelet tabs to body ground (see Figure 3).

8. Is voltage drop from each ground location less than 0.2 volts?
  - **YES** — This bulletin does NOT apply. Continue diagnosis using the applicable Repair Manual.
  - **NO** — A voltage drop of 0.2 volts or more from either of the ground locations may indicate poor continuity in the ground circuit. Proceed to step 9.
9. With battery disconnected, remove the left hand fender bracket from the apron for inspection.

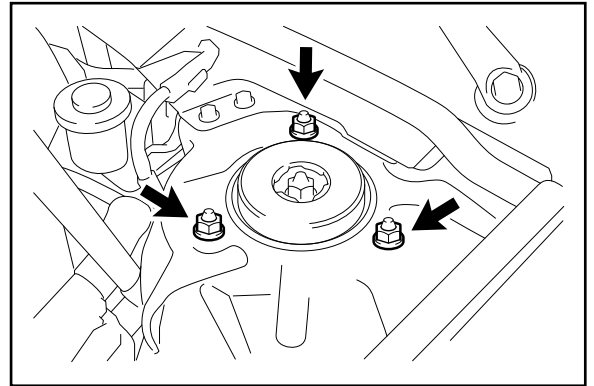
Figure 4.

- A. Use a left front strut tower mounting bolt as a good body ground (see Figure 4).
- B. To perform voltage drop test, connect the negative lead of the DVOM to the strut tower bolt, and the positive lead to the ground wire eyelet tab.

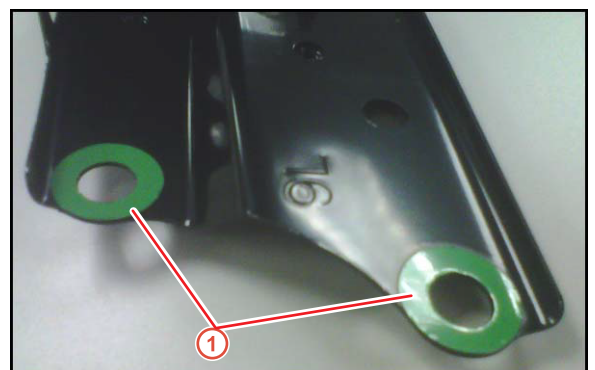
Figure 6.

- Ground bolts are “E” bolts (see Figures 5 and 7).
- Apron bolts should be “E” bolts if left hand fender bracket has been replaced (see Figures 5 and 7).
- The area around the bracket to apron mounting bolt holes (see Figure 6) is free of paint.
- The area around the apron mounting bolt holes do not show masking tape or painted masking tape (see Figures 5 and 6).

<b>1</b>	Masking Tape — REMOVE After Painting, NO Paint in This Area
----------	---

- It is important that the bracket to apron mounting bolts/washers are free of paint on the front portion of the bracket.
- The new part number bracket comes with instructions that should be followed carefully when replacing.
- The new bracket also comes with green tape around the apron mounting bolts to protect it during the painting phase (see Figures 5 and 6). ***This green masking tape MUST be removed in order for the bracket to be properly installed on the vehicle.***
- The new bracket includes new apron “E” mounting bolts. It is important that the new “E” bolts are used and are torqued properly. See Figure 7 on how to identify new bolts.

- **NO** — Replace the left hand fender bracket.
- **YES** — Remove the tape or paint and continue to step 12.

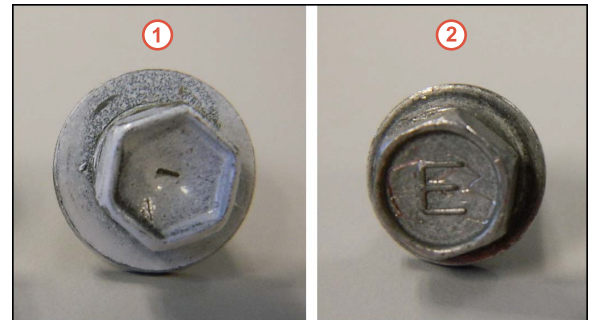
Figure 7.

<b>1</b>	Old Bolt: DO NOT USE or Reuse These Bolts
<b>2</b>	NEW “E” Bolt

**Torque: Ground Bolts:**  
 6.9 – 9.8 N\*m (70 – 100 kgf\*cm,  
 5.1 – 7.2 ft\*lbf)

**Torque: Bracket to Apron Bolts:**  
 3.9 – 8.8 N\*m (40 – 90 kgf\*cm,  
 2.8 – 6.5 ft\*lbf)

12. Once areas are repaired and secured with new “E” bolts, replace the Engine Room Junction Block Assembly.
