INVESTIGATION AND ELASTO-PLASTIC ANALYSIS OF AN RC BUILDING IN WHICH MAJOR SLIPPAGE OCCURRED ON THE 1ST FLOOR-SLAB DURING THE 1995 HYOGO-KEN NANBU EARTH-QUAKE

Tomoko ONODERA¹, Eiji MAKITANI², Akira MIZUKAMI³ And Wataru SHINAGAWA⁴

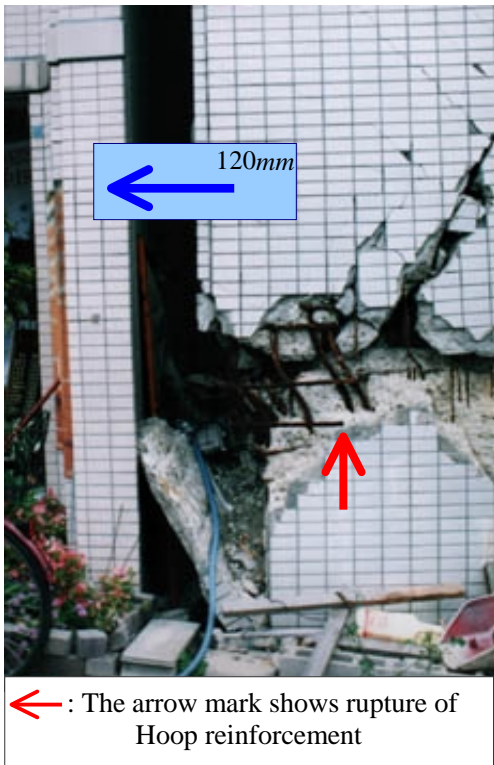
The collapse of the building originates in the great slippage of columns and walls which was caused on the first floor because the concrete interface of structures between the first story and basement story was constructed by smooth finish. Such a phenomenon has not been seen in the disasters of past great earthquakes in Japan. The shear failure occurred on the frame and the shear wall with openings in the external first story, where a corner column moved greatly outward after the shear failure at its base, as shown in Photo.3. It was observed in many buildings that the hoop reinforcement of column was broken at the corner and the intermediate straight portion. The same rupture was seen at the hoop reinforcement of the connection of the corner column and the first floor beam, as shown in Photo.3. Otherwise, shear failure was recognized in the connection of first story column and second floor beam. The same phenomenon was also found in many buildings in which great damage was caused, as shown in Photo.4.

Photo.3 Shear failure by slippage in bottom of corner column of first story

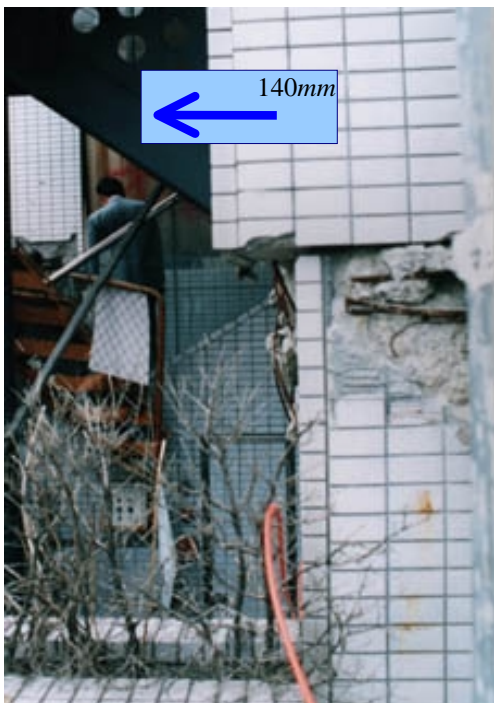
Photo.5 Failure of wall by slippage in elevator-shaft

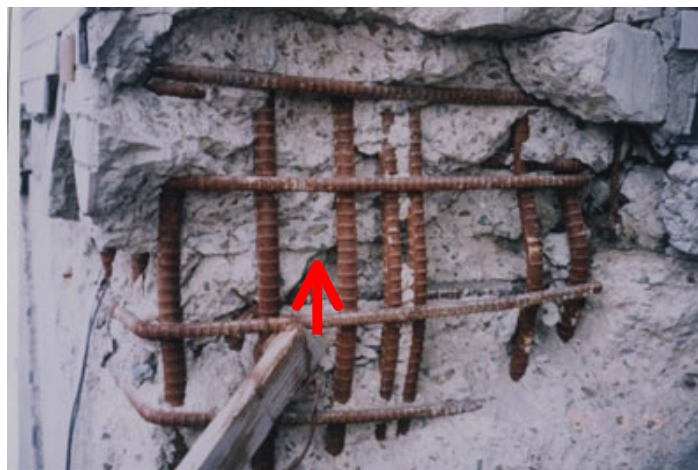
Photo.6 Slippage in the bottom connection of corner column on the first floor

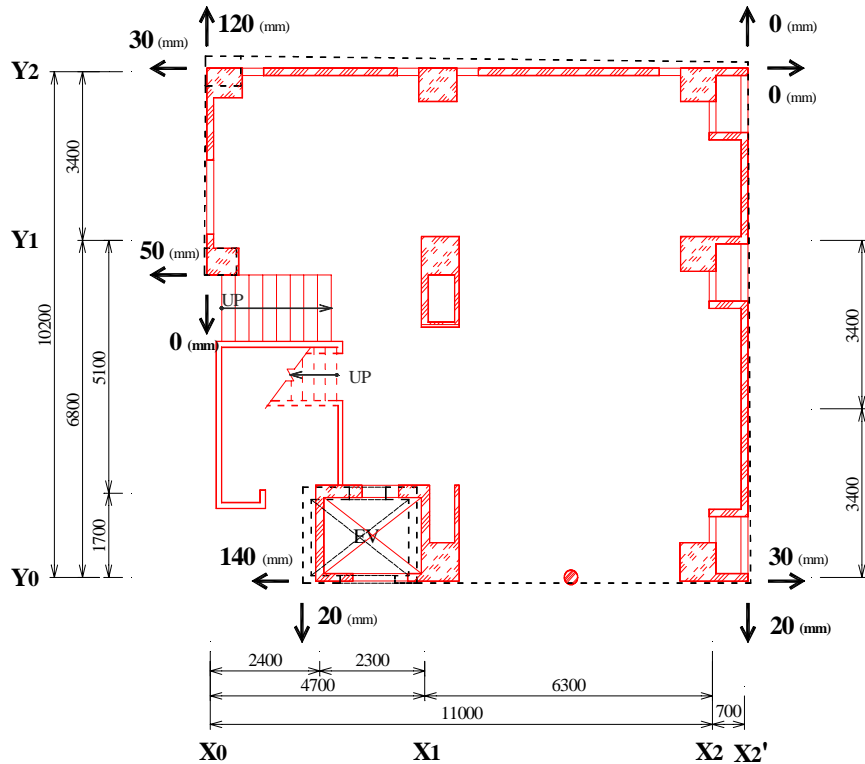
The outward movements of corner columns and walls on the surface of the first floor in X and Y directions are depicted by dotted lines in Fig.2. The movement indicates the residual displacement by slippage and the maximum values are measured as 120 (mm) and 50 (mm) at the corner columns in X direction as shown in Photo.3 and Photo.6 respectively and 140 (mm) at the elevator shaft wall in Y direction respectively, as shown in Photo.5. Therefore, it is recognized that those movements are affected by the torsion caused from the eccentricity of external walls in X direction. They occurred because the interface of concrete connection was constructed by not rough finish but smooth one, where the mean height of concave and convex is measured as 1.86 (mm) using a laser type of displacement meter as shown in Fig.3, although it should be more than 4 to 5 (mm).

Fig.2 Slip displacement of corner columns and wall in first floor

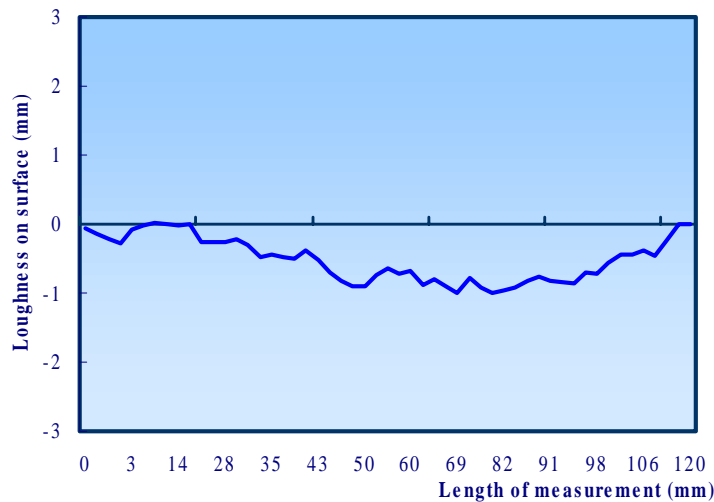
Fig.3 Result of measurement for roughness on the surface of first floor

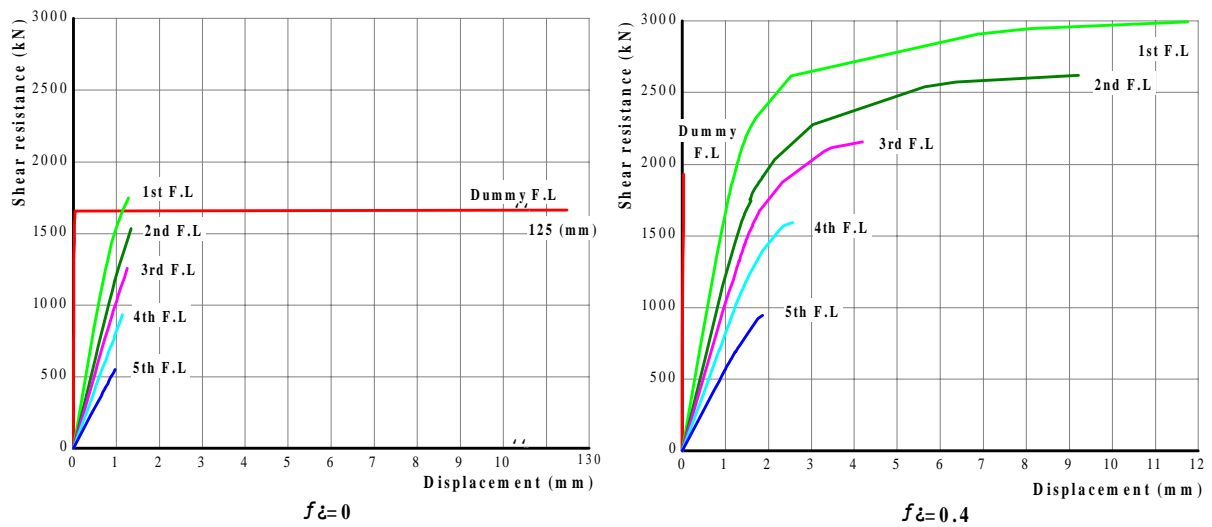
The relationships between shear resistance and lateral displacement in each floor are plotted for $\alpha=0$ and $\alpha=0.4$ in Fig.5, where the lateral displacement concentrates in the first floor. In the upper floors it is very small in the case of $\alpha=0$.

Fig.5 Relationships shear resistance and lateral displacement for $\alpha=0$ and $\alpha=0.4$

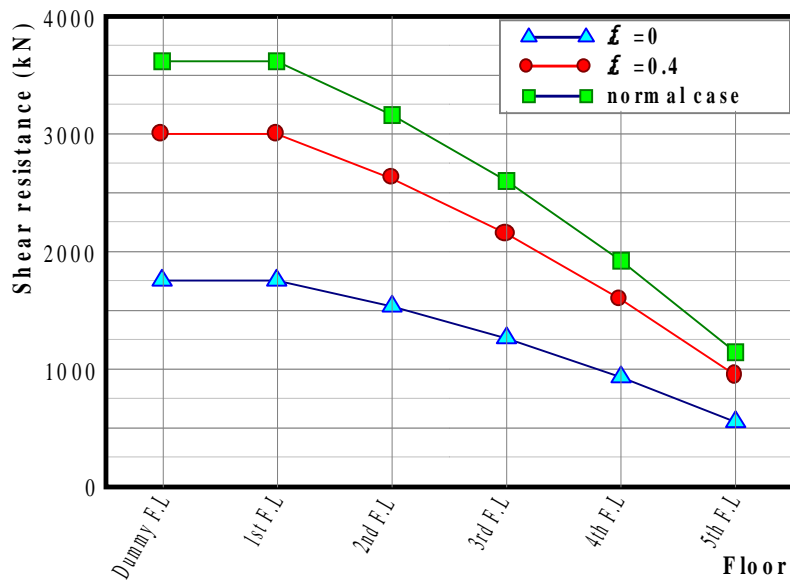
The shear resistances in each story are plotted for the case of $\alpha=0$ and $\alpha=0.4$ as well as the normal case which does not evaluate the slippage in Fig.6.

The shear resistance in frame is observed to reduce remarkably as the value of α decreases. It is found that the slippage of column in the first floor gives a great influence to the shear resistance in the frame.

Fig.6 Shear resistance for each floor
