# INVESTIGATION OF THE MARCH 31, 2013 TEMPORARY OVERHEAD CRANE COLLAPSE AT ARKANSAS NUCLEAR ONE POWER PLANT IN LONDON/RUSSELLVILLE, AR

U.S. Department of Labor  
Occupational Safety and Health Administration  
Directorate of Construction

August 2013

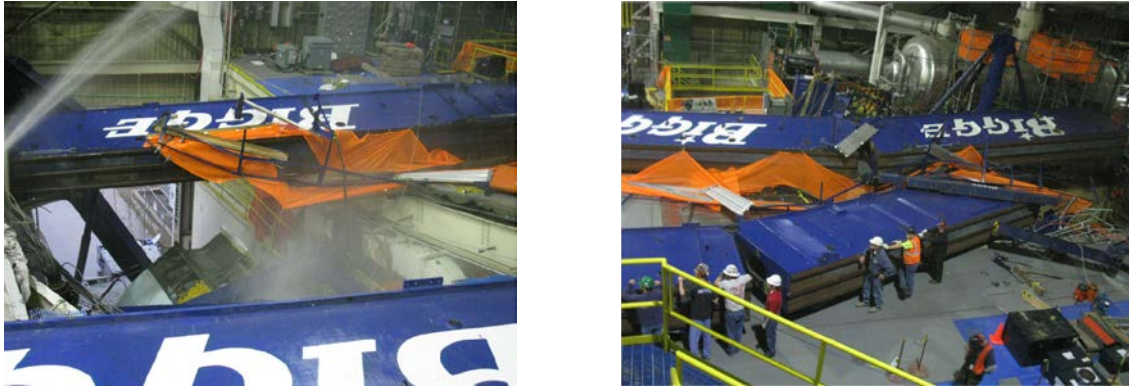
removed, the crane failed and fell onto the deck, killing one of those PSC employees who just removed the railing, see figure 8.

Figure 8 – Runaway girders after the collapse

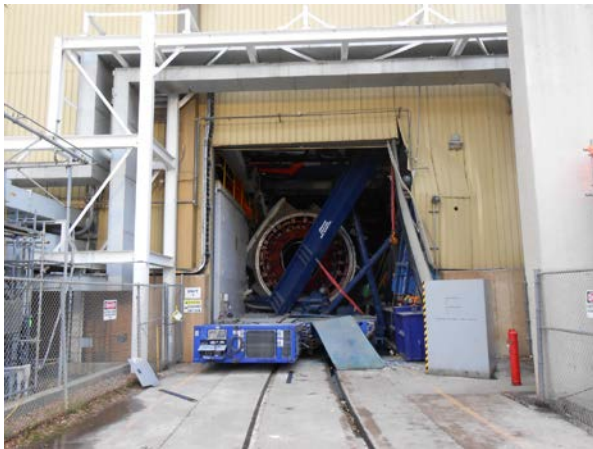
The actual movement of the stator began approximately 6:40 a.m. The stator was moved for approximately an hour when it reached within a few feet of the final destination when the stator was to be rotated. At approximately 7:50 a.m., the crane collapsed towards the west, crashing the two 8 foot deep girders on the turbine deck, with all the north supporting frames twisted and intertwined with the stator which partially dropped into the train bay, see figures 9, 10 and 13.

Figure 9 – Stator looking west

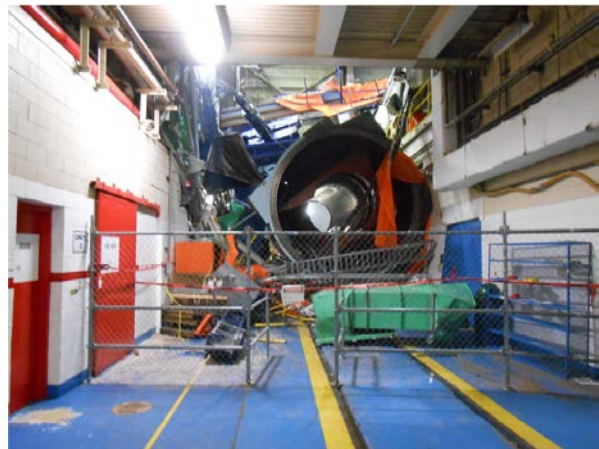
Figure 10 – Stator looking east

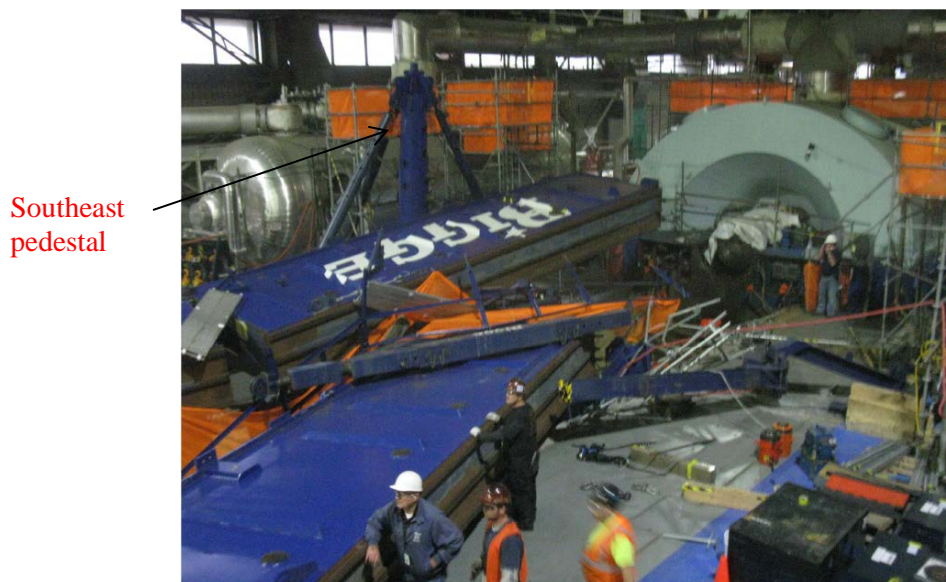
The two blue gantry girders fell towards the west. The girders consisted of three segments which remained connected to each other at the bottom flanges with the pins, while the top compression flanges separated as they were not positively connected to each other. The girders sustained little damage. The southeast pedestal remained standing while the southwest pedestal fell into the pit, see figure 11. Most of the damage occurred on the north frame supporting the gantry girders. The stator fell into the train bay.

Figure 11 – Southeast pedestal remained standing

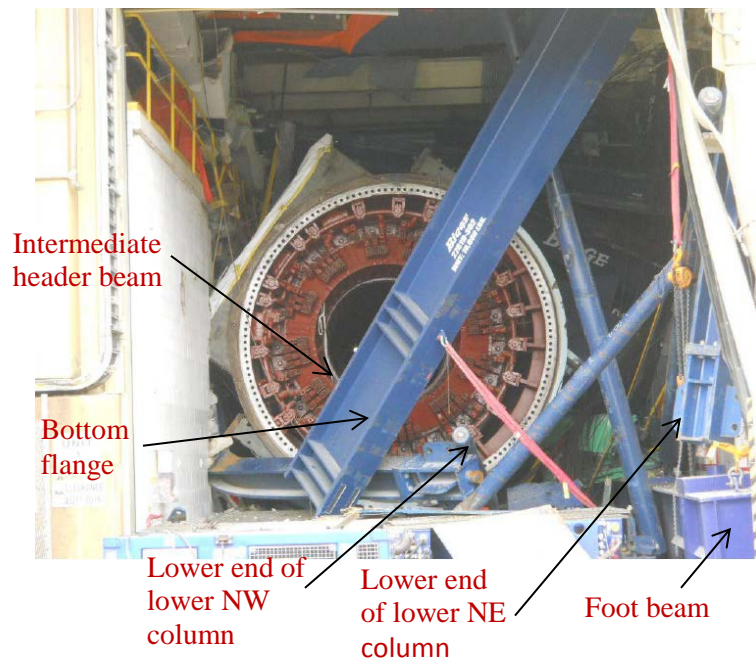
The upper connection of the lower northwest column to the intermediate header beam bottom flange failed at the welds. The lower pinned connection of the lower northwest column to the foot beam was intact except it jumped out of its socket, and was lying flat. The stator fell over the lower northwest column creating a sharp bend, see figure 12.

The upper northwest column remained intact except that the welded connection to the upper flange of the intermediate beam failed similarly to the failed welded connection of the lower northwest column. The northeast columns remained intact except that at the junction of the

intermediate header beam, the columns rotated through the pin but remained straight, and were not damaged. The upper header beam also remained undamaged. See, figures 12 and 13, below with all fallen members identified.

Figure 12 – Stator looking west

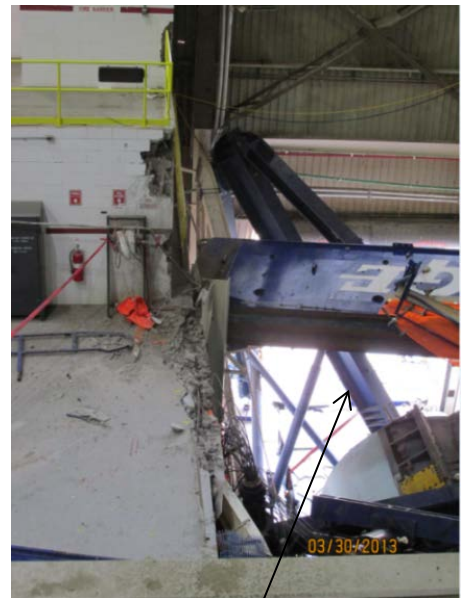
Figure 13 – NE column and west girder

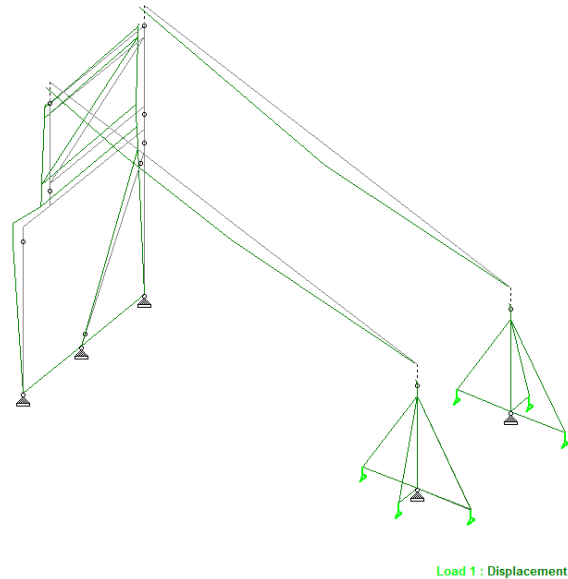
We ran a three-dimensional structural analysis using the commercially available program STAAD.Pro V8i. Our analysis indicated that the failure initiated at the lower NW column essentially due to instability as the top of the column underwent increasing lateral displacements in the N-S direction.

Figure 15 – Displacements

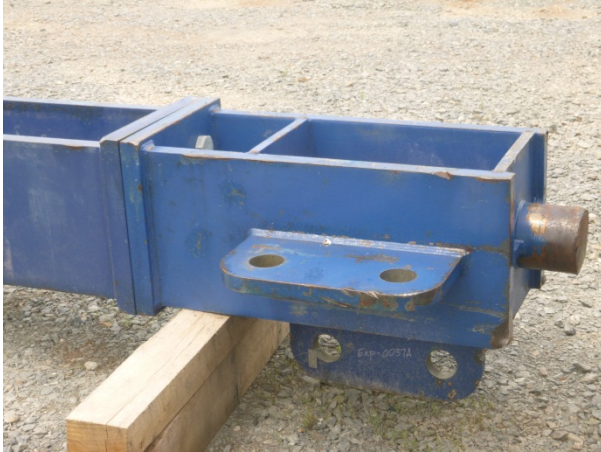
This was the most damaged structural member, the damage coming from the direct hit by the falling stator. The member had to be cut during the retrieval process. The sharp bend sustained by the upper piece of the column is illustrated in the figure, below. In addition to the bend, the flanges had local deformations as a result of the collapse. The lower true pin was intact, see figure 22 but the upper unidirectional pin welded connection to the bottom flange of the intermediate header beam was sheared off, see figures 23 to 25. The 16" long fillet welds on either side of the two 2 ½" thick plates failed, see figure 26 and 27. The welds connecting the four lower 1½" plates to the top of the column remained intact. The pin was practically undamaged.

Figure 22 – Bottom pin of lower NW column

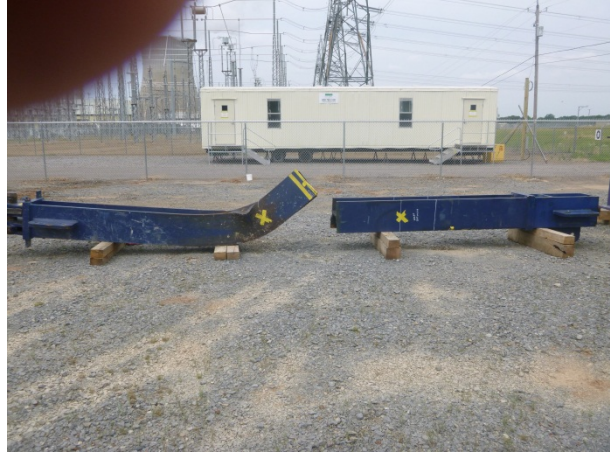
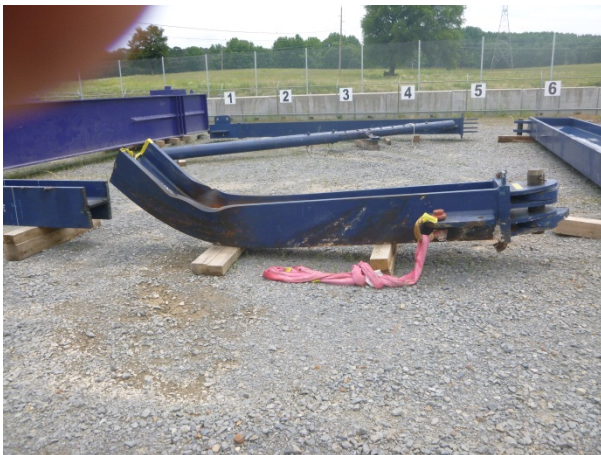
Figure 23 – Lower NW column

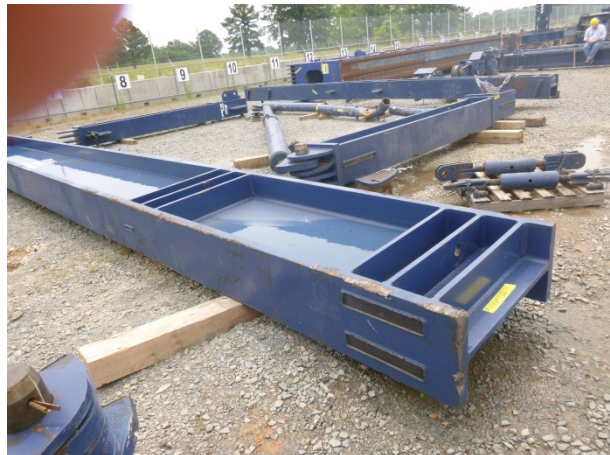
Figure 25 – Top connection of the lower NW column

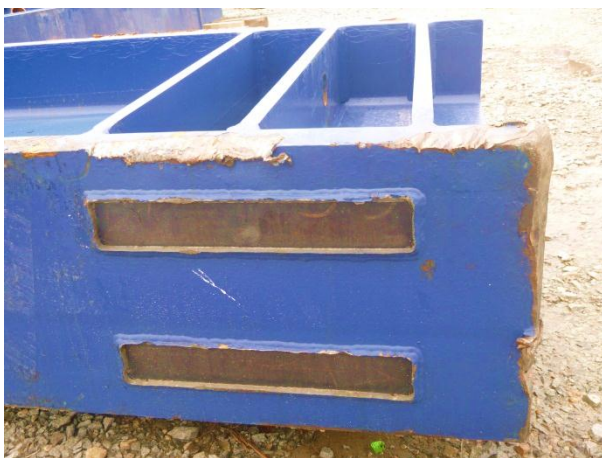
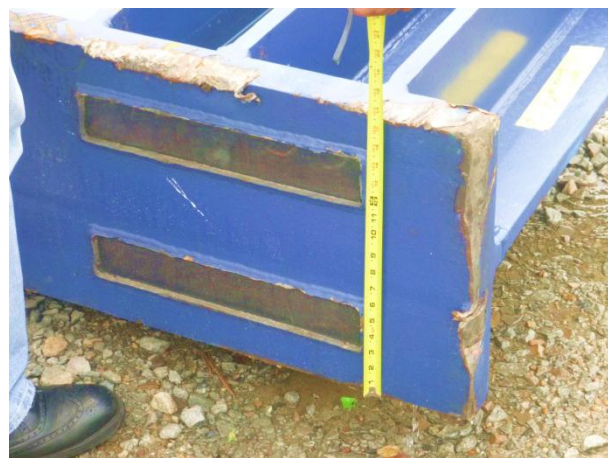
Figure 26 – Close-up of lower NW column

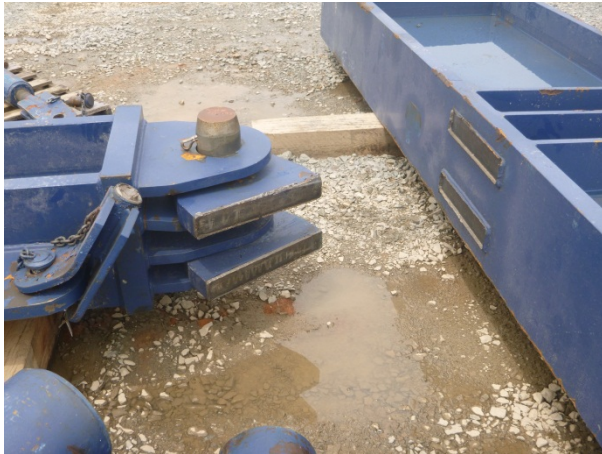
The upper column remained intact except that the lower unidirectional pinned connection failed in a manner similar to the lower NW column. The welds connecting the 2 ½” plates to the top flange of the intermediate header beam fractured, see figures 28 and 29. The top true pin remained intact, see figure 30. No remarkable observations were made on the column except those mentioned above.

Figure 28 – Lower connection of the NW column.

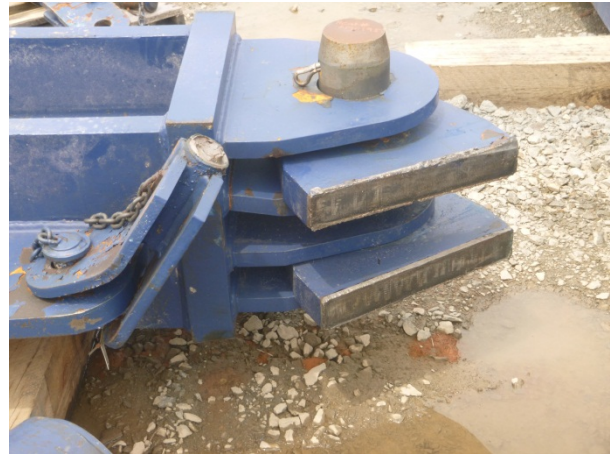
Figure 29 – Close-up of the lower upper connection.

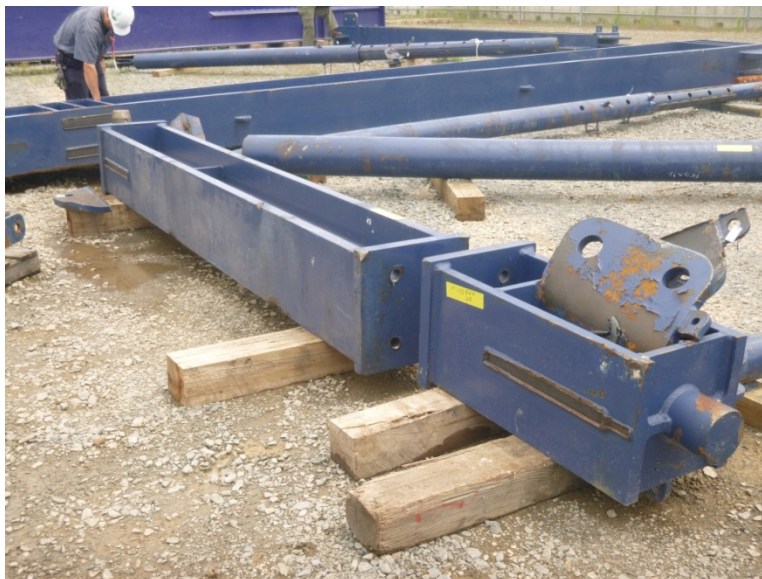
Figure 30 – Top pin connection of the upper NW column

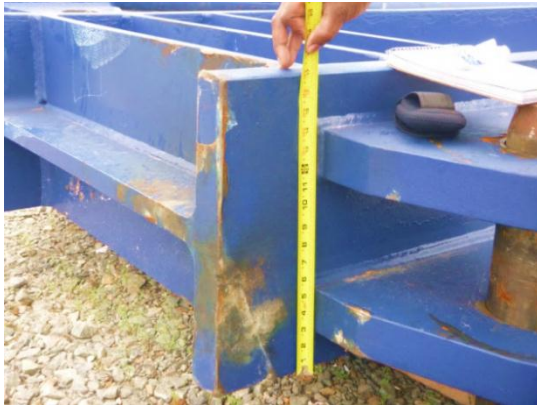
The columns were unremarkable. Unlike the NW lower and upper columns, the NE column uni-directional pin connections to the bottom and top flanges of the intermediate header beam did not fail. The connection was undone during retrieval process, see figures 31 and 32.

Figure 31 – Upper connection of the lower NE column

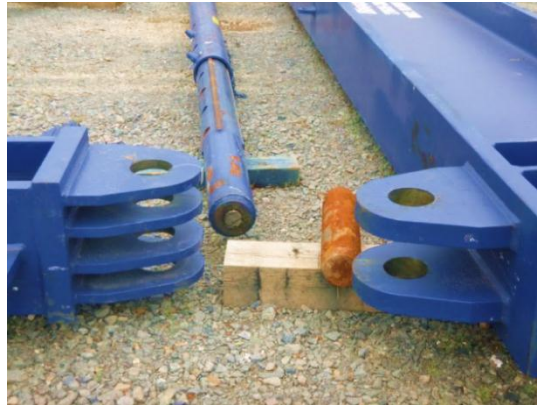
Figure 32 – Lower connection of the upper NE column.

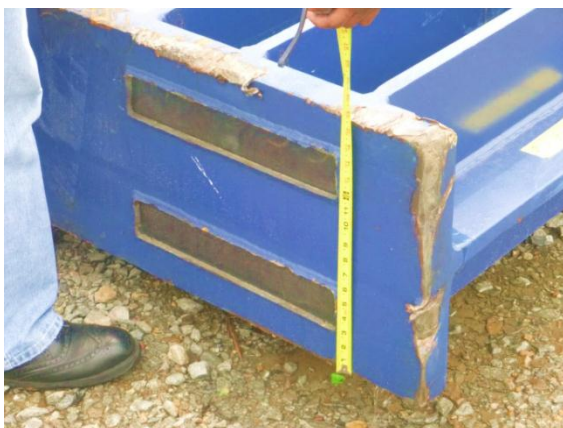
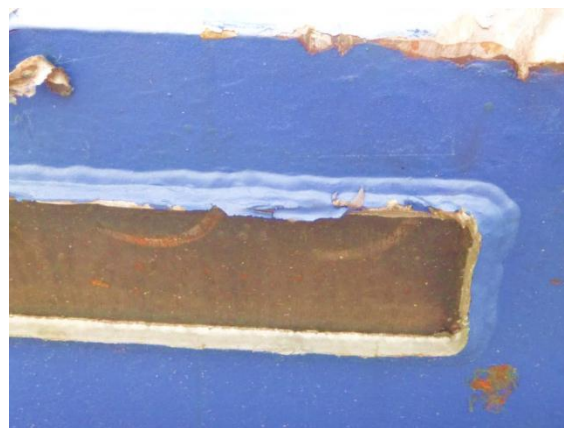
The beam remained intact and practically without any bow or deformation. The failure of the welds at the lower and the upper flanges could be seen as the welds remained attached to the flanges with a clear separation with the 2 ½” plates, see figures 25 to 27, 33 and 34. Both pins remained intact. No torsional twist or damage was visibly noticeable. The stiffeners were undamaged and the beam survived remarkably well.

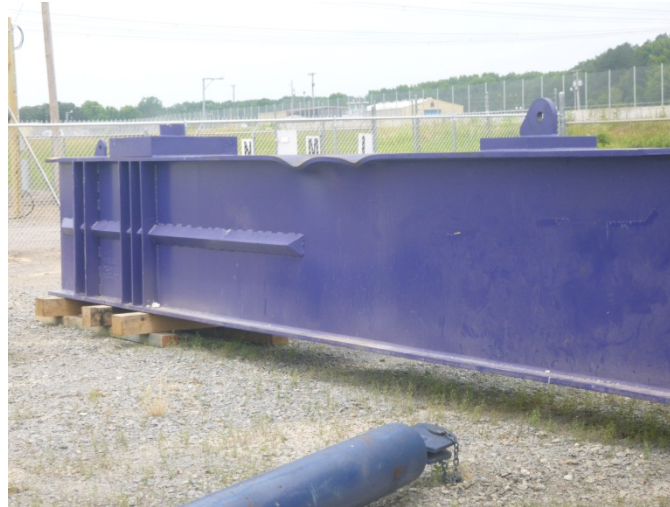
The top flange of the 4-ft. deep foot beam sustained local deformations believed to be the result of the collapse but otherwise remained unremarkable, see figure 35. The plates containing the open ended receptacles for the pins sustained no visible damage. Most of the stiffeners were intact.

Figure 35 – Foot beam

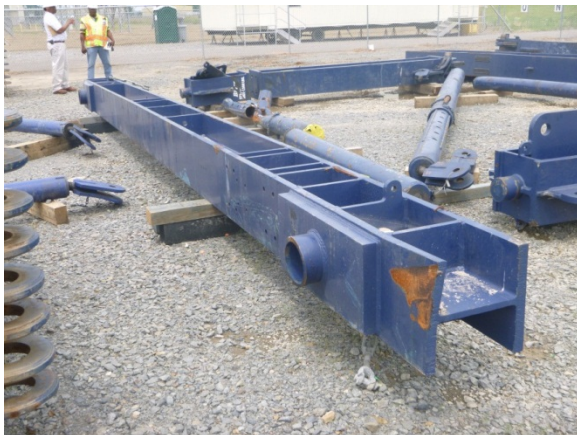
See figures 36 and 37 for the top header beam which was practically undamaged. The plates containing the receptacles for the true pins were intact. Little damage is seen elsewhere.

Figure 36 – East end of the top header beam

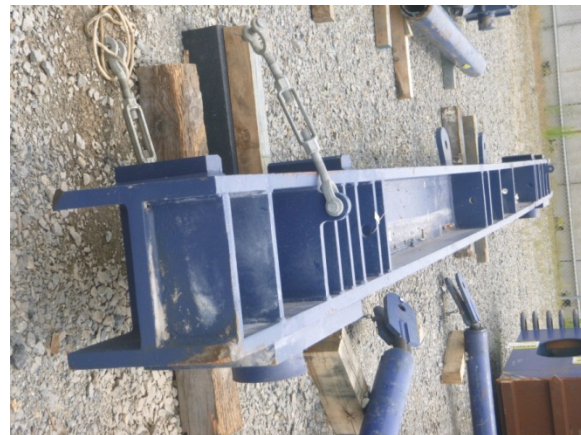
Figure 37 – West end of the top header beam
