ITT ENGINEERED VALVES

Final Report to the NRC of
10 CFR 21 Event 54118, reported by ITT 06/14/19
Concerning #25 AM diaphragm valves

Original submittal was 8/13/19; this revision 1 is dated 8/20/19

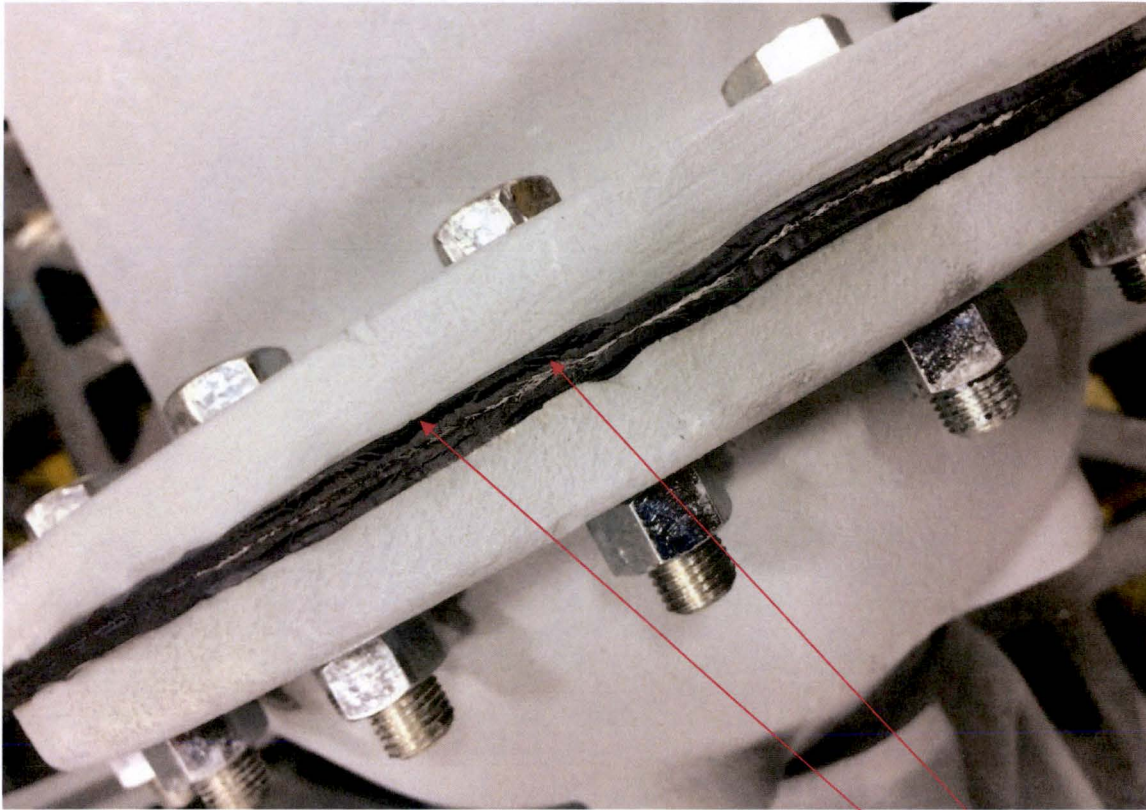
The damage to the airmotor diaphragms was evident once the valves were retrieved from storage and brought out for disassembly. Splitting of the elastomer was visible on the edge of the diaphragm, even before the valves were taken apart, see Figure 1. After disassembly, the splitting could no longer be easily seen, but the delamination of each diaphragm was now plainly visible, see Figure 2. All five diaphragms showed the same type of splitting and delamination, with the delamination ranging from 30% to 75% of the circumference. The delamination in all cases began at the outer diameter of the diaphragm and extended radially to the inner edge of the flange clamping area.

It had been noted at the time of disassembly of the valves by the shop floor technician who had worked on the original assembly that these particular assemblies that were assembled in May of 2018 required excessive bolt torque in order to pass the production test for this component, which is pressurization of the lower chamber at 110 psig.

The reason that excessive torque was applied in this case was that the joint formed by the upper and lower cover and the diaphragm was not able to pass the 110 psig production test using the specified assembly torque of 72-79 in-lb. The finish of the covers is as cast, and was not sufficiently flat enough to accommodate the seal without compensating by applying torque well in excess of the specified value.

Figure 1: Diaphragm damage noted before disassembly. Note splitting of elastomer on edge of diaphragm.

1. A finishing step will be added to address the actuator covers, to ensure flat sealing surfaces.
2. A routing step will be installed to specify that the airmotor torque is to be recorded as part of the shop order documentation.
3. If the 110 psig proof test cannot be successfully completed with the specified torque, production shall halt and the assembly disassembled and examined.

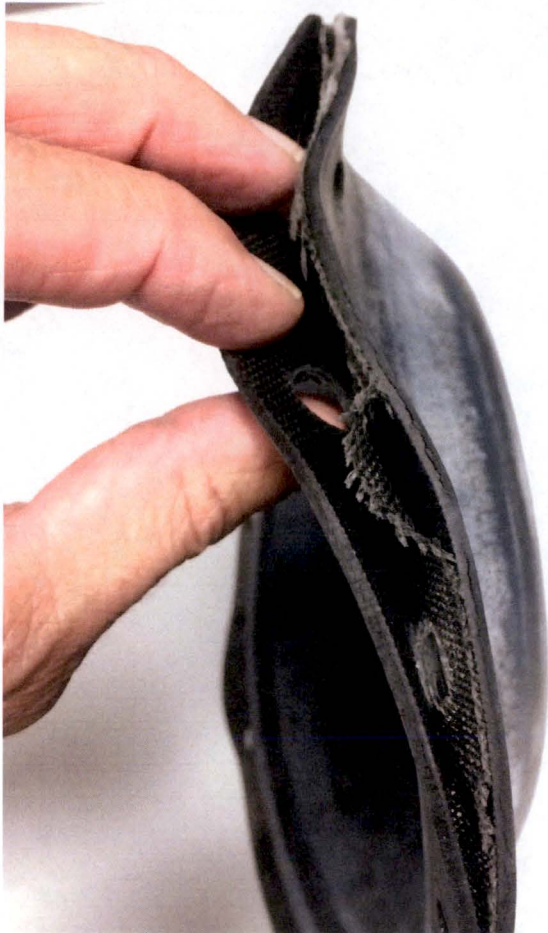
Figure 2: Delamination of fabric from elastomer

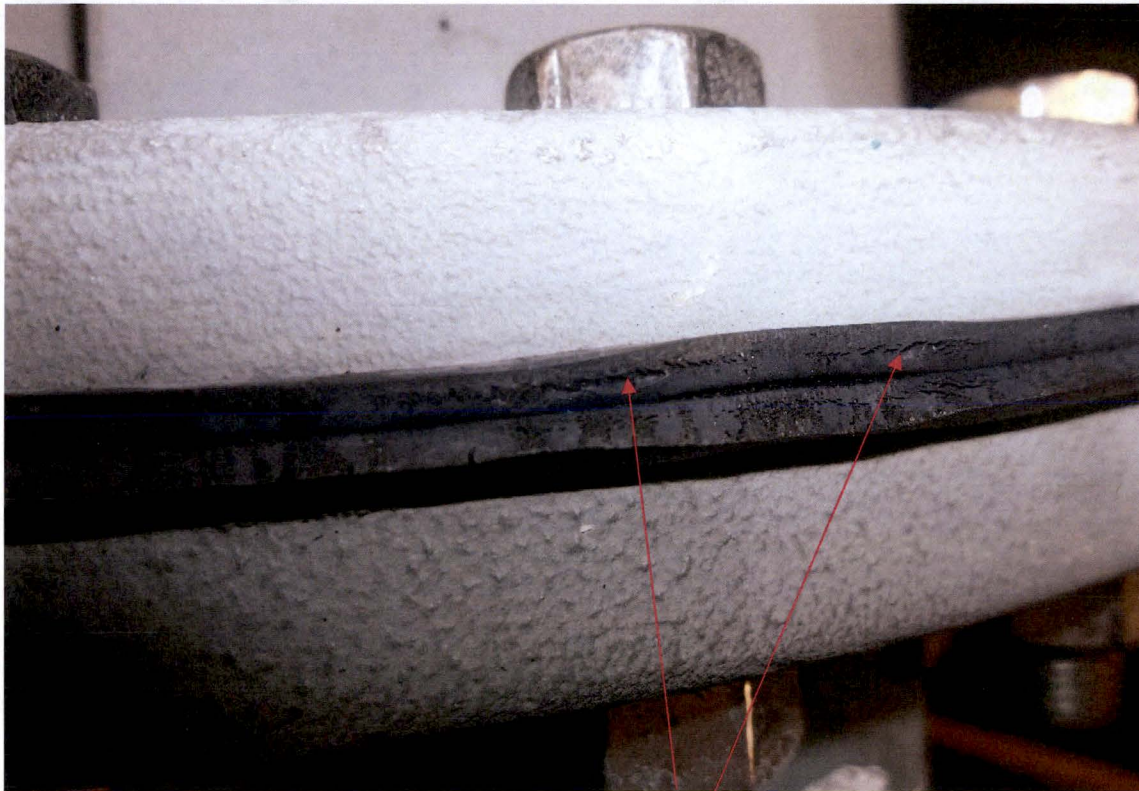
time. At the four week point, cracks were observed on the outer edge of the diaphragm that were not present at initial assembly, similar to those that were seen on the damaged diaphragms (see Figure 3). Repeated observations of the diaphragm over time showed that at week seven more cracks were found that had not been previously seen. In addition, some delamination was observed on the edge of the diaphragm, corresponding to the bolt location, see Figure 4. It became apparent that as time went on more cracks would initiate and existing cracks would deepen. This was seen as clear evidence that the cause of the damage was the high level of assembly torque that in time would manifest itself in permanent damage.

Figure 3: Splitting of diaphragm on simulated test unit

The simulation test proved that over time, the effect of the high bolt torque generates forces that have a long term, deleterious effect on the airmotor diaphragm such that the elastomer material will split and the fabric will delaminate from the elastomer.

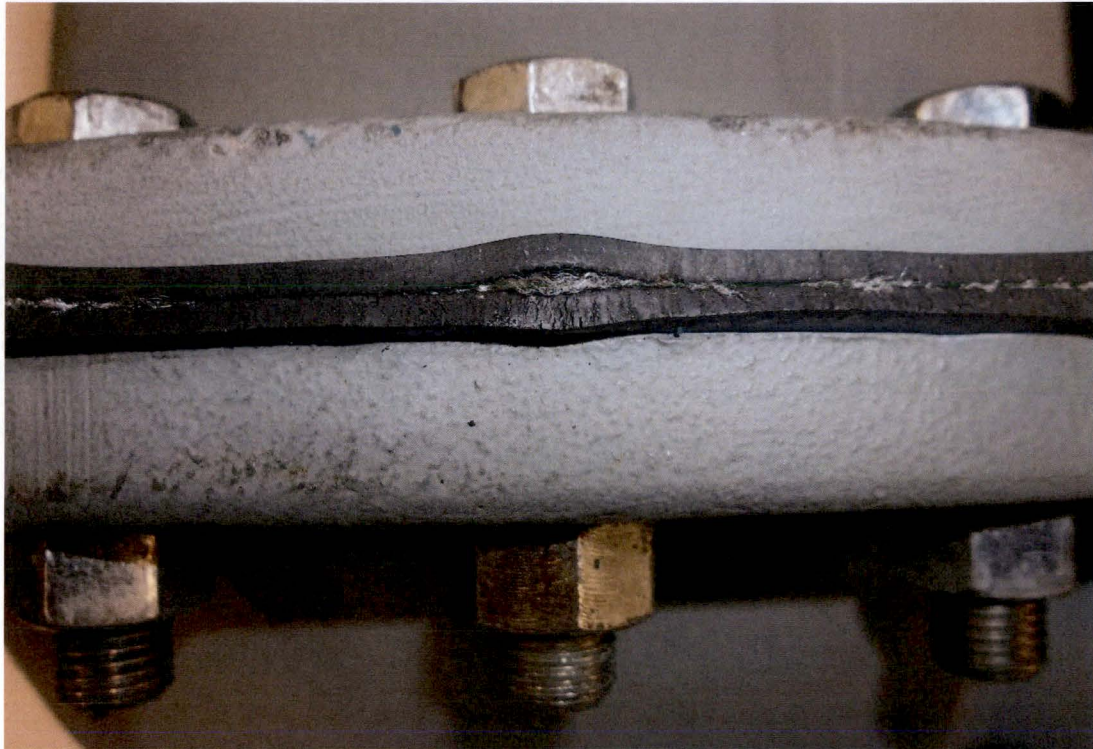
On August 9, after the 8th week of observation, it was concluded that the root cause of the diaphragm damage was the excessive torque.

Figure 4: Delamination of simulation unit

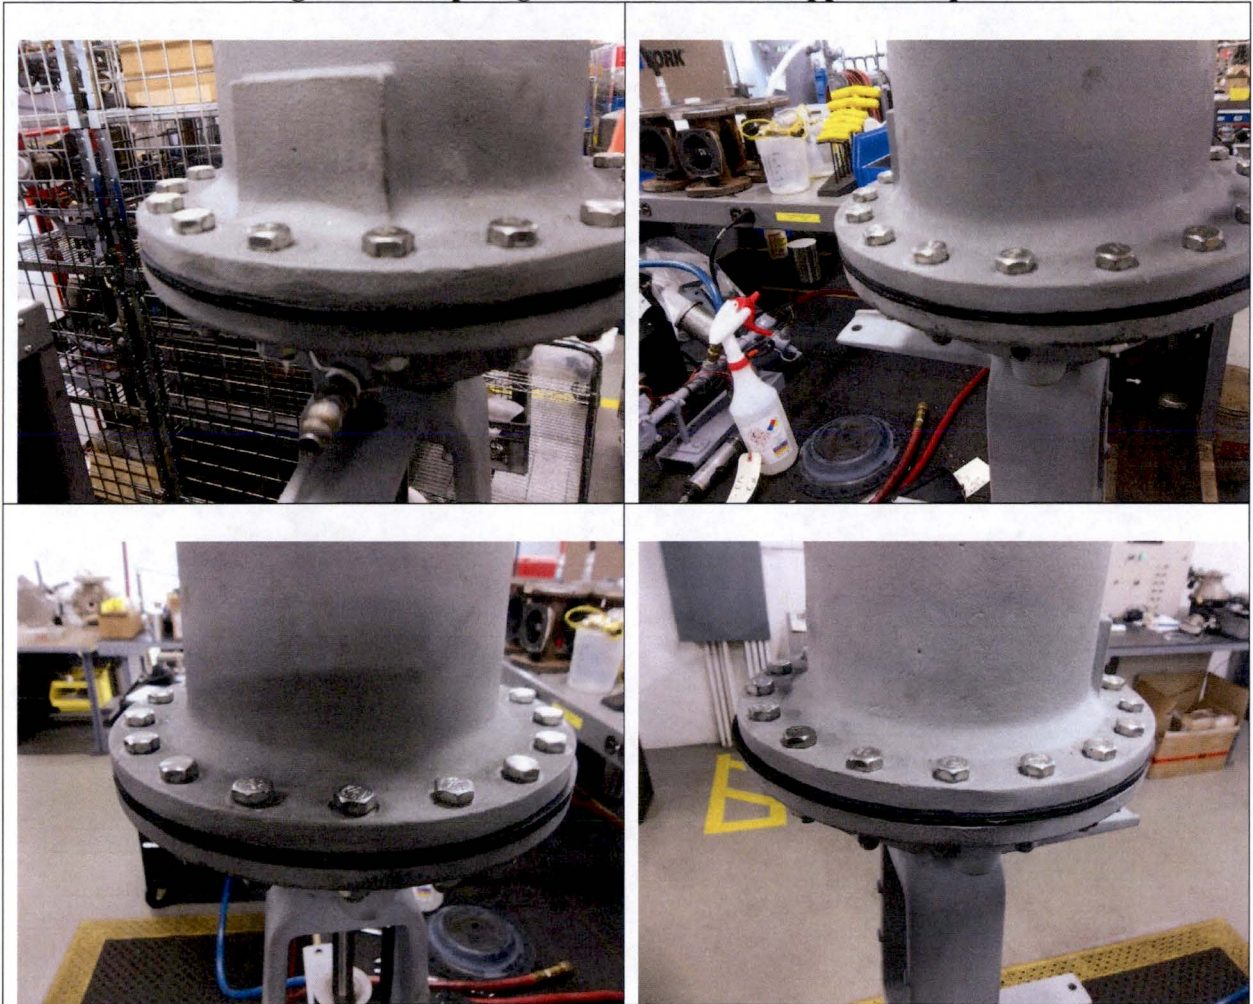
Excessive bolt torque causes damage to the airmotor diaphragm, but it also provides visual indications that enable a user to identify problematic assemblies. See Figures 5 and 6 for a comparison of a properly assembled airmotor versus one with a known excessive bolt torque. Normally the OD of the assembled diaphragm is the same diameter as the metal covers. If excessive torque is applied the elastomer diaphragm may extrude and extend as much as 0.12" beyond the OD of the covers, see Figures 6 and 7.

Figure 5: Diaphragm with 72 in lbs of applied torque

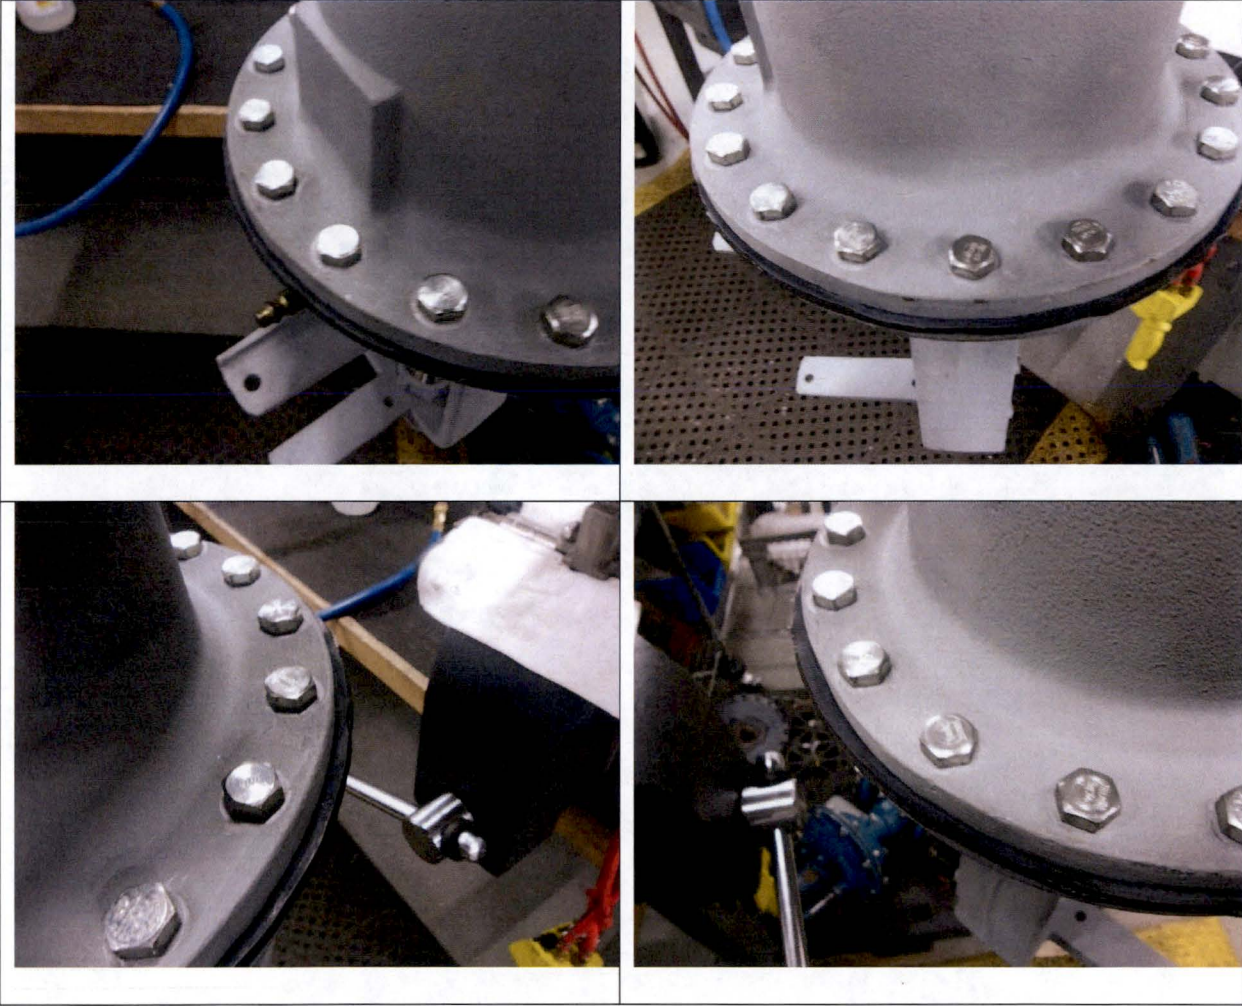
Figure 6: Diaphragm with 300 in lbs of applied bolt torque

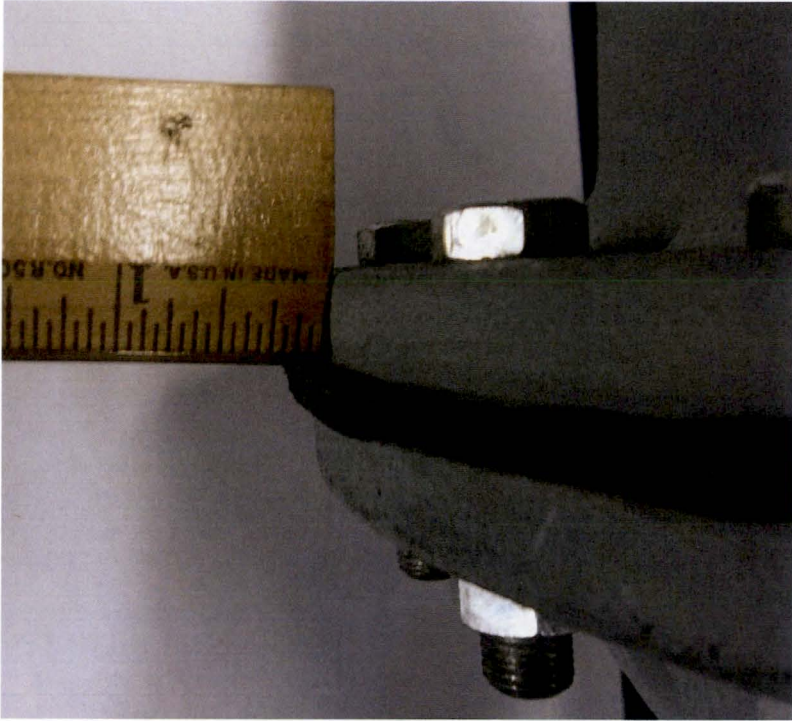
Figure 7: 300 in-lb - Extrusion of edge by 1/8"

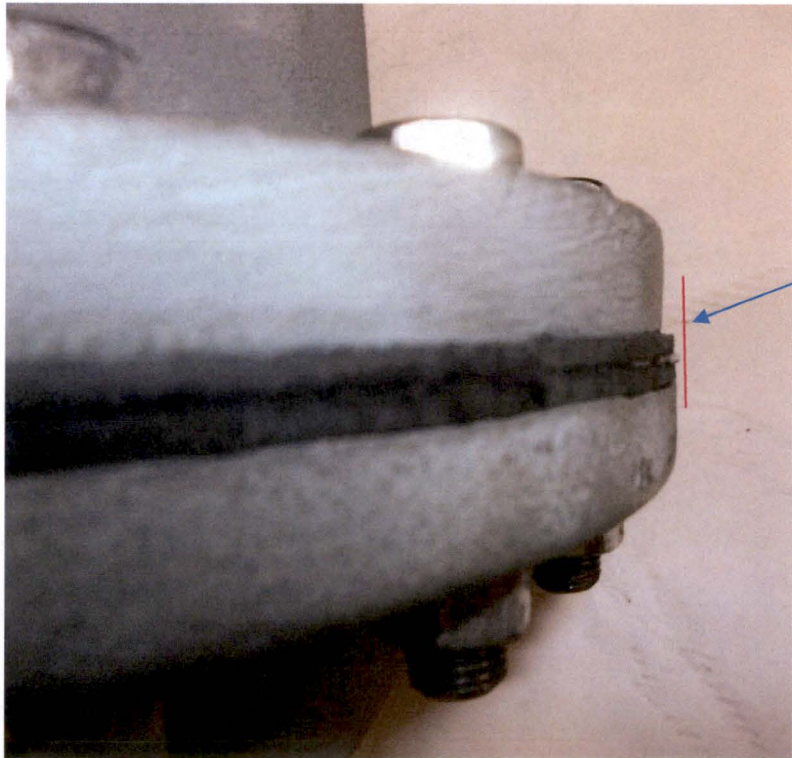
Square edge

Another indicator that is visible is the shape of the edge of the diaphragm. The elastomer surface on the OD should remain square if the assembly was properly assembled, see Figure 8. If excessive torque is applied the edge of the diaphragm will not remain square, instead the outer edges will grow out further than the part of the edge that contacts the fabric in the middle, see Figure 11 and the comparison between Figures 9 and 10.

Figure 8: 72 in-lb – nominal extrusion, square edge

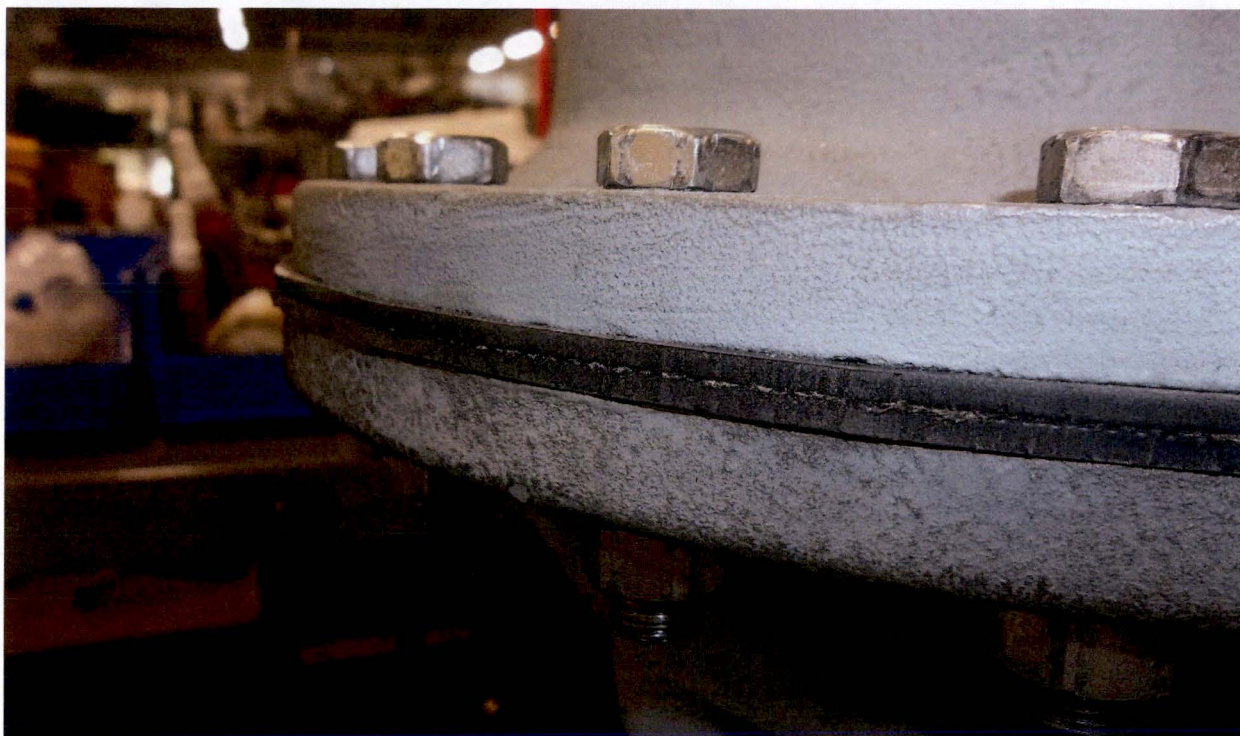
Figure 9: Diaphragm with 72 in-lb applied torque – undistorted, square edge

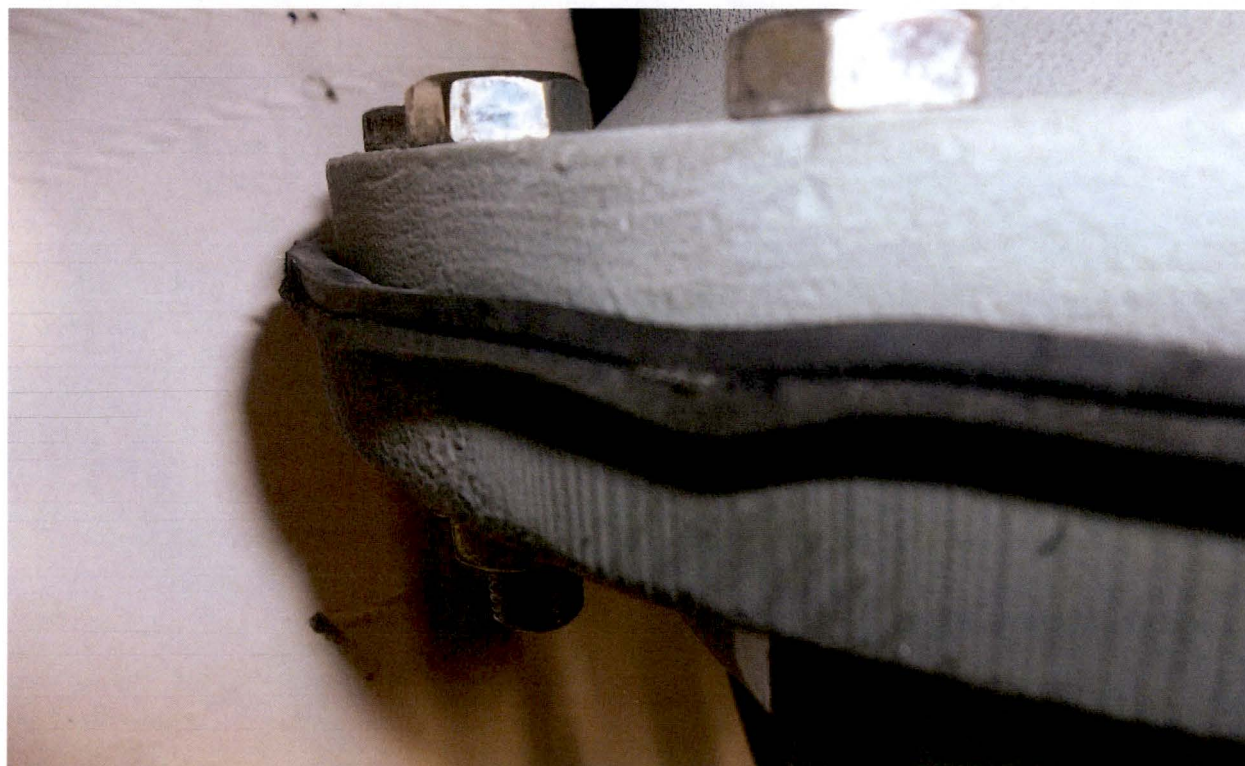
During the first week of the investigation a simulation test was started, with the intention of trying to replicate the damage seen on these valves. Using the same valve hardware as before, one brand new #25 airmotor diaphragm of March 2019 construction date was installed in a valve assembly. This assembly was intentionally over torqued to 300 in-lb in order to accelerate the effect seen on the problematic valves. The airmotor diaphragm was examined at the perimeter to see if the same cracks and delamination as seen in the damaged diaphragms (Figure 1) could be observed. While the diaphragm was extruded beyond the diameter of the covers and some distortion was noted (see Figure 10 in Appendix A), no cracks or delamination was initially visible.

Figure 10: Diaphragm with 300 in-lb applied torque – Distorted, edge not square

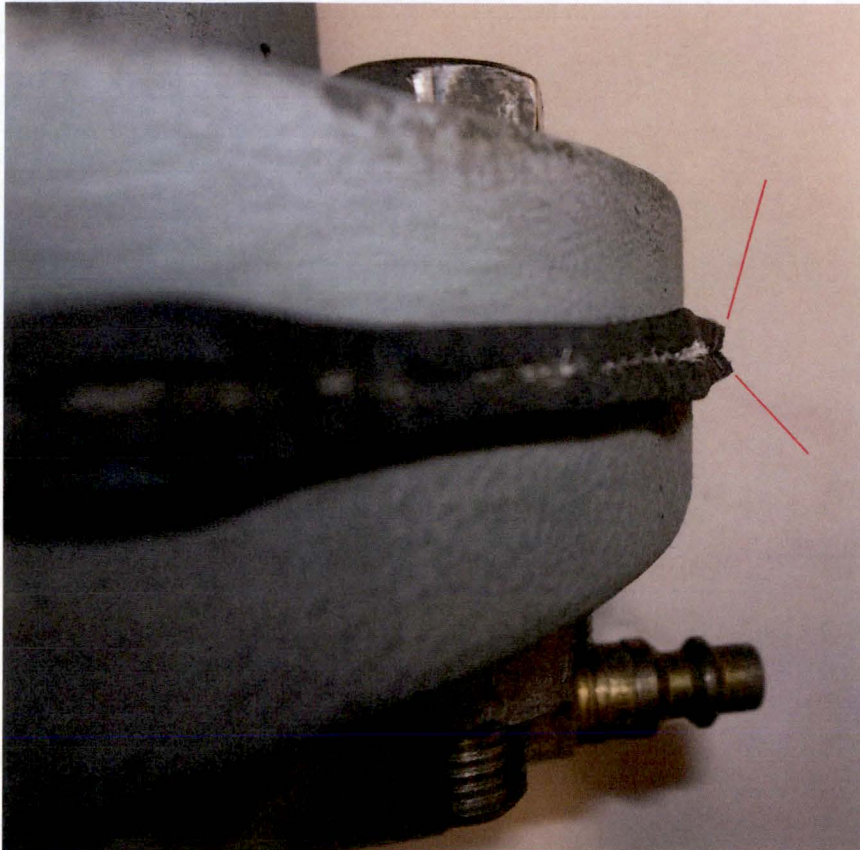
Figure 11: Diaphragm with 300 in-lb applied torque – Distorted, edge not square
