STAFF REPORT

SUBJECT: **PROVIDE DIRECTION ON PLANNING PROCESS FOR THE
RENOVATION AND REUSE OF THE HISTORIC TRAIN DEPOT AND
CITY-OWNED DEPOT LOT IN DOWNTOWN NOVATO**

CONDITION ASSESSMENT AND RECOMMENDATIONS

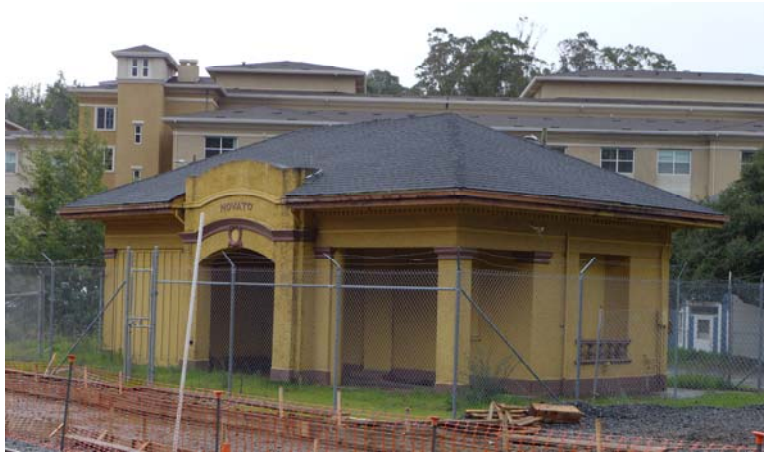
Figure 25. The hipped roof.

Condition: The composition shingles have been installed within the last ten years and are in good condition with little to no signs of wear or deterioration.

Recommendations: A roof is a highly vulnerable element of any structure. It is also the first line of defense against water intrusion. Asphalt shingle roofing has a finite life span and the assembly will inevitably fail as a result of normal weather exposure and wear. The following are general recommendations:

- Perform a complete internal and external inspection of the roof, roofing system and related features annually, identifying changes and areas of failure. Flashing – a major cause of deterioration – should be carefully inspected for poor installation, thermal stress and metal deterioration. Inspect all sealant joints between unlike roofing materials. If the roof structure appears sound, the substrate should be closely examined, particularly around the roof plates, under any exterior patches, at intersections of roof planes, and at vertical surfaces. Water penetration should be readily apparent, usually as a damp spot or stain.

- If 20% or more of any one surface appears to be eroded, cracked, broken, or missing mineral surfacing, replacement should be considered. Replacement should also be considered if evidence of pervasive moisture damage is found in the attic, ceilings or exposed porch roofs.

- Replace damaged asphalt shingles with shingles to match size, color, and exposure of original. Class A fire rated asphalt composition shingles with a 40-year life span are recommended.

- Should shingles require replacement, careful research, design, specifications and selection of a skilled roofer are necessary.
- Avoid sparse shingle coverage and heavy building papers.
- Avoid staples and inferior flashing. Use stainless steel nails instead.
- Avoid patching deteriorated historic roof sheathing with plywood or composite materials. Replace deteriorated sheathing in-kind.
- Replace all flashings with painted copper.
- Clean and maintain gutters and leaders on a regular basis. Clogs in these systems will cause water to back up and seep into the adjacent sheathing and wall top plate. Gutters should be cleaned at least twice a year.
- Implement a regular maintenance plan to extend the life of the roof. Maintenance should include regular visual inspections, and the use of standard repairs.

When contemplating a roof cladding replacement project, consideration should be given to the addition of a plywood shear diaphragm while the historic roof sheathing is exposed, if recommended by the structural engineer.

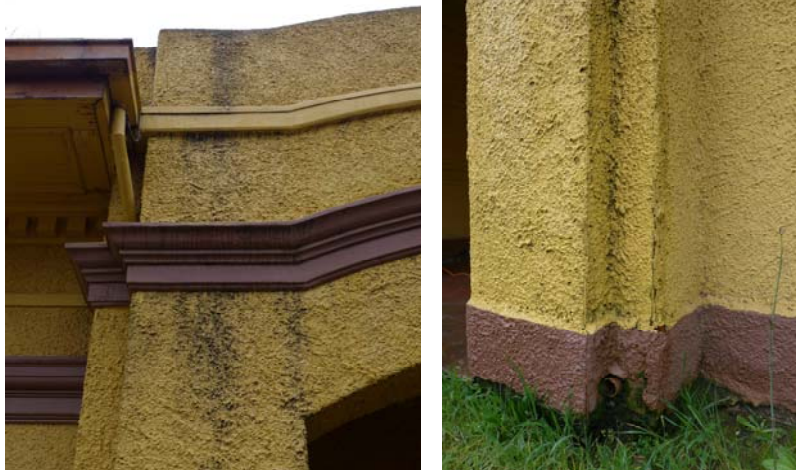
Figures 26 and 27. Gutters (left) and the downspout penetration (right) on the front façade.

Condition: The metal gutters are moderately deteriorated at joints from water damage and weathering. The downspouts, both the enclosed and exposed, are severely deteriorated. Connections between the gutter and downspouts are so deteriorated that the downspout has sheared from the gutter and is no longer connected. If heavy rain occurs, it is likely water would run down the stucco through this broken joint in the downspout which could lead to stucco

deterioration. The gutters are filled with debris which could cause drainage problems. From the ground, plant growth was observed in the gutters.

Recommendations: The metal fascia gutters are not historic and should be replaced in-kind with painted copper to match the building. The repair or replacement procedures should be as follows:

- Replace badly deteriorated or missing gutter sections to match original.
- Replace damaged rainwater leaders with new copper units, painted to match the building. New rain leaders should be sized to carry the amount of water shed by the tributary area of the roof.
- Survey the entire gutter system twice annually, noting leaks and deficient conditions, and repair as needed.
- Clean gutters at least twice annually, as part of the building's regular maintenance.

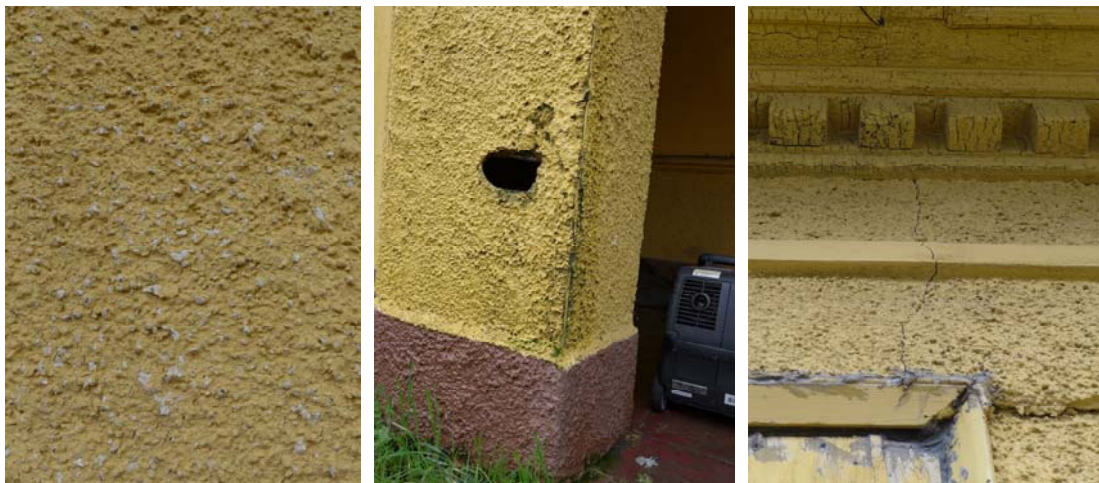
Figures 28, 29 and 30. (Left to right) Scaling paint, the hole on the front elevation, and cracking.

Condition: The stucco cladding has only a few cracks, none of which are larger than 1/8" wide. One 6" hole is visible near the southern downspout on the front elevation. The paint is scaling and delaminating on the entire stucco surface.

Recommendations: Perform a detailed cladding survey to identify conditions such as cracks and delamination from lath. If structural repairs require removal of this material, it should be carefully removed where required. Depending on the determined use of the building, the stucco cladding should be repaired where incompatible past alterations occurred. General recommendations are as follows:

- Remove dirt, debris, loose and flaking paint, and miscellaneous nonfunctional attachments from stucco surface.
- Analyze the existing stucco to allow for the selection of compatible stucco mix to use for repairs.
- Survey the surface for additional cracks and damage.
- Cut out area around cracks ¼" or larger and repair. For larger areas, metal lath over building paper would be required
- Install new three-coat cement plaster at larger cracks and holes.
- For cracks less than ¼", fill with elastomeric caulk prior to painting.
- Texture stucco to match adjacent surfaces.
- Prepare surfaces and paint.

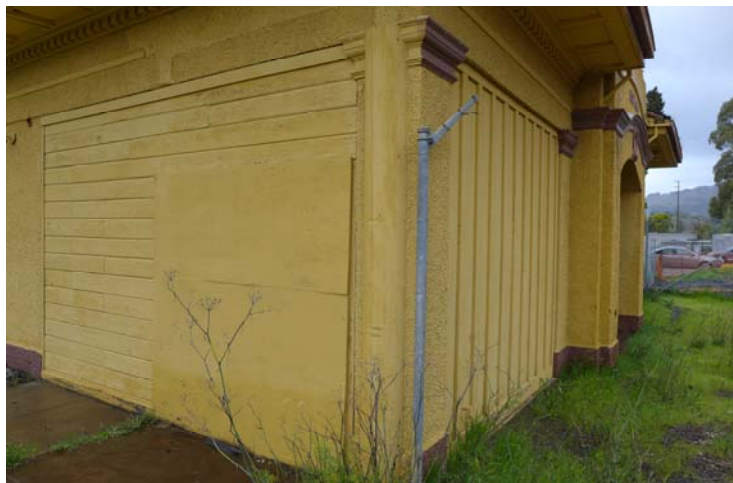
Figure 31. Wood siding at the southeast corner.

Condition: The wood cladding is in fair condition. Deterioration includes peeling, blistering and general deterioration of the paint, longitudinal cracking and water damage near the base of the building.

Recommendations: Perform a detailed cladding survey to identify conditions such as breaks, cracks, loose or missing boards, insect damage, and dry rot. If structural repairs require removal of this material, it should be carefully salvaged, catalogued, and reinstalled at its current location. Depending on the determined use of the building, the wood siding may be removed, restoring earlier condition of the open waiting area under the overhang. General recommendations are as follows:

- Replace any broken or deteriorated boards in-kind. Pre-treat with wood preservative and back-prime all surfaces prior to installation.
- Patch and repair wood damage with epoxy consolidant or repair compound formulated for wood.
- Reattach any loose elements with stainless steel fasteners.
- Treat with a fungicide if required, then prime and paint. Include fungicide in the paint to discourage future biological growth.
- Repaint using historically appropriate paint colors. If siding is removed – prime backs and edges prior to reinstallation.

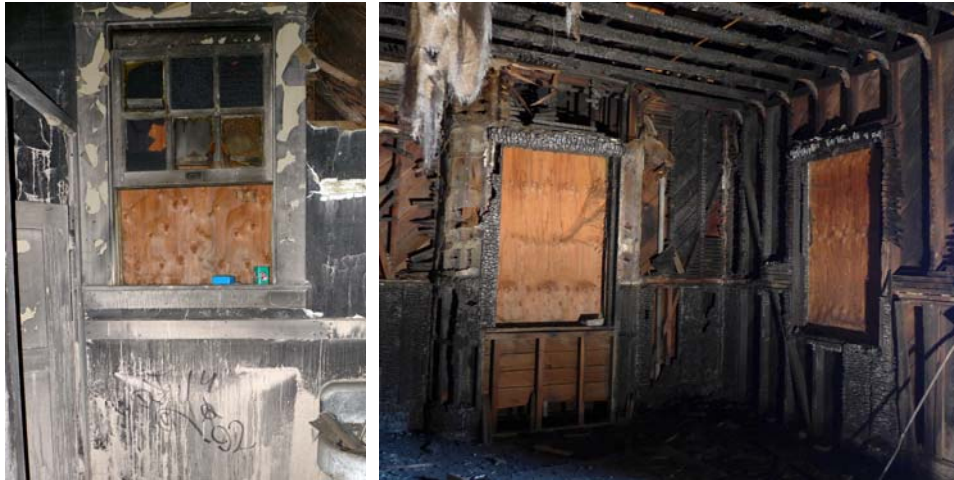
Figure 32 and 33. The remaining window (left) and windows in the main room (right).

Condition: The windows are in poor condition. As a result of the fire and abandonment only one of the windows remains intact while the rest have been destroyed over the years. The paint is deteriorated due to weathering and exposure to fire. In the remaining window much of the glazing compound is dried, cracked or missing. Several of the lites have broken or have missing glazing. In addition to lead in the existing paint, asbestos may be found in the glazing compound. The sills on all sides of the building have paint and wood deterioration.

Repair existing windows as follows:

- Survey and examine in detail the existing condition of all wood windows.
- Remove all dirt and debris.
- Remove paint to obtain clean surface where repairs are required.

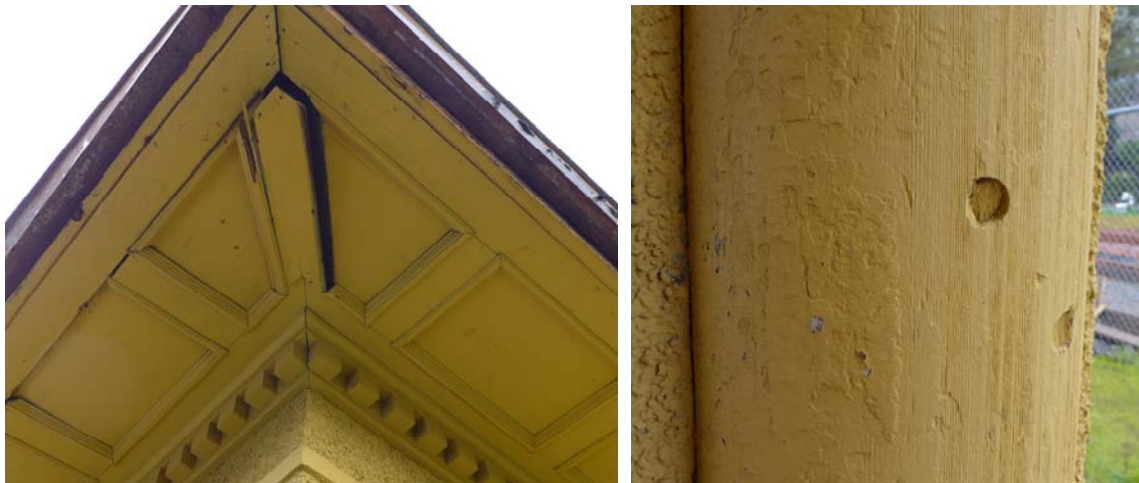
Figures 34 and 35. Cornice paneling (left) and semi-circular timber (right).

Condition: The trim around the windows and doors is in fair condition showing weathering and paint deterioration. The window sills that are exposed directly to the elements are extremely weathered. The wood log pilasters at the covered walkway have peeling paint and wood deterioration. Some areas of the wood surface have been repaired with a cementitious compound. The wood fascia and rake boards have peeling paint and, in some locations, large areas of wood are exposed to the elements. At the cornice, dentils are missing in a few locations and paneling pieces at the soffit are missing or detached. The wood elements at the cornice and soffit are deteriorated and weathered.

Address the wood trim repairs as follows:

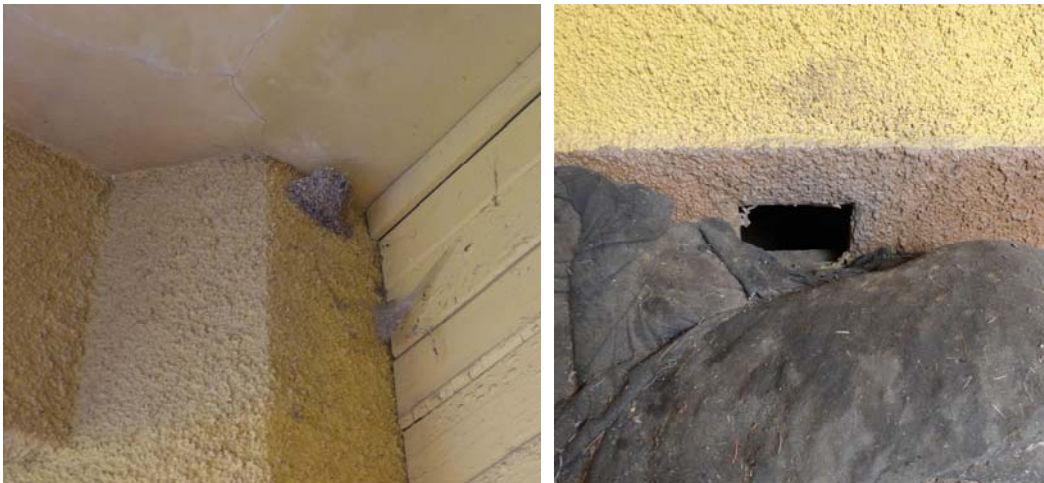
Figures 39 and 40. Bird's nest under the walkway (left) and the open vent (right).

Condition: Currently, a bird's nest is visible under the covered walkway. There are open vents - missing covers - which could allow small rodents into the crawl space under the building. No termite damage was visible, but the building should be inspected for termites.

Recommendations: For general pests, determine if and how the pests enter the structure and then, once they are removed, block the access points in an architecturally compatible manner. Follow legal and ethical procedures for the removal of these pests and wildlife. The structure should be tented and fumigated to eliminate termites if they are found to be present.

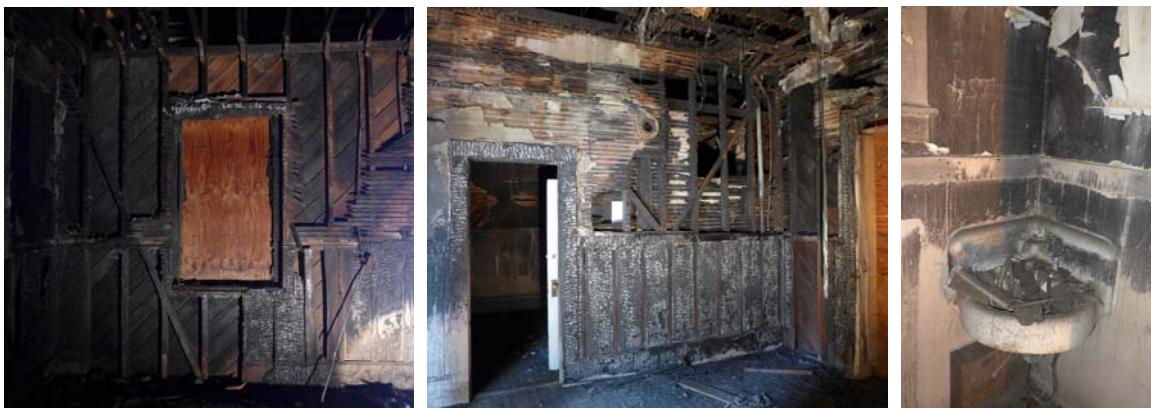
Figures 41, 42 and 43. Interior of the depot.

The interior of the depot has been heavily damage by fire. Every effort should be made to preserve the remaining existing historic fabric. Where modifications must occur, relegate them to non-contributing areas wherever possible. Stabilize and repair existing historically significant finishes and components. Replace missing components in-kind when replacement is required. Stabilize and repair existing original materials, components, finishes and spaces.

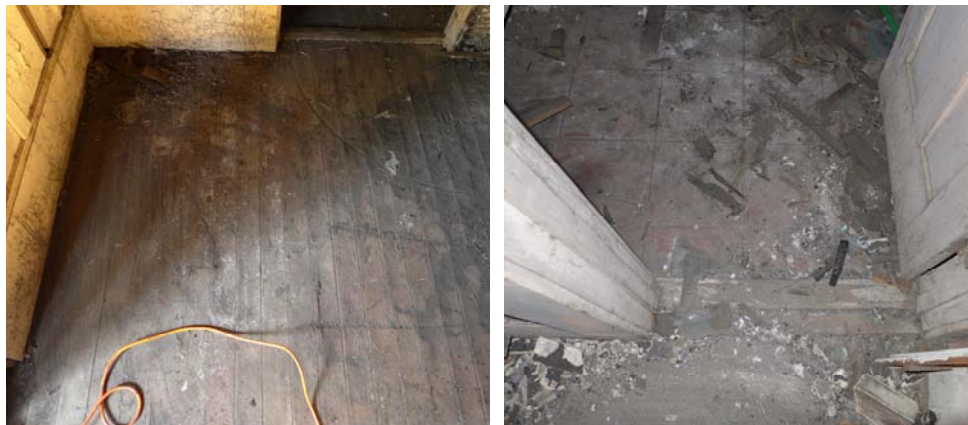
Figures 44 and 45. Wood flooring in the main room (left) and the vinyl flooring in the restroom (right).

Condition: The finish of the wood floors is indistinguishable because of wear and fire residue.

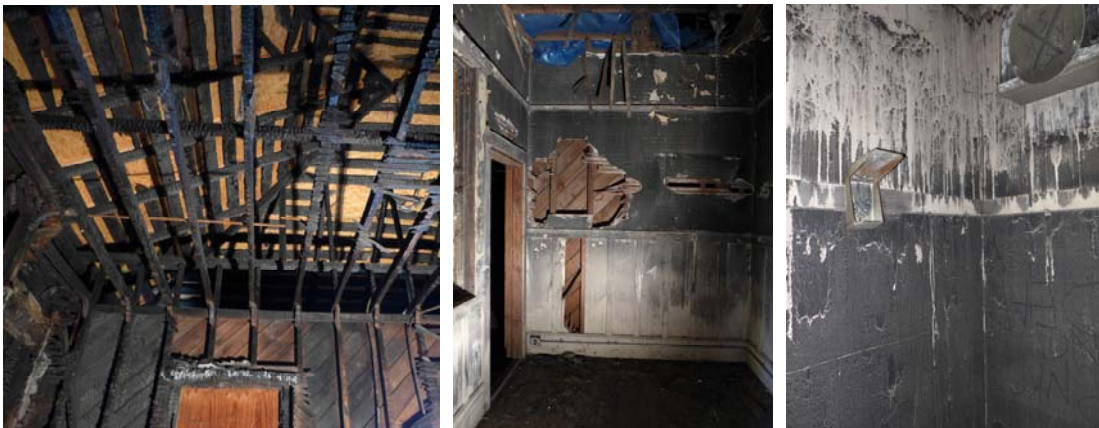
Figures 46, 47 and 48. (Left to right) Ceiling of the main room, the wainscot and plaster in the office, and restroom finishes.

Condition: The depot walls range in condition from fair to poor. The majority of the wall finish – plaster and wood wainscot – is missing from the main room of the depot. The finishes were damaged or removed as a result of the fire. Where plaster is missing, the lath is also missing or damaged, exposing the diagonal sheathing on the exterior side of the wall. The wainscot and plaster in the office remain intact for the most part. However, the surfaces show signs of damage related to the fire – smoke residue and blistering. All finishes in the restroom are covered in soot. The plaster ceilings are in a similar condition as the walls. The ceiling, both plaster and lath, in the main room is missing. The majority of the lath remains in the office, but the plaster is missing.

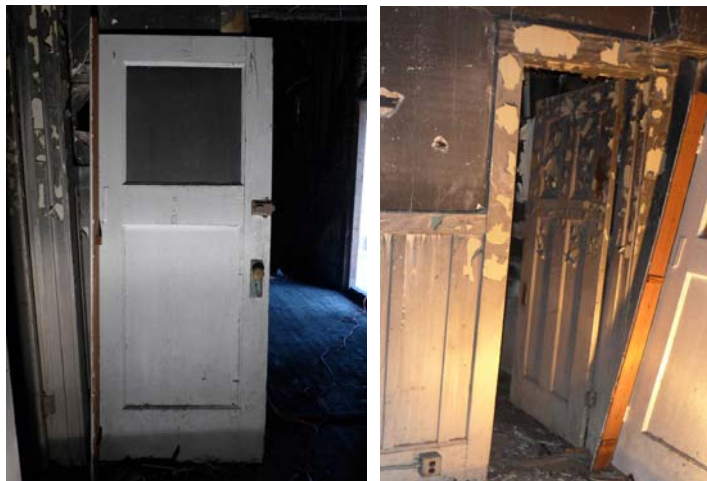
Figures 49 and 50. Existing interior doors.

Condition: The interior doors are in fair condition with some wear showing around knobs and locks. Much of the hardware remains.

Recommendation: Restore, repair and re-use existing wood doors.

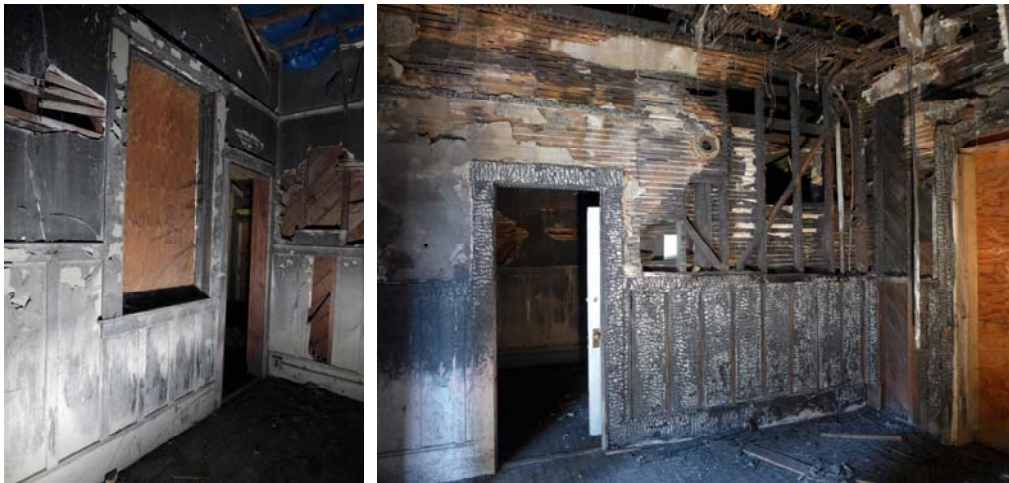
Figures 51 and 52. Wood trim in the office (left) and in the main room (right).

Condition: Where the interior wood trim remains, the wood elements appear to be in generally fair condition. Door and window trim is generally worn and contains multiple layers of paint. The base trim is damaged in several locations. The picture rail is separating in areas from the wall and at joints.

Recommendations: Retain, repair and re-use original wood trim and paneling components. Restore deteriorated or damaged wood elements as follows:
