Middle School

Summary update of diagnostic
work performed from 7/5/05
through 7/26/05

Report on work performed from 7/20/05 through 7/26/05.

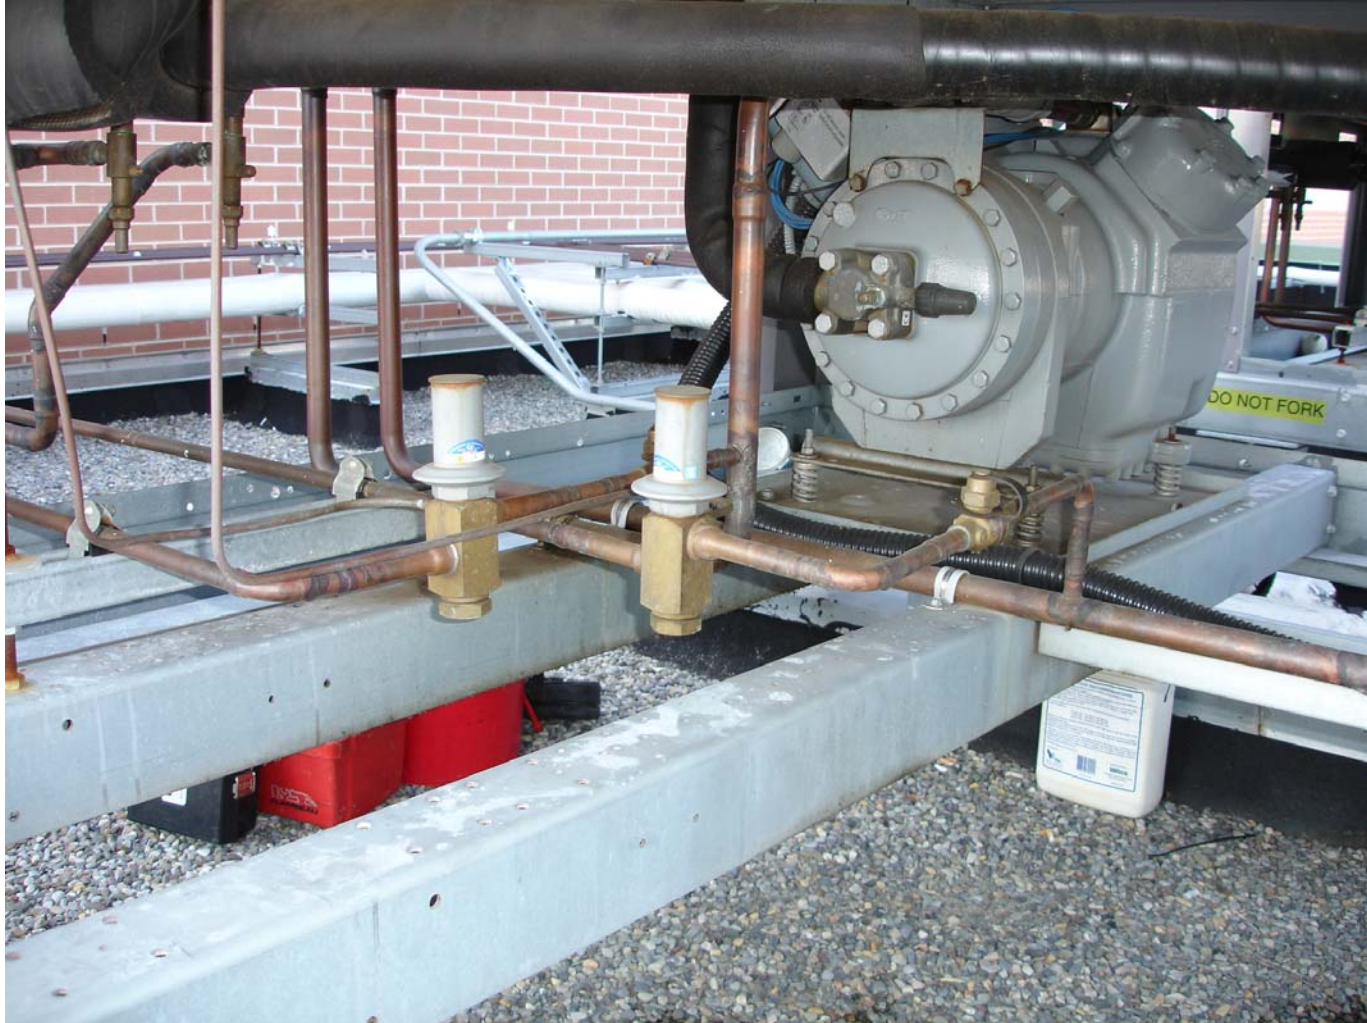
Photo #1408

- Missing hot gas bypass solenoid valve and wiring upstream of hot gas valve. See photo #1408.
- Compressor #1 unloader incorrectly set causing compressor to operate mostly unloaded.

Hot gas bypass valves. Note missing solenoid valves.

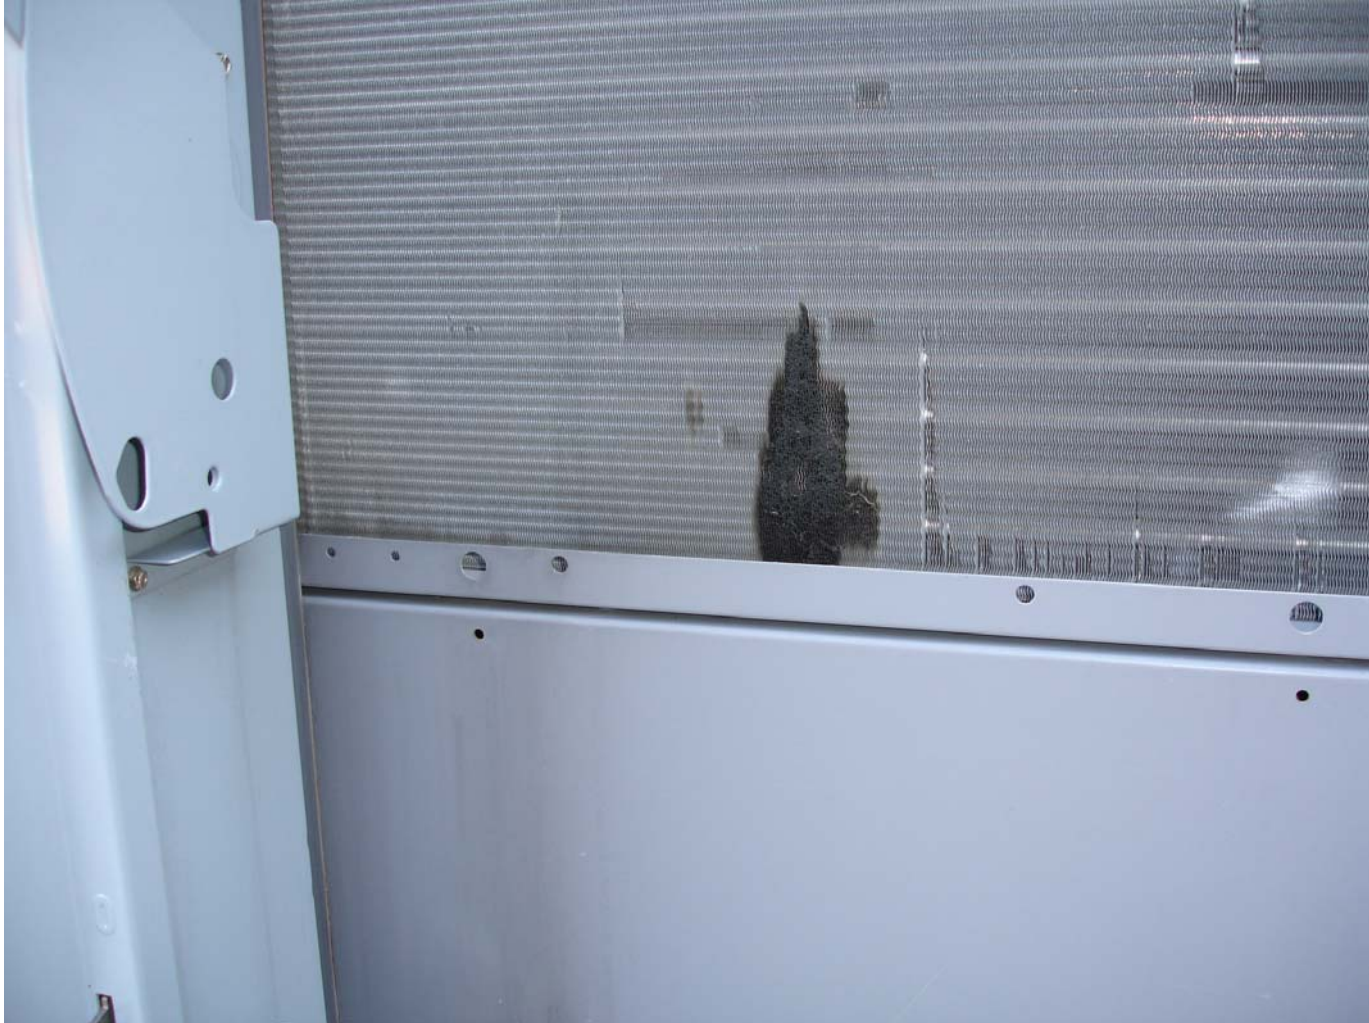
Condenser coil photo #1402

- Condenser coil is matted. See photos #1405, 1406, 1429.
- Oily matted residue on a few spots on the condenser coil which could indicate a refrigerant leak at these locations. Possible oil stain on roof. See photo's #1402, 1403, 1407.

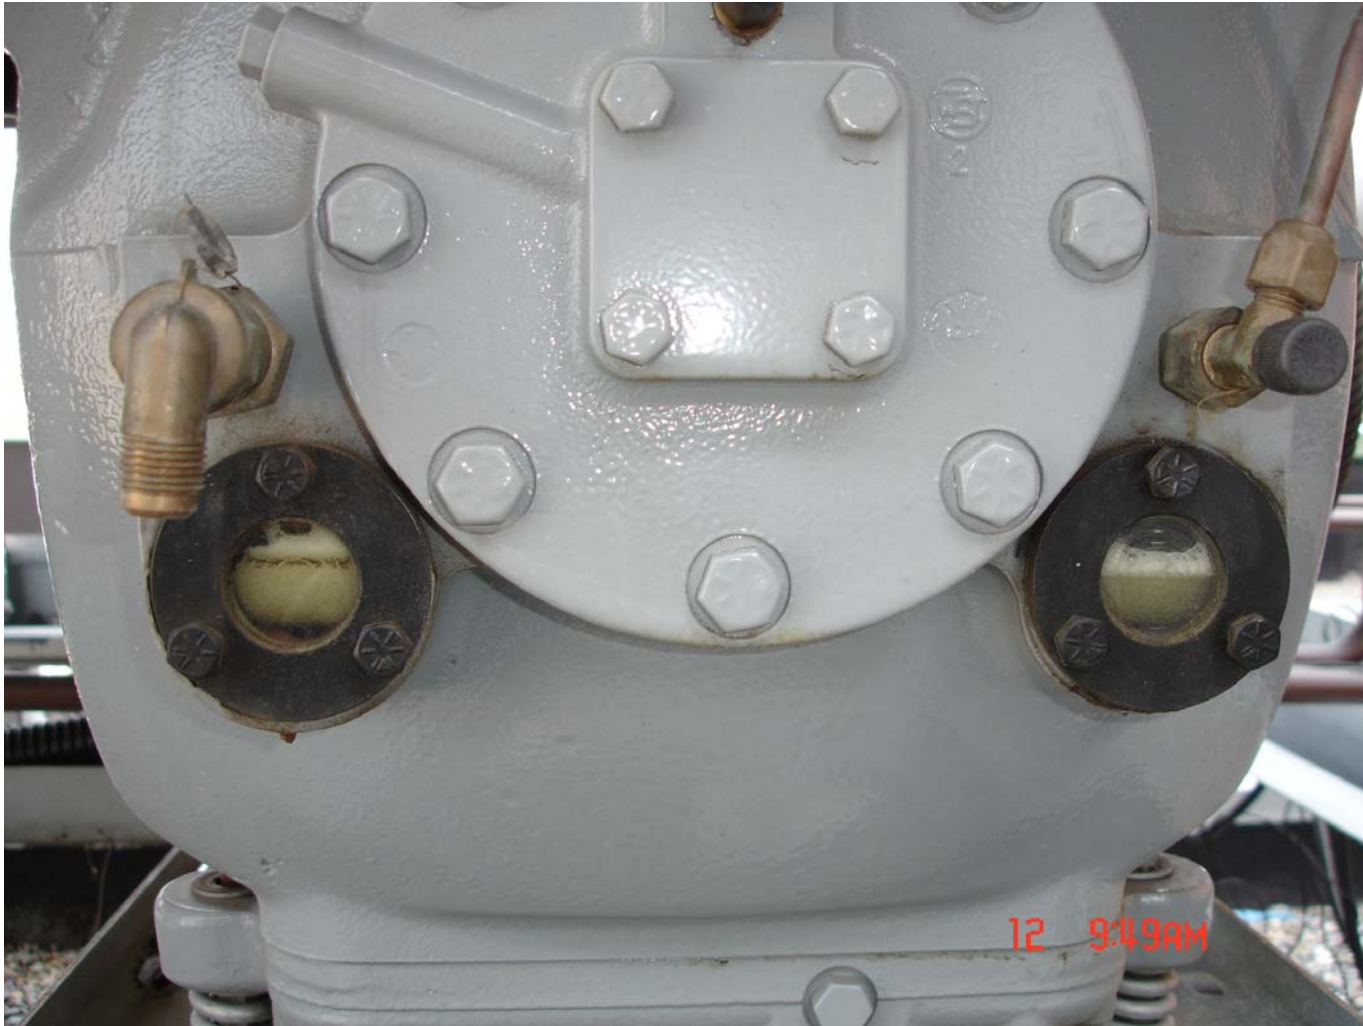
Compressor oil level photo #1434.

- Oil level in both compressors is higher than recommended by Carlyle (should be 1/8-3/8 gin the sight glass). See photo #1434.
- Net oil pressure on compressor #1 and #2 was 30 psig and 36 psig respectively (within the normal range).

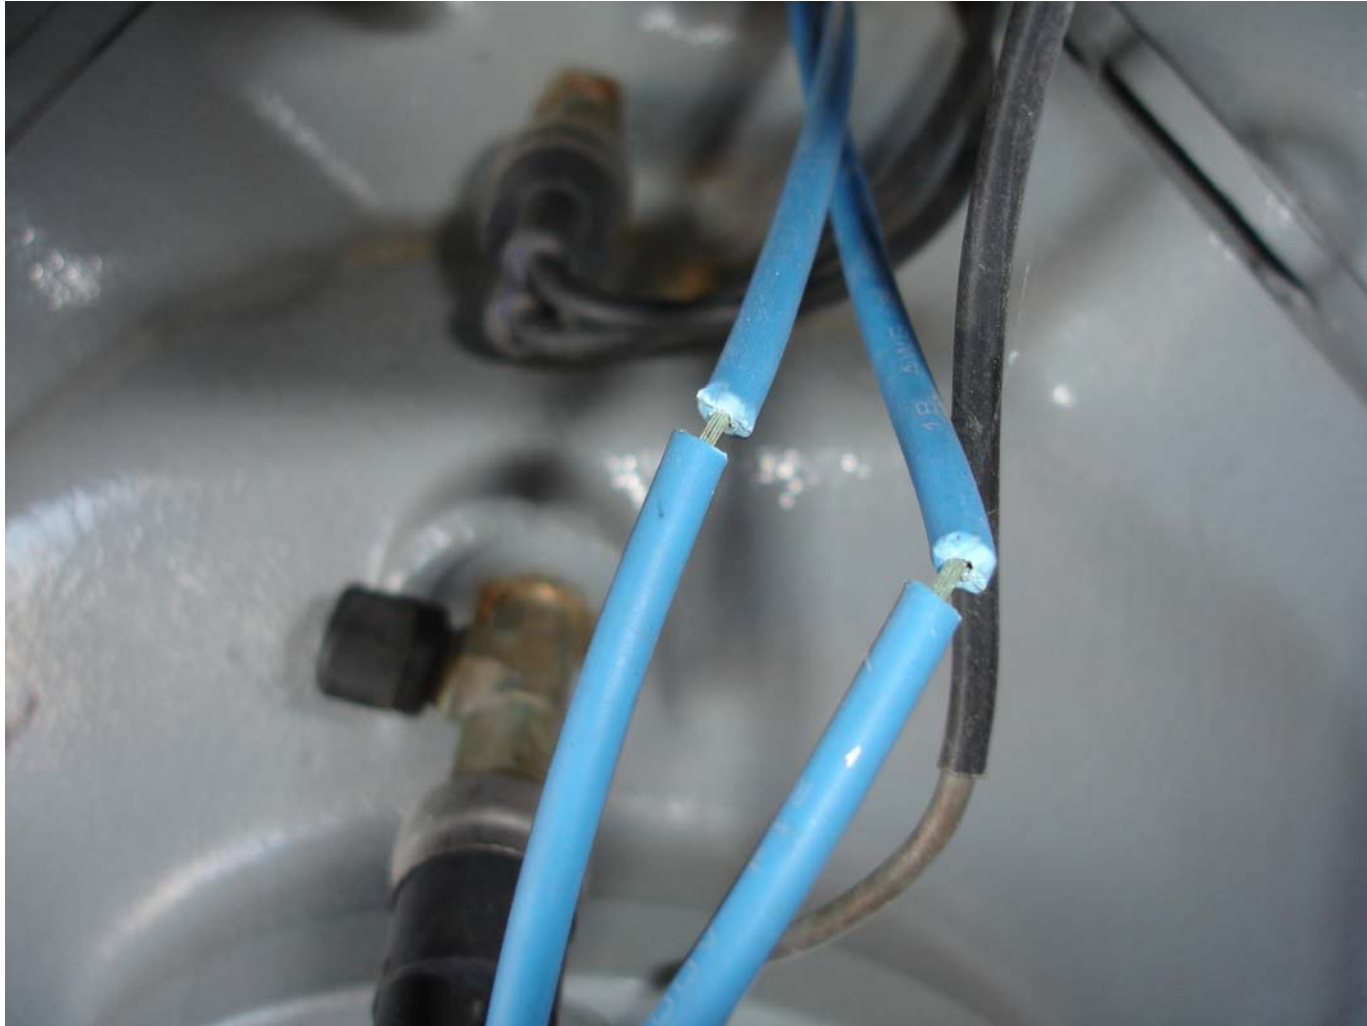
Compressor low pressure switch photo #1410.

- Both refrigerant sight glasses were clear when both stages were running.
- Low pressure switches on both compressors have insulation stripped to expose a small section of wire. See photo's #1410 and 1411.

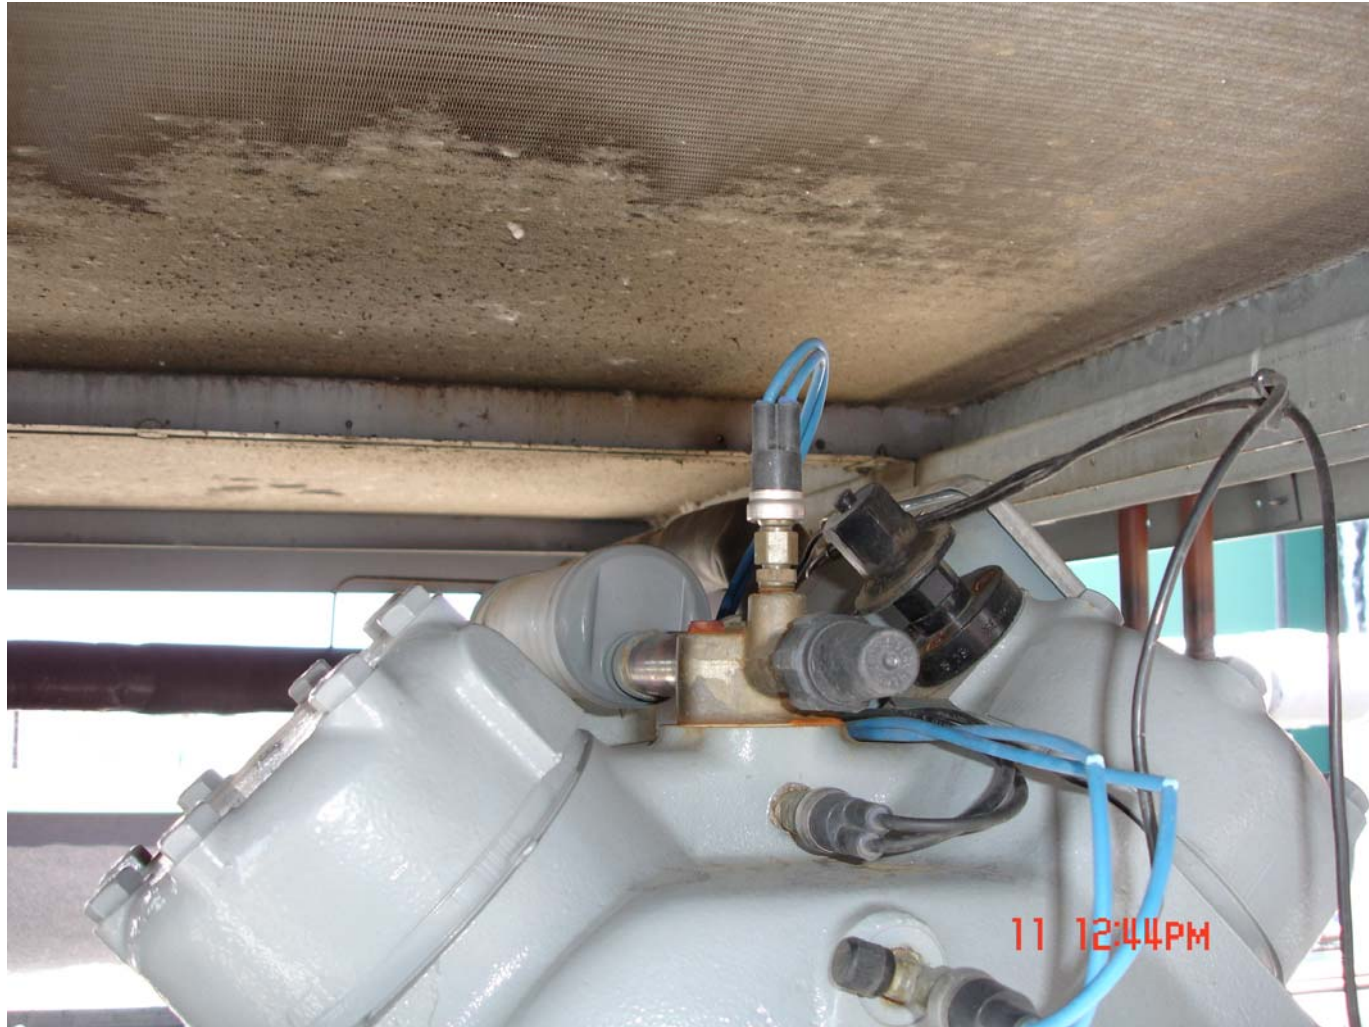
Condenser fan cycling pressure switch photo #1429 (factory).

- The condenser fan pressure control is connected to the backseat port of the discharge service valve (factory). See photo #1429.

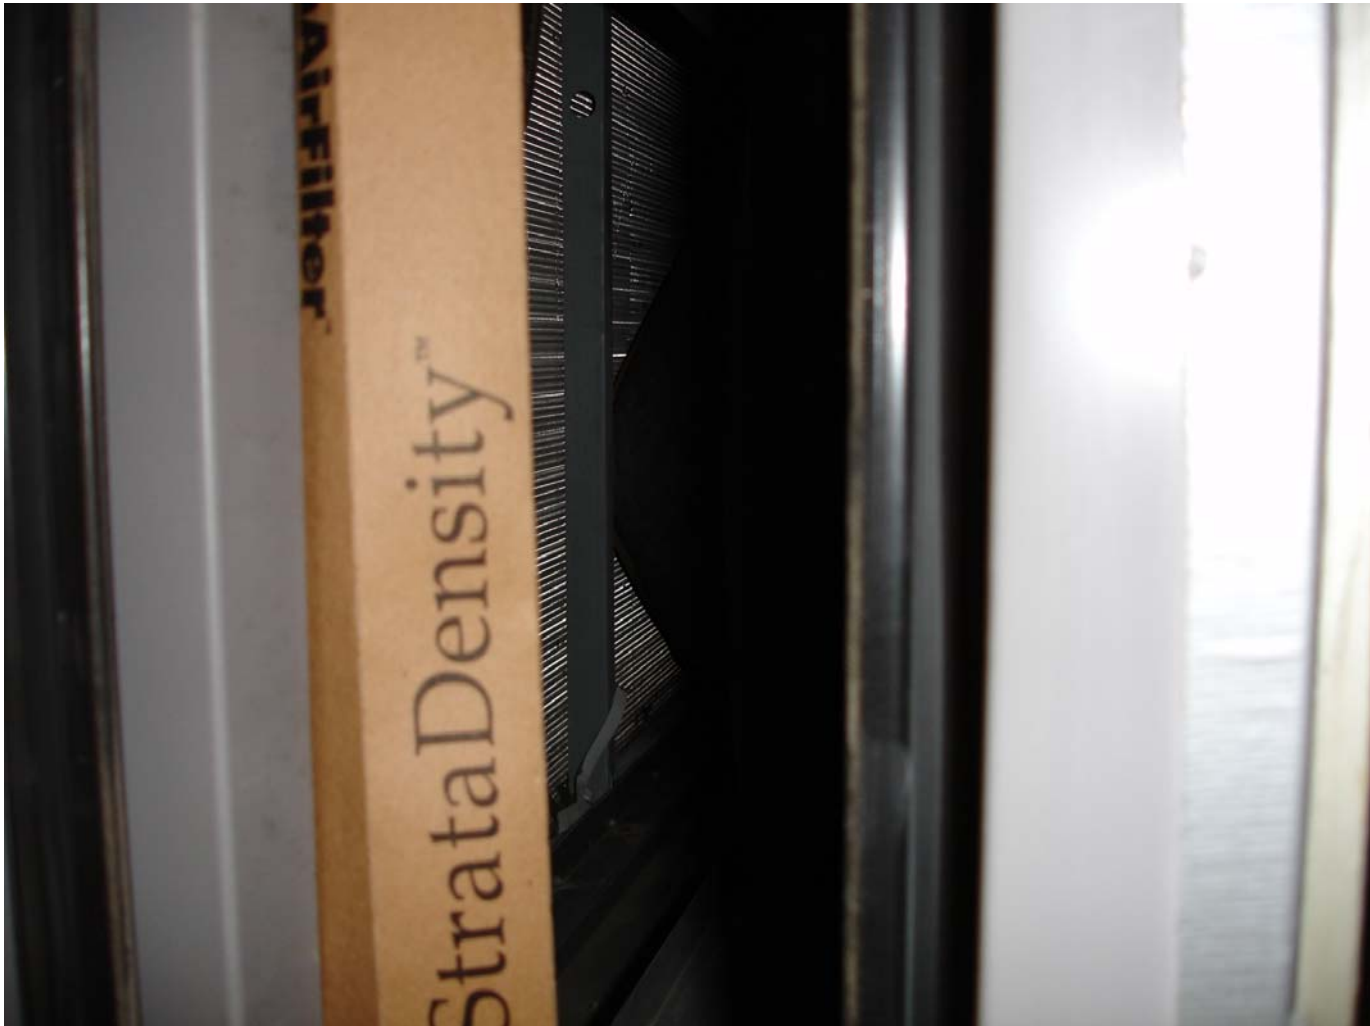
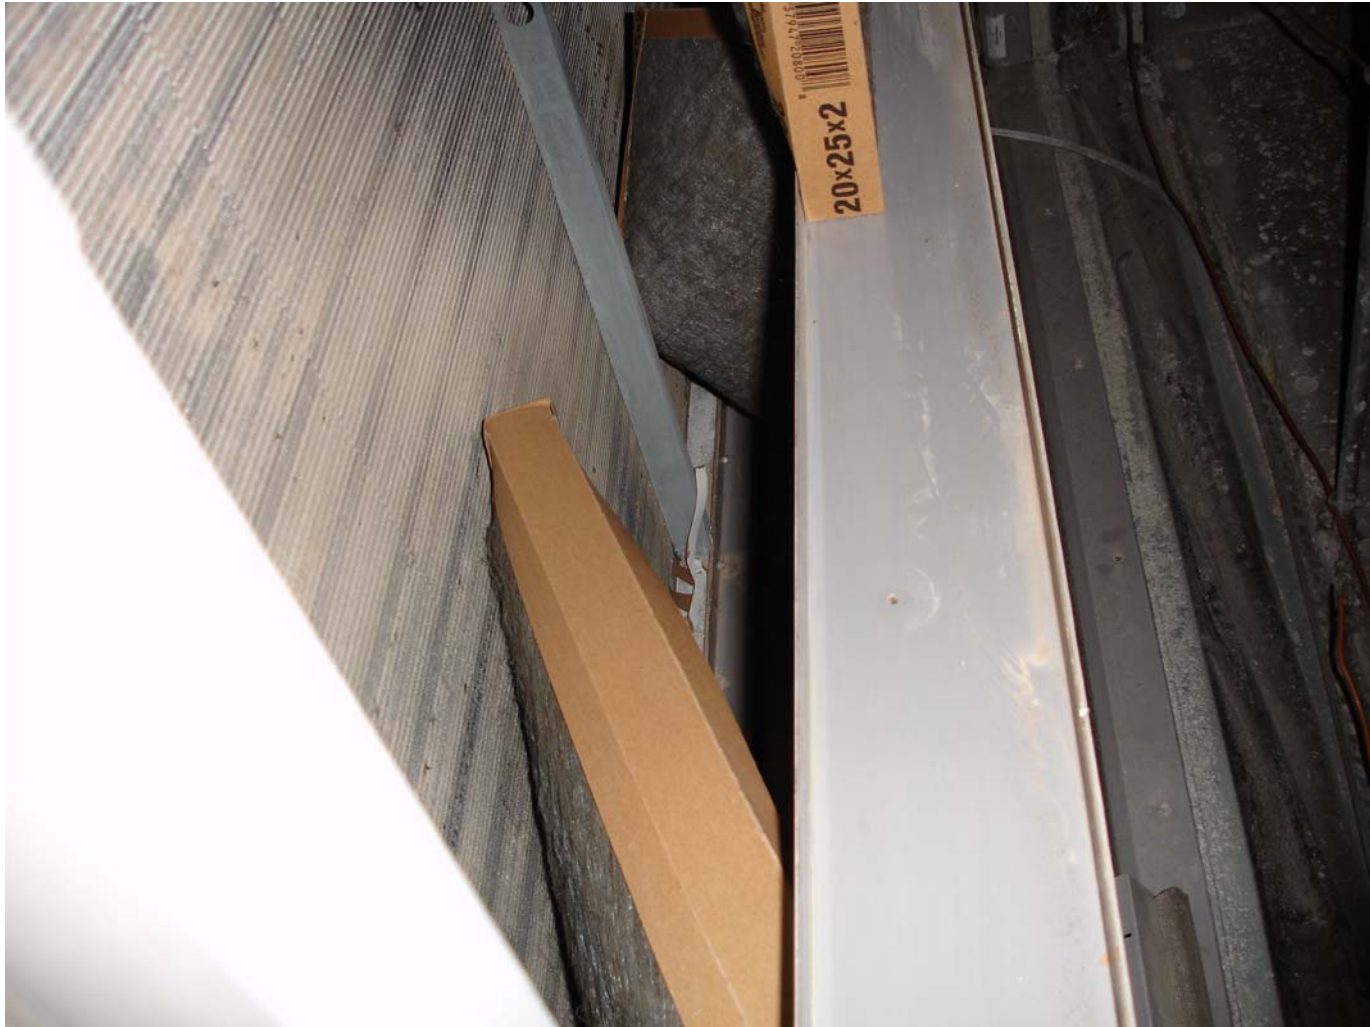
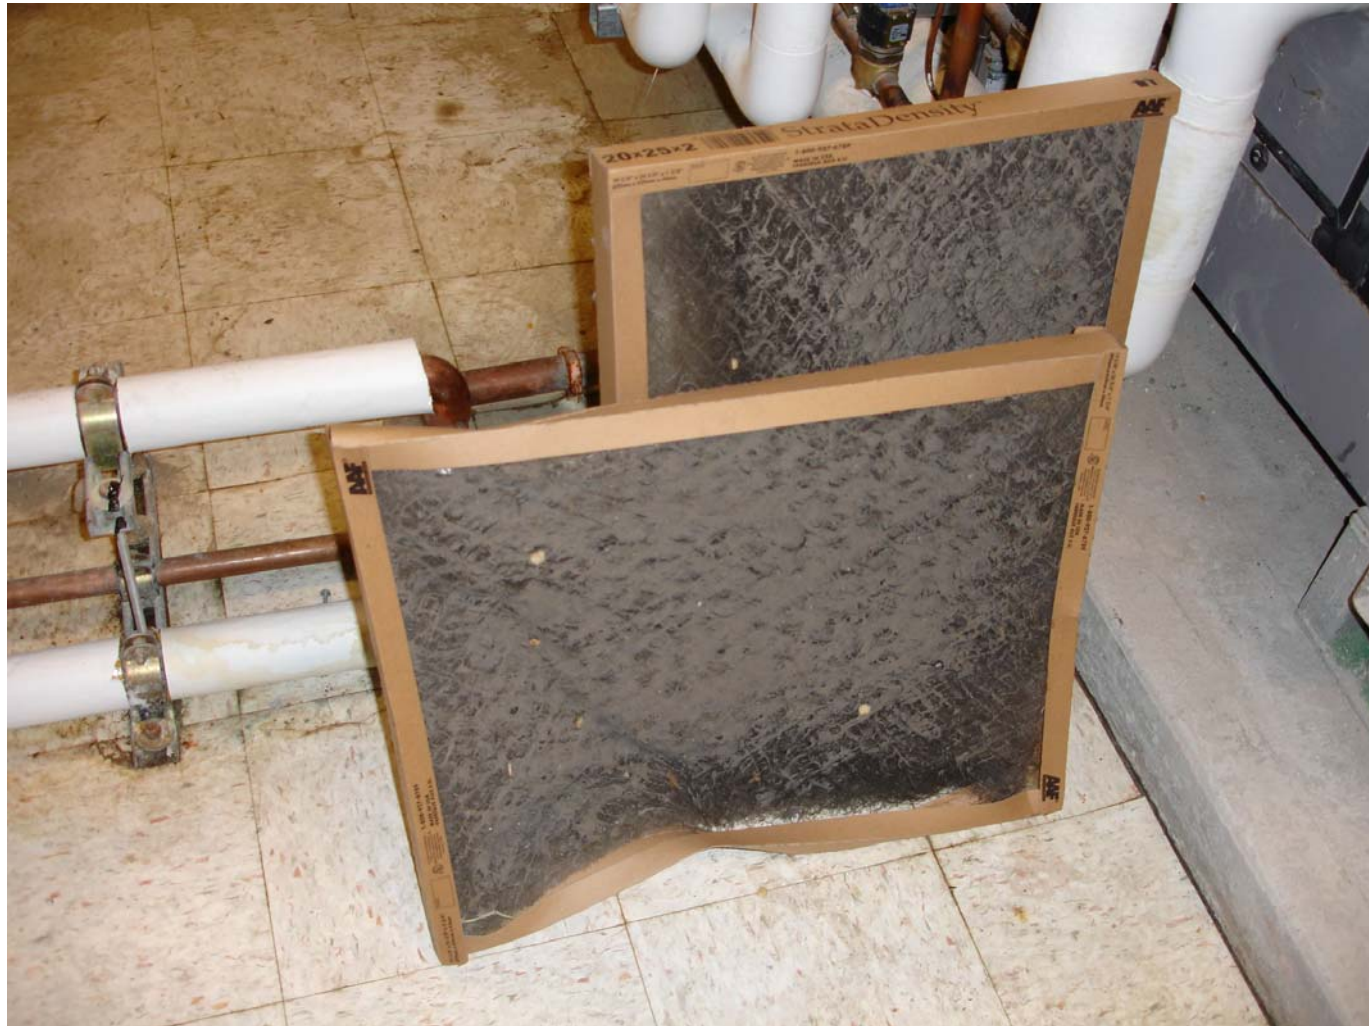
- Air filters plugged, incorrect depth, and dislodged from rack. See photo's #1414-1416.
- Insulation missing on #2 suction line. See photo #1423.
- Penetrations for refrigerant piping not sealed and in some cases the piping is in direct contact with the sheet metal casing which will result in a future leaks. See photo's #1425, 1426, 1483, 1484.

Air filter photo #1414.

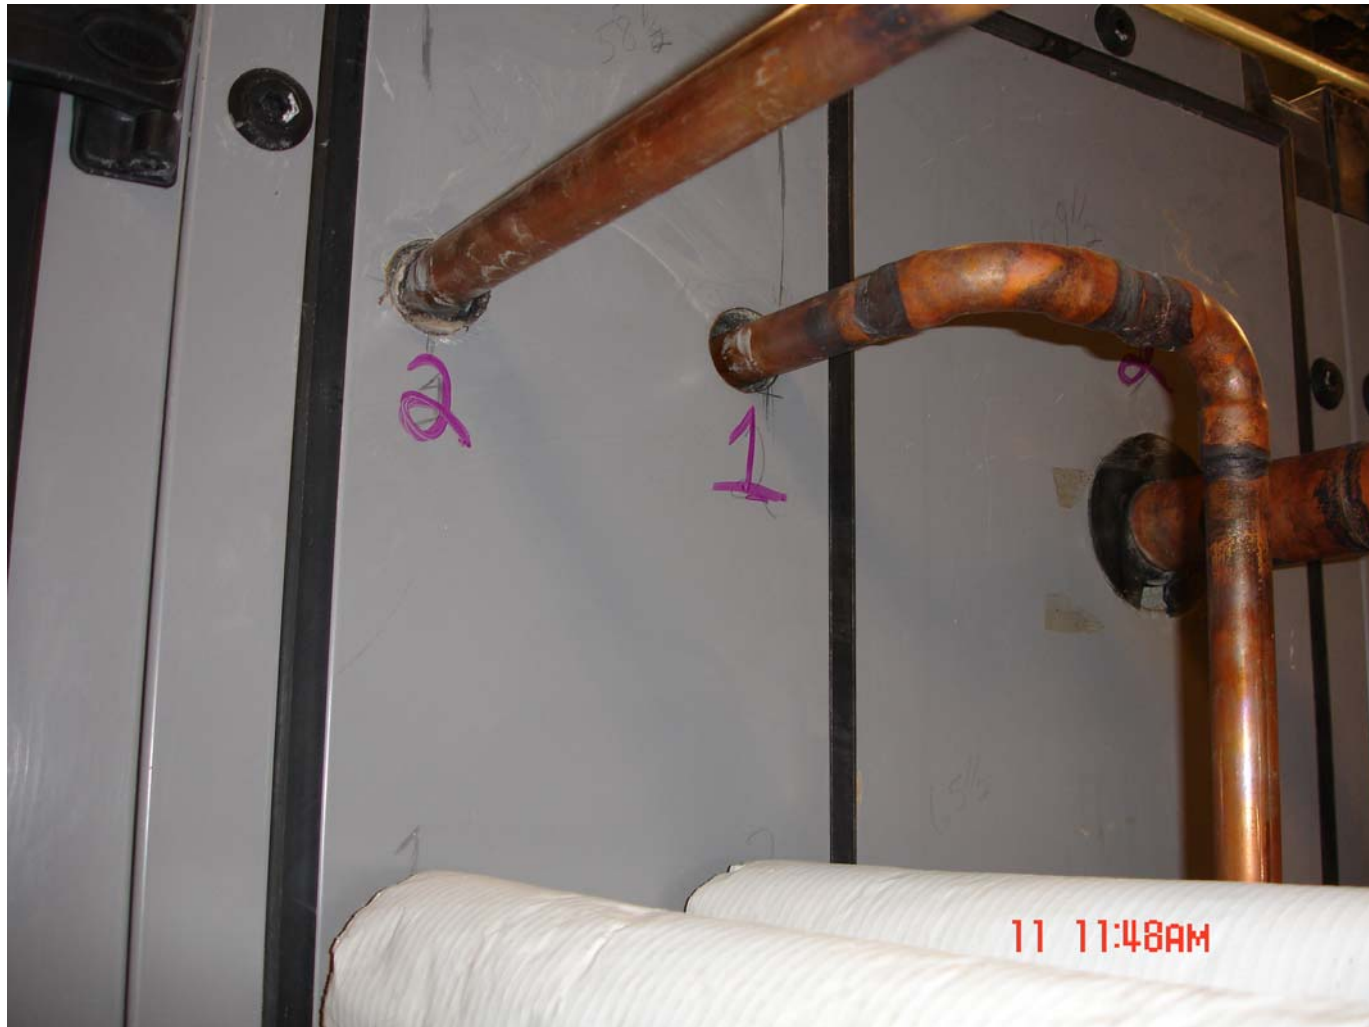
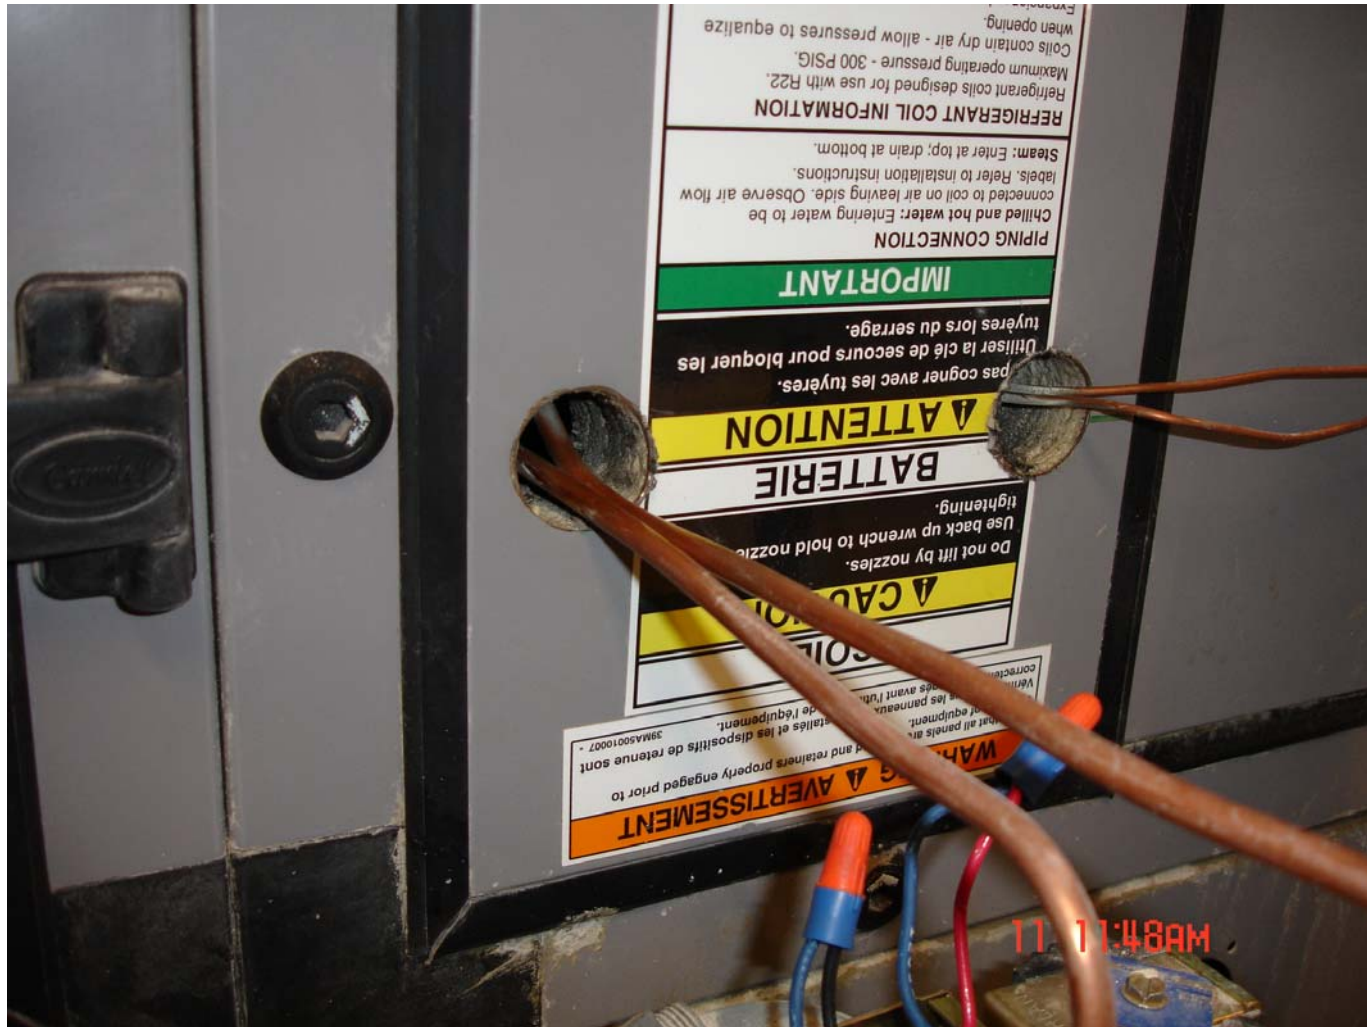
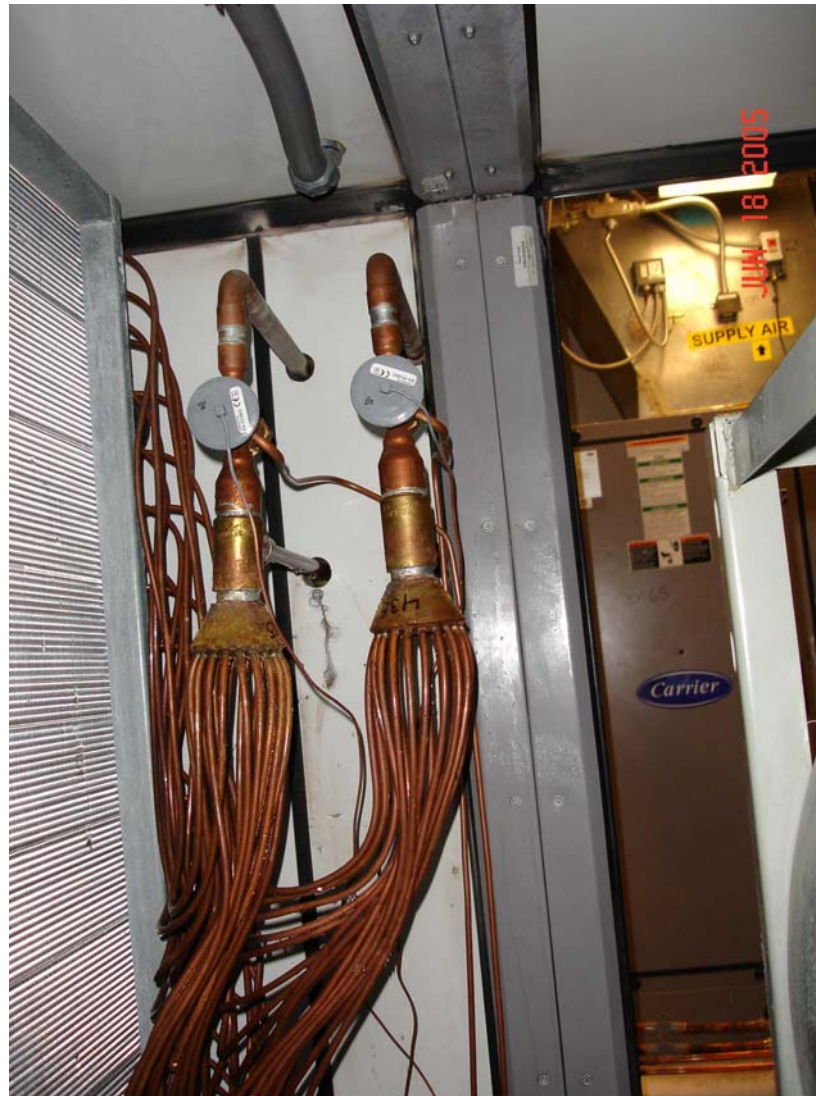
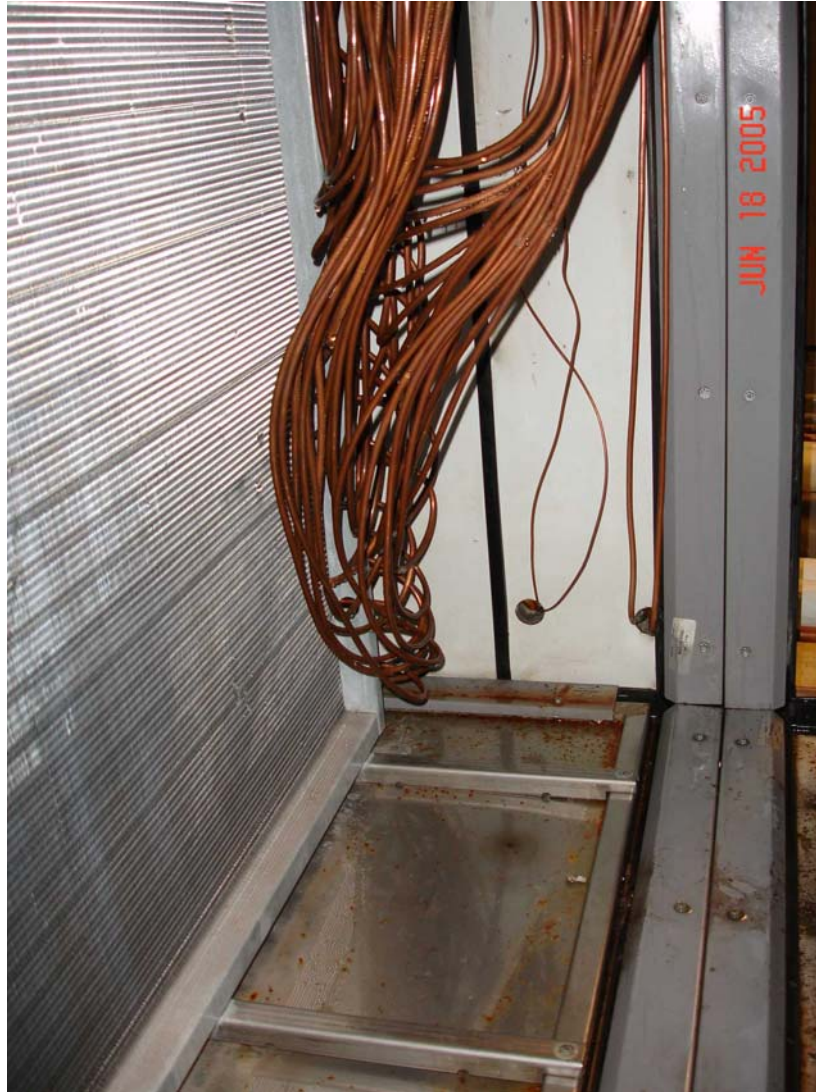
Piping penetration photo #1425.

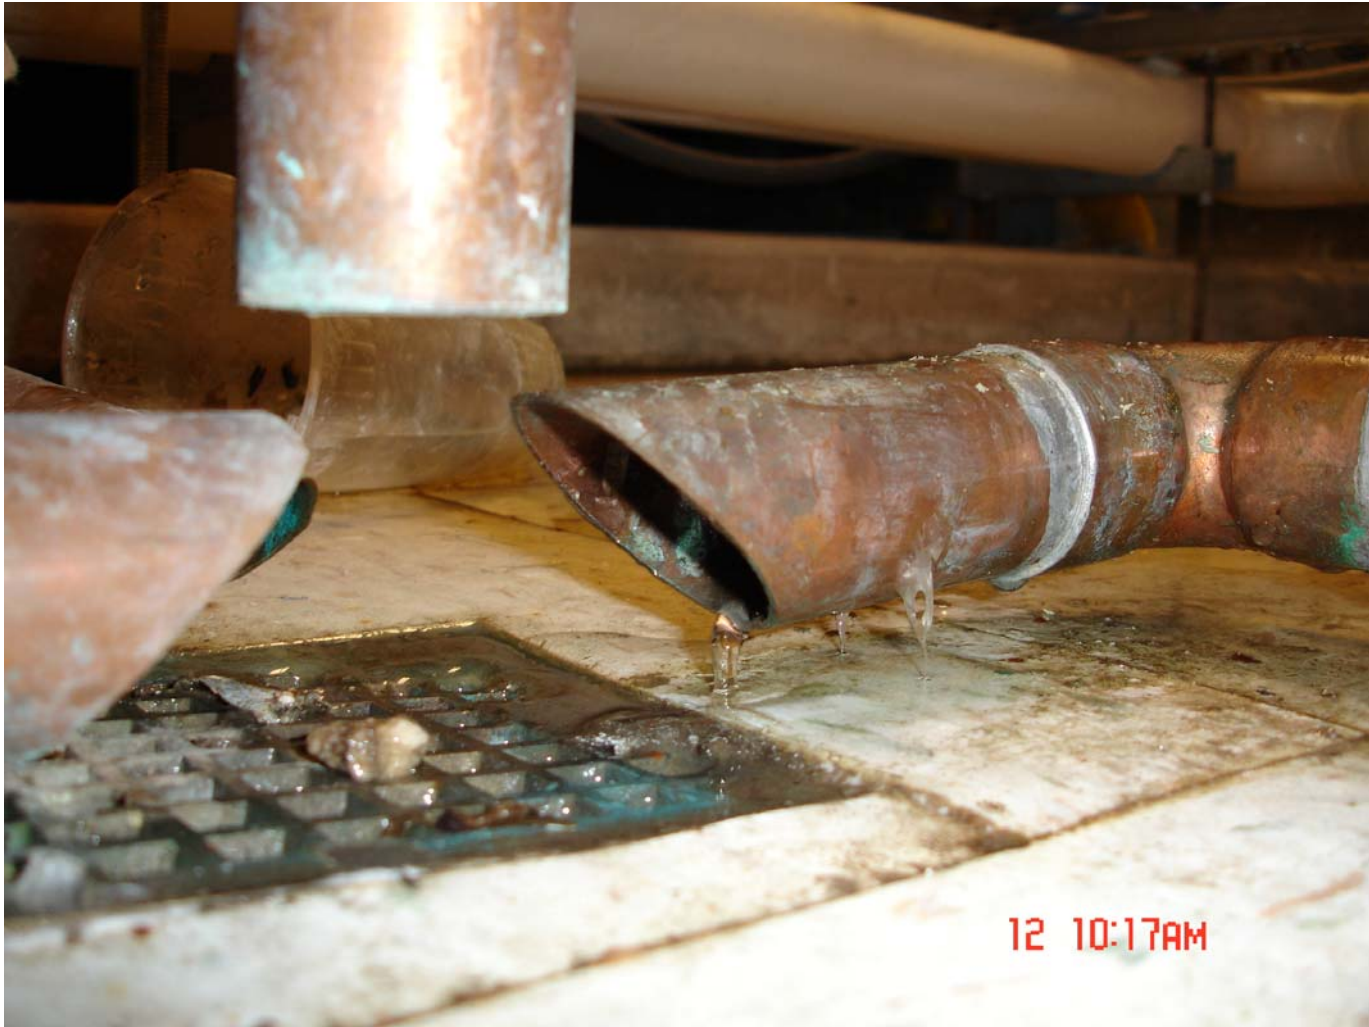
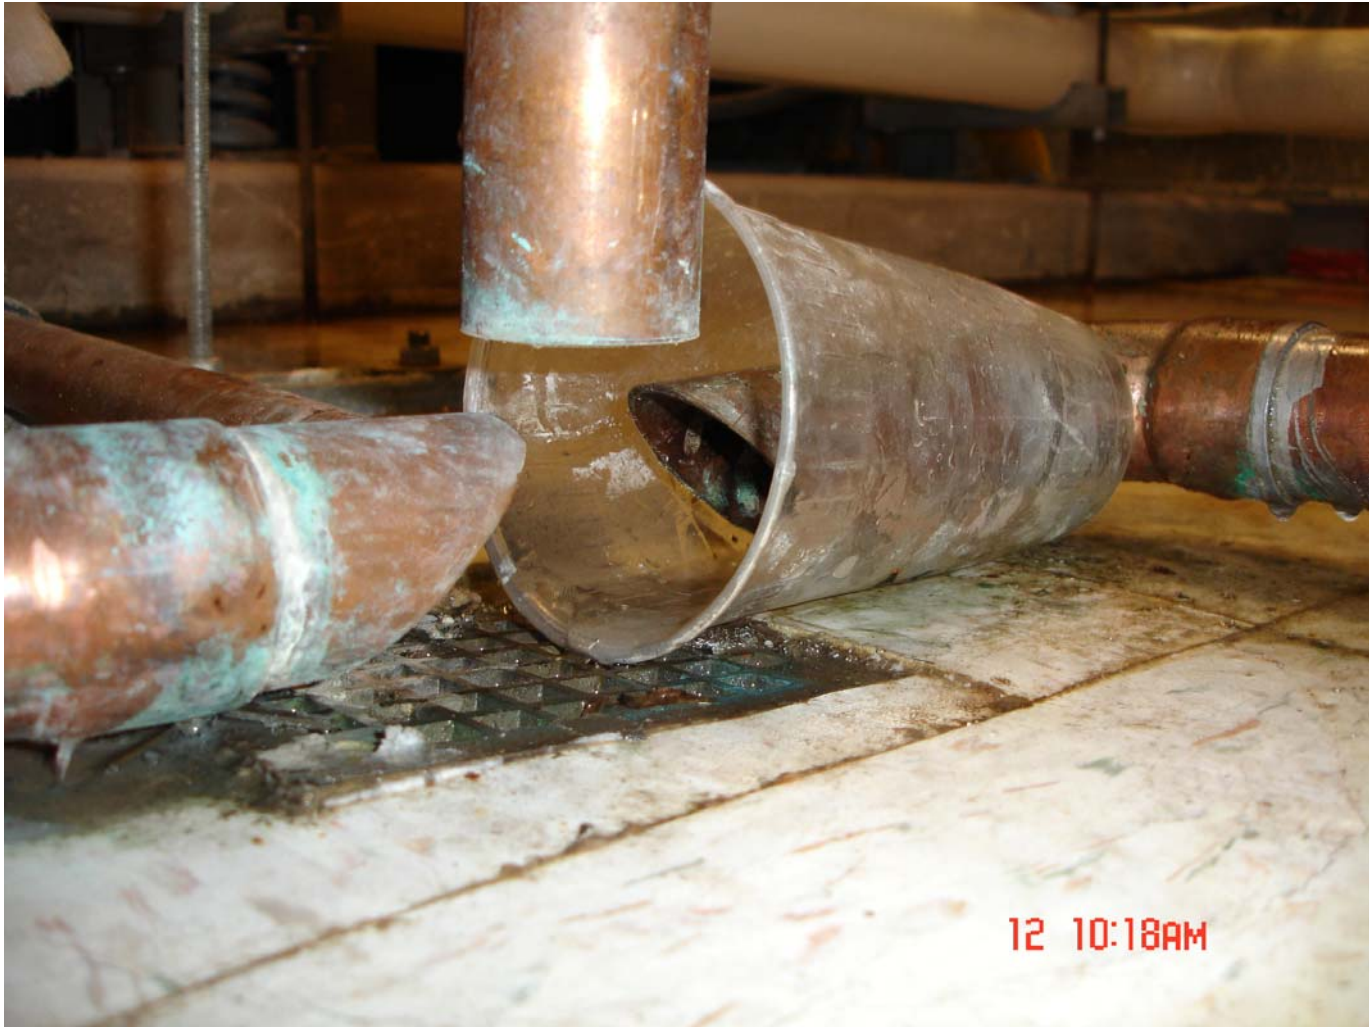
- Refrigerant piping making metal to metal contact at casing penetration in some cases.
- Condensate drain piping drains short of the floor drain. See photo's #1439 and 1440.

Condensate drain piping photo #1439.

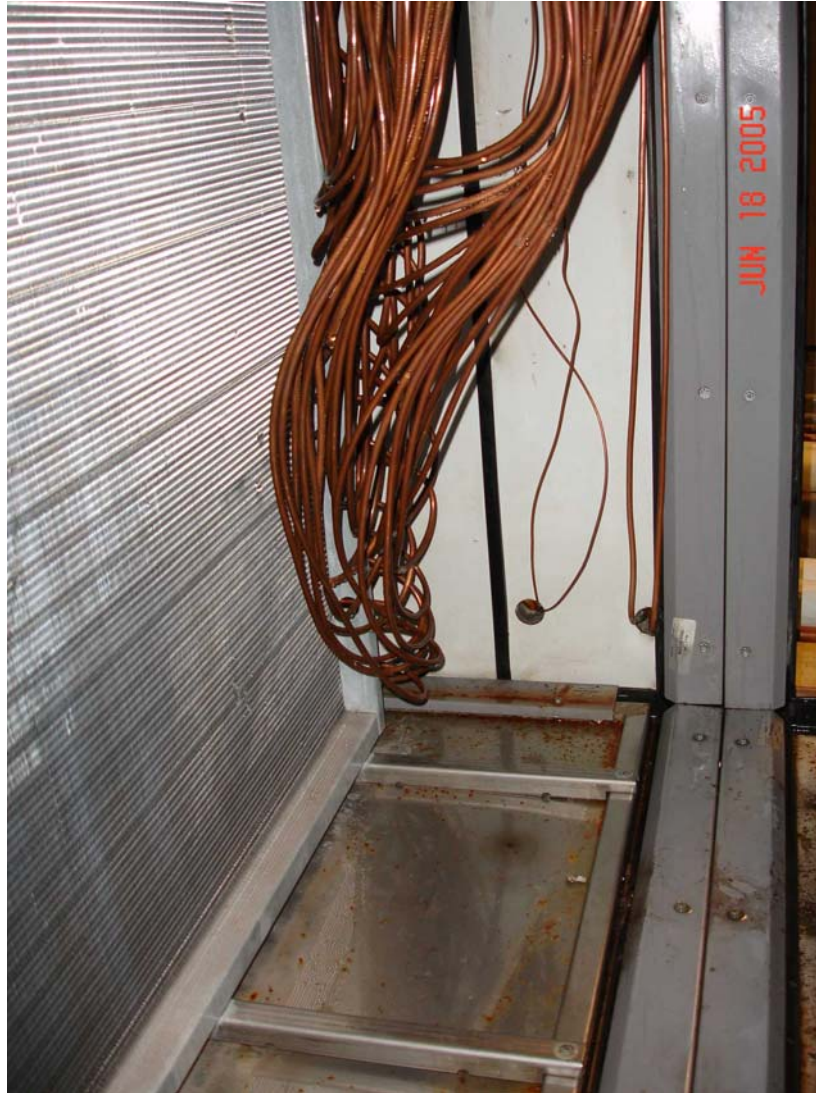
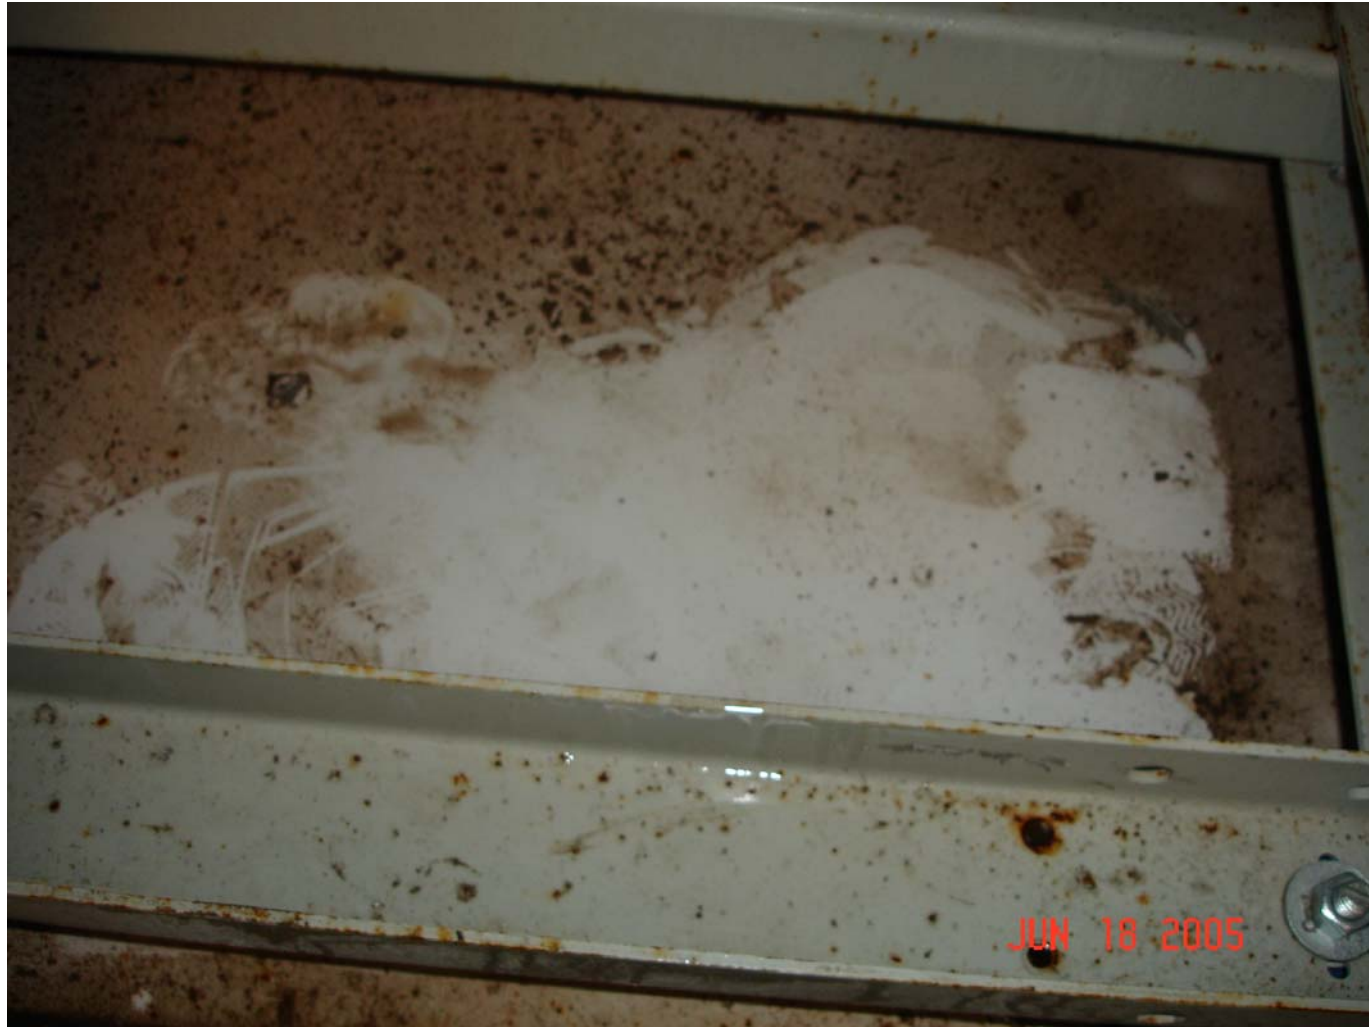
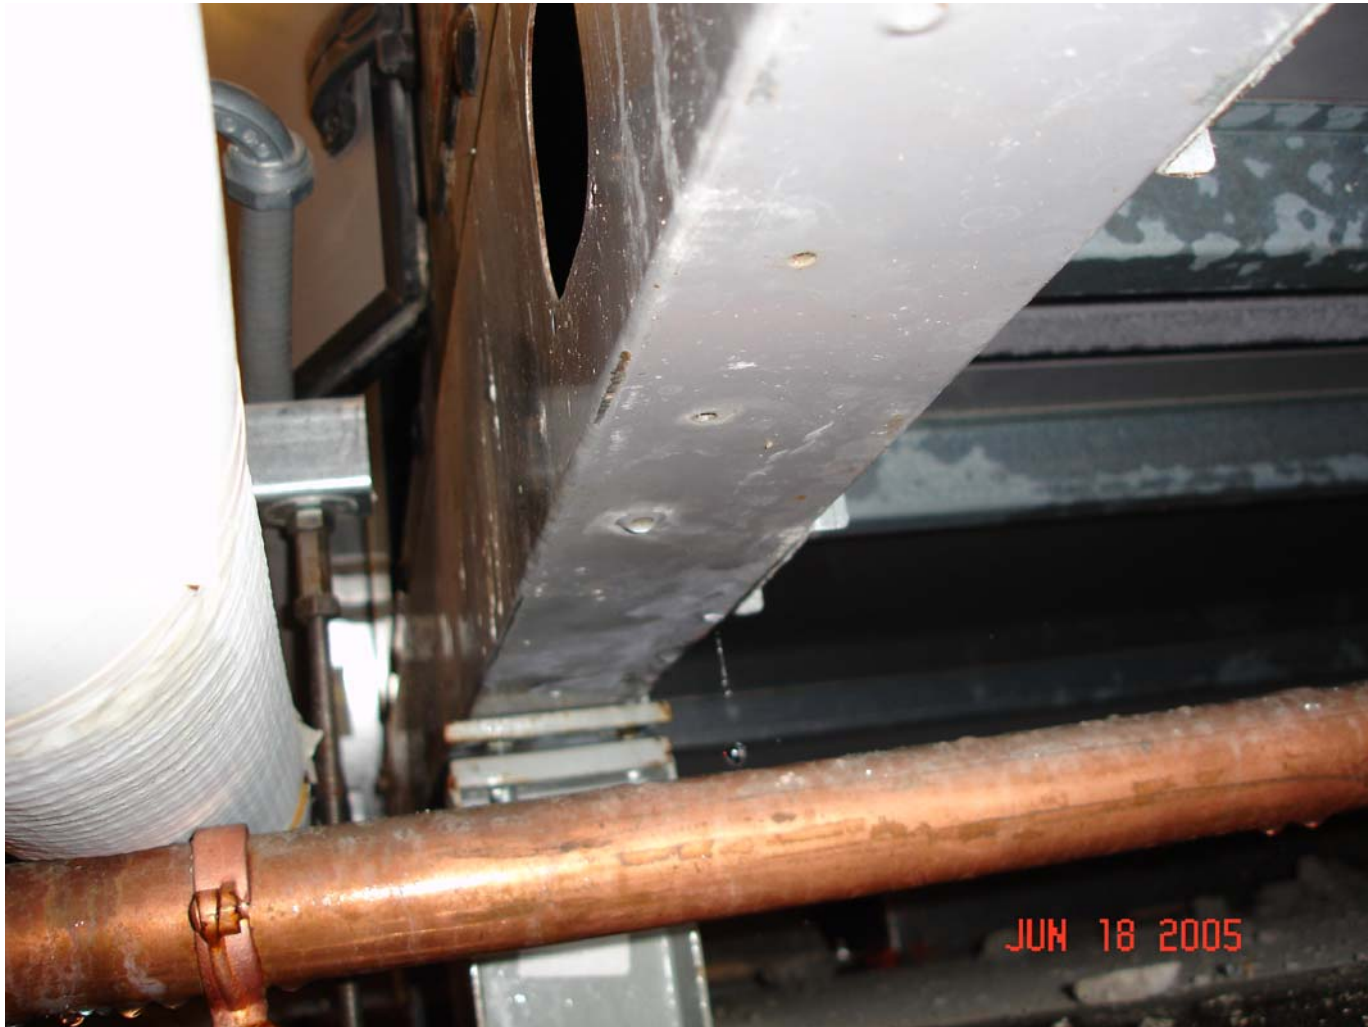
- Possible condensate carry-over from the cooling coil into the fan section. See photo's #1484, 1485, 1486.
- Condensate forming on the exterior of the duct work at the air handler and also in the boiler room (high dew point in the spaces). See photo's #1458, 1463, 1464.

Possible condensate carry-over photo #1484.
