Middle School

Summary update of diagnostic
work performed from 7/5/05
through 7/26/05

Report on work performed from 7/20/05 through 7/26/05.

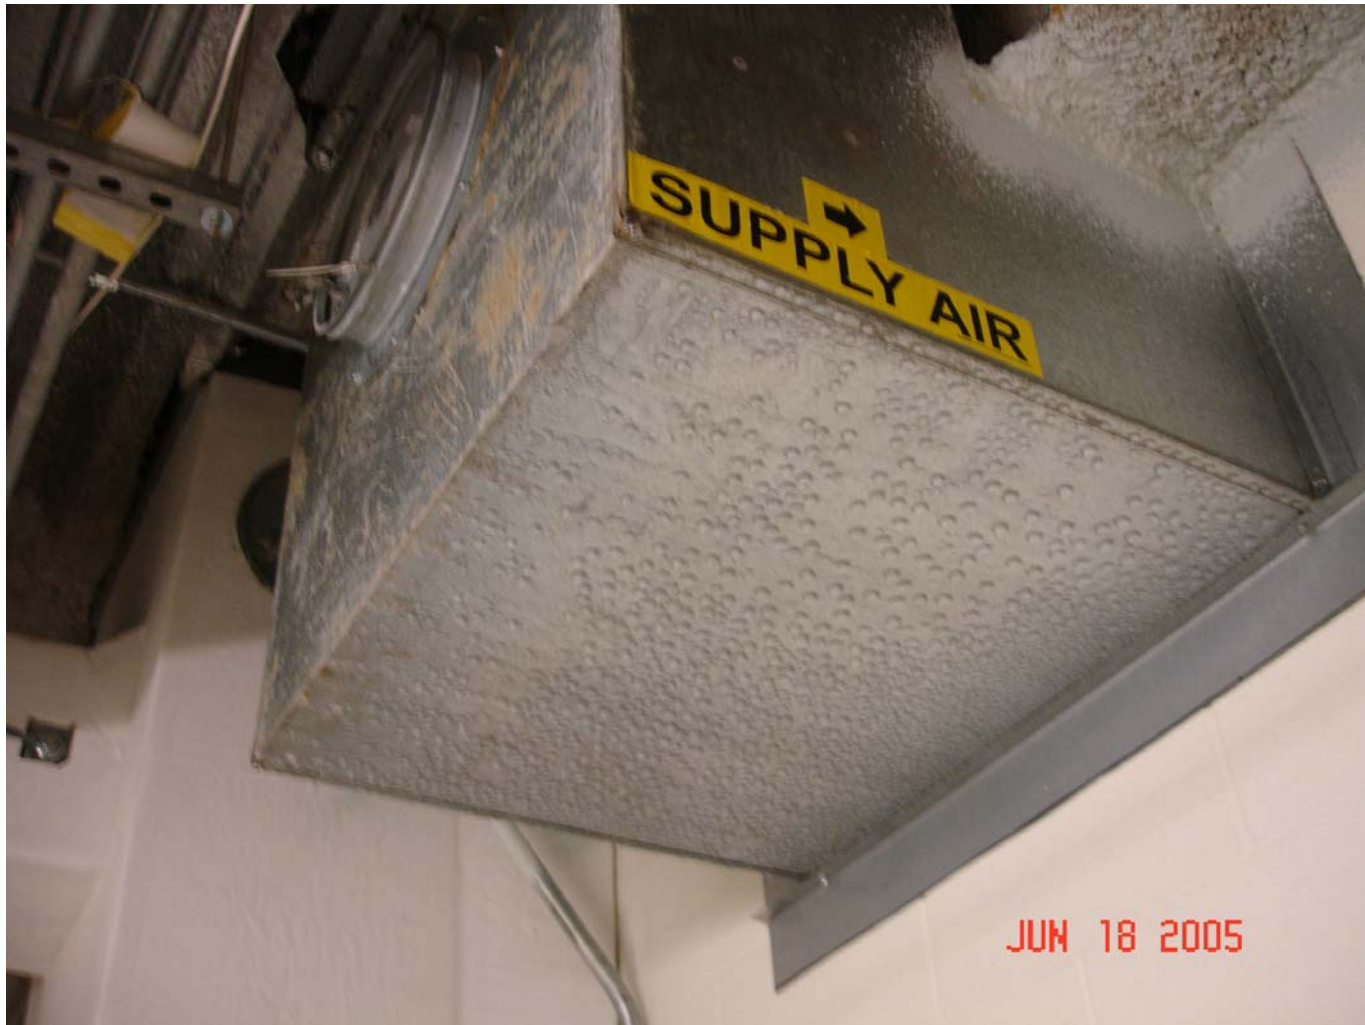
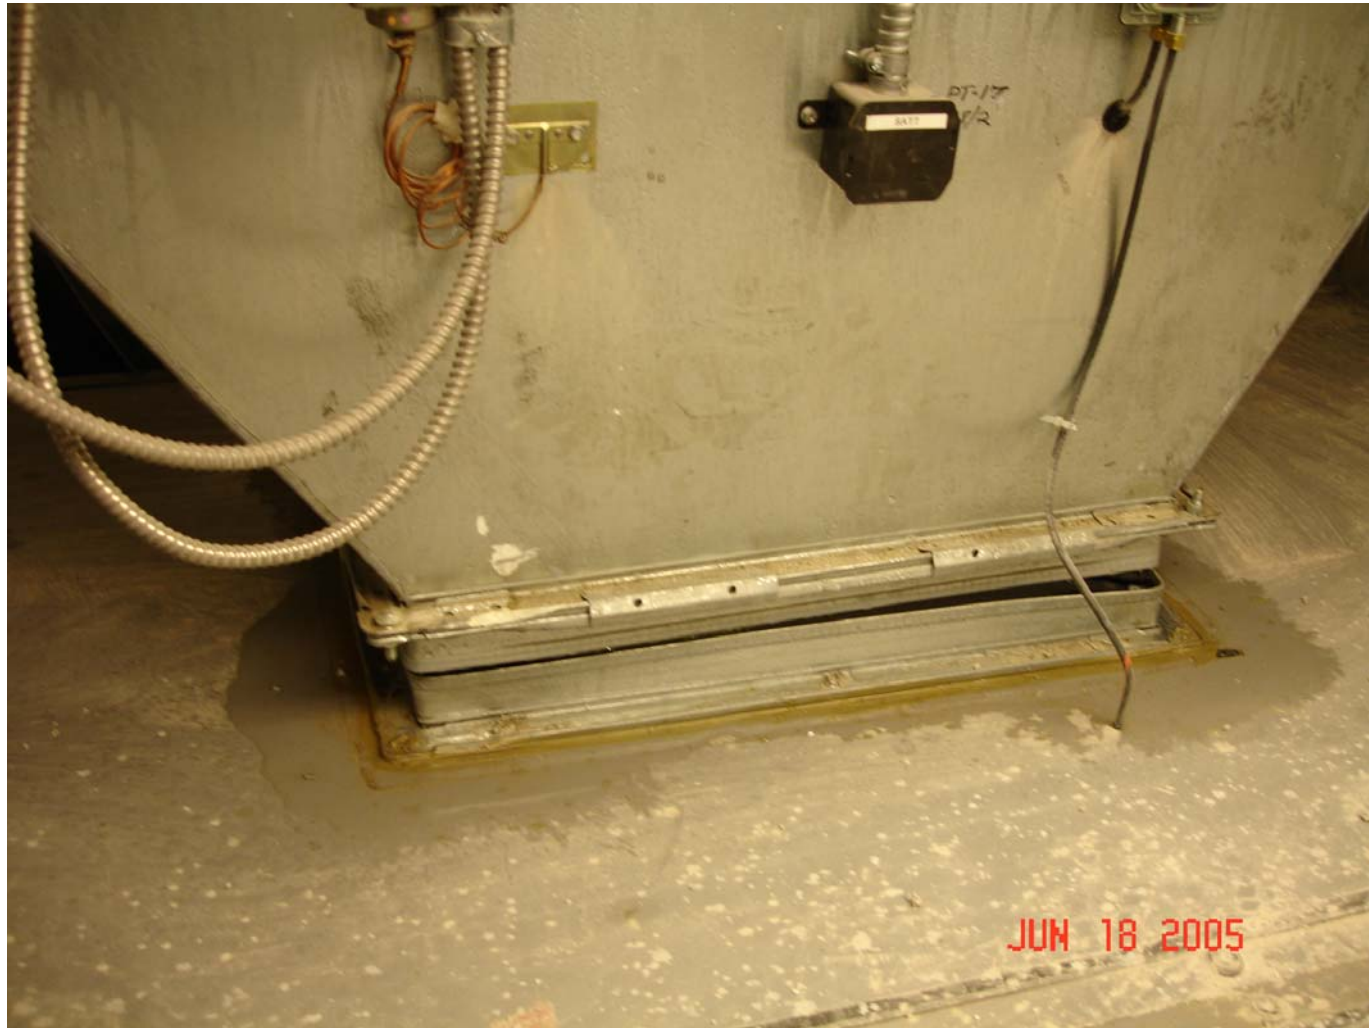
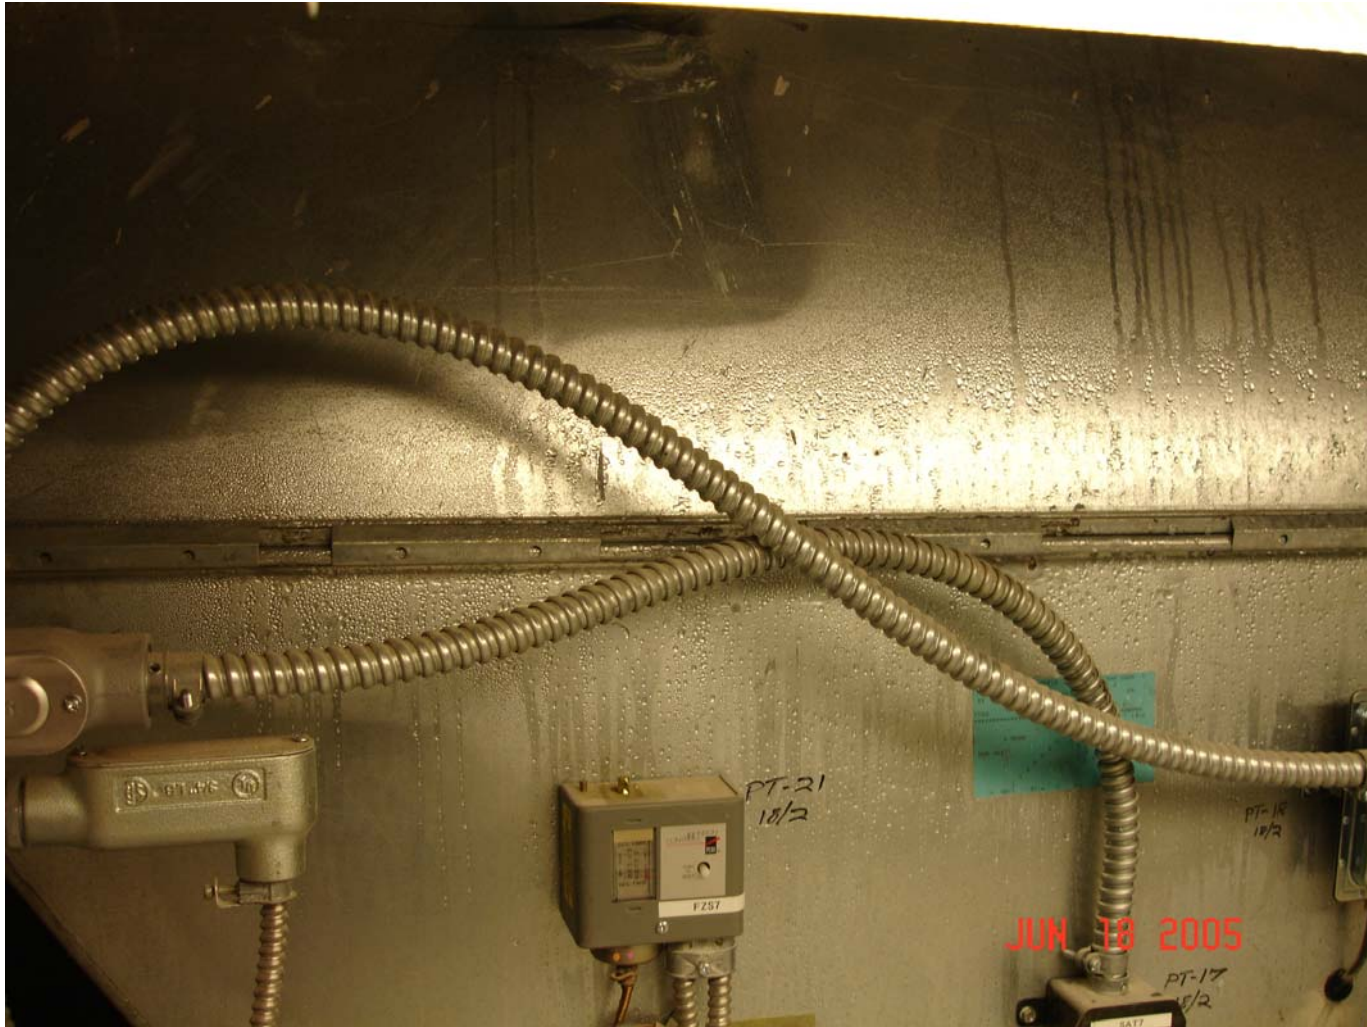
- Possible condensate carry-over from the cooling coil into the fan section. See photo's #1484, 1485, 1486.
- Condensate forming on the exterior of the duct work at the air handler and also in the boiler room (high dew point in the spaces). See photo's #1458, 1463, 1464.

Condensate on exterior of duct photo #1458.

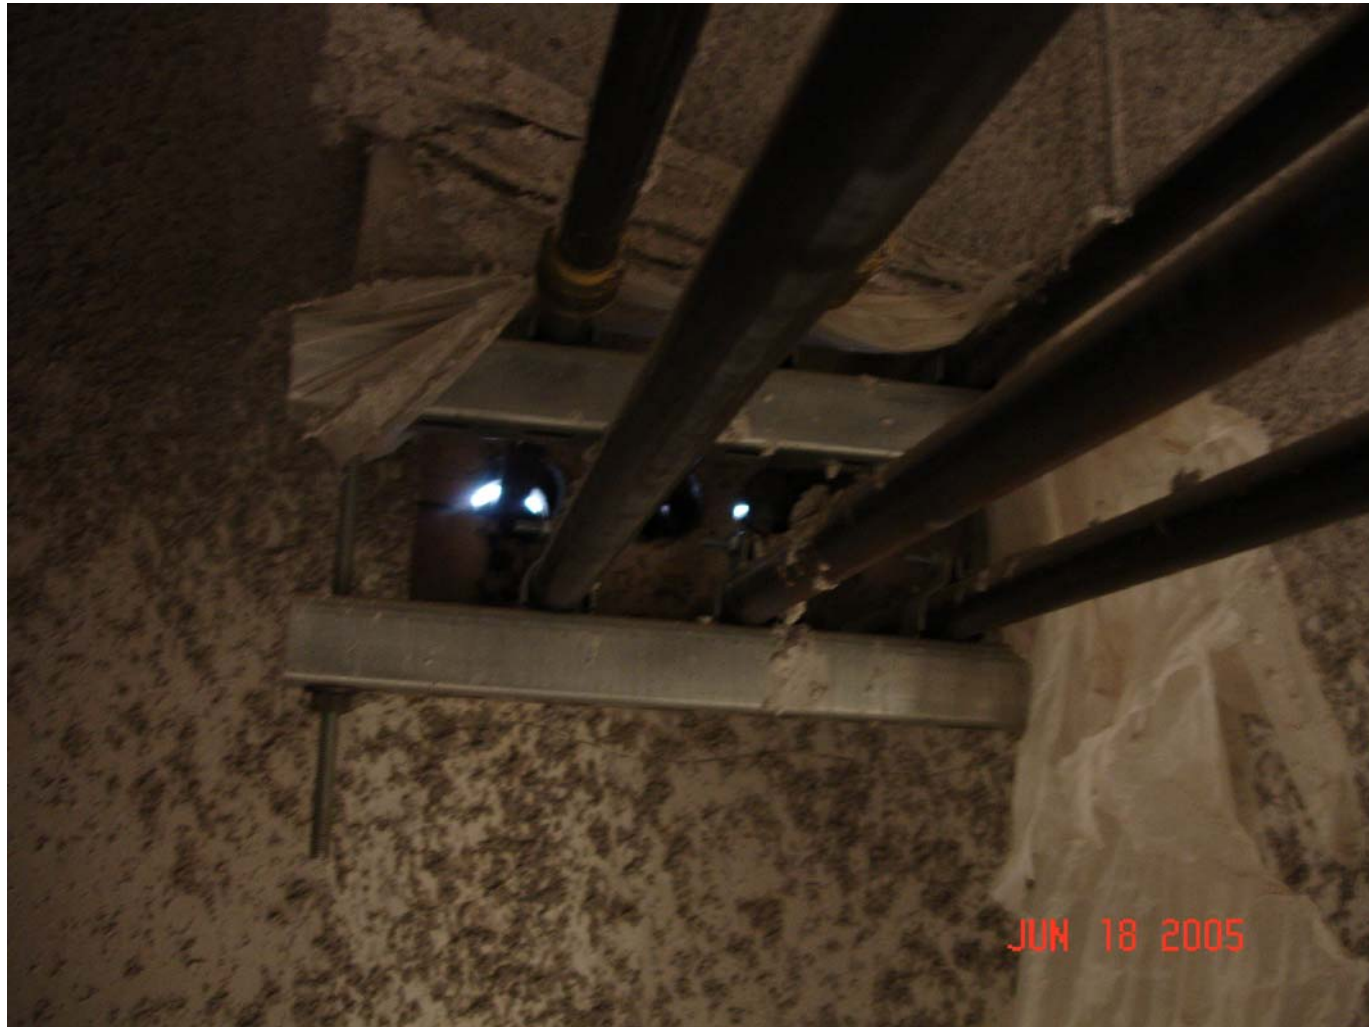
Gas vent penetration photo #1465.

- Gas vent penetrations to outdoors are not sealed. See photo #1465.
- Air bypass from fan discharge to fan suction on the supply fan. See photo's #1475, 1476, 1479.

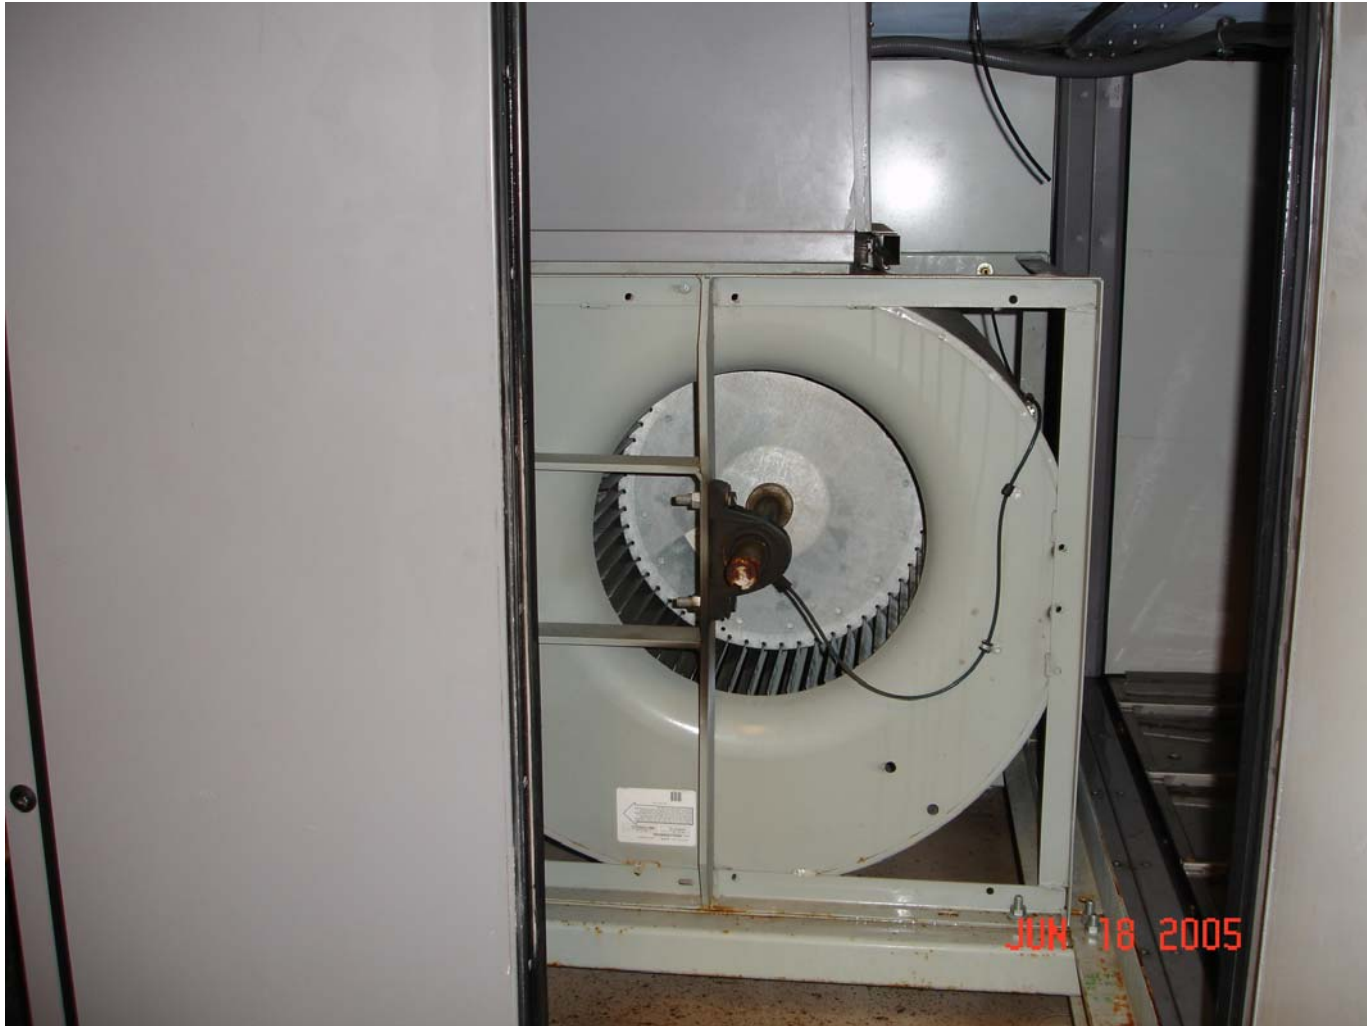
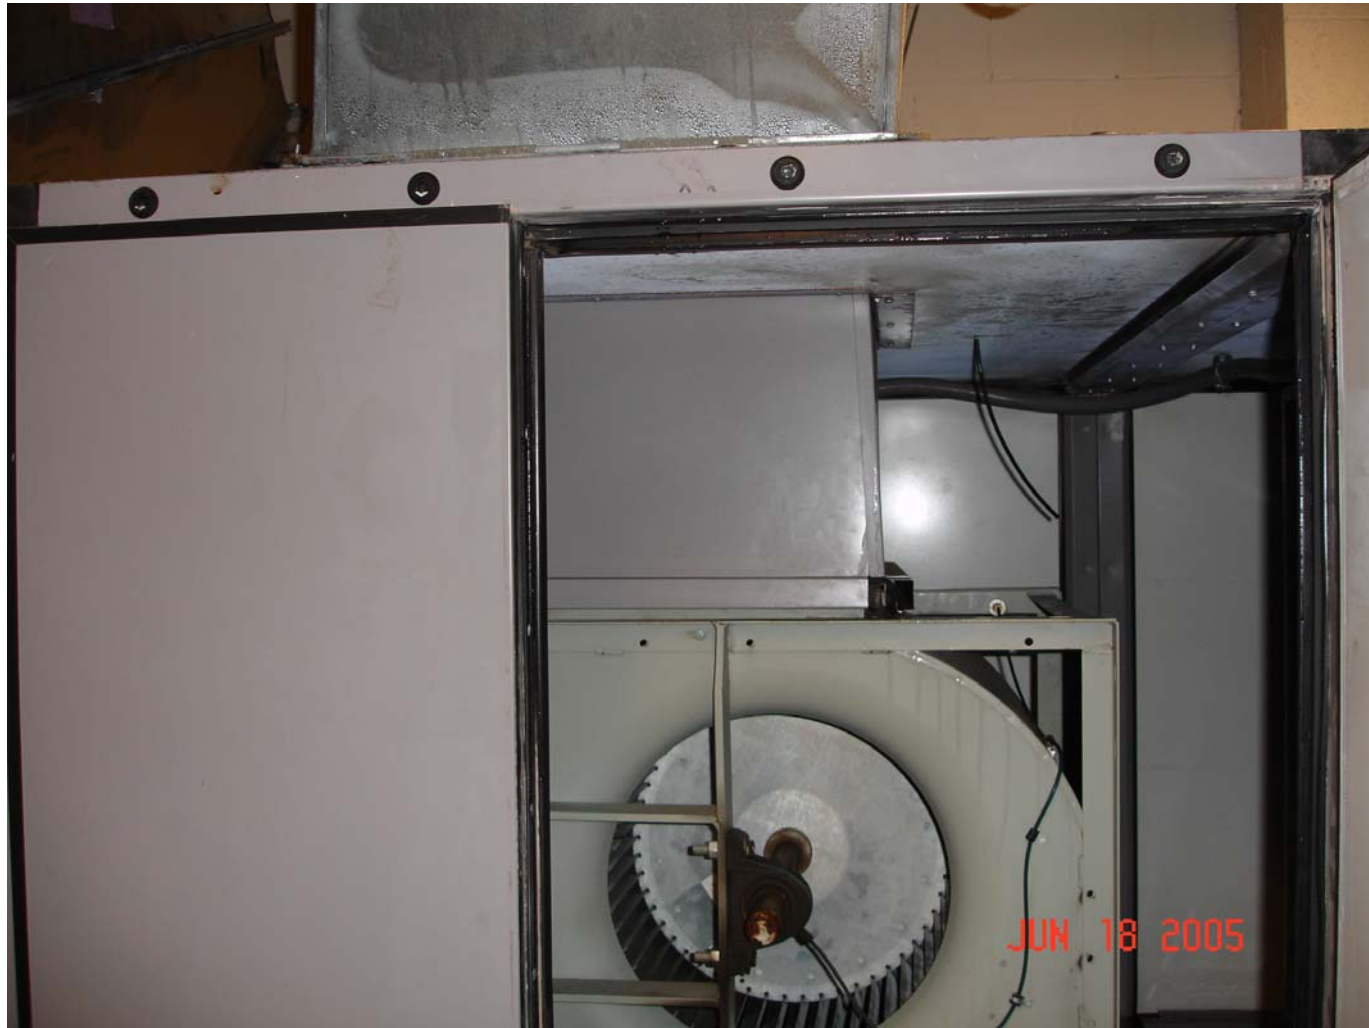
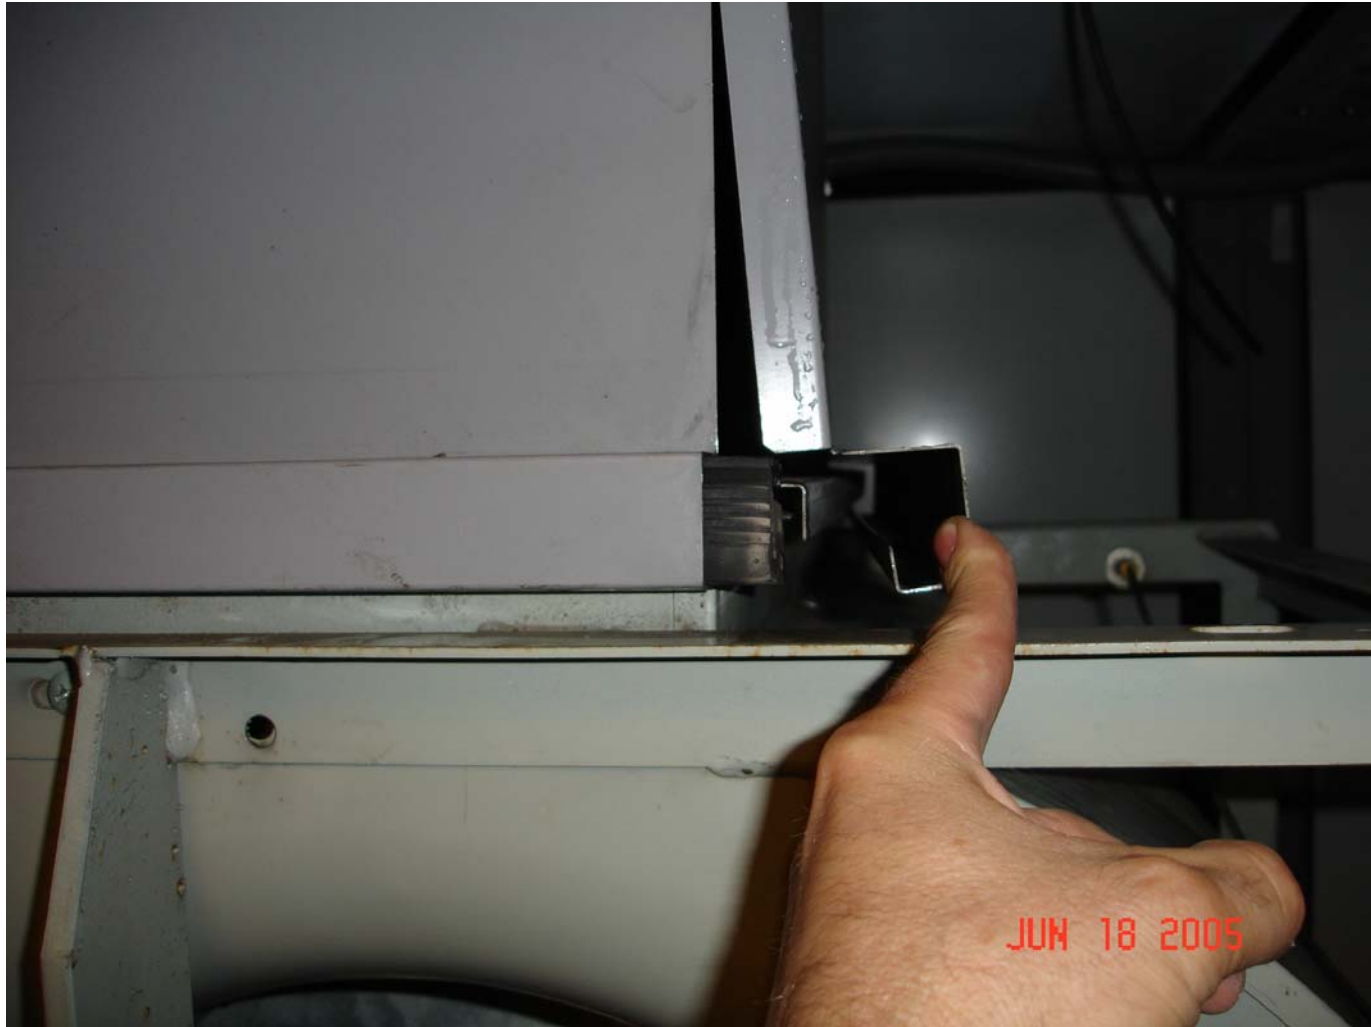
Supply fan air bypass photo #1475.

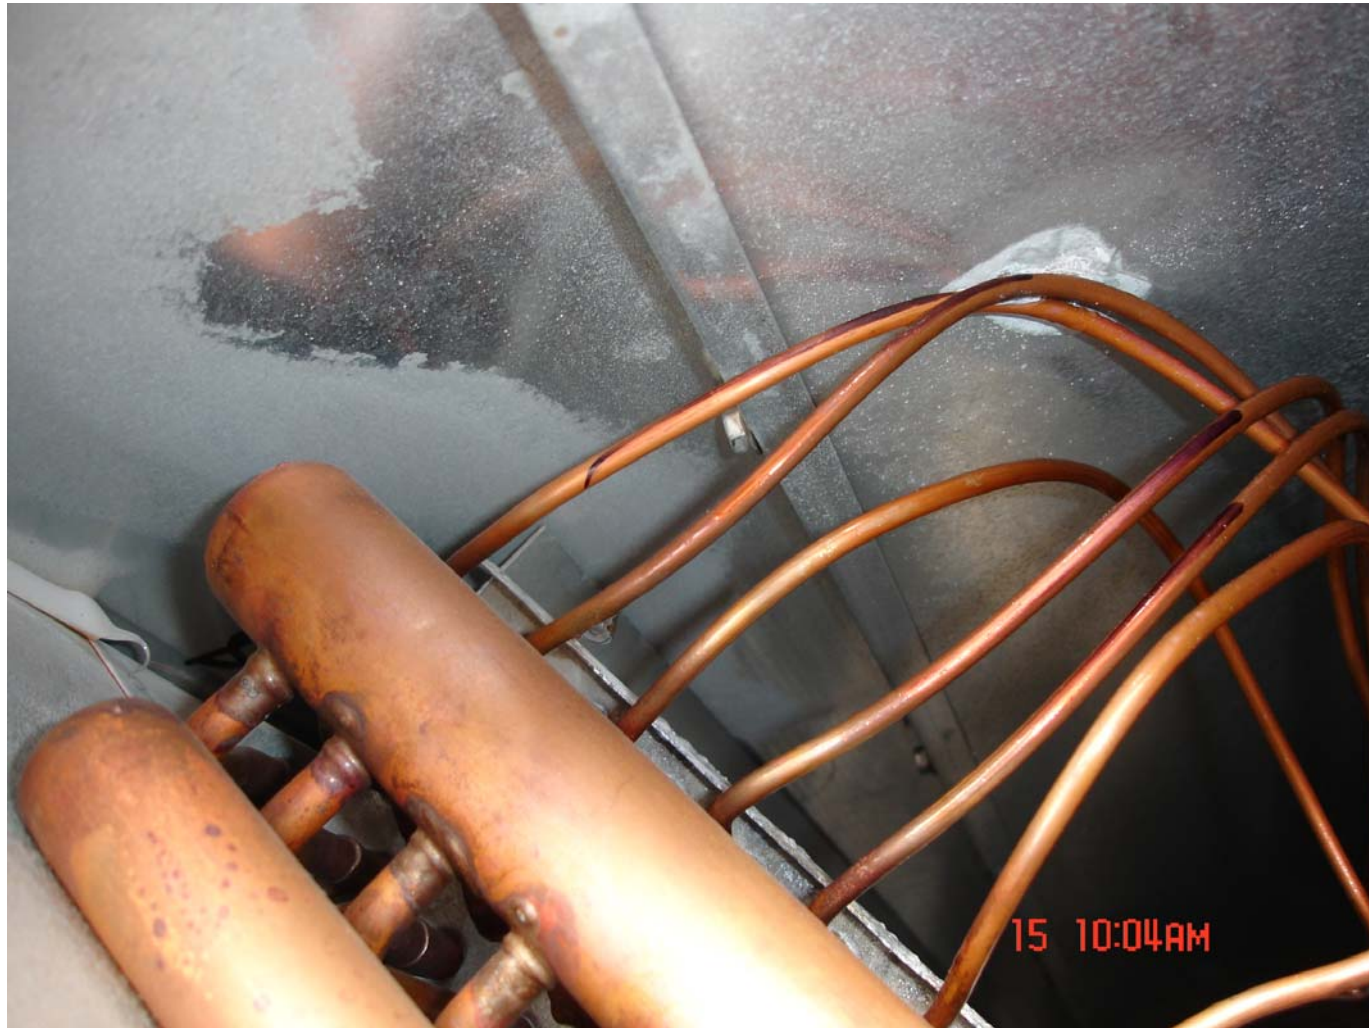
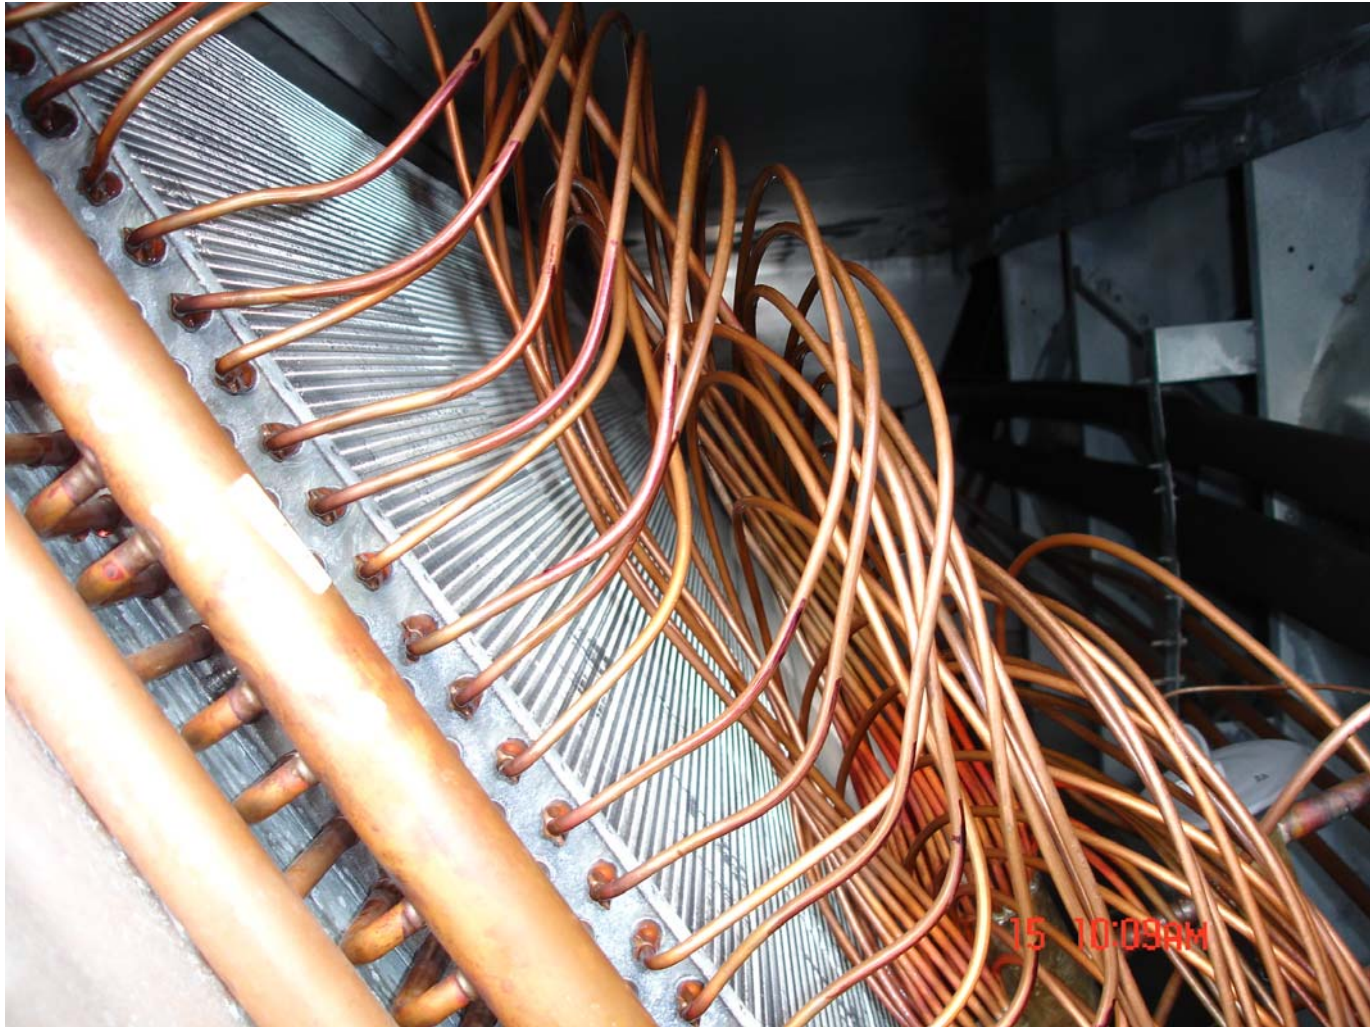
- Superheat on all circuits is a little on the high side (approx 25°). May require adjustment based on compressor discharge temperatures.
- Distributor tubing rubbing on the top of the unit. See photo's #1449 and 1450.

Distributor tubing photo #1449.

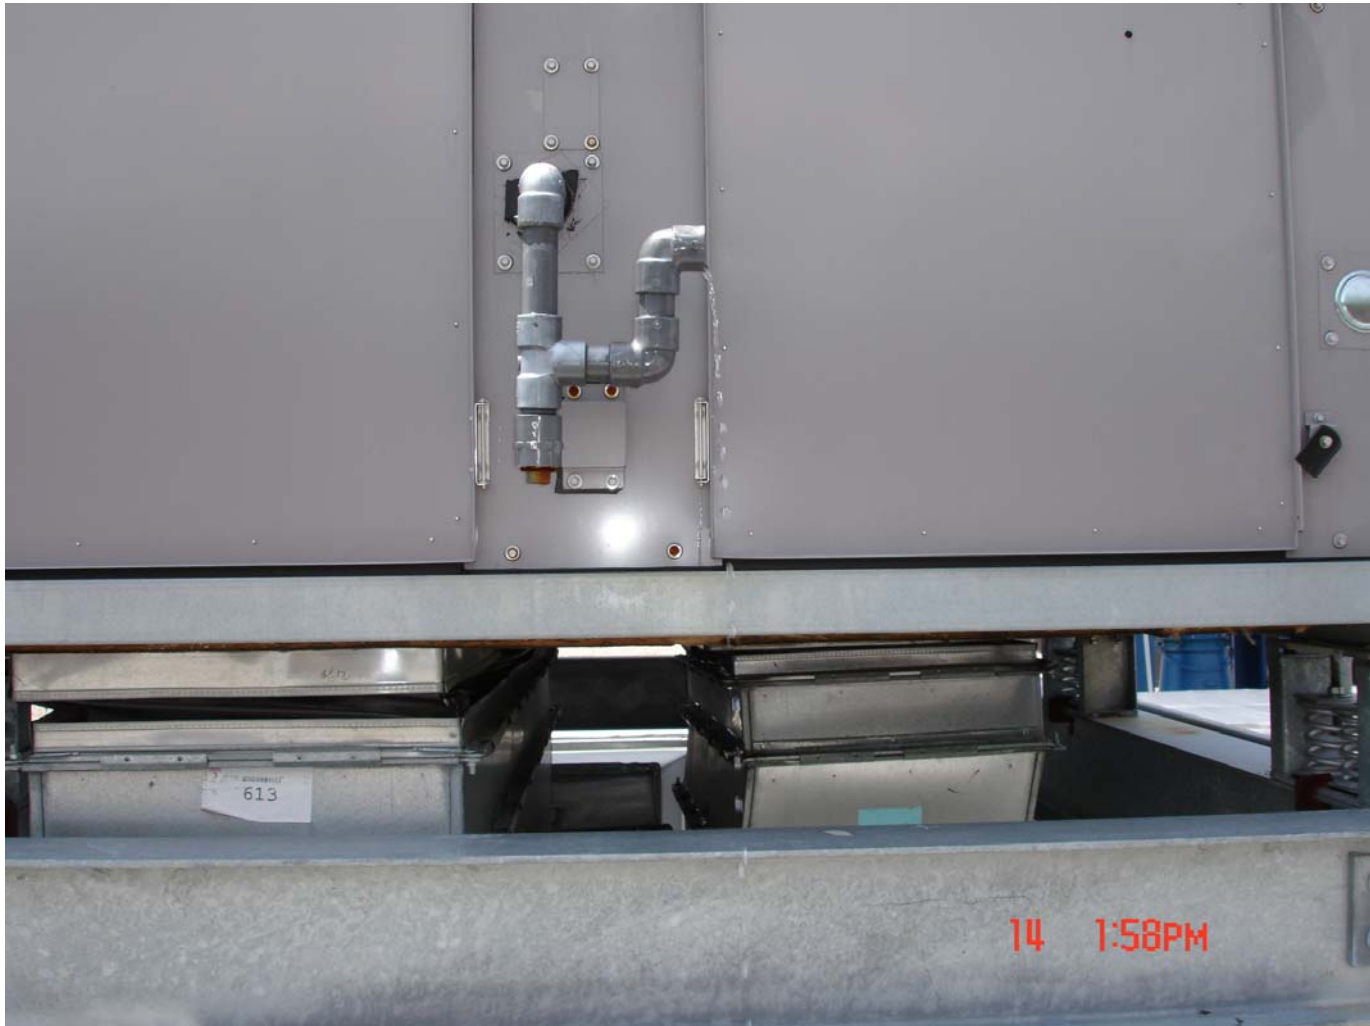
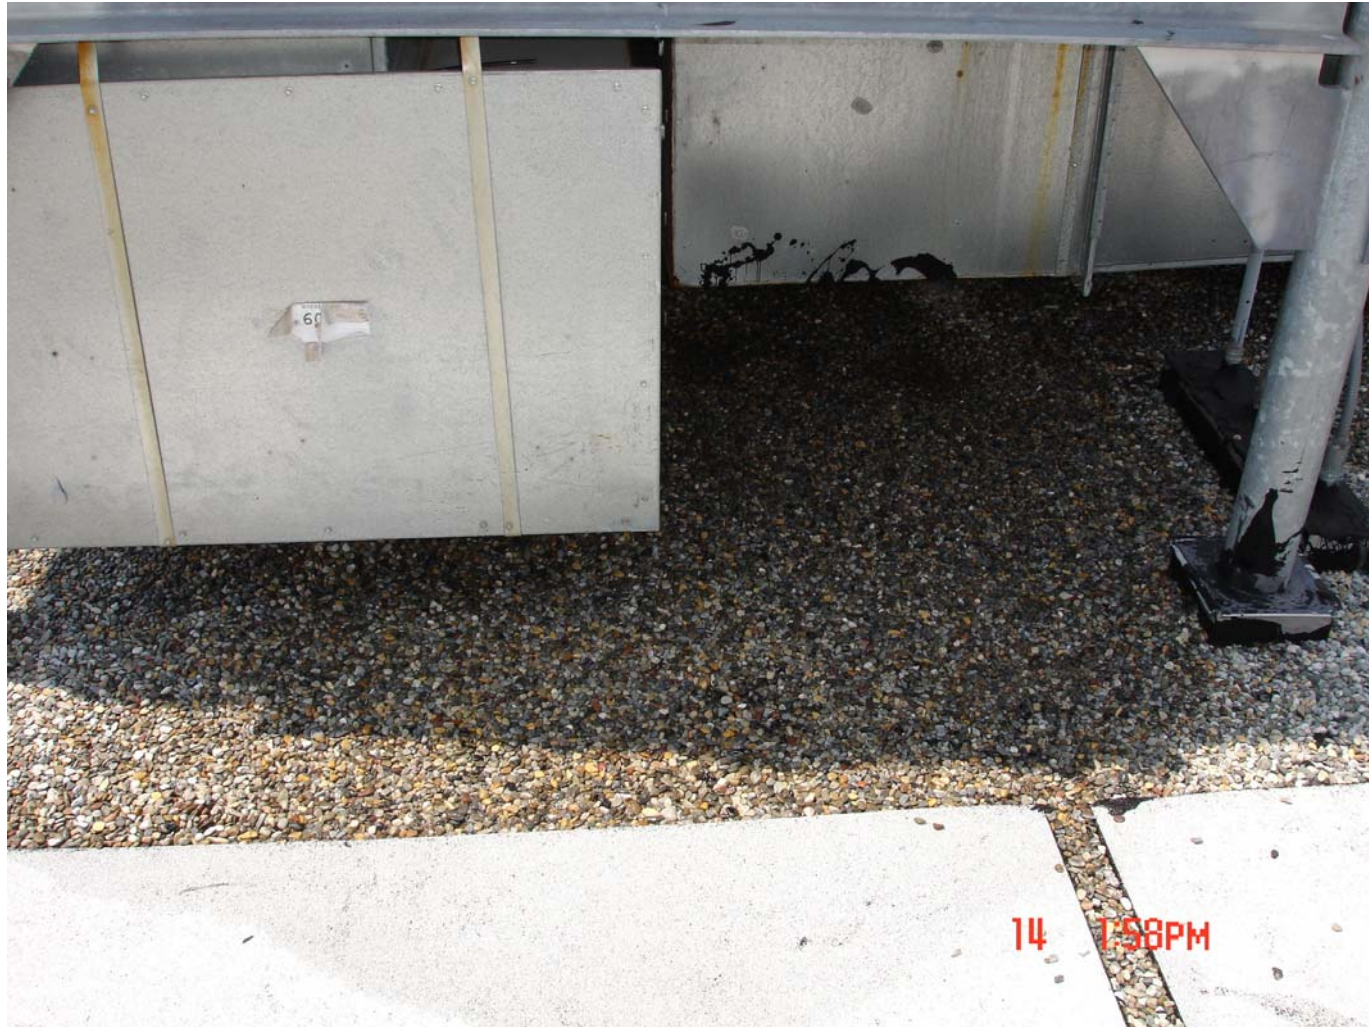
- Condensate discharges directly to the roof from a relatively high outlet (possible future roof problem). See photo's #1447, 1448.
- Supply air reset (by CCN controller) requires further investigation. Measurements were taken along with several screen captures but the data has not been processed.

Condensate drain photo #1447.

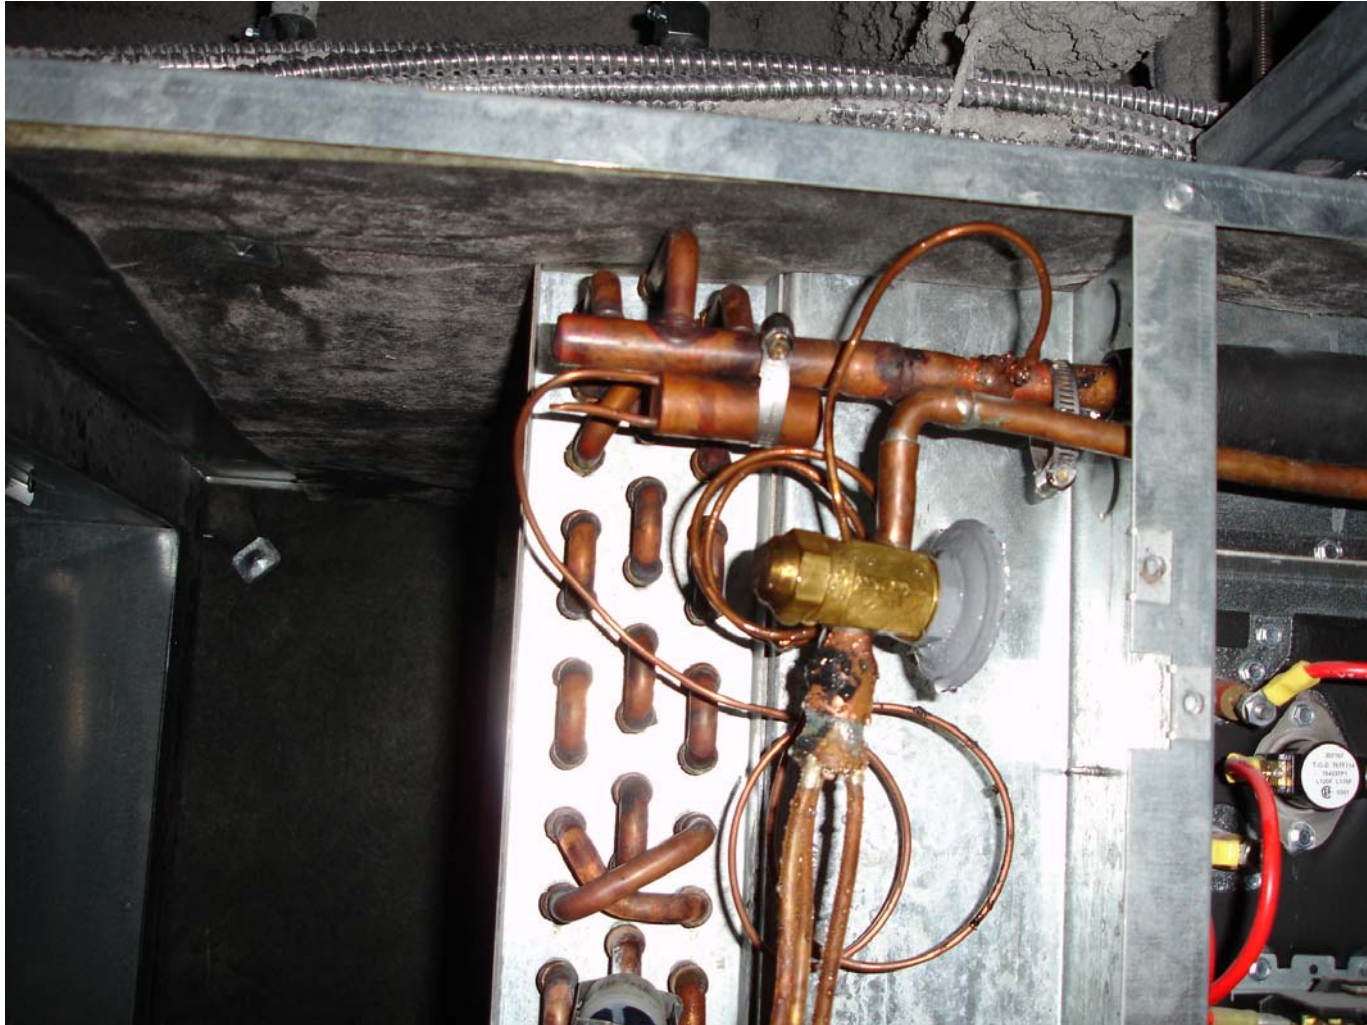
- Found faulty expansion valve. See photo's #1400, 1401.
- Dirty filter. See photo's #1396, 1397.

Expansion valve photo #1400 showing liquid entering suction line through external equalizer. Note condensate.

- None. Reported problem to construction manager and correction was assigned to others. Disposition unknown.

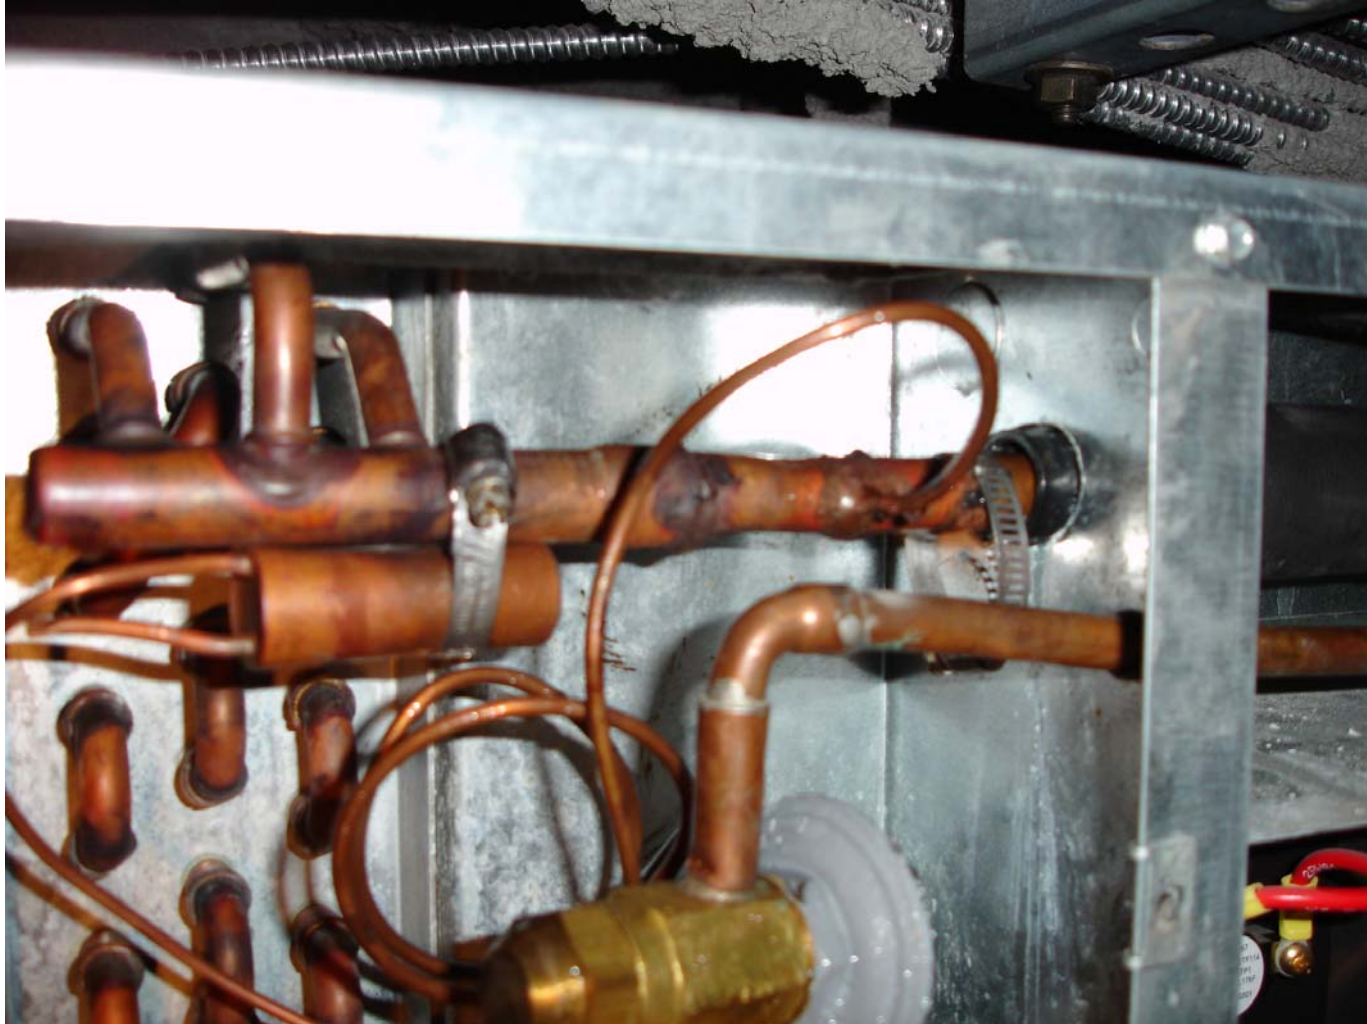
Expansion valve photo #1401 showing liquid entering suction line through external equalizer. Note condensate.

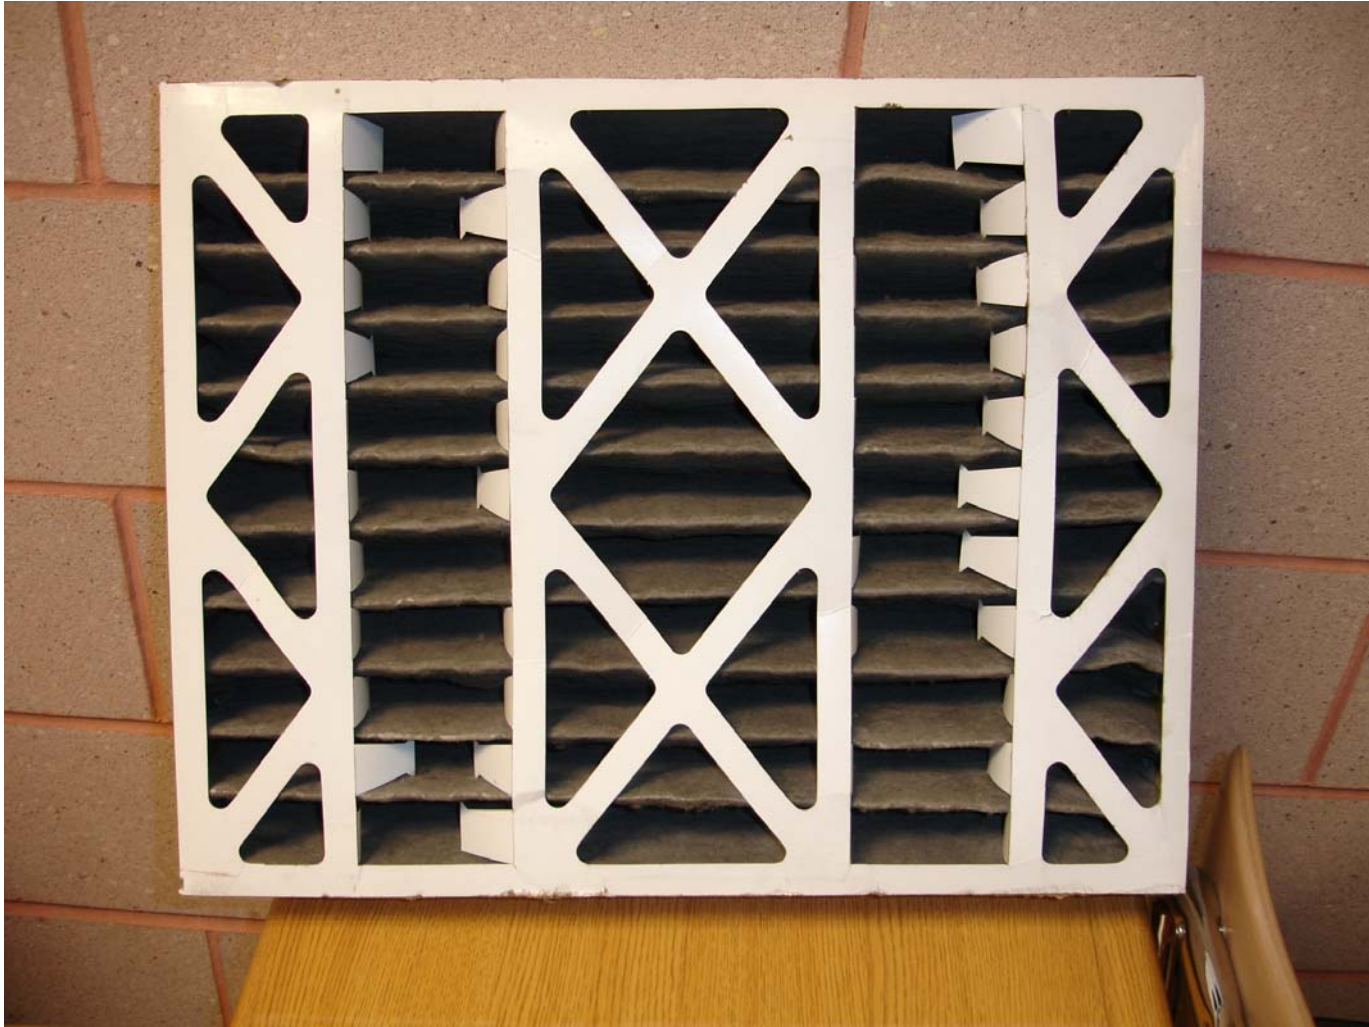
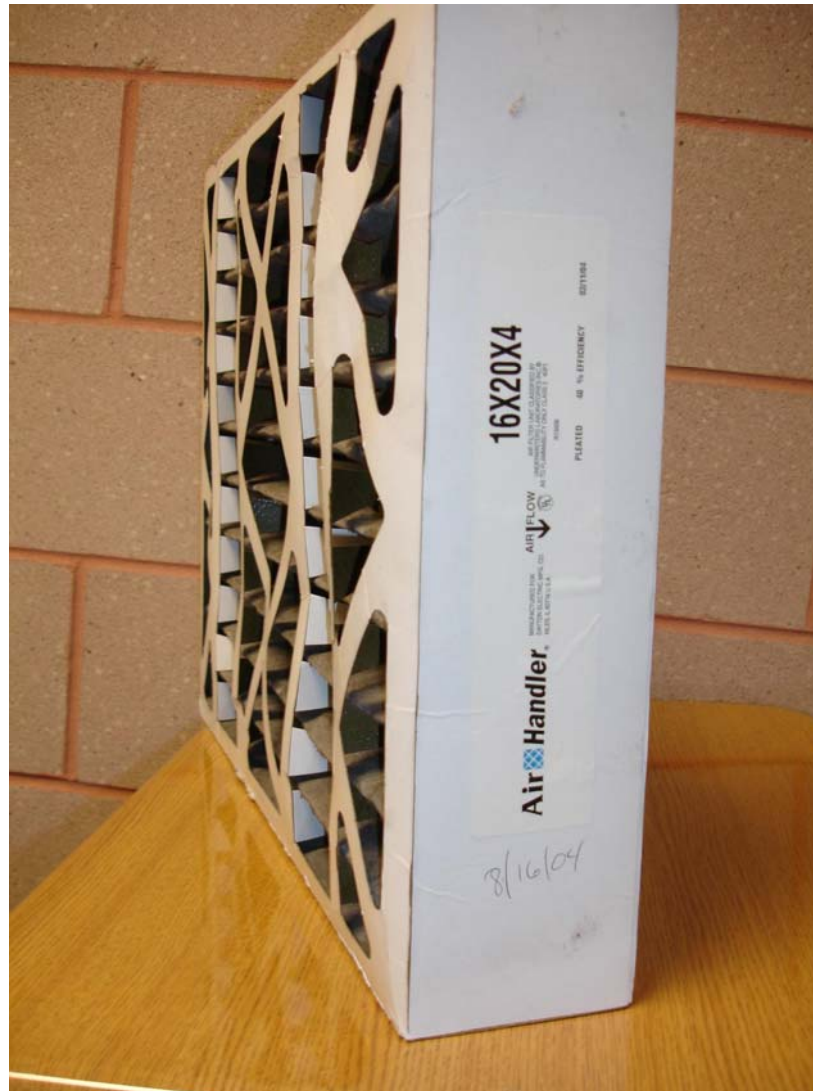
Air filter photo #1396.

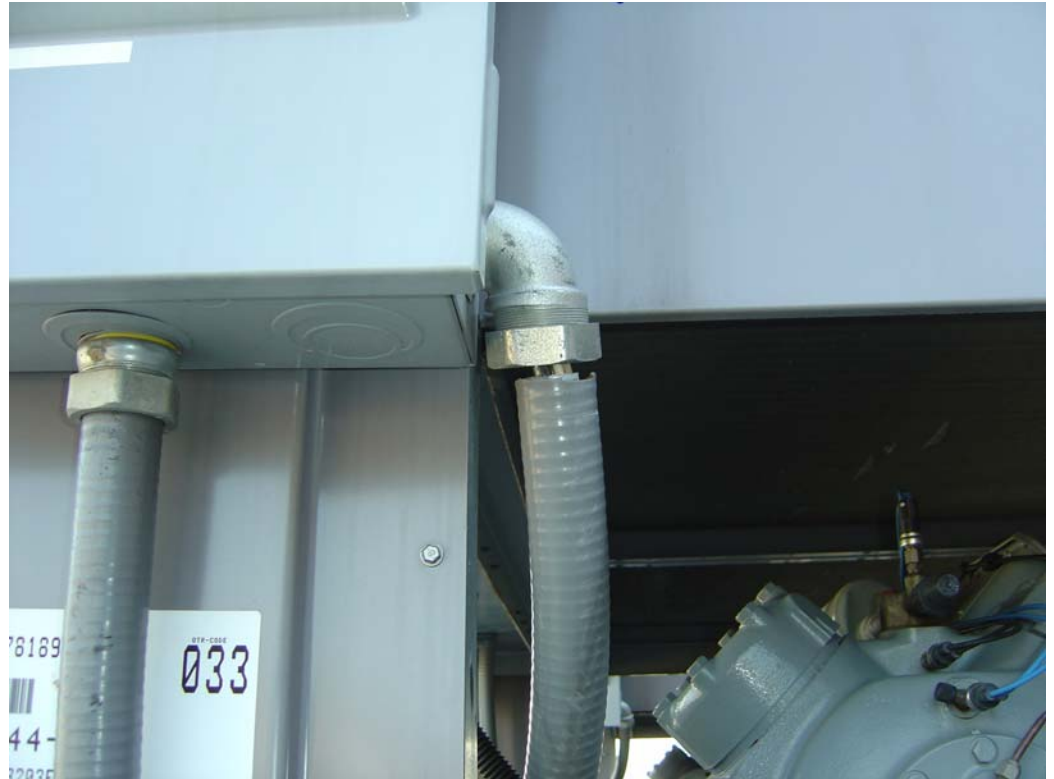
Air handler 6, Photo #1409

- Separated liquid tight flexible conduit.

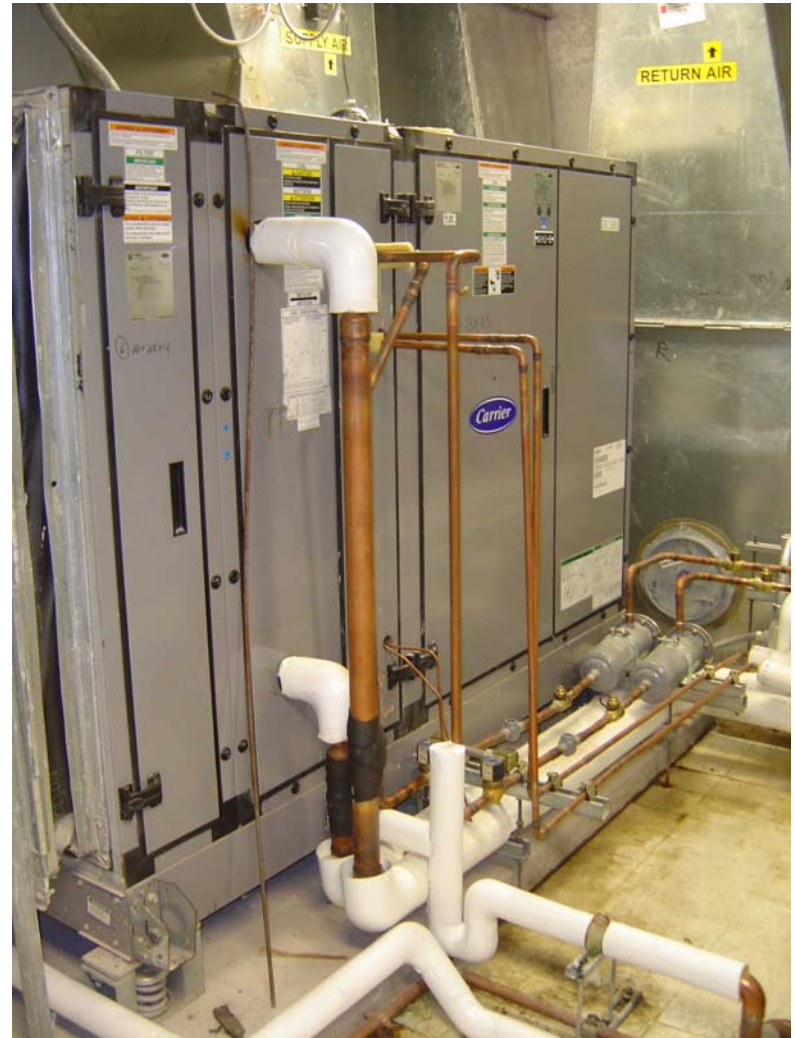
Air handler 6, Photo #1409

Suction line insulation missing which adds to condensate problem.
