Middle School

Summary update of diagnostic
work performed from 7/5/05
through 7/26/05

Report on work performed from 7/20/05 through 7/26/05.

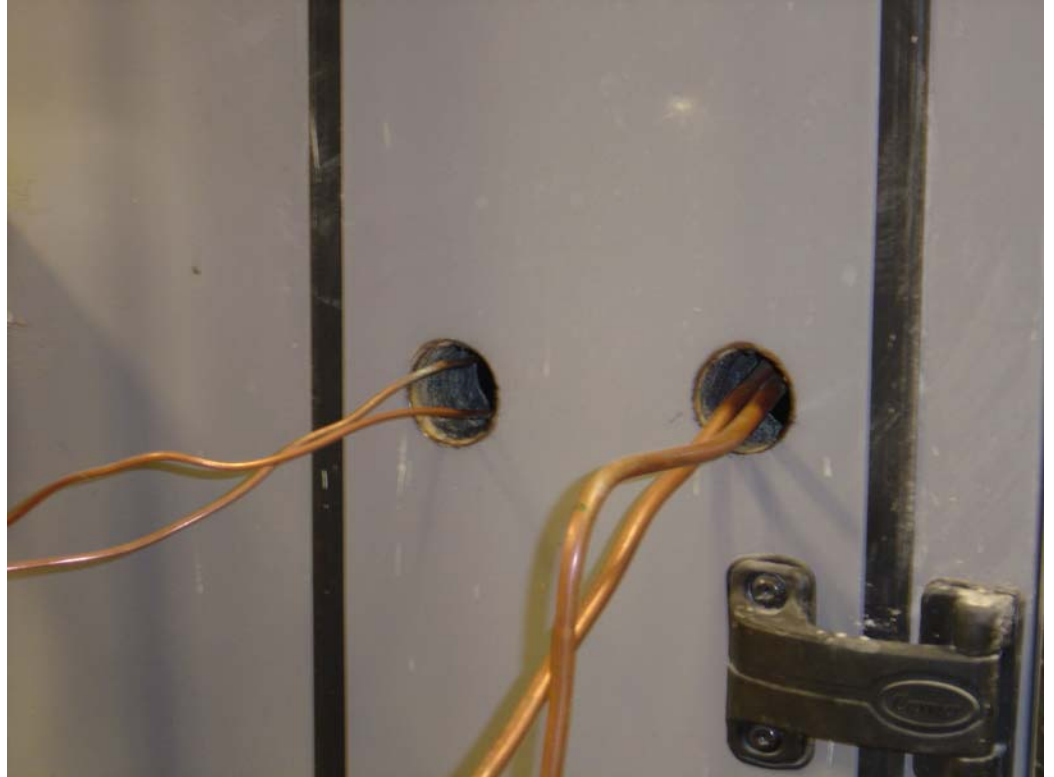
Air handler 6, photo #1411

- Copper tubing in contact with sheet metal.
- Penetrations not sealed.

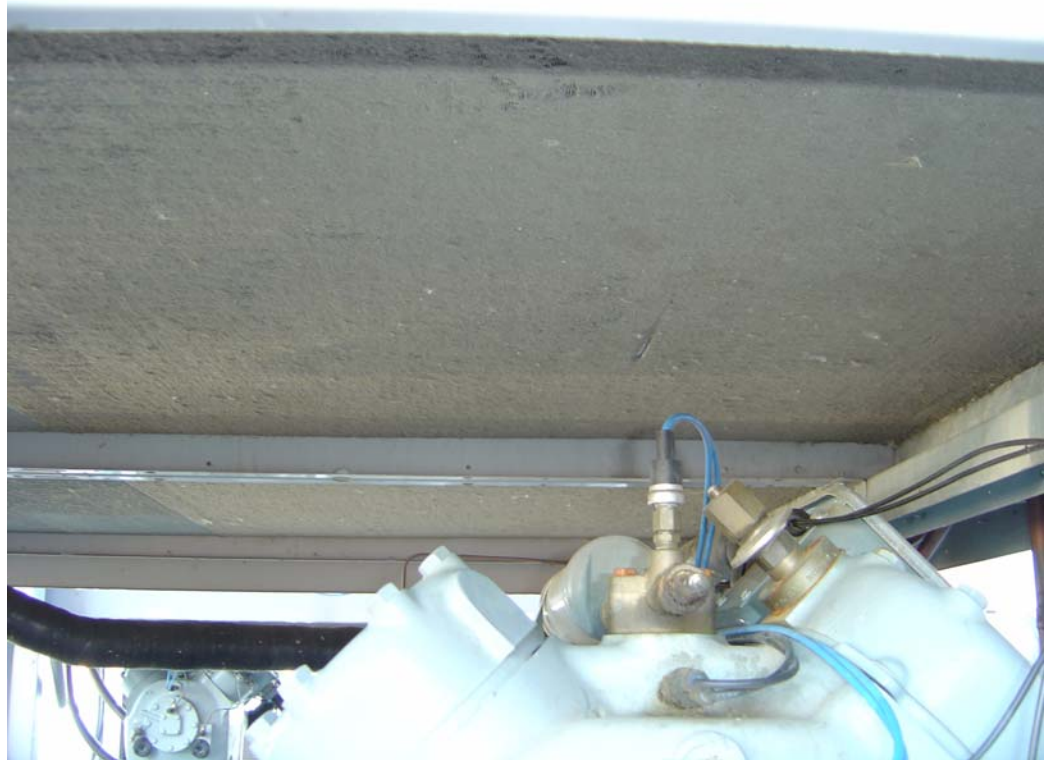
Condensing unit 6, photo #1413

- Dirty condenser coil.
- Service valve missing cap.

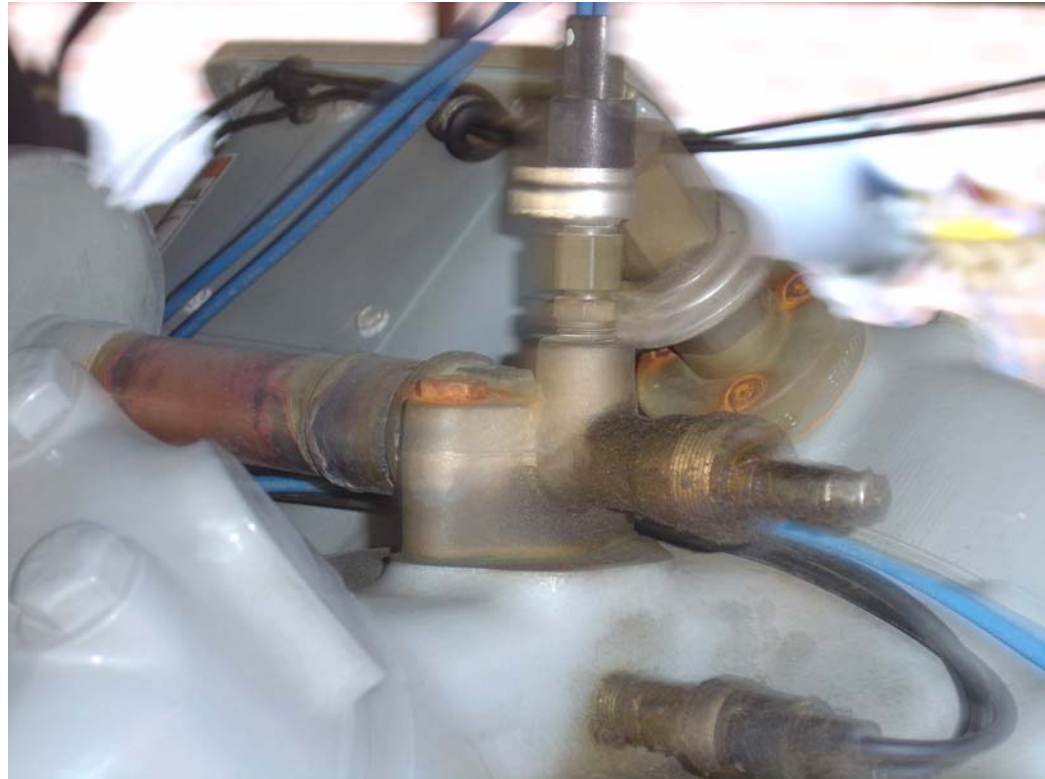
Condensing unit 6, photo #1419

- Missing refrigeration valve caps.
- Evidence of leaking due to missing cap.

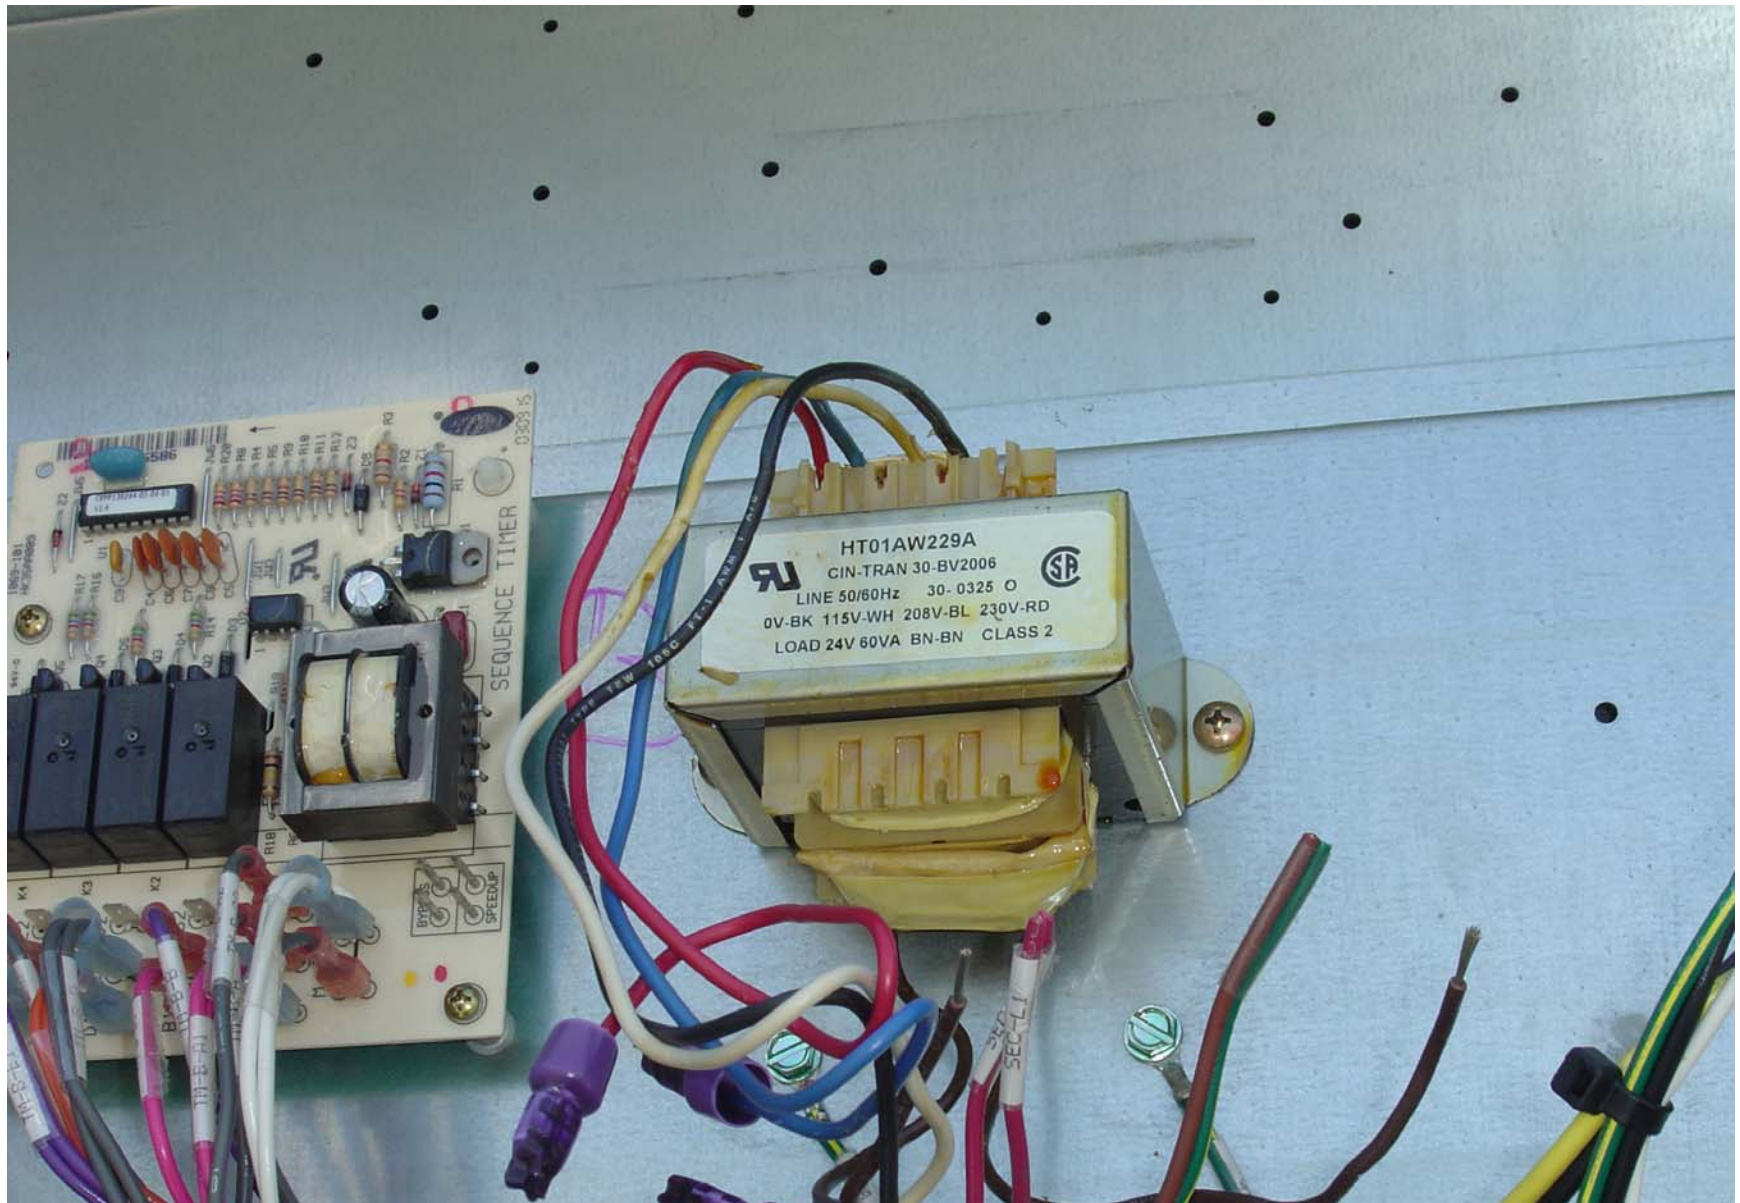
- Compressors not operating and condenser fans running.
- Faulty transformer for safety lockout circuit.
- Circuit #1 running high discharge pressure and high subcooling.
- Circuit #1 superheat a little low at the compressor.
- Reheat valve for 3rd floor reheat (RHV-9) bleeding by when closed.
- Dirty and matted condenser coil.

Condensing unit 6, photo #1420, faulty transformer

- Replaced faulty control transformer.
- Started unit.
- Took a full set of readings.
- Adjusted superheat on circuit #1 to 24 deg.

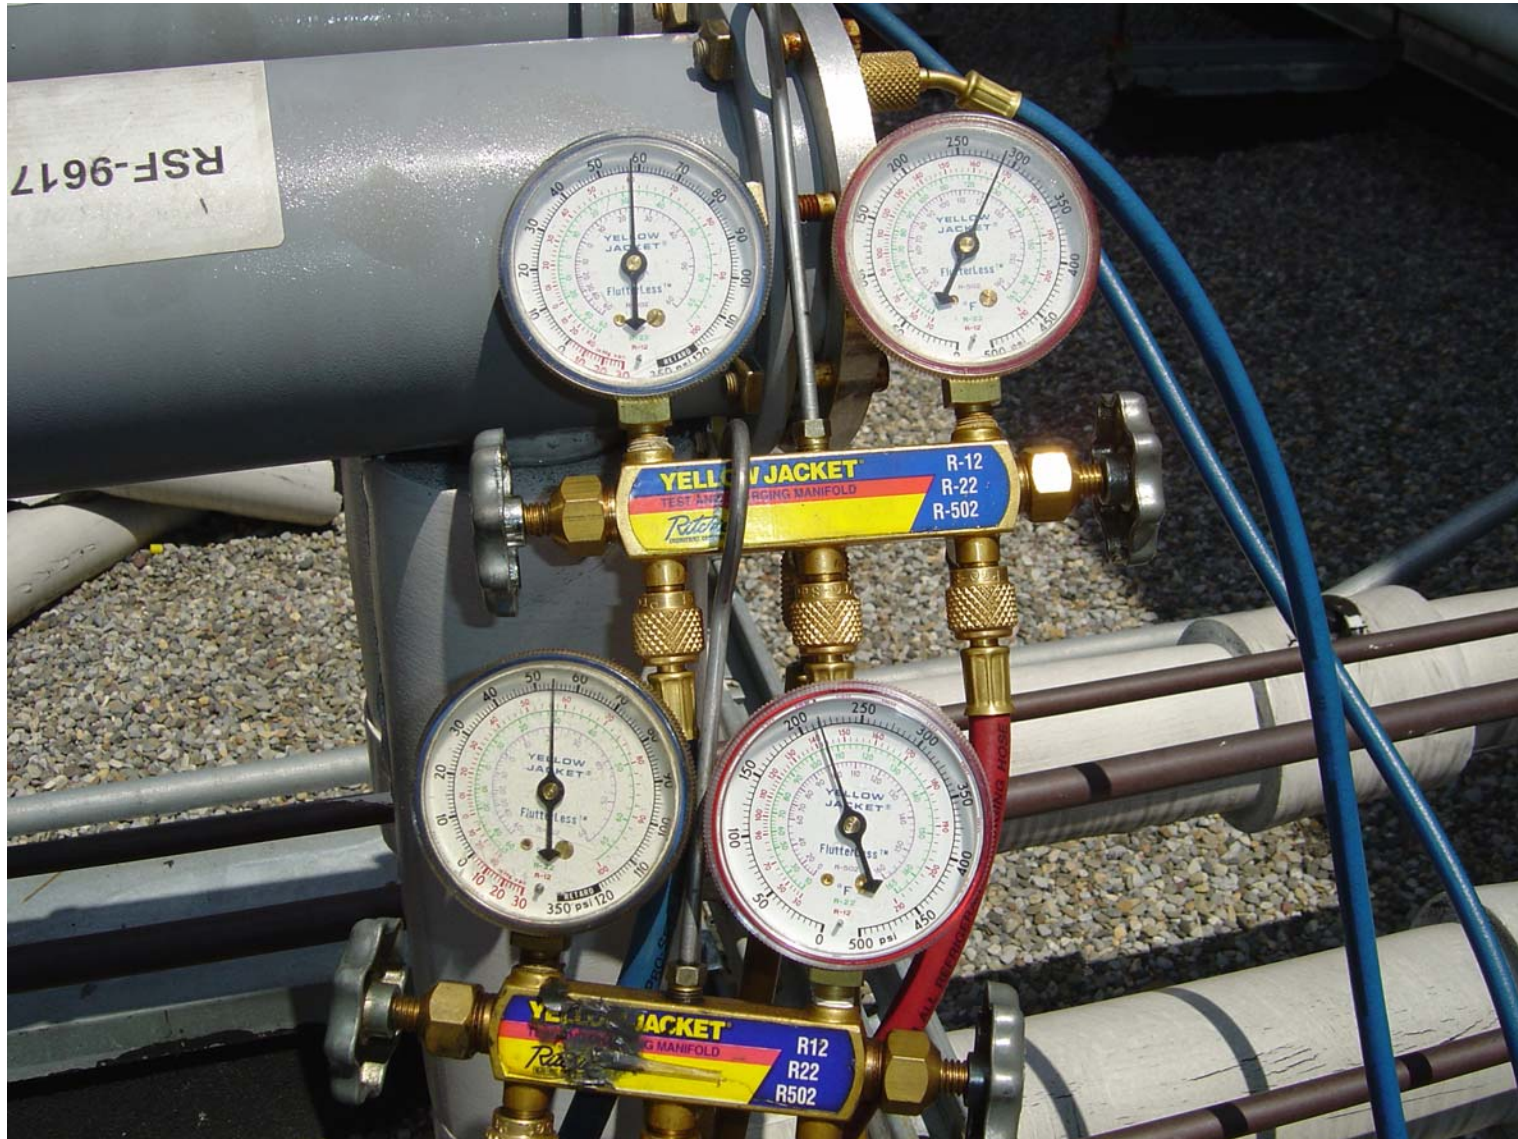
- Circuit #1 is running high head pressure. Could be overcharged. This should be investigated further addressed.
- Circuit #2 compressor oil level is high (7/8 glass).

Condensing unit 6, photo #1420, discharge pressure comparison ckt #1 vs. ckt #2

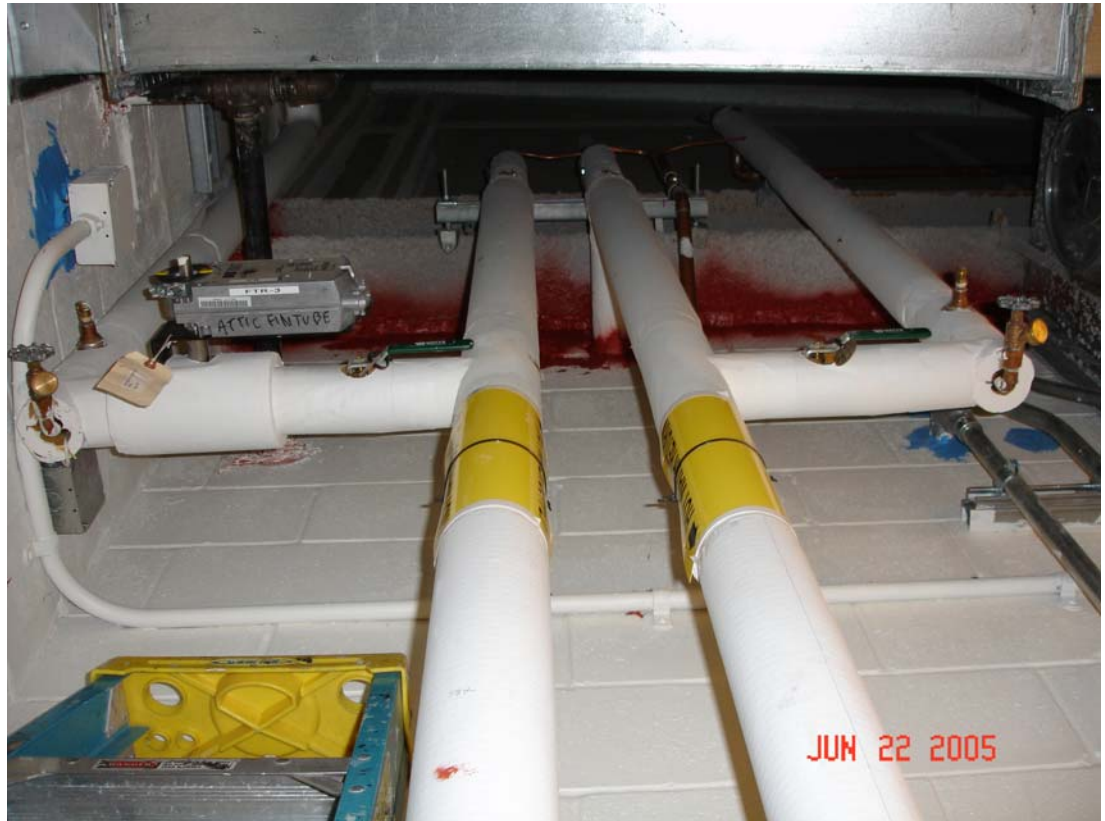
Attic finned tube radiation, photo #1576

- Attic loop is piped to the main boiler loop (180 deg). Attic loop water is not reset based on outdoor temperature.

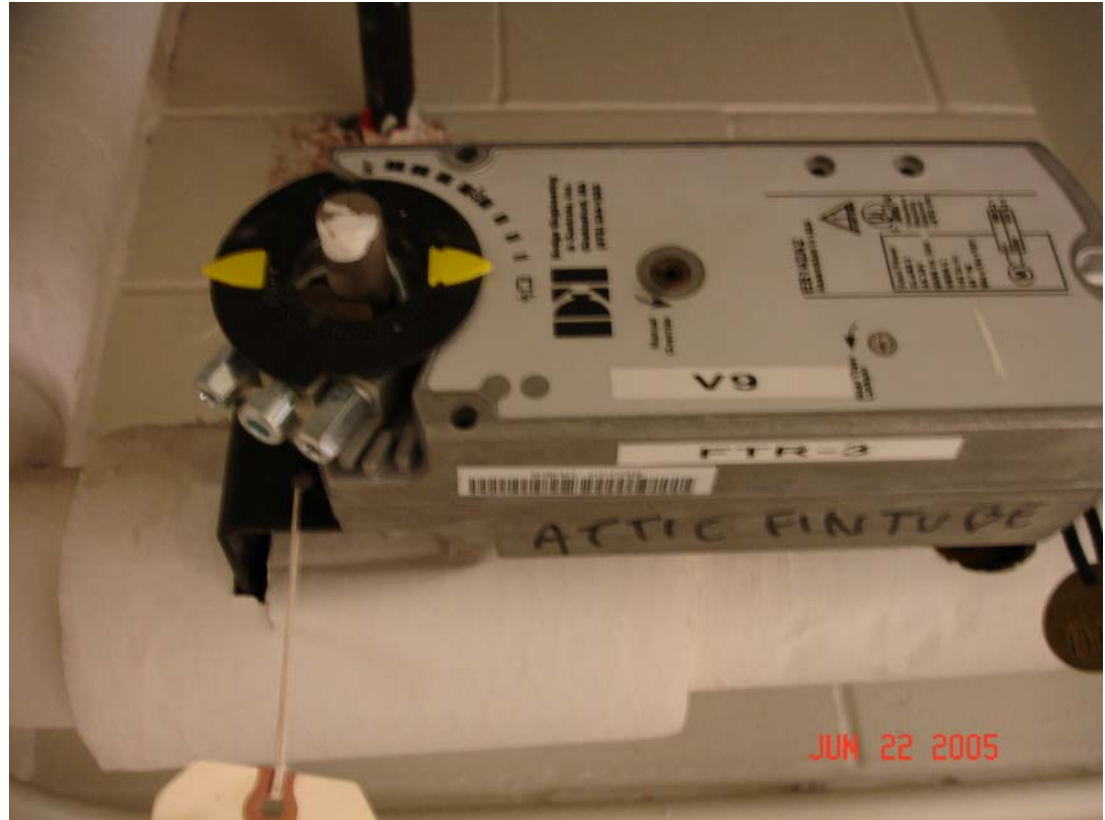
Attic finned tube radiation, photo #1575

- Unable to locate source of control. Valve is in the 100% open position. Anytime the boiler pumps are on this will allow full flow.

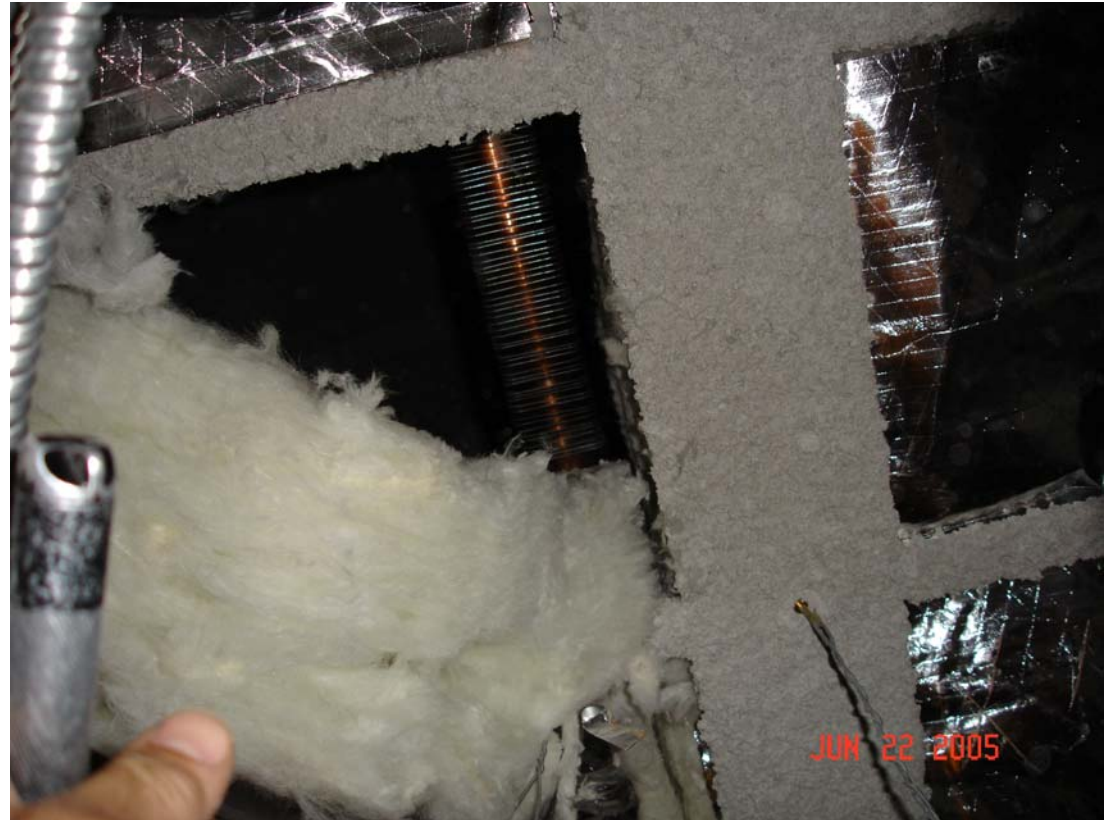
Attic finned tube radiation, photo #1576

Finned tube installed above insulation in corridor.
Question for Engineer: Is this correct?

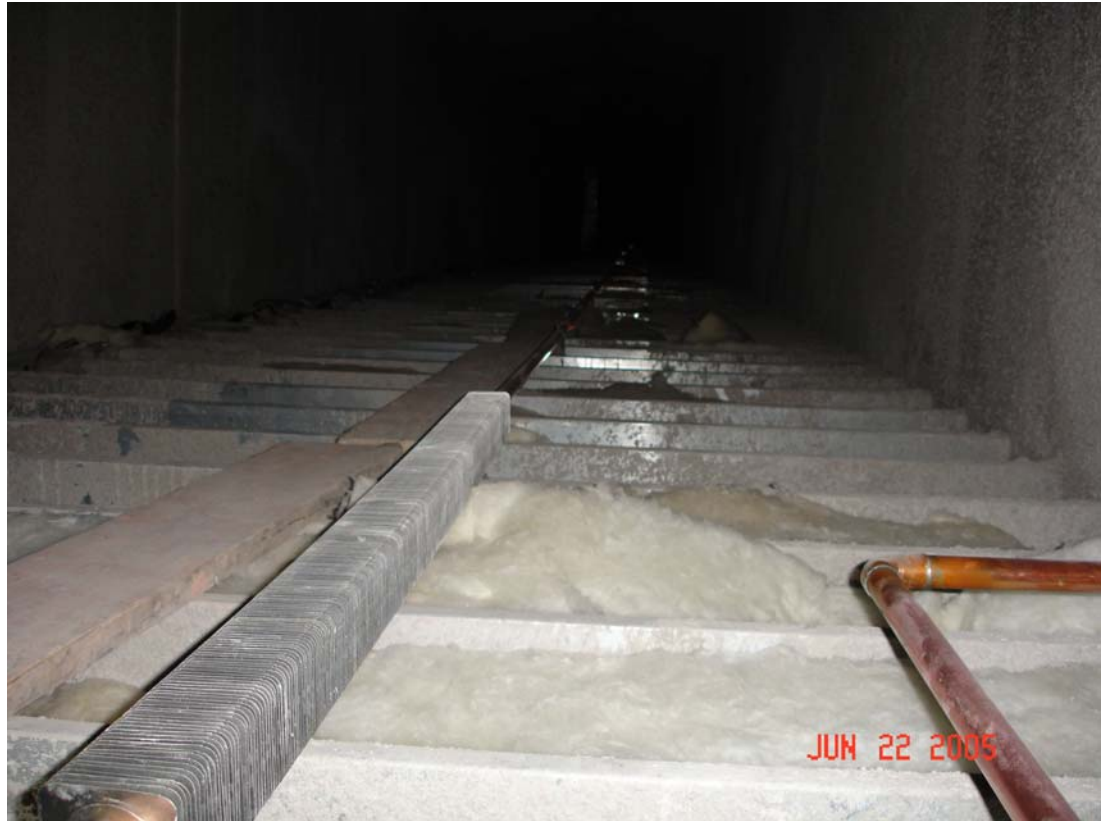
Attic finned tube radiation, photo #1585

Finned tube and piping
installed above insulation in
uninsulated attic space.

Is this correct?

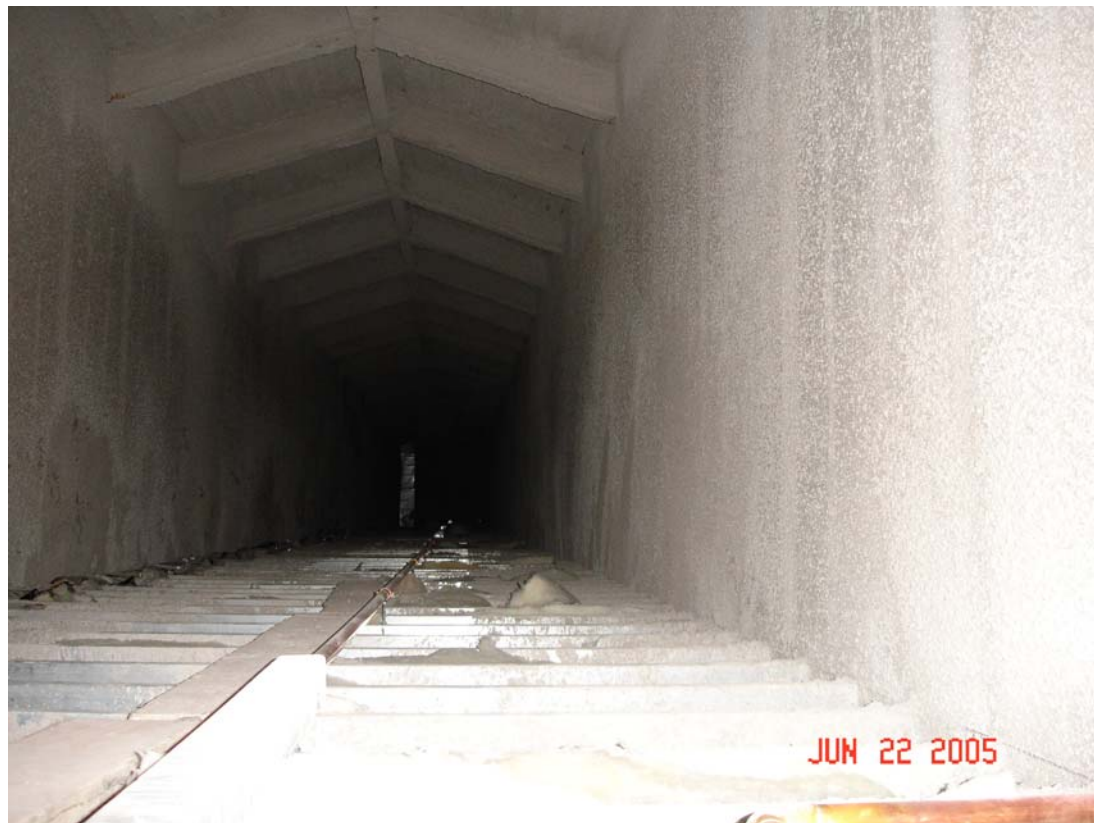
Attic finned tube radiation, photo #1587

Another photo of the attic radiation in the uninsulated space. This photo is above the corridor on the 3rd floor.

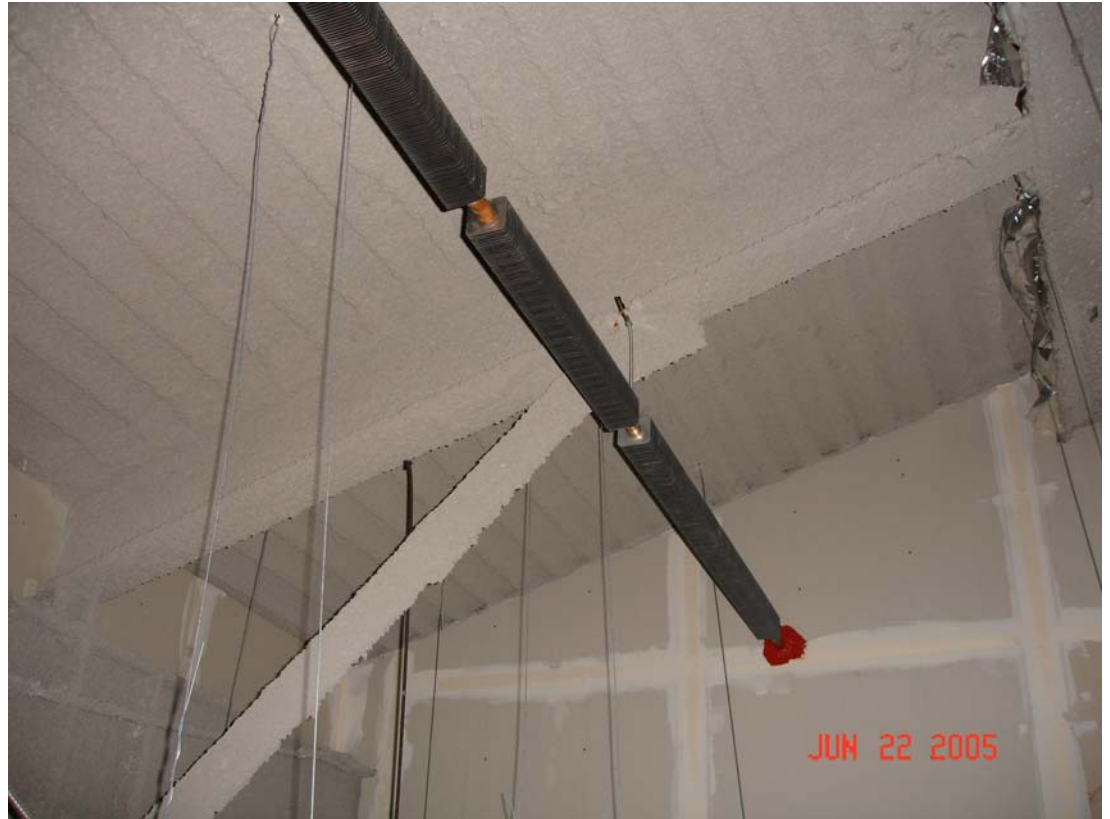
Attic finned tube radiation, photo #1588

- This photo shows attic finned tube radiation. Actual piping is reversed from that shown on drawing. Since flow was also reversed, the only impact is the 16' sections and the 18' sections of finned tube are installed on the opposite side of the building from how it is shown on drawing #M7.

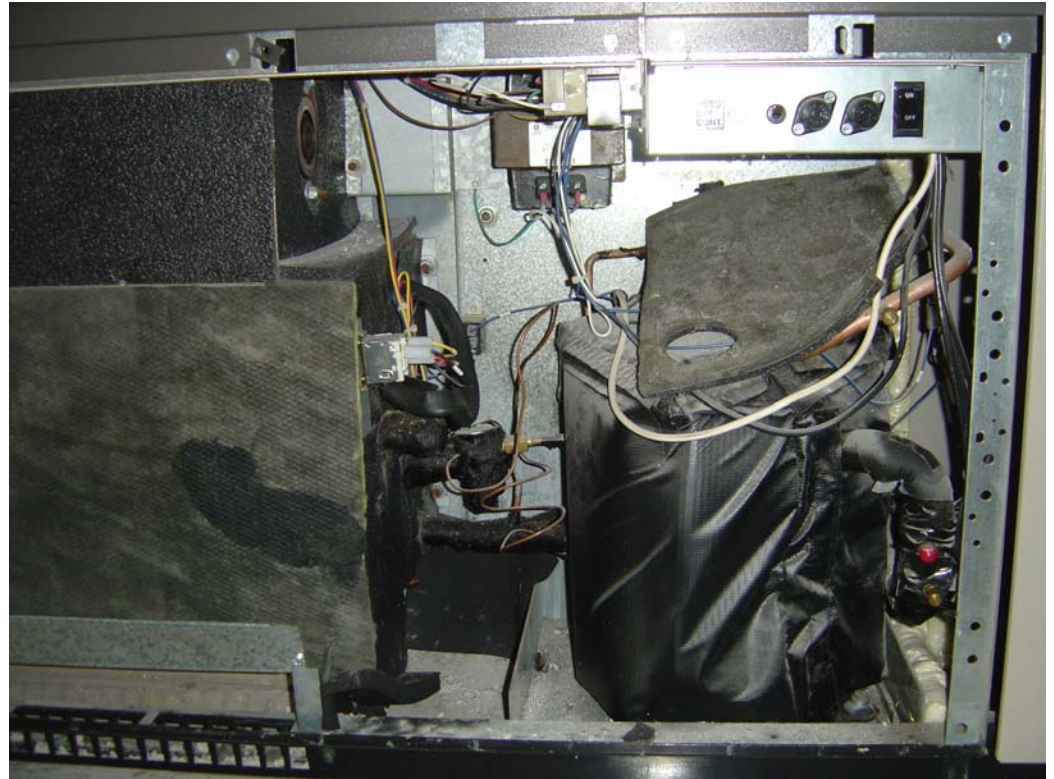
Unit ventilator, Photo #1389

- The electrical box insulation has fallen off on all units. We (MSC) re-glued this last winter but the adhesive apparently did not adhere properly since the casing temperature was low. Welded pins should be used.

Electrical panel insulation loose. Insulation glues to the bottom of the electrical panel.

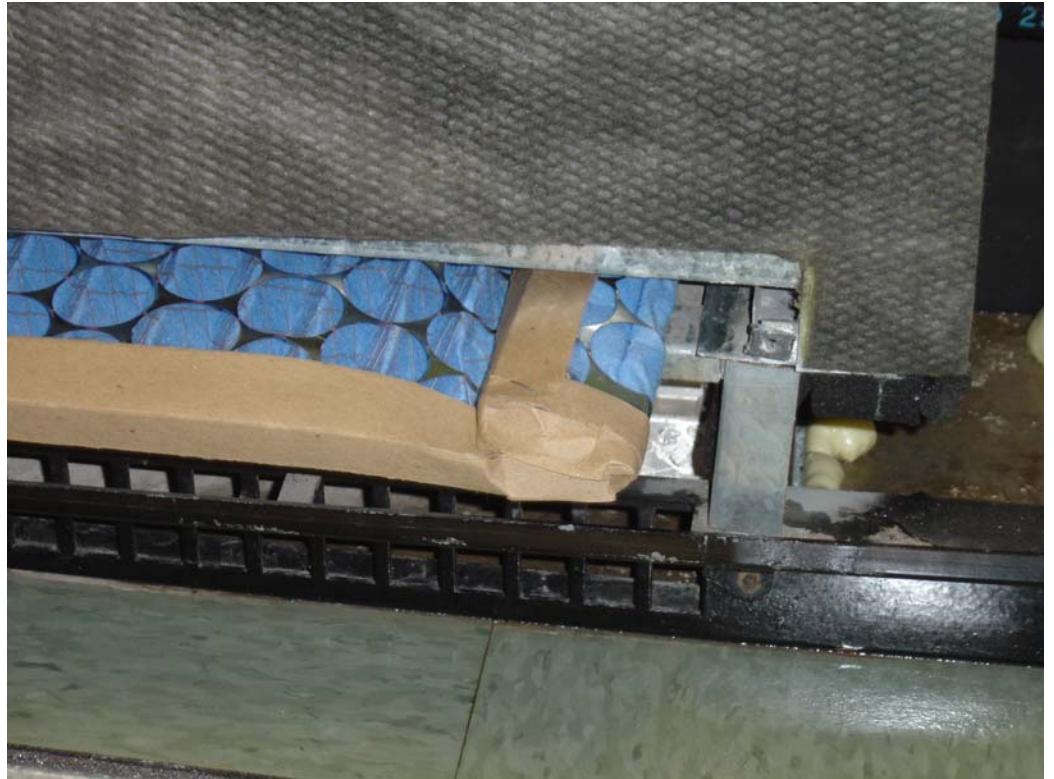
Unit ventilator, Photo #1390

Improper filter installation.

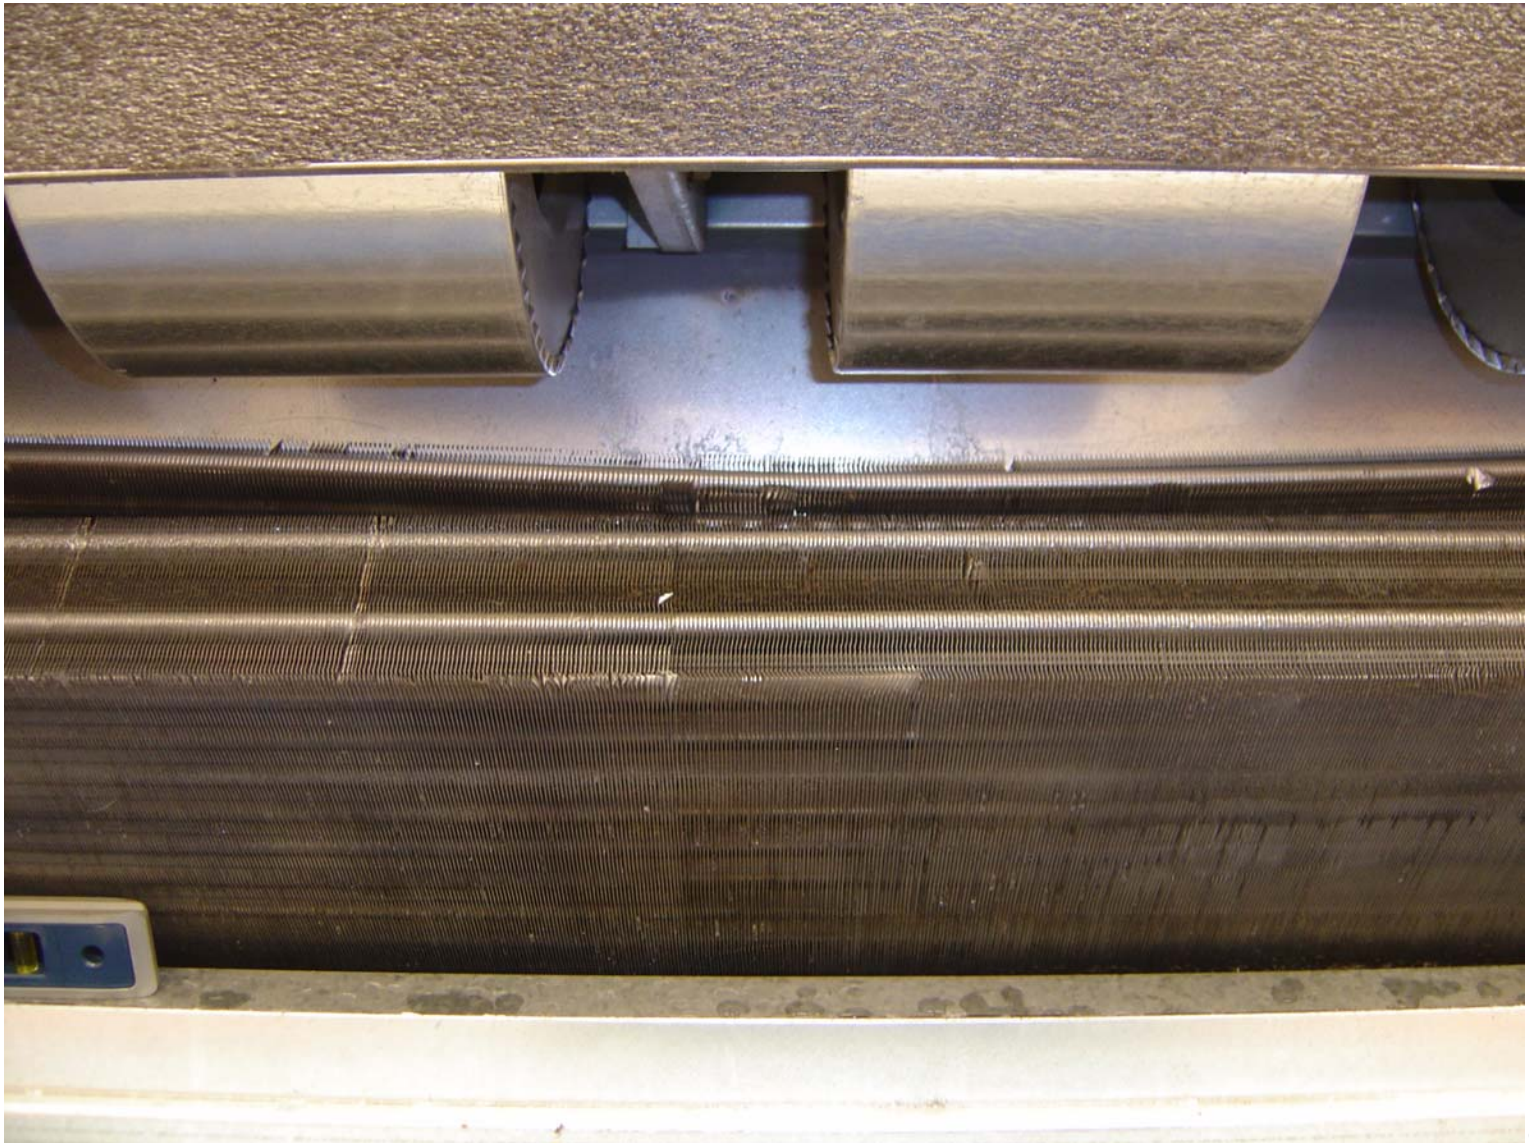
- Room 227: Unit off due to condensate leak. Unit has been leveled (by others) but the condensate pan is still sloped away from the drain. The heating coil on this unit is slightly buckled indicating damage at some point. See photo #1404.

Unit ventilator, Photo #1404
Note bowed coil

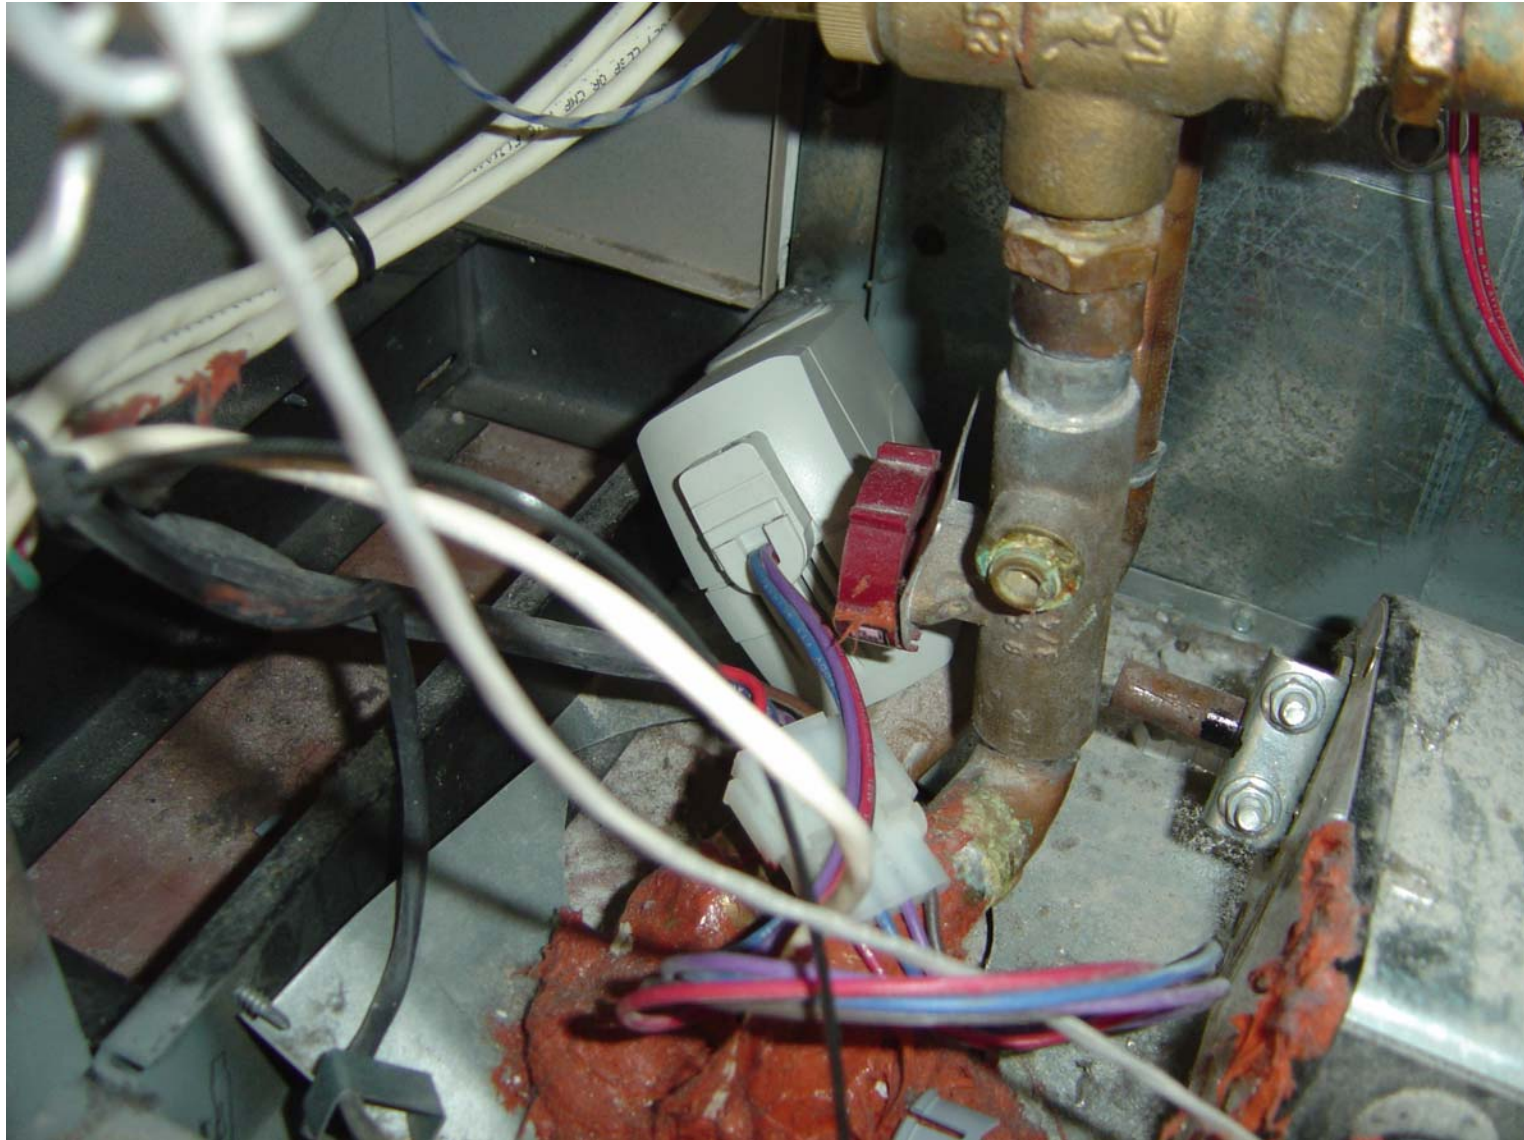
- Room 224: Heat valve actuator is hanging alongside valve and is not attached. See photo #1425.
- Room 306: Compressor noisy at startup.
- Room 111: Found wiring harness to motor pulled out.

Unit ventilator, Photo #1425 Valve actuator not attached to 3-way valve. Attachment device snapped.

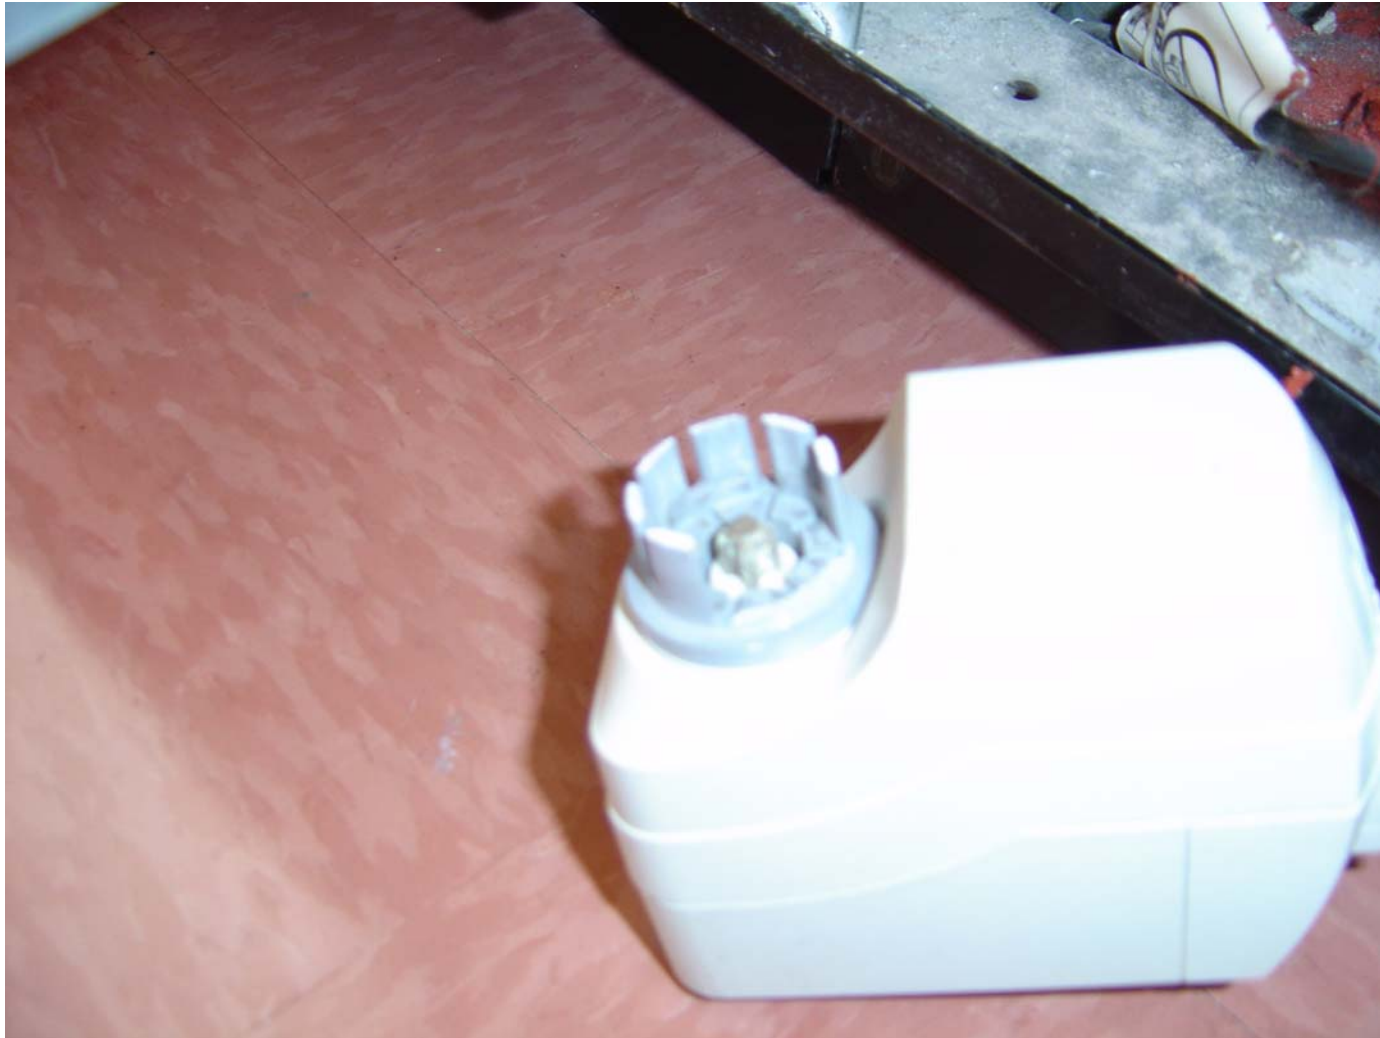
Unit ventilator, Photo #1426. View of broken attachment device for above actuator.

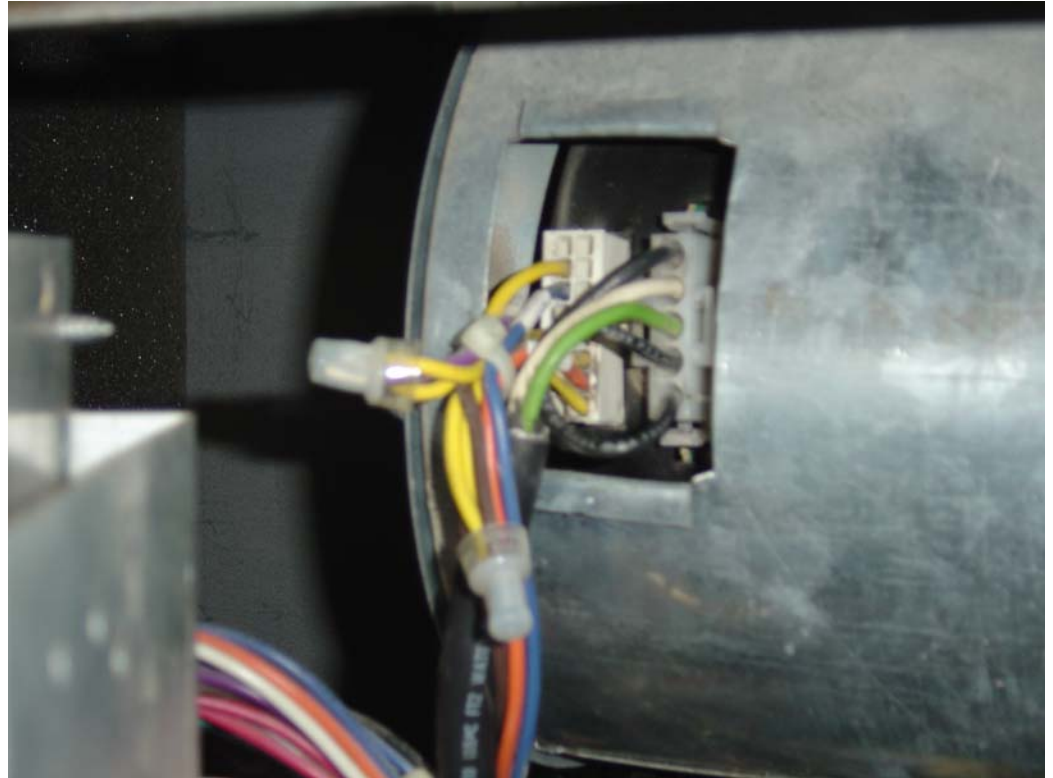
Unit ventilator, Photo #1393

The fan motor power and control connectors were found disconnected on room 111. The fan was not operating but the compressor was still cycling on and off on the mechanical freeze-stat supplied by the manufacturer.

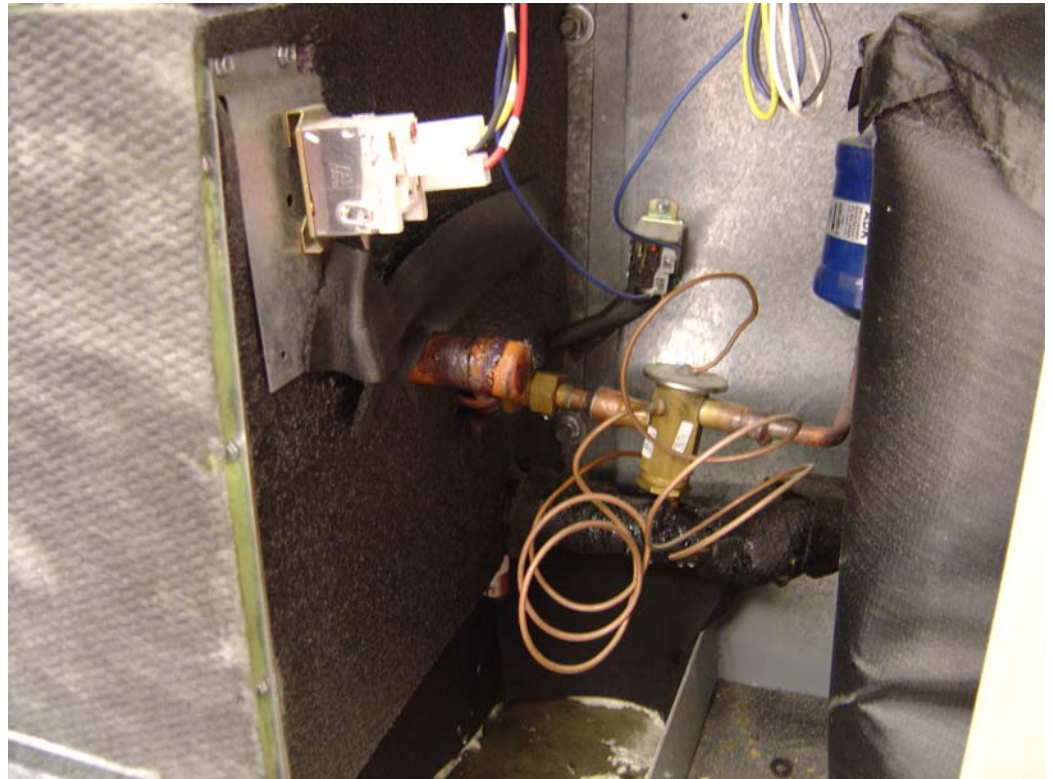
Unit ventilator, Photo #1392

Expansion valve and distributor sweating in compressor compartment. Insulation is missing.

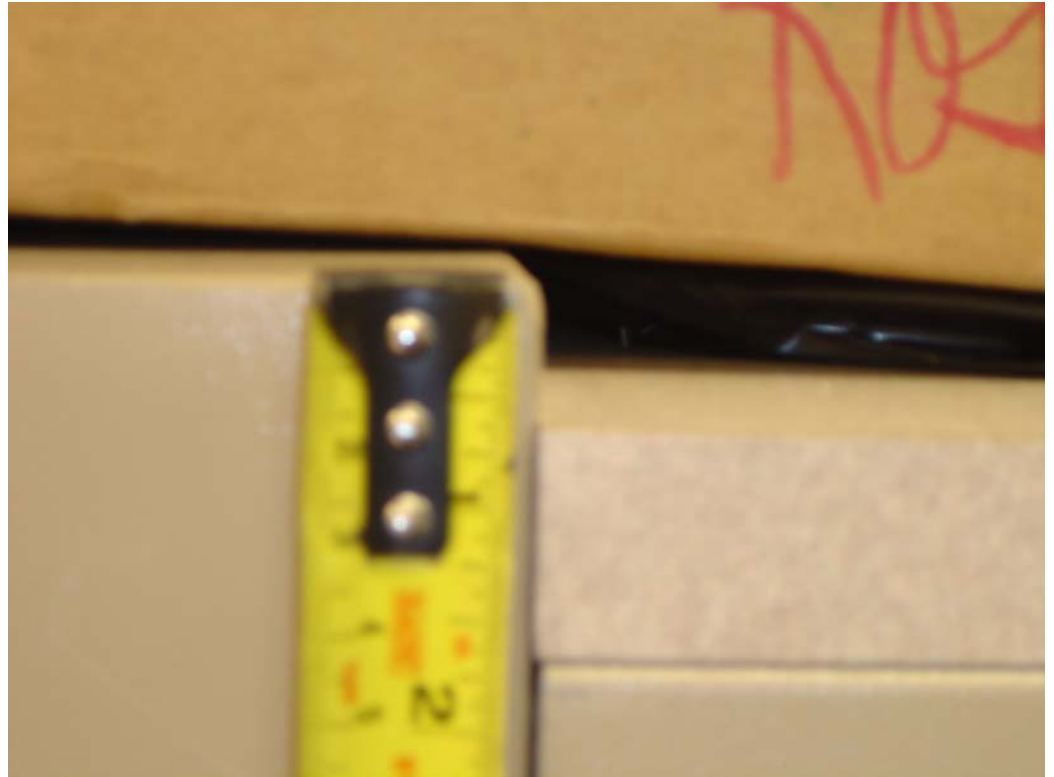
Unit ventilator, Photo #1406 room #227

- Photo shows approximate 5/8" deviation between top of unit and adjacent book shelf after shimming (by others).
- Unit still leaks as condensate pan is distorted.

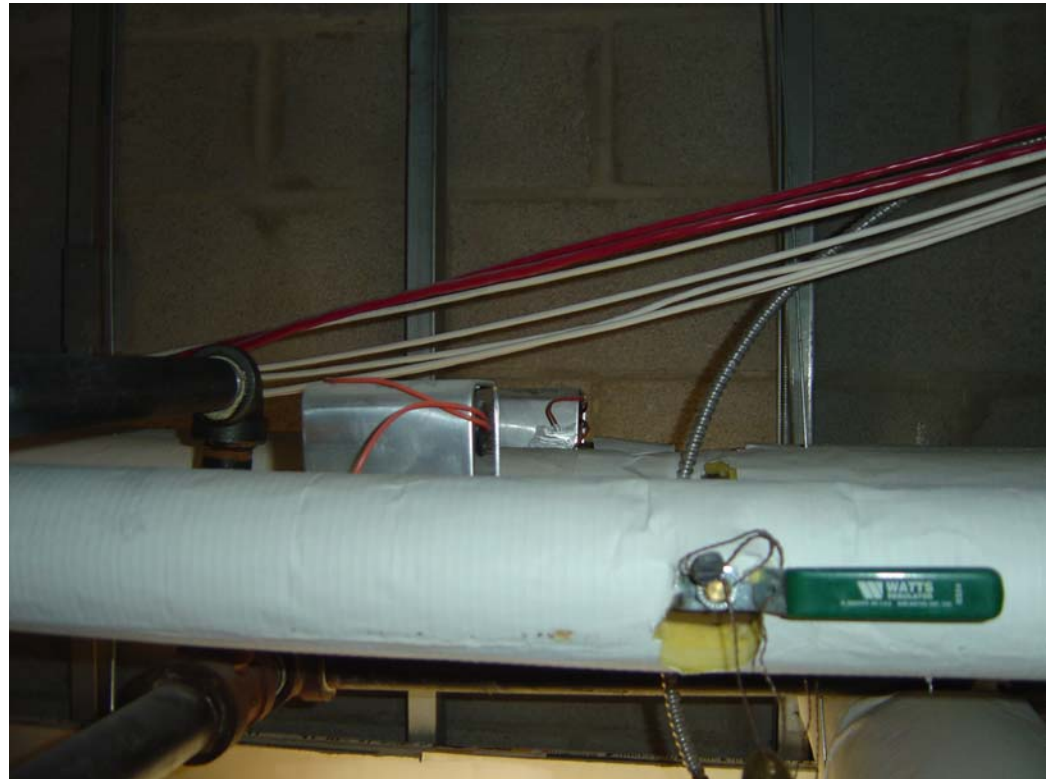
Unit ventilator, Photo #1422 room #127 ceiling

- Photo shows two hot water baseboard zone valves installed above the ceiling of room #127. These valves control the hot water baseboard behind the book cases in rooms #127 and #222.
- Both valves are not wired and are manually locked in the open position.
- Both rooms have been reported to overheat.
- We only sampled this area. We did not check other units.
