Middle School

Summary update of diagnostic
work performed from 7/5/05
through 7/26/05

Report on work performed from 7/20/05 through 7/26/05.

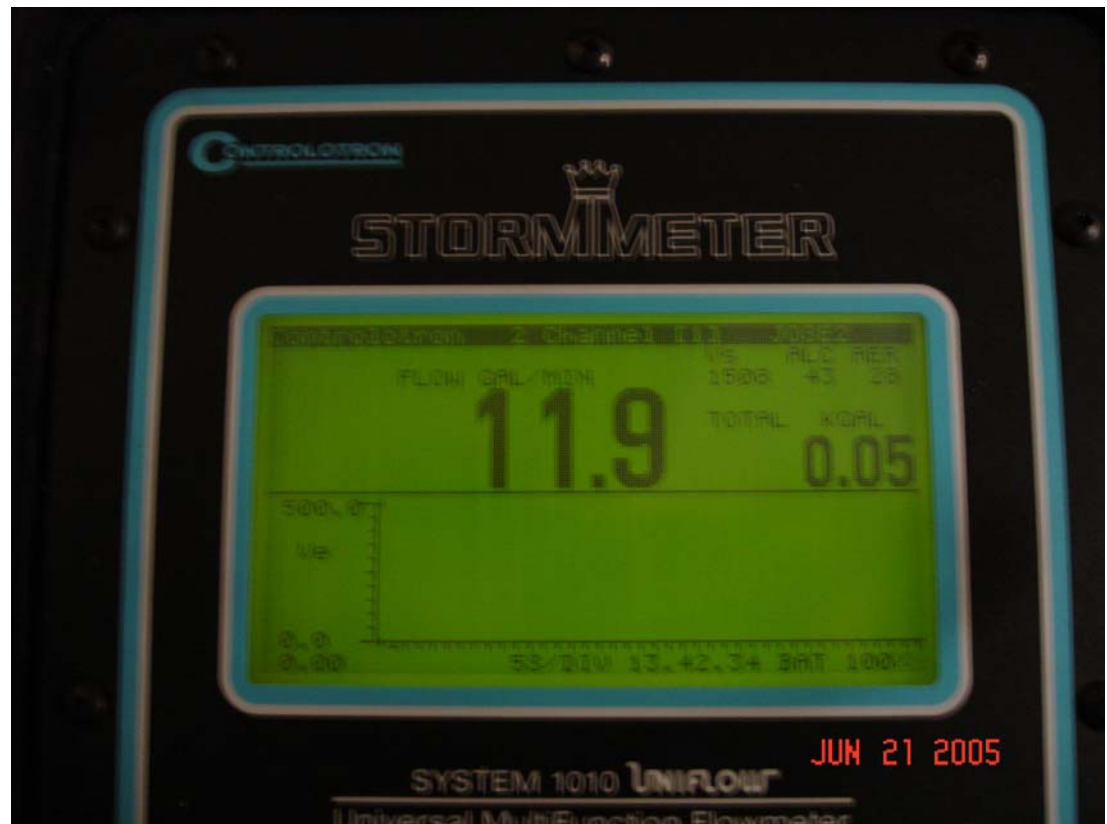
Radiant loop, Photo #1559

- Pump PR1 / PR2 (radiation pumps) flow found at 11.9 GPM at the pump station. (see photo #1559). Design flow is 40 GPM. Balancer's report shows a flow of 12.2 GPM.
- Flow rate at the Principals' office varied from 0.36 to 0.45 GPM (design is 0.98 GPM). Flow dropped to 0.26 GPM when the zone valve in an adjacent room was opened.
- No pressure taps on pumps to allow a cutoff test.
- Strainers clean.
- Found 2" circuit setter closed. The 1" circuit setter was 100% open.

Ultrasonic flow meter. Shows GPM flow on radiant loop as found.

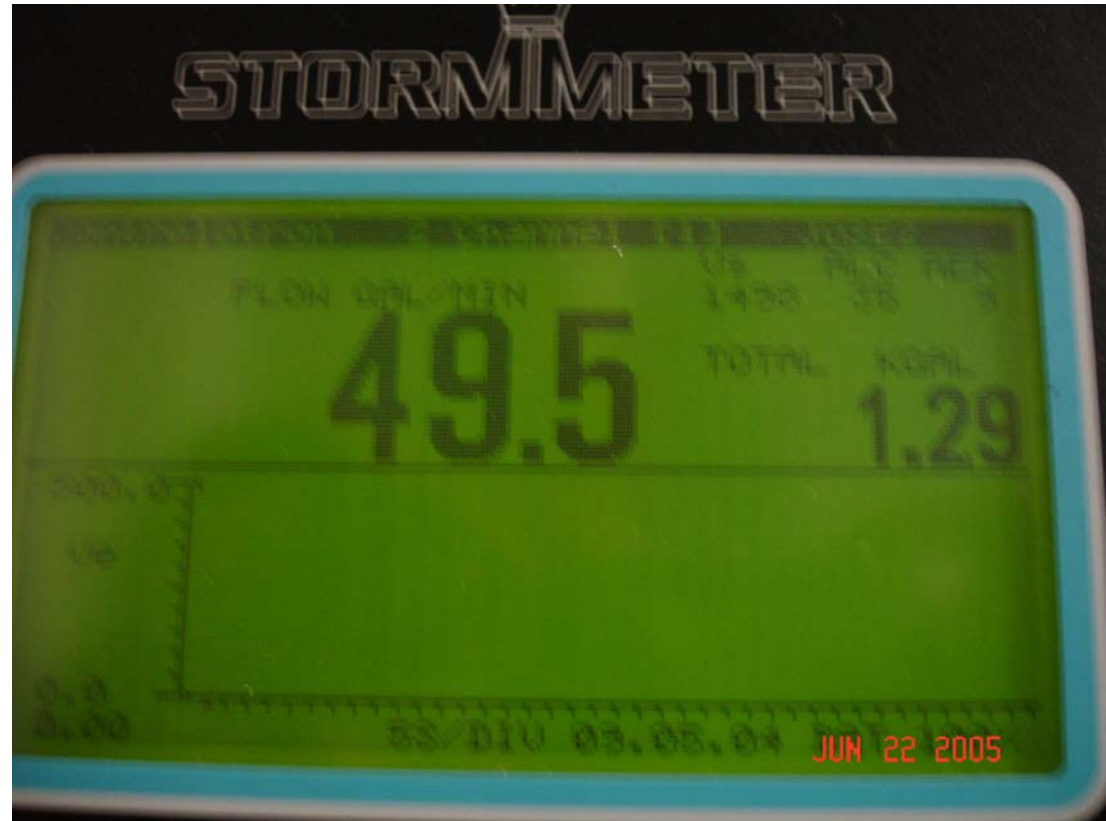
Radiant loop, Photo #1574

Ultrasonic flow meter. Shows GPM flow on radiant loop after the 2" circuit setter was opened.

- Set 2" circuit setter to fully open. Pump flow increased to 49.5 GPM.
- Set the circuit setter to approximately 30 GPM to distribute as intended by the Engineer.
- Re-measured flow in Principals' office at 1.48 GPM. No true balancing valve installed to balance each zone of baseboard.

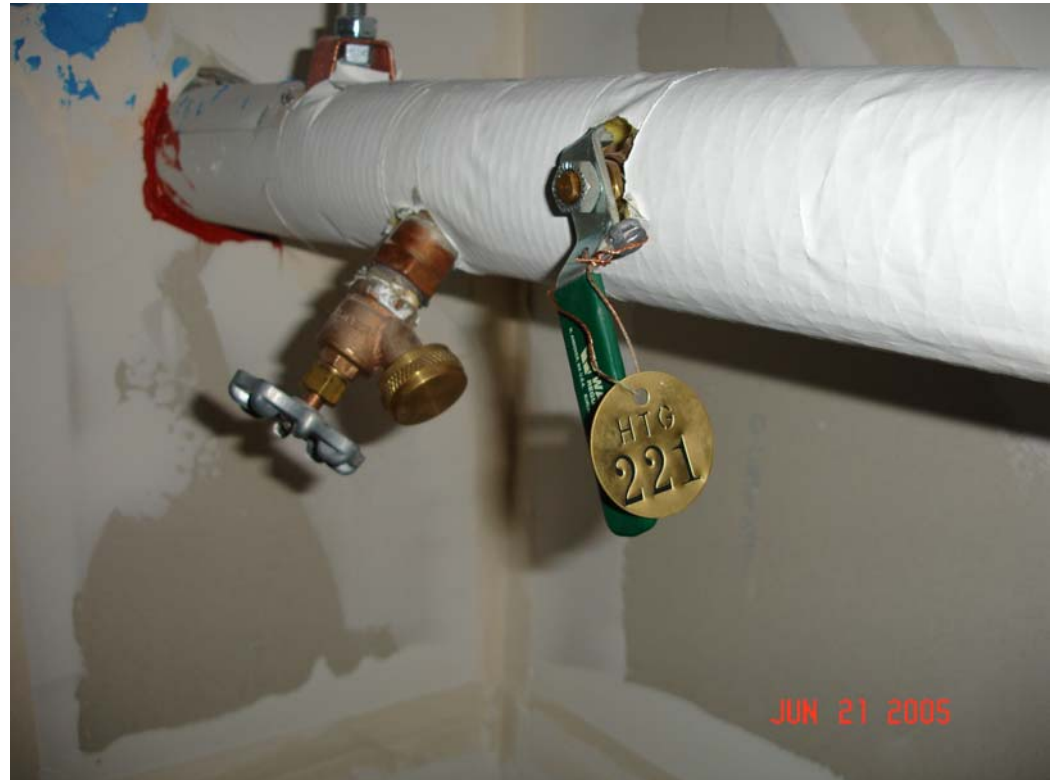
Radiant loop, Photo #1543

Photo shows hand valves possibly adjusted for flow (used as balancing valves).

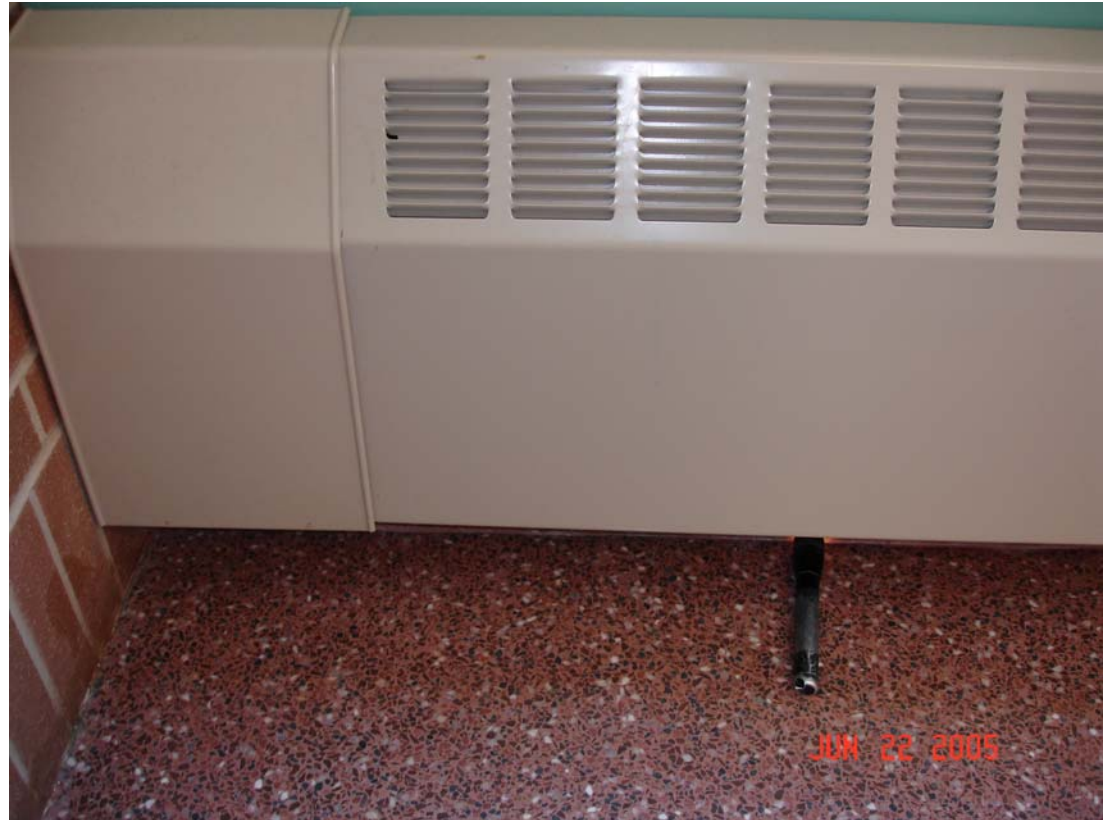
Radiant loop, Photo #1590

Typical baseboard cover.
Thermostatic radiator valve is
installed at the location of the
flashlight on the floor and is
not readily accessible.

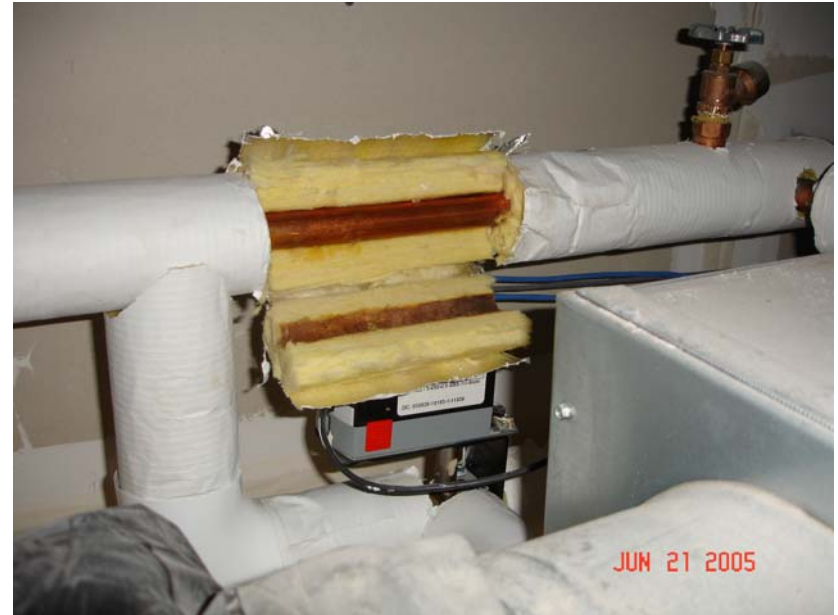
VAV 104 , Photo #1547

- VAV reheat actuator on 3 way valve would not move when commanded by controller. Problem must be investigated and corrected.

View of balancer's flow reading location. AI took flow readings on the other side of the tee and read 0.75 GPM. The balancer reported 0.1 GPM. Flow is available, but the 3-way will not permit it to flow through the coil.

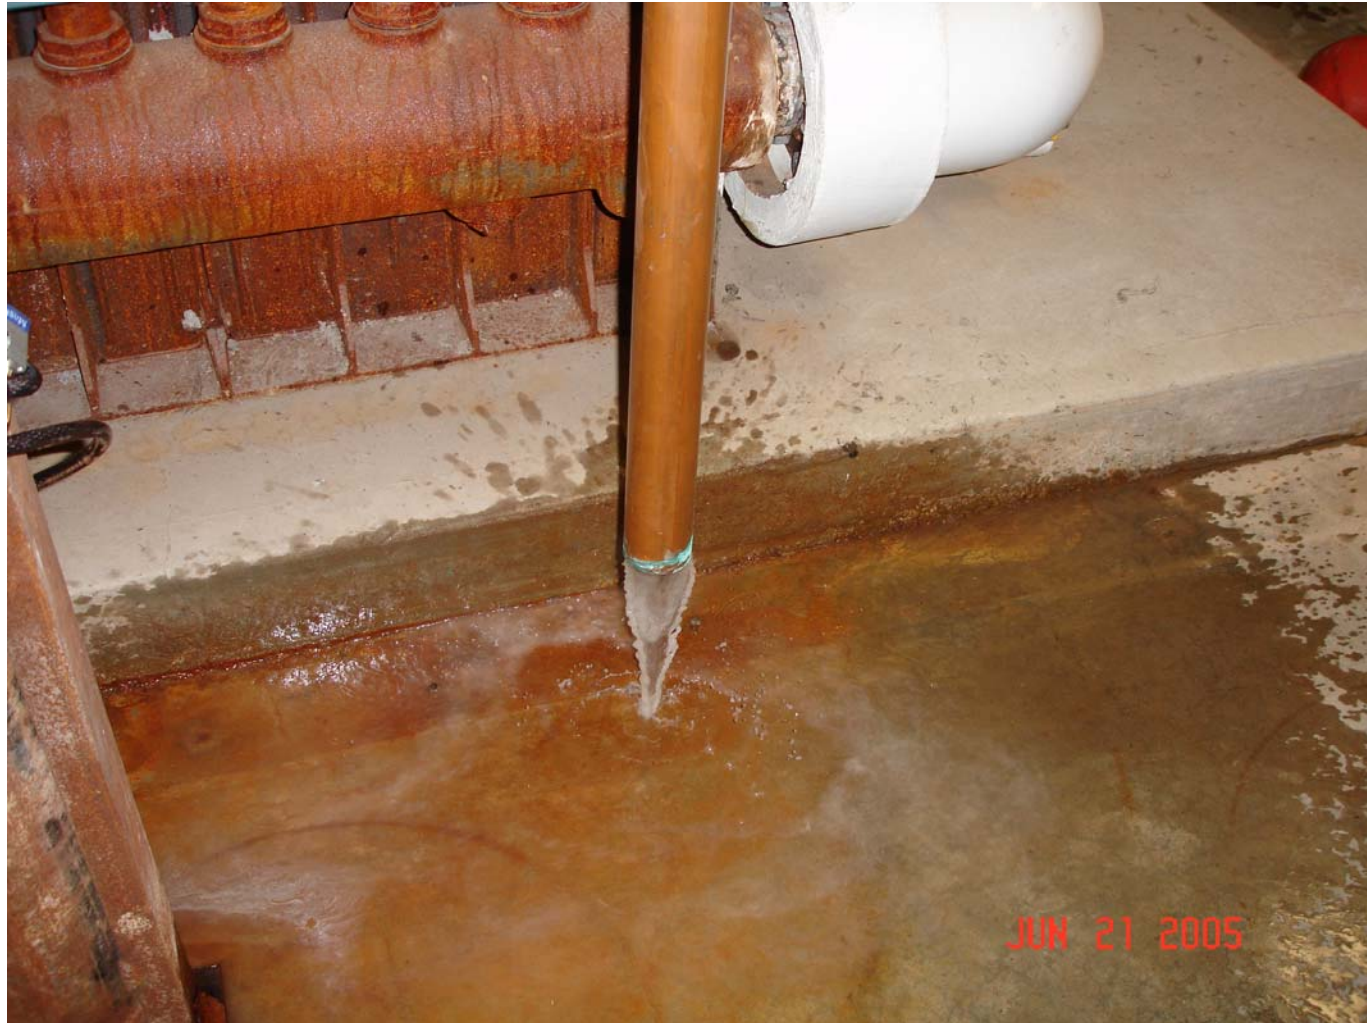
Boiler photo #1528

- Relief valves on both boilers are lifting each time the boilers fire from a cold start.
- Makeup valve set for 32 psig.
- Induced draft fan belts slapping and very loose.

Relief valves lift as boiler heats

- Investigate and determine the cause of the relief valves lifting.
- Install a gauge between the makeup regulator and the ball valve to provide a gauge reading after adjustment.
- Repair belts.
- Boiler control circuit including outside air damper control were not tested.

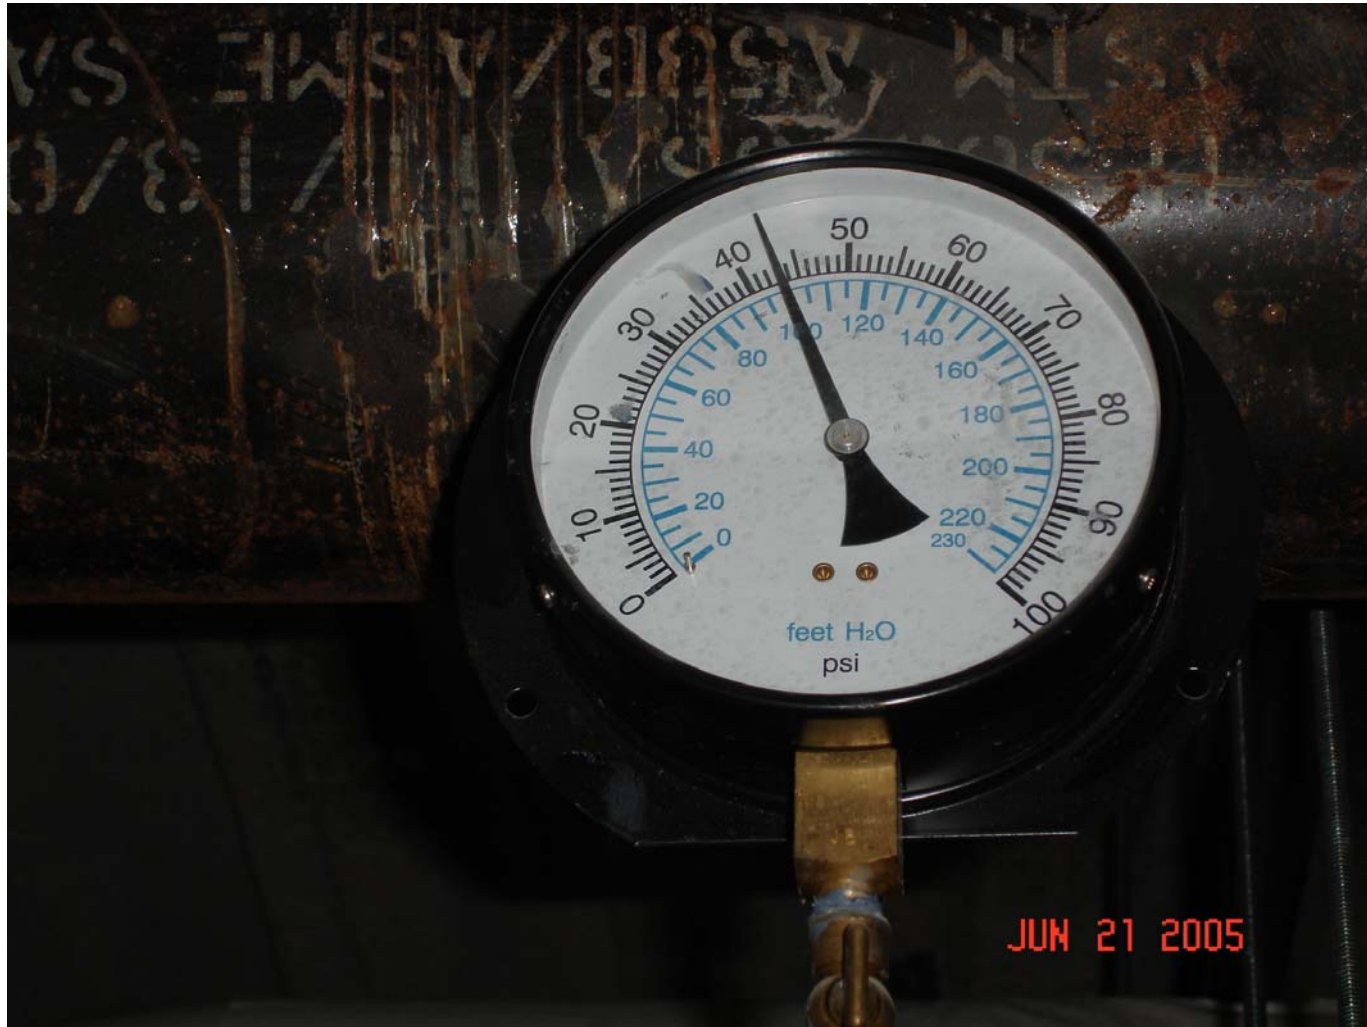
Boiler photo #1533

System pressure above setting of relief valves
