MAIB TRILOGY REPORT

***Korenbloem***

***Osprey III***

***Optik***

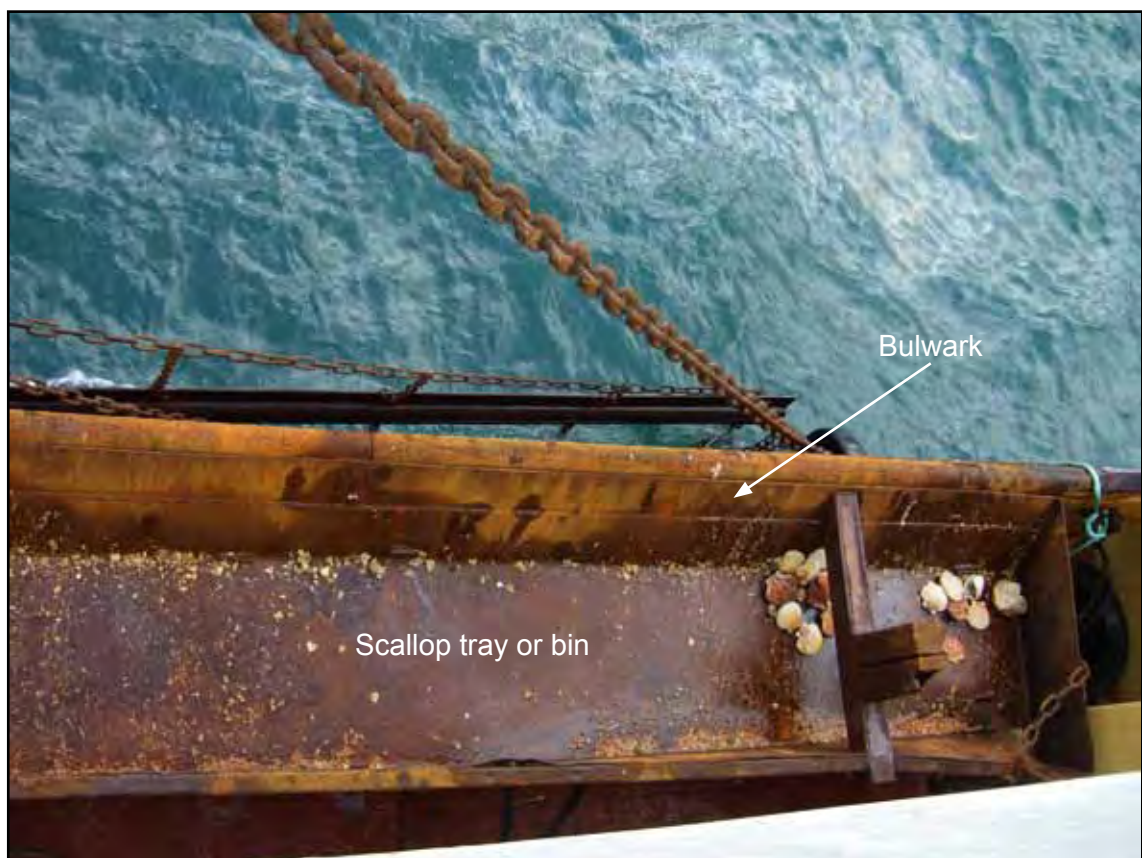
Figure 1

*Korenbloem* is a beam trawler with the ability to carry out either white fishing or scallop dredging depending on the fishing gear fitted. At the time of the accident she was working as a scallop dredger, operating 12 dredge bags on either side. At the end of each haul the dredge bags, which were suspended between the towing beams and tipping bars, were emptied into long trays (bins) adjacent to the bulwarks by lifting the tipping bar using the gilson winch. During hauling and shooting the gear, deckhands had to climb on top of the bins to attach or detach the gilson clips. The top edges of the bins were nearly at the same height as the bulwarks (**Figure 1**).

Scallop trays or bins adjacent to the bulwark

*Korenbloem* was surveyed twice in 4 years, and inspected once annually. However, the potential hazard posed by fitting the scallop bins flush with the bulwark was not identified during these surveys.

In practice, the bins extended the bulwark inboard and, as such, did not pose a hazard until anyone climbed on top of them to operate the gilson clips. As the bins are removed during the surveys, it is understandable that the danger of falling into the sea from the bins was not readily apparent to the attending

In order to appreciate the implications of fitting additional equipment, such as bins, it is necessary for the surveyor to see them in place. Therefore, it would be prudent for surveyors to insist on seeing the vessel in the 'ready to sail' condition during surveys and inspections.

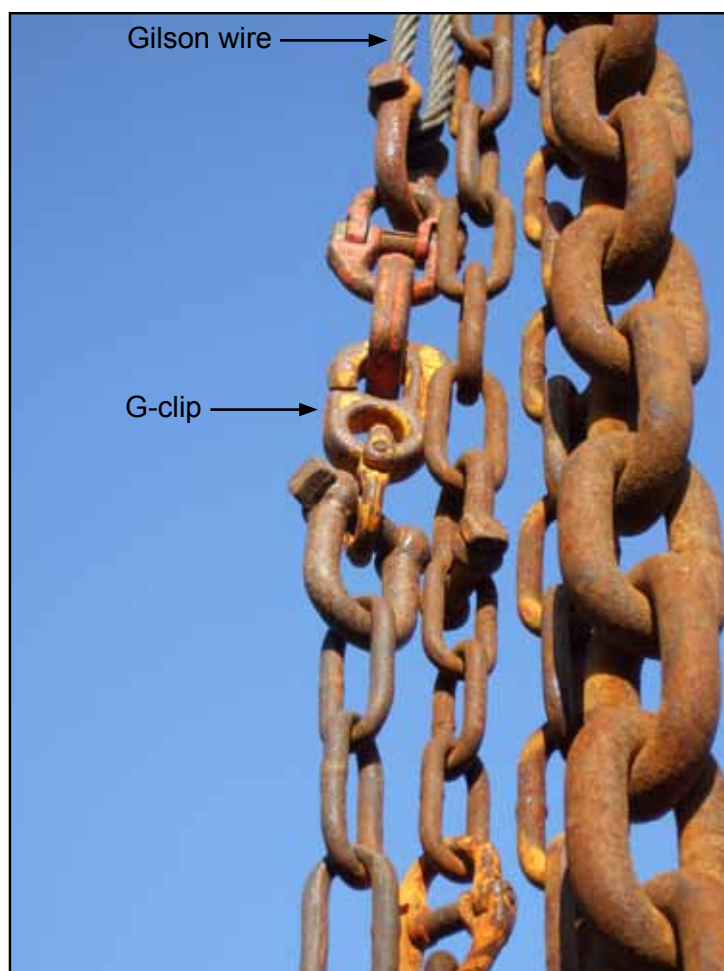
Figure 4

Gilson wire with G-clips

The risks associated with standing on a catch of scallops, without any guardrails or restraints, to unhook the Gilson G-clips were obvious and those risks were multiplied by the vessel's movement in rough weather. The acceptance of such working practices as routine demonstrates an unacceptably high tolerance of risk. In this instance the risk became reality, and a man lost his life. There is no need for such unsafe working practices to go unchallenged; skippers and crews, supported by the owners, must start taking more responsibility for their own safety if the fishing industry is to reduce its high fatality rate.

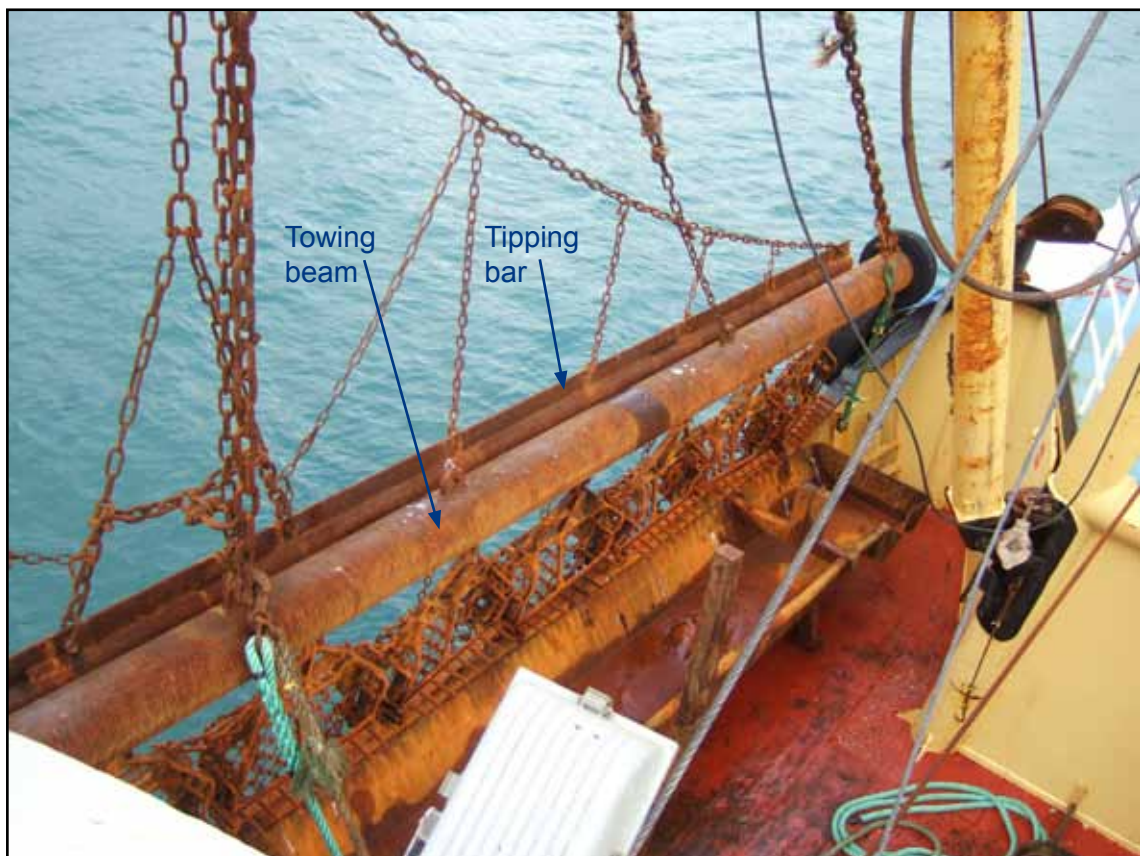
Towing beam and tipping bar with bridle chains

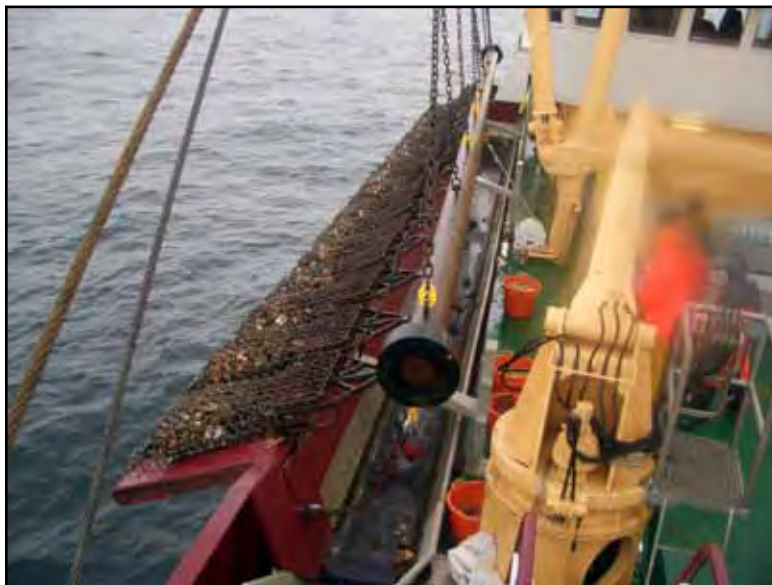
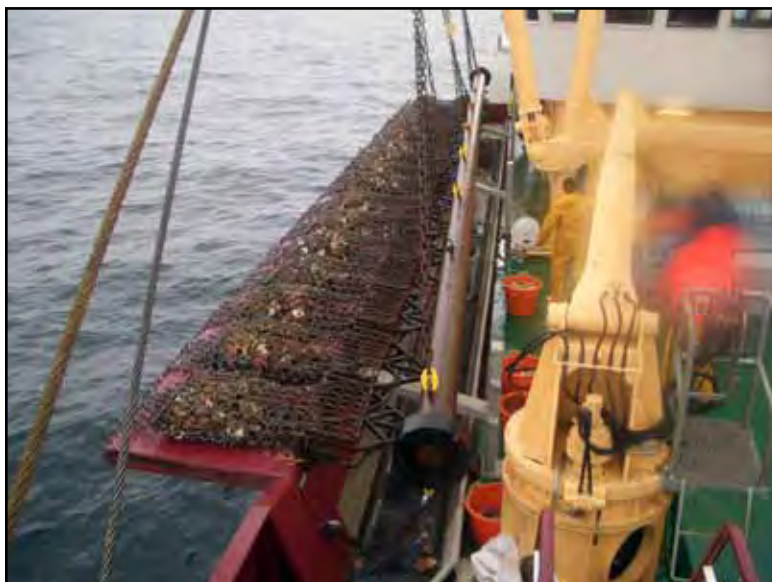
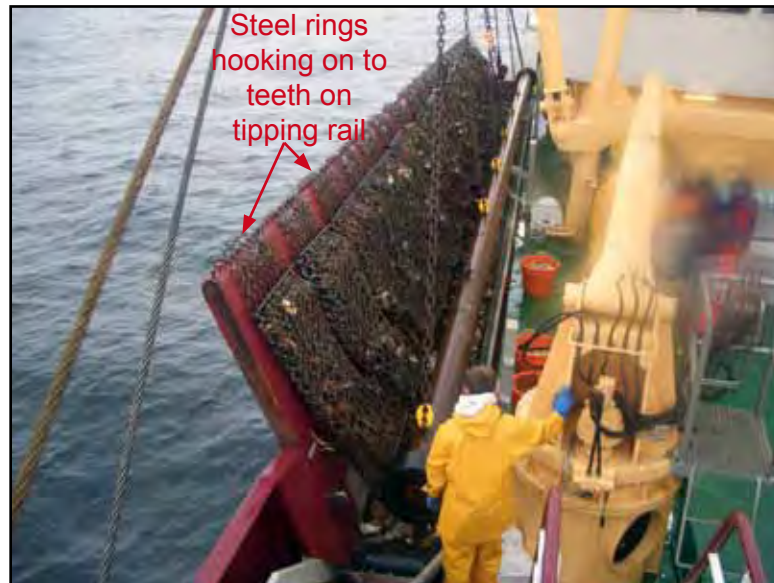
Figure 8a

Tipping rail mechanism

The tipping rail system is a recent innovation, and it is possible that as the industry gains experience of its use it will find new hazards which have not yet been identified. However, at present the tipping rail system appears to significantly improve crew safety compared with existing systems.

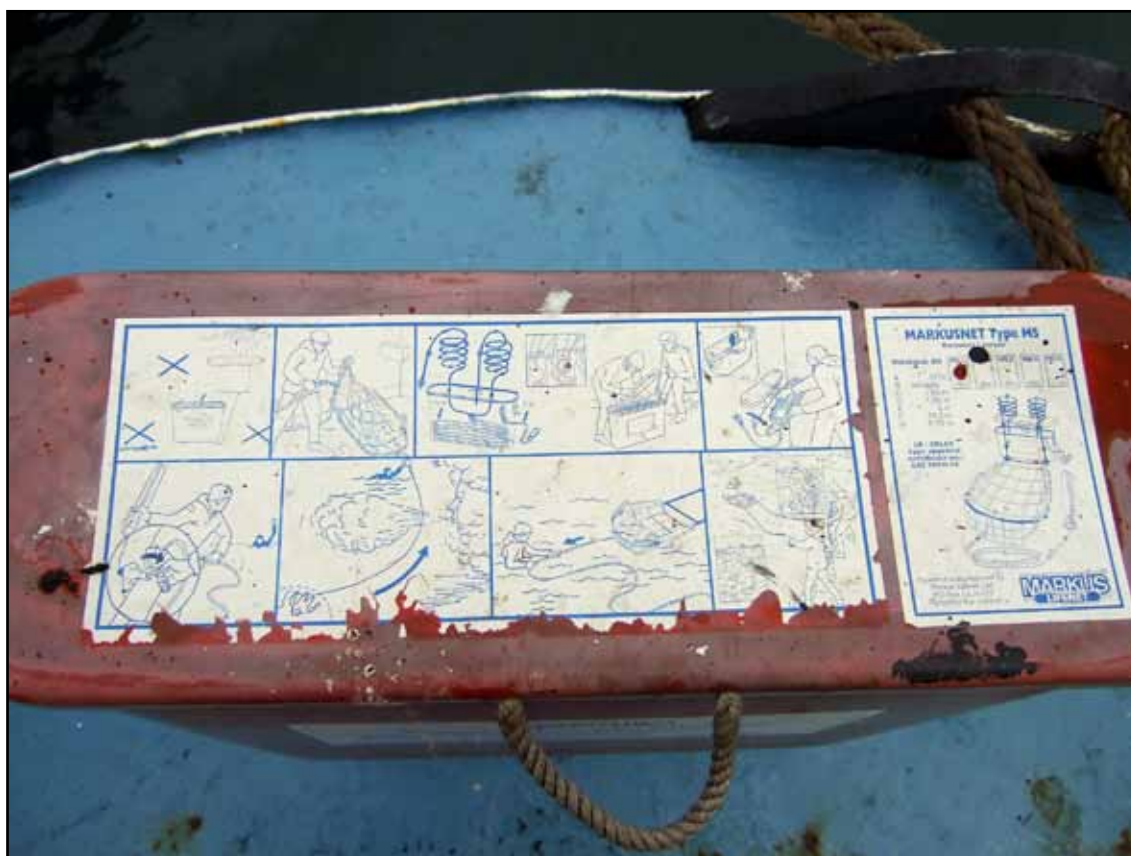
Figure 9

The MOB recovery system on *Korenbloem* was a Markus Net. The crew was unfamiliar with it and did not know how to use it. The model on board was a 'Markus MS2' which had a 14m attachment line, a 20m lifting line on the inner end, and a 25m throw line with a chest-loop (**Figure 9**). The net weighed 4kg and was enclosed in a portable storage container. The MOB could be lifted manually, or hoisted with a crane or winch in a standing, sitting or horizontal position. To rescue an unconscious person from the water, another person attached to a life-line had to enter the water and physically drag the casualty into the net.

Markus net

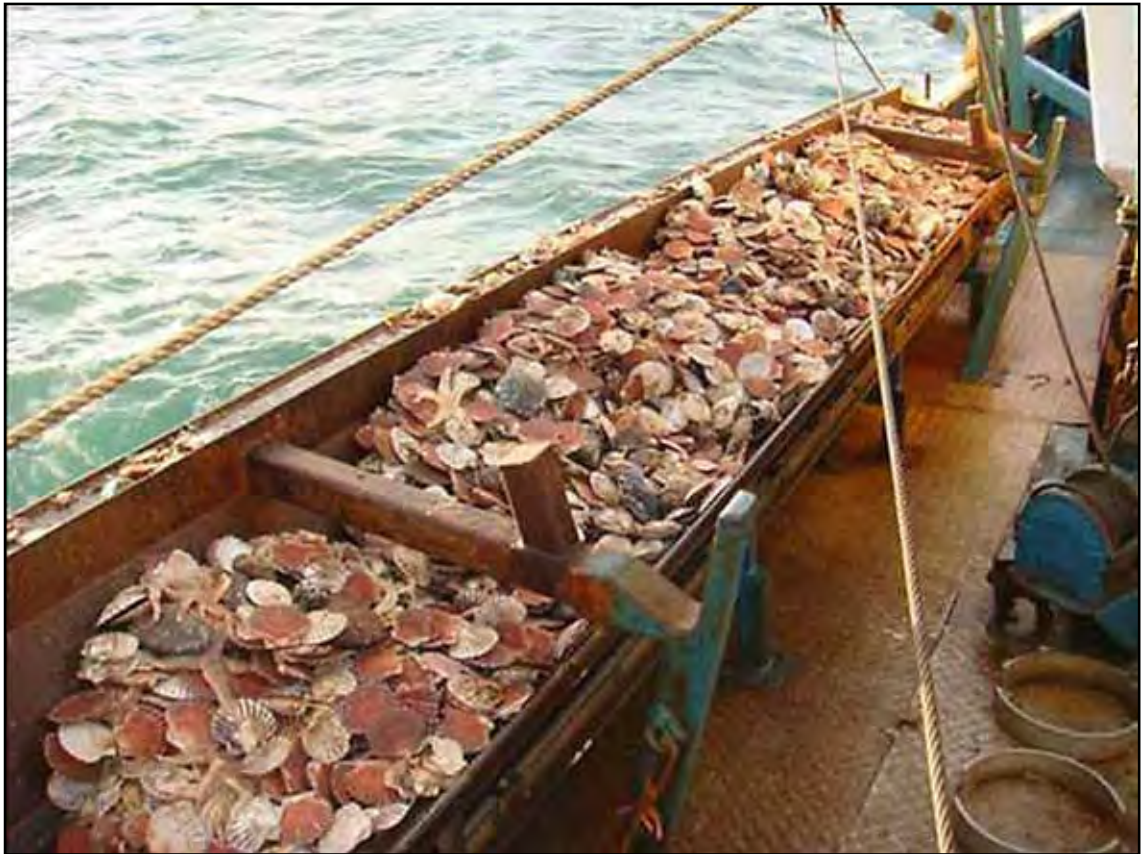
James Grindy was last seen, by the skipper, standing on the catch in the port bin waiting for the second crewman to join him so that he could unhook the gilson wire from the tipping bar chains. As there was no eye witness, it is not possible to establish the exact sequence of events immediately before and during the accident. It is unlikely that James was knocked into the water by the towing beam because it had already been lowered over the side ready for him to unhook the gilson clip. However, as the vessel's engine was stopped, the towing beams and tipping bars would have been swinging about considerably due to the roll of the vessel in a beam sea. The instinctive reaction of the skipper on seeing James in the water was to top the derrick out, indicating the beam was still quite close to the vessel's side when James fell in. Therefore, there is a very strong likelihood that either James fell between the vessel's side and the towing beam, or he ended up in that position while attempting to rescue himself. In any case the blunt object, which struck him, causing the *unsurvivable* injuries, was most probably the towing beam either crashing onto him or crushing him momentarily against the ship's side.

Heavy rain, possibly refracting the deck lights; severe rolling of the stopped vessel in a beam sea without the damping effect of the gear in the water; strong winds; having to stand on the wet and slippery catch (**Figure 12**); and obstructive metal partitions in the bin concealed by the catch, all contributed to making the activity of standing or moving on the bin an extremely dangerous one. In addition, it is possible that under the poor weather conditions, the skipper made an error of judgment and topped the gear out further than normal as he had no means of calibrating its position, except visually. In any case, the tipping bar suspended from the 'monkey face' and a slack gilson wire, would have swung like a pendulum as the vessel rolled. James, in reaching out to unhook the gilson clips, either could have over-extended himself and lost his balance, or more simply lost his footing, causing him to fall overboard.

Scallop tray or bin with catch (not from *Korenbloem*)

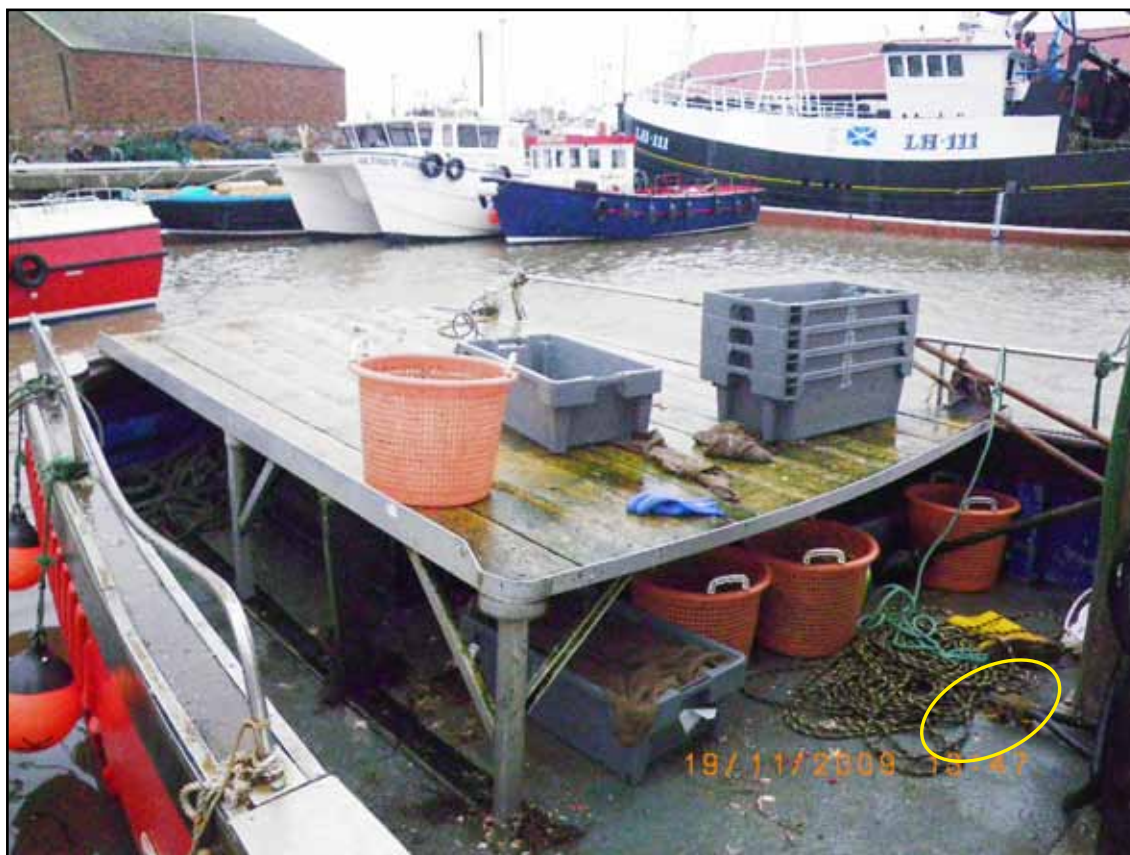
*Optik's* deck (after the accident) showing the approximate position of the crewman before he was dragged overboard by the rope shown

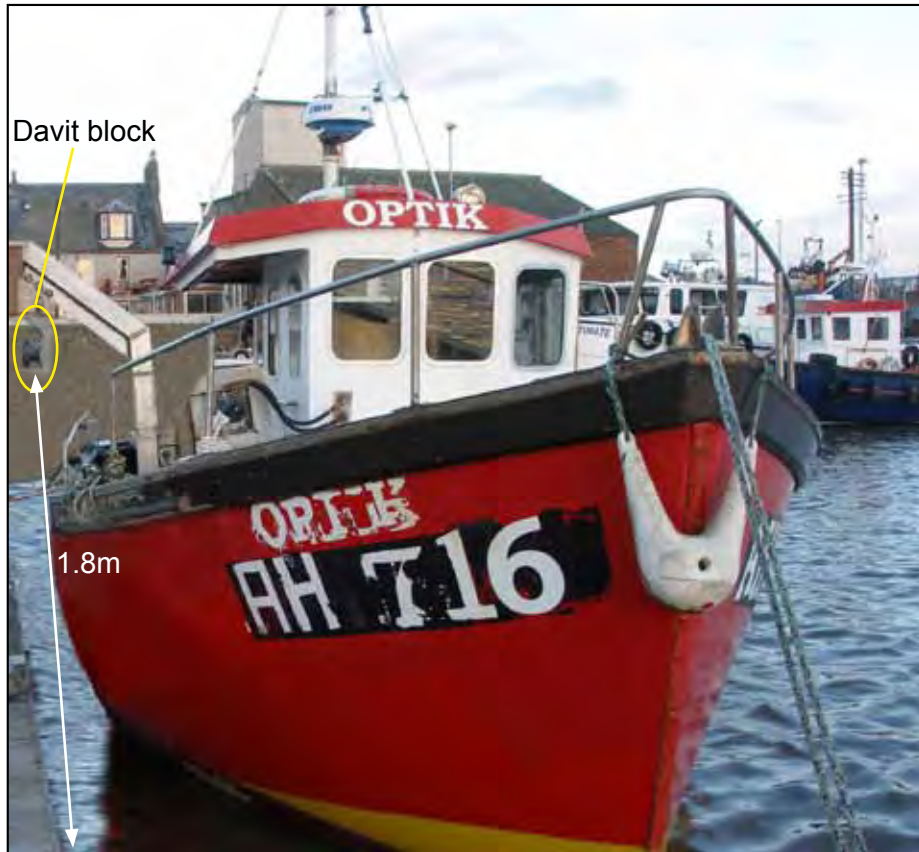
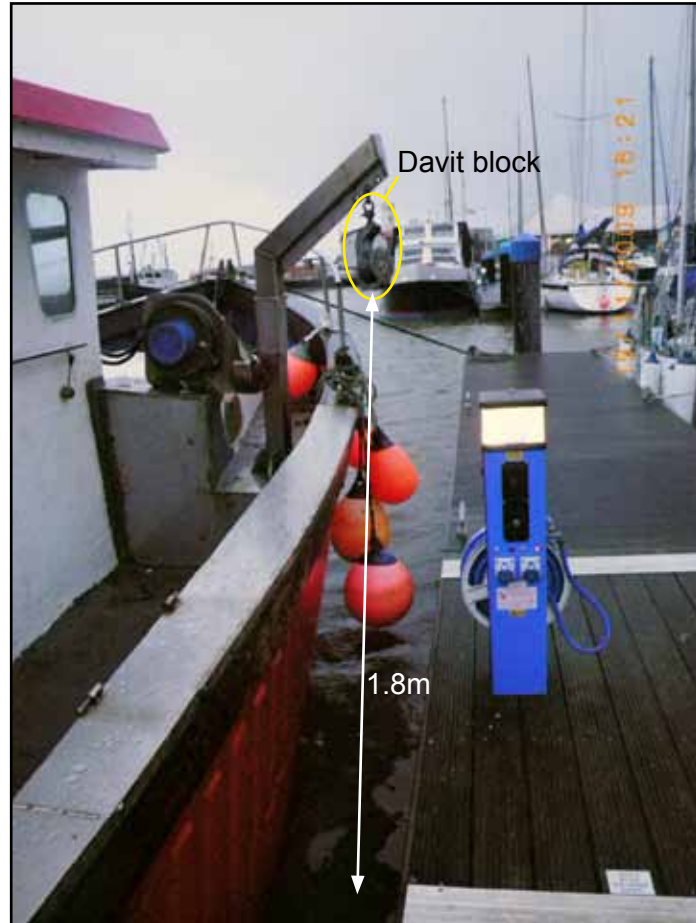
Figure 20a

*Optik's* skipper continued to haul the rope until the casualty's ankle was touching the davit block (**Figures 20a & 20b**) and he was suspended, head down, towards the sea. There were no signs of life in him at this time. The skipper cut the rope free from around the casualty's torso and attempted to pull him back on board. Despite several attempts, the skipper was unable to get sufficient grip to haul the casualty up and over the bulwarks and slack the retaining rope from the hauler at the same time. Realising he could not recover the casualty alone, he ran into the wheelhouse to use the VHF to call the nearby fishing vessel *Orianne* for help.

Davit block used to recover the casualty

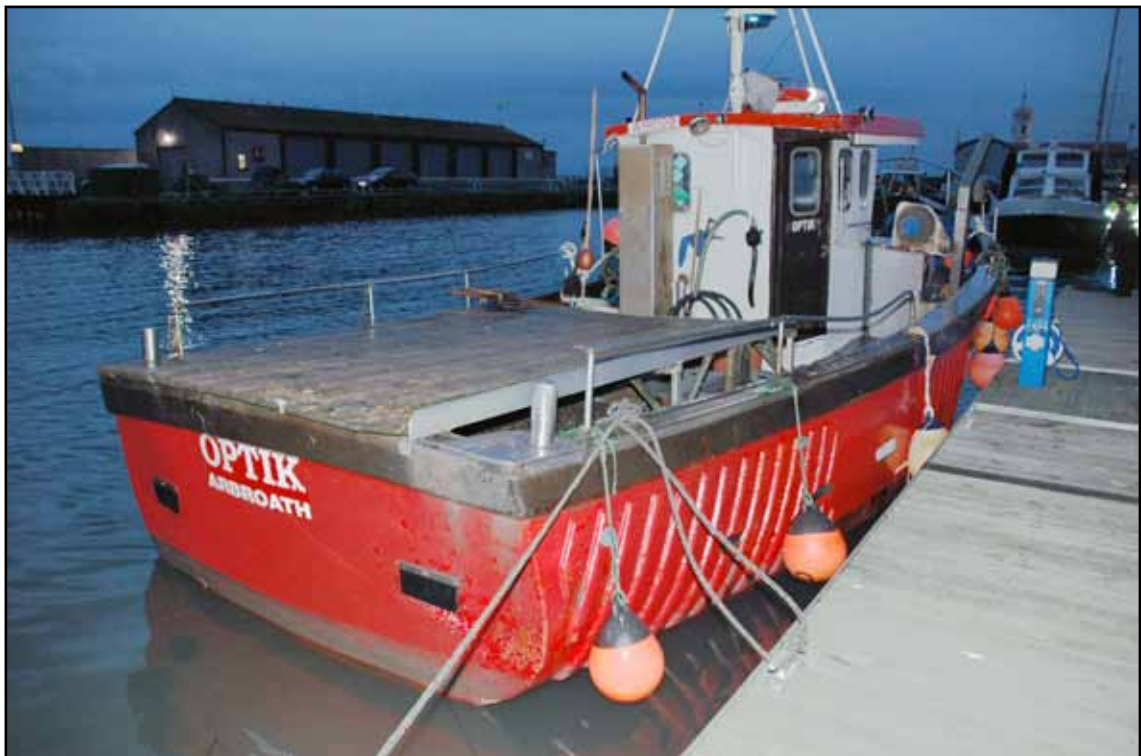
Figure 21

When *Optik* was purchased, the current owner fitted a shooting table, or platform, on the working deck aft to facilitate “self shooting” of creels (**Figure 21**). This was a common practice on many Arbroath creel vessels at the time. The shooting table measured 3.65m long x 2.44m at its widest point and tapered slightly towards the stern. This allowed approximately 24 creels to be stowed flat on the table with a walkway down its starboard side and free deck space of 1.07m between the front of the table and aft wheelhouse bulkhead. Installation of this shooting table blocked off the dedicated engine space access hatch from the main deck, requiring an alternative access to be opened up in the watertight bulkhead between the forecastle and engine space.

Shooting table on aft deck of *Optik*

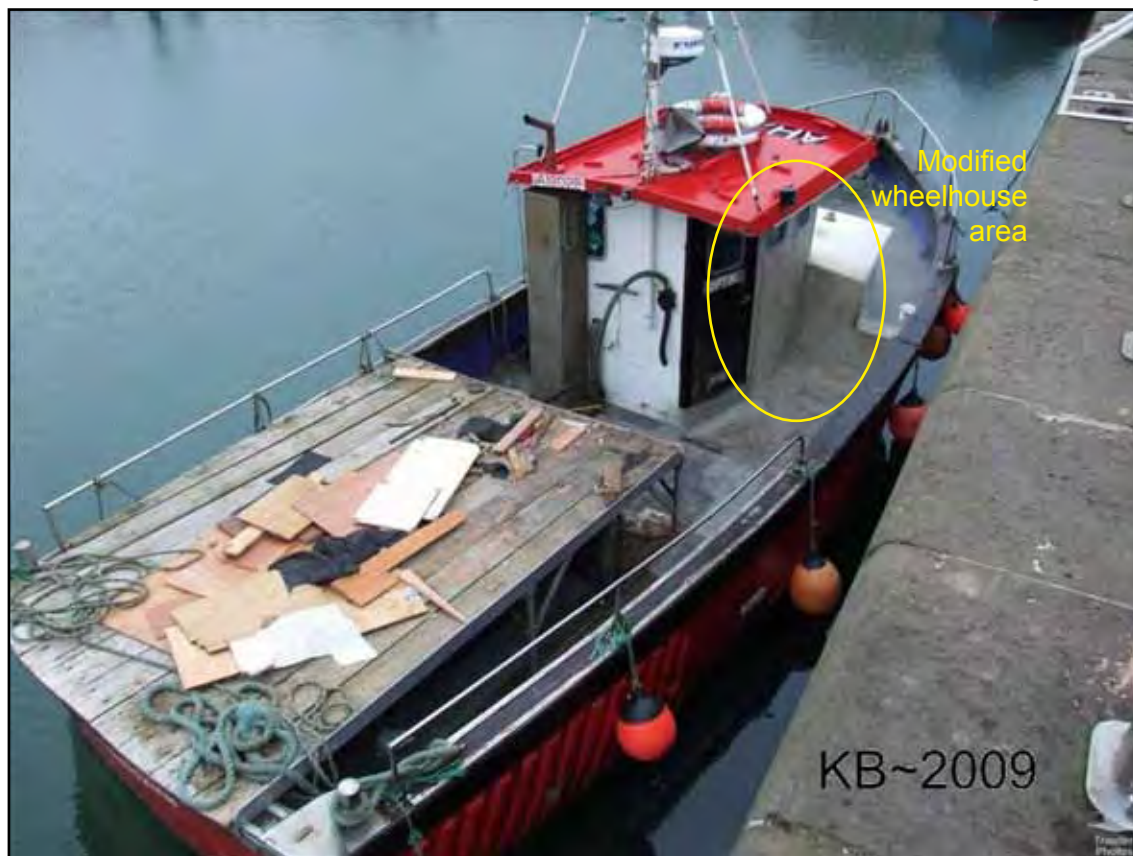
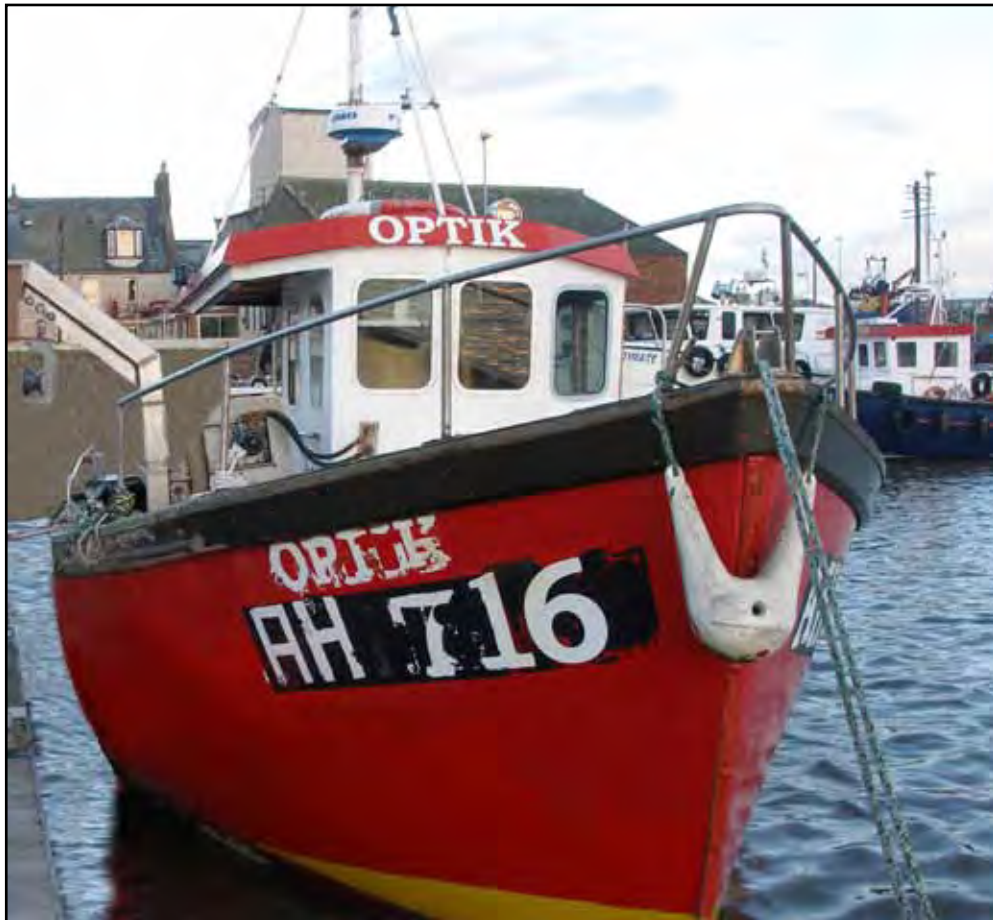
Figure 22a

In June 2009 the skipper further modified the vessel by removing part of the wheelhouse from *Optik's* starboard side (**Figures 22a and 22b**). The modification provided more clear deck space and therefore improved safety in the area of the hauling position. A new sleeved box section hauling davit was also installed at this time, enabling the davit arm to be lifted and rotated through 90°, and prevent it from becoming fouled when *Optik* was moored alongside other fishing vessels. The snatch block on the outboard end of the davit was 1.8m above the waterline (**Figures 20a and b**).

*Optik* undergoing modifications to starboard side of wheelhouse to enlarge deck space

*Optik* showing completed modifications to wheelhouse and davit arm
