# Large Steam Turbine Vibration Resonance of Pedestal and Linkage System RCA, Detail Vibration Investigation / Measurement at Site and Countermeasures

## **Preface**

**A Large Steam Turbine had been in operation for several years and this turbine experienced the wear damage of governor linkage.**

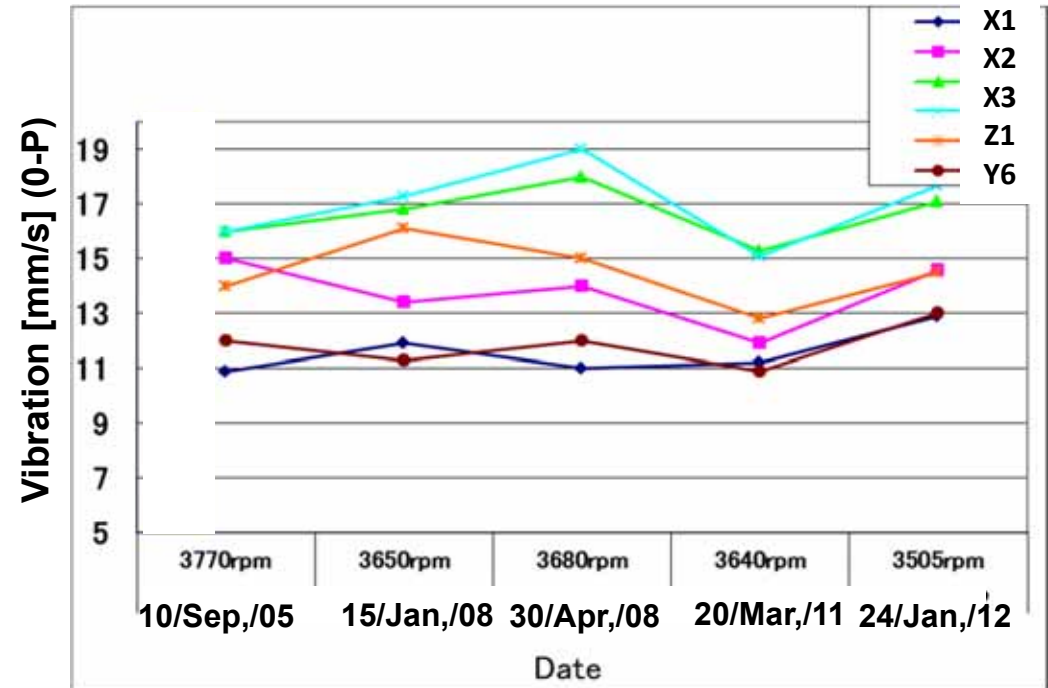
Pedestal vibration record from 2005 to 2012

- Turbine start up in 2002
- Gov, side pedestal Vibration increase from around 2005
- Vibration up to 20 mm/s in 2012 by turbine load/speed up
- Vibration causes linkage lever wear and required control limit

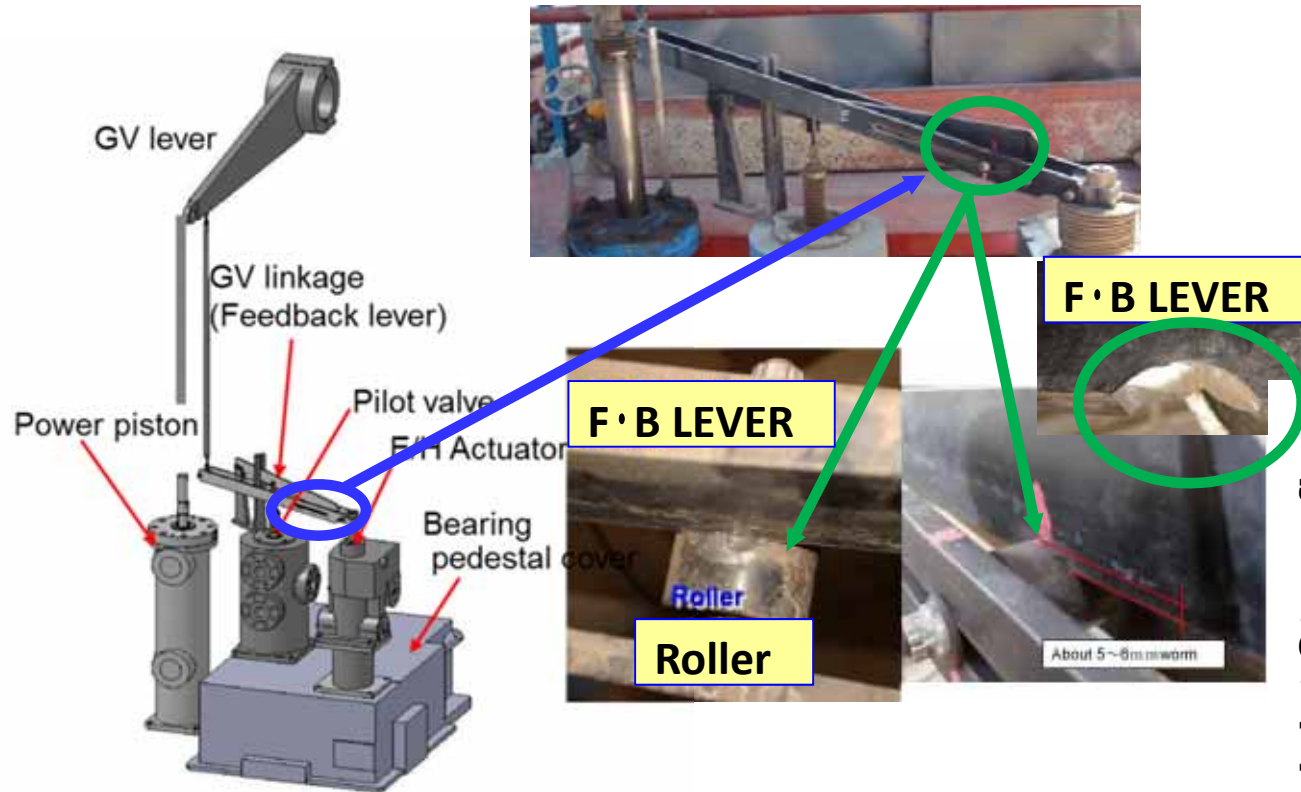
GV linkage damage condition

**Operation condition ;**  
It was shifted actual inlet steam flow against E/H actuator signal.  
Occurred Impossible control area.

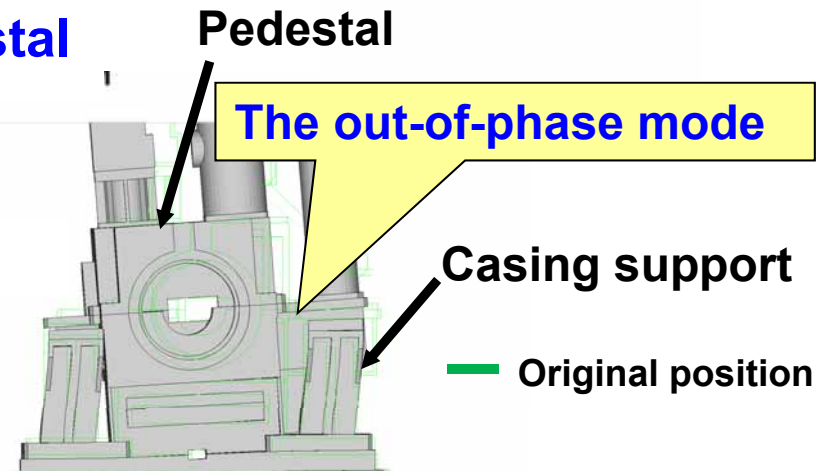
**Measured vibration mode at 3555 rpm**

**The main characteristic of the vibration mode is an out-of-phase (counter-motion) mode between main pedestal and casing support**

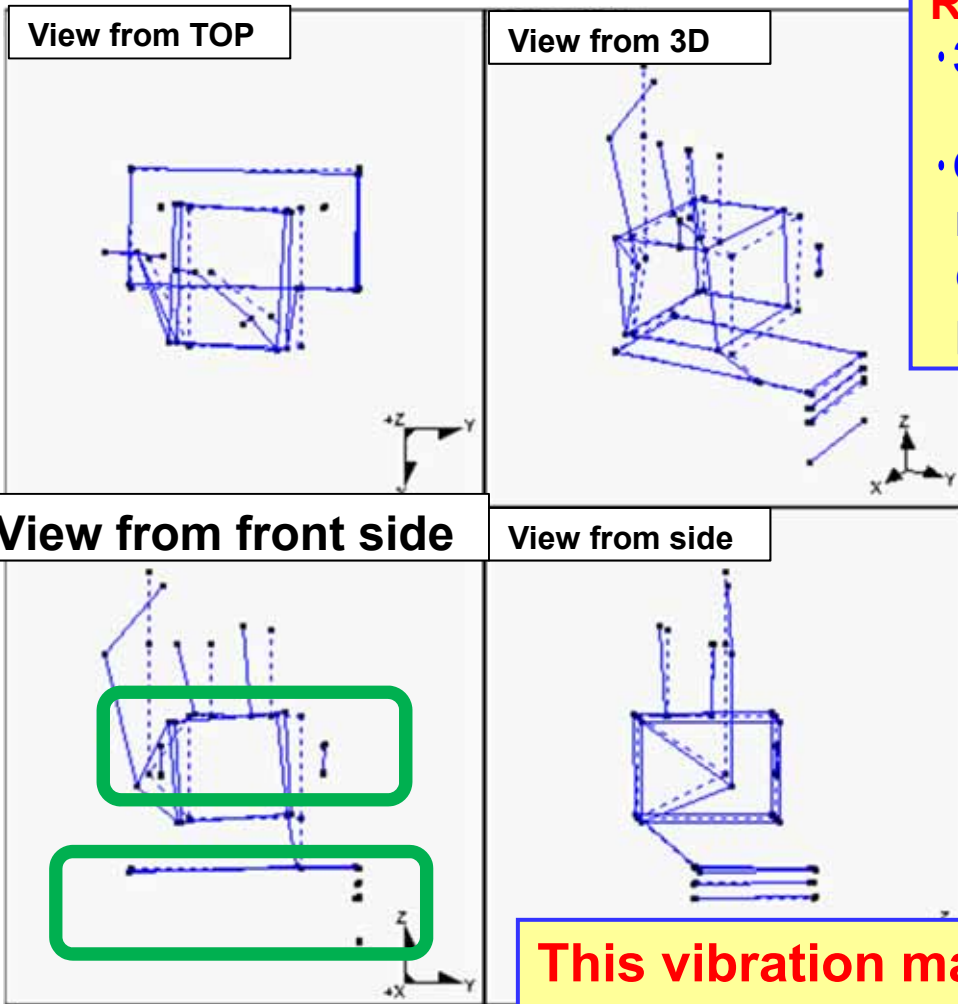
**Result;**

- 3D response analysis method is almost suitable for site operating condition.
- Confirm the out-of-phase(counter-motion) mode between main pedestal and upper casing support, and moving up for pedestal contact surface.

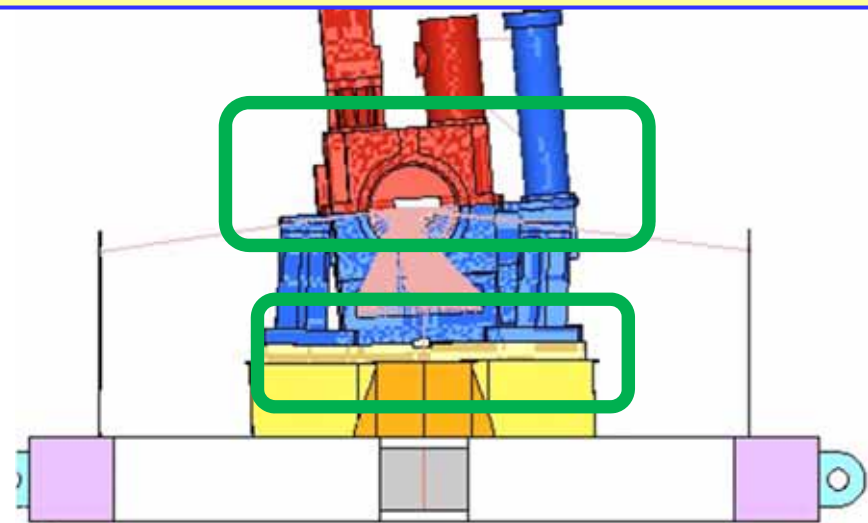
Measured vibration mode at site

**This vibration main cause is the decrease of pedestal stiffness**

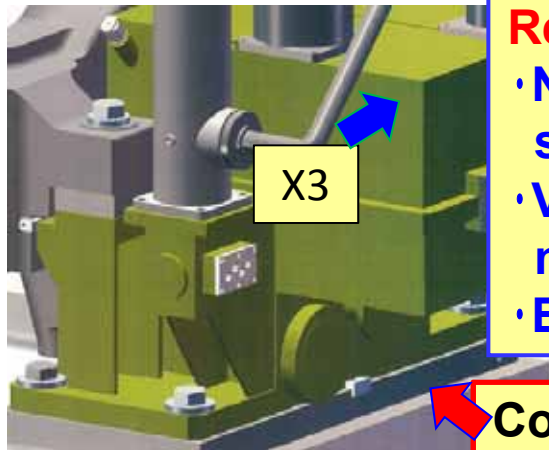
Final analysis results of **fabricated pedestal type**

**Result;**

- Natural frequency 61.8Hz is in to the turbine operating speed range at hot condition, it shifted from cold condition.
- Vibration level in analysis is 10 to 30mm/s 0-P around normal to max speed as same as site vibration level.
- Equivalent to full contact area of pedestal to be reduced.

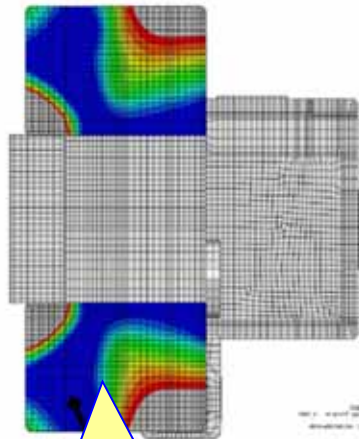
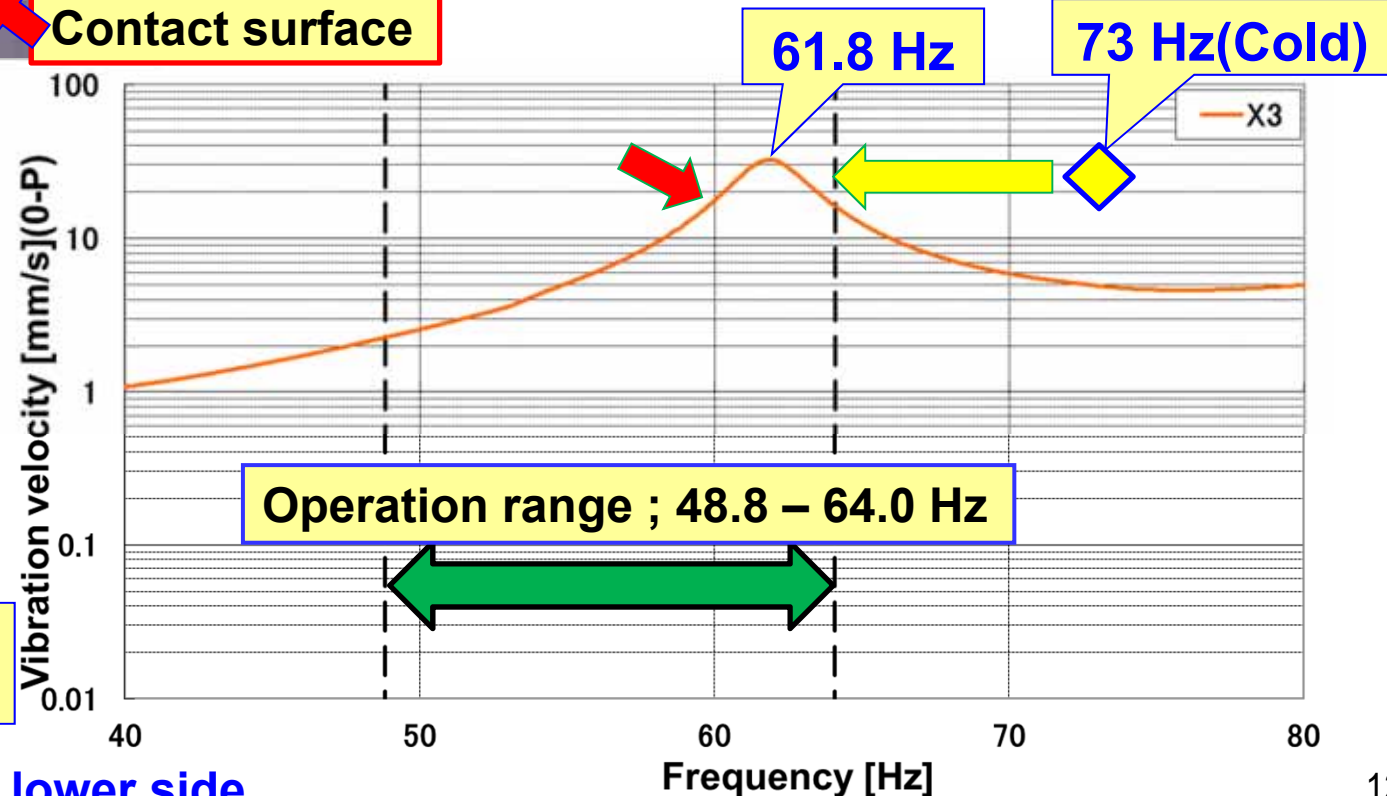
**Contact surface**

**Full contact blue colored only**

- 1) Full contact condition of pedestal surface.
- 2) Rigidly connection between pedestal body and casing support without freestanding.

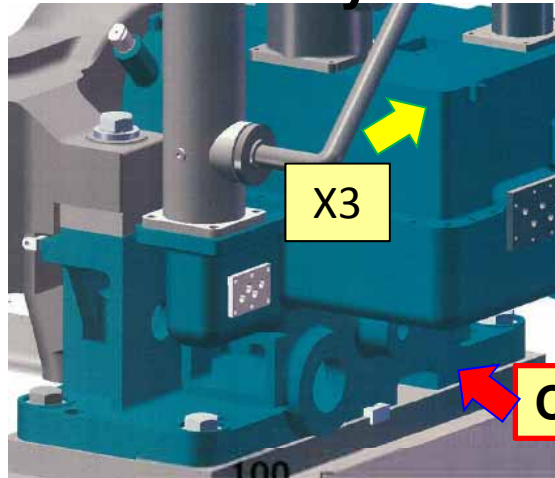
Final analysis results of **Casting pedestal type**

**Result;**

- a) Natural frequency 40.7Hz to be out of operation range, and satisfied with API standard (less than 41Hz).
- b) Vibration level in operation to be much lower at 0.3 to 1 mm/s 0-P even by 5-times of API unbalanced limit

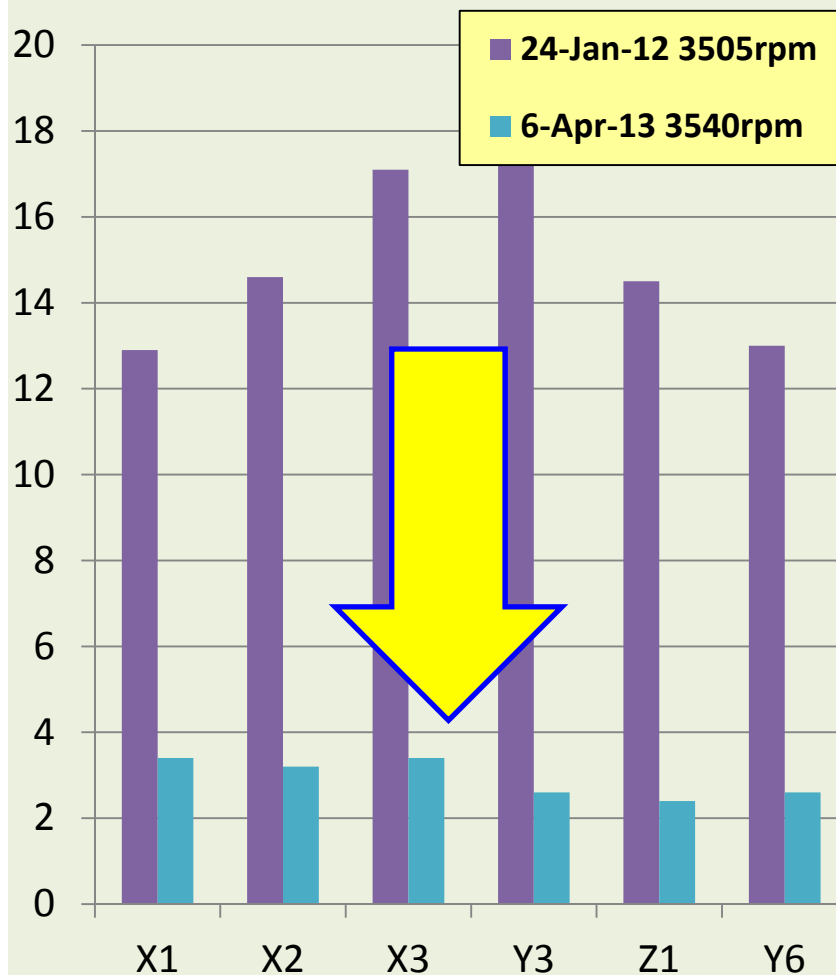
**Vibration record improved pedestal in 2013**

**Result ;**  
Vibration level in rotating speed to be much reduced to less than 3.0 mm /sec (0-P) , which means reduction of 80% compared with the existing pedestal vibration level.
