GE  
159 Plastics Avenue  
Pittsfield, MA 01201  
USA

October 14, 2011

**Re: GE-Pittsfield/Housatonic River Site  
Newell Street Area I (GECD440)  
Summary of September 2011 Post-Storm Inspection Activities**

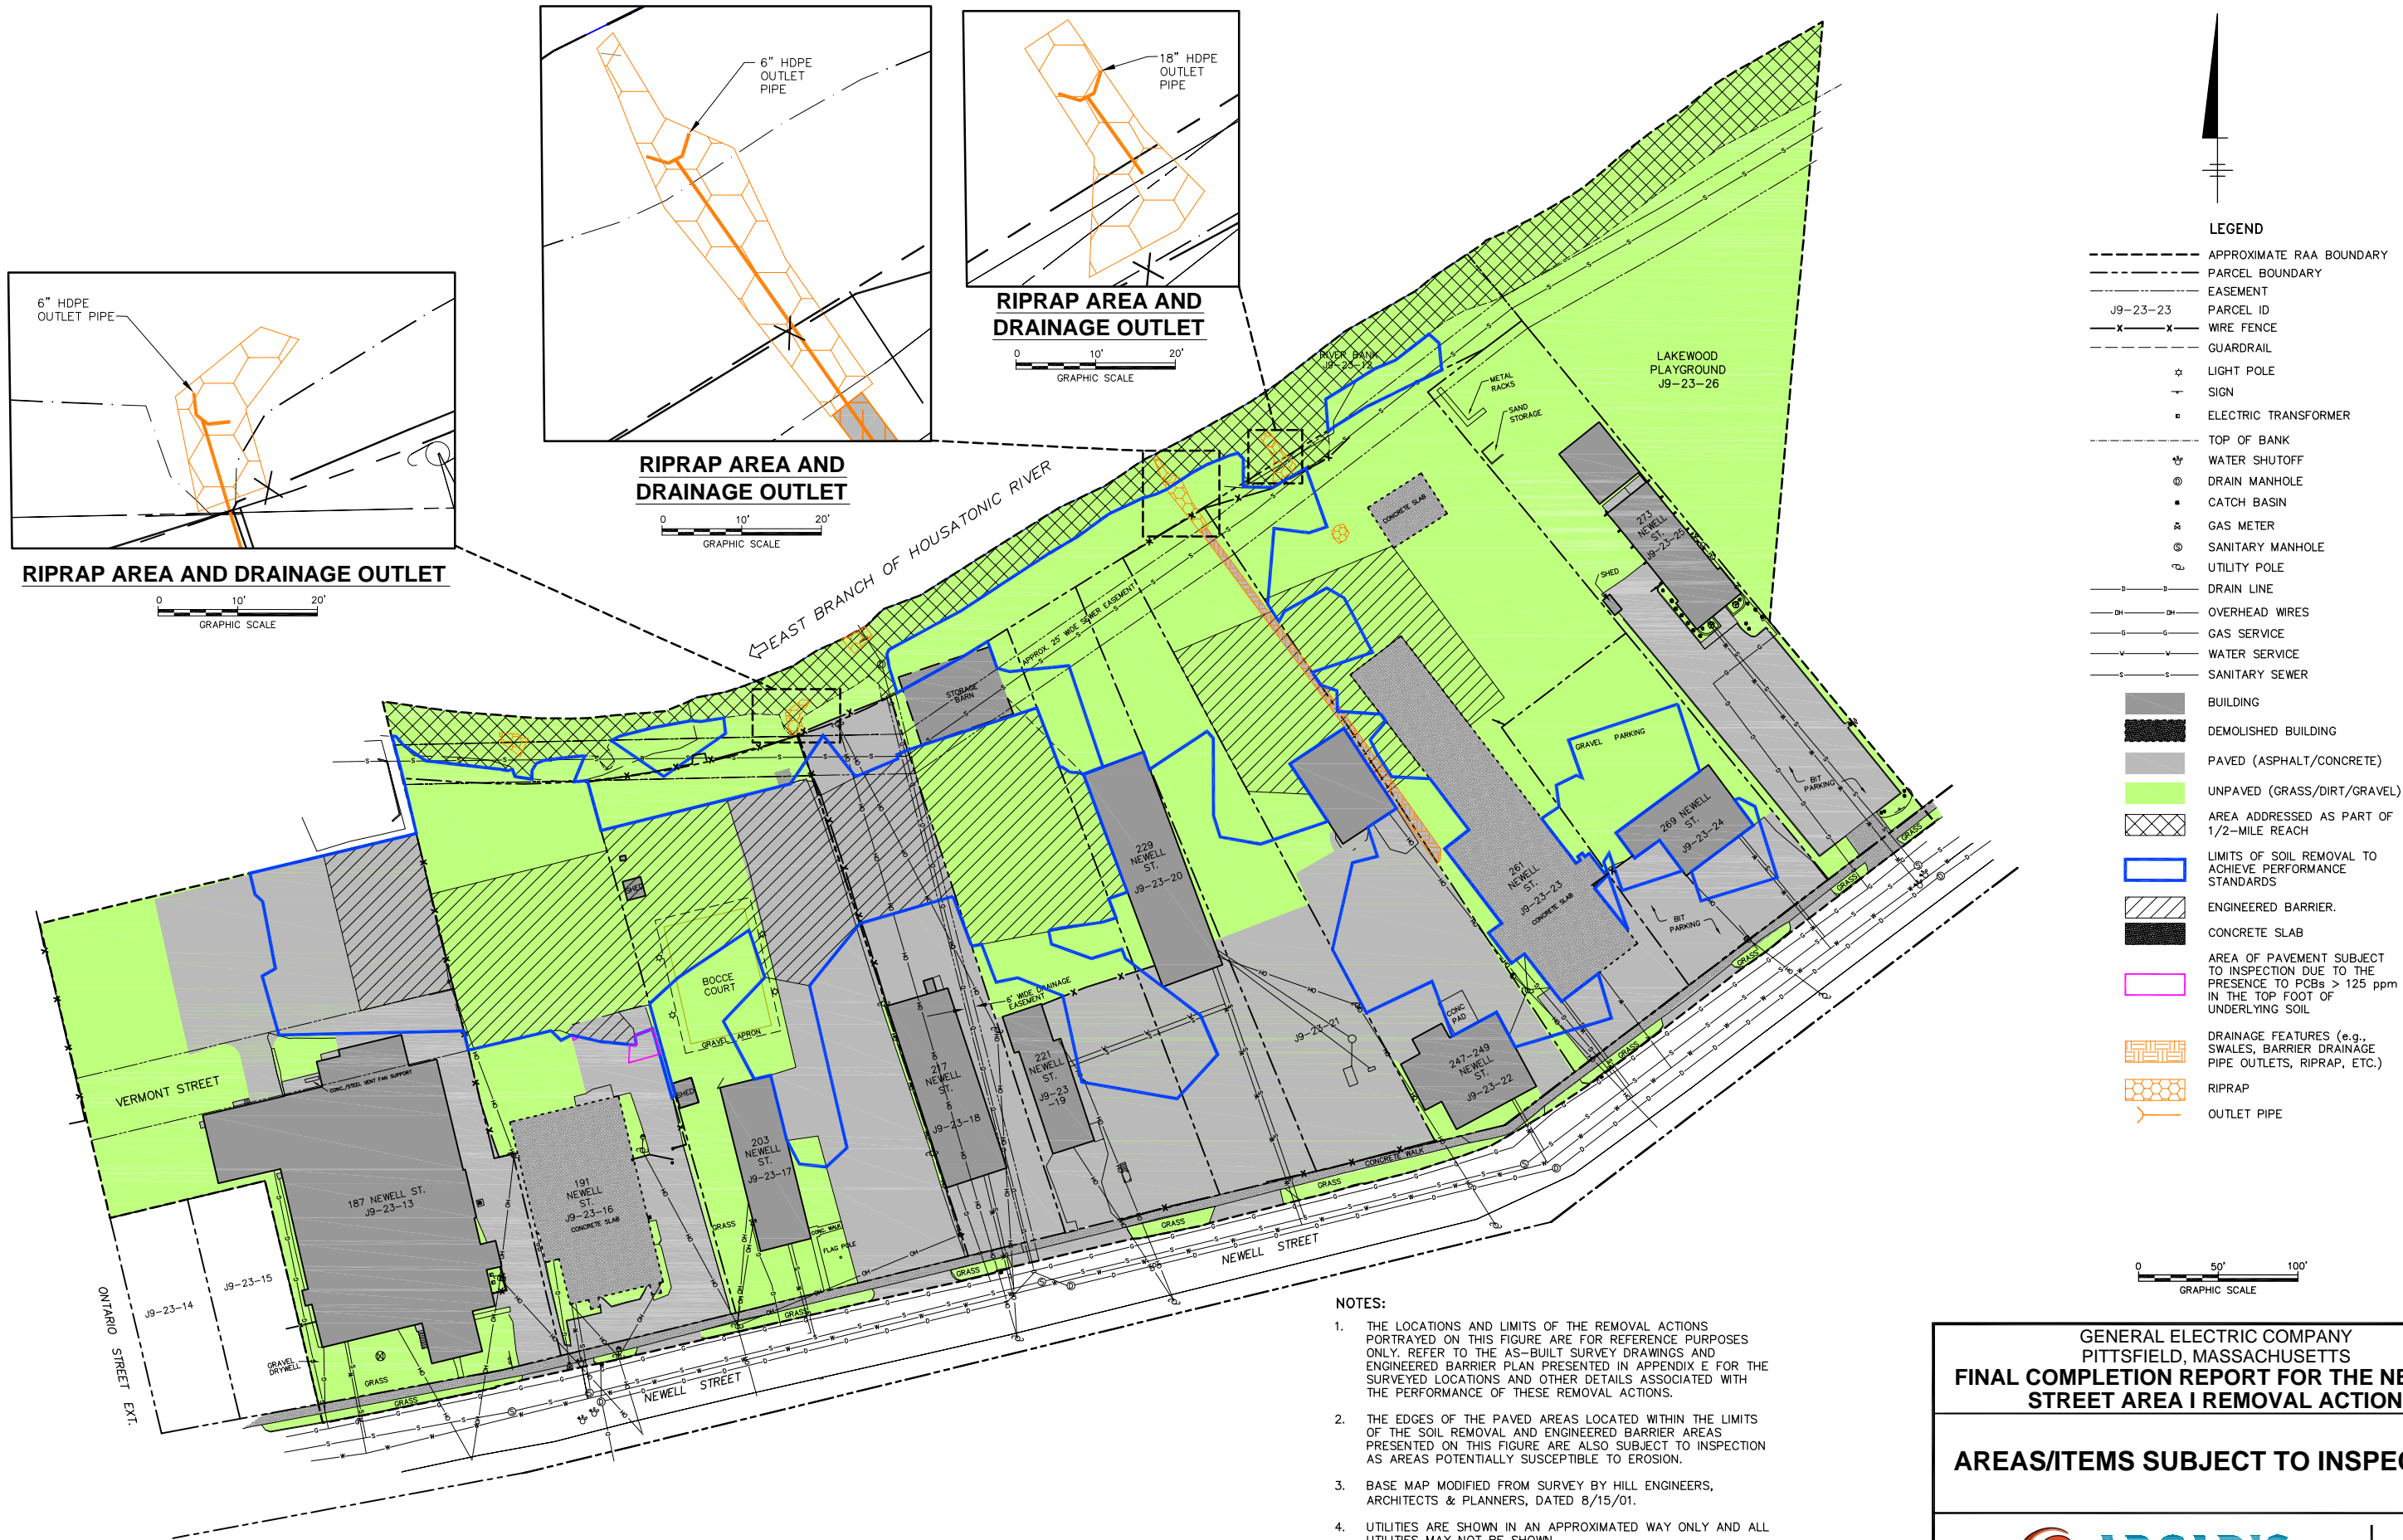
**AREAS/ITEMS SUBJECT TO INSPECTION**

edges of pavement), as specified in the Final Completion Report; and (d) other conditions that could jeopardize the performance of the completed remediation activities. The inspection also included observation of the two areas on Parcel J9-23-16 that (a) are not covered by an engineered barrier, (b) were evaluated as paved, and (c) contain polychlorinated biphenyl (PCB) concentrations in the top foot of soil under the pavement that would exceed the applicable "not-to-exceed" (NTE) level for that particular type of property; these areas are identified on the attached Figure 3 from the Final Completion Report.

This inspection indicated that the backfilled/restored areas inspected at Newell Street Area I were in good overall condition. No maintenance or repair activities were identified.

- All areas in good condition.
