Level I Accident Investigation  
Report  
March 1, 2010  
Fatal Bobcat/Backhoe Accident  
At the White Bluffs Substation

**Report Date:  
March 31, 2010**

**BPA**  
**Level I Bobcat/Backhoe Accident, March 1, 2010 at White Bluffs Substation**  
**Final Report**

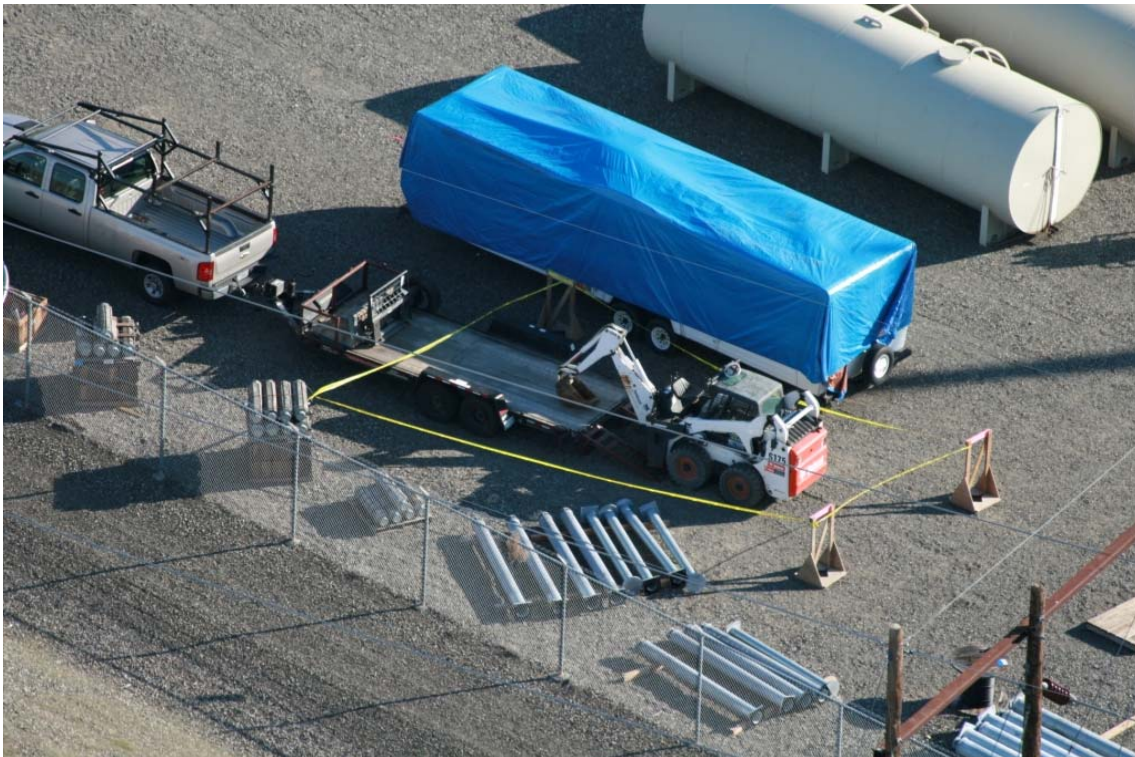
**Figure 1-1: Aerial View of Accident Scene**

On March 1, 2010, at approximately 0850, a Christenson Electric, Inc (Christenson) employee was fatally injured at the Bonneville Power Administration's (BPA) White Bluffs Substation near Richland, Washington while loading a BPA-owned Bobcat equipped with a backhoe attachment onto a trailer for transport to another work site. The accident occurred as the Contract Heavy Equipment Operator, now referred to as CHEO, moved into a position between the Bobcat Roll Over Protection Structure (ROPS) cage and the backhoe attachment; lowered the seat bar, bypassing the BICS™; and engaged the hydraulic systems which caused the Bobcat lift arms to raise the backhoe attachment, pinning the CHEO between the backhoe attachment seat and the Bobcat ROPS.

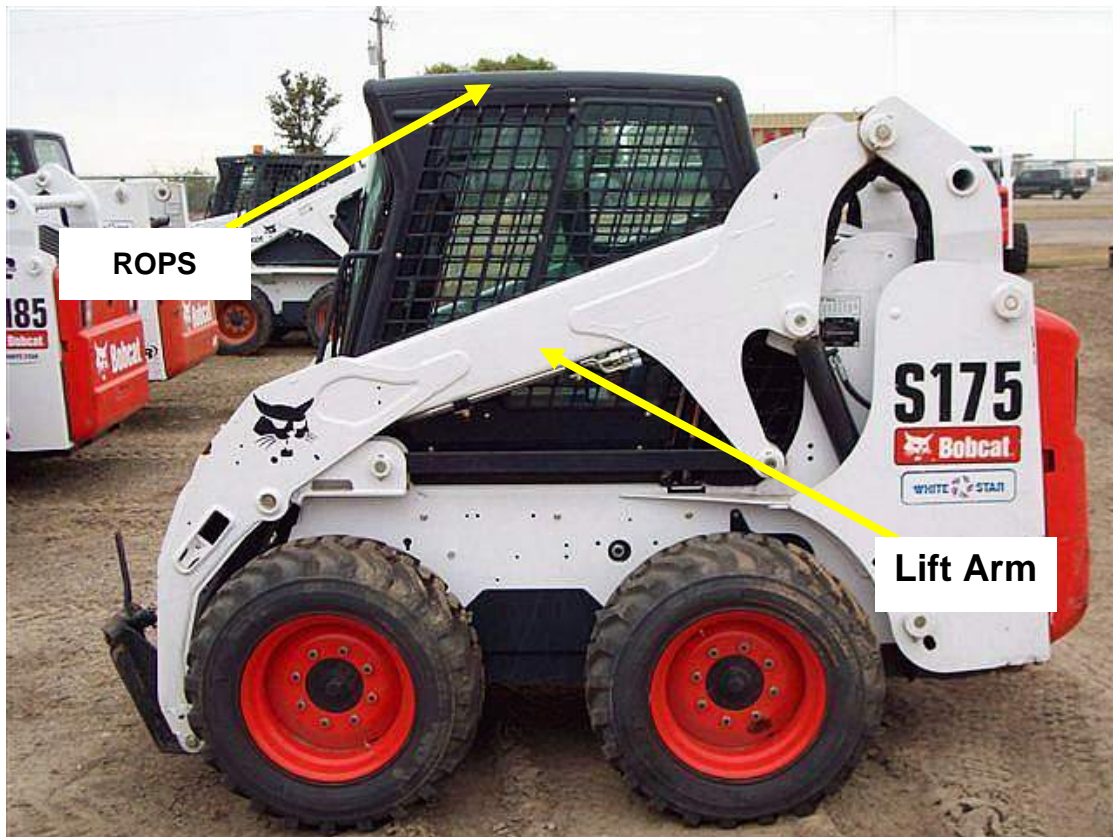
**Figure 2-1: Bobcat S175**

The Bobcat S175 Skid-steer loader is a small rigid-frame, rubber-tired machine weighing 6,220 lbs, and 68'' wide. It is a diesel-powered machine with lift arms used to attach a wide variety of tools or attachments. The Bobcat, a four-wheel drive machine, has the left-side drive wheels independent of the right-side drive wheels. By having the drive wheels independent of each other, wheel speed and rotational direction of the wheels determine the direction of the loader. Forward, reverse, travel speed and steering are controlled by two hand levers. Two foot pedals control the hydraulics that raise and lower the lift arms and the dump and rollback of the bucket. Bobcats are capable of zero-radius, "pirouette" turning, which makes them extremely maneuverable and valuable for applications that require a compact, agile loader. The lift arms on these machines are alongside the driver seat outside the cab with the pivot points behind the driver. Bobcats have fully-enclosed cabs and other features to protect the operator.

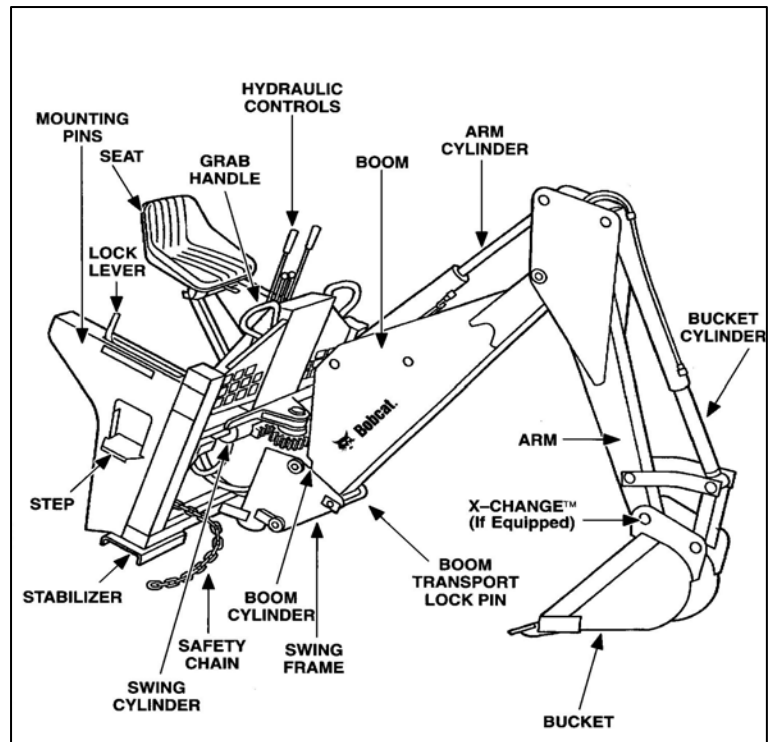
**Figure 2-2: Backhoe Attachment**

A Bobcat backhoe attachment is a piece of excavating equipment consisting of a digging bucket on the end of a two-part articulated arm. It mounts on the front of the Bobcat using the “Bob-Tach” system. The boom is closest to the Bobcat and the section that carries the bucket is known as the arm. The seat and controls for the functions of the backhoe attachment are independent of the Bobcat. See Figure 2-2 for backhoe nomenclature.

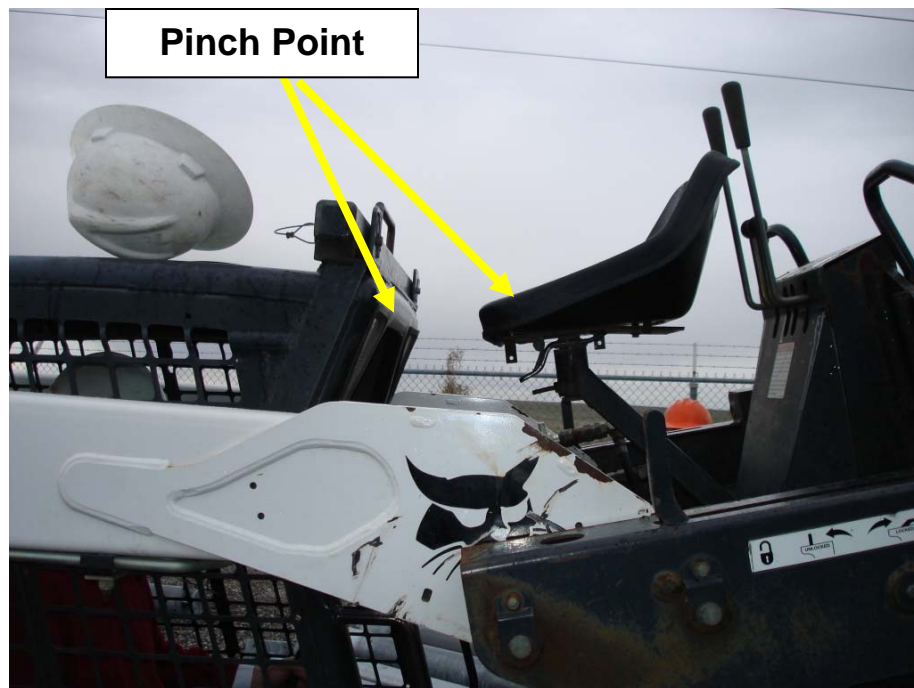
**Figure 2-3: Pinch Point Between Bobcat and Backhoe Attachment**

The CHEO again re-entered the machine, and either remained standing, put the seat bar down and activated the BICS™ system or, put the seat bar down, sat on the bar and activated the BICS™. The CHEO reached for the backhoe seat to either pull from a seated position or, hold on to the backhoe seat for support. In either case, the CHEO depressed the left foot hydraulic pedal which resulted in the Bobcat lift arms being raised, pinning the CHEO between the backhoe attachment seat and the ROPS of the Bobcat. The CL1 turned off the Bobcat and summoned the crew for assistance.

Causal factors consist of direct, root and contributing causes. A direct cause is the immediate event or condition that caused the accident. The AIB concluded that the direct cause of this accident was the CHEO activated the hydraulic controls while standing in the pinch point.

The root causes of the accident are the fundamental causes that, if corrected, would prevent recurrence of this and similar accidents. The AIB concluded that the root cause of this accident was that the CHEO bypassed the Bobcat safety features. The AIB also identified contributing causes that are events or conditions that, collectively with the other causes, increase the likelihood of the accident, but individually did not cause the accident. The AIB concluded that a contributing cause of this accident was the CHEO did not receive a sufficient J-1 (pre-job briefing that included work planning, job hazards analysis, and controls). Interview with the BCFMI and a review of the written J-1 the day of the accident indicate that the briefing the CHEO received, an hour after the crew's job briefing, was verbal and only included assignment of job tasks associated with moving tools and equipment to a new job site.

**RECOMMENDATION:** BPA management Chief Operating Officer (COO) shall require all BPA employees who operate mobile fleet equipment receive proper training in the safe use of this equipment. BPA management shall require that all contracts for operating mobile equipment include a requirement that contractor certify that their employees who will operate mobile fleet equipment under this contract have received proper training in the safe use of this equipment.

**FINDING:** The CHEO failed to follow instructions in operation and maintenance manual.

**RECOMMENDATION:** Site management shall require all BPA and contract personnel to follow operation and maintenance manuals of mobile fleet equipment.

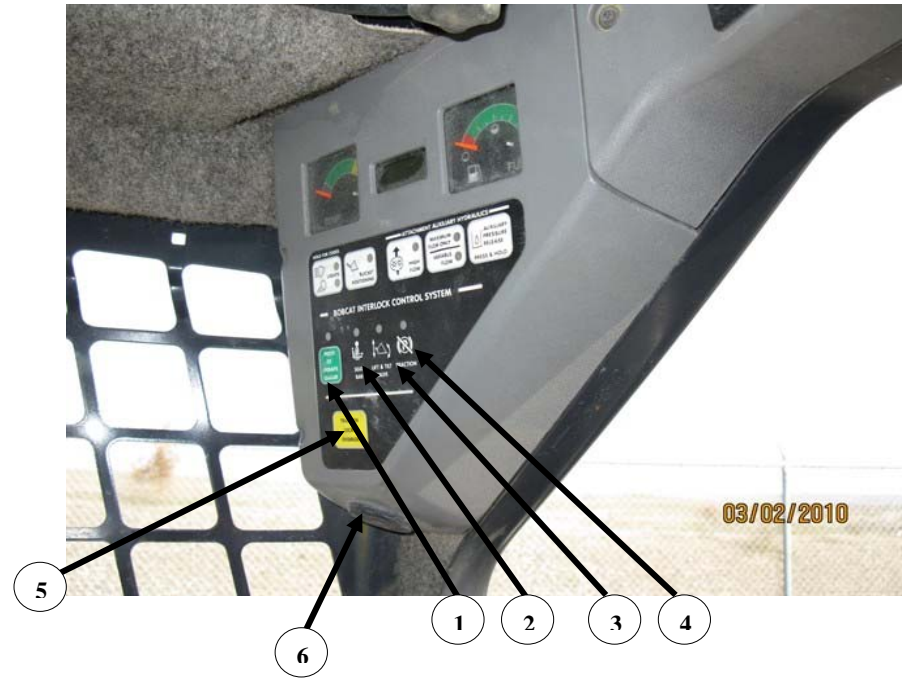
**Figure D-1: Bobcat Interlock Control System (BICS™)**

The Bobcat S175 is equipped with a safety interlock system, the Bobcat Interlock Control System (BICS™). To activate the hydraulic lift/tilt functions, the BICS™ requires the seat bar to be in the lowered position, the engine running, and the “press to operate loader” button pushed. See Appendix D: Bobcat Interlock Control System.
