LIMITED ASBESTOS AND LEAD BASED PAINT ASSESSMENT

GREENVILLE COUNTY LIBRARY

505 PENNSYLVANIA AVENUE
GREER, SOUTH CAROLINA 29650

ECS PROJECT NO. 49:6949

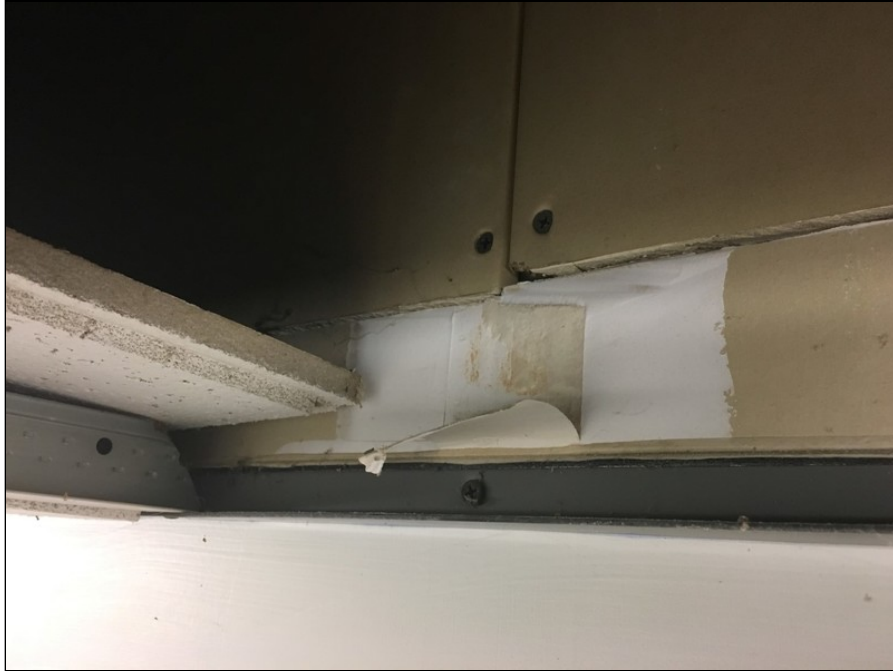
3 - View of Drywall/Joint Compound (Sample 01) above the drop ceiling

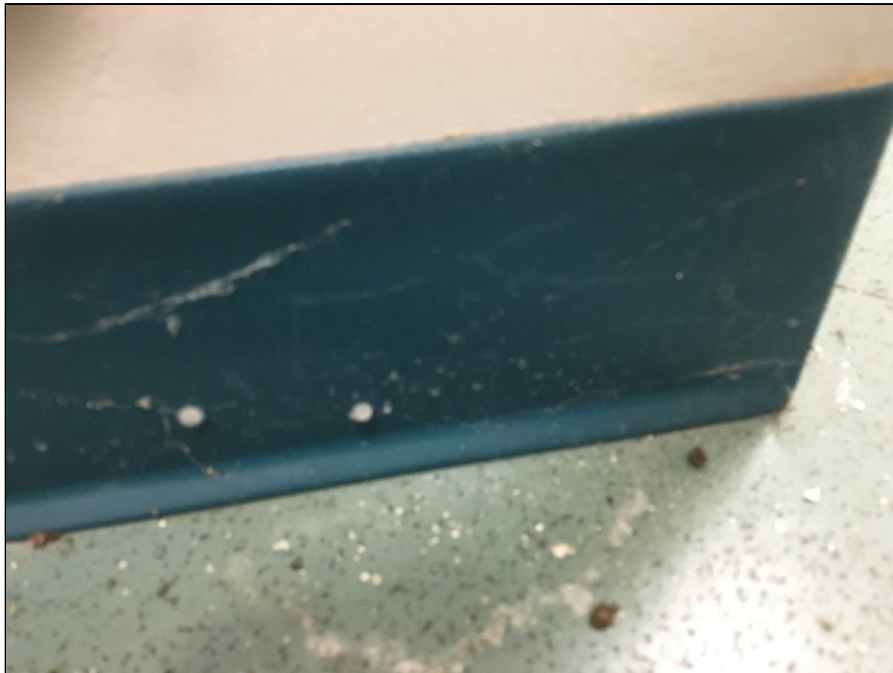
4 - View of the green cove base (Sample 02) located throughout the structure

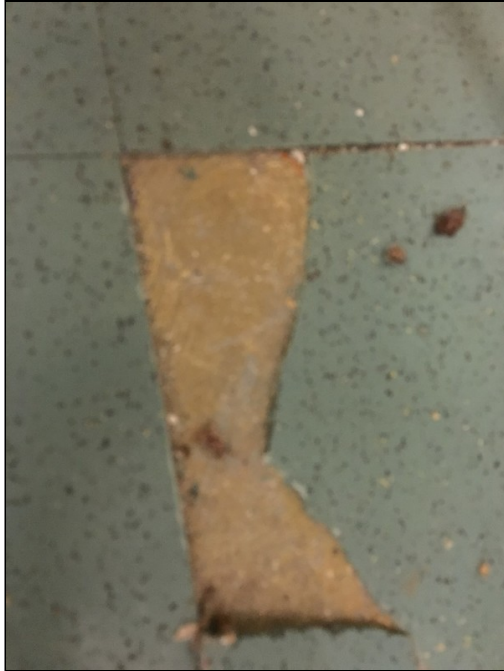
5 - View of the green floor tile and mastic (Sample 03) located in the storage room

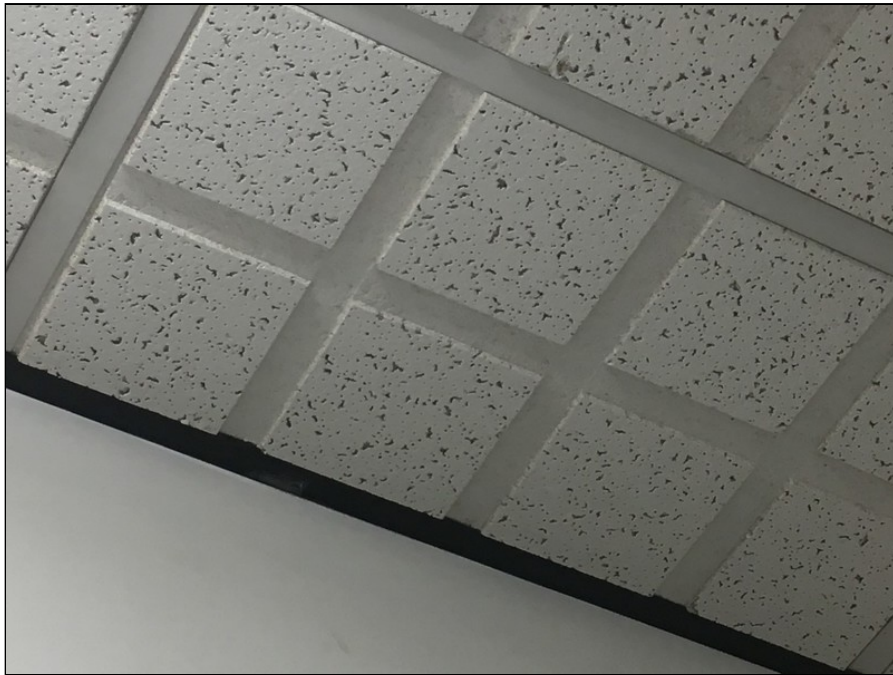
6 - View of the ceiling tile (Sample 06) located throughout the structure

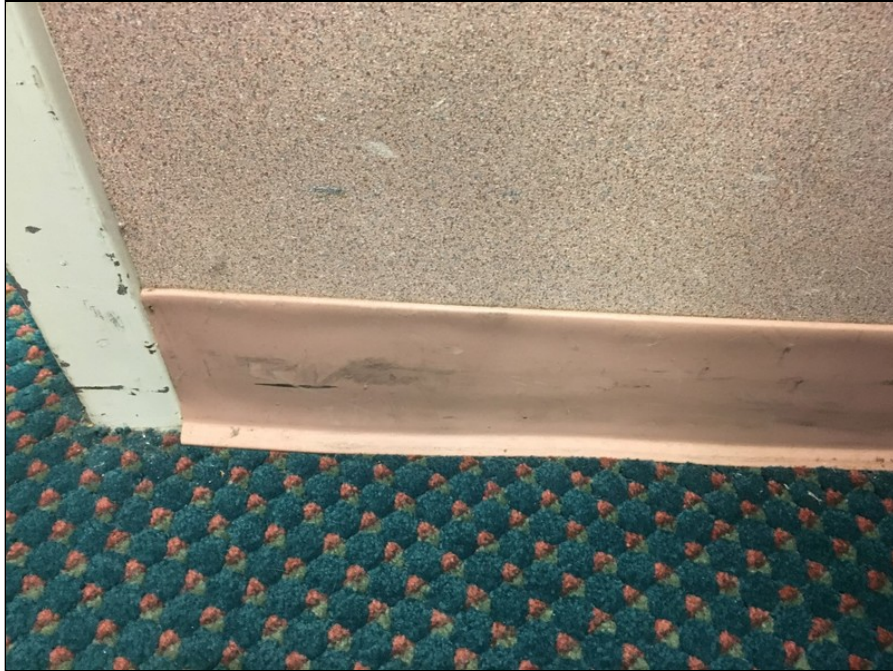
7 - View of the pink cove base (Sample 07) located throughout the office area

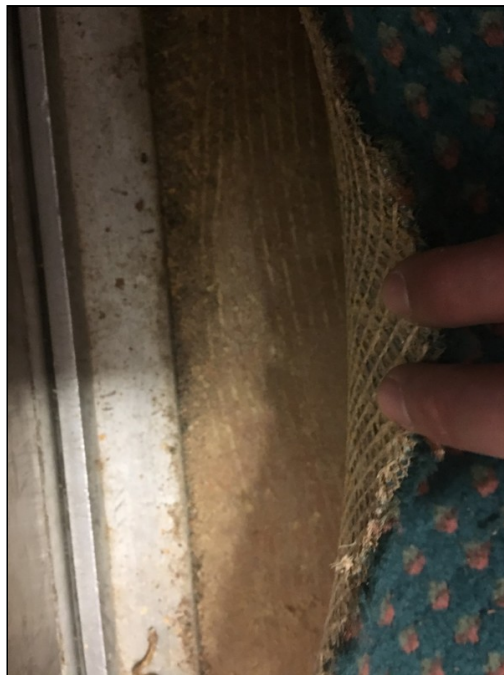
8 - View of the carpet and mastic (Sample 09) located throughout the structure

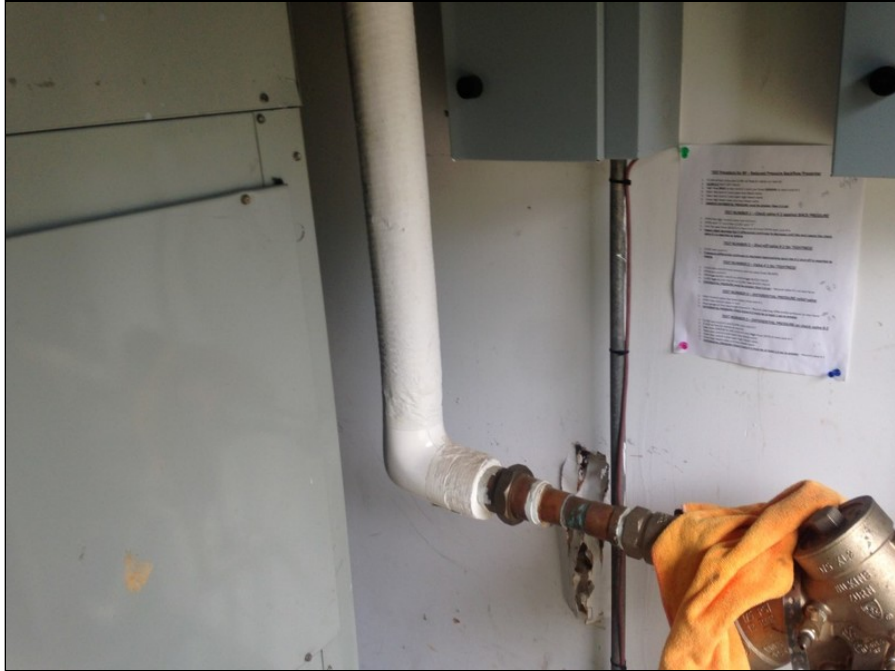
9 - View of piping and wall materials in the mechanical room

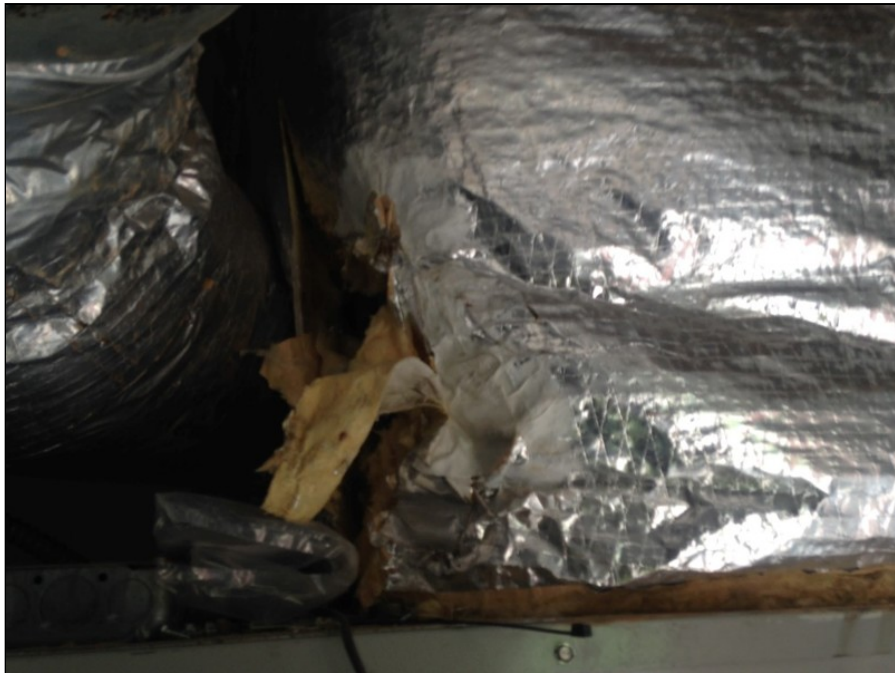
10 - View of HVAC Mastic (Sample 08)

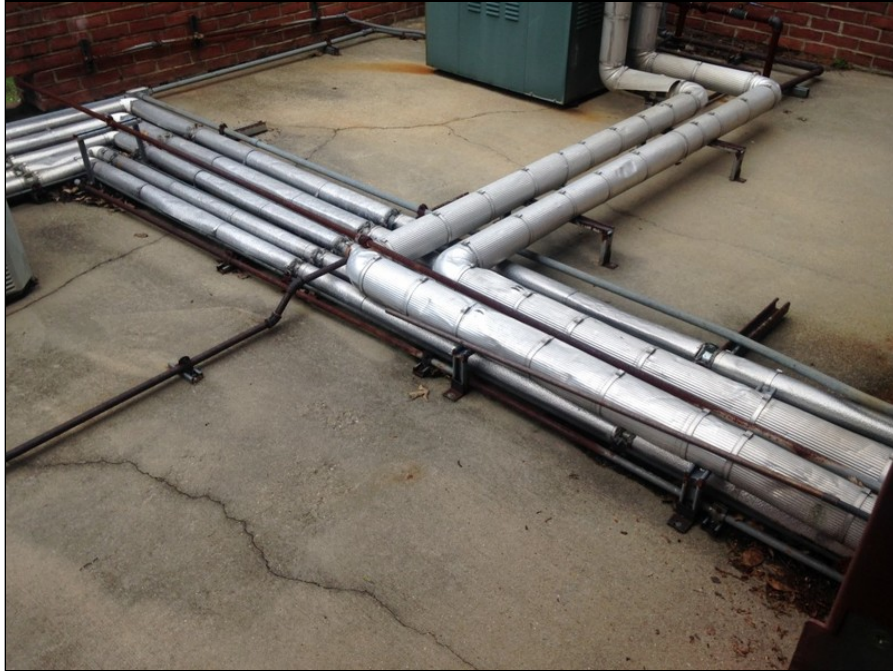
11 - View of exterior piping

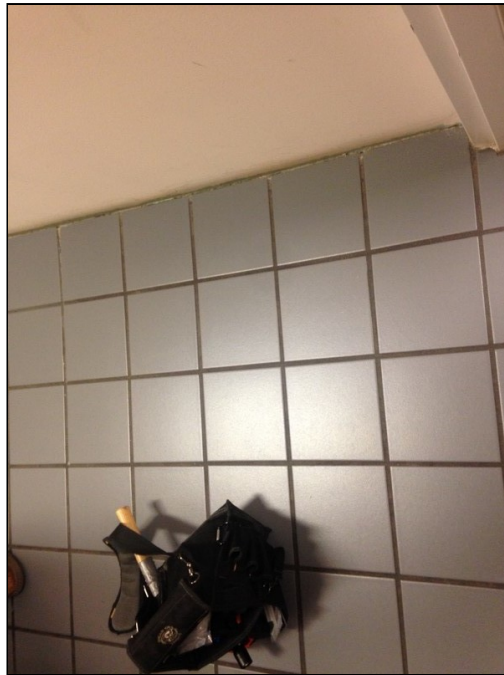
- Beige ceramic flooring in the kitchen

Location	Color	Substrate	Component	Condition	Lead Concentration (mg/cm ²)
Kitchen	Beige	Ceramic	Floor	Intact	3.4
Kitchen	Beige	Ceramic	Floor	Intact	2.5
Hallway	Beige	Metal	Door	Intact	0.01
Break Room	Beige	Drywall	Wall	Intact	0.01

12 - View of beige ceramic tile in the kitchen area - Lead Based Coating

the contractor performing renovation work will be required to conduct this monitoring and follow applicable requirements under 29 CFR 1926.62 if disturbing lead-containing paint.

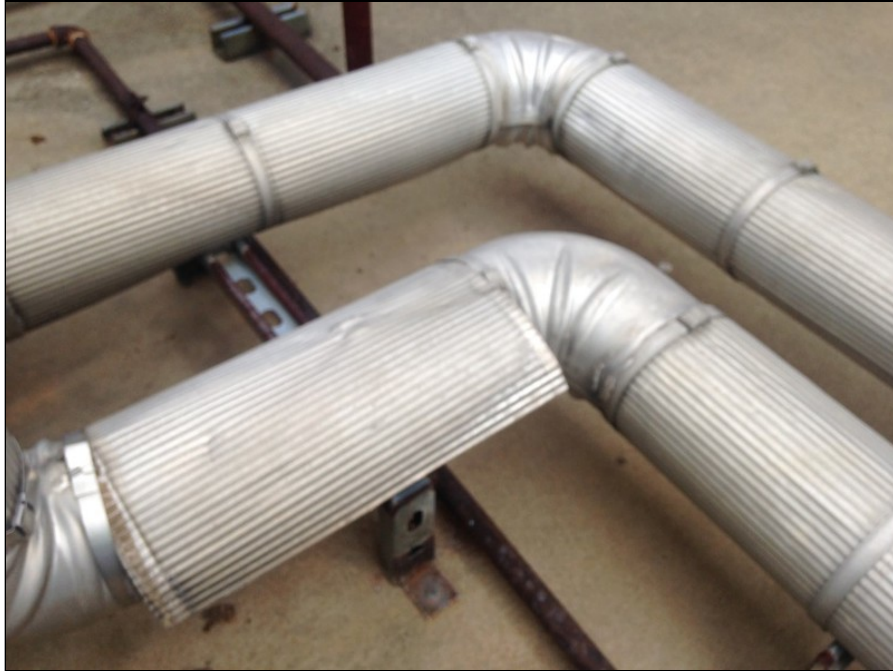
13 - View of exterior piping

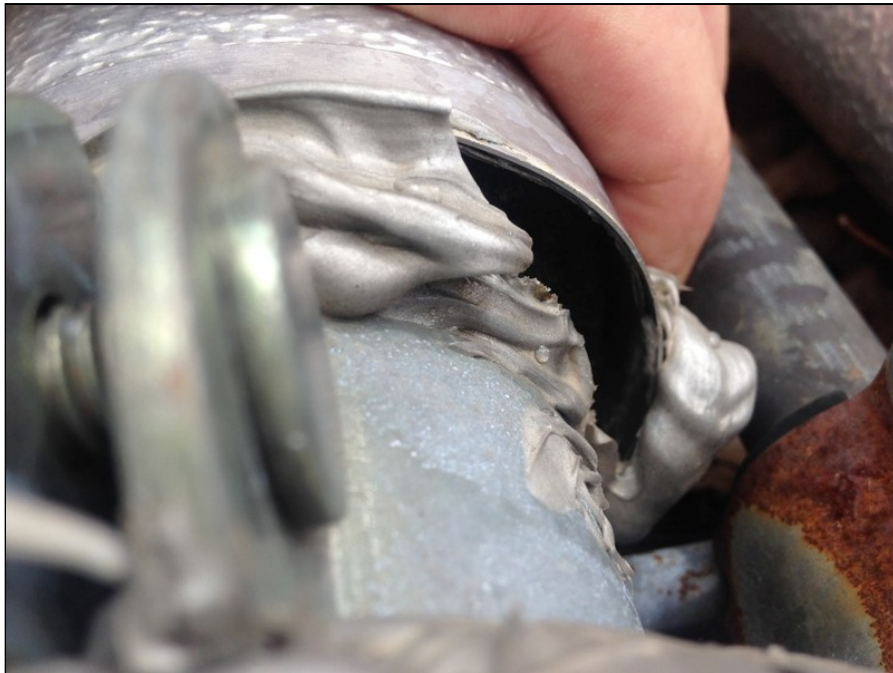
14 - View of HVAC Mastic

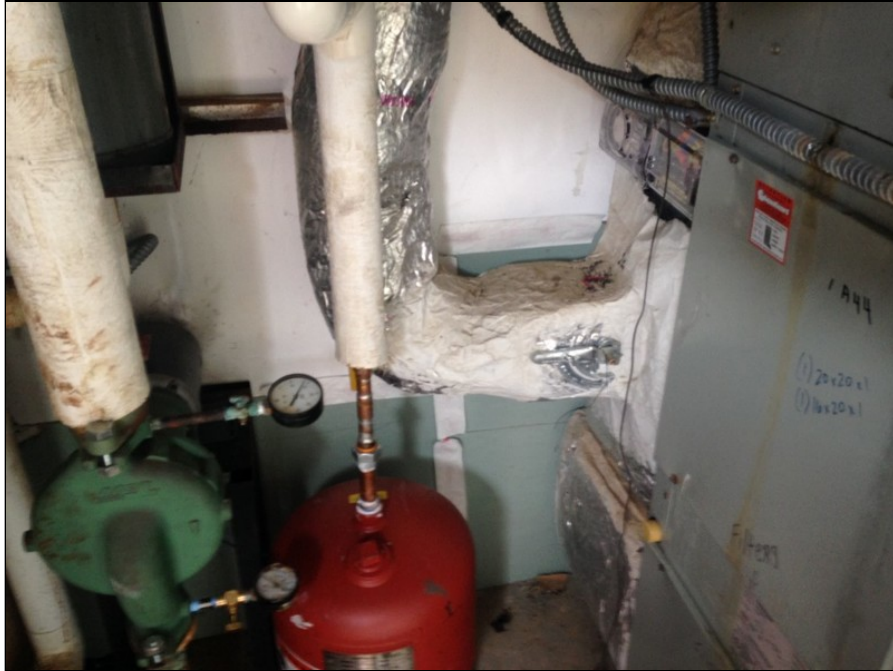
15 - View of HVAC Mastic
