Report on the investigation of
a fatality on board the workboat

Llanddwyn Island

1 March 2010

Report No 14/2010
November 2010

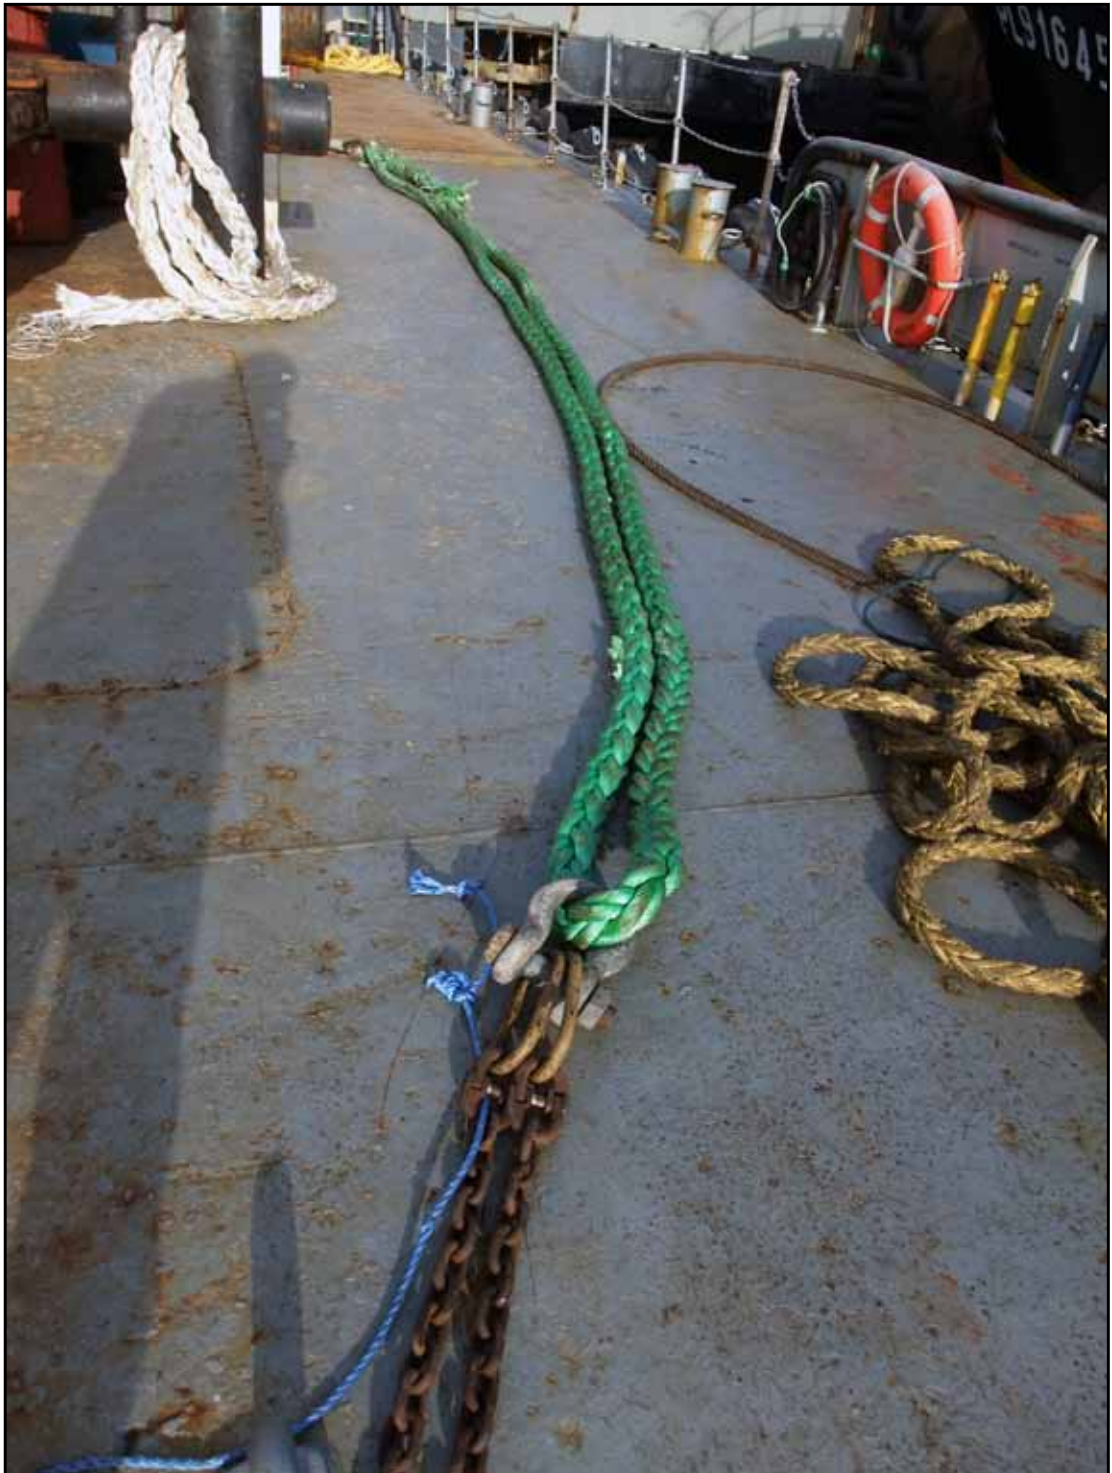
Figure 4

Towing hawser

During the handover between the night and day crews on the morning of 1 March 2010, Edward was informed that the stretcher had been replaced with a stronger rope and he was advised to be wary of the chain, which was considered to be the weakest part of the hawser.

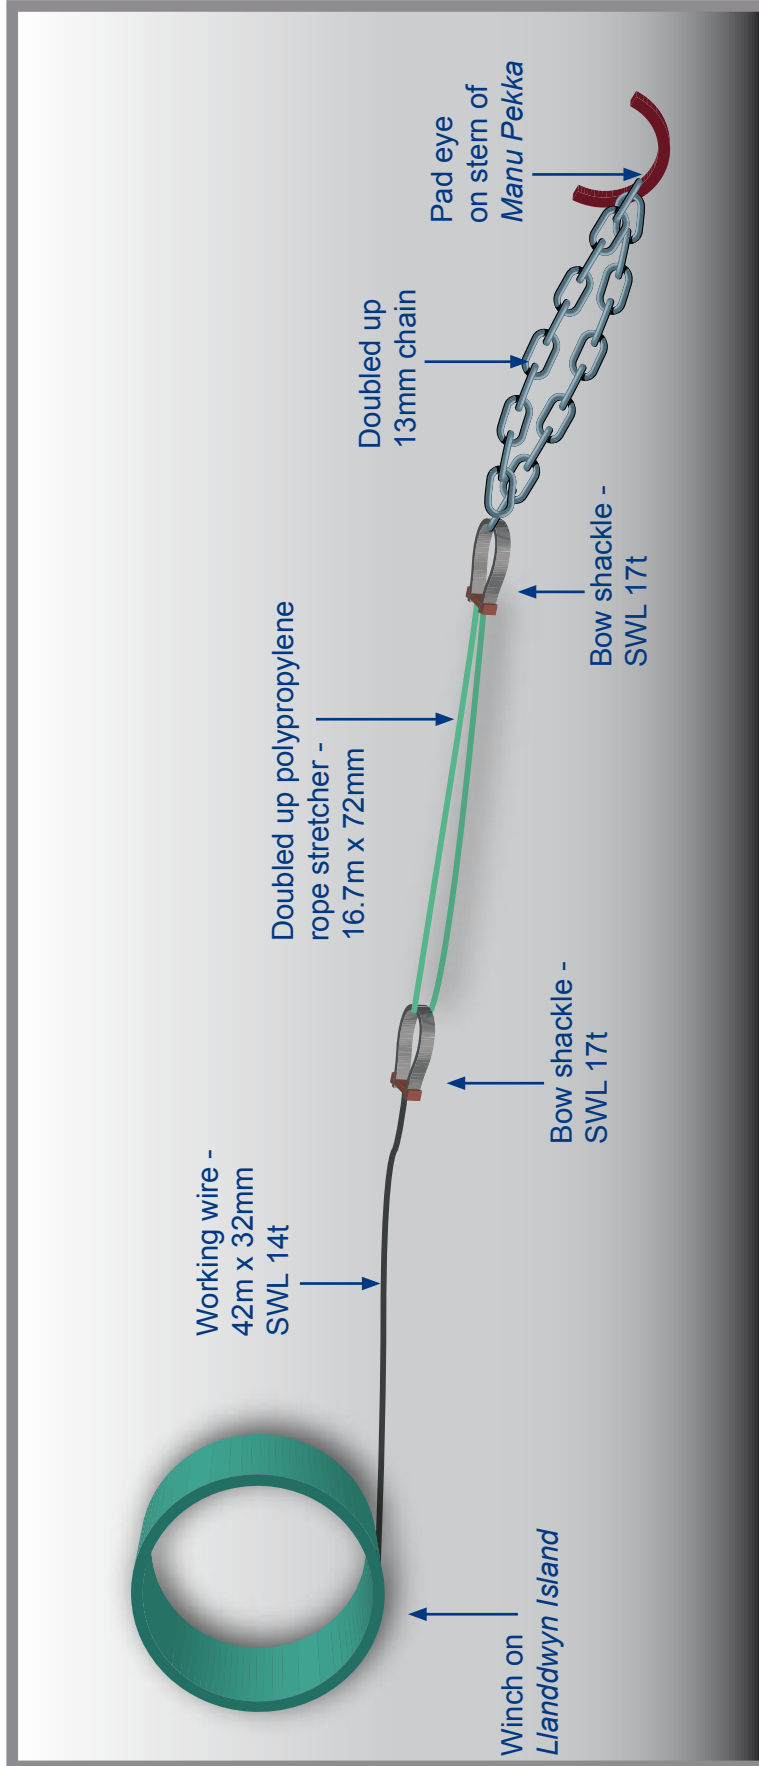
Figure 5

Hawser elements

Note: The SWL shown is one fifth of the breaking strain. However, within the towage industry, the SWL used by some operators is one third of the breaking strain

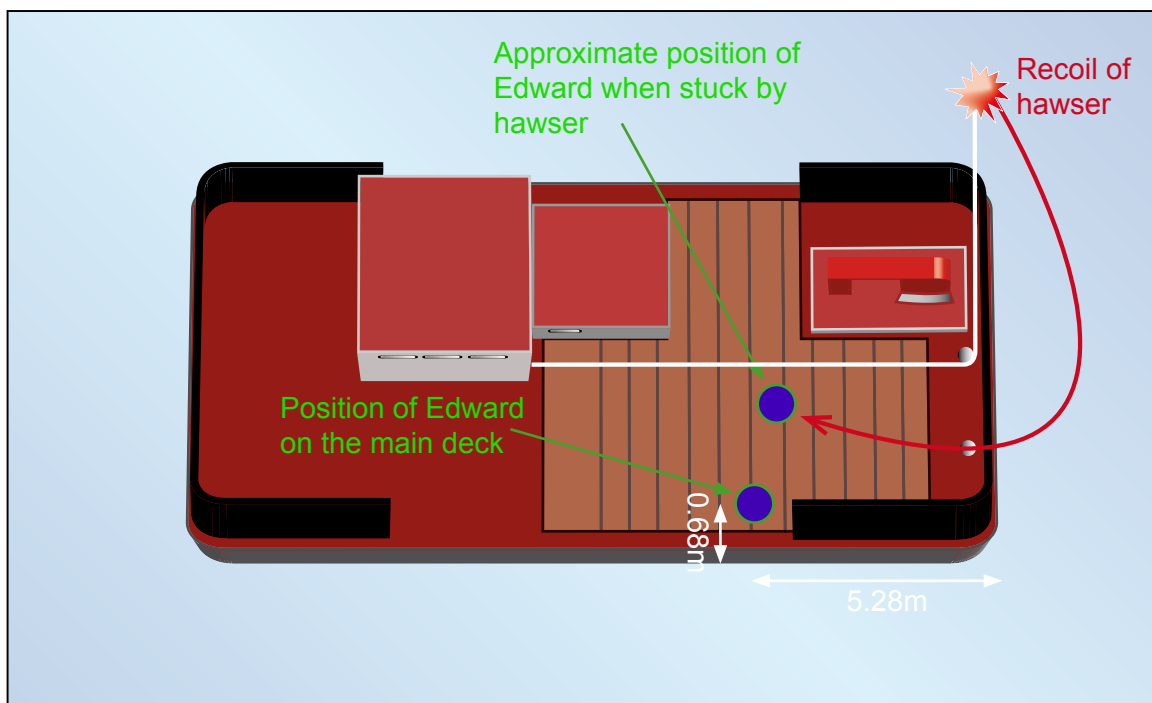
Figure 10

Meanwhile, Edward moved forward on the starboard side of the main deck. Suddenly, and without warning, the chain connecting the hawser to the pad eye parted. The hawser recoiled and struck Edward, who was thrown against the starboard rail before falling on to the deck (**Figure 10**).

Hawser failure

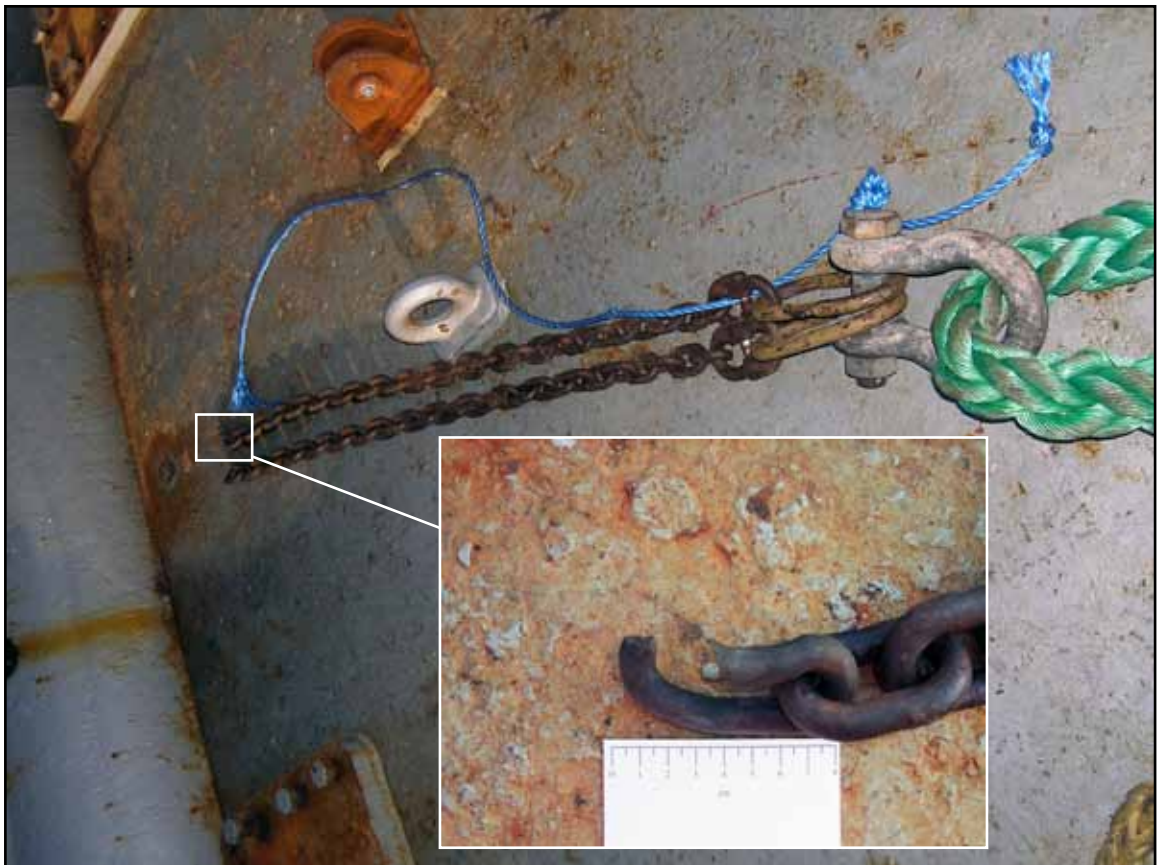
Figure 11

The parted steel chain (**Figure 11**) was recovered and sent to Tension Technology International Ltd (TTI) for inspection and testing. The test report (**Annex A**) summary included:

- *“Two breaking load measurements have been conducted on samples from the failed 13mm chain sling, with an average result of 224.3kN. Therefore the chain satisfied the minimum strength requirement for 13mm grade 8 short link chain for lifting purposes (in accordance with BS EN 818-2)*

- *The fracture surfaces of the failed link were too corroded for detailed (microscopic) examination. However, the general appearance of the failure (gross plastic distortion) indicates a failure caused by high loading rather than fatigue. Subsequent testing indicated that the failure mechanism was in the form of an overload whilst the chain was doubled back on itself around a (pad-eye) pin.*

- *Two tests were conducted to break a length of 7mm chain doubled over a pin (180° wrap) scaled to match the diameter of the pad eye. The average breaking strength of the chain in this condition was found to be 48.94kN, a reduction of 25% in strength when compared to the straight chain strength.*

- *These findings would equate to a breaking load for the 13mm sling in the doubled up condition of 336.5kN.*

- *Even though the doubled back chain configuration was found to have reduced the average breaking strength (BF) of the straight chain, at 75% of BF the residual strength was still in excess of the Working Load Limit by a factor of 3.*
- *Although the strength of the doubled back chain was in excess of the same chain in the straight configuration, its ability to absorb (shock loading) energy in this configuration would be very considerably reduced. This finding is highly significant in the context of strain driven (e.g. marine) environments.”*

Parted steel chain

1. The doubled-up chain was the hawser's weakest element, and its inclusion was therefore not in accordance with best towing practice and was inappropriate for the work being conducted. [2.2]
2. In view of the potential hazards on the deck of *Llanddwyn Island* when engaged in towing or pushing, procedural measures such as toolbox talks, briefings, and positive communication were essential. [2.3]
3. A number of factors indicate that the safety management of *Llanddwyn Island* was rudimentary. [2.4]

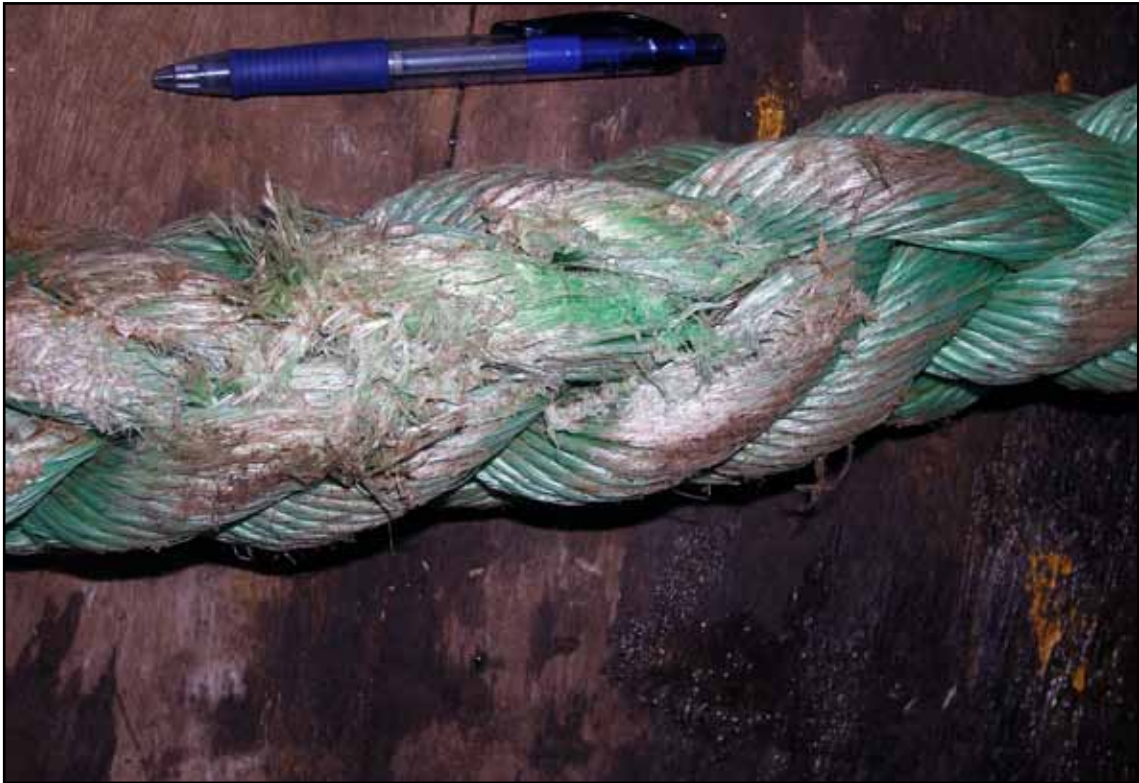
Examination of the polypropylene stretcher revealed chafing damage at the point where it had been in contact with the dolly pins (**Figure 12**). Evidence of rope chafing was also found on the port dolly pin³ (**Figure 13**) and the deck roller.

Chafing damage to rope stretcher

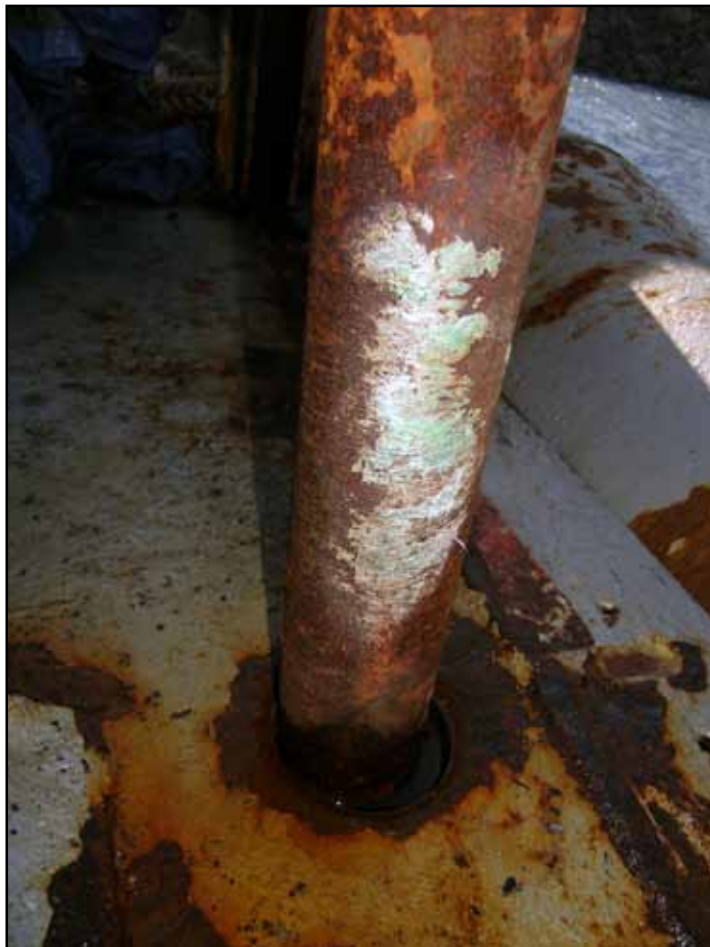
Figure 13

Chafing marks on port dolly pin

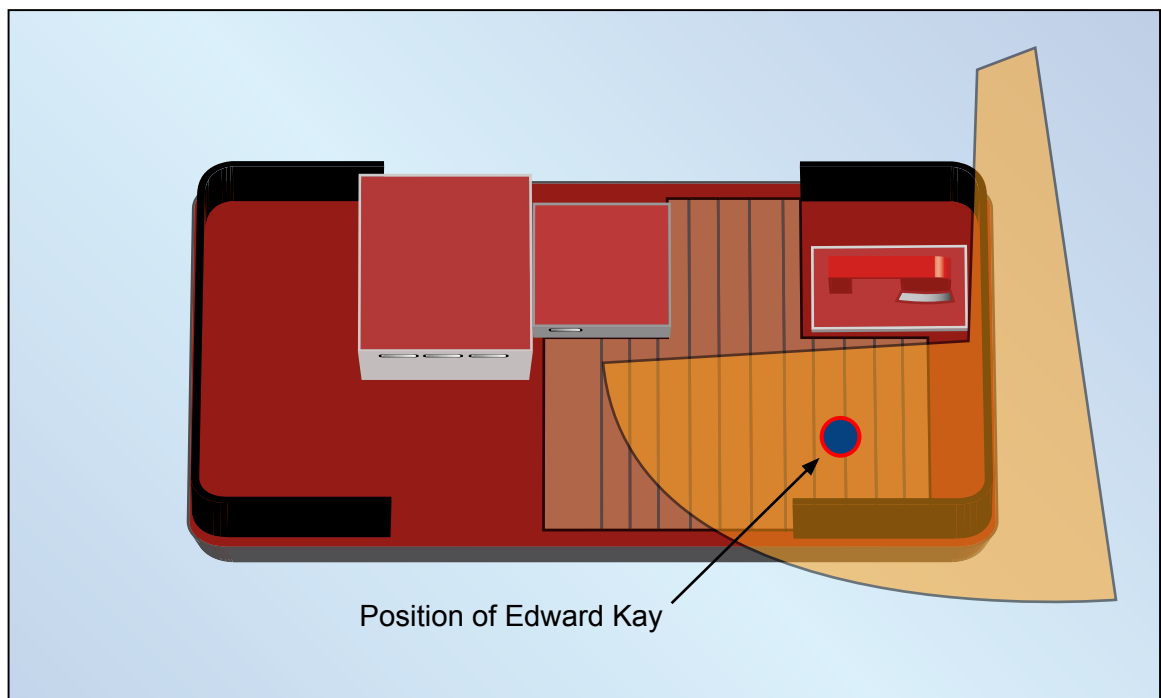
Figure 16

The recoil or 'snap-back' area to *Llanddwyn Island*'s forward deck when working with a hawser around the port dolly pin is shown at **Figure 16**. Edward was an experienced deckhand who was undoubtedly aware of the dangers associated with a tensioned line. It is not known why he moved to the forward part of the deck while *Llanddwyn Island* was still manoeuvring ahead against the hawser, particularly as the skipper had not signalled to him that it was safe to do so. It is possible that he assumed that the move was complete when he saw the dredger's spud legs being lowered. This would usually have been the case, but because the skipper did not hear the message from the backhoe operator that he was in position and lowering the remaining spud legs, the skipper kept *Llanddwyn Island* pushing against the hawser.

'Snap-back' area

Unlike the mooring decks on conventional vessels, it would have been an impractical task to identify and mark the 'snap-back' areas on *Llanddwyn Island's* deck as recommended in the COSWP and MGN 308. Indeed, because of the diverse nature of her employment, there were probably no permanently safe areas on *Llanddwyn Island's* deck. Consequently, the need to ensure the safety of personnel, and remind crew of the hazards encountered through procedural measures such as toolbox talks, briefings, and positive communication as detailed in MGN 308 was essential.

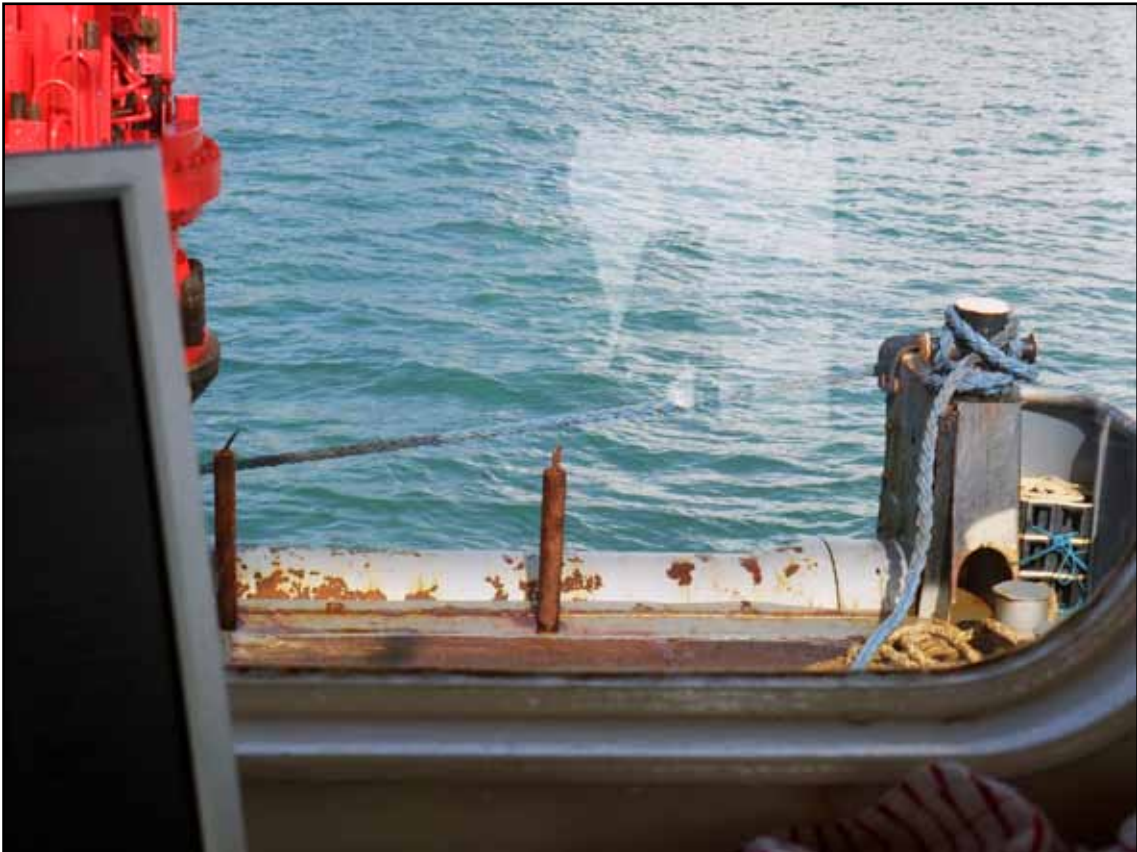
It was clearly dangerous for Edward to move into the 'snap-back' zone but, given the visibility of the forward deck from the wheelhouse (**Figure 17**) and the speed of events, it is possible that the skipper did not have sufficient time to challenge Edward's actions.

View from the wheelhouse
